Cow Tag

33

Plank - Hooded End

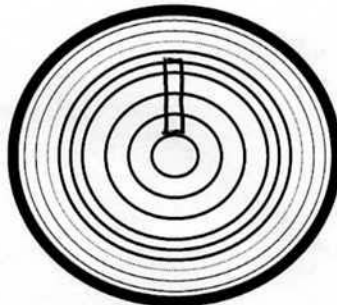
Description 131cm in length, 27cm wide, 3cm thick. Good condition. Thirteen metal fasteners, nails no longer in situ. Head impressions remain. Shafts measure 7cm x 7cm. Heads are 2cm in diameter and roughly circular in shape. Distance between nails horizontally varies from between 27cm and 38cm. Distance between top and bottom row of nails is 22cm. One complete trenail hole and one partial hole exist. Trenails no longer in situ. Diameter of holes are 3.3cm. Large knot hole in centre of the plank. No clench plate impressions. up to 20 inscribed lines are present on upper edge outboard. possible wear marks on outboard surface (End B). Evidence of fire damage at end B - hood end.

- Bark Yes No
- Sapwood Yes No
- Knotty No
- Straight grained No - except around knots

slow grown
Two large knots
radially split.
Approx 100 rings.

Dendro sample 3014

DISCARDED
