DB 11/3/8

Cow Tag 385	Function Code P45	
Brief Description: [timber element, p/s, condition, fragments] GOOD CONDITION		
Notable Features: [tool marks, scribed lines, decoration, repairs] POINTS TO LOOK OUT FOR WHEN RECORDING ufos INBOARD: SOME SCRIBED MARKS LINES, ADDITIONAL NAILS (2) OUTBOARD: ADDITIONAL NAIL + SOME UNSCRIBED LINES. Possible wood borer hole		
Wood Science: [rings, ARW, knots, sapwood, conversion] Intermediate c65A ARW = 205/65 Some wavy grain.

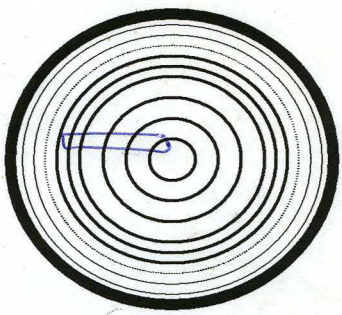
not a
 thin!
 possible wood bases
 water deposit = calc. mineral or fungus?
 depth hole ~ 2-3mm diameter

Recommended action: [samples, additional photos, moulding, queries and problems] Photo of possible wood borer hole.		
Cleaned: 14/10/05 HPM, TNJ	Recorded: 17/10/2005 11/1/7 M.S.	Photos: 16/02/06 MMR D IN: INS. LINES OUT: WOOD BORER HOLE & TREE NAIL
Checked: [corrections needed]	Initials & Date: NN 4/11/5.	
Corrections Done [desktop, Faro Arm?]:	Initials & Date:
