DB 5/3/2008 TAVL12

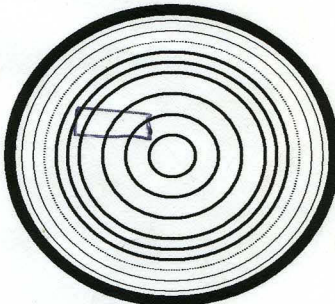
Cow Tag 414		Function Code OB Tingle
Brief Description: [timber element, p/s, condition, fragments] VERY WELL PRESERVED OB Tingle Attached to P3: 7 413		
Notable Features: [tool marks, scribed lines, decoration, repairs] POINTS TO LOOK OUT FOR WHEN RECORDING ufos 1 VERY NICE WOODEN SPIKE		
Wood Science: [rings, ARW, knots, sapwood, conversion] Tangential c40H ARW = 97/40

Recommended action: [samples, additional photos, moulding, queries and problems] General photo? Overall photo of OB face.		
Cleaned: 03.03.06 MHR, AK	Recorded: TNS 09.05.06	Photos: 2/3/6/18/4/16
Checked: [corrections needed]		Initials & Date:
Corrections Done [desktop, Faro Arm?]:		Initials & Date:
