Cow Tag 578		Function Code P2.8	
Brief Description: [timber element, p/s, condition, fragments] <i>very well preserved, slight damage on aft end</i>			
Notable Features: [tool marks, scribed lines, decoration, repairs] POINTS TO LOOK OUT FOR WHEN RECORDING ufos			
<ul style="list-style-type: none"> - NO TREENAILS - POSSIBLE INSCRIBED LINE, OUTBD., AFTEND - INSCRIBED LINE ON LAND, OUTBD., NEXT TO NAIL HOLE AND 1337 - ADDITIONAL NAIL NEXT TO NAIL HOLE, LAND, OUTBD. (NEXT TO 4th NAIL FROM AFTEND) - HAD LOADS OF TAR/PITCH ON BOTH FACES (sample taken) - WOODEN PEG IN IN MIDDLE OF PLANK JUST ABOVE 1337 - 2 INSCRIBED LINES ON INBOARD FACE (1 NEXT TO COWTAG, 1 IN NEXT TO FCT. CODE) 			
Wood Science: [rings, ARW, knots, sapwood, conversion]

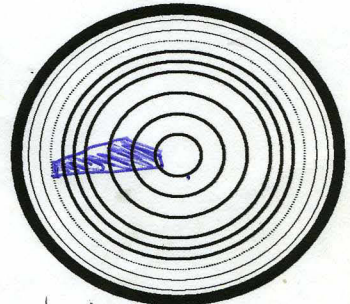
- 2 WOODEN NAILS ON LAND, INBD.

<p><i>Radial c 75% ARW = 174/75 at aft scarf becoming intermediate at forward scarf edge.</i></p> <p><i>NB 2 2mm x 1mm on outboard edge, nail 'broken' holes over both.</i></p> <p><i>Pith at inner edge?</i></p>			
Recommended action: [samples, additional photos, moulding, queries and problems]			
Cleaned:	Recorded:	Photos:	
<i>08.09.05 MM, AW</i>	<i>TNS 21.09.05</i>	<i>14/03/06 MMR</i>	
Checked: [corrections needed]		<i>IN: INSC. LINES & TOOL MARKS</i> <i>OUT: TOOL MARKS & 'EXTRACTION' LINES.</i>	
<i>P.W.S. of these?</i>		Initials & Date:	
		<i>MM 11/10/05</i>	
Corrections Done [desktop, Faro Arm?]:		Initials & Date:

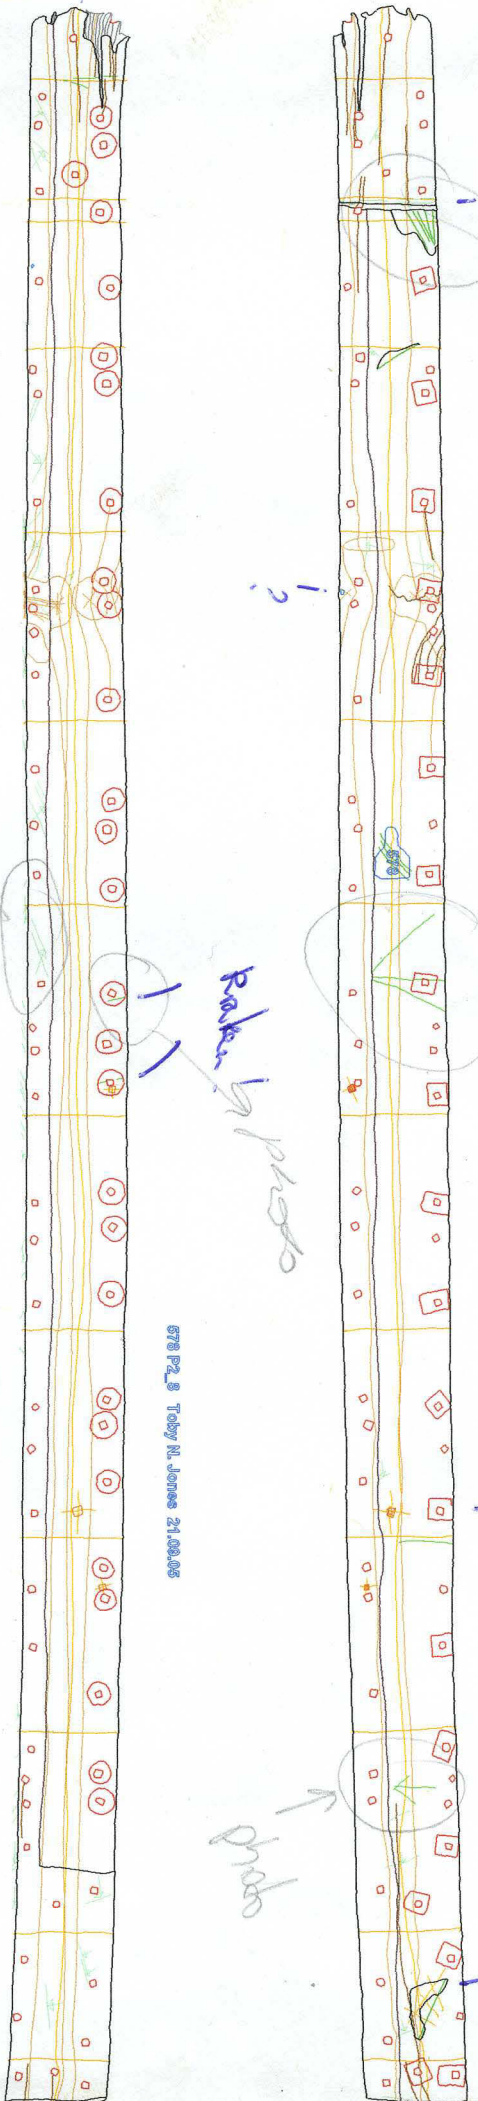
678 Pg. 8 Toby N. Jones 21.09.05

near on photo scarf
