Cow Tag 639	Function Code # F3-0
-------------	-------------------------

Brief Description: [timber element, p/s, condition, fragments]  
 Fragment of ~~frame~~ Floor with a number of cracks.

639 F3\_0 Ben R. Jennings 26 January 2007

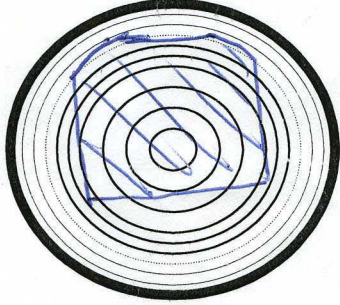
v. decayed.  
 lots of Sapwood - good for levels?  
 Hacked in ~~an~~ at part end  
 NB no indications of purple located at F58.

C + c 40 H + 10 S  
 ARW = 16/50

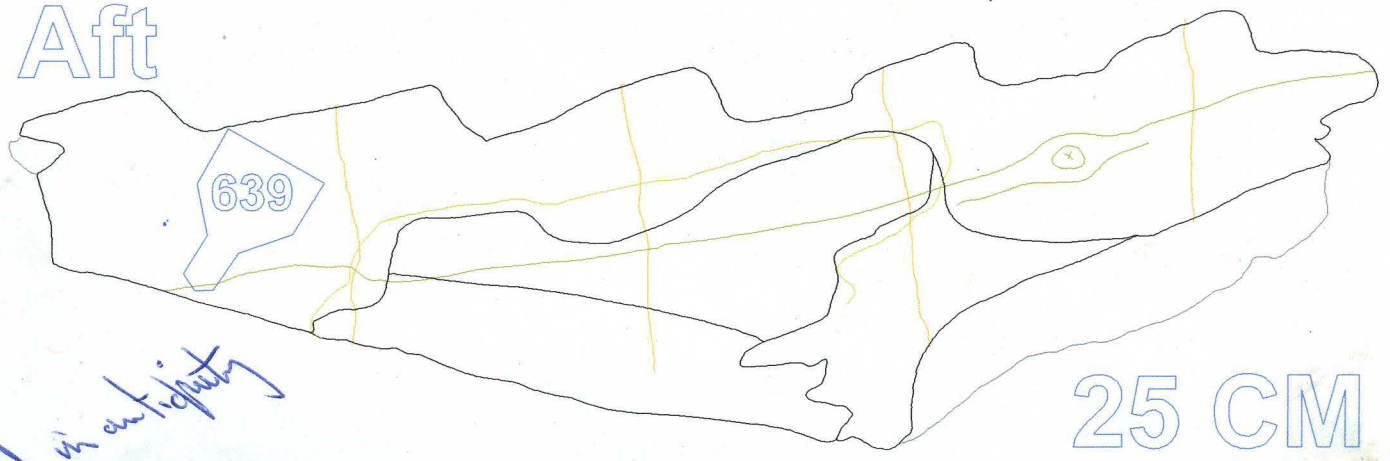
Aft

*hacked in anti-gravity*
