D8 21/05/2010 Retained for handling collection 11/5/10

Cow Tag 68	Type structural post or part of a frame
-------------------	---

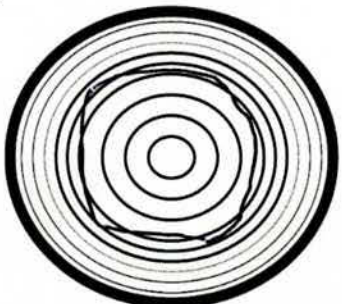
Wood Science:		<p>50 tree rings approx possibly oak slow grown one or two knots</p>

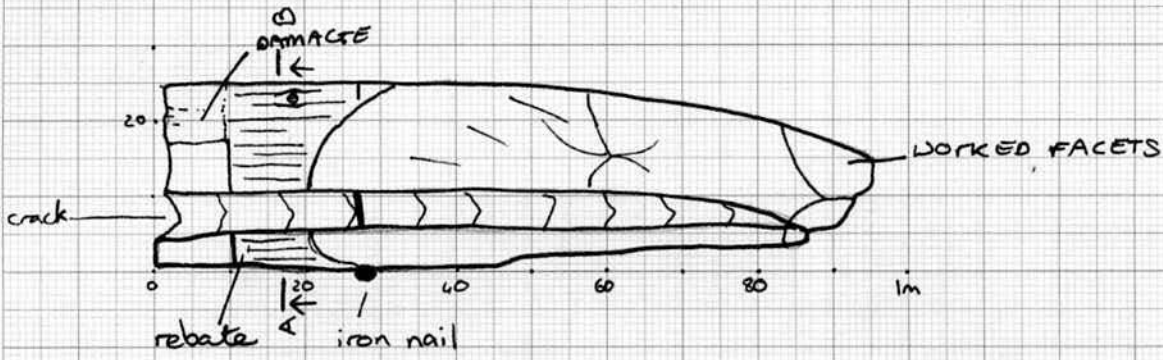
SURFACE A

Description 95cm in length, 25cm wide x 23cm thick. One joggle or rebate 2cm deep. Large crack runs the length of the piece. One iron nail (blind) Head measures 3cm in diameter shaft, (visible where timber is cracked) is square in profile. This piece tapers in thickness almost to a point. Worked facets are visible
