The King's Road, Sunderland

Cultural Heritage Desk-Based Assessment

November 2014

Prepared for:
HB Villages Ltd

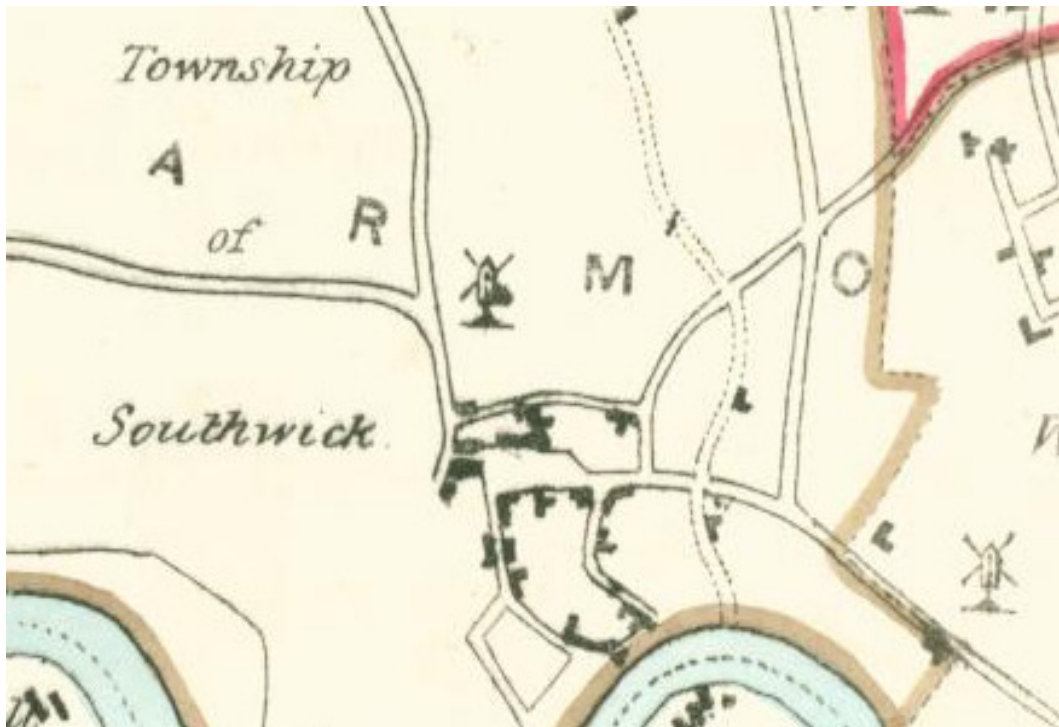
Plate 2: Extract from HMSO map dated 1832 showing village layout and corn mill.

A corn windmill to the north of Southwick is recorded on the HER (HER **2755**) and early 19th century mapping shows the general arrangement around the village and the location of the mill to the north-east of the development site (not illustrated) (Plate 2). A track leading from the north to river's edge is annotated on the map and is likely to depict the wagonways built between 1790-1800 (HER **2676** and **2682**).

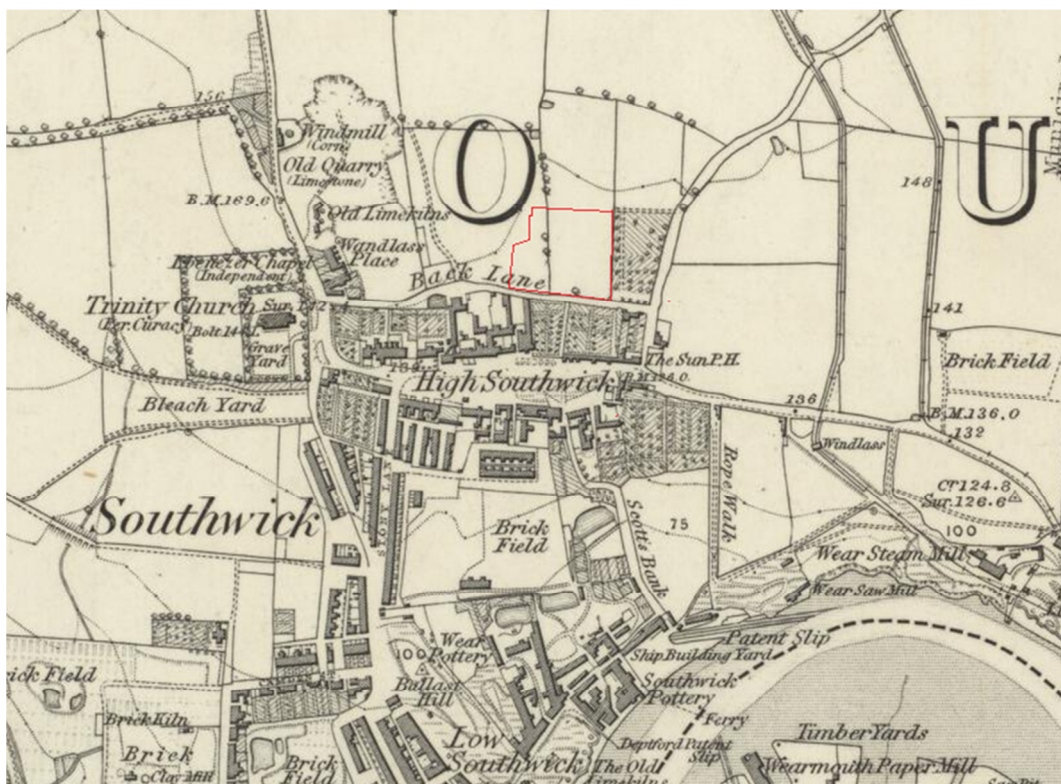
In the Ordnance Survey (OS) map surveyed in 1855 (Plate 3) the development site was occupied by fields to the rear of Back Lane (latterly named The King's Road). A tree-lined field boundary, aligned north-south and noted on 18th century mapping, is still present through the western half of the site. The field boundary is consistent with the prevailing north-south and east-west alignments visible in the wider landscape and likely derives from Parliamentary Inclosure.

The windmill noted on earlier mapping (HER **2755**); a limestone quarry and a row of limekilns (HER **2756**) are visible to the north-west of the site. Landscaped gardens are located to the east and south of the site, beyond Back Lane.

Plate 3: Extract from OS map surveyed 1855, published 1862, scale 1:10,560

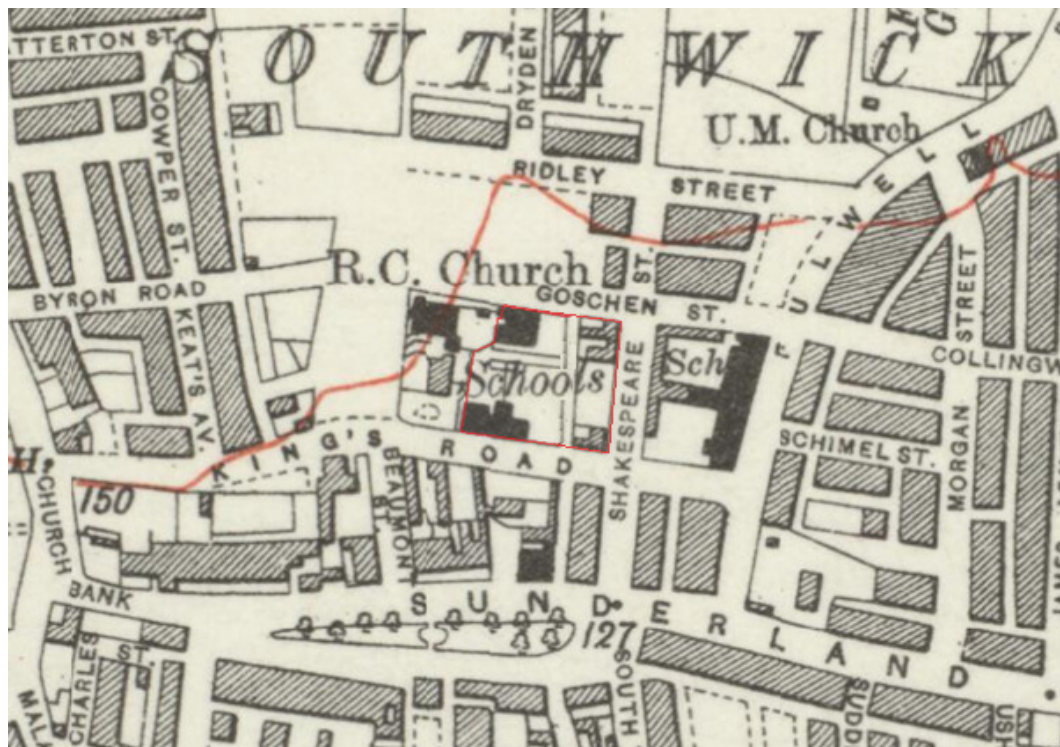
St Hilda's school opened on 1st June 1903 and on the OS map surveyed 1913-1914 the building layout is clearly annotated (Plate 4). Four separate buildings occupy the four corners of the site and a pathway bisects the site north-south. To the west, adjacent to the school is the Roman Catholic Church of St Hilda and the presbytery building.

Plate 4: Extract from OS map surveyed 1913-1914 Durham Sheet VIII SW, published 1921, scale 1:10,560

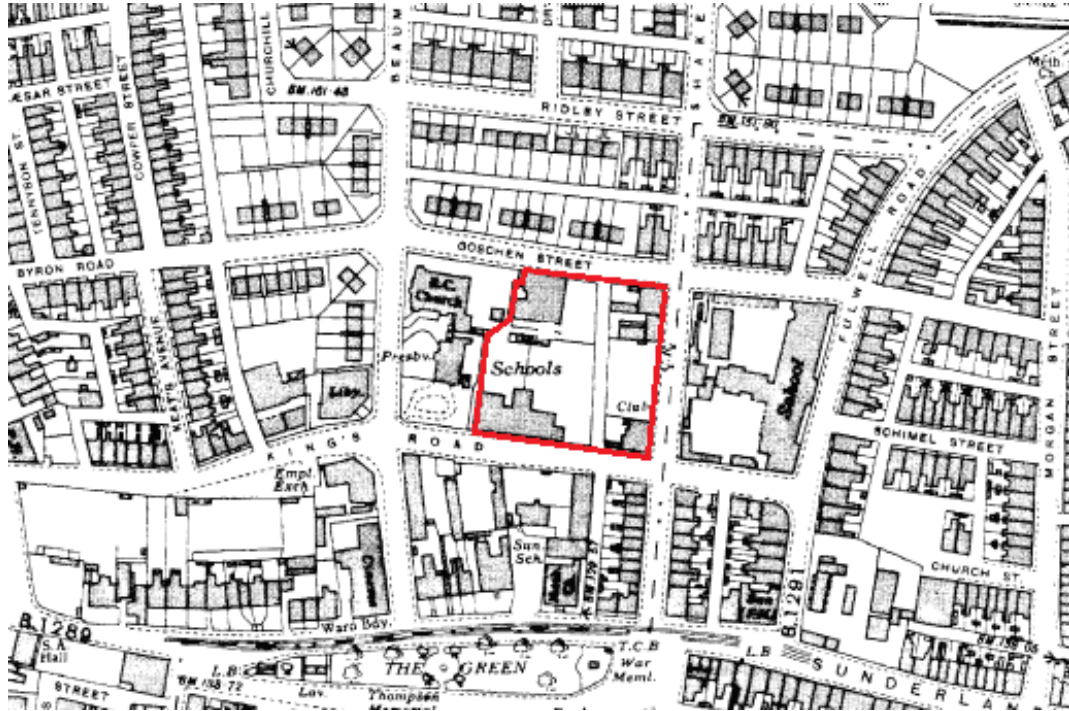
A pre-World War II (WWII) map (Plate 6) shows an extension at the eastern gable-end of the school building fronting The King's Road in the south-west corner of the site. No other changes are noted within the site.

Plate 6: Pre-WWII OS map scale 1:2,500

The majority of the building is constructed in a single phase. The easternmost block is a later addition (Plate 24) appears on pre-WWII mapping (Plate 6) and is likely to date from the mid-1930s. A short extension added to one of the north facing gable-ends was constructed post-WWII and is likely to date from the early 1950s (Plate 25).

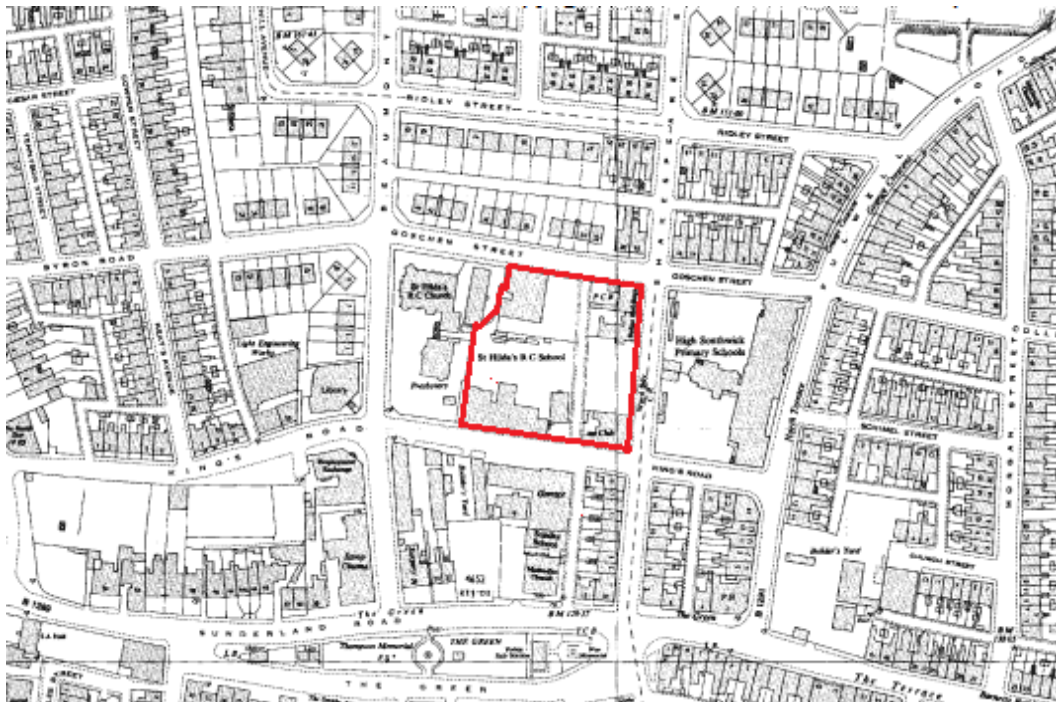
Post-WWII mapping shows an additional building has been constructed to the east of the school building fronting The King's Road. The new building is detached and is set back from the road. A small detached building has also been added at the northwestern edge of the club building which is in the southeastern corner of the site (Plate 7).

Plate 7: Post-WWII map shows additional buildings constructed within the site.

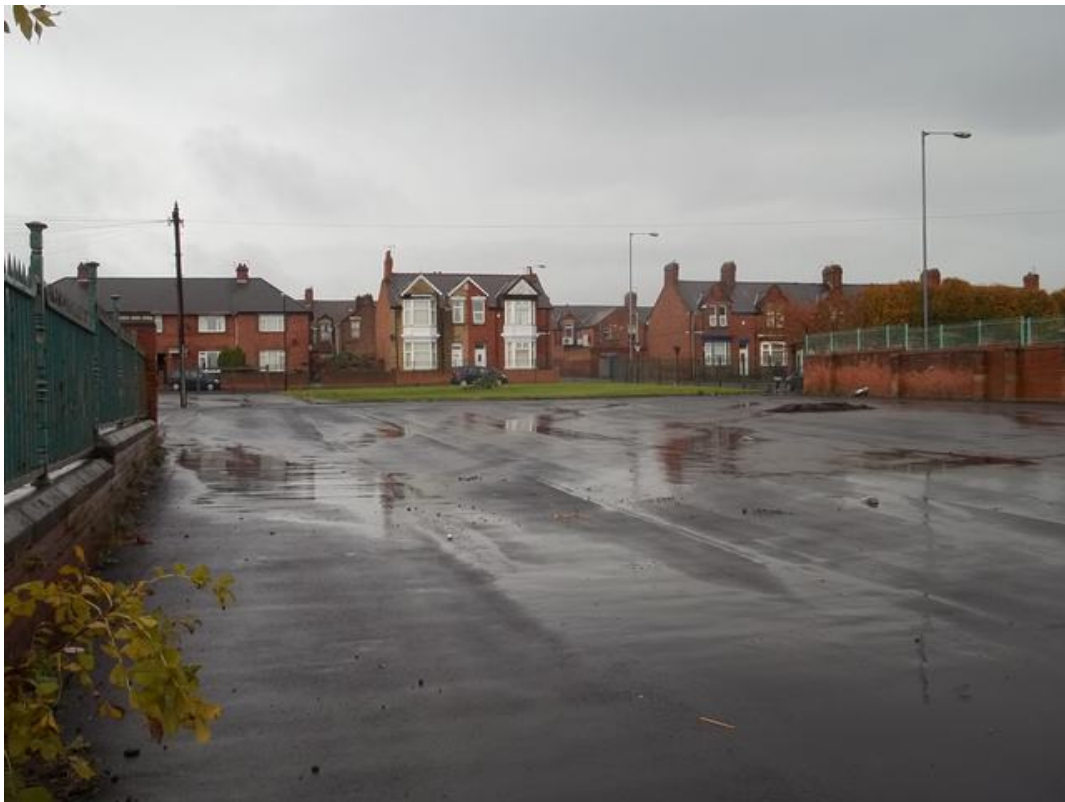
Beyond the footprint of the extant school buildings is the former school yard. Ground coverage is predominantly hardstanding (tarmac) with an area of grass in the northeastern corner of the site where the former police station was located. Several inspection covers are visible denoting the presence of buried cables and pipes. The site is enclosed by a low brick wall topped with iron railings at the front (south) and east boundary, and modern steel railings along the rear (northern) boundary.

Plate 12: View of development site. View from the south looking north-east. Grassed area in NE corner of site is visible in background view

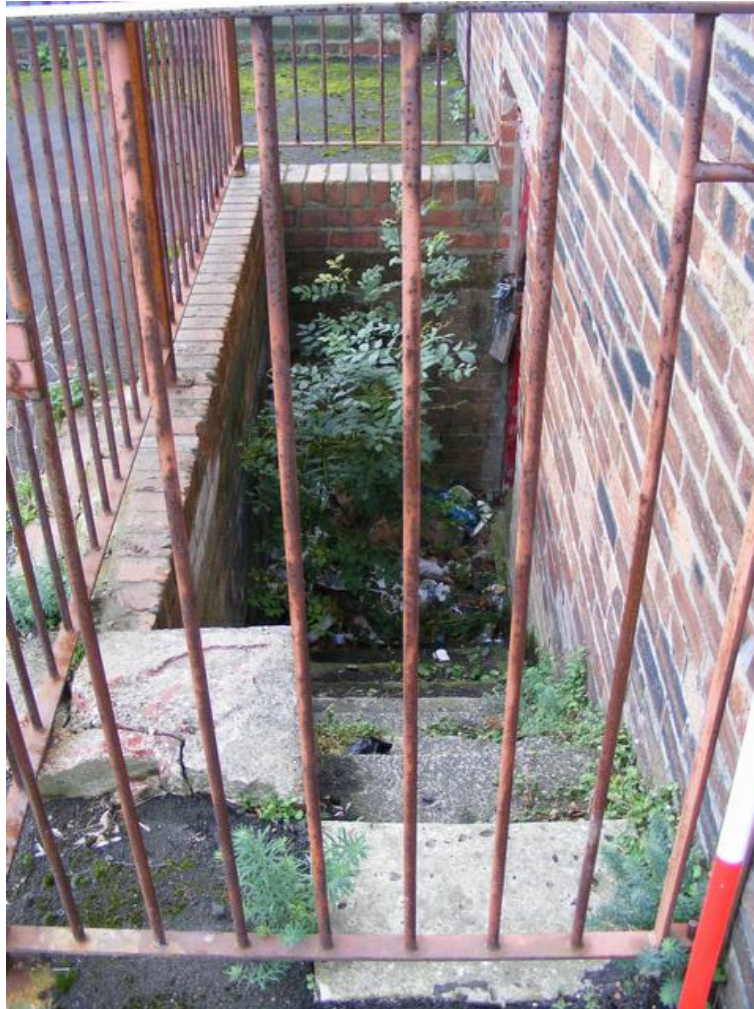
There is evidence for basements beneath the school buildings fronting The King's Road. Steps lead down to a basement access at the eastern end of the school buildings (Plate 13). The basement was inaccessible but anecdotal evidence suggests the basement extends beneath the footprint of the later extension at the eastern gable-end of the school building as noted in Plate 6.

Plate 13: Access steps leading to basement in eastern gable-end of school building.

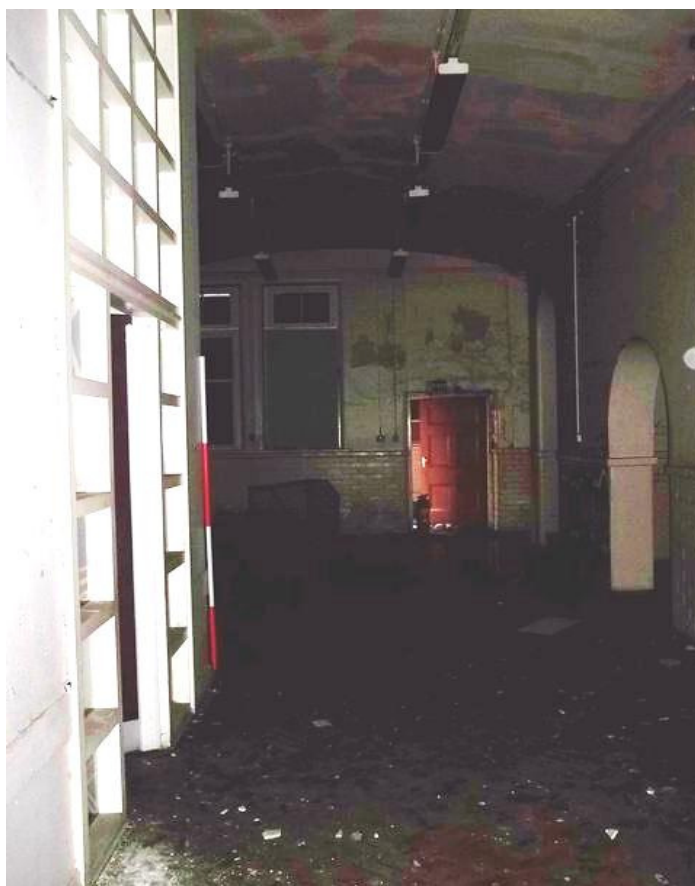
The building is constructed from red brick in stretcher bond with a pitched slate roof and comprises two rectangular blocks, aligned east-west, connected by a central corridor with an internal arched roof (Figure 3) (Plate 14). The southernmost block is single-storey and double height; the northern range is two-storey. An access porch is located at the western end of the central corridor (Plate 15) with another double-door access at the eastern end of the corridor.

Plate 14: View to the west. Central corridor between northern and southern ranges

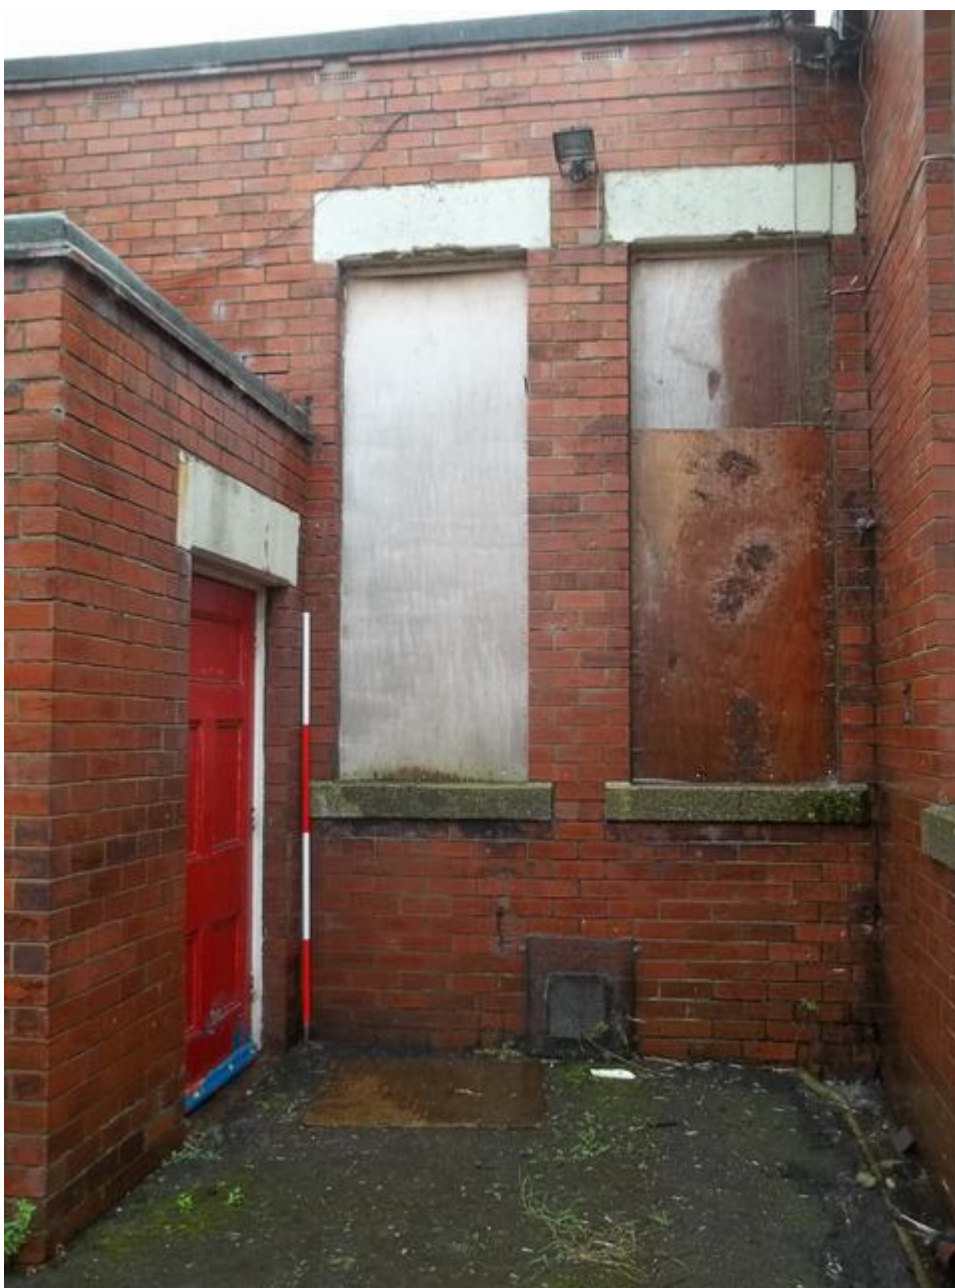
Plate 15: Access door at western end of central corridor

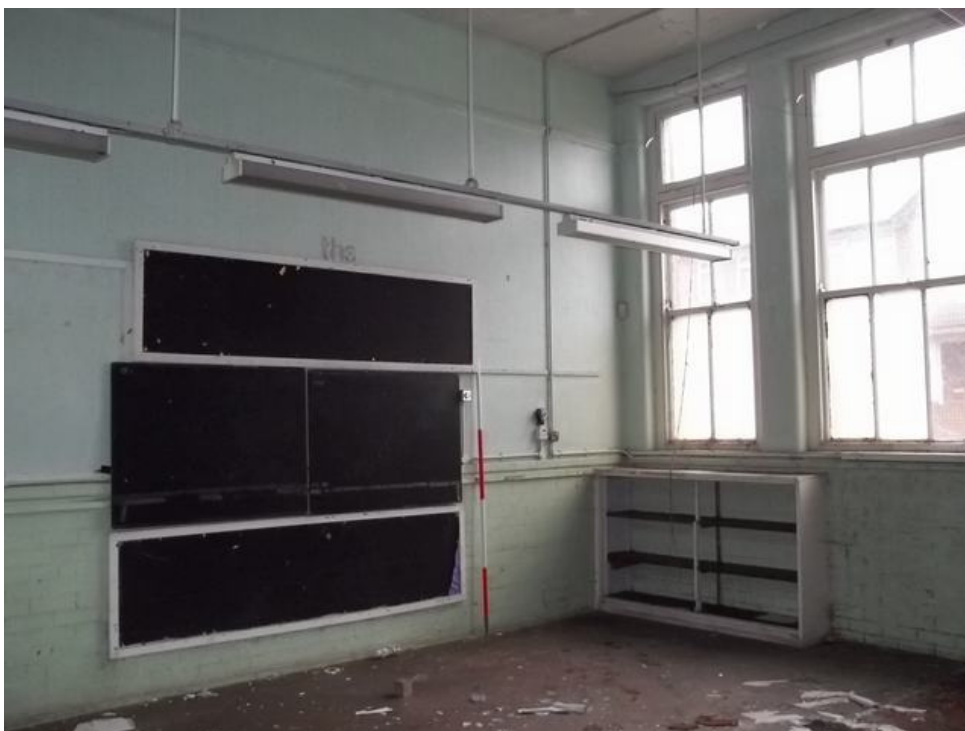
The northern block consists of a large classroom in the northwestern corner (Plate 16) with a circulation area and toilet blocks occupying the remaining space.

The classroom walls are plastered with painted exposed brickwork along the lower sections of the wall. At the north-facing elevation are three wooden framed 6-panel and 9-panel sash windows which extend from the top of the exposed brickwork to the full height of the room.

Plate 16: View to the north-west. Large classroom in NW corner of building

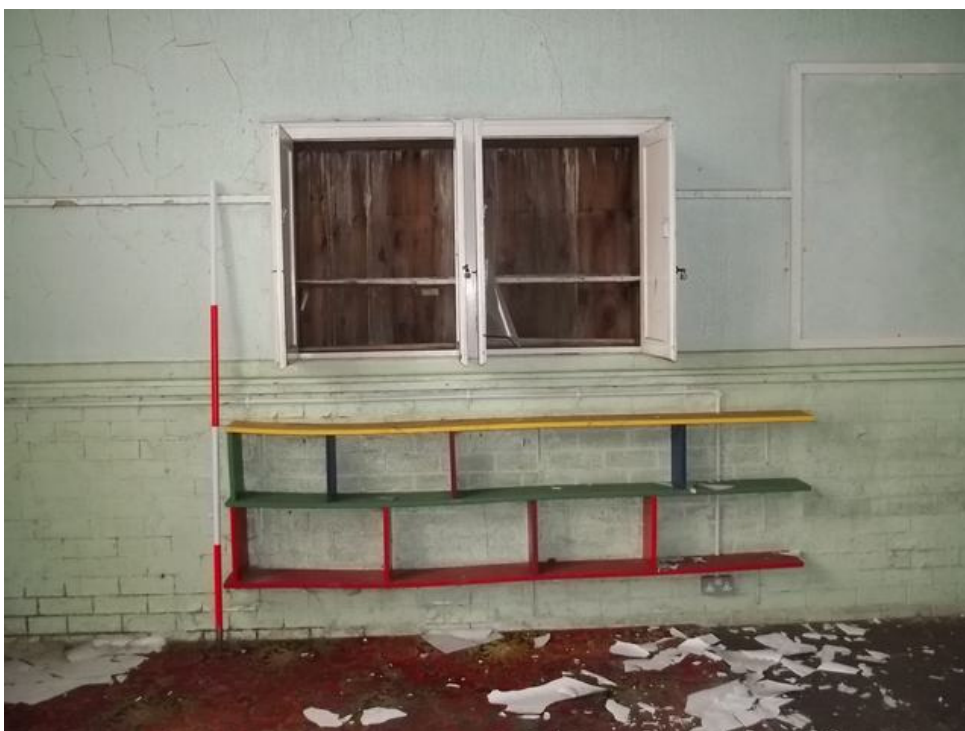
The eastern wall contains small storage cupboards which may have originally been access hatches to the room beyond (Plate 17). The classroom has little architectural detail.

Plate 17: View to the east. Wall cupboards and shelves in NW corner of classroom

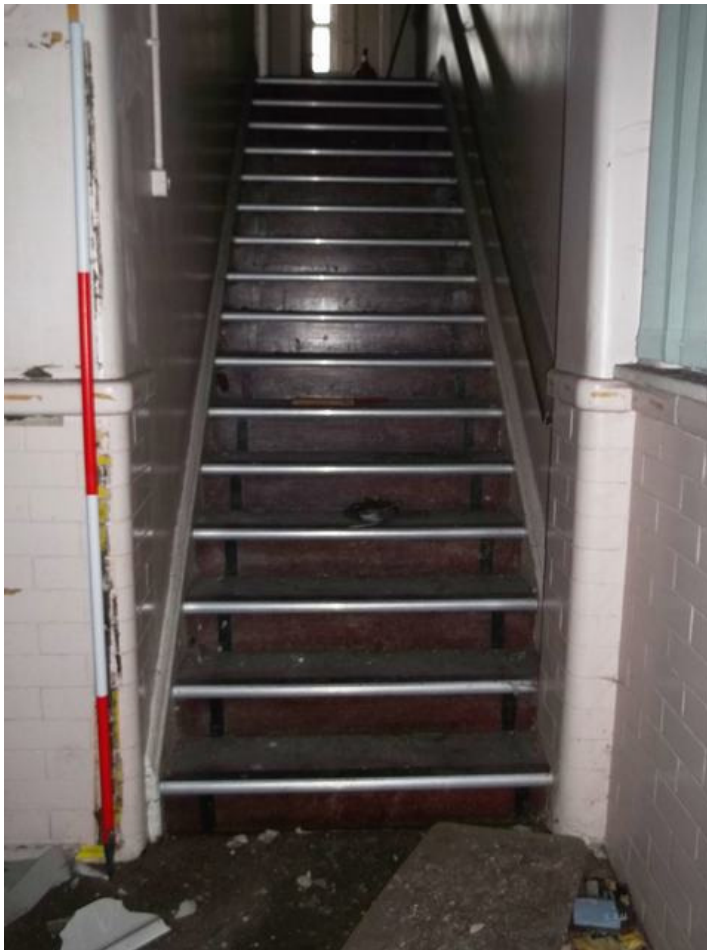
Further along the central corridor are two staircases leading to the first floor (Plate 18). The space between the staircases is occupied by a small circulation area containing wall hooks for hanging coats along with a small kitchen area comprising storage cupboards and a sink. Either

Plate 18: Easternmost staircase leading to first floor

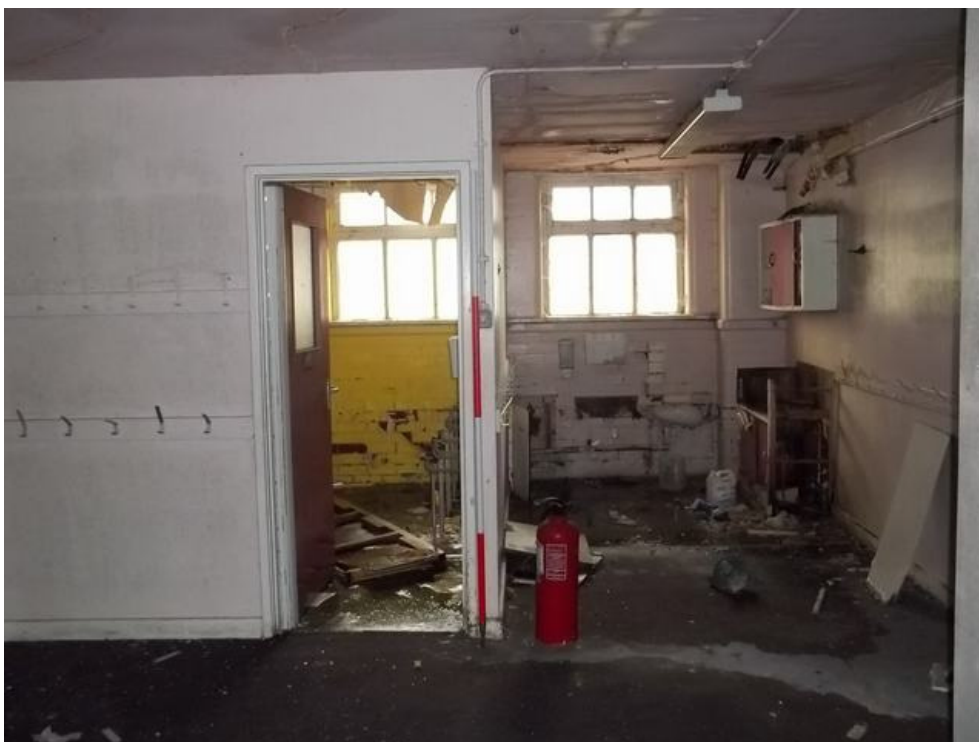
Plate 19: View to the north. Boys toilet block (painted yellow) with coat storage area outside

The walls of both toilet blocks were not brick and are not part of the original building layout. The ceilings of both toilet rooms have collapsed and there is significant water ingress which has damaged the floor which comprises vinyl overlying wooden block flooring.

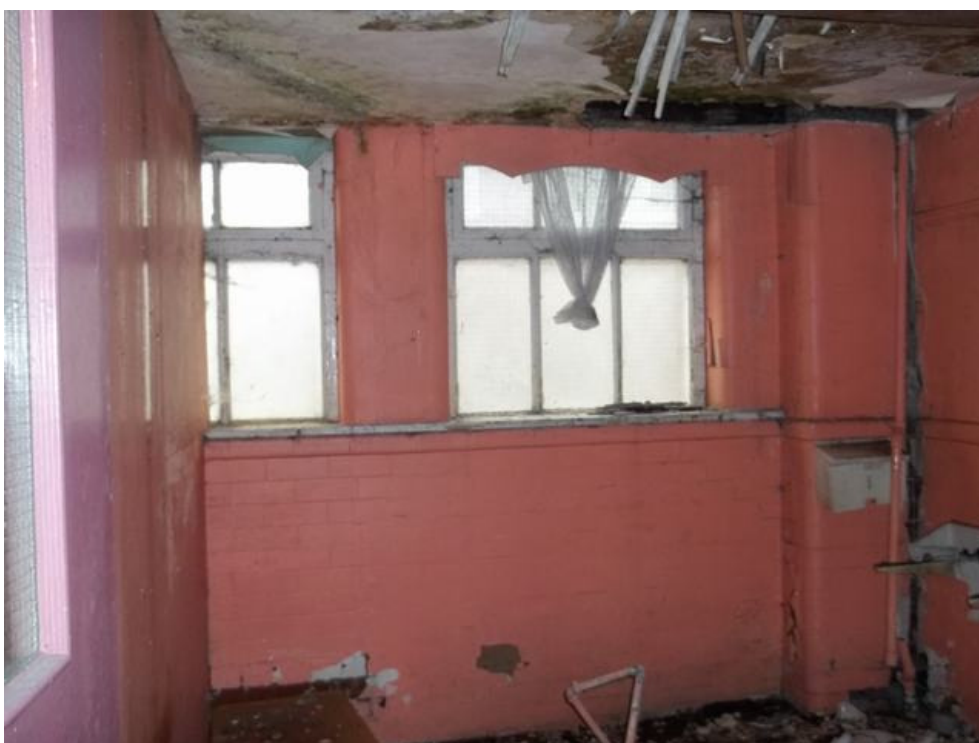
Plate 20: Pink toilet rooms on the eastern side of the coat storage area (no access)

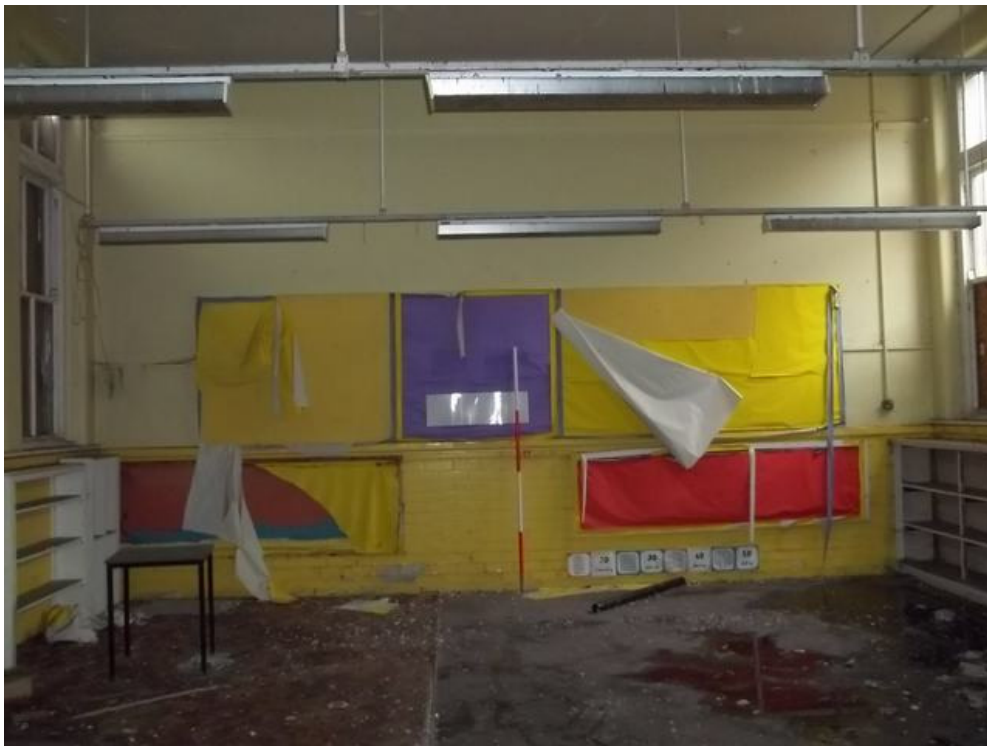
On the southern side of the central corridor are two large classrooms. Both classrooms have plastered/ painted walls and painted exposed brickwork along the lower sections of the walls. Large 9-pane sash windows allow light in from the south facing façade and windows are also located at the internal wall which would have increased internal lighting levels along the central corridor. Other than the original windows, doors and frames, there is little architectural detail in either room.

Plate 21: View to the east. Classroom in southeastern corner of school building

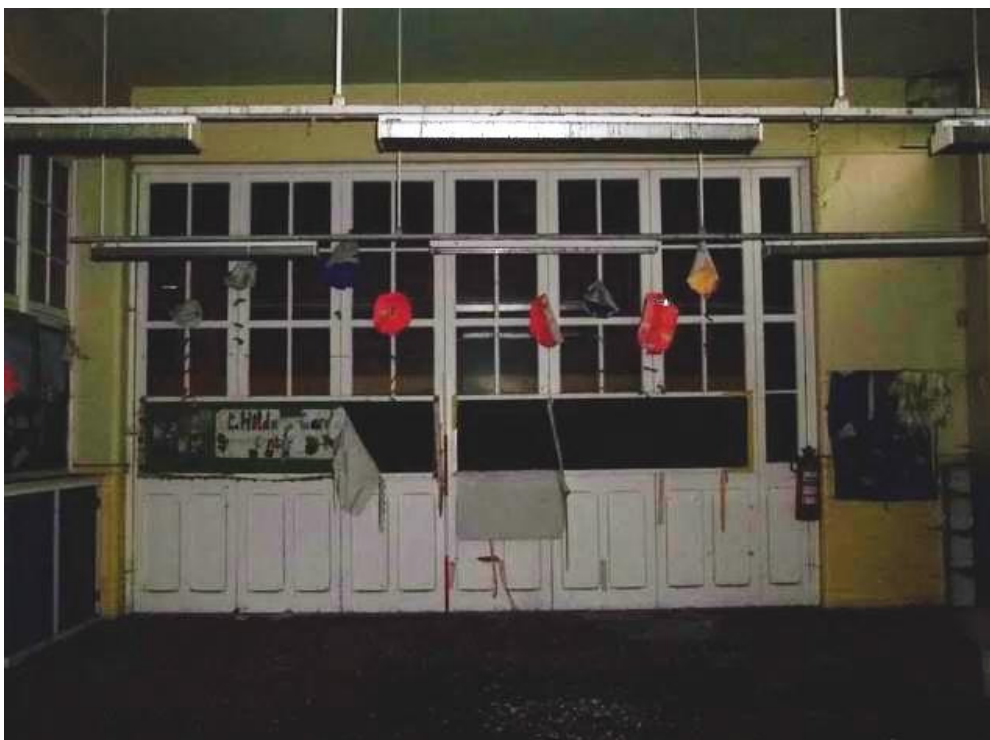
The westernmost classroom in the southern block has built in cupboards with large panelled doors which extend almost to the full ceiling height (Plate 22).

Plate 22: Storage cupboards with panelled wooden doors

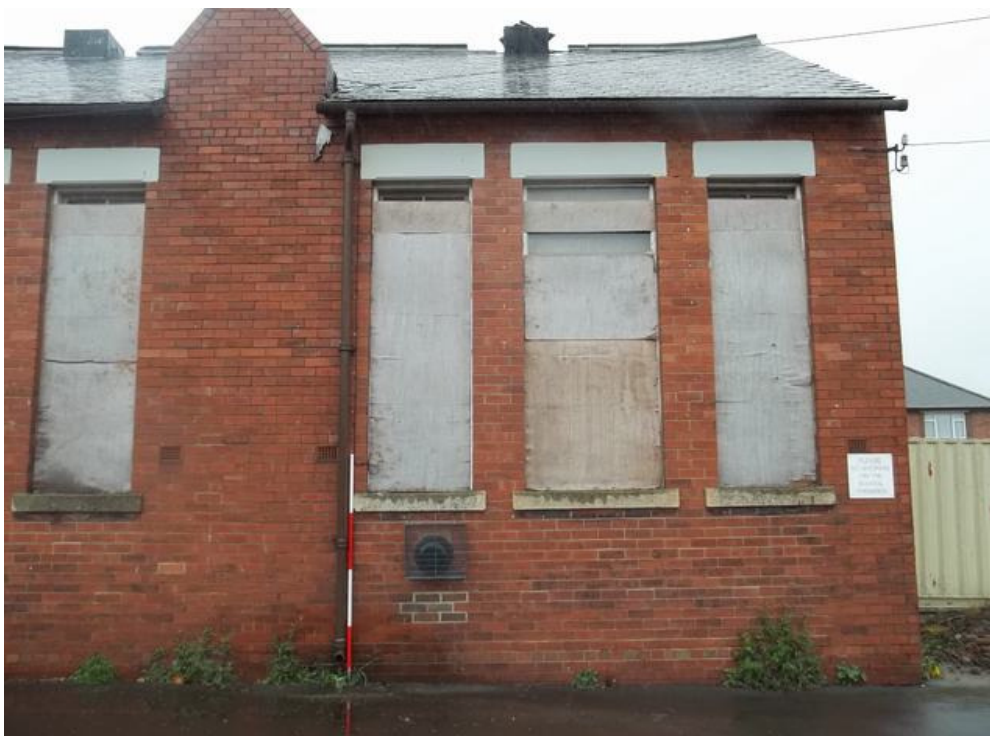
Patches of the original wooden block flooring survives but the majority has been removed and what remains is significantly water damaged. Externally all of the windows within the southern block have deep concrete lintels and sills (Plate 23). There are two prominent chimneys set within the south-facing façade.

Plate 23: South-facing façade

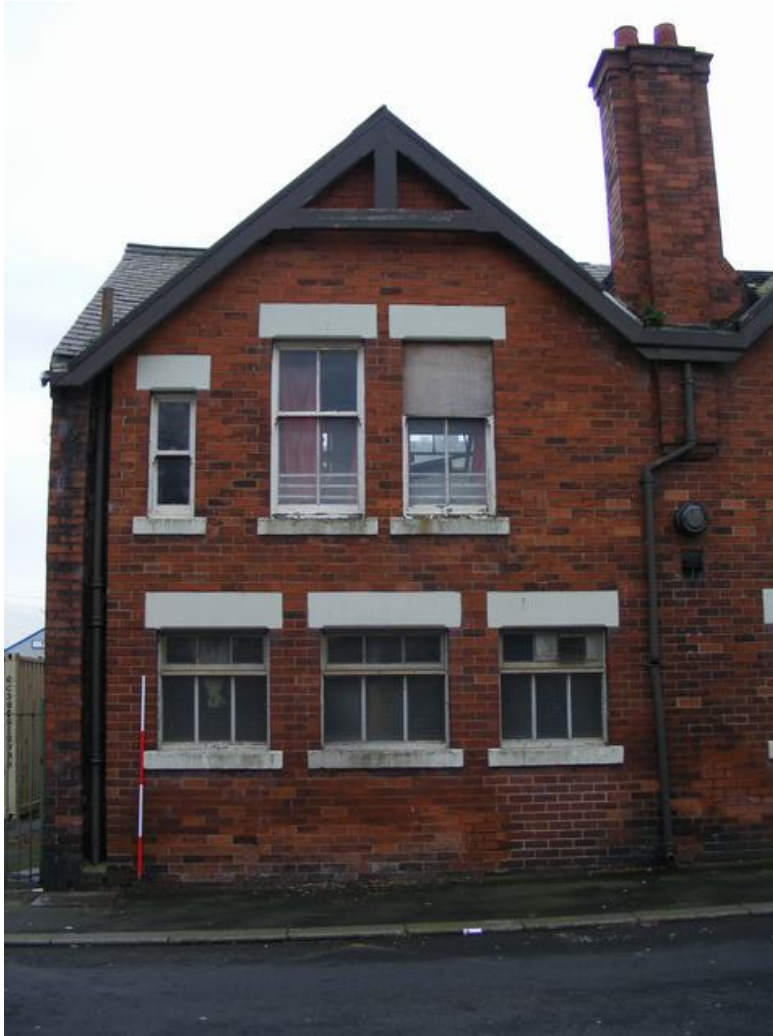
The northern block has a type of cross gable roof resulting in three gables forming the north façade. The north façade of the northern block is more visible to passers-by, and has more decorative architectural features than the south face of the southern block which faces inwards towards the school yard.

Plate 23a: North facing elevation of north-western school building

The windows in the north façade consist of 6-pane sash windows along the ground floor and four-pane sash windows on the first (inaccessible) floor with deep concrete lintels and sills. The projecting gable ends have mock timber plain bargeboards with no decorative finials. Two prominent chimneys are situated down the slope of the roof between the three gables (Plate 23a). There is evidence of repointing along sections of each façade, but there is no evidence for any significant alteration of the original fabric or building layout.

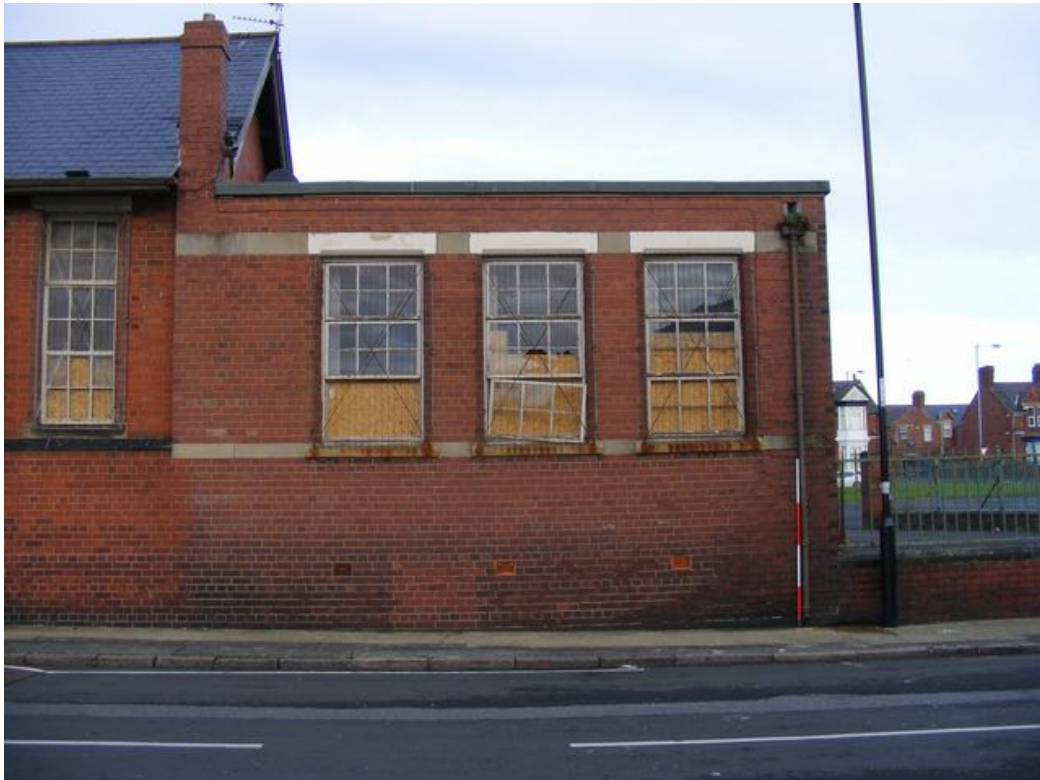
Plate 24: Eastern extension constructed during the 1930s

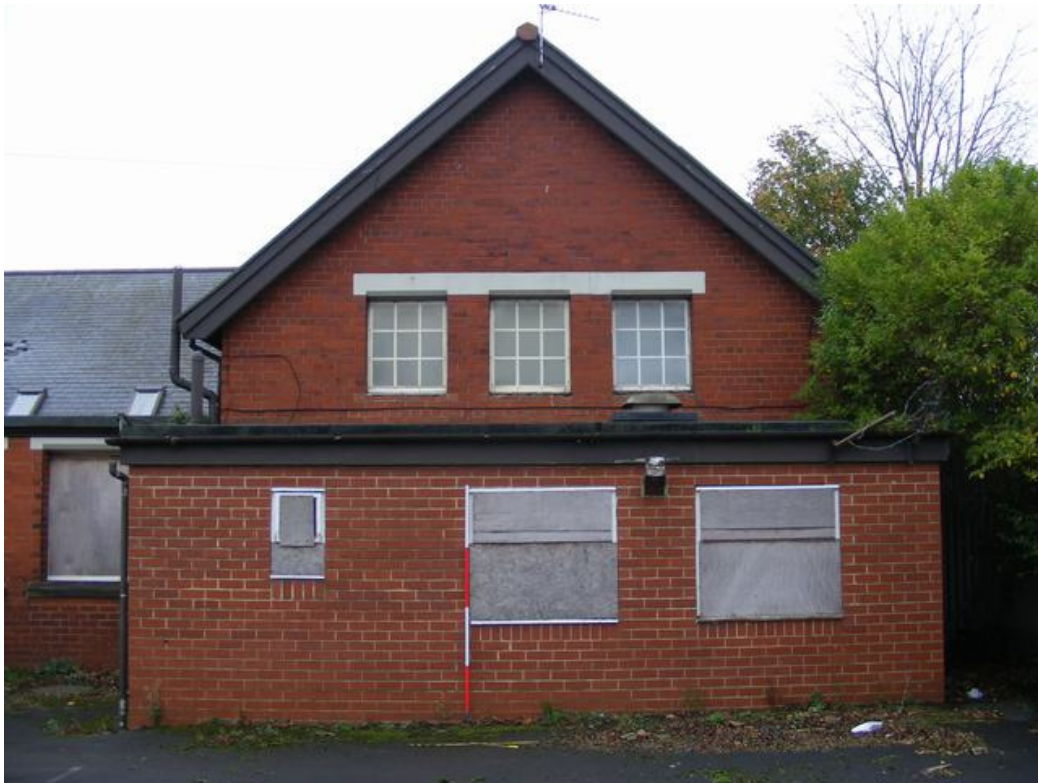
Plate 25: Single-storey extension at north-facing gable-end

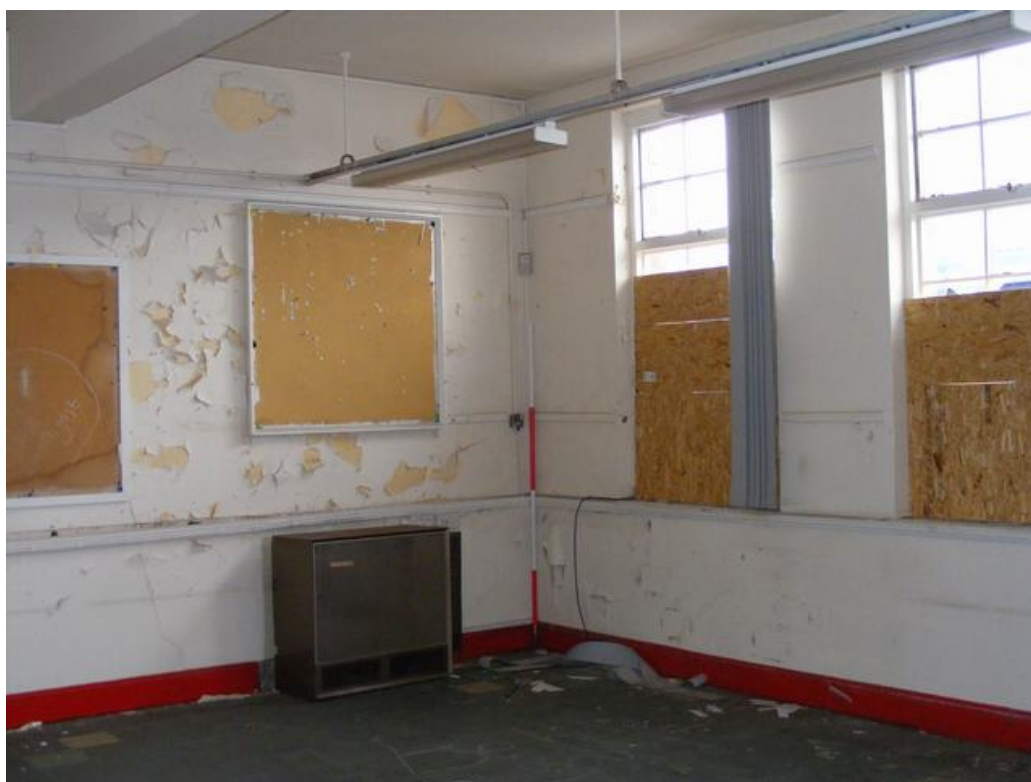
The southeastern classroom is located in the extension that was added during the 1930s. The room contains deep wooden skirting but no other fixtures or fittings of note (Plate 26). The next classroom (to the west) contains the remains of a fireplace in its north-west corner (Plate 27). The grate and fireplace surround has been removed and only the brick hearth remains.

Plate 26: View to the south-east. Classroom in south-east corner of school building

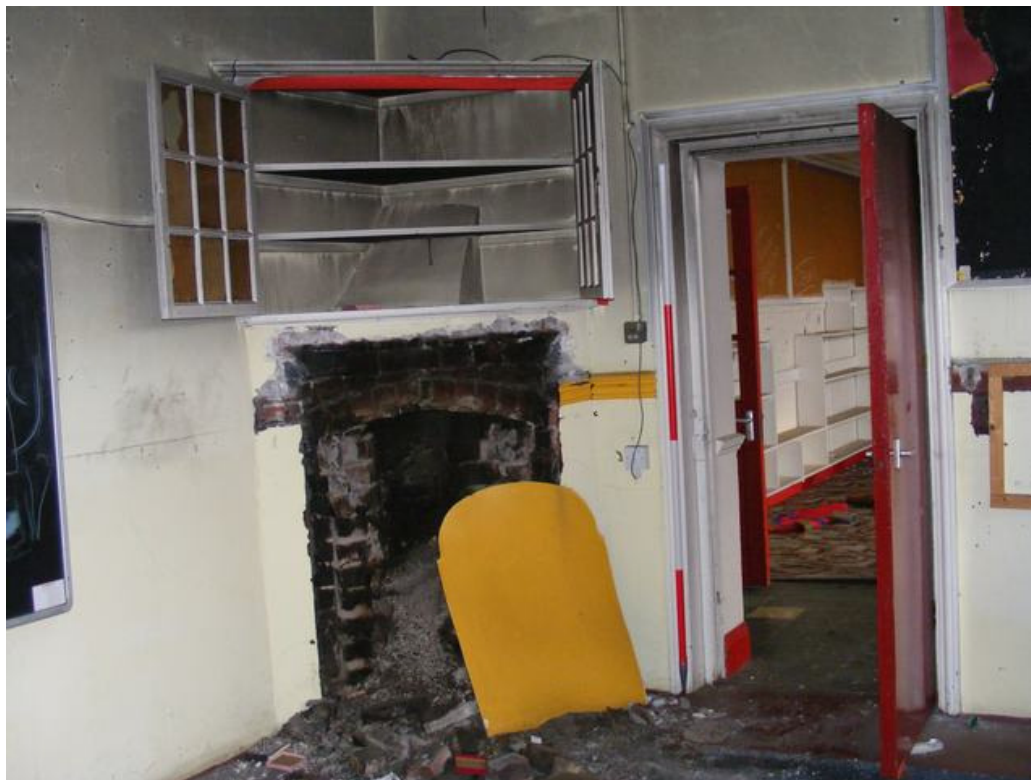
Plate 27: Fireplace in NW corner of classroom

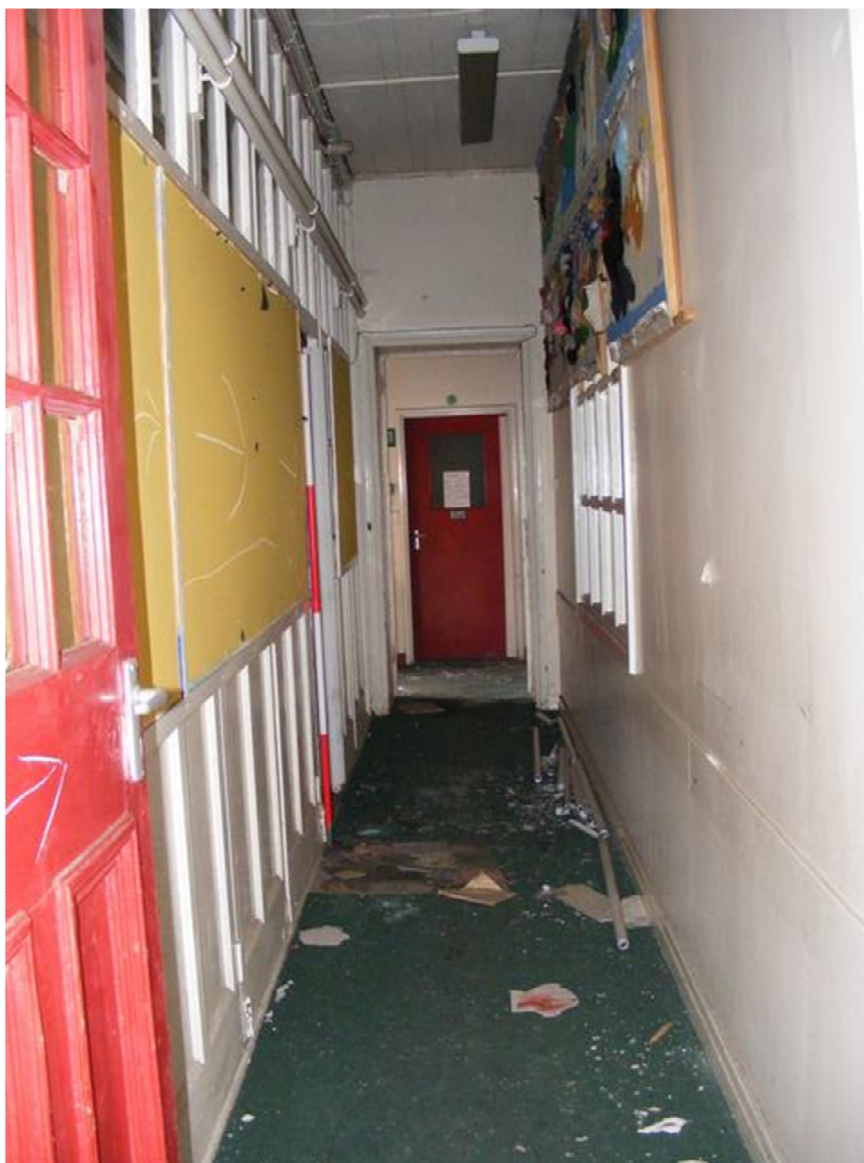
All of the classrooms have connecting doors with the neighbouring room, and all classrooms are accessible via the central corridor (Plate 28).

Plate 28: View to the west. Central corridor which runs length of school

The corridor is relatively narrow and poorly lit, but internal glass panels between the corridor and the classrooms to the south increase internal light levels. In addition, skylights have been inserted into the roof to allow additional light into the space (Plate 29).

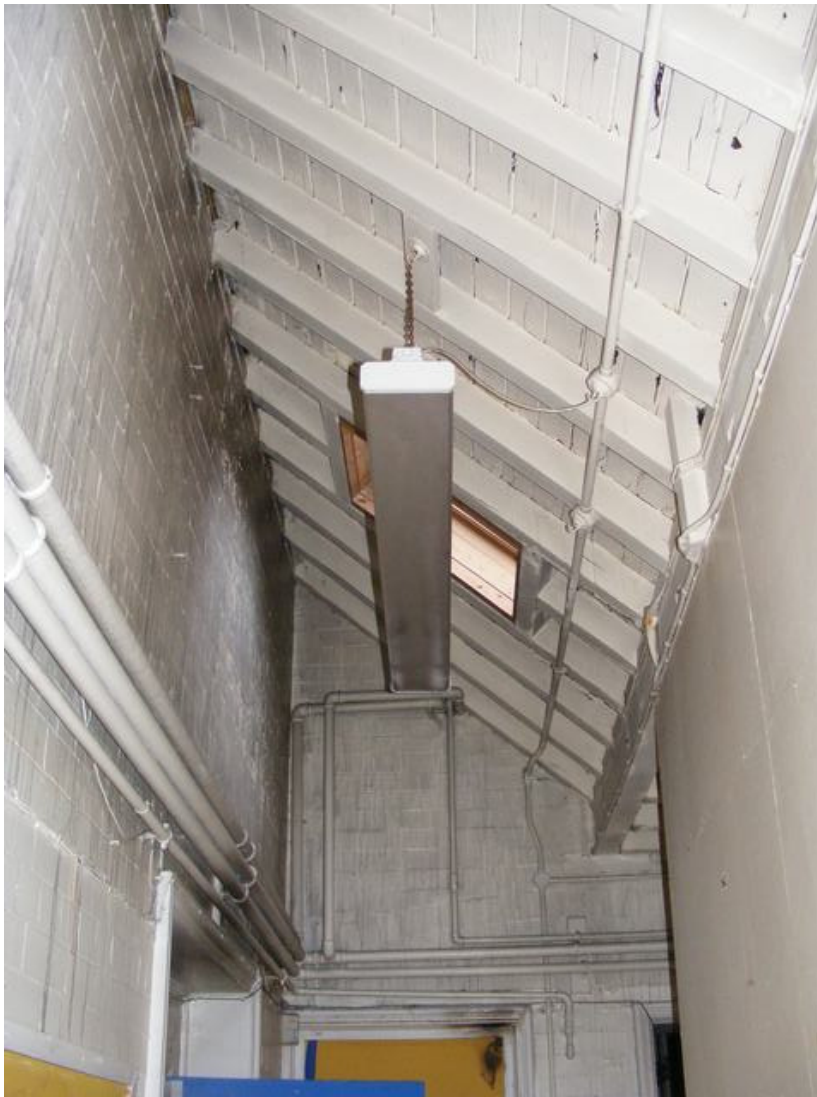
Plate 29: Skylight in roof space above central corridor

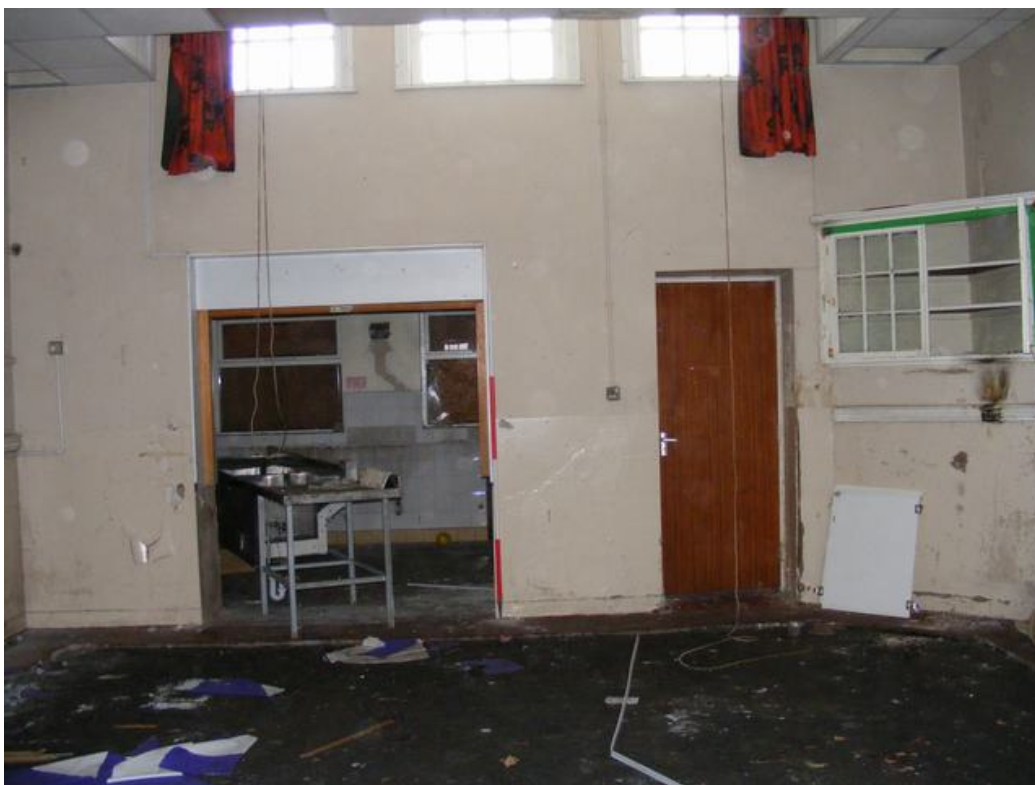
A large classroom at the western end of the school building extends the full depth of the building and has a small kitchen area at the northern gable-end (Plate 30). The room has a suspended ceiling which obscures the upper section of the long panelled windows and is large enough to accommodate all of the school's pupils and was possibly used for assembly or dining, although all desks and tables have been removed. There are no architectural features, fixtures or fittings of note.

Plate 30: View to the north. Small kitchen area at the northern gable-end of large classroom
