The King's Road, Sunderland

Cultural Heritage Desk-Based Assessment

November 2014

Prepared for:
HB Villages Ltd

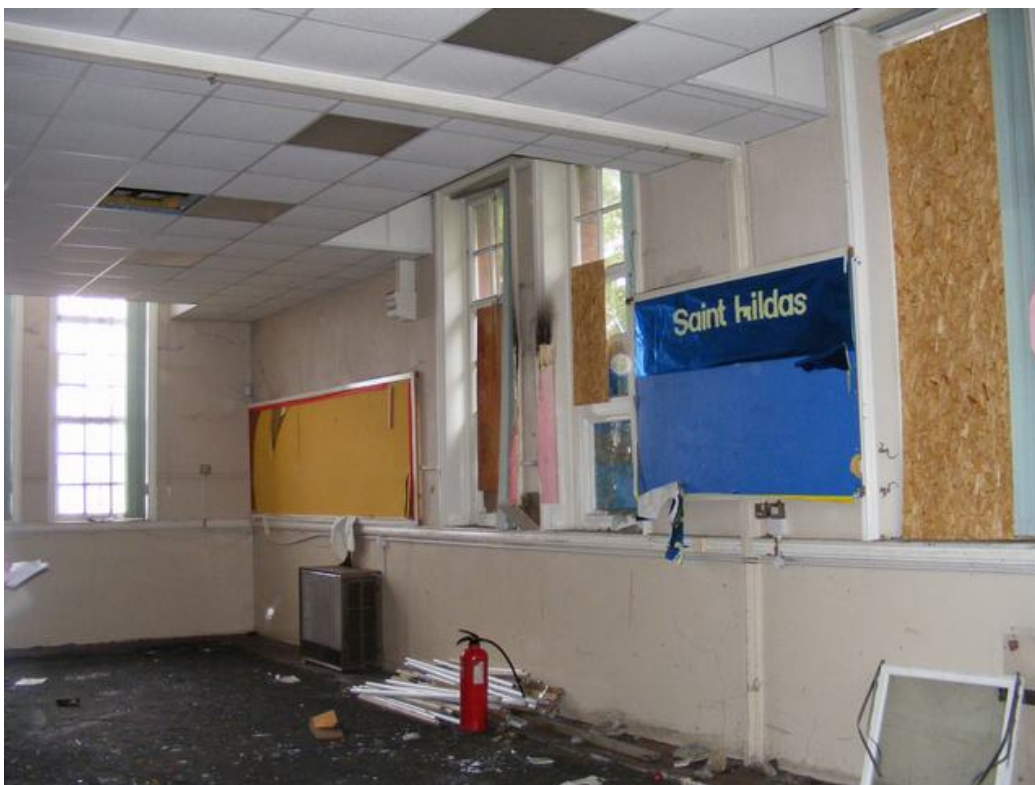
Plate 31: View to the south-west. General shot of interior of large classroom

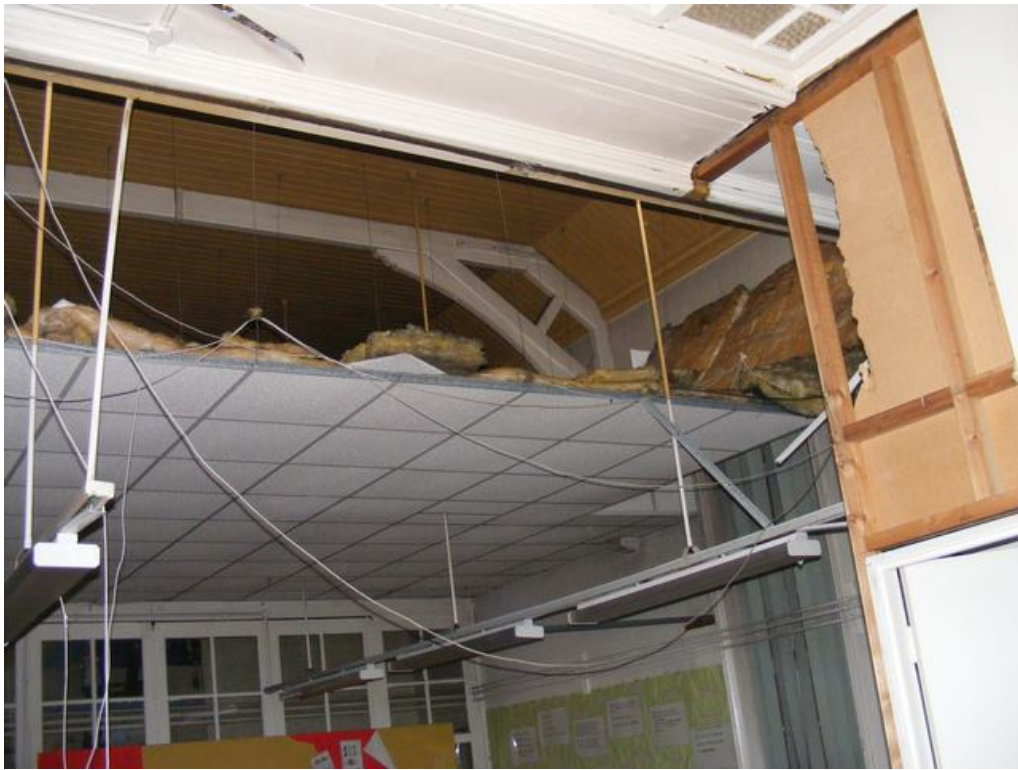
All of the rooms have a suspended ceiling, however the roof beams are visible in areas where the ceiling has collapsed or been dismantled (Plate 32).

Plate 32: Roof beams visible above suspended ceiling tiles

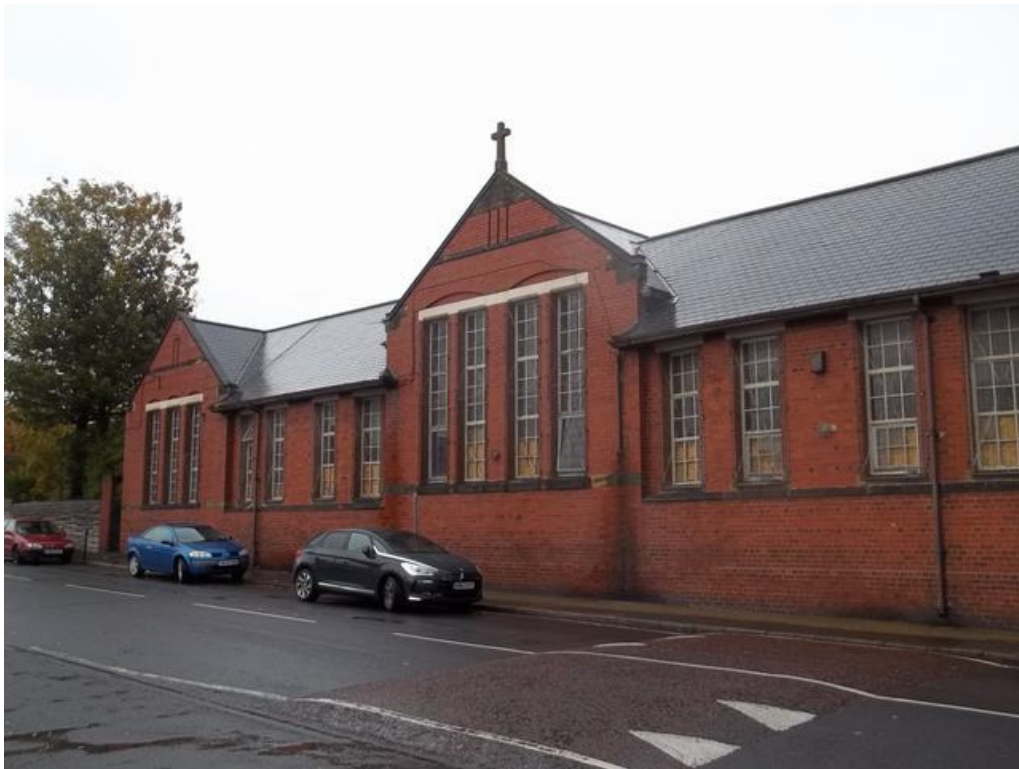
The windows, which comprise 18-pane sash and tall 27-pane sash windows in the central and end gables, have dressed stone lintels and sills. Above the stone lintels in the gable ends are shallow brick arch lintels which suggest the stone lintels are a later addition (Plate 33).

Plate 33: Front south-facing façade of school building in south-west of site; brick arch lintels are visible above the stone lintels in the central and end (western) gables
