## **Southampton Archaeology Unit**

Report: 937

Archaeological watching brief at the northern end of  
Fratton Road, Portsmouth. 2009/52

Client: Portsmouth City Council

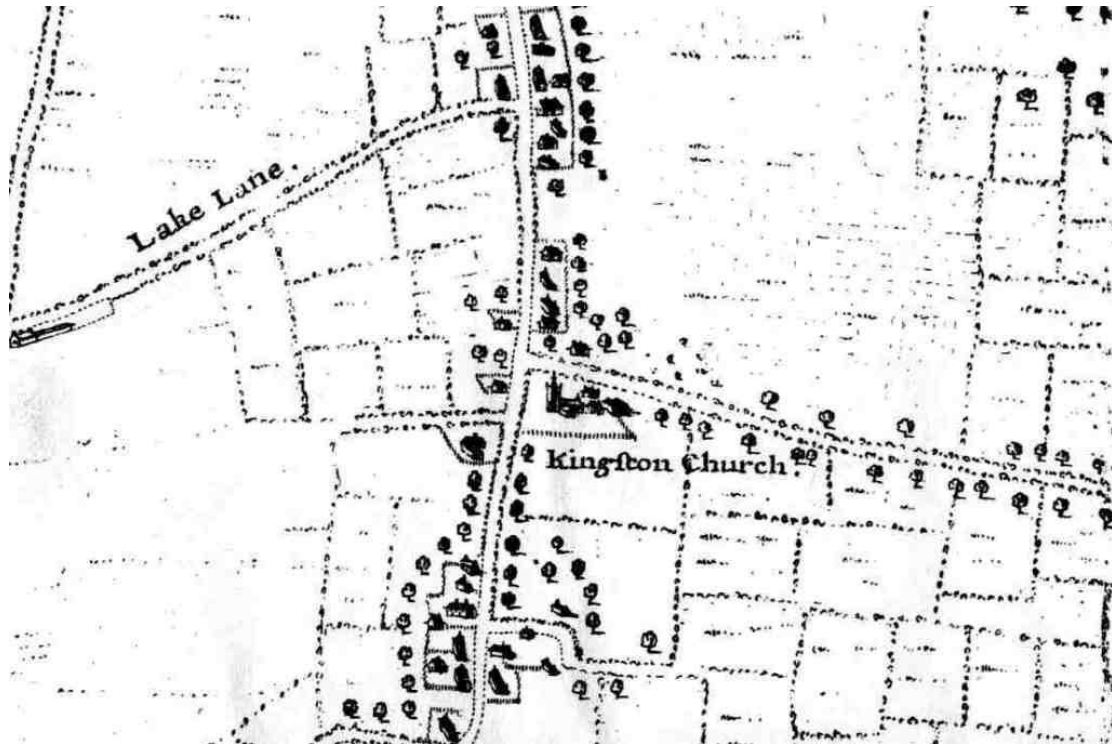
Figure 2: Edwards map of 1716

6.2 The site lies between the vicarage and the site of the medieval church as shown in Edwards map of 1716 (fig 2).

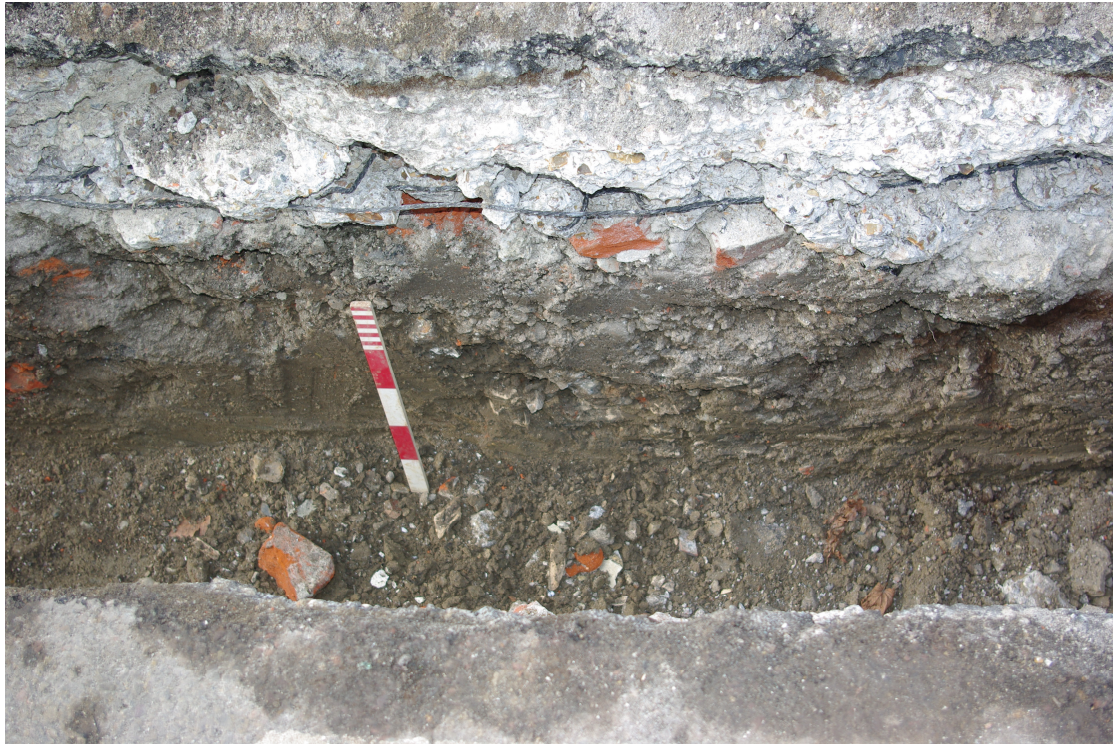
Figure 4: East facing section showing pit 1

Pit 1 was situated in the east facing section opposite the entrance to St Mary's Church. It was 900mm long, 490mm deep and had a rounded base. It was filled with a greyish brown (10YR5/2) clay loam, context 2. It contained several cow metacarpals and metatarsals, fragments of brick, a fragment of 18/19<sup>th</sup> century Verwood pottery and fragments of 19<sup>th</sup> century glass (fig 4).

One pit was observed, it contained several cow metacarpals and metatarsals, fragments of brick, a fragment of 18/19<sup>th</sup> century Verwood pottery and fragments of 19<sup>th</sup> century glass.

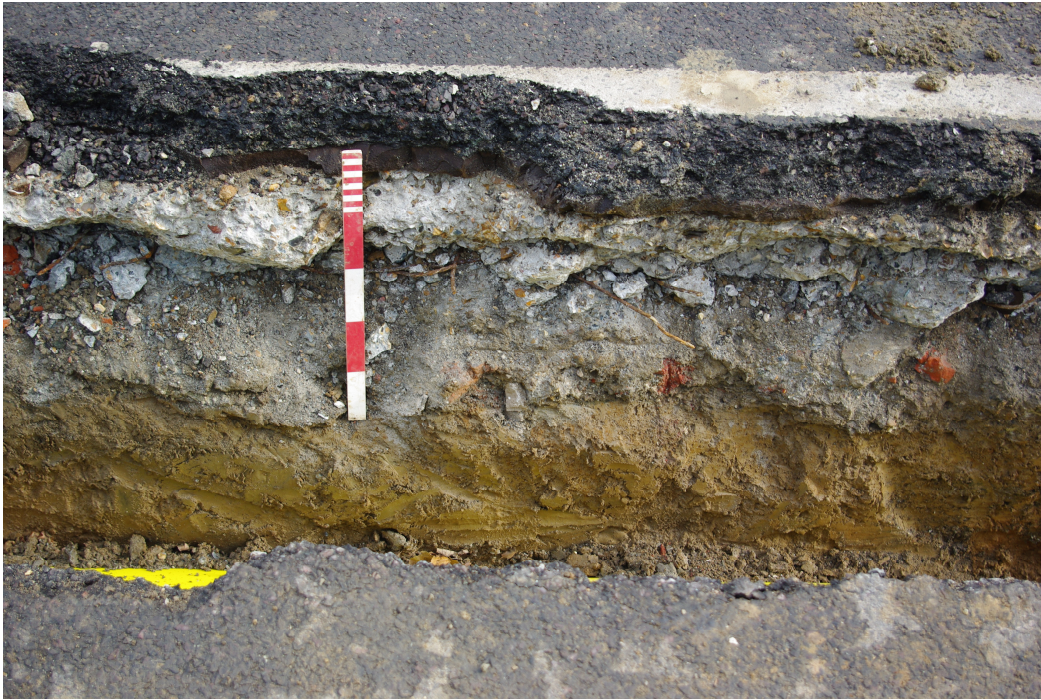
Figure 5: West facing section showing road 9 above the London Clay 12

Natural 12 was situated between 0.60m and 0.85m below the surface and was at least 500mm thick (fig 5). It was a brownish yellow (10YR 6/6) clay loam in the southern end of the trench, and changed to an olive brown (2.5YR5/4) in the north of the trench. It was the weathered upper surface of the London Clay.

Gravel road surface 9 was situated to the south of Church Road and arched into Fratton Road. It was light brownish grey (10YR 6/2) gravel with a sandy clay loam matrix. It was 300mm thick and was 250mm below the modern road surface (fig 5). Feature 7 was later seen to be part of the road and could have been a wheel rut. It was 700mm long and 300mm deep with a rounded base. It was filled with a large amount of slate in a greyish brown (10YR5/2) clay loam soil, context 8 (fig 6).

A gravel road surface, context 9, shows where Church Road once met Fratton Road suggesting that Church Road extended further east and that Fratton Road was located further east.

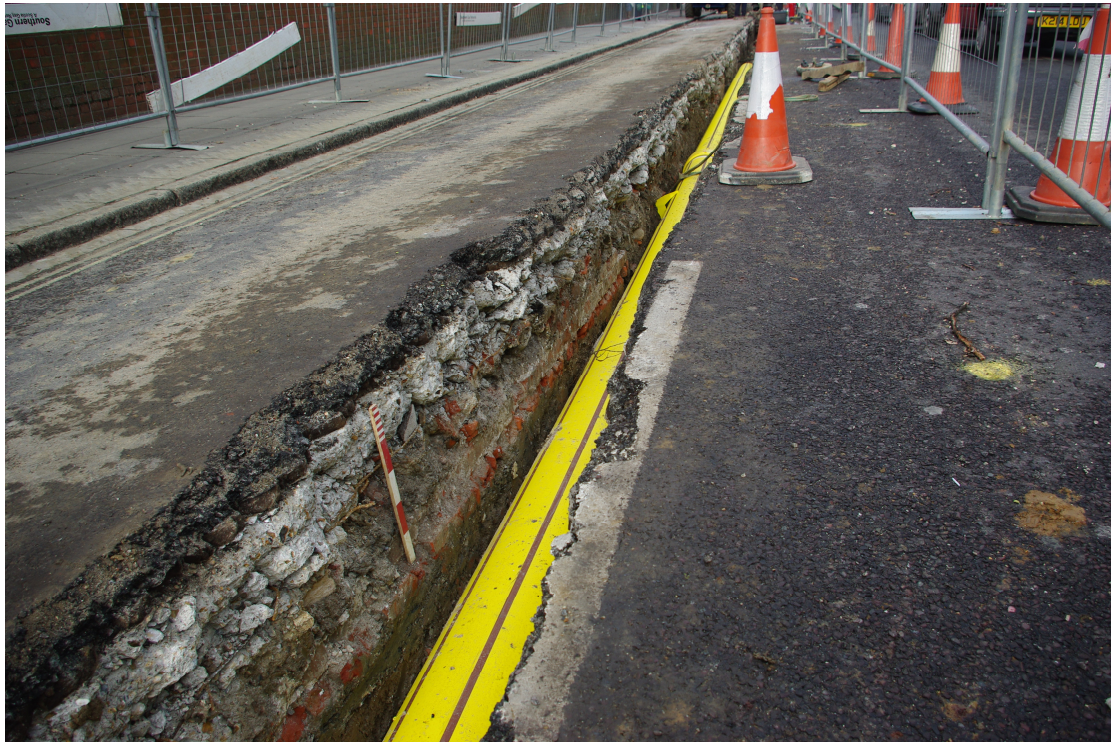
Figure 7: Wall 3

Footing 3 was situated between wall 4 and 5. It was at least 3m long and was 400mm deep. It was made of bricks in a mortar matrix. The bricks were 108mm wide and 64mm thick. They had no frogs. The coursing was English garden wall bond (fig 7).

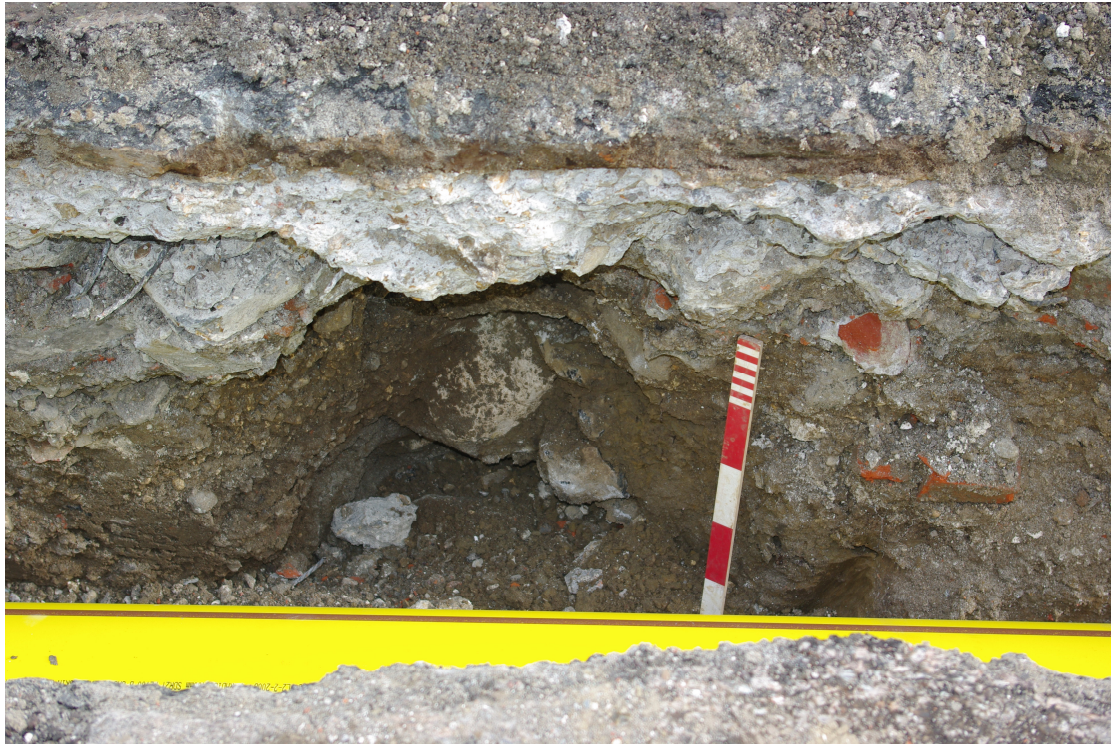
Figure 8: West facing section showing wall 4

Wall 4 was situated 7.8m south of wall 3. It ran east-west across the trench, was 500mm wide and 400mm deep. It was made up of large limestone blocks and flint nodules (fig 8).

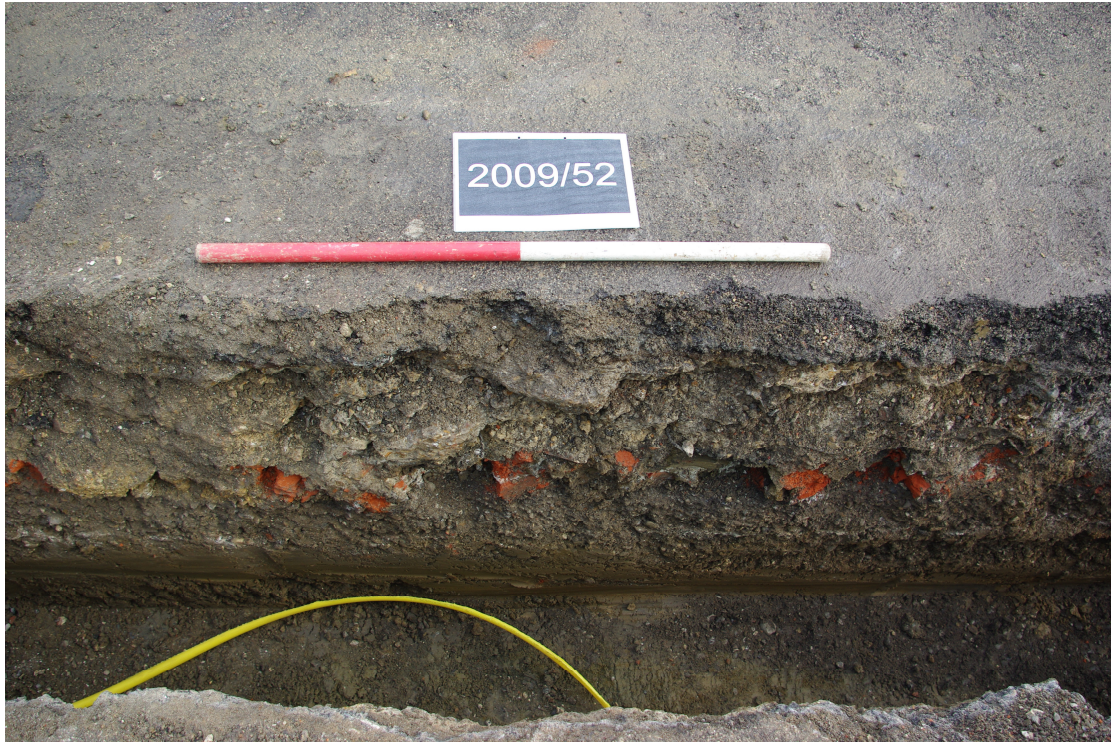
Figure 9: West facing section showing wall 10

Wall 10 was situated in the north part of the trench. It ran roughly north-south for 5m. It was a brick and mortar wall on a chalk raft. The bricks were 108mm wide and 64mm thick. They had been made of brickearth and had no frogs (fig 9).
