Southampton Archaeology Unit Report 1159

Archaeological Building Recording of Pond Cottage, Boldre, Hampshire

Southampton Archaeology Report	1159
Grid reference	SZ 31504 99176
Application reference	12/97342

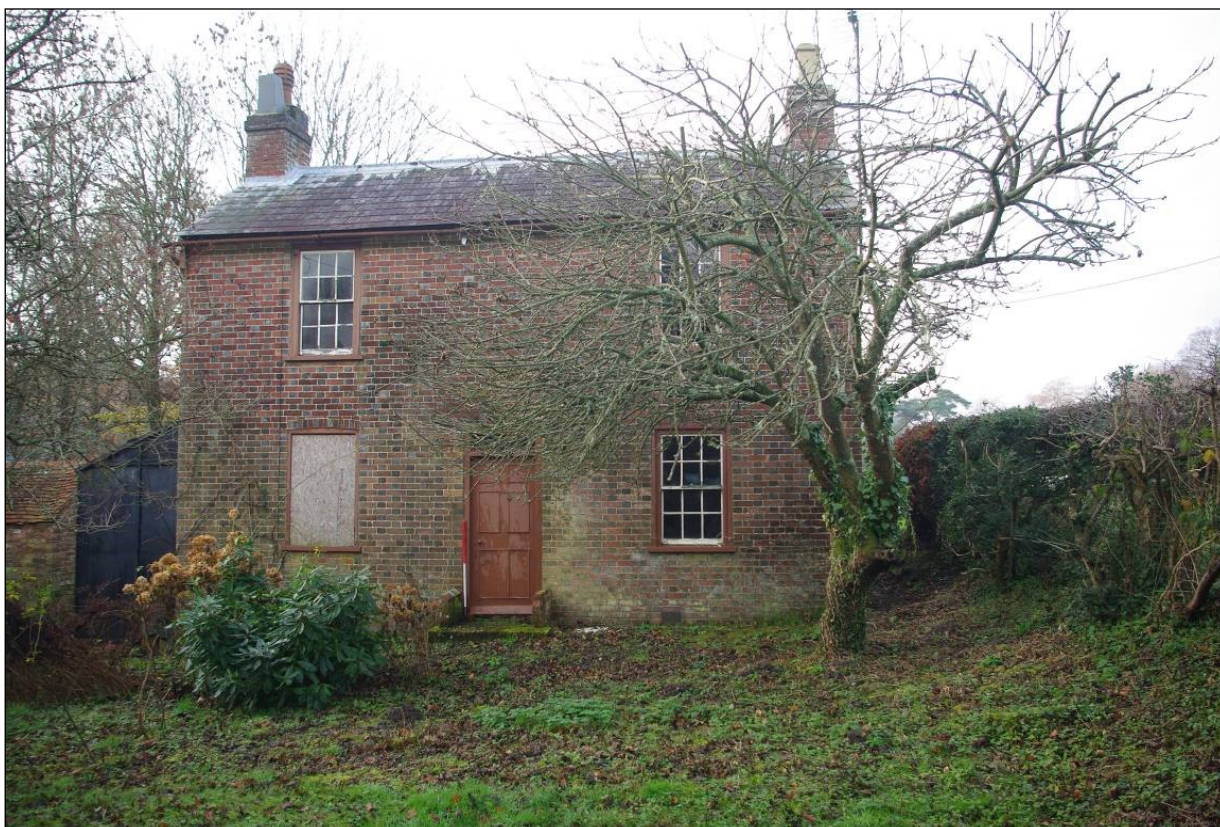
Figure 2. East elevation (front). Note possibly original slate chimney pot on right hand stack.

The front elevation was built with carefully selected blue vitrified headers and contrasting red stretchers in Flemish bond (fig 2). The bricks were 225mm by 114mm by 63.5mm (8 7/8th by 4 1/4 by 2 1/2 inches). There was a central six-panel door with tripartite fanlight above with two sash windows to each floor on either side. The mouldings around the panels appeared to be more recent additions, or possibly replacements. The door and lower windows had shallow segmental arched heads, each of 14 bricks on edge. The lower windows had housings in the frames where shutters had once been attached. The windows were six-over-six pane sliding sashes. There was a dentilled eaves course beneath a pitched roof of Welsh slate. The roof had a lead ridge. Cast iron grilles beneath each ground floor window ventilated the under floor spaces. The building sat on sloping ground and a basal plinth was visible at the south end, and gradually disappearing below ground level to the north. The front door had a concrete step with small side walls, probably a more recent addition.

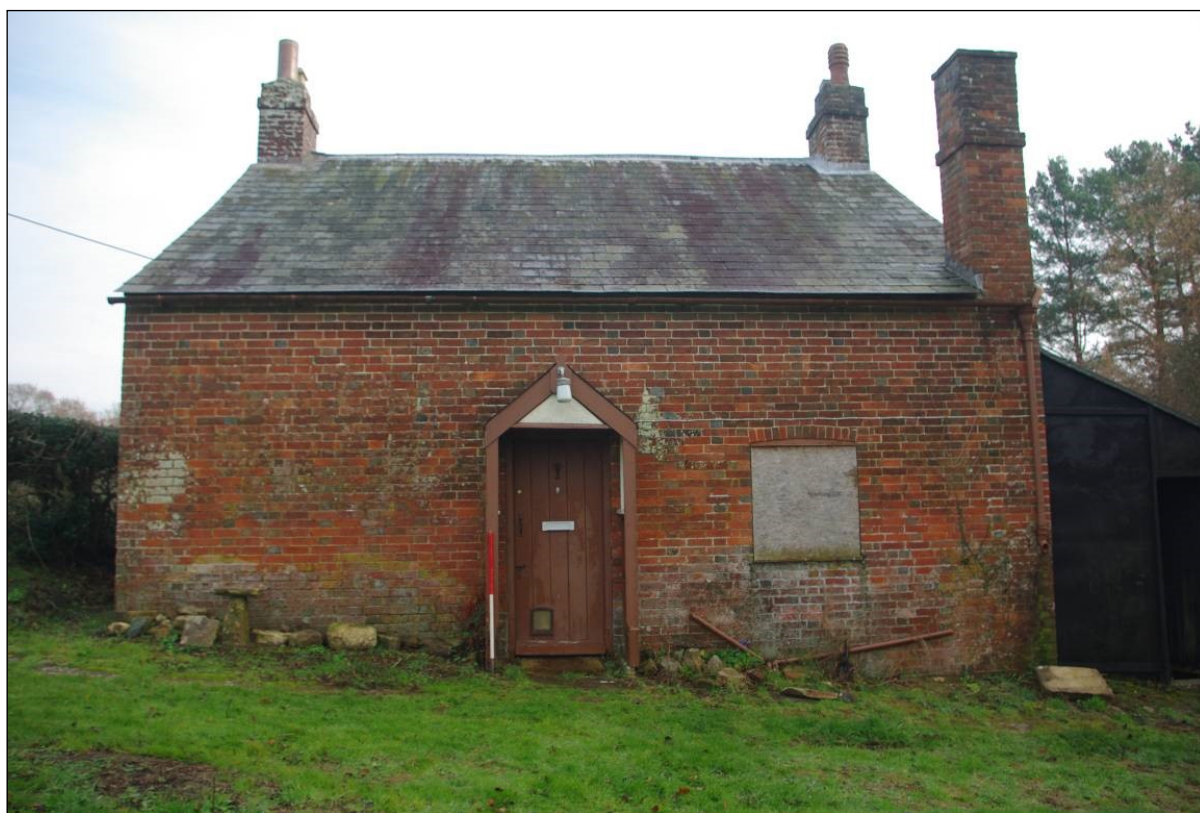
Figure 3. West elevation (rear). Right hand single stack for copper in scullery.

The rear elevation was single-storey under a cat-slide roof (fig 3). The wall was in Sussex bond with red stretchers, and mostly blue headers, but a good proportion were red, so the pattern was less noticeable than the front elevation. This elevation contained a single window and the rear door into the scullery. The door was probably original, but the softwood porch was more recent, and the marks of an earlier porch could be seen. The door opening was 3 feet wide with a segmented arched head of 13 headers. The wooden door frame was original with pegged corners and chamfers to the outside arisses. The lower portions of the frame had rotted and repairs had been scarfed in. The door was constructed of five planks, ledged and braced internally, with a Suffolk latch, and a lock in a wooden box. The door was hung on 457mm (16") tee-hinges with large-headed screws.

The window lit the scullery. It had a segmented arched top of 14 headers but the casement window frame was modern.

South wall: painted brick, with a copper to the left and a cupboard, probably originally a fireplace, to the right (fig 14). Both had been boxed in obscuring the original layout. The copper was of cast iron, above a flue with cast-iron grate and firebox. The smoke exited to the chimney on the southwest corner of the house (fig 3).

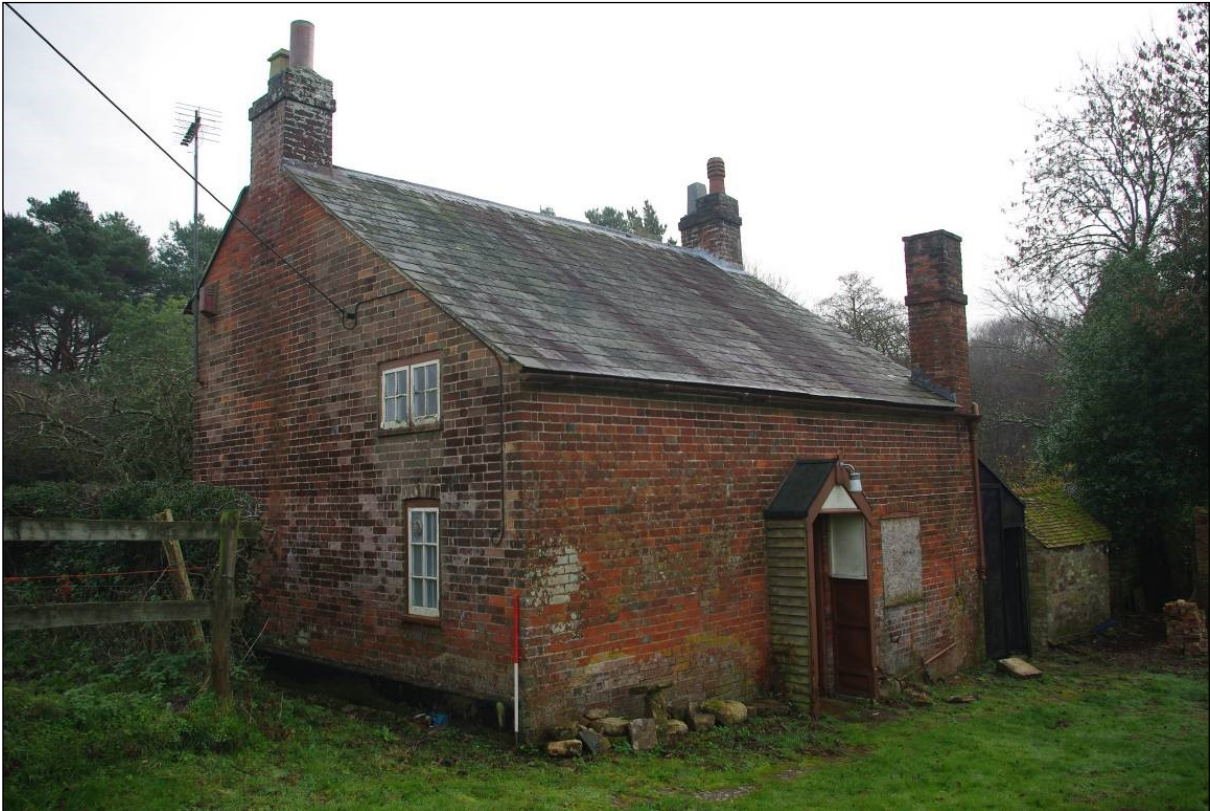
Figure 4. North and west elevations.

Brick wall in Sussex bond (fig 4). The lower four courses had been treated with a cement render, possibly an attempt at damp-proofing; the field just to the north was some 700mm higher than the base of the wall. A chimney with two flues rose above the roof ridge. The left pot was a square, buff, ceramic pot; the right pot was a section of glazed stoneware pipe. A narrow ground floor window, with a side-hung casement window, under an eight header arch lit the larder. Above it a rectangular window with side-hung casements beneath a flat head lit the first floor back store. Both were original.

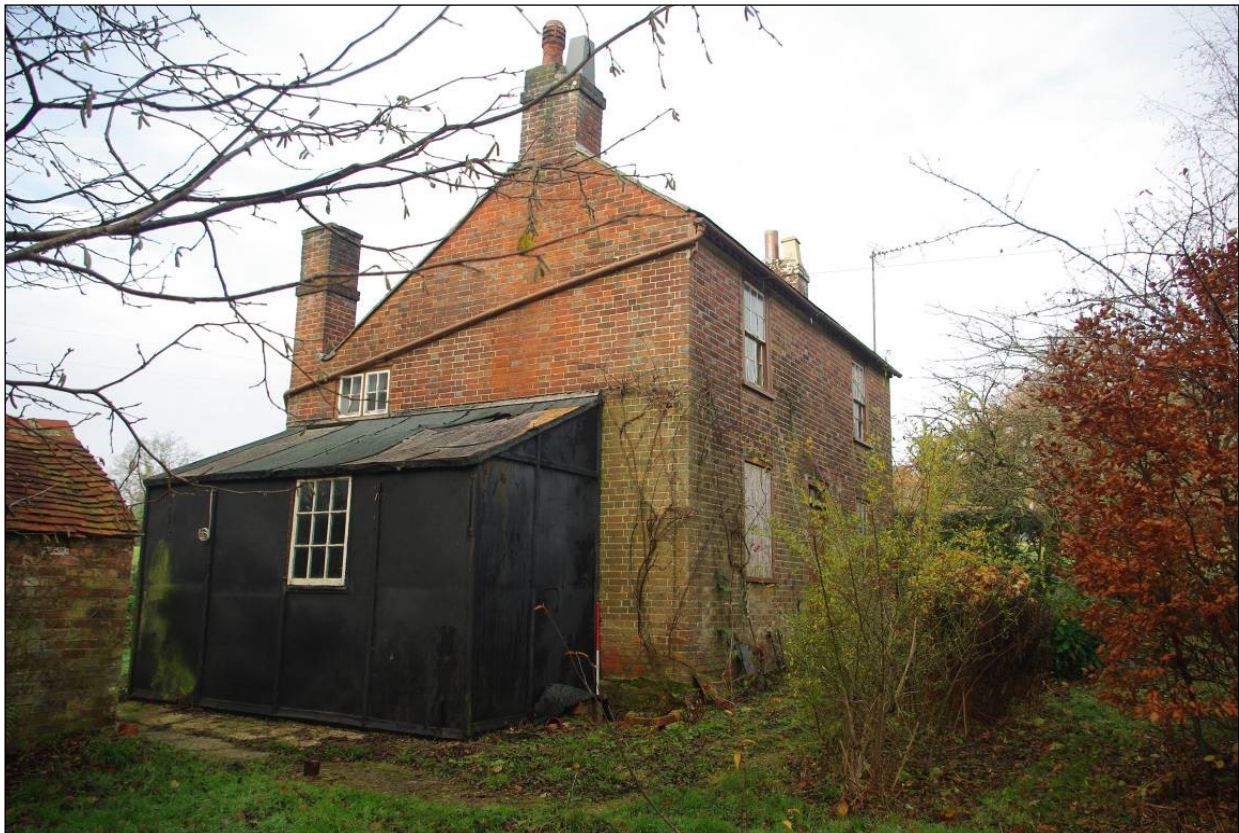
Figure 5. South and east elevations.

The elevation was built-in brick in Sussex bond, using red and blue headers (fig 5). There was a brick plinth at ground level. The lower part of the south elevation was partly obscured by the external timber shed (room 11). There were traces on the wall suggesting at least one earlier lean-to had stood there. A chimney with two flues rose above the roof ridge. The left pot was a circular louvred ceramic pot; the right pot was constructed from four tapering pieces of slate wired together, and was perhaps original. A flat-headed rectangular window lit the first floor back bedroom 3. It was original. On the southwest angle was a brick chimney, built as one with the south wall. It had a plat band three-quarters of the way up the stack. No chimney pot was visible.

The lean-to timber shed was built of re-used, machine-sawn softwood timber, mostly 76mm by 76mm (3" by 3"), with signs of previous use. It was clad in tarred hardboard. Soot staining on the exterior wall of the cottage probably reflects the flue in the scullery. The room had until recently been used to store coal. South wall had three-by-three pane window (fig 5).

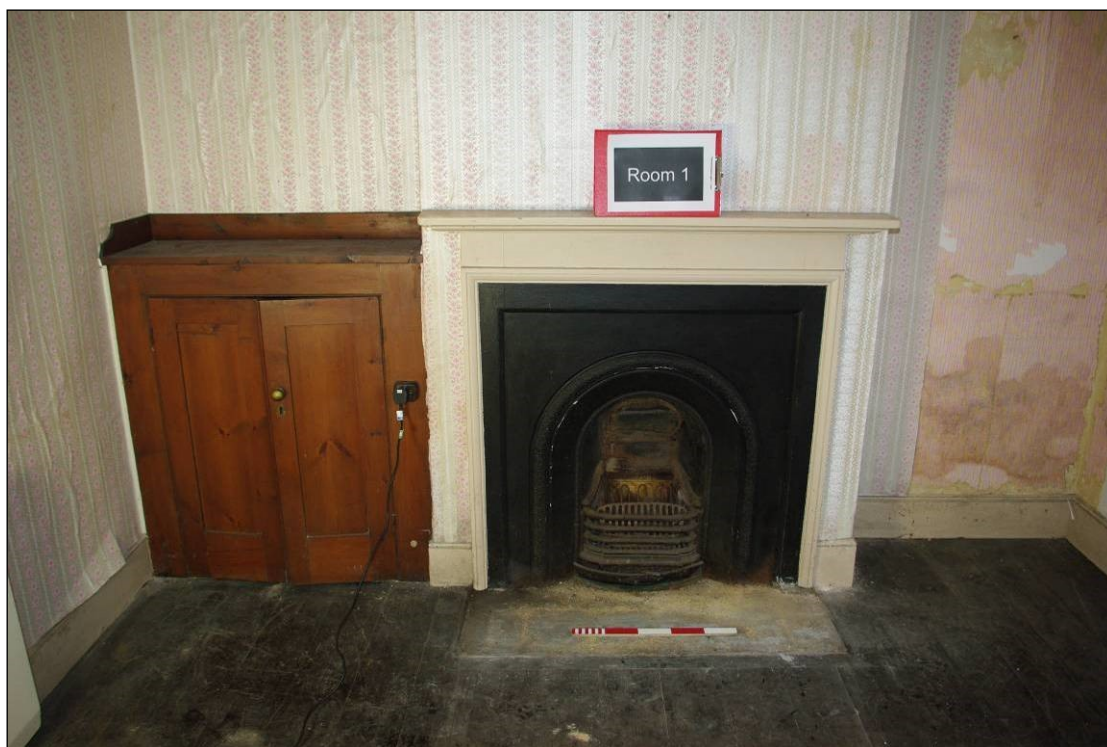
Figure 6. Fireplace and built-in cupboard in Room 1.

North wall: chimney breast 1.37m (4' 6") wide, with wooden fire surround and mantel shelf some 1.23m (4' ½") high, and 1.13m (3' 8 ½") wide (fig 6). Simple ogee moulding around fire, and cast-iron insert with floral outer arch and beaded inner arch. Built-in cupboard to left of chimney is probably a fairly recent fitting as it is laid over the skirting, and is in stained pine when all other original woodwork in the house is painted.

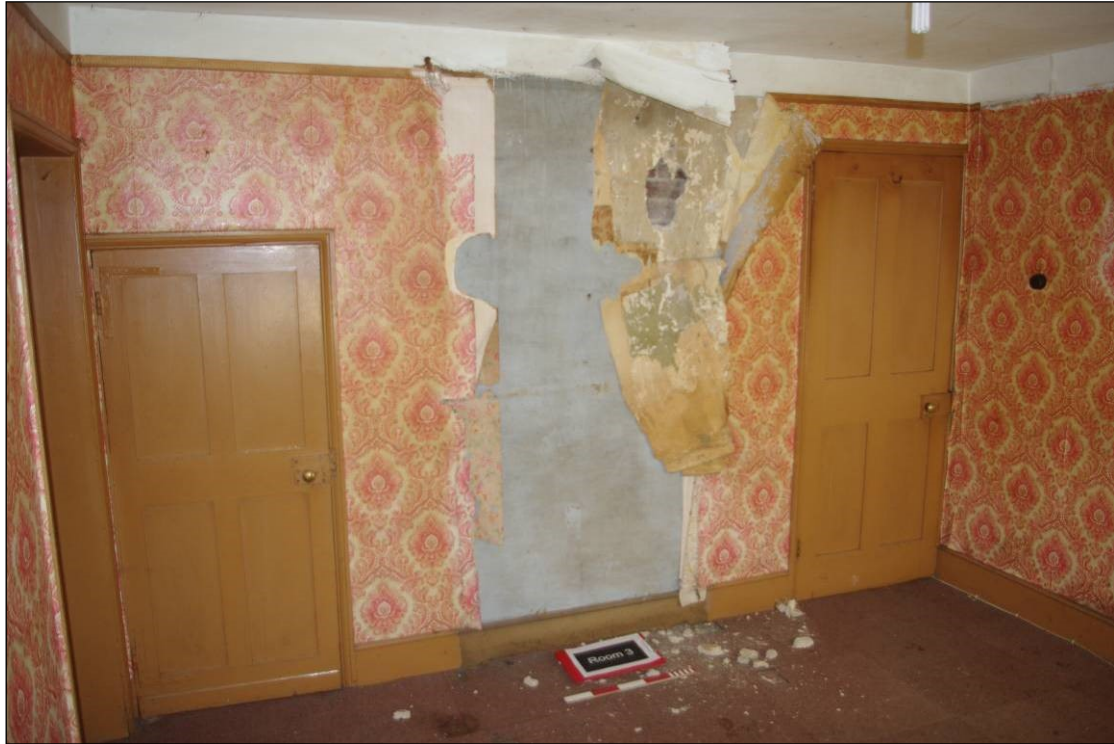
Figure 8. North wall of Room 3. Left hand door to under-stairs cupboard, right door to Room 2, hallway.

North wall: fallen plaster revealed 12mm (½") thick lime plaster with a small admixture of hair on brickwork. On the right was a door from the hallway on butt hinges with replacement lock and handle, on the left was a door with HL hinges and original latch to an under-stairs cupboard (fig 8).

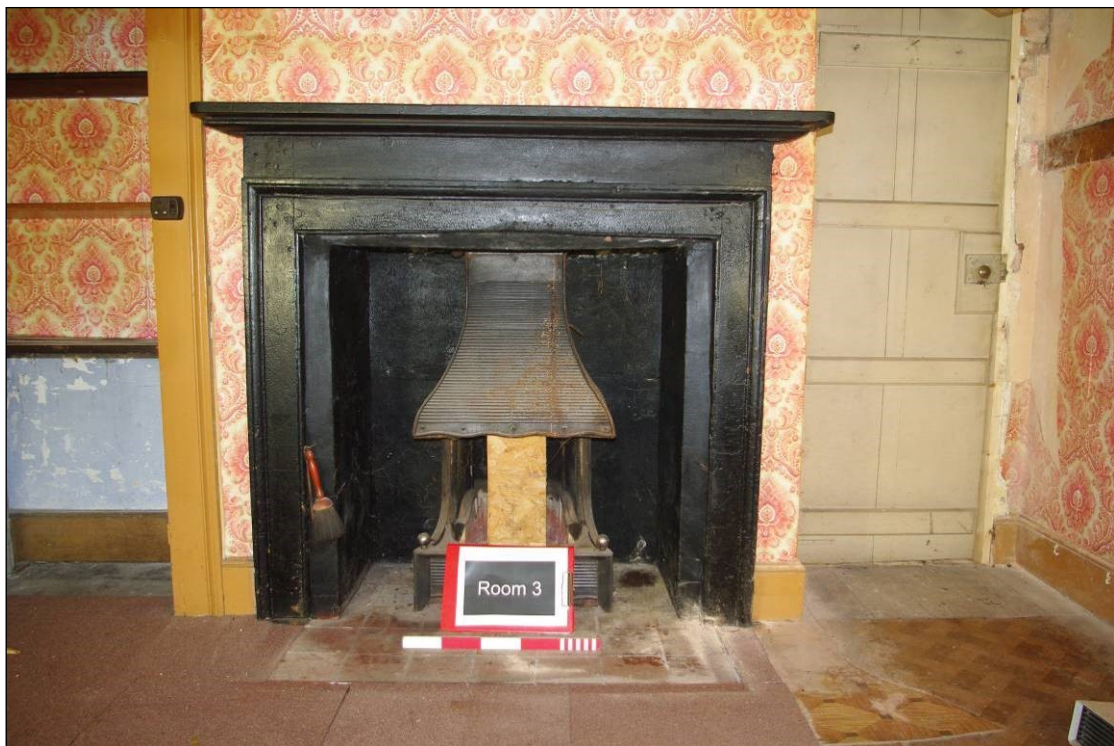
Figure 9. Fireplace in Room 3, in original opening for the range.

South wall: central chimney breast 4' 4" (1.32m) wide with 914mm (3ft) wide opening for a range (fig 9). Mantel shelf 4' 4 ¾" (1.34m high). Present tiled hearth had modern 101mm (4") red ceramic quarry tiles. Built-in cupboard to left of chimney with ogee architrave surround (fig 10). One original shelf together with two more recent replacements. Shelf to right of fireplace had been removed and there were layers of wallpaper beneath the positions of the shelf supports showing this was not an original feature.

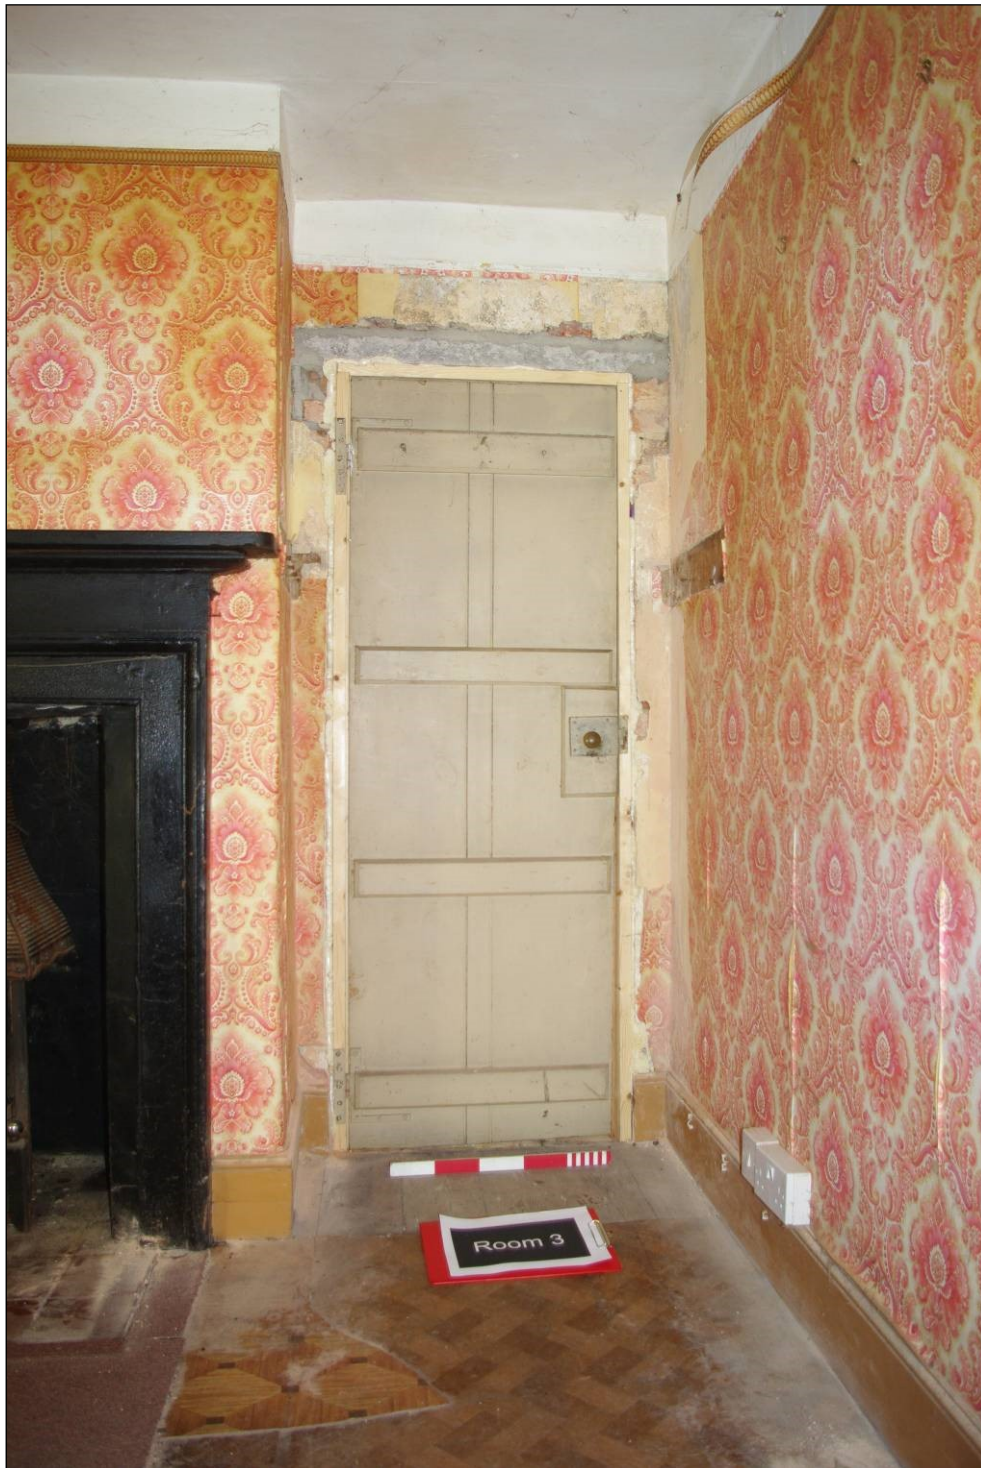
Figure 11. Door from Room 3 to Room 6, recently inserted, and originally in Room 10.

A doorway had been recently cut through the south wall using a disc cutter, demonstrating that the house was built without a cavity. A doorframe had been inserted in the opening and the door from between Rooms 9 and 10, with its original HL hinges had been hung in the opening (fig 11).

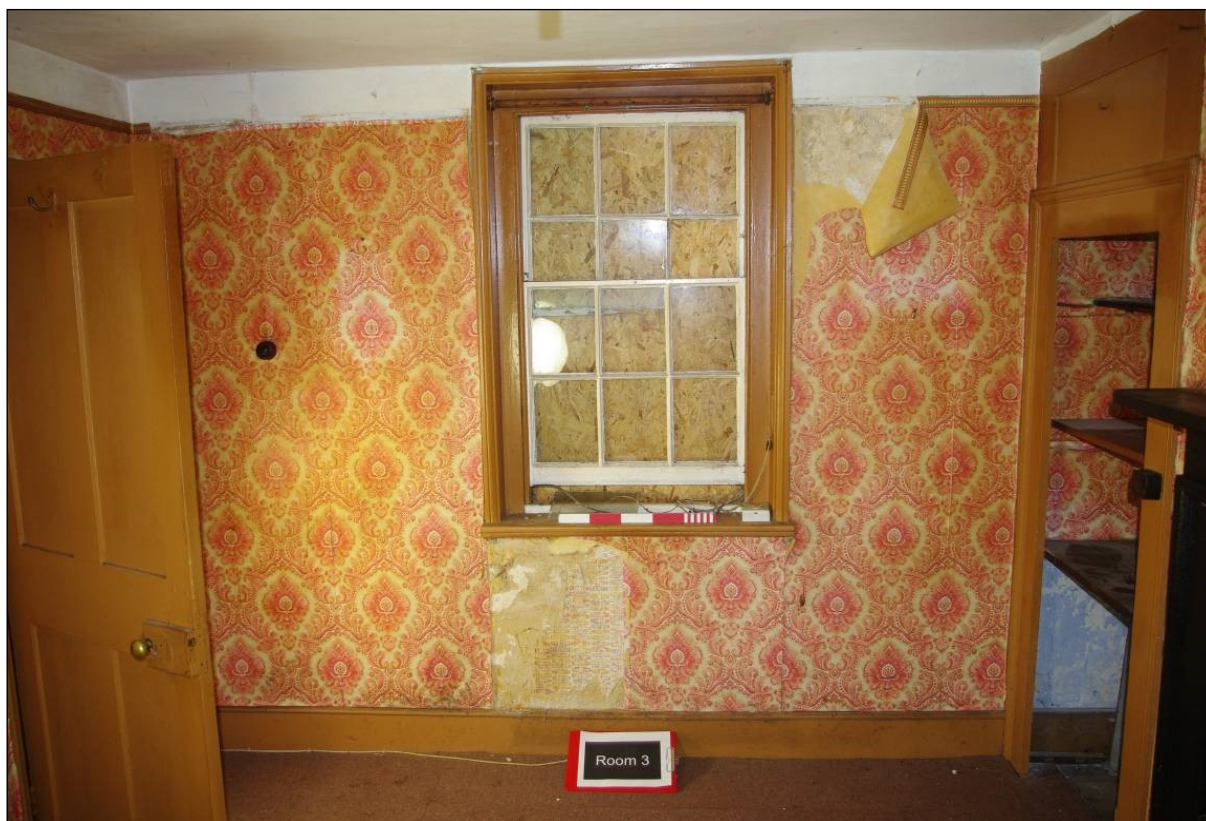
Figure 12. East wall in Room 3 showing sash window, door to Room 2 at left.

East wall: central window opening 0.97m (3' 2") wide by 1.4m (4' 7") high, with original six-over-six pane sliding sash (fig 12).

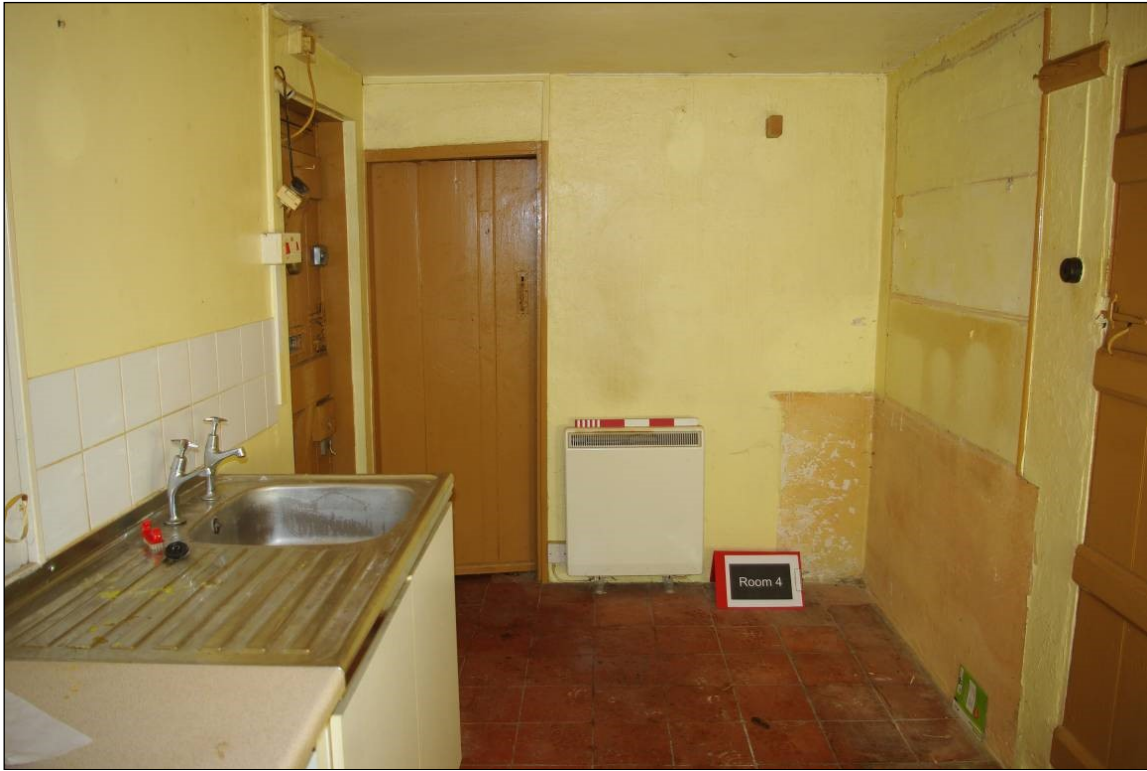
Figure 13. North wall of Room 4, with door to exterior on left, door to Room 5 in centre, door to Room 3 on right. Note traces of where dresser stood to right.

North wall: painted brick with a plank door with Suffolk latch leading to the larder area (Room 5) (fig 13).

East wall: painted plaster on brick, showing a ghost of a dresser-like set of shelves over a work top (fig 13). A door opening with a four-plank door with Suffolk latch led to the old kitchen (Room 3). Two lengths of dado rail were nailed to the wall carrying a number of nails and staples for hanging utensils.

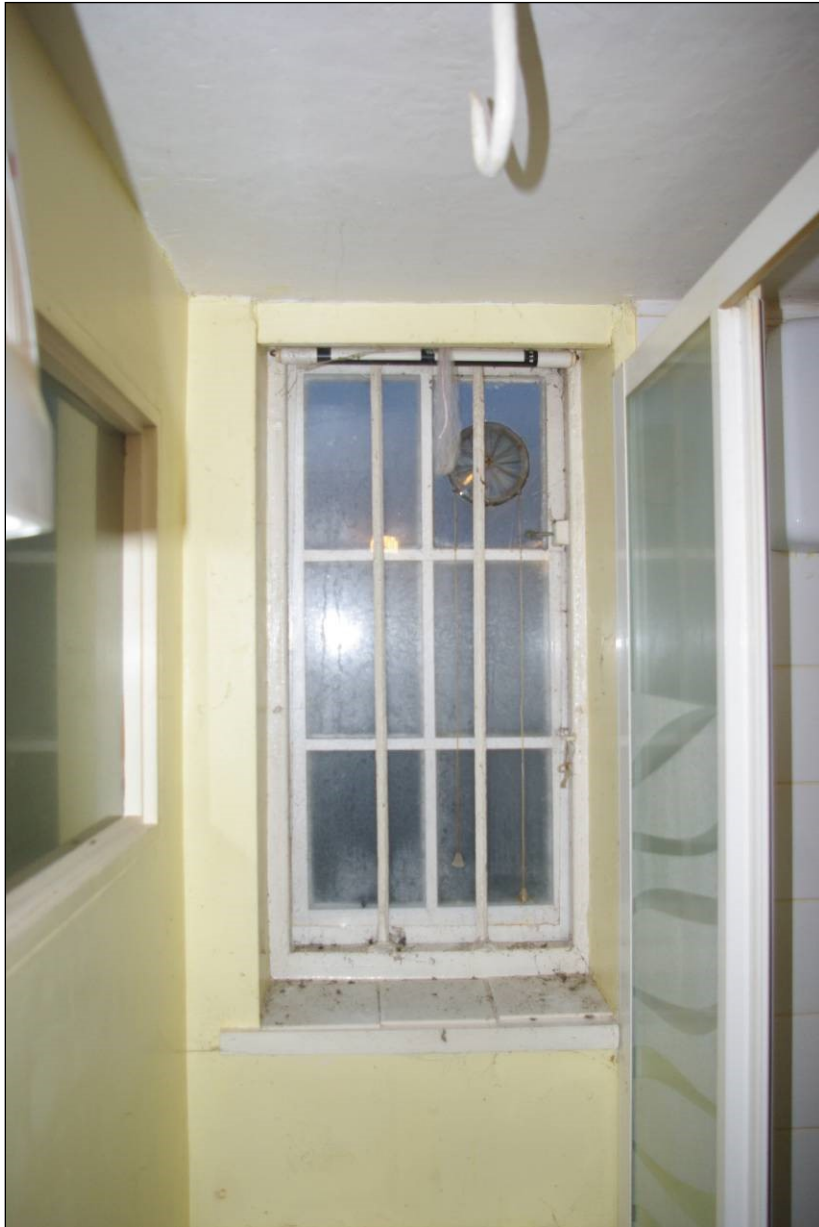
Figure 15. Barred window and carcass hanging hook in ceiling in room 5.

Now a modern shower room and toilet obscuring all original surfaces, but the four hooks in the central beam of the ceiling for butchering/hanging two carcasses suggest this was originally a larder (fig 15). The floor was solid with modern quarry tiles. A partition in the south part of the room divided off a corridor that led to a door opening into Room 1. The window was original with two substantial, vertical iron bars fixed to the wooden frame (fig 15).

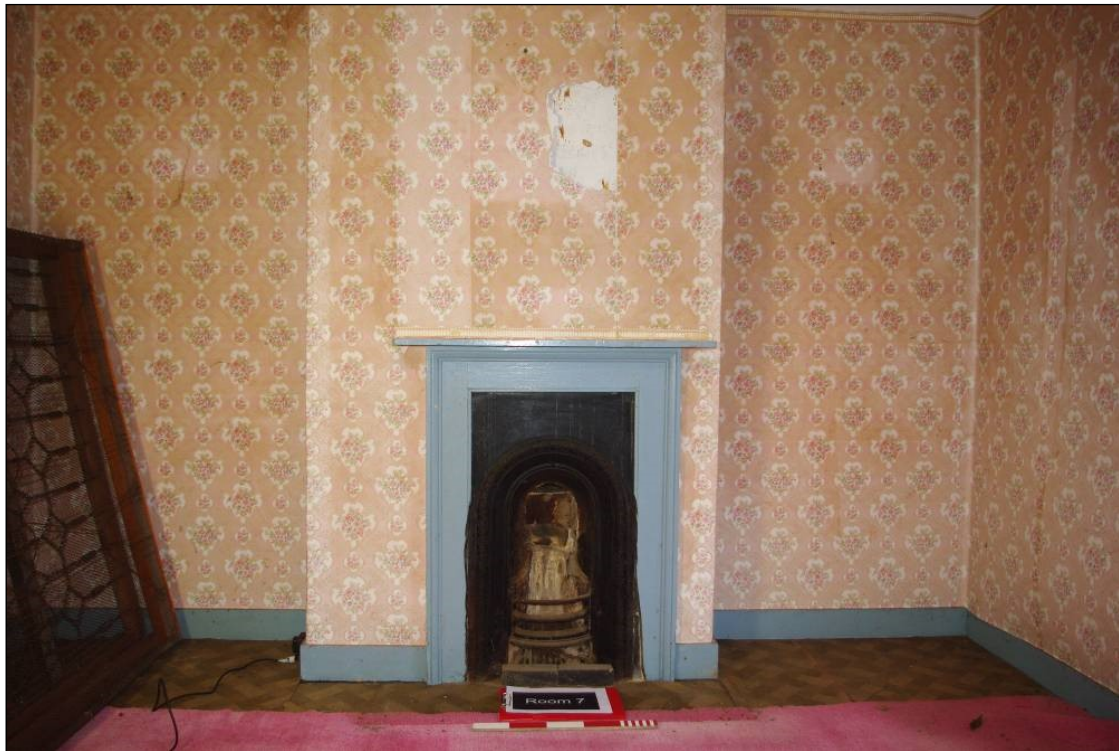
Figure 17. North wall of Room 7.

North wall: chimney breast 1.27m (4' 2") wide. The mantel was 1.06m (3' 6") tall and 0.76m (2' 6") wide. The cast-iron fire insert was 500mm (1' 8") by 900mm (3'), with a floral arch. The grate was very small, some 228mm (9") wide by 127mm (5") deep (fig 17).

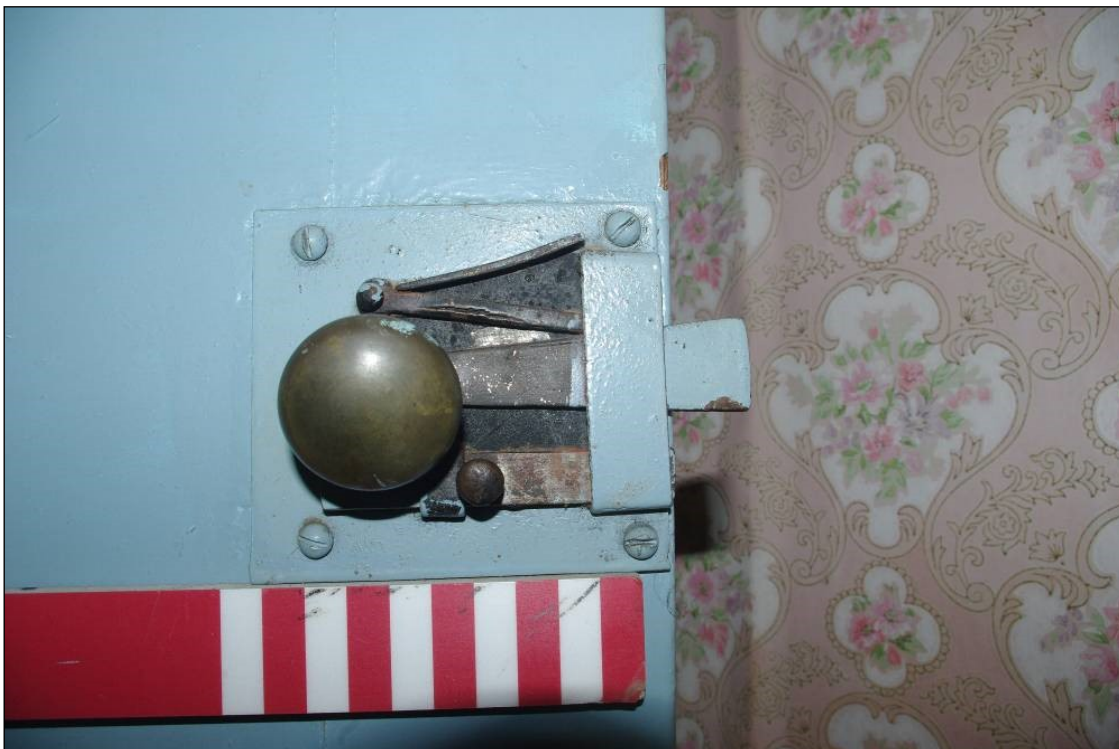
Figure 18. Door latch with privacy lock in Room 7.

South wall: Papered wall, built-in cupboard over hallway, and entrance door from stairs with original latch and handle (fig 18).

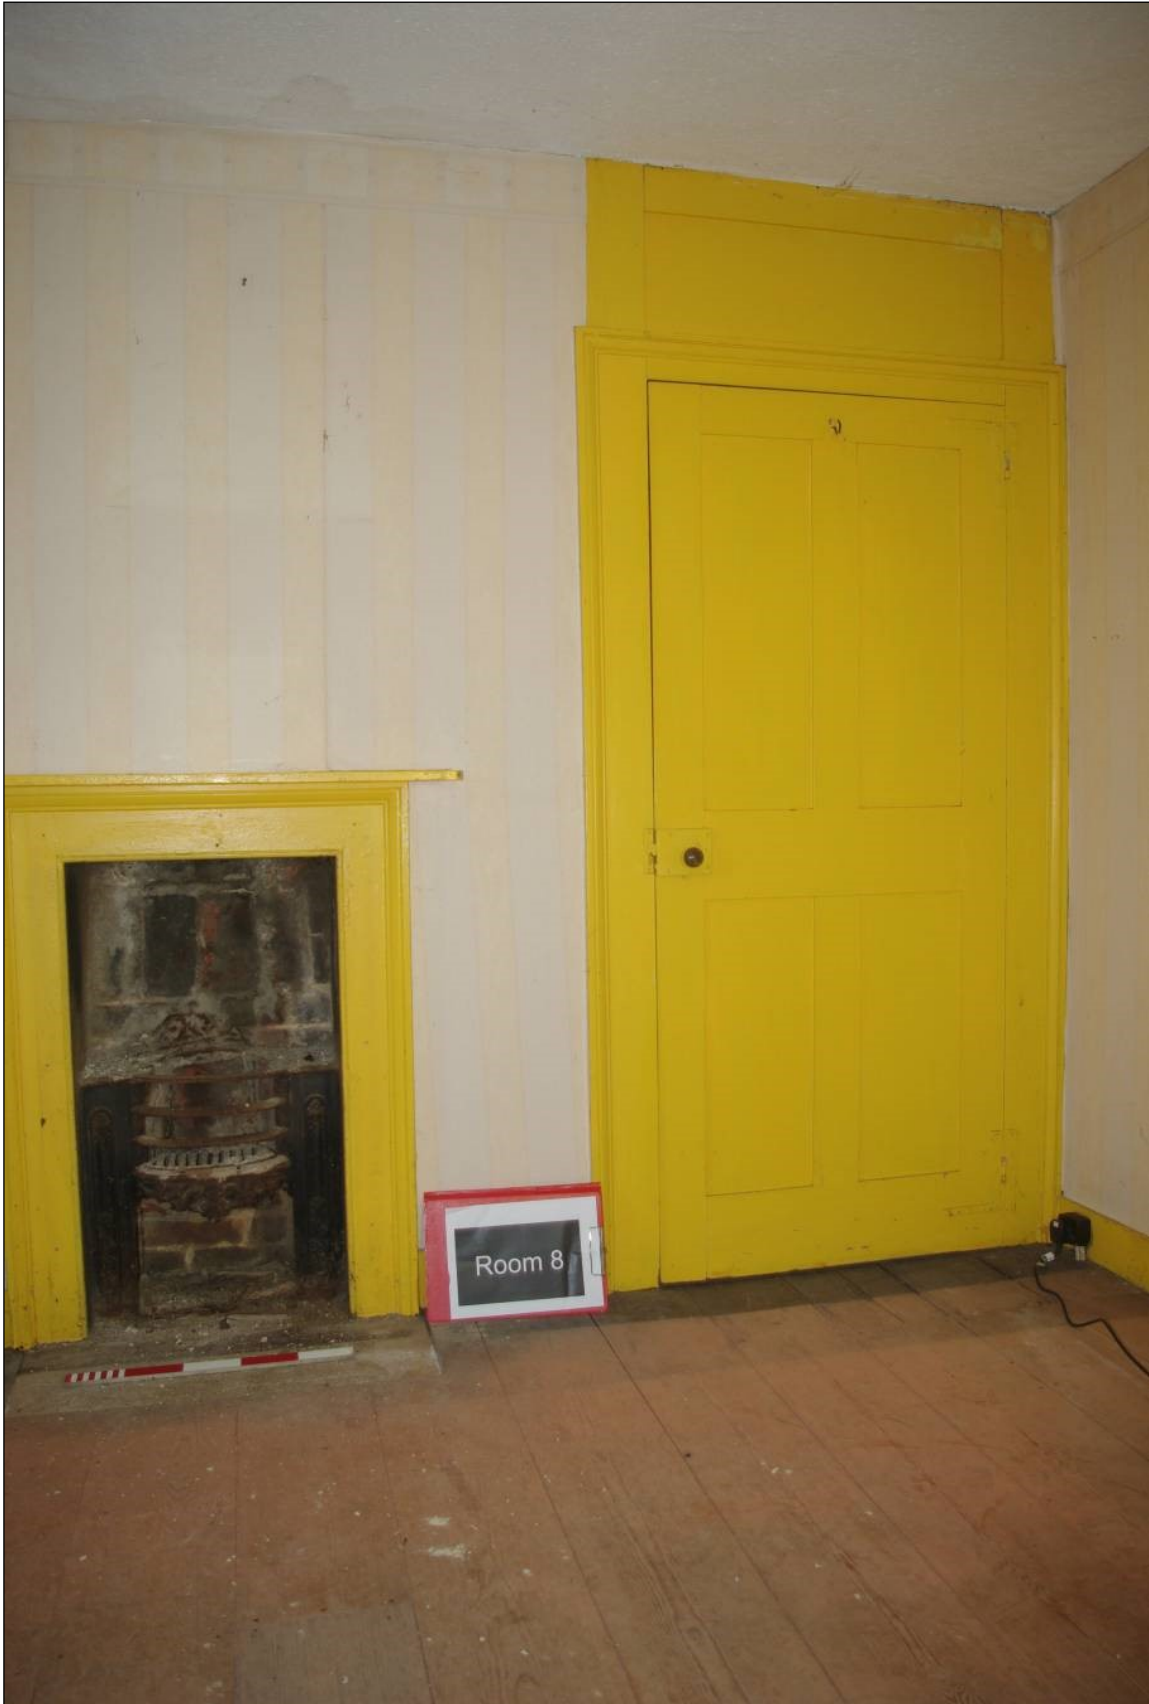
Figure 20. South wall of Room 8 with fireplace and built-in cupboard.

South wall: chimney breast 1.25m wide. The mantel was 1.06m (4' 1") tall and 0.76m (2' 6") wide. The cast-iron fire insert was 500mm (1' 8") by 900mm (3'), with a cheeked opening on which a kettle or pot could be sat. To the side of the chimney breast was a built-in cupboard with HL hinges, held on by nails (fig 20). The two shelves were missing.

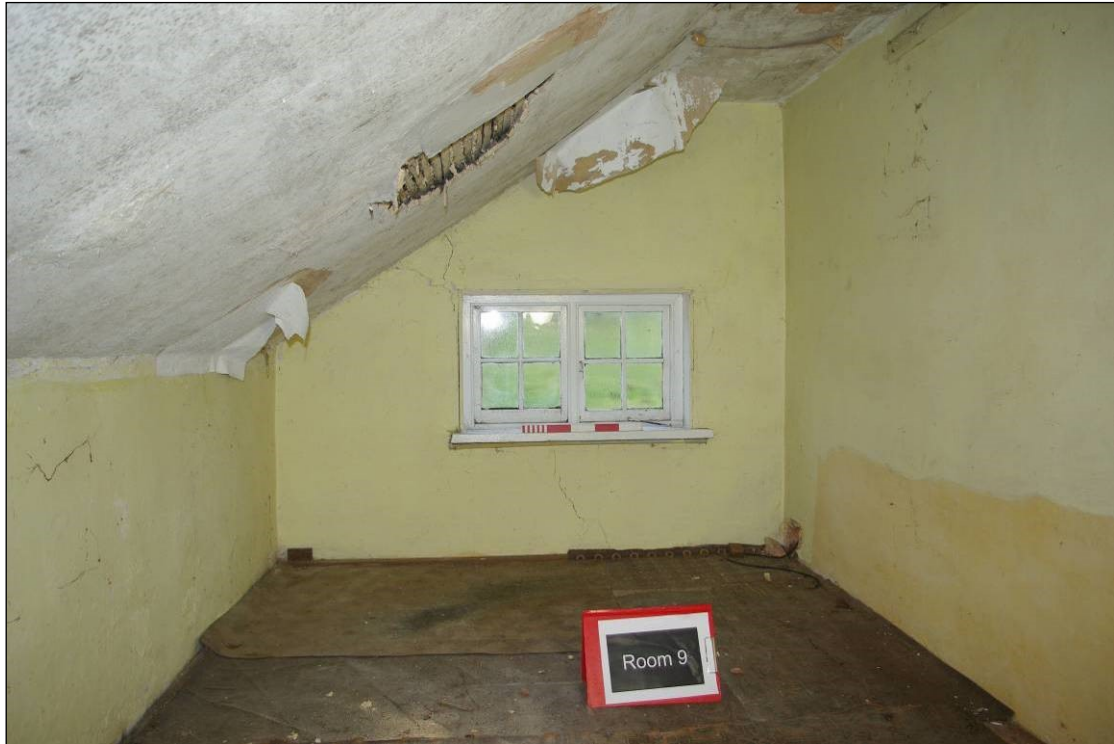
Figure 21. North wall of Room 9, beneath the cat-slide roof.

North wall: window with two four-by-four pane casements, one opening (fig 21).

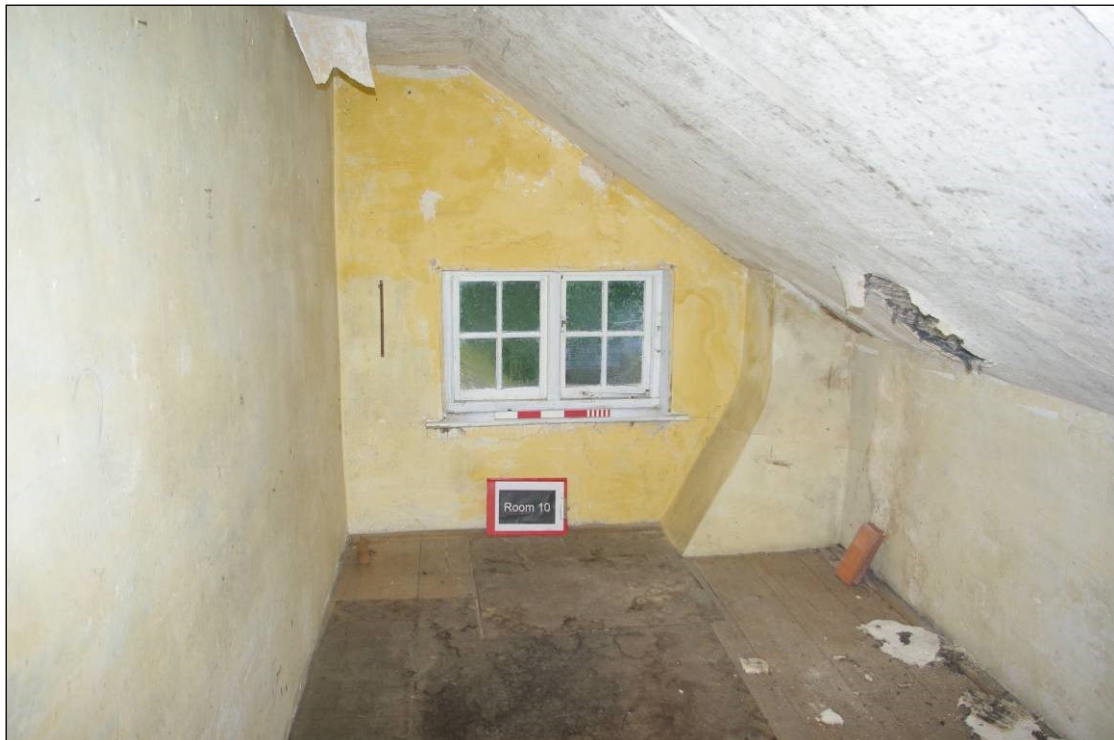
Figure 22. South wall of Room 10, with flue from copper below.

South wall: Painted plaster, window with two four-by-four pane casements, one opening (fig 22).

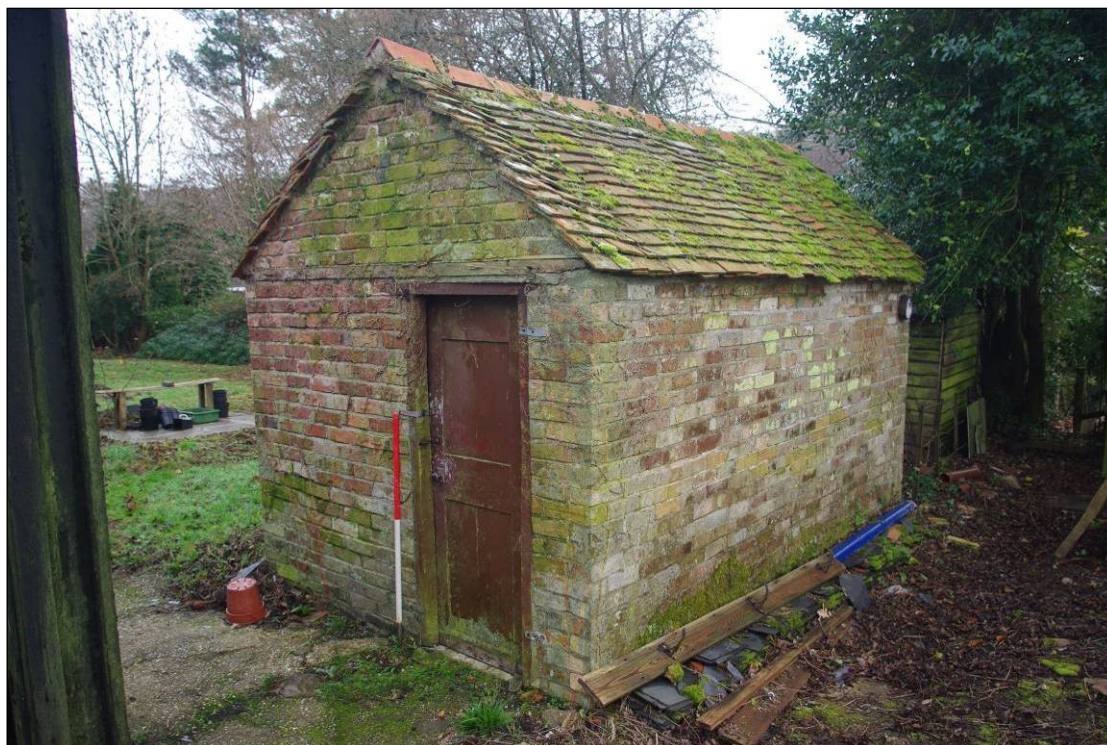
Figure 24. Room 11 external brick shed, from the northwest.

To the south of the cottage was a brick shed (fig 24). It first appears on the 1970-1 OS map. It was crudely built of re-used bricks with traces of whitewash from their previous use, bonded with coarse sandy cement mortar. The roof was of peg tiles, with a ceramic ridge. There was an opening in the east elevation, containing a window frame made from 50mm square softwood to which two sheets of glass had been tacked. There was a door opening in the north elevation.

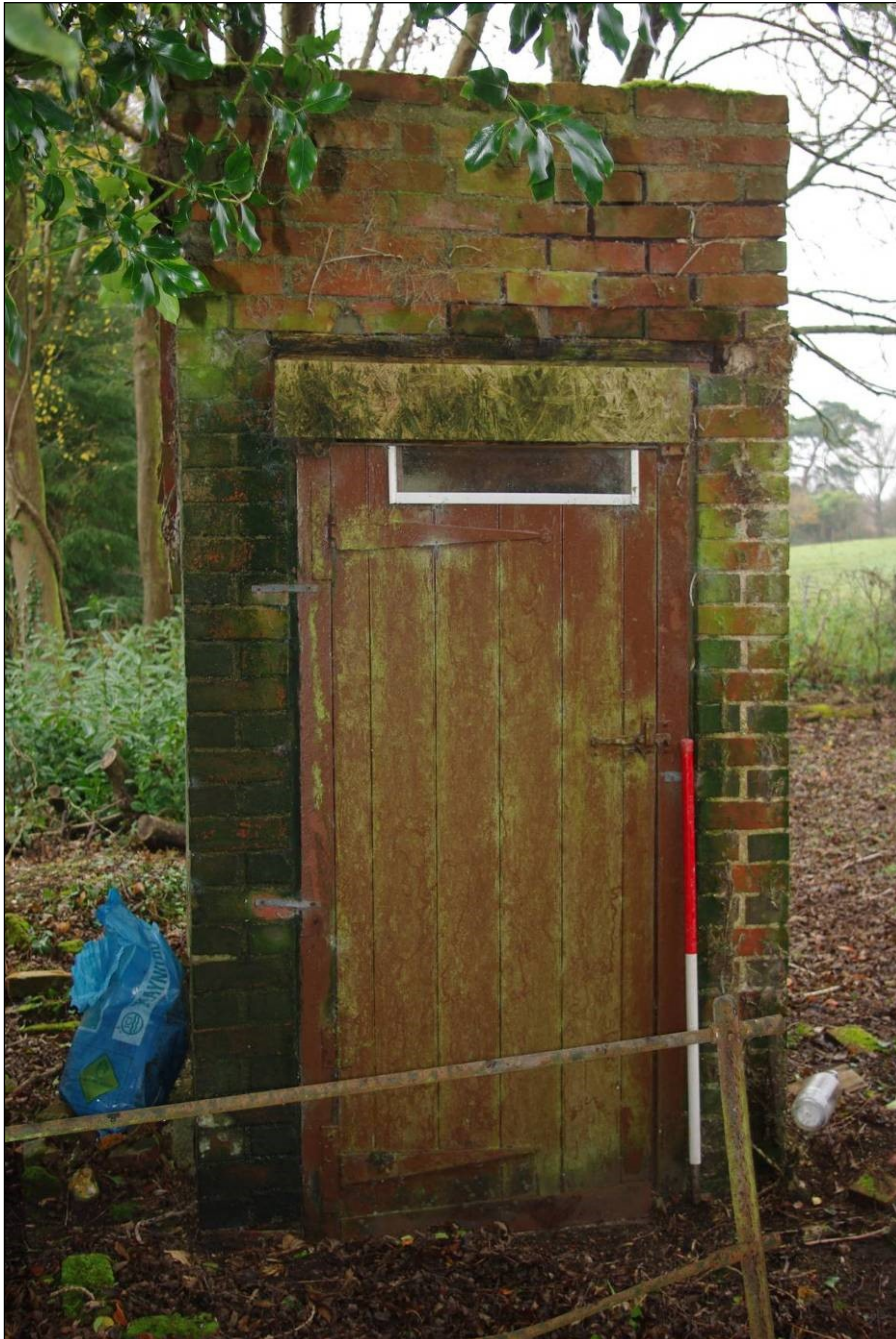
Figure 25. Brick earth-closet, Room 12, from east.

To the southwest of the cottage was a brick-built earth-closet. It had 228mm (9") brick walls on the north, south, and east elevations, which made use of red stretchers and blue headers in Sussex bond (figs 25 and 26). The west elevation, and the part of the east

elevation above the door was only a half brick thick and in stretcher bond (figs 25 and 27). The door was in the east elevation and was planked, with tee hinges and a Suffolk latch (fig 25). The door may originally have had a cut-out at the top for light and ventilation, this had been glazed more recently (fig 25). The west wall had a low opening with timber lintel at ground level (fig 27) to allow the bucket to be removed from beneath the seat, which was missing. The roof was of clay tiles, which may have replaced a slate roof, as the brickwork beneath the roof had been rebuilt in the same cement mortar as the brick shed room 11, and there were a number of whole slates in the vicinity of the earth-closet and stacked against the west wall of the brick shed.
