Report 1139

**Archaeological Watching Brief at 29-33 Market Street,
Poole.**

POOMS: AR 1927

Archaeological Watching Brief at 29-33 Market Street, Poole.

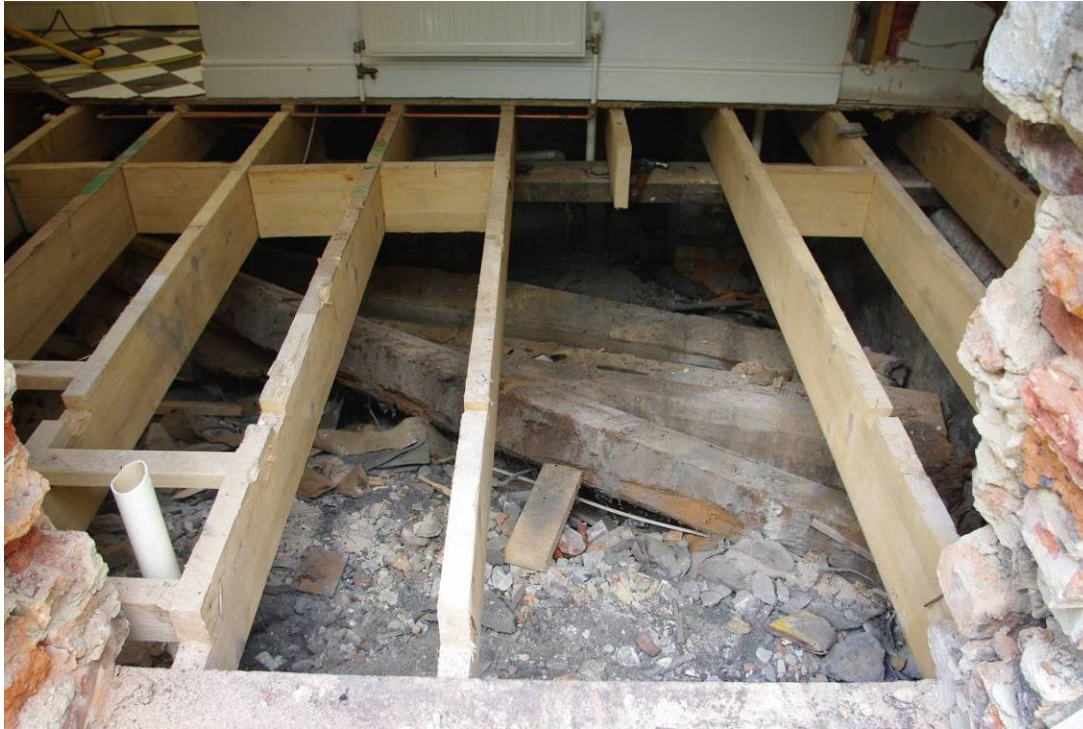
Clearance of the cellar was limited to removing up to 300mm of demolition material (Context 5), deposited within the room (Fig 2). Context 5 was very loose, dusty silt, dark grey in colour with very common inclusions of 20th century material. Four beams, not in situ, were found in the cellar and retrieved before closure of the room due to the presence of asbestos. All the beams were cut in half to enable them to be removed from the building and recorded.

Fig 2. Cellar filled with context 5.

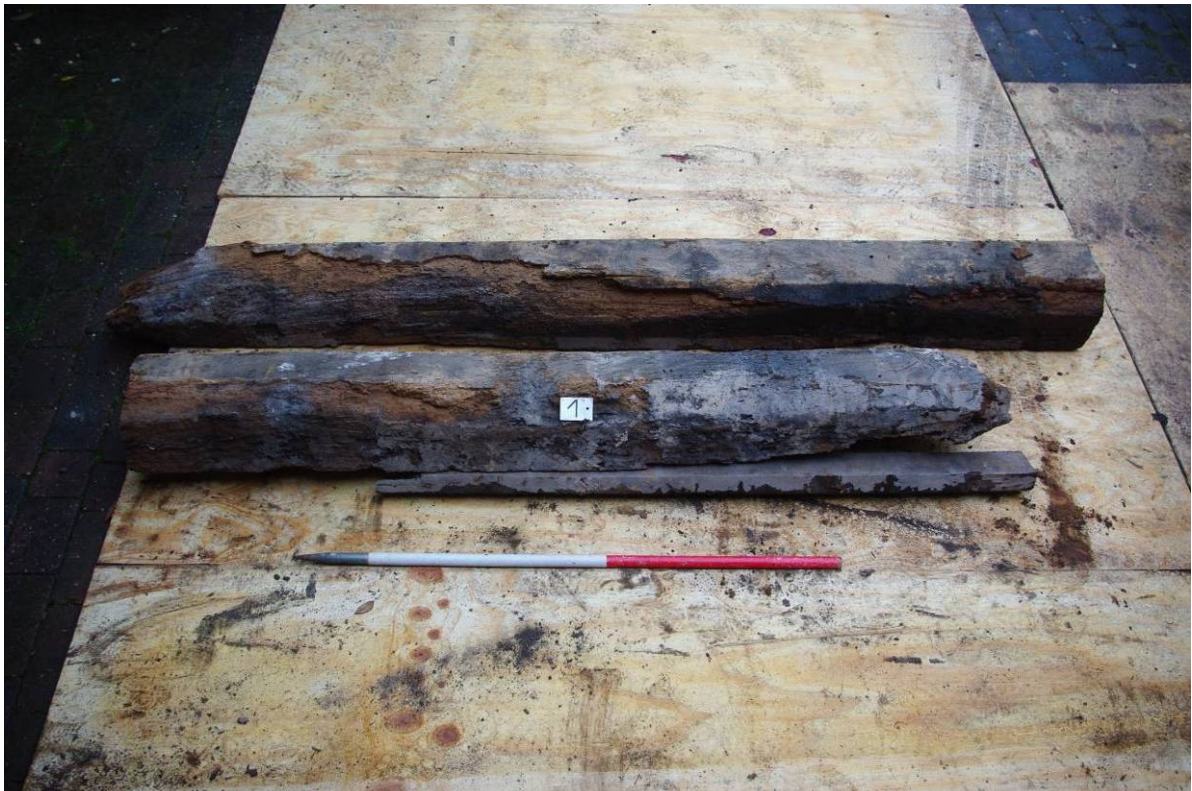
Beam 1 (Context 1) was 4.35 m long, 240mm wide and 190mm thick (Fig 3). It was made of oak, partly rotten, with traces of hand sawing and adzing. There were no carpenter's marks. One damaged mortice hole (250mm long x 60mm wide x 30mm deep) was present at the very end of the beam. The beam had been reinforced by a 1.45 m long, 80mm wide and 50mm thick, machine sawn, softwood plank. It had been nailed to the timber with modern nails.

Fig 3. Beam 1

The beams in the cellar were probably parts of the floor/ceiling above the cellar, removed when the building was last refurbished. The artefacts retrieved from the cellar backfill suggest that the cellar was being used to dispose of rubbish in the early 20th century. Due to the unexpected discovery of asbestos, only a small proportion of the artefacts and timbers were recorded but they provide useful information about the building and its construction.

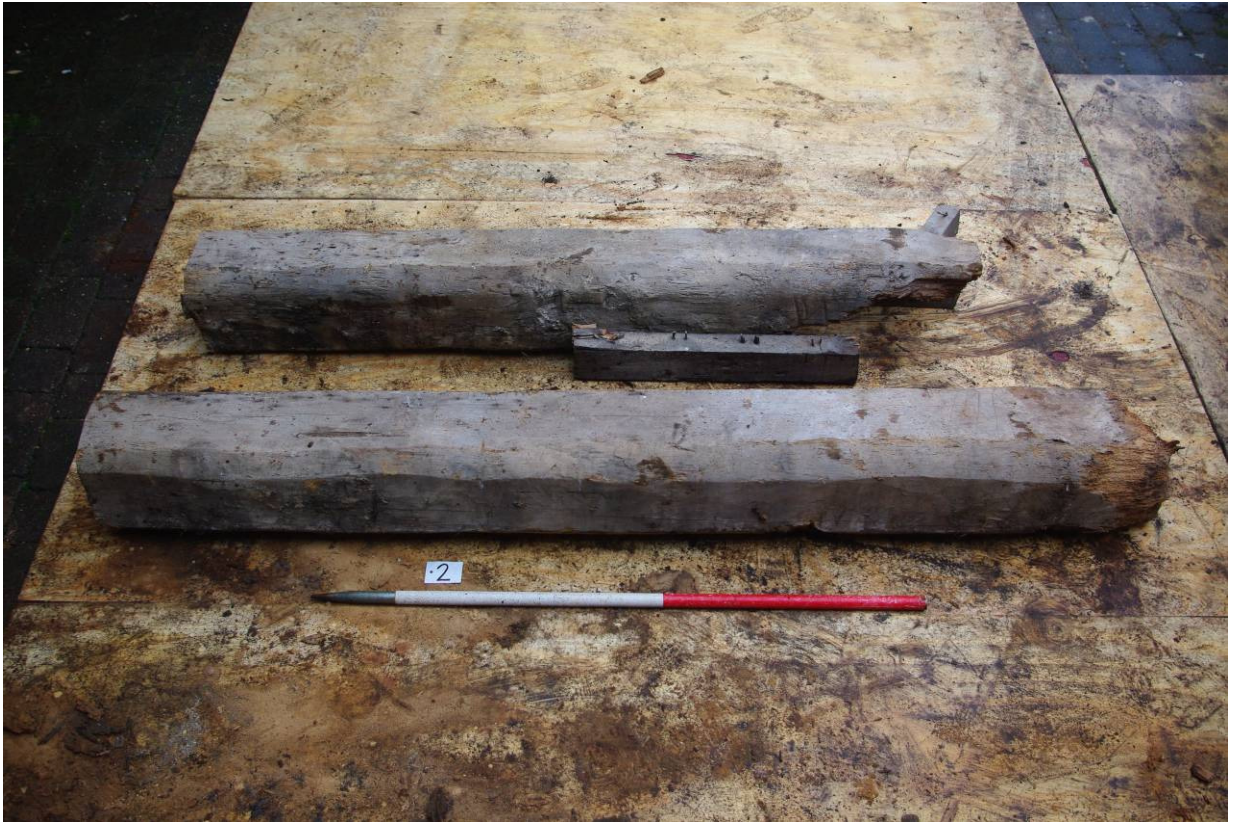
Beam 2 (Context 2) was 3.75 m long, 210mm wide and 200mm thick (Figs 4 & 5). It was made of oak, partly rotten, with evidence of hand sawing. It was partly adzed on the sides and trimmed by adze at one end. It had been lime washed. Two carpenter's marks (VIII) and three damaged mortises (260mm long x 60mm wide x 30mm deep)

were present on the beam. A number of lengths of machine sawn, softwood joists had been attached with modern nails.

Fig 4. Beam 2, under side.

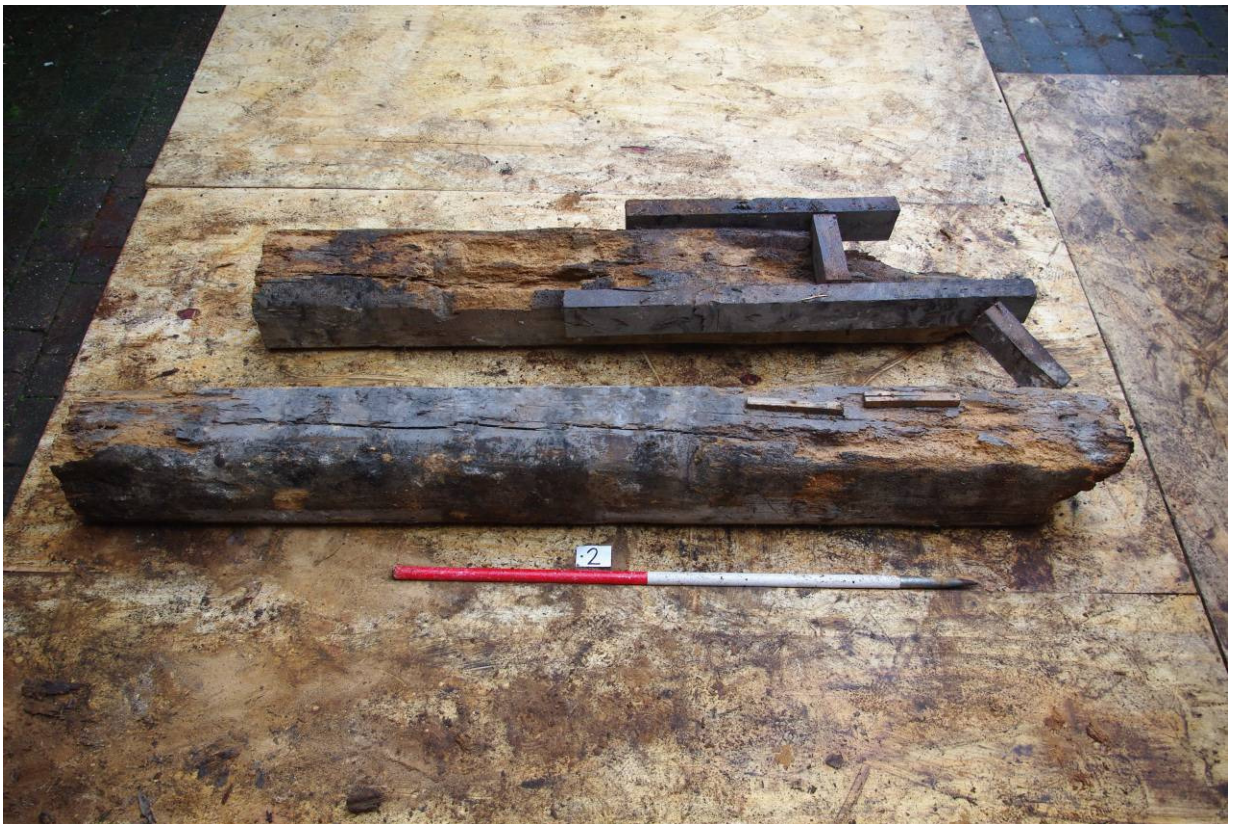
Fig 5. Beam 2, upper side.

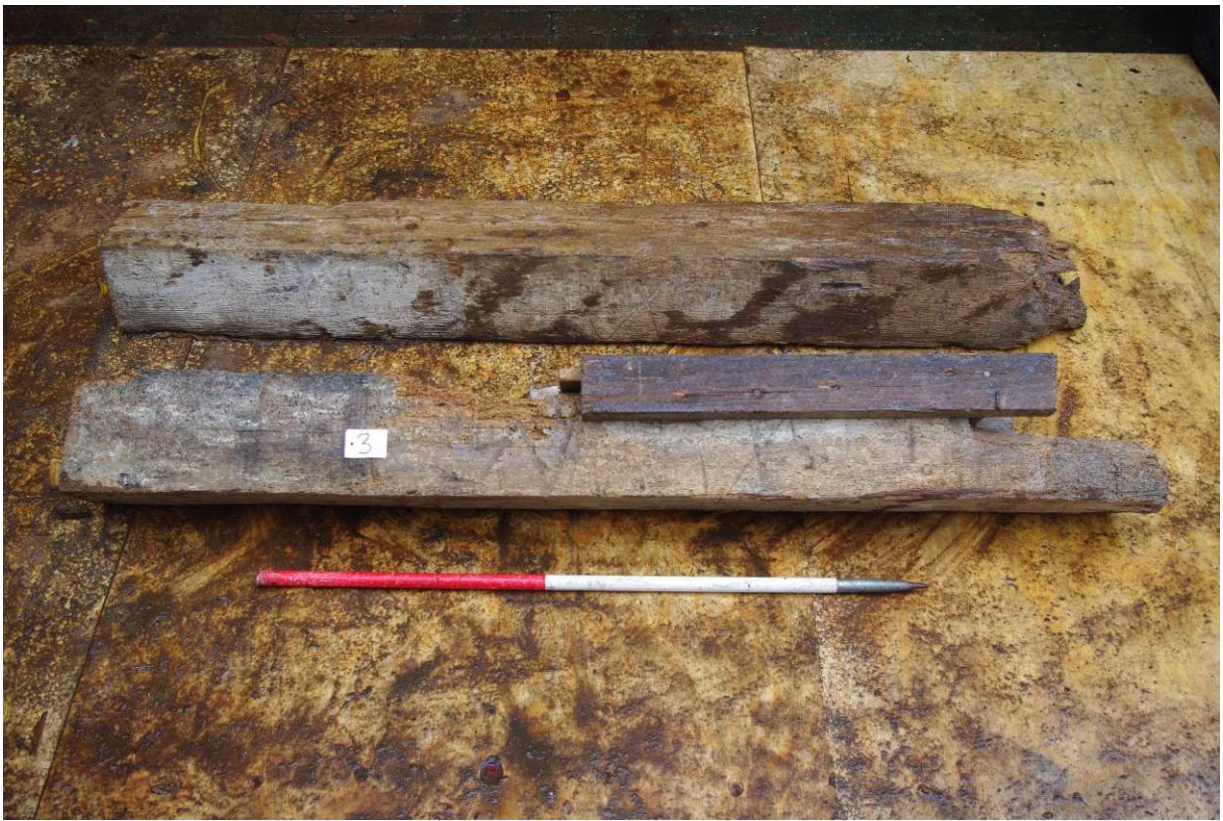
Beam 3 (Context 3) was 3.9 m long, 230mm wide and 210mm thick (Fig 6). It was made of oak. Three sides were hand sawn and was one adzed. Four carpenter's marks (2 of VII and 2 of IXI) (Fig 7) and one mortise (80mm long x 20mm wide x 15 mm deep) were present. Context 3 was reinforced with a machine sawn, softwood plank.

Fig 6. Beam 3.

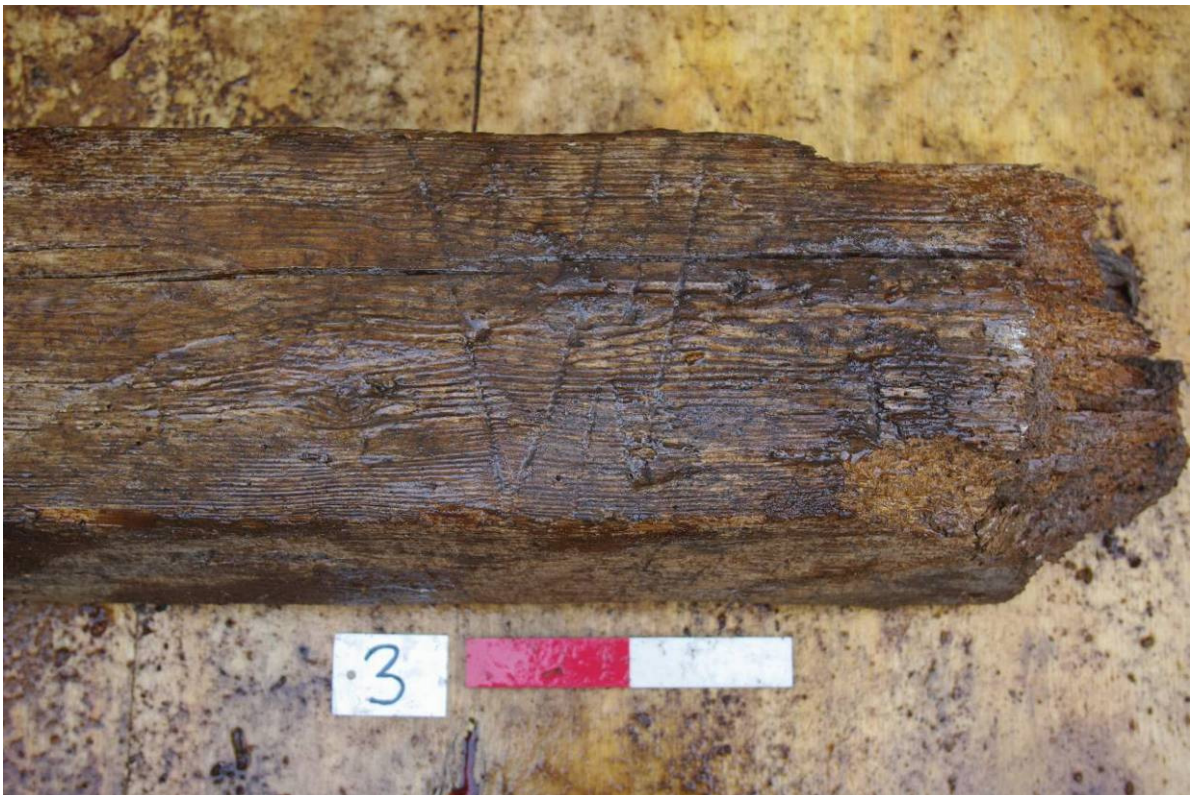
Fig 7. Carpenters Mark VII on Beam 3.

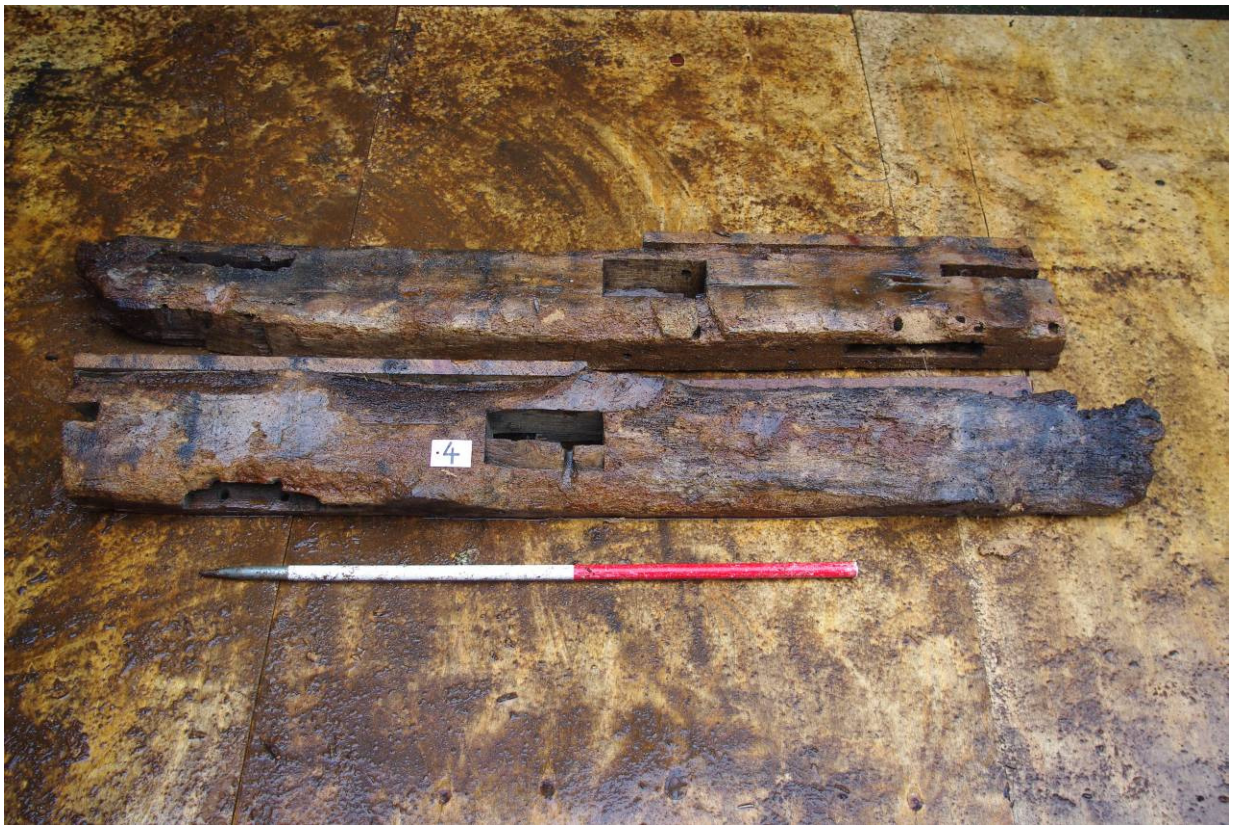
Beam 4 (Context 4) was 4.0 m long, 270mm wide and 120mm thick. It was made of oak, partly rotten, hand sawn, with no carpenter's marks. It bore seven mortices and numerous peg-holes (Fig 8). The mortices varied from 200mm to 250 mm in length, 30mm to 100mm in width and 20mm to 120mm in depth. A modern, machine sawn, softwood plank had been nailed to it at one end.

Fig 8. Beam 4.
