### Report on the Archaeological Watching Brief at Green Ash, Lower Sandy Down, Boldre, New Forest National Park.

EL Anderson BA MA AlfA and AD Russel BA PhD MifA  
2013  
Report 1144  
Client: John Dodwell

Site code	A2013.28
Archaeology Unit report	1144
Ordnance Survey grid reference	NGR SZ 308994
Planning application number	12/97410
Accession Number	A2013.28

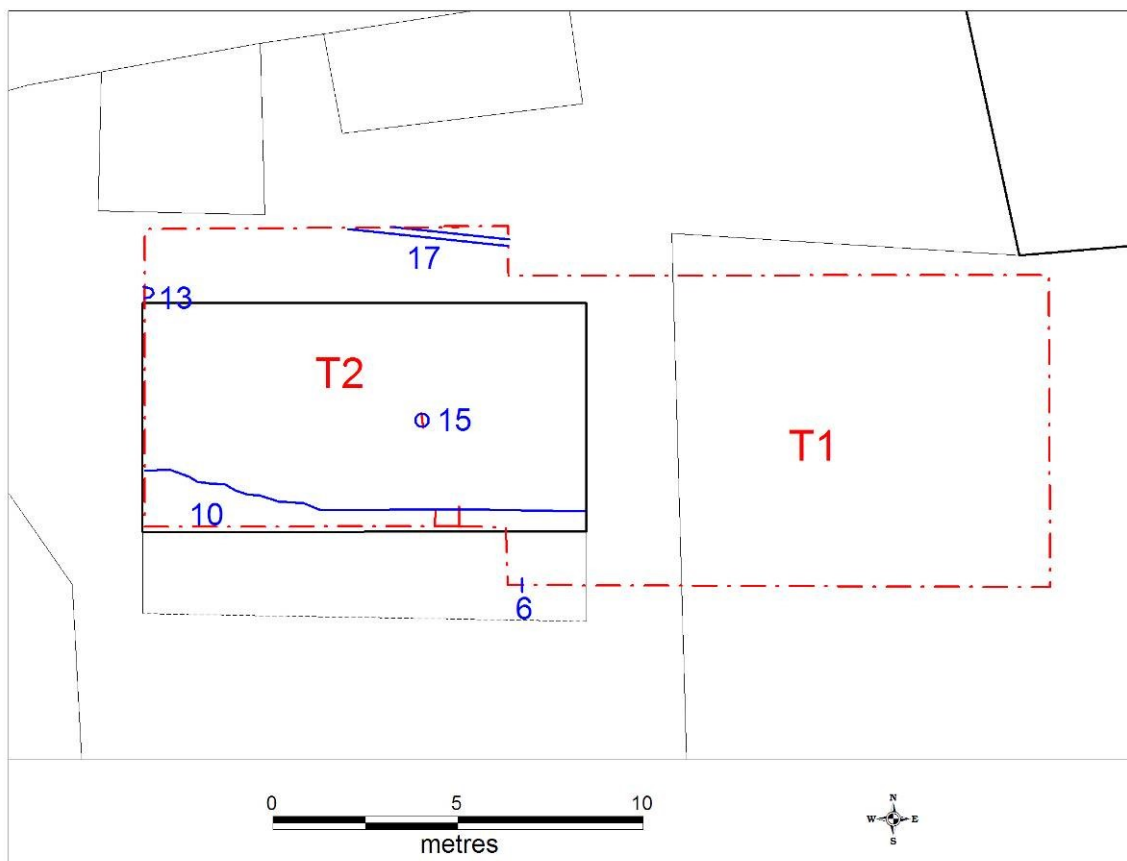
**Figure 2: Trench location, trenches 1 and 2 shown in red, and features in blue**

The Victorian extensions and part of the original 18<sup>th</sup> century thatched cottage were removed to make way for the extension. A total of two trenches were dug (fig 1 and 2). Trench 1 was to the east of the 18<sup>th</sup> century cottage after the demolition of the Victorian extension and was dug for the foundations of the new extension. It was 15m long, 8.5m wide and ranged from 0.5m to 1.7m deep; the majority of this trench was excavated before the archaeological contractor was informed of the groundworks. Trench 2 was situated within what remained of the 18<sup>th</sup> century thatched cottage. It was dug to remove the concrete floor within the building and for a level reduction to the north of the building. It was 10m long, 8m wide and ranged from 0.3m deep in the south and 0.6m deep in the north.

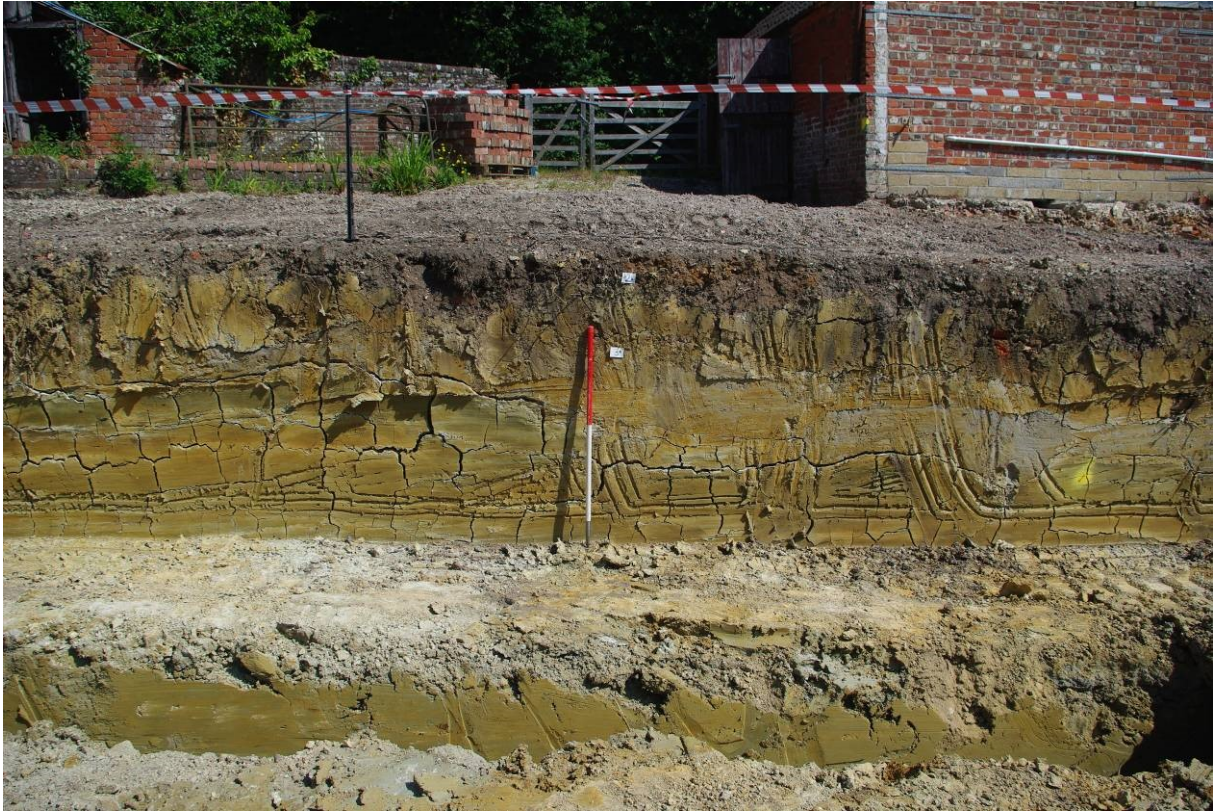
**Figure 3: South facing section showing layers 2 and 3**

Natural sand and clay, 4, was situated 1.8 – 1.9m below the surface and was at least 0.2m thick (figs 3 & 7). It was mostly light grey (10YR 7/1) sand with patches of pinkish grey (5YR6/2) clay.

Above 4 was natural clay 3, some 0.2-0.5m below the surface. It was observed in both trenches 1 and 2 (figs 3 and 7). It was a yellow (10YR7/8) silty clay and was 1.85m thick.

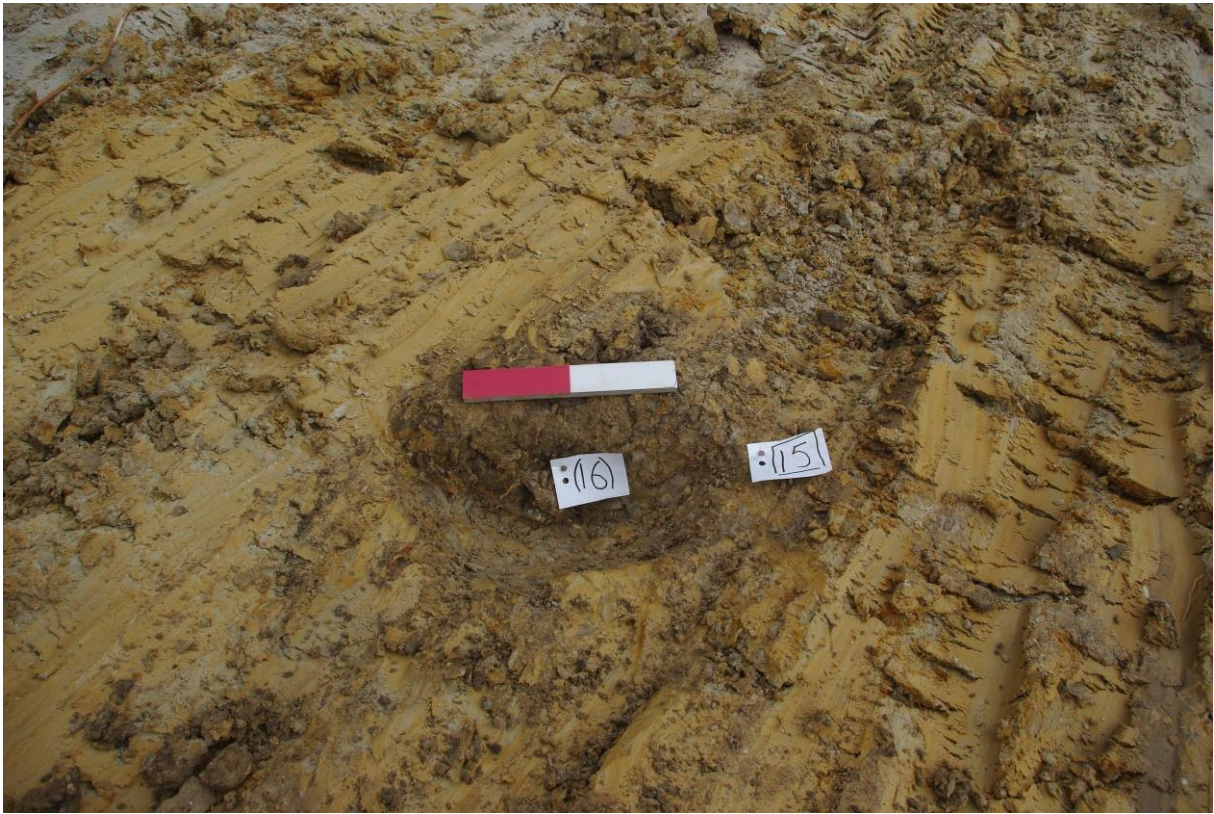
Figure 4: East facing section of posthole 15

Posthole 15 was situated in trench 2 near the east end (figs 2, 4, and 5). It was 350mm long, 340mm wide and 150mm deep. The sides sloped gradually and the base was concave. It was filled with a light brownish grey (10YR6/2) sandy clay loam containing some charcoal and burnt flints, context 16. One fragment of burnt flint, one worked flint flake and one fragment of abraded 17<sup>th</sup> century Verwood pottery was recovered.

The natural consisted of sand and clay. Posthole 15, beneath the floor of the 18<sup>th</sup> century cottage, was probably prehistoric in date, as it contained burnt flints and a struck flint flake. The fragment of 17<sup>th</sup> century pottery that was also recovered was probably intrusive, perhaps being introduced when the site was cleared for construction in the 18<sup>th</sup> century. Similar features may have been present in the area of trench 1 but this area was removed before the watching brief commenced.

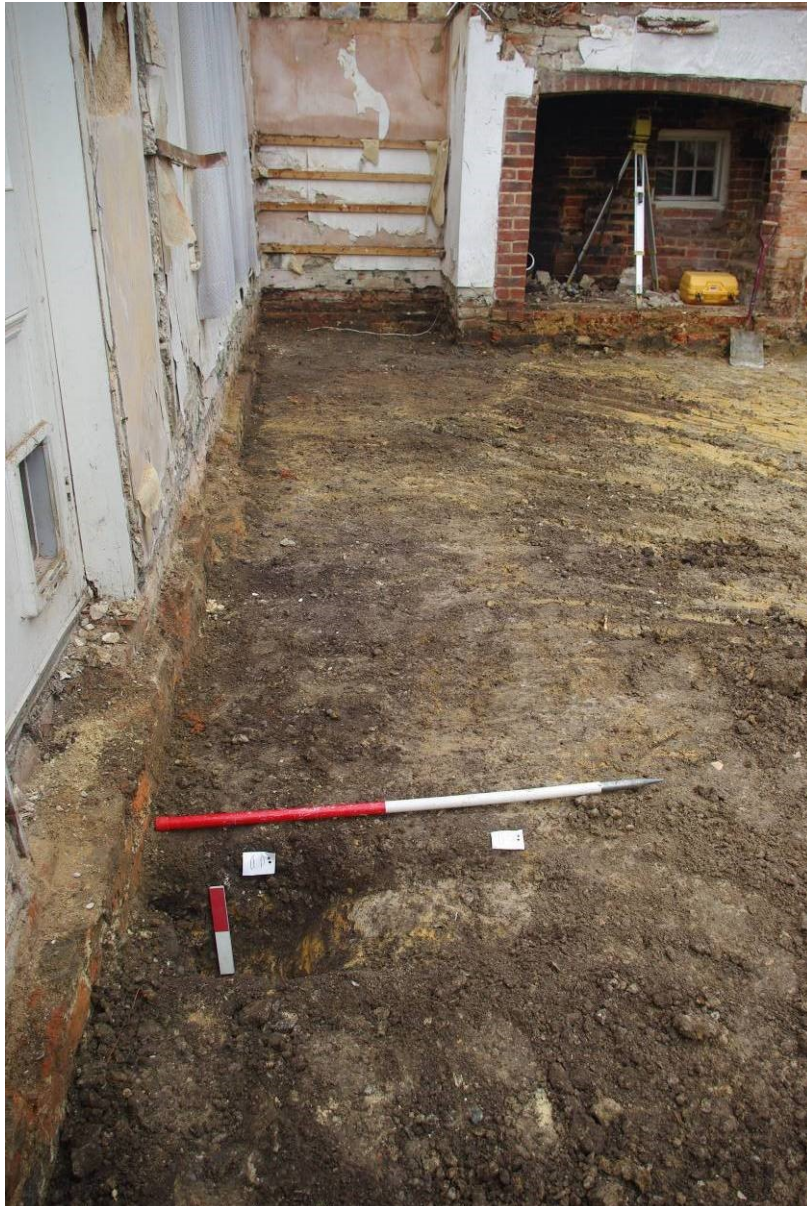
**Figure 5: East facing section of construction trench 10**

Feature 10 was a construction trench for the southern wall of the 18<sup>th</sup> century cottage (figs 2 and 5). It ran east-west and was 6.5m long at least 1m wide and 0.2m deep.

The sides sloped gradually and the base appeared flat. It was filled with the foundation of the 18<sup>th</sup> century cottage, context 12. The bricks were 204mm by 110mm by 62mm. The trench had then been backfilled with context 11, a dark greyish brown (10YR4/2), silty clay loam. It contained a fragment of 19<sup>th</sup> century Welsh slate, one fragment of 19<sup>th</sup> / 20<sup>th</sup> century glass and a fragment of 19<sup>th</sup> / 20<sup>th</sup> century china.

The foundation trench for the 18<sup>th</sup> century cottage contained 19<sup>th</sup>/20<sup>th</sup> century finds. These suggest a later date for the building, but they could have been intrusive from rodent activity or from when the floor level was reduced and a concrete floor with damp-proof membrane was inserted in the second half of the 20<sup>th</sup> century.

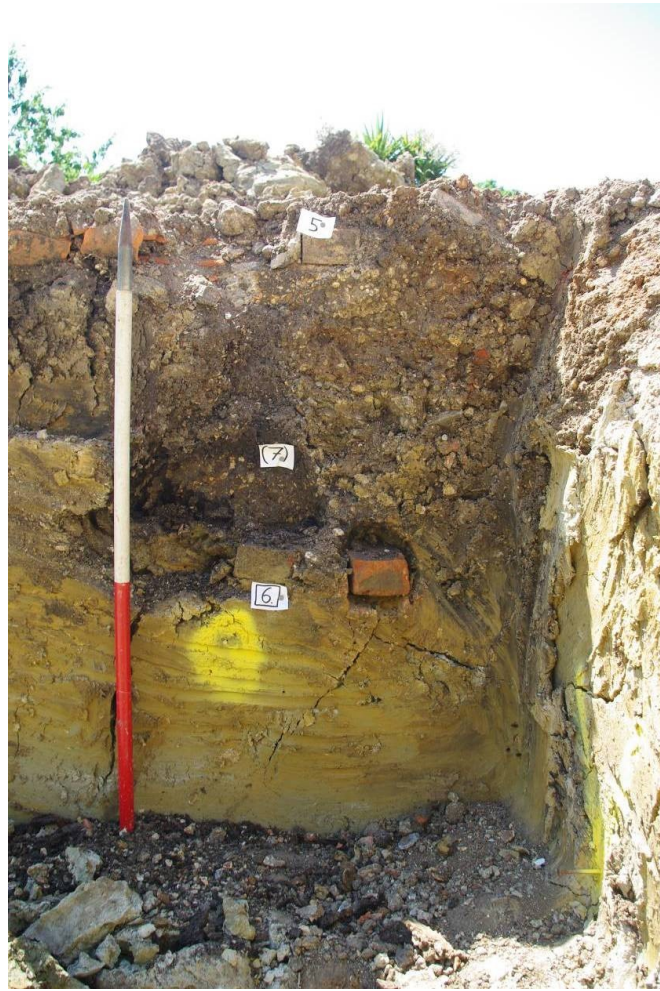
Figure 6: North facing section of 6

Feature 6 was observed in the southwest corner of trench 1, and could have been associated with the Victorian extension in this area (figs 2, 6 and 7). Its full extent was not observed but it was at least 0.9m long, 0.15m wide and 0.65m deep. The sides were steep and it had a flat base. It was filled with a very mixed silty clay loam, context 7. The fill was badly disturbed when the foundations were removed, but it contained Victorian bricks 225mm by 106mm by 66mm. The bricks were handmade and did not have frogs.

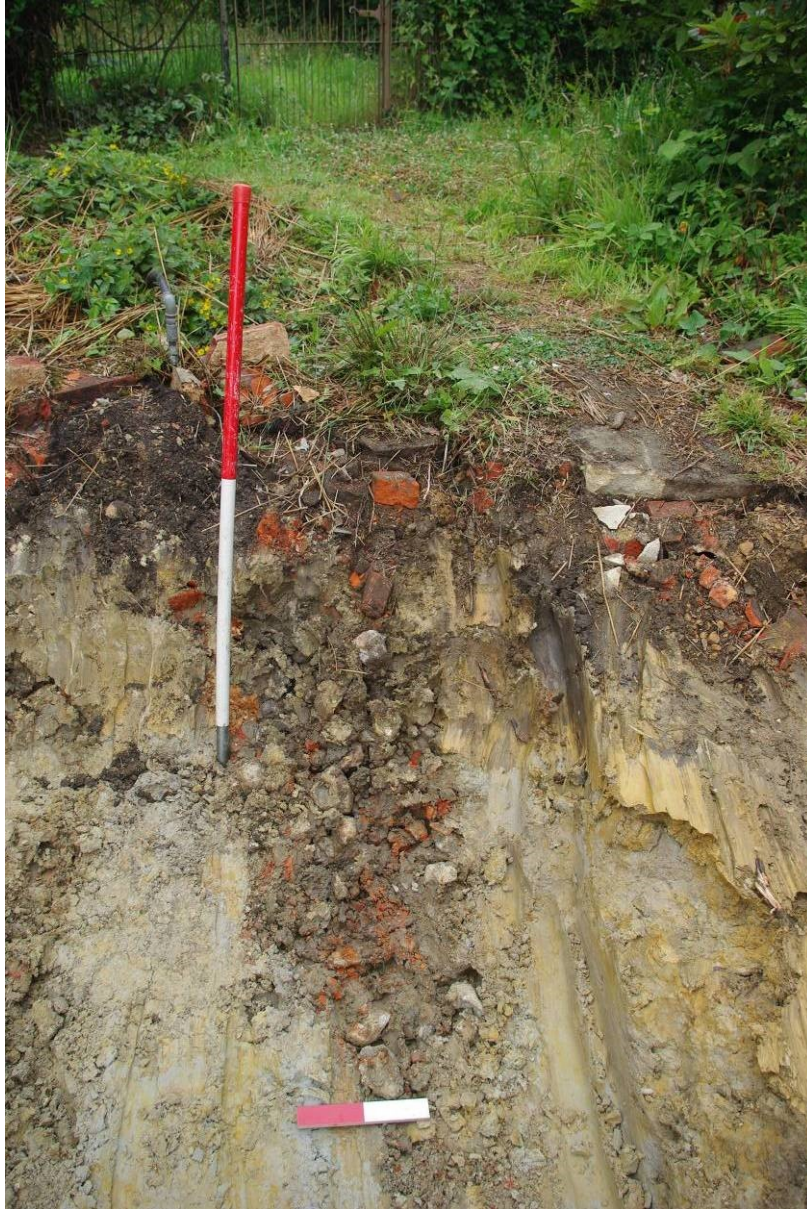
**Figure 8: East facing section of drain 13**

Land drain 13 was situated in the northwest section of trench 2. It was 0.3m wide, 0.6m deep and was at least 0.8m long (fig 8). The sides were near vertical and the base was concave. It was filled with a dark greyish brown (10YR4/2) silty clay loam with abundant brick fragments and flint cobbles, context 14. One fragment of 19<sup>th</sup> / 20<sup>th</sup> tile was recovered from this context.

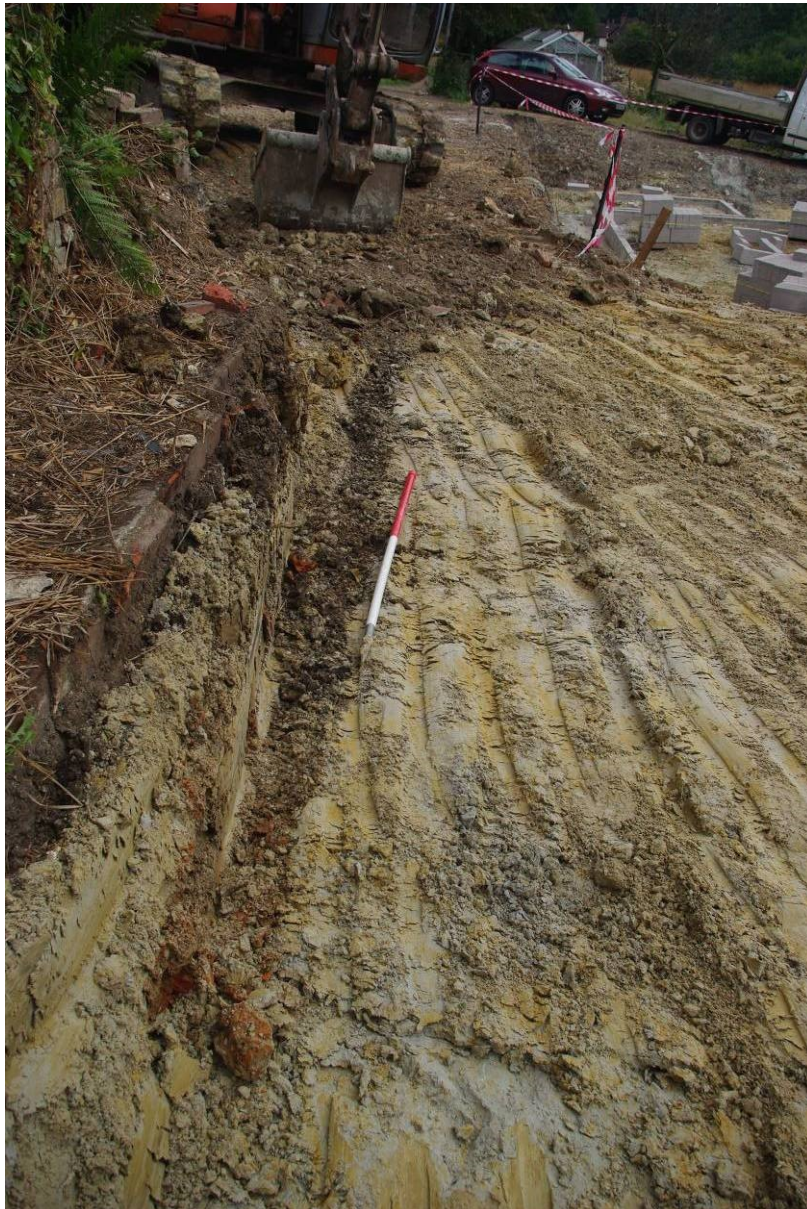
**Figure 9: Drain 17**

Land drain 17 ran roughly southeast-northwest across the northern end of trench 2 (figs 2 and 9). It was 0.3m wide, 0.4m deep and at least 3m long, with near vertical sides. It was filled with a dark greyish brown (10YR5/2) silty clay loam, containing large amounts of flint cobbles, context 18. Fragments of 19<sup>th</sup> / 20<sup>th</sup> century glass was observed but not retained from this feature.
