Archaeological Evaluation at 12-14 Millbrook Road East, Southampton.

SOU 1846

Report 1405
Version 2

Archaeological Evaluation at rear of 12-14 Millbrook Road East, Southampton

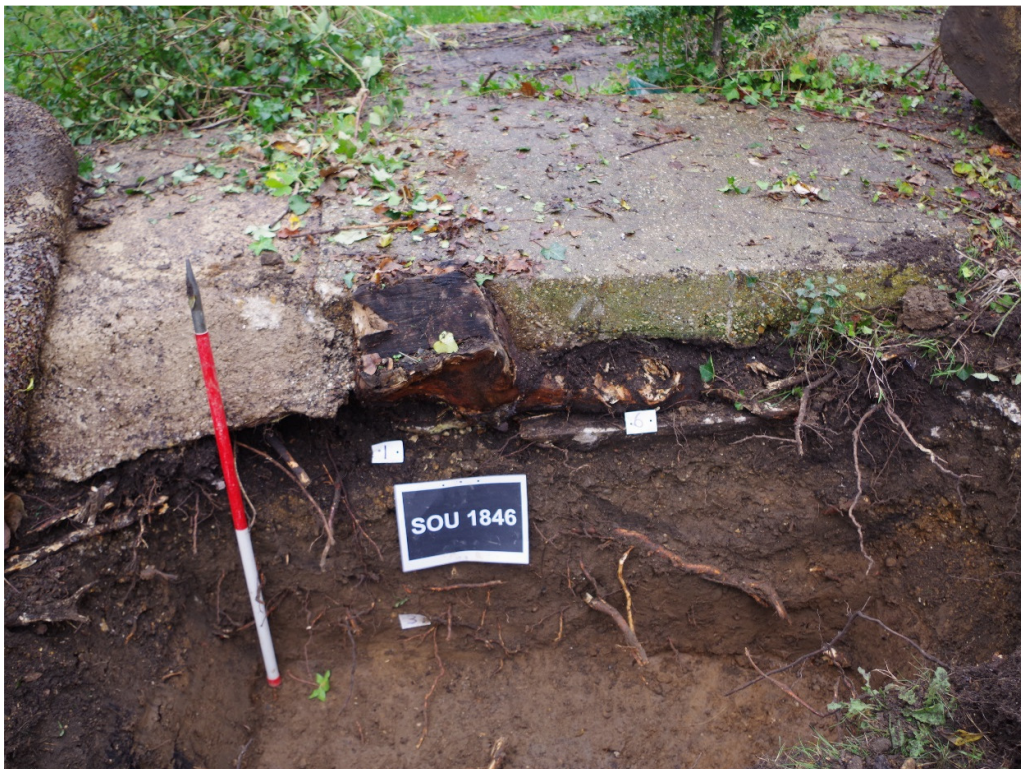
Front cover: Trench 3 showing typical section through the deposits.

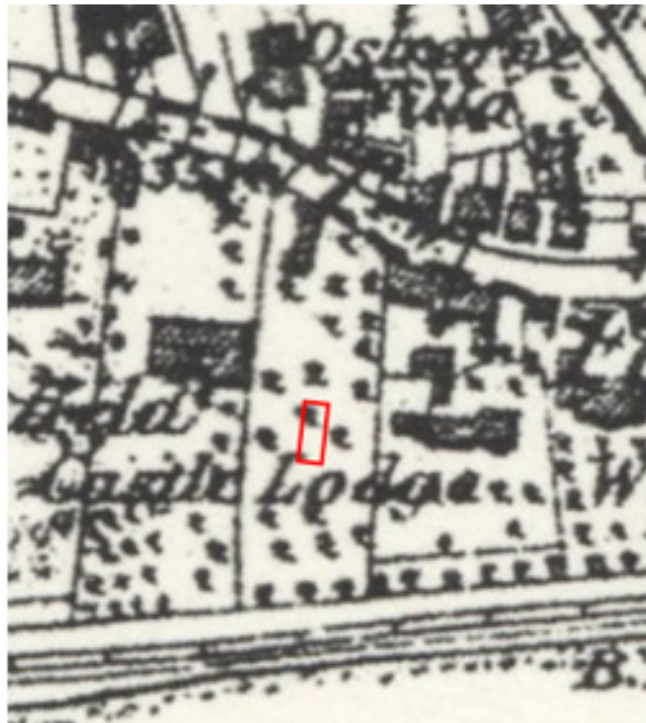
Figure 4. Extract from the 6 inch map of Hampshire & Isle of Wight sheet LXV. Surveyed 1866 to 1869 and published in 1871. Nos 12 and 14 Millbrook road were one single plot situated between Elmfield to the west and Castle Lodge to the east. The approximate area of the concrete investigated is outlined in red.

4.2 Historic maps show the area as undeveloped until the early 19th century (fig 3). The 1871 6 inch map shows that the later Nos 12 and 14 Millbrook Road occupied one single plot situated between *Elmfield* to the west and *Castle Lodge* to the east (fig 4). The two houses were built by 1895 (fig 5).

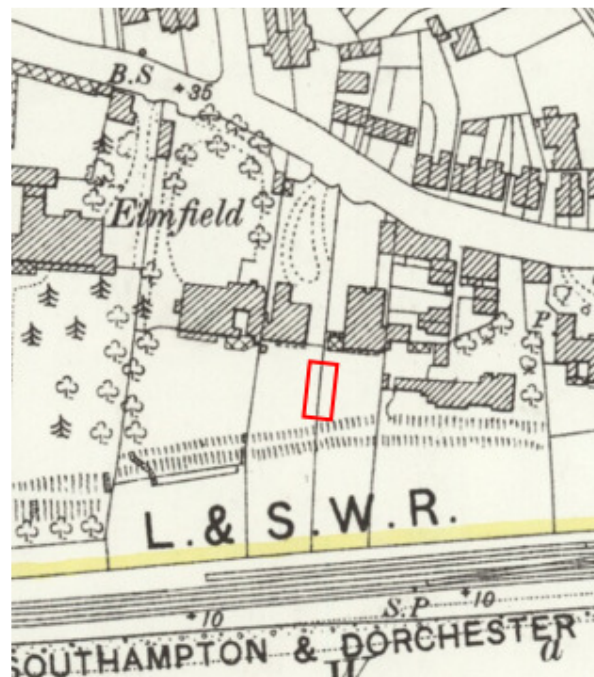
Figure 5. Extract for the 25 inch map of Hampshire and Isle of Wight Sheet LXV.10, revised 1895 and published 1897. Numbers 12 and 14 Millbrook road are shown. The approximate area of the concrete

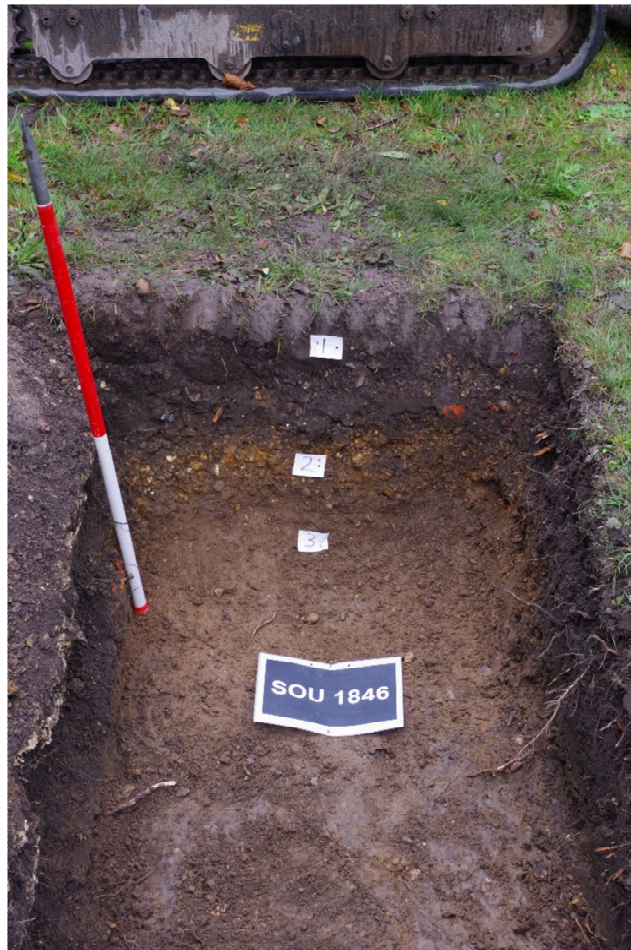
Figure 8. Trench 2 looking west. Brickearth 3 at base of trench overlain by gravel 2 and topsoil 1.

8.1.1 The earliest deposit was natural brickearth, context 3. It was found at the base of Trench 2 at 420mm below the surface (fig. 8) and at the base of trench 3 some 900mm below the surface (fig. 9). It was yellowish brown (10YR 5/4) silty clay loam with some evidence of worm activity in both trenches and common tree roots in Trench 3.

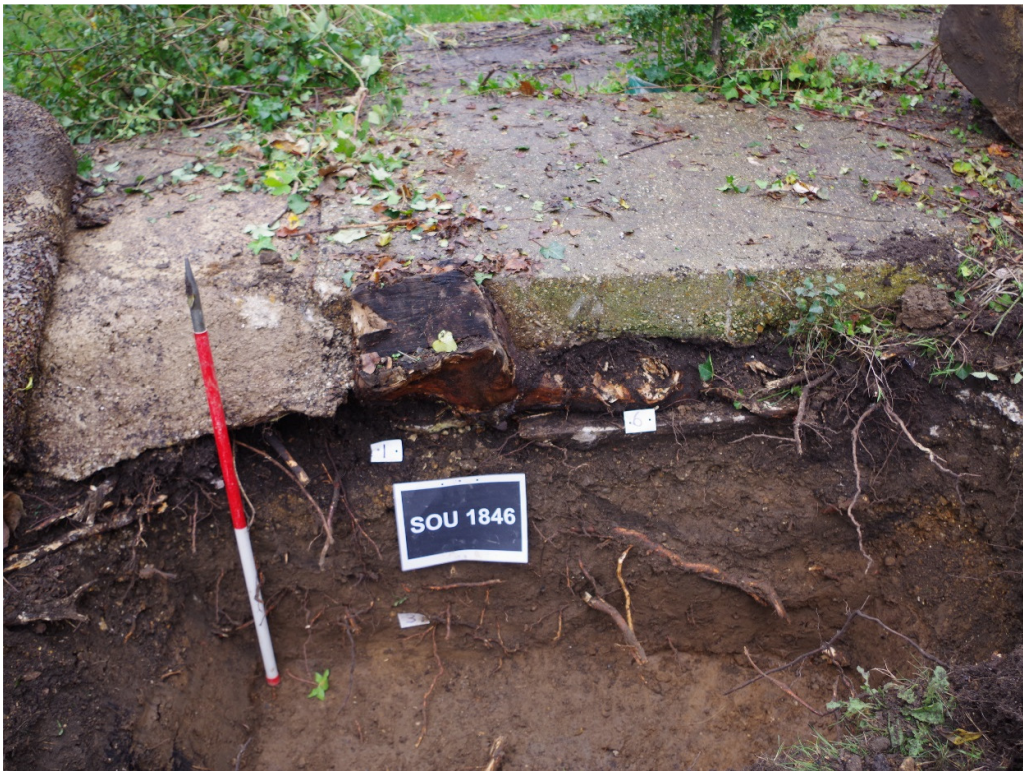
Figure 9. Trench 3 looking west. Brickearth 3 at base of trench, below topsoil 1. Flagstones of path 6 visible below the concrete.

8.2.2 The stone-flagged path was also visible in the west section of Trench 3 (fig. 9).

8.3.1 Concrete slabs were found to east and west of wall 5. Trench 3 showed that it had there been laid over path 6 (fig. 9) in two sections, slightly stepped. On the west of the wall was a single concrete slab, perhaps the base of a shed. The brick wall had been demolished to ground level after the episodes of concreting.

8.4.1 The most recent phase of activity was the construction of a square play area at the south edge of the site. Its construction cut the brick wall and the stone path. It was joined to the concrete slabs by a further strip of concrete with a contoured upper surface which had been coated in a layer of rubber chippings (fig. 9).

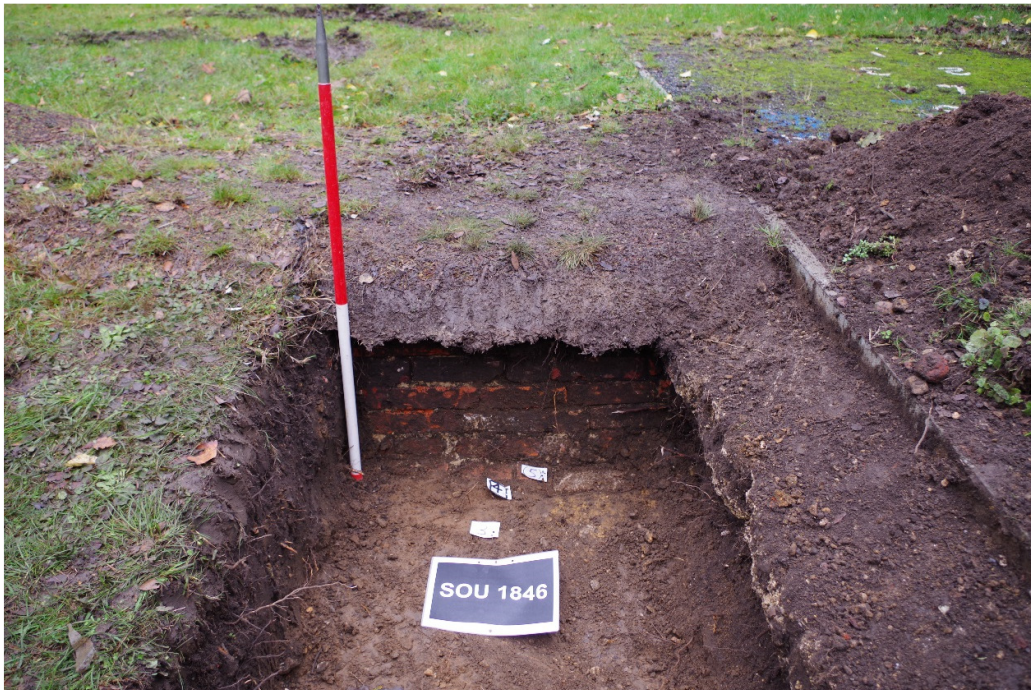
Figure 10. Trench 2 looking east with brick wall 5 in the far section. Concrete haunching of play area to right.

8.2.1 When the plot was developed in the late 19th century a foundation trench, 4, was excavated and brick wall 5 was built in it. The foundation trench was some 730mm. The wall was built of red bricks, some 225mm by 110mm by 65mm with shallow frogs. It was exposed in Trench 2 (figs. 10 and 11) and could be seen at ground level further north between later slabs of concrete. To the west of the brick wall in trench 2 was a layer of gravel, 2, (fig. 8), which contained fragments of 19th century brick. To the east was a flower bed and then a Purbeck stone-flagged path, context 6. The topsoil, layer 1 probably existed prior to these works, as it lay beneath the stone path, but it had been redeposited over the gravel 2 in trench 2. The topsoil was a very dark gray (10YR 3/1) silty clay loam up to 500mm thick.

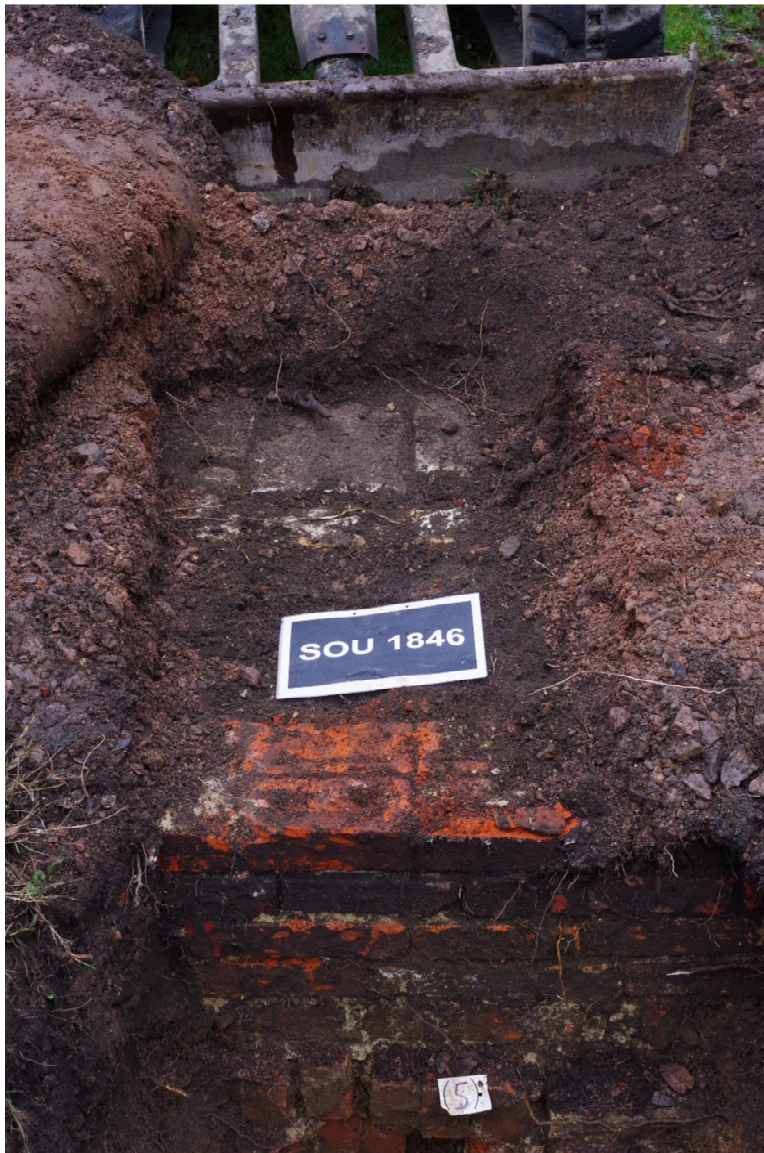
Figure 11. Trench 2 looking east with brick wall 5 in the foreground. Beyond lies a narrow flowerbed, then Purbeck stone path 6 with a brick edging beneath the peeled back rubber chipping layer.
