## **Southampton Archaeology Unit Report 1420**

**Archaeological Watching Brief at Gordon Hall Offices, 9 Carlton  
Road, Southampton.**

**SOU 1855**

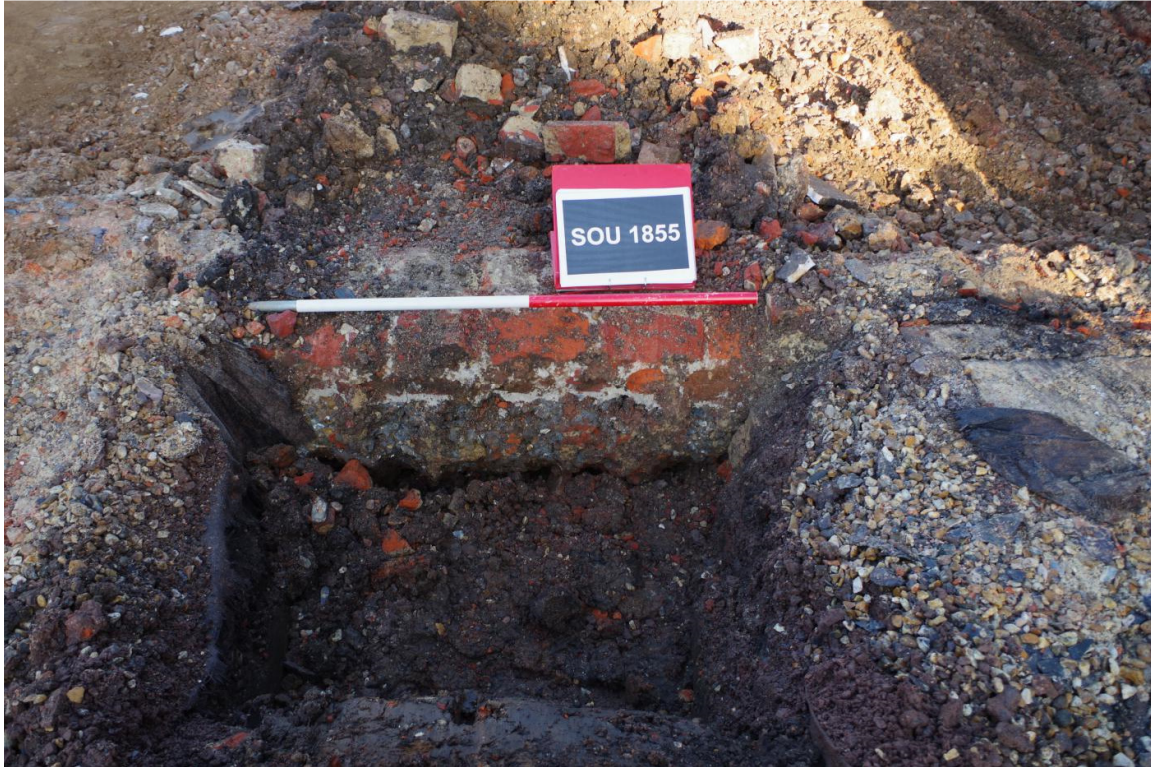
**Plate 1. South-facing section of Foundation 4.**

8.2.2 Context number 3 was assigned to the construction trenches of the Gordon Hall (Plate 1) demolished before the project started. They covered an area 11.9m long, 7m wide, and 0.5m deep. They cut layers 5 and 7. The construction trenches were filled by brick and concrete foundations 4 (Plate 1 & 2). The brickwork was 200mm thick with a slate damp course being observed in the northern wall and the concrete underneath was 300mm thick. Many of the bricks appeared to be wasters of varying sizes, with complete bricks measured 234mm x 112mm x 69mm. Fill 4 was below layer 1, and butted by layers 2 and 6.

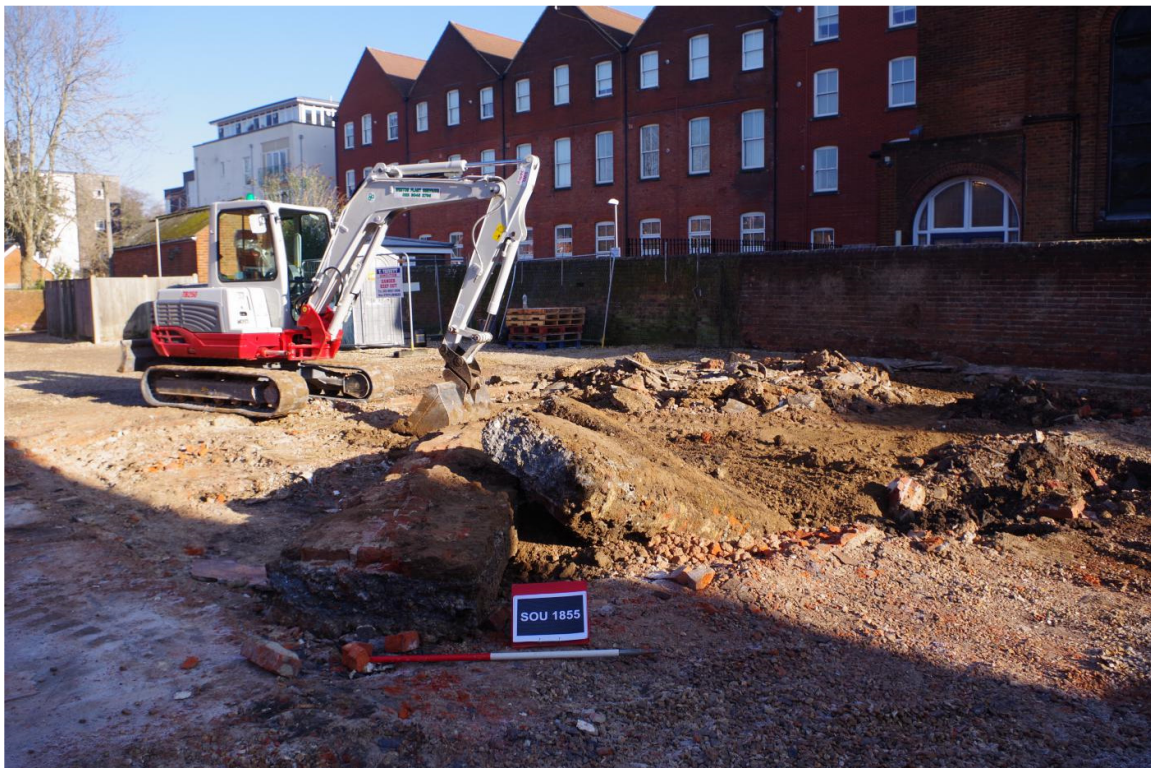
**Plate 2. View of trench 1 looking northeast, showing context 4.**

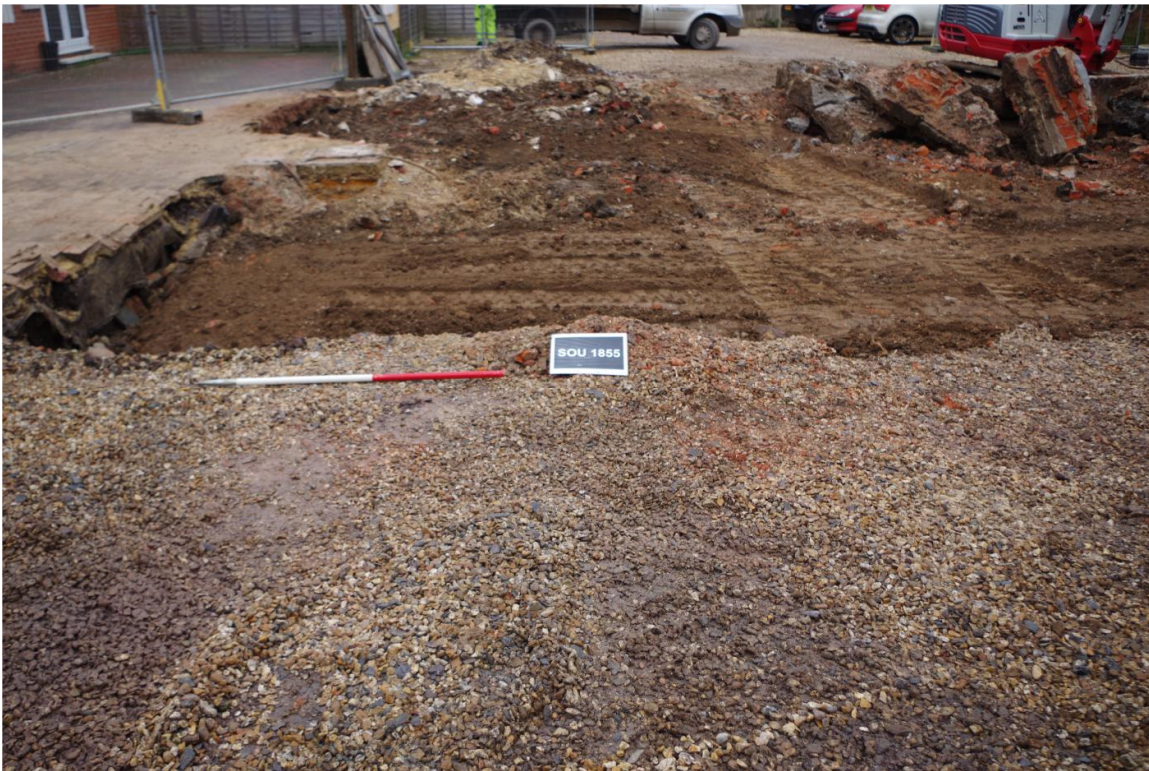
**Plate 3. View of West end of Trench 1, after footing removal. Context 9 visible to the west.**

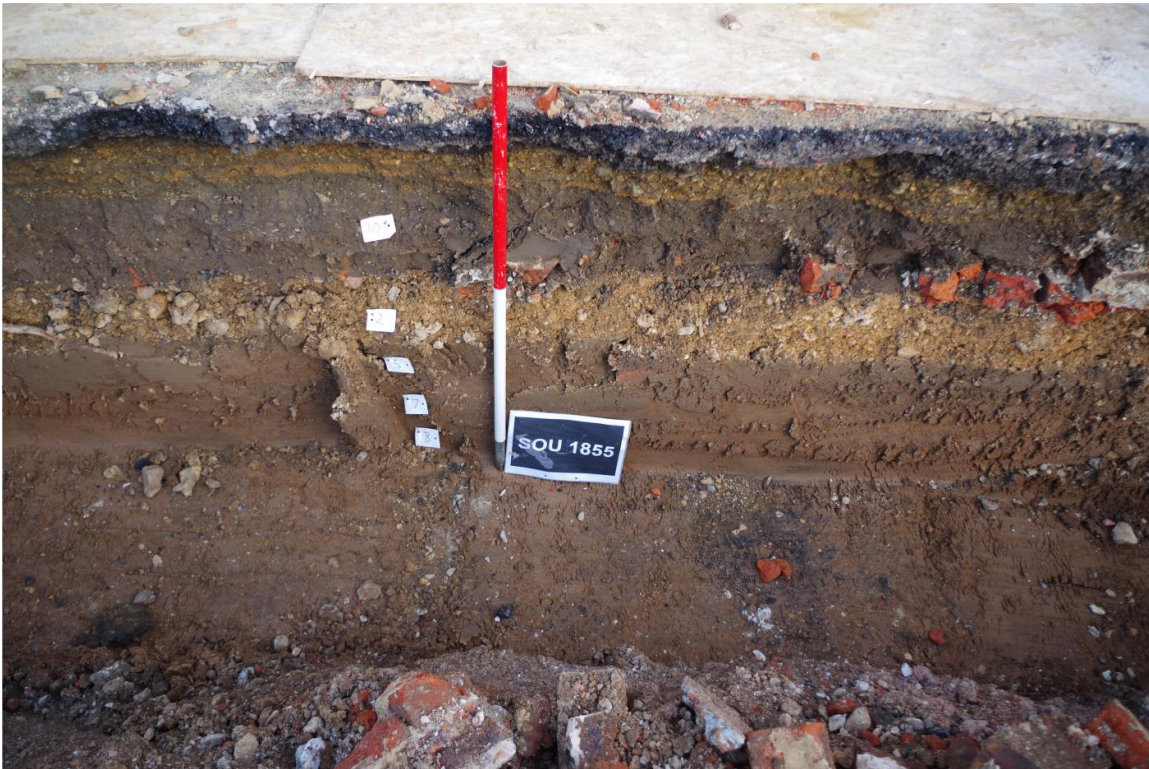
**Plate 4. West-facing section of Trench 2, showing brickearth layers 8 and 7.**

8.1.2 The earliest deposit was context 11 (Plate 5), a deposit of brownish yellow (10YR6/6) natural River Terrace gravel found some 1400mm below the surface in trench 7. The gravel was overlain by a very slightly stony, brownish yellow (10YR6/6) silty clay loam (natural brickearth) 8 (Plate 4). It was 900mm thick and situated some 500-700mm below the surface, over the entire site.

8.1.4 Overlying the weathered brickearth was Layer 5, a slightly stony, dark grey (10YR4/1) silty clay loam garden/plough soil, 500mm thick. (Plate 4) It contained some fragments of oyster shell and brick. It was below layer 6, and was cut by foundation trench 3.

8.2.3 Layer 2 was a mix of light yellowish brown (10YR6/4) sandy clay loam soil, flint gravel and brick rubble, with slate and concrete fragments (Plate 4). It was 200mm thick and contained complete bricks that measured 234mm x 112mm x 69mm. It was above layer 7, below layers 1 and 10, and butted fill 4.

8.2.5 Context 10 was a slightly stony, dark grayish brown (10YR4/2) silty clay loam topsoil layer, 300mm thick, observed in the east of the site (Plate 4) It had been removed by the carpark, 6, in the rest of the site. It was above layer 2.

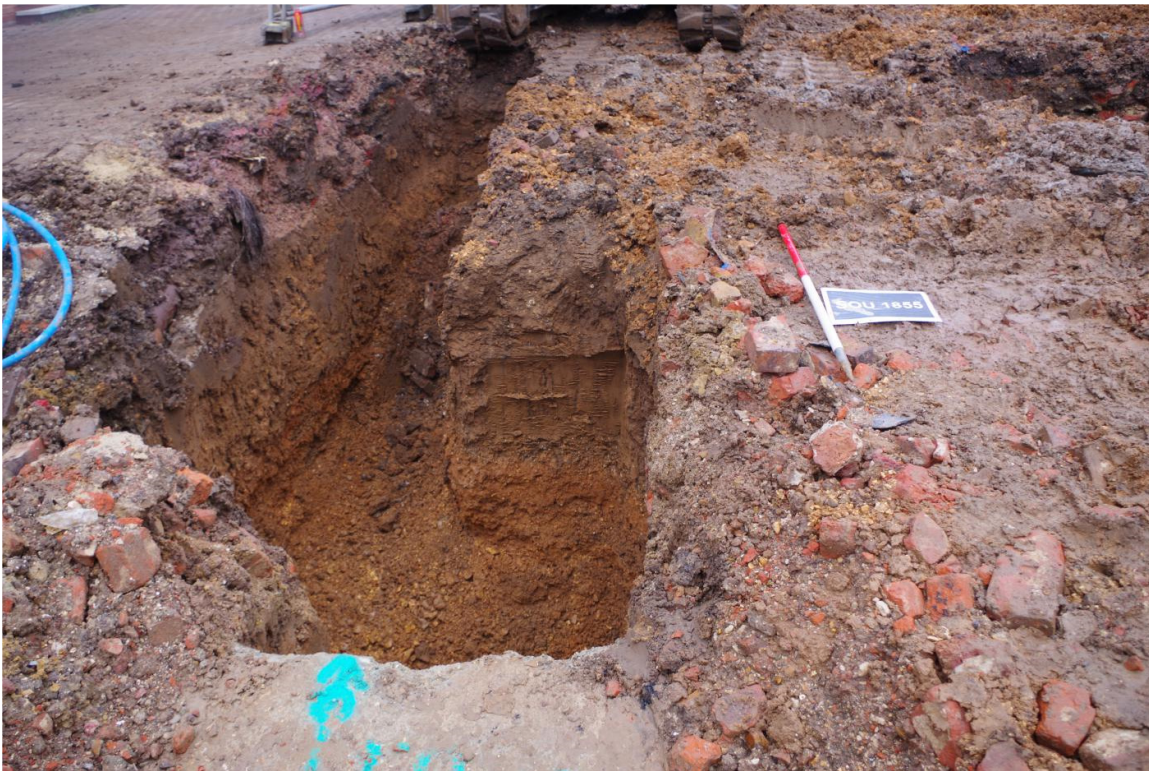
**Plate 5. View of Trench 7, looking north, showing the River Terrace gravel in the base of the trench.**

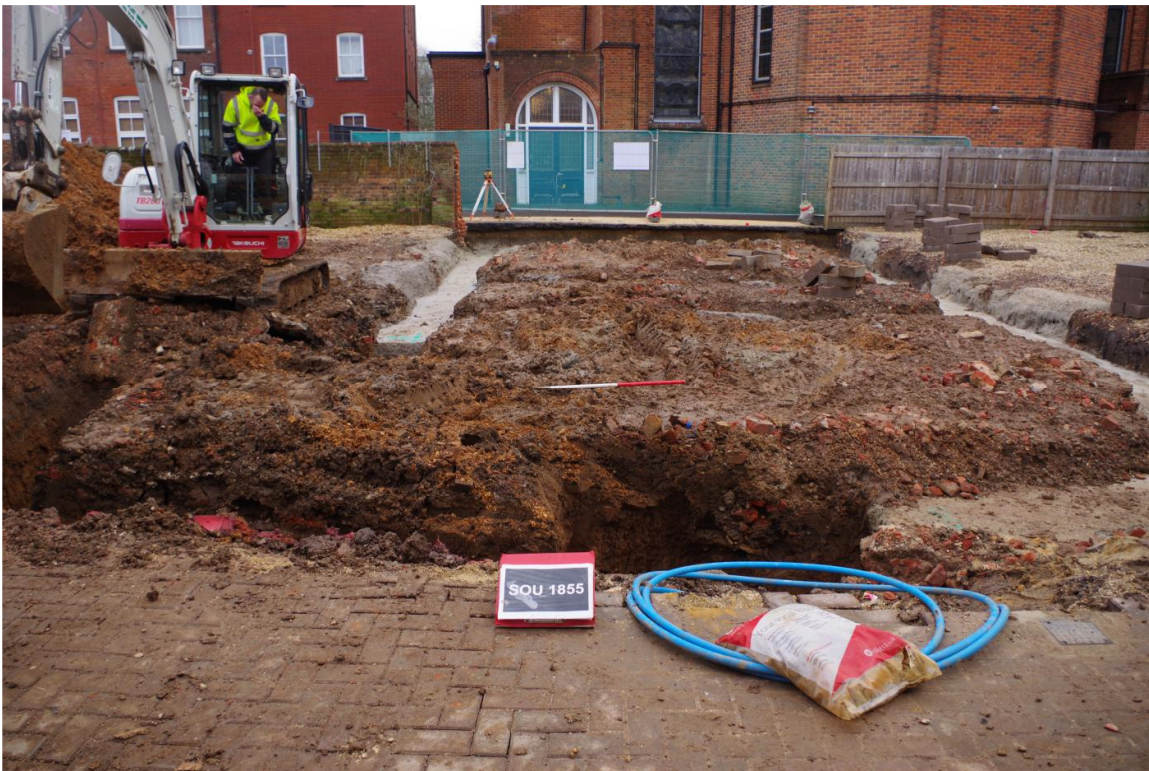
**Plate 6. Overview of site showing foundation trenches near completion.**

8.2.7 Layer 9 was observed in the west of the site, and comprised brick paving slabs in a sandy gravel bedding on-top of a geotextile membrane. (Plate 6) It was 0.3m thick and at least 7m wide.
