55 SIDBURY, WORCESTER –
ARCHAEOLOGICAL WATCHING BRIEF

WCM102293

55 Sidbury, Worcester – archaeological watching brief WCM102293

16th June 2022

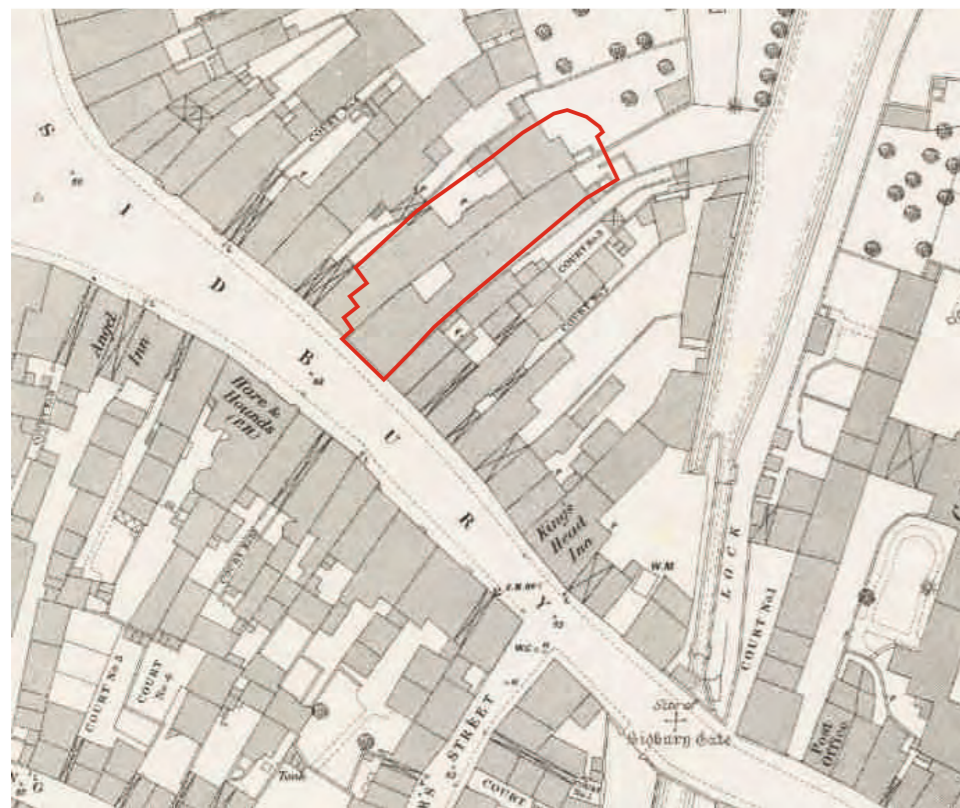
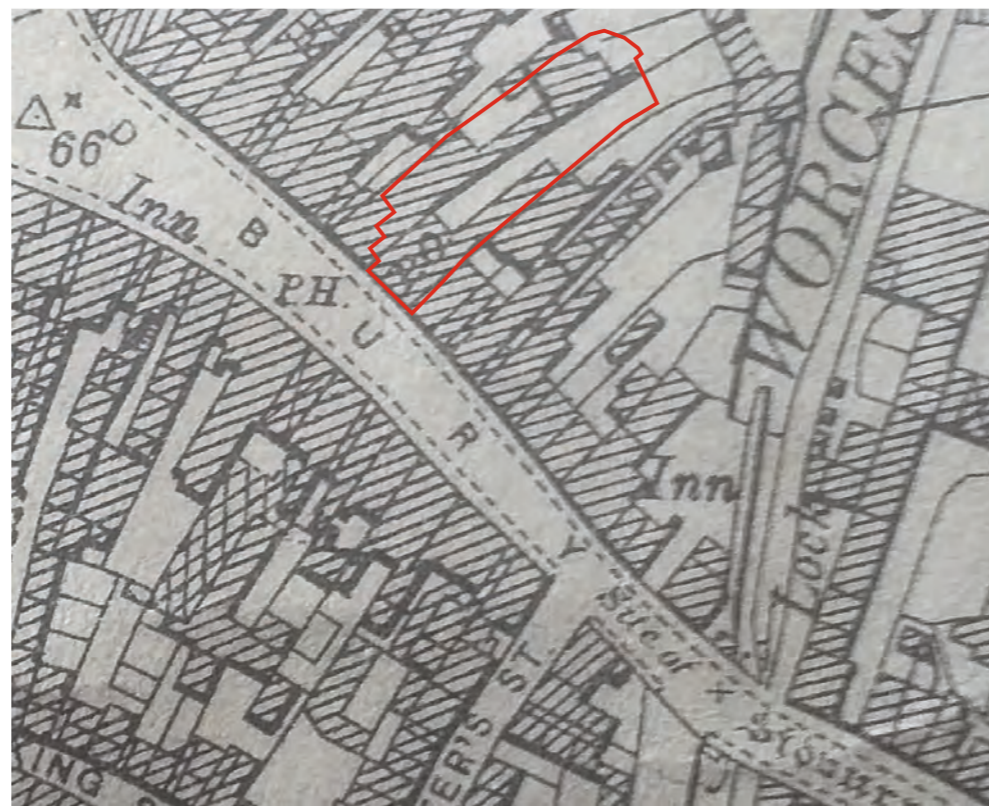
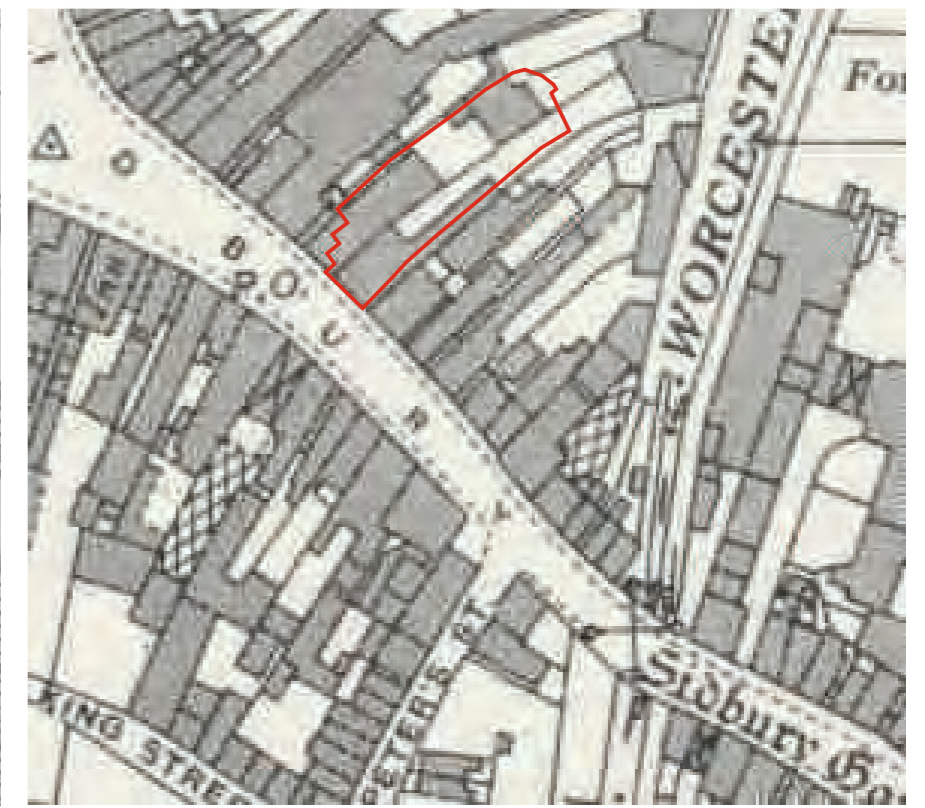
Figure 1: Site location 55 Sidbury and historic mapping showing area pre clearance for City Walls Rd and widening of Sidbury

1883

1904

1947

3.1 The site lies in an area that was previously developed as a continuous building line on the northern side of Sidbury (Figs 1 and 2) . The presently empty plot adjoining no 55 was until the late 1960s entirely built up with a mixture of residential, retail and industrial usage. The pattern of building reflected burgage plots established in the medieval period in an area that had probably served some form of roadside market function in the later Roman to post Roman period. The available historic mapping and historic photographic evidence suggests that most of the structures cleared for the City Walls Road junction were of 18th to mid 20th Century date . No 55 was itself re-built towards the end of the 19th Century retaining only a rear domestic wing from the early 19th Century (demolished at the end of the 20th Century)

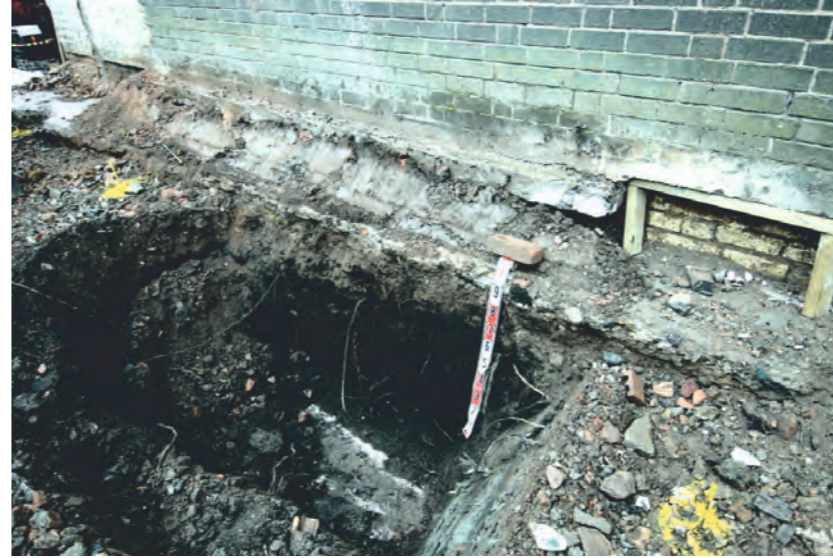
View facing NE along former boundary line - stripped area all recent deposits

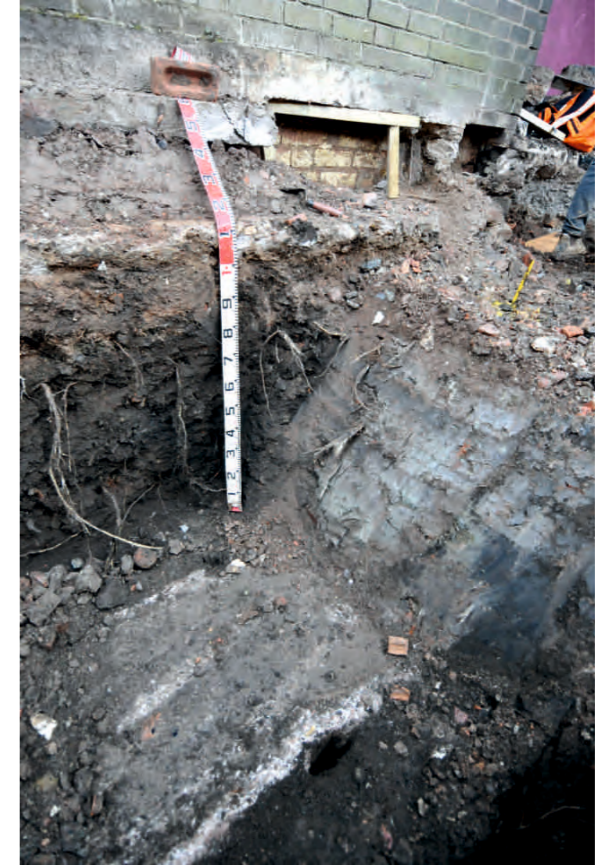
Note imported blue-grey clay infill over concrete

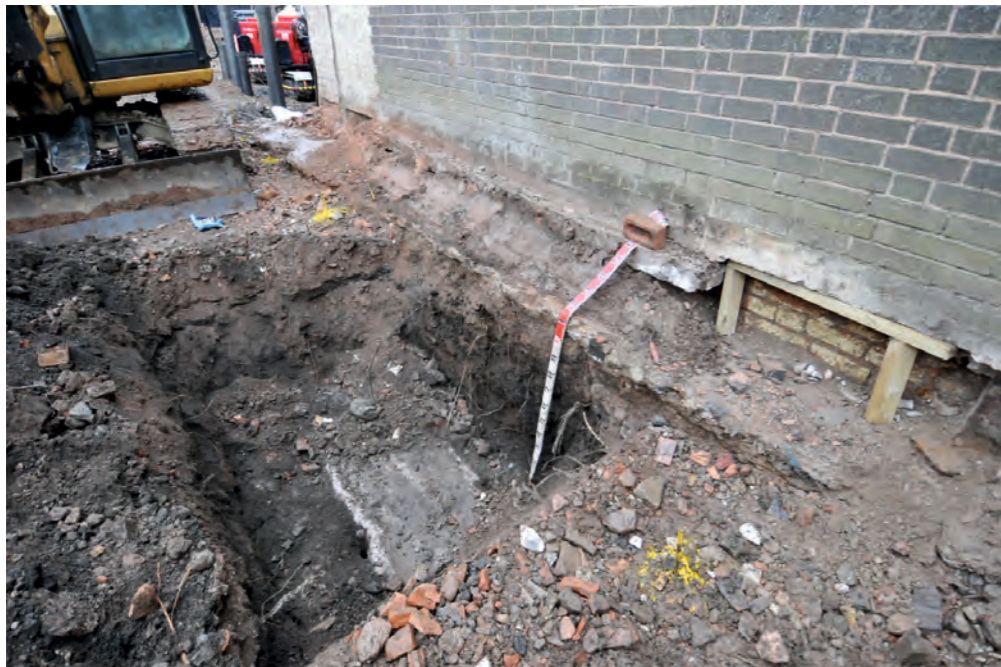
Area of deepest excavation

- 4.4 Observations against the side of the existing concrete foundation revealed disturbed archaeologically significant deposits consisting of around 1.2m of dark sandy cultivation type soils without visible ceramic inclusions. The absence of tile fragments in these soils suggests a pre-15th Century date, as tile became abundant in the City by the late 14th -early 15th

Century. No excavations were made into these deposits, which had been previously disturbed by withdrawal of the 1970s temporary sheet piling. Piling operations identified sand at 2.2m.

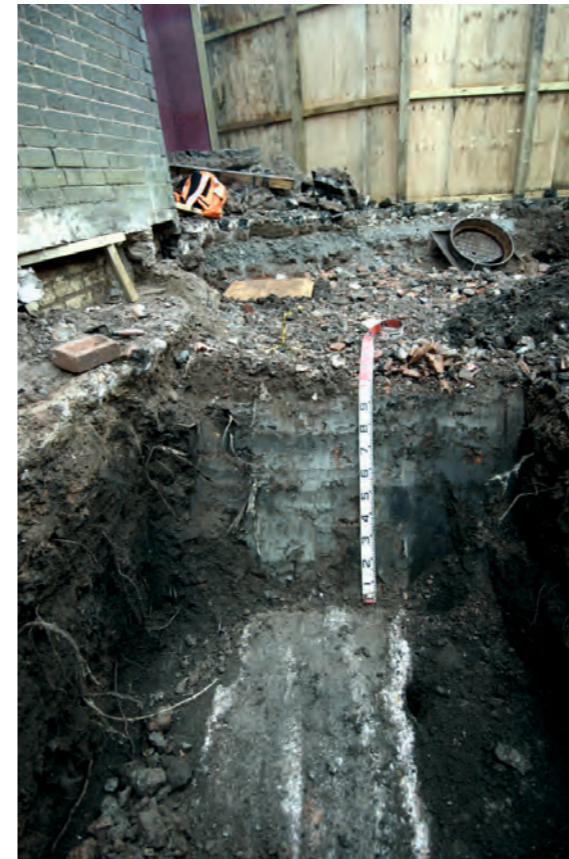
Trench for earlier concrete foundation
(note no sign that the foundation had previously been built on)

- 4.3 Excavation of a larger test pit against the existing side wall of No 55 revealed approximately 1.2m of recent soil deposits cut by a cast concrete foundation determined by probing to be 2.2m deep. The foundation had been cast in a trench supported by metal sheet piling, the shape of the withdrawn piles being clear in the sides of the cast concrete. Remarkably the foundation showed no signs of having been ever built on, and the upper part of the trench had been infilled with material including blue clay. The clay would appear to have been imported to the site and was mixed with late 20th C building materials. The presence of this foundation (close to but not below the side wall of No 55) led to a design change in the proposed foundations, and the proposed piles in this area omitted.

- 5.1 Whilst the watching brief did not reveal any additional information about the historic landuse or archaeology of the site it did reveal something of the level of peripheral disturbance caused by the construction of City Walls Road. The construction zone here was clearly much wider than the eventual roadway, and possibly the layout was changed during construction. The presence of a never-used cast concrete foundation on the site of 56 Sidbury is intriguing – it may possibly relate to temporary shoring of the neighbouring building, or more likely represents an abandoned plan to construct a narrow corner building south west of No 55. In the event the foundation was nearly 50 years premature, but now serves a similar purpose.
