WATCHING BRIEF DURING  
GROUNDWORKS FOR  
SCOOTER STORE,  
WARMSTRY COURT, QUAY STREET,  
WORCESTER

WCM 101910

# Watching brief during groundworks for scooter store, Warmstry Court, Quay Street, Worcester WCM 101910

22<sup>nd</sup> May 2012  
Mike Napthan MIFA

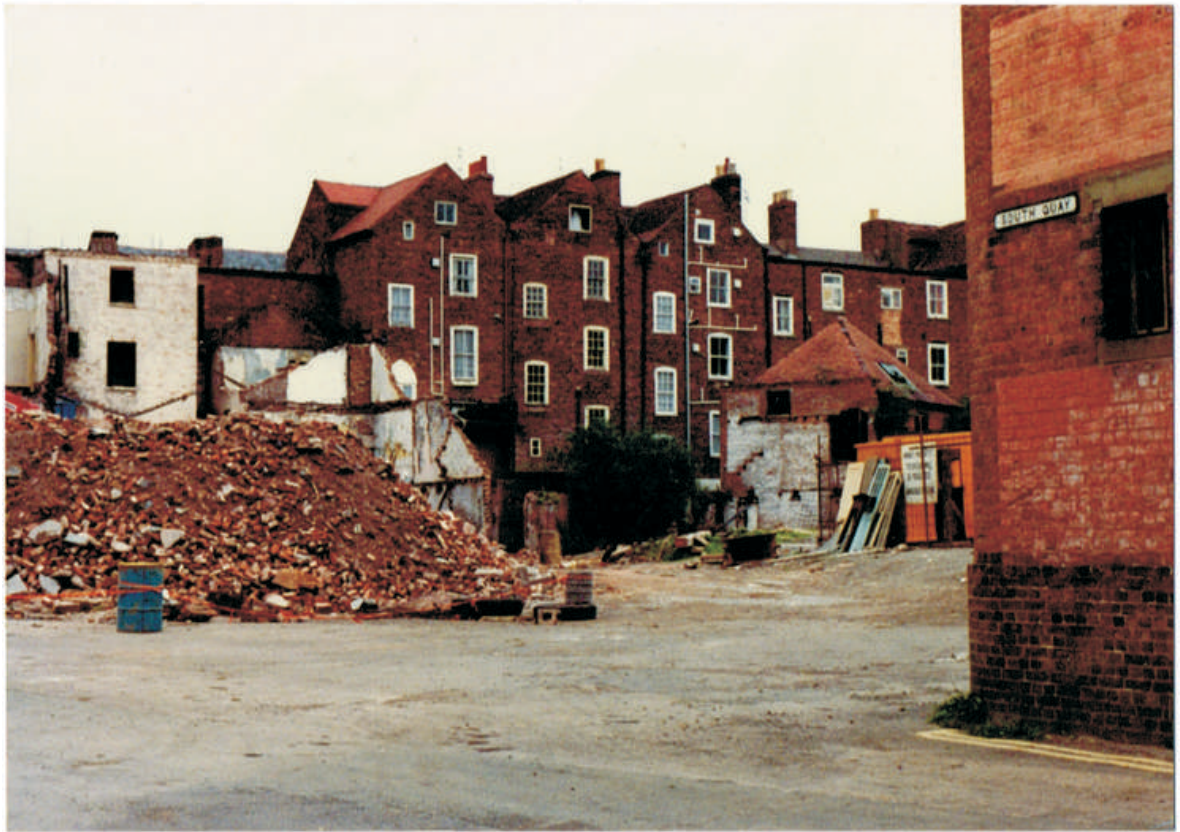
View facing north-west from Hood St/South Quay junction circa 1982-3 showing future Warmstry Court site reduced to South Quay street level

Figure 3: Photographs of the Warmstry Court site prior to the construction of the present sheltered housing scheme (Source: MNA reference collection - photographer unknown)

*Photographs of the site taken circa 1982-3 show that following demolition of the earlier buildings on the site (which appear from contemporary photographs to have been predominantly of 18<sup>th</sup> Century appearance) the south-western half of the site was cleared down to the street level of the Hood St/South Quay junction, with a progressive rise up to the north-east. The present observations appear to indicate that most of the site within the “courtyard” was subsequently raised above general flood levels using a mixture of demolition material, builder’s debris and roadstone. Whilst these deposits contain occasional fragments of earlier building materials (such as sandstone and 18<sup>th</sup> C brick) they are not archaeologically significant. The archaeologically significant horizons at this point may be anticipated to potentially survive from a depth of circa 1.3-1.5m below current carpark level. The precise total depth of archaeologically significant deposits at this point is unknown, but likely to be several metres. Anecdotal evidence indicates that the exceptional depth of concrete needed for the foundations of the present building was a contributory factor in the original contractors having gone out of business during construction.*

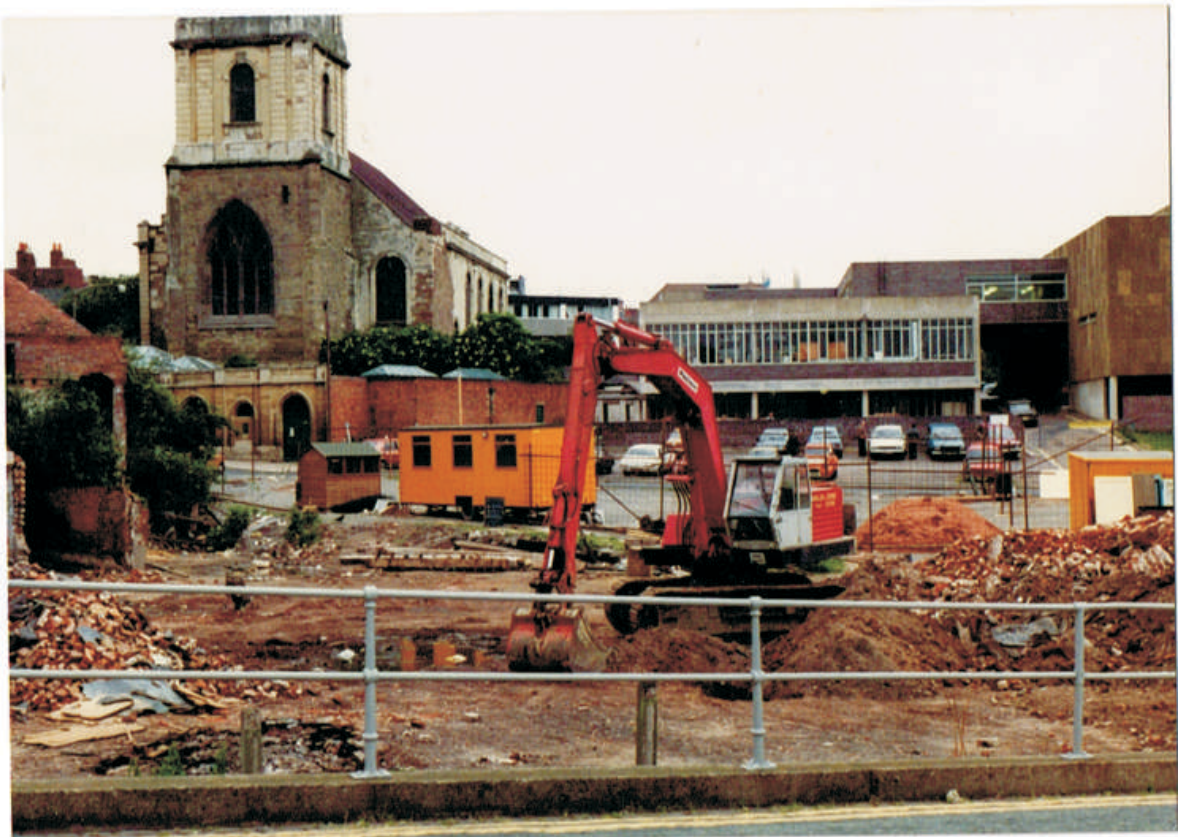
View north-east across present Warmstry Court site during site clearance in circa 1982-3 showing the site surface cleared to below the level of South Parade (roadway in foreground)

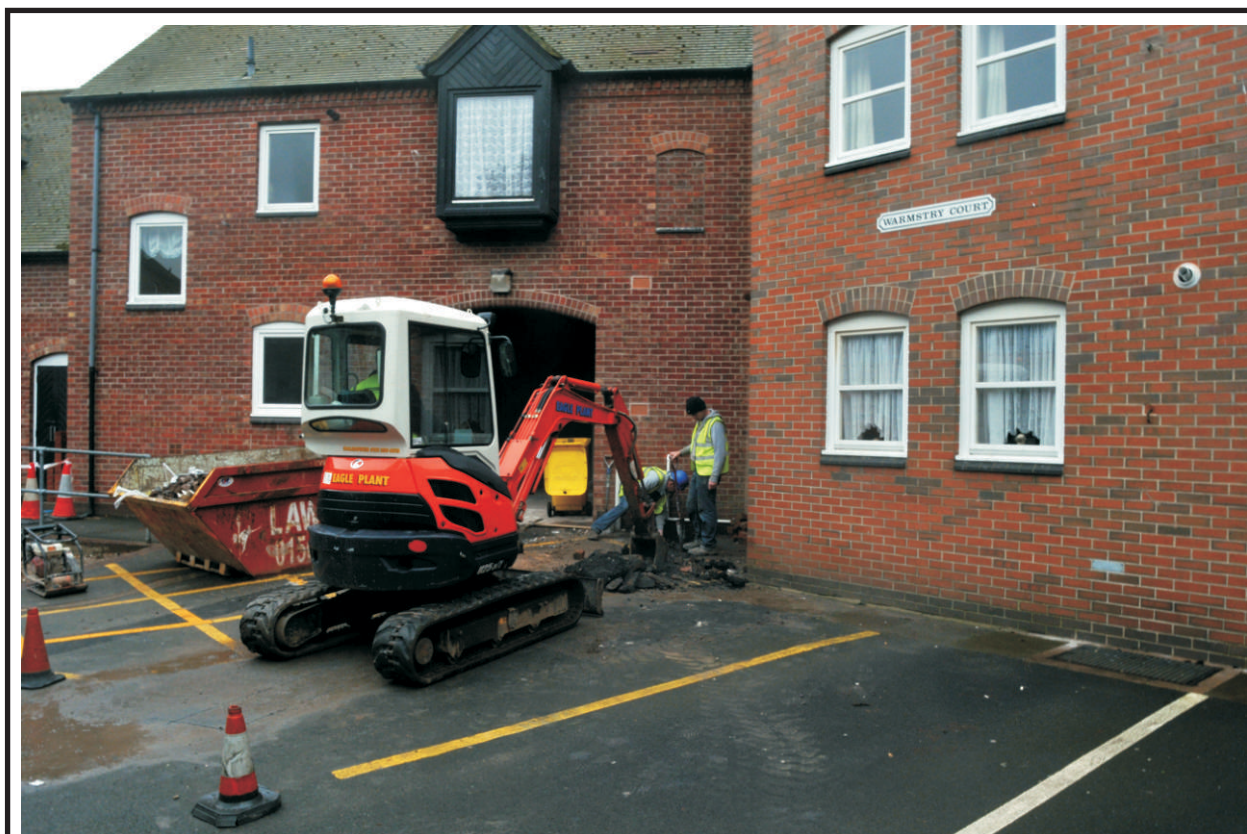
View facing south

Figure 4: Excavation of new water-main trench

- 5.1.1 The new watermain trench lay across part of the car-parking area close to the new boiler room. The trench was nominally 800mm deep and 300mm wide, with local variations, particularly at its southern end where it was necessary to avoid an existing man-hole chamber. The deposits generally consisted of two layers of tarmac overlying roadstone which overlay very mixed rubble and rubbish (including plastic sheeting, modern bricks, concrete kerbstones, metal wheel-barrow frame etc). Moderate amounts of earlier brick and sandstone rubble, including 18<sup>th</sup> and 19<sup>th</sup> C brick were present together with fragments of guttering etc indicating that they derived from the site clearance of the early 1980s. A former kerb-line was encountered in the trench, but this appears to relate to a fairly recent re-arrangement of the car-parking bays. Two plastic small diameter water service pipes were also encountered, and these appear to have been laid whilst the building rubble was being deposited as there were no clear trench cuts.

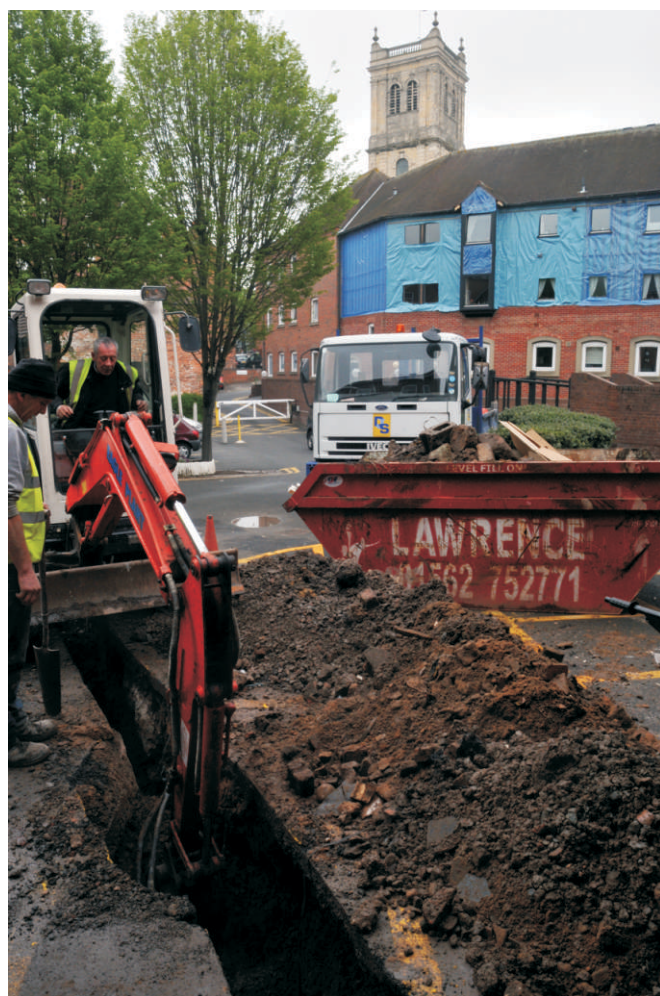
View facing north-east - no significant deposits were encountered as the trench did not penetrate beneath the horizon of 1980s construction debris and site make-up. Trench depth was 800-900mm

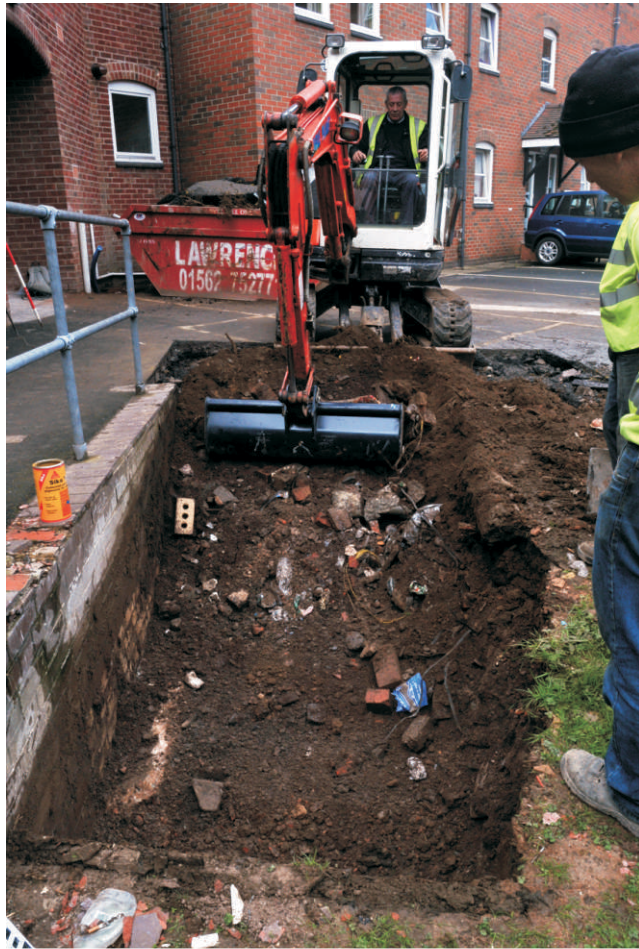
Excavating area of new mobility scooter store - all observed deposits contained recent building debris and rubbish mixed with some demolition debris and roadstone

Figure 5: Groundworks for mobility scooter store

store foundation consists of a raft construction independent of the retaining wall of the adjacent walkway. The excavation therefore consisted of a rectangular hole approximately 3mx4m and a maximum of 1m deep. Deposits in this area consisted of tarmac over roadstone over builder's rubble for the hardstanding and shallow turf/topsoil over builder's rubble and rubbish for the planted area. All of the deposits were consistent with deposition in the early 1980s or later, and included plastic sheeting, plastic strapping, milk bottles, soft drinks cans, crisp packets together with modern building materials and some demolition debris.

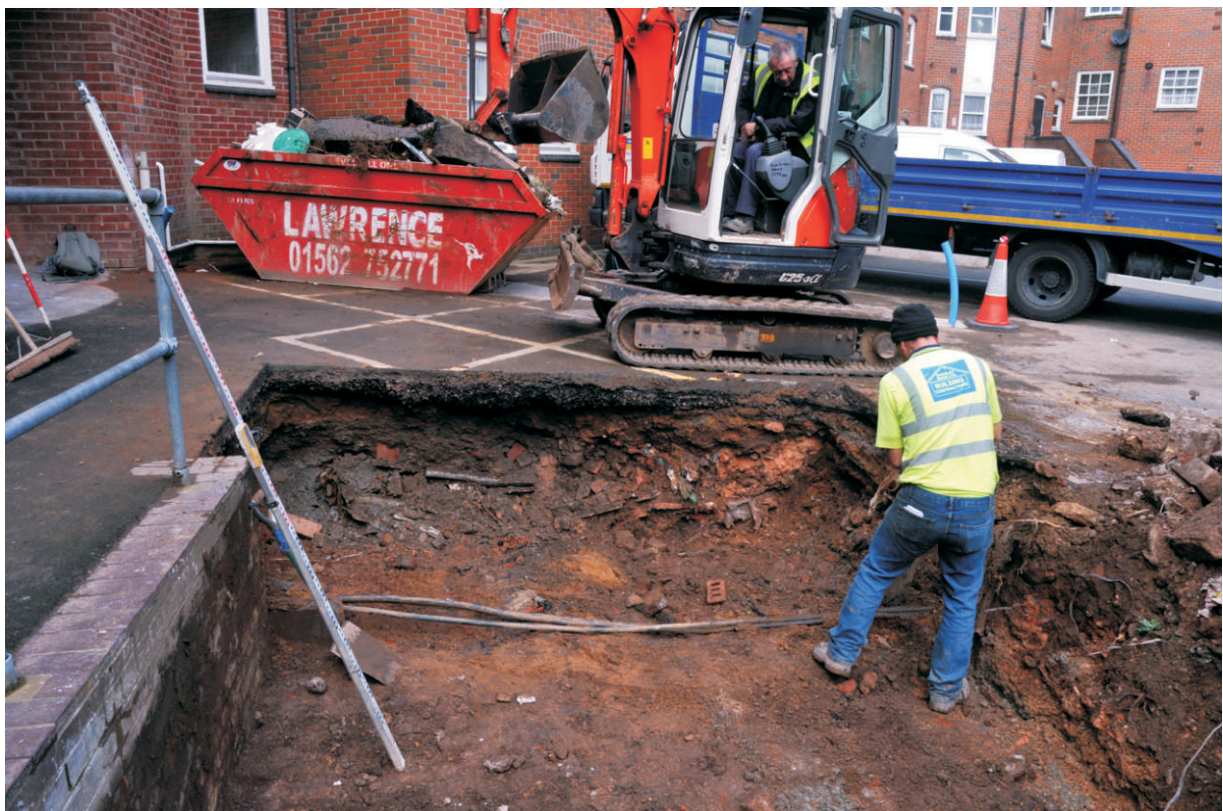
View of scooter store excavation facing west
