Access visit at Royal Grammar School, Britannia House, Tything, Worcester during groundworks for flagpole and sign WCM 101947

Mike Napthan MIFA

29th August 2012

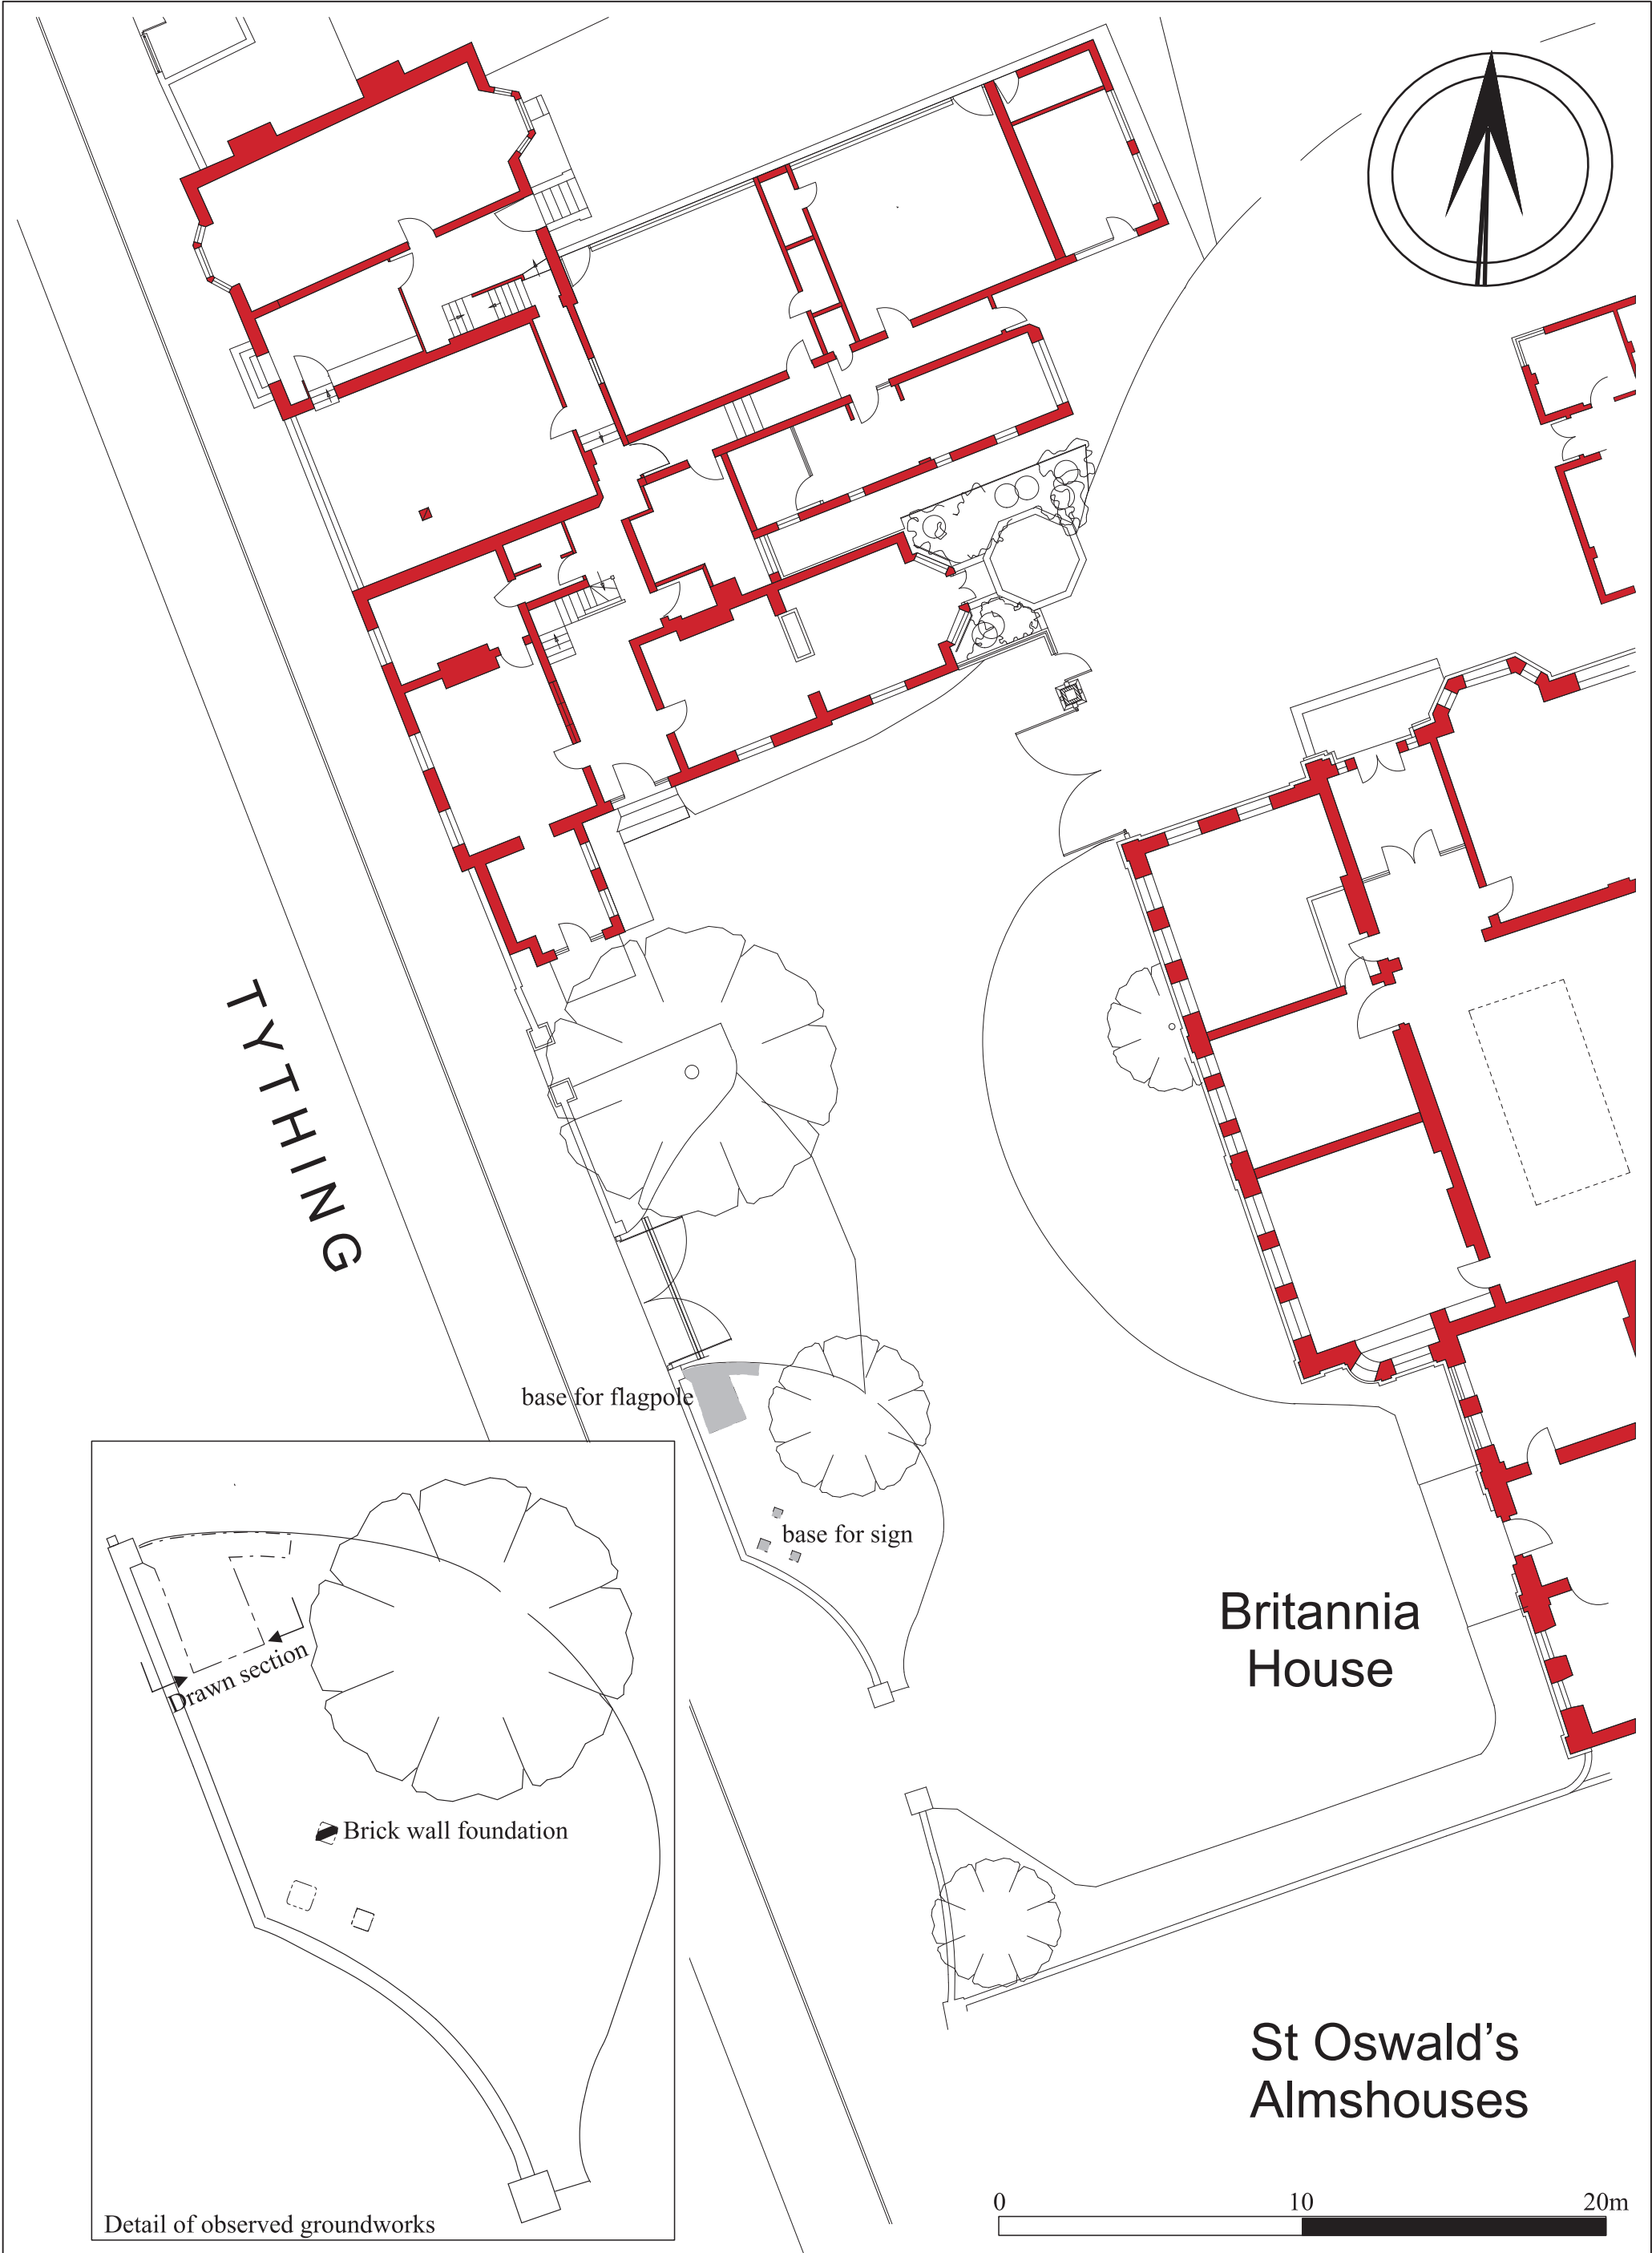
Figure 1: Site location and plan

An archaeological access visit was undertaken during excavation of minor groundworks for the base of a flagpole and sign at the Grammar School, Tything, Worcester (NGR SO 8479 5534: Fig 1).

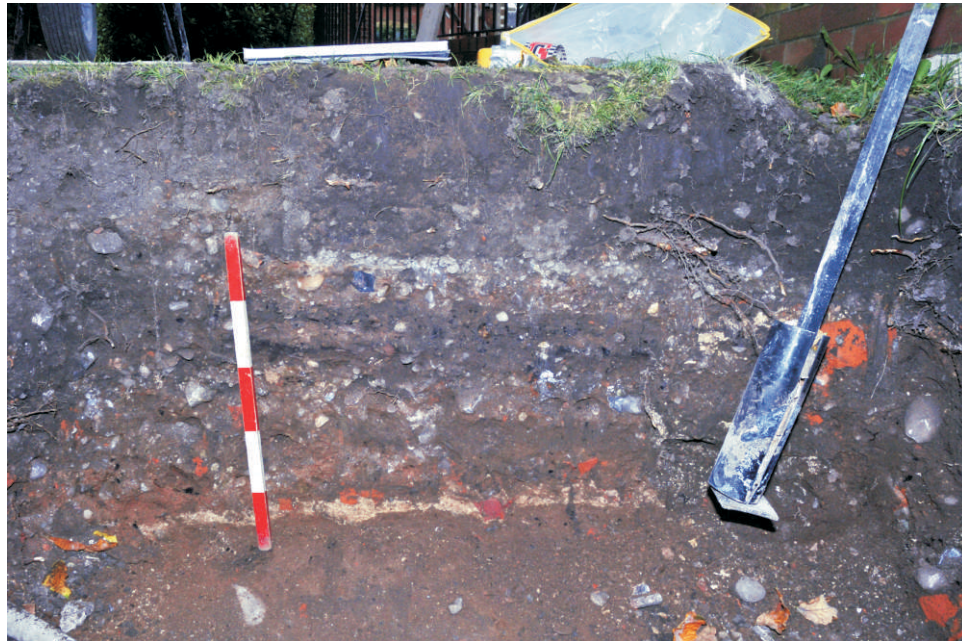
Four small holes were excavated in a turfed area – the largest being that for the concrete base to the intended flagpole – the dimensions being 1.2x1.5mx0.7m deep (Figs 2 and 3). The other excavations were three small postholes approx 0.4-0.5m wide and 0.5m deep. No archaeologically significant deposits were observed in any of the excavated areas. The sequence of deposits in the hole for the flagpole proved to be all of later post-medieval date, representing a layer of lime mortar overlaid by a sequence of compacted material incorporating brick and tile fragments interspersed with gravelled surfaces compatible with paths or driveways. The lime mortar layer is likely to be circa 18th C but no precise dating was possible.

Section exposed in pit for flag-pole - view facing south

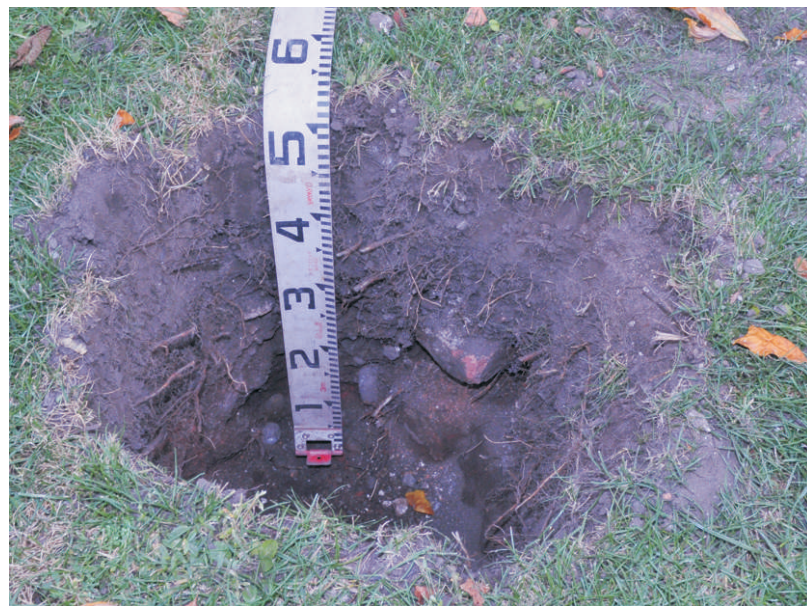
One of the post holes dug for the sign revealed a short section of what appeared to be a garden boundary wall (only 4" thick) running perpendicularly back from the Tything frontage. The brick appeared to be of later 18th C date (Fig 3), but this brick may be re-used in the present context. The three postholes for the sign were excavated primarily through turf and topsoil (plus a concrete base for a fencing base), and no earlier stratigraphy was visible.

Brickwork exposed in posthole for signpost

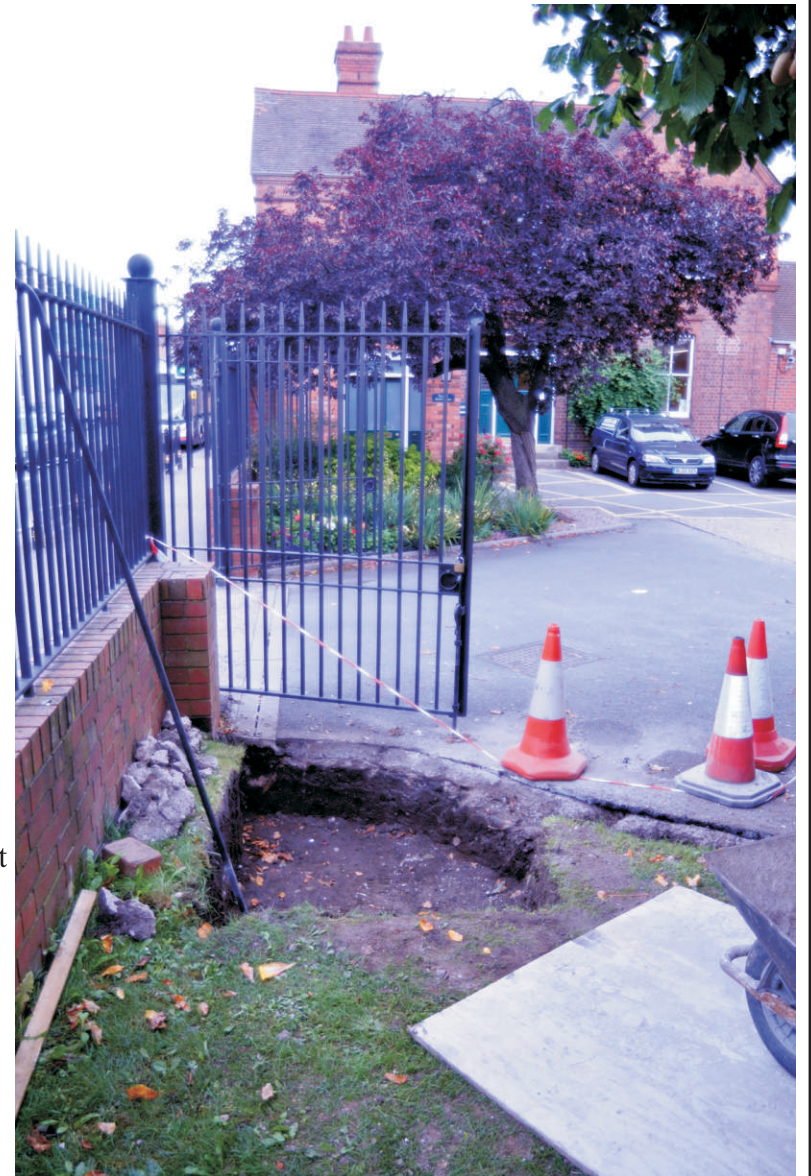
Figure 3: Site Photographs

View facing north towards flag pole base pit
