BUILDING RECORDING AT
LUMBER TREE FARM
WELLAND,
WORCESTERSHIRE

WSM 464741

Building recording at Lumber Tree Farm Welland, Worcestershire

14th June 2012

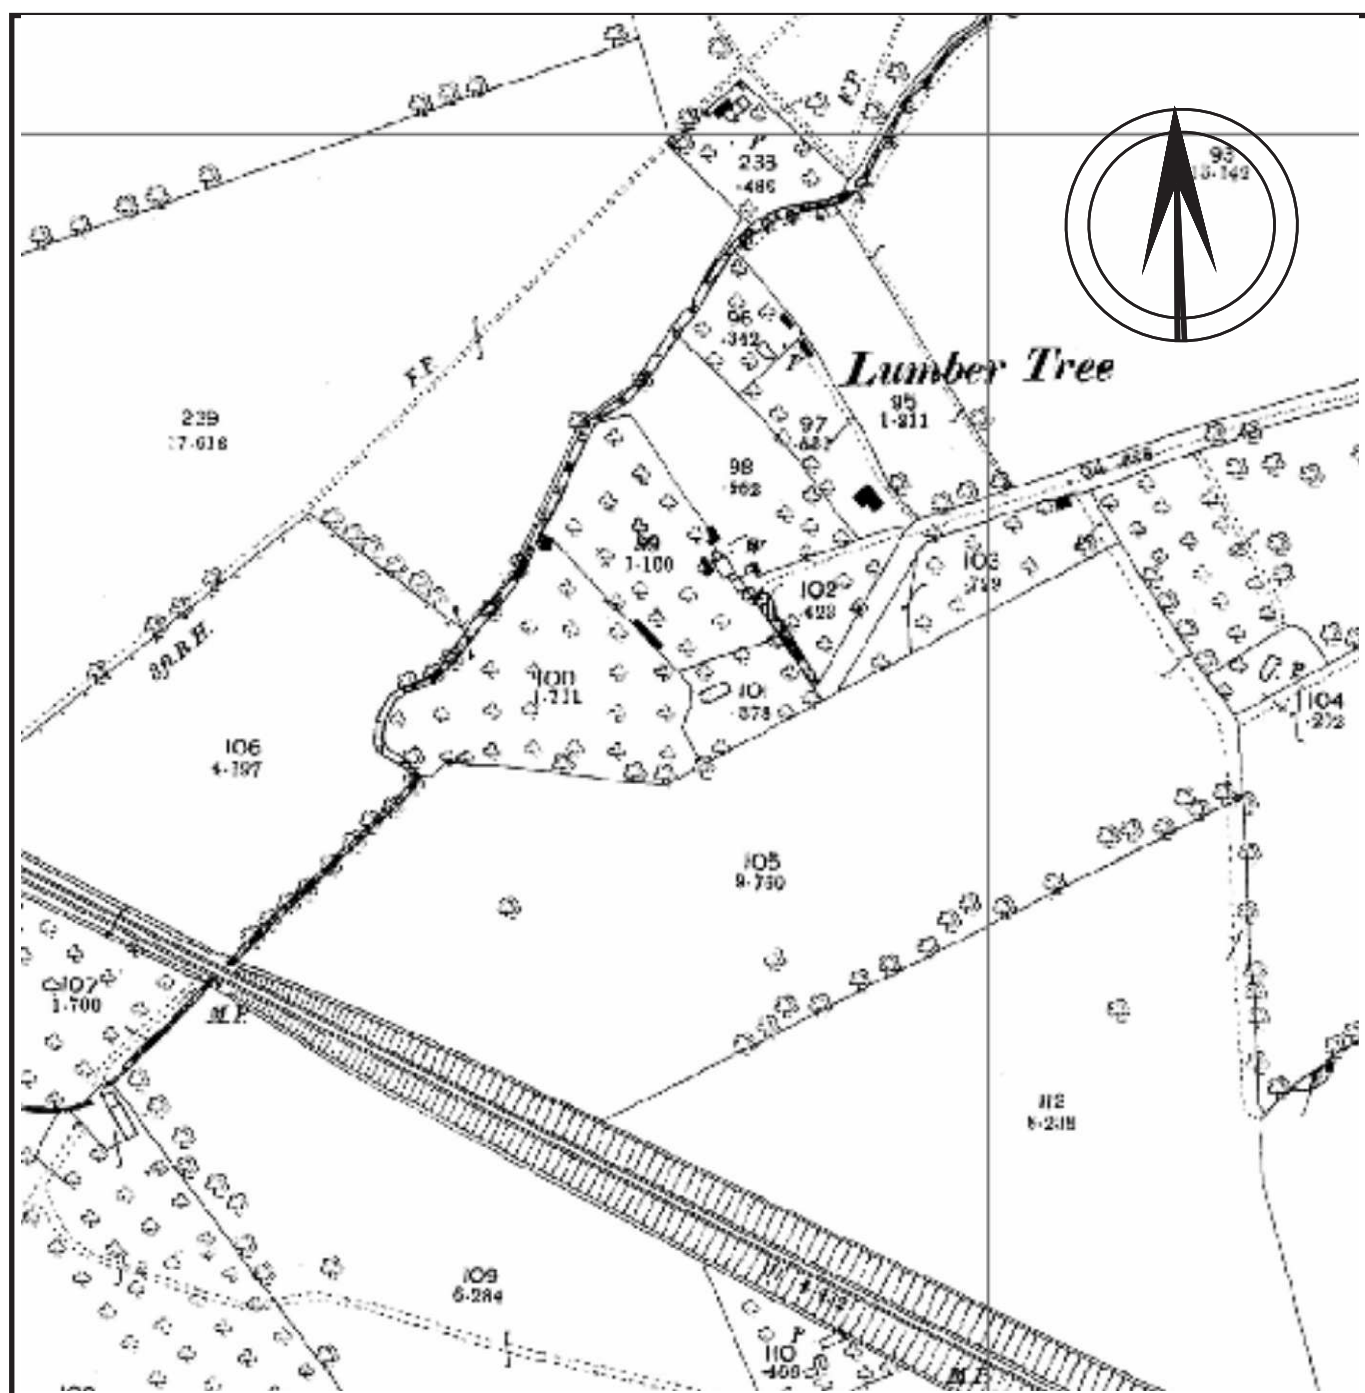
Figure 2: 1886 Ordnance Survey mapping

- 7.2 The 1880s Ordnance Survey (Fig 3), and subsequent editions, show a marked increase in the size of the building between 1840-41 and 1885. The southern block has been added, and interestingly is shown as being in two sections. The western lean-to block has also been built by this date, as well as several outbuildings. The cottages to the north and south of the current house are still present at this date (though they were both gone by 1904). The 1904 mapping shows a new outbuilding immediately to the west of the house, and a small detached building to the north appears to be a glass-house. Additions to the southern block (in the location of the current “potting shed”) appear to be possibly a pair of pig sties. The 1928 arrangements do not appear any different to those of 1904. The farm appears to have retained the same layout in 1945 (AP on Google Earth), and most of the present building ranges date to post 1950.

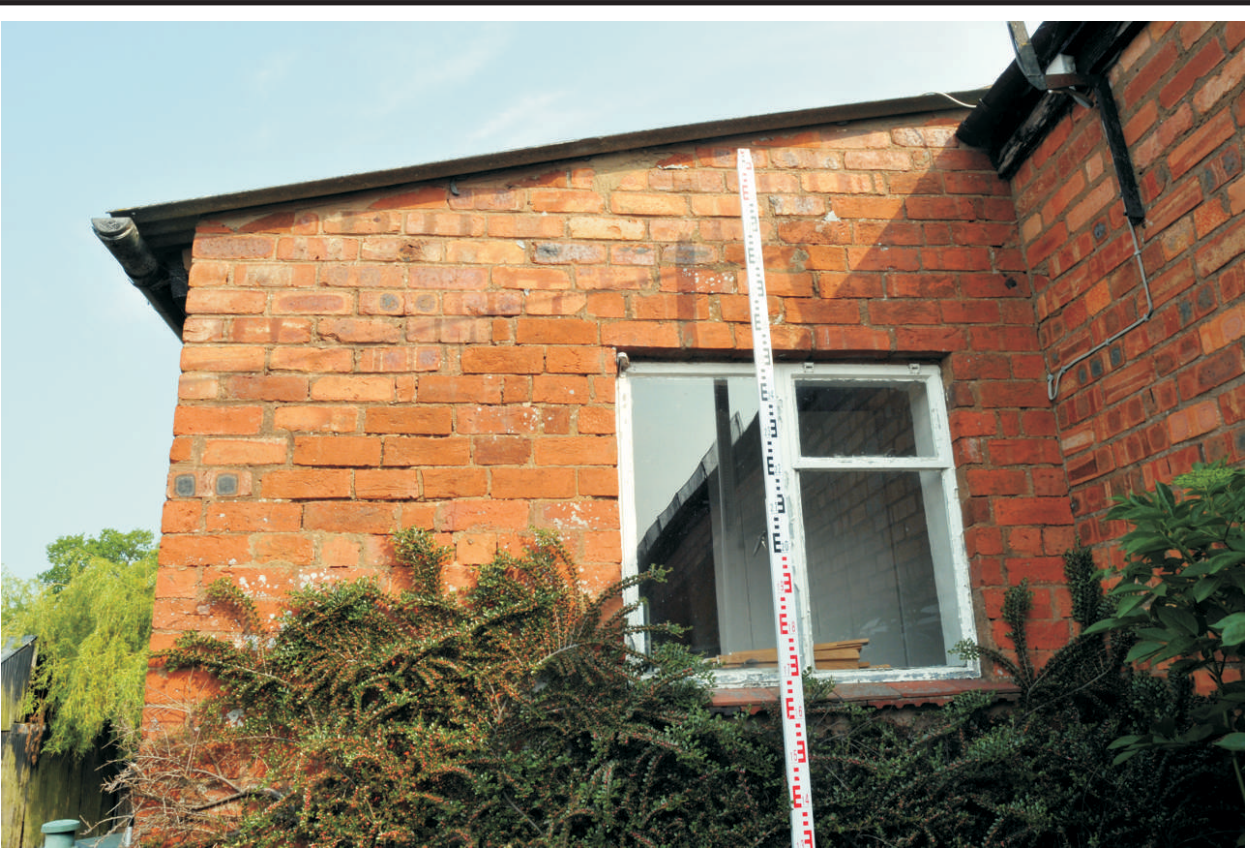
Detail of raised roofline of western lean-to

- 9.5.2 The domestic use of the upper floor of the western block could just be original, but may well have been as the result of a later conversion. The construction of the bedrooms is not closely dateable. The floor comprises of softwood joists (wider than they are deep) that are clearly mill-sawn, and likely to be later 19th C. The boarding is of wide softwood planks that again indicate a date broadly between 1860s and 1920s. On this basis the upper floor seems to have been present by the early 20th C. The rooms thus created would have had only very limited headroom, with steeply sloping ceilings, perhaps suitable only for storage or children’s bedrooms. In order to create rooms with adequate head-room for their full width it was clearly necessary to raise the roof line over the western eaves, and this appears to have occurred in the 1940s or 1950s, the brickwork being of this date, set in cement mortar, and the corrugated asbestos cement roofing was a material available in the 1930s but more commonly used in wartime and immediately post war during material shortages. The two windows in the upper floor are of metal framed designs of the mid 20th C. They are similar in size and design to windows widely used in the nearby military hospital buildings, and could be possibly re-used (though they show no traces of the standard military paint colour). These openings are inserted. There are no indications of any original window openings in the brickwork, and it is likely that prior to the roof being replaced there were west facing dormers.

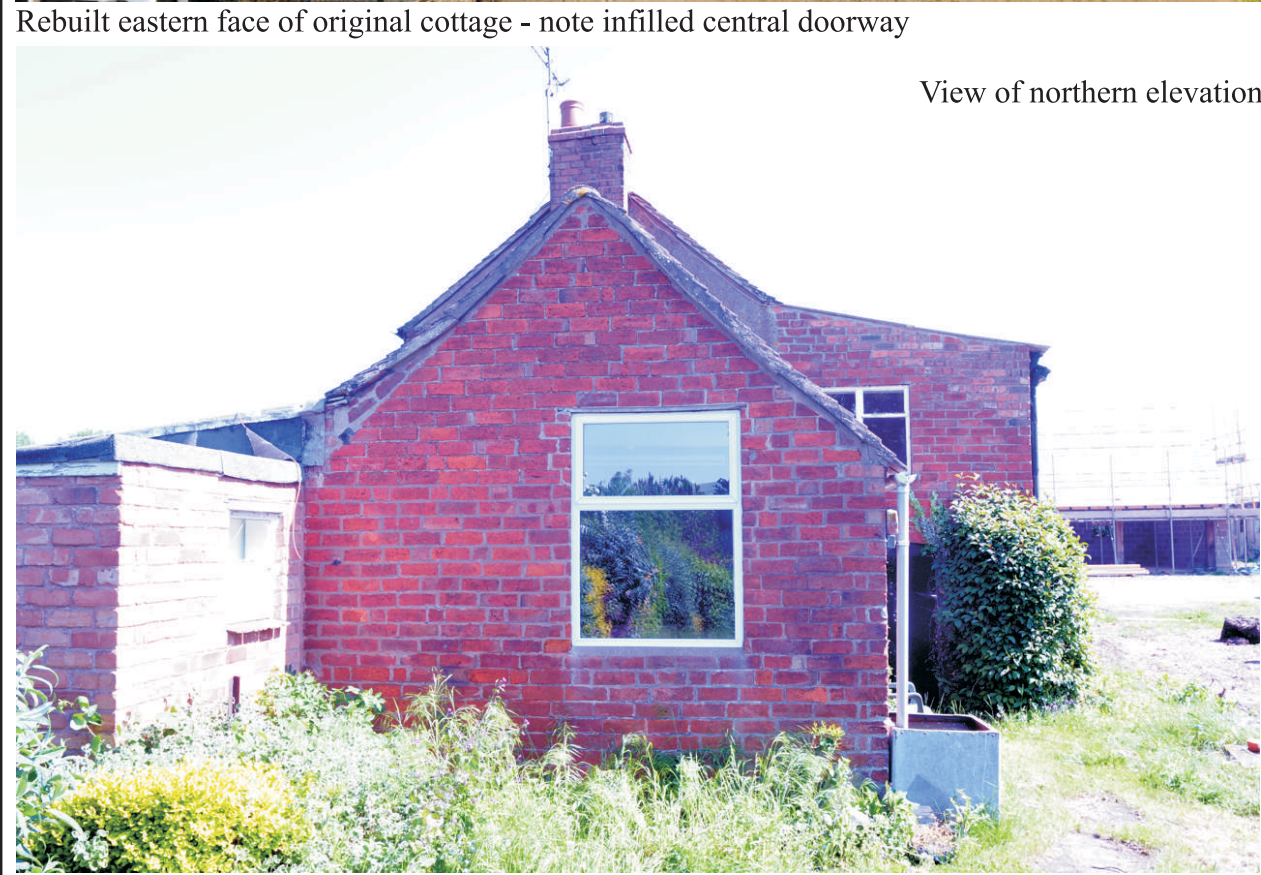
View of northern elevation

9.6.1 The northern part of the house comprises of several phases of single storey extensions and conversions (Fig 4). The earliest element is a single storey brick structure, with a double pitched tiled roof (GF8). A building is shown at this position on the 1840s Tithe mapping, and it is possible that the present structure is circa 1830-40, though there are no surviving dateable features excepting the brickwork, which has been at least partially rebuilt. The eastern pitch of the roof has been raised, and it is likely that the roof structure has also been replaced, though this was not exposed. Only the western and northern elevations are now visible, and these have been altered in the mid 20th C. A wide doorway at the southern end of the western elevation has been infilled, and two large window openings inserted. Internally there are no features of significance. The recess in the eastern wall of GF8 was probably originally a small east facing window. There is in the NW corner a late 18th C corner cupboard, with finely shaped shelves, but unfortunately this has been badly mutilated by removal of the bottom half. It has clearly been added to the room in recent times. The room backs onto the original cottage chimney, and it is possible that it originated as a bake-house/wash-house/scullery, though no evidence of this was visible, the room having modern finishes throughout.

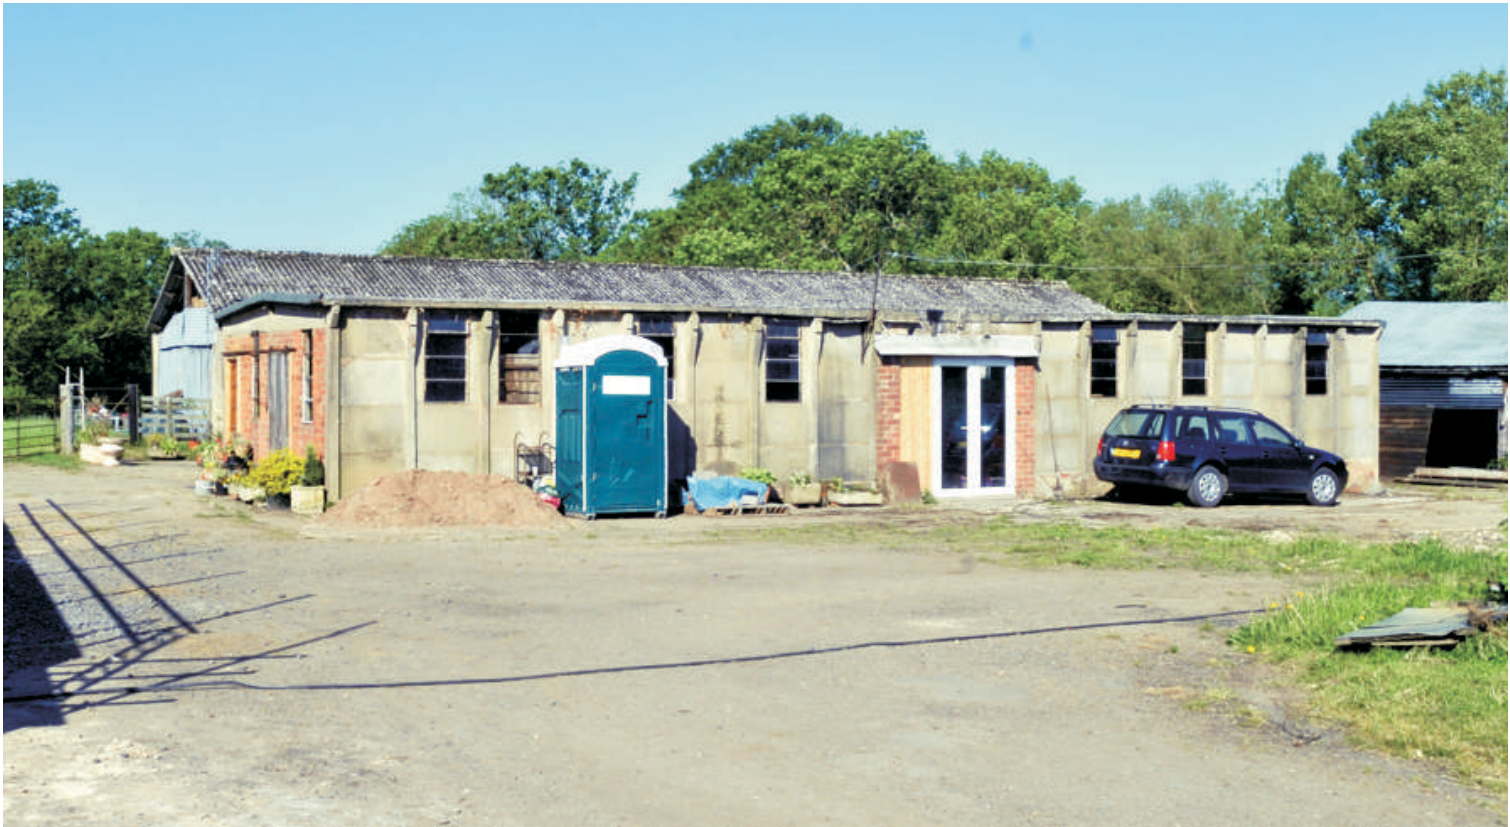
View of farmyard west of house showing re-located WW2 prefabricated concrete building

9.1 Lumber Tree Farm is a small and rather informally laid out farmstead, most of the buildings of which appear to be of 20th C date. There are several wartime prefabricated concrete office or hospital ward buildings which were re-erected here after 1945 (they do not show on 1945 aerial photographs). The design of the buildings is not one known to have been present at any of nearest three wartime military hospitals (Blackmoor Park, Merebrook and Brickbarns; Napthan 2005, Collins & Collins 2008 and 2010), and this lends credence to anecdotal evidence that they were moved circa 1950 from Hartlebury (Mr Partridge pers comm.). The buildings show clear signs of re-erection. The other remaining buildings of the farmstead are mainly of timber post/steel girder construction clad in corrugated sheeting. The building immediately to the south of the house had been recently demolished and replaced with a garage/bat loft building shortly before the farmstead was inspected, and therefore could not be inspected.

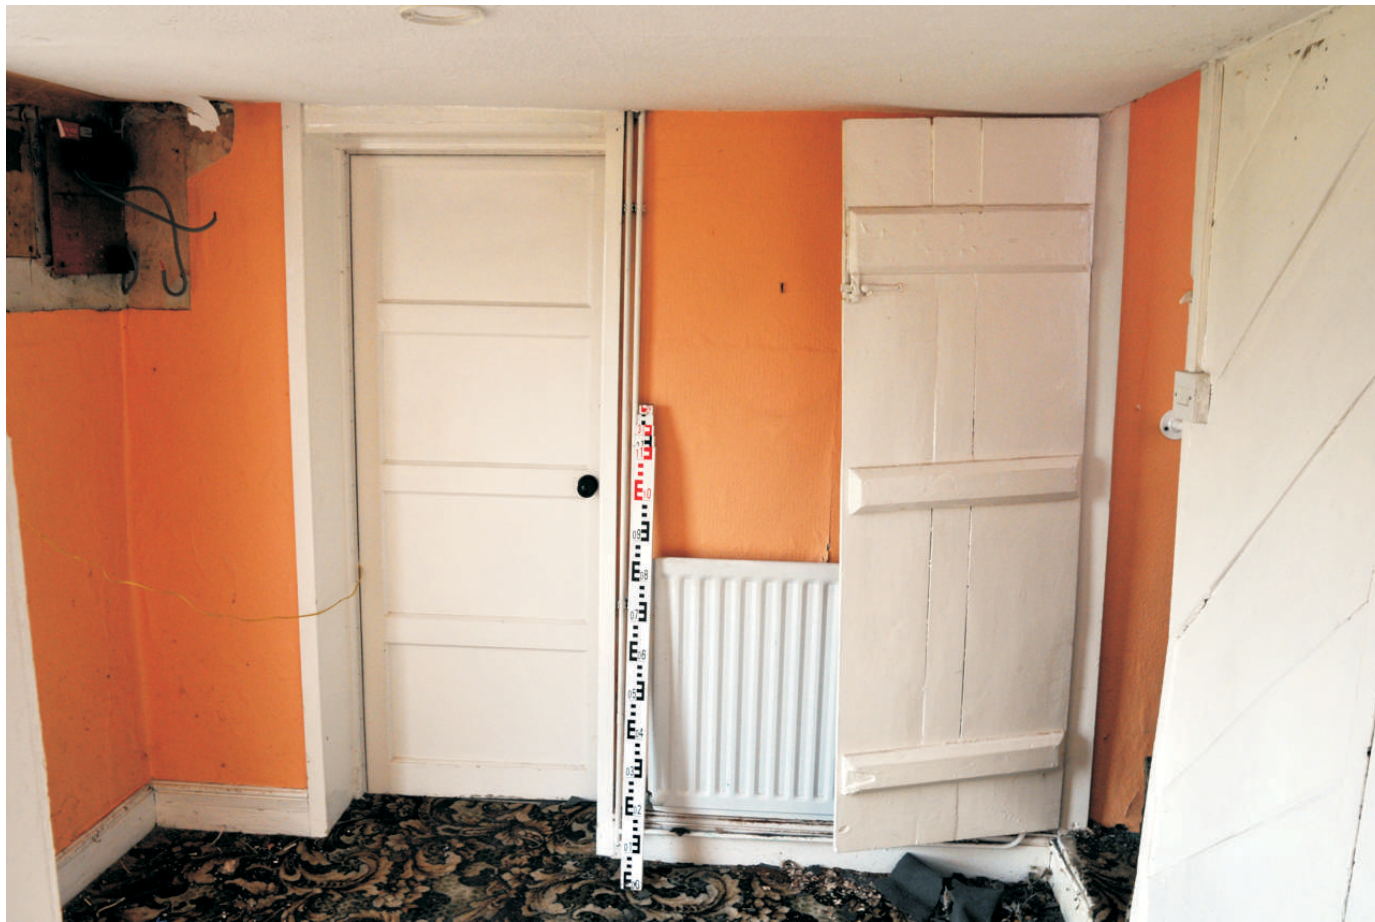
GF 4 facing south

- 9.4.6 The southern room GF4 now serves as a hallway, there being a modern external door to the eastern elevation and a mid 20th C panelled ply door to GF3. It is likely that this latter doorway is also inserted, but the plaster was not stripped to test this assumption. The remaining doorway leads to GF 5, the door having been removed. The principal feature of GF4 is the stair enclosure (Figs 6, 10 and 11), which incorporates two doors of 17th C date. The stair itself appears to be of hardwood and is of crude construction. The flight is both steep and tightly turning. The stair enclosure conceals a small understairs cupboard. The three plank door has a sunken central panel, the outer planks being edge moulded, the door is directly comparable with an example of 1681 (Hall 2005, fig 2.44). The door has heart-shaped piercings. The door at the bottom of the stairs is also a three-panel ledged door, the central panel being flush. All three panels have edge mouldings of late 17th-early 18th C character. The method of rebating and lapping the panels is rather unusual, and the door has been pieced together from two sections of similar doors. The "T" hinges for both doors are of 17th-early 18th C character. The combined handle/latch lifter is of early to mid 17th C date, and if as appears the case, the handle is contemporary with the door then the door is likely to be of mid 17th C origin.

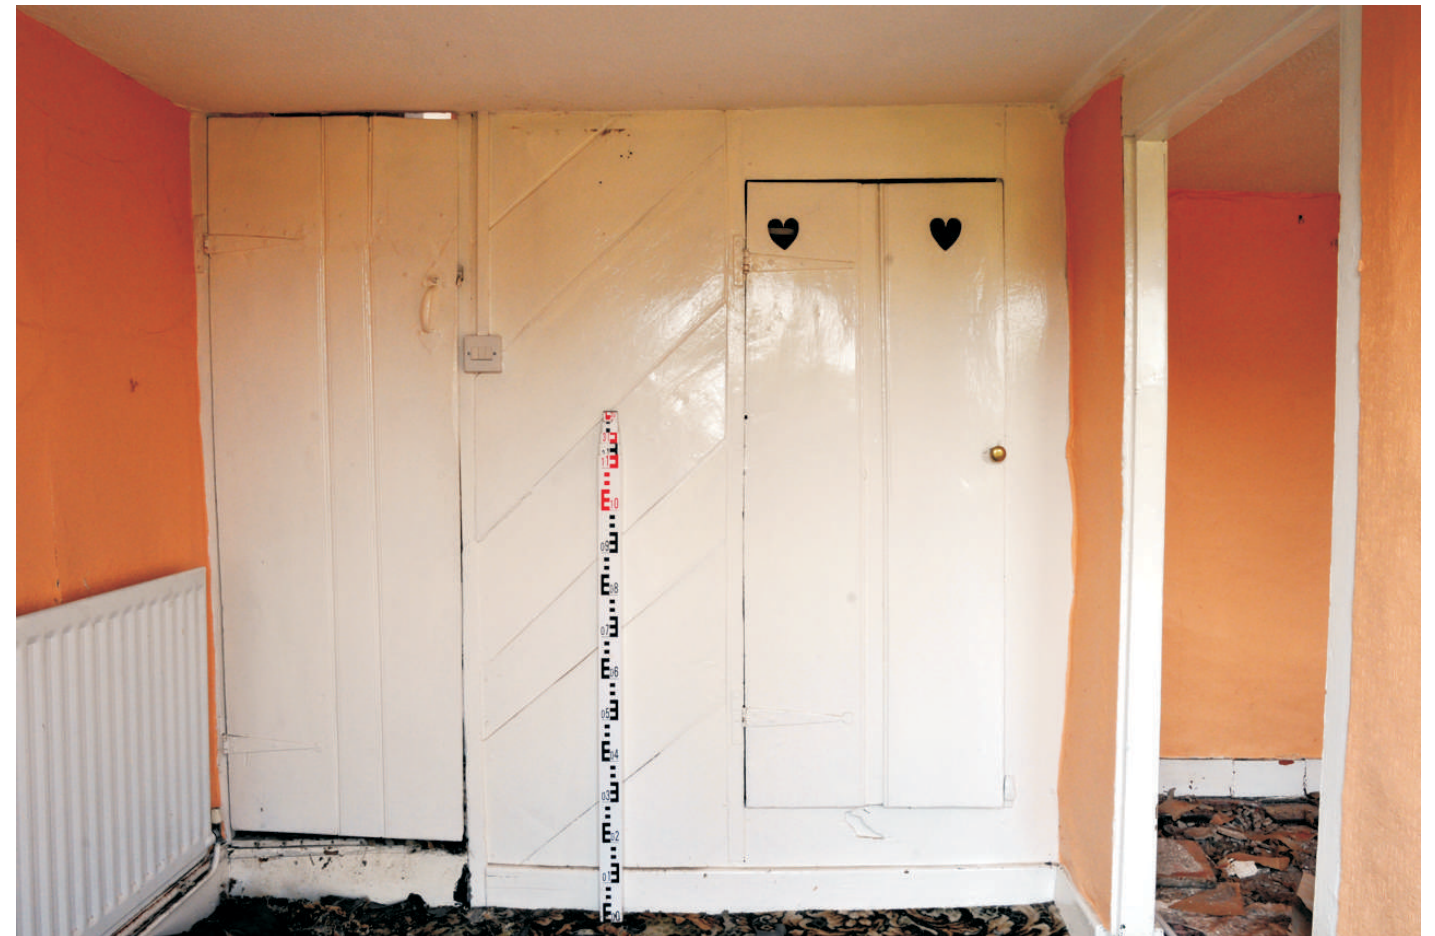
Detail of stair partition GF 4

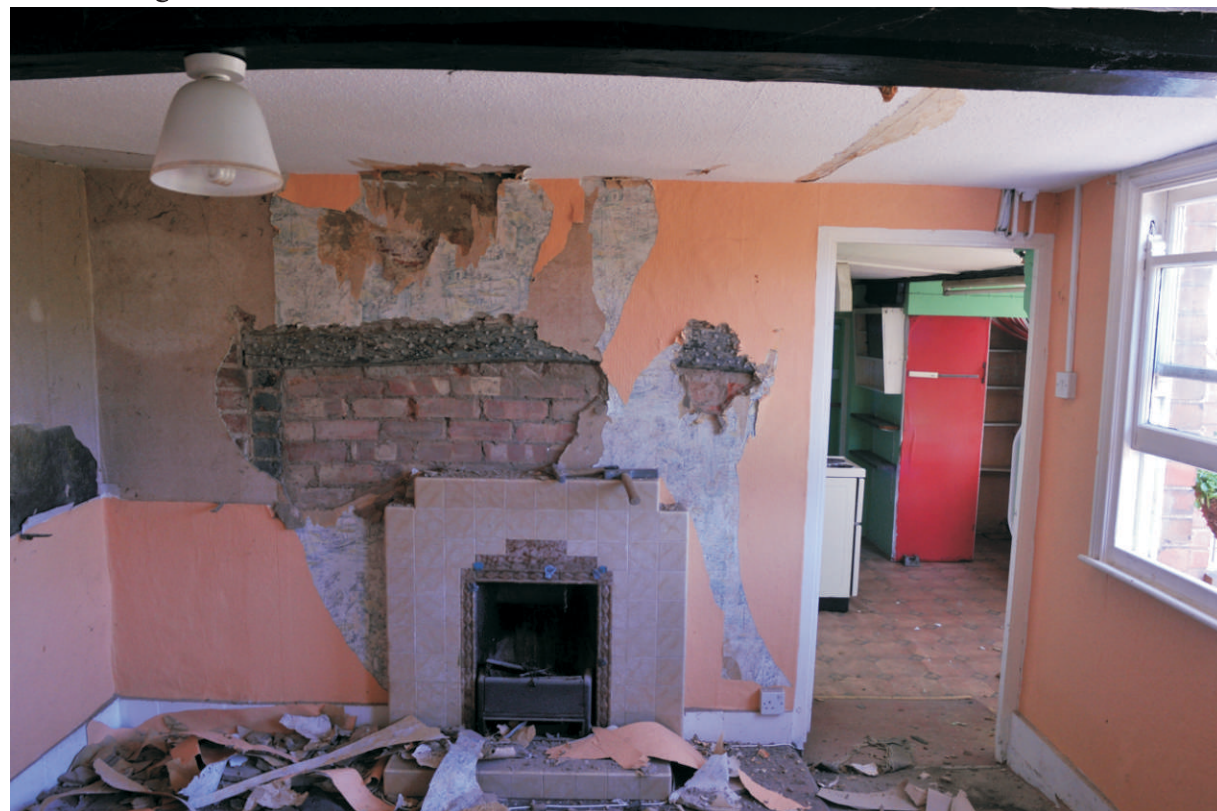
GF 5 view facing north, showing exposed lintel of former fireplace

- 9.4.4 The chimney stack has been partially rebuilt, and is otherwise concealed within the building, making interpretation difficult. On measuring the building it was found that the chimney base was unusually deep and wide for what appeared to be a late 18th-early 19th C cottage, and plaster/render was then stripped from the area around the modern (1950s-60s) fire surround. This revealed the curving hearth-lintel of a substantial “inglenook” type fireplace, but unfortunately the intractable nature of the 1960s brick and cement infill resisted attempts to expose the interior of this earlier fireplace. The hearth lintel bore traces of the timber brackets which formerly supported a lost mantelshelf. The brackets had been pegged to the hearth-lintel, which was of oak.

- 9.4.7 In the northern room GF5 is bridged by a small scantling bridging beam aligned east-west. There are plain chamfer stops only at the eastern end. The ground floor ceiling/first floor structure has been otherwise entirely reconstructed, the ceiling being lined with matchboard panelling underlaid with fibreboard. The walls are plastered, the plaster to the southern and western walls being probably L18th-early 19th C, the remaining walls having later (mainly 20th C plasterwork). The tiled fire surround is a mass produced example of the 1950s or more probably 1960s. It is set into the blocking of the earlier fireplace (described above). The earlier fireplace lintel has been truncated by the insertion of a doorway to the kitchen extension, which also removed the eastern jamb of the inglenook. The two sash windows to this room are consistent with a late 19th C date, most probably of the 1870s-80s. The southern-most window has been re-located in a former doorway, as described above. Post dating the blocking of the doorway the room was provided with a skirting of thin brick pavours set on edge. There were several layers of wall-paper, the earliest possibly dating to the 1930s-40s. A corner wall cupboard had been installed in the NW corner, partially overlaying both this wallpaper and the 1960s blocking of the original fireplace. The outline of the removed cupboard suggests that it was of late 18th-early 19th C type.

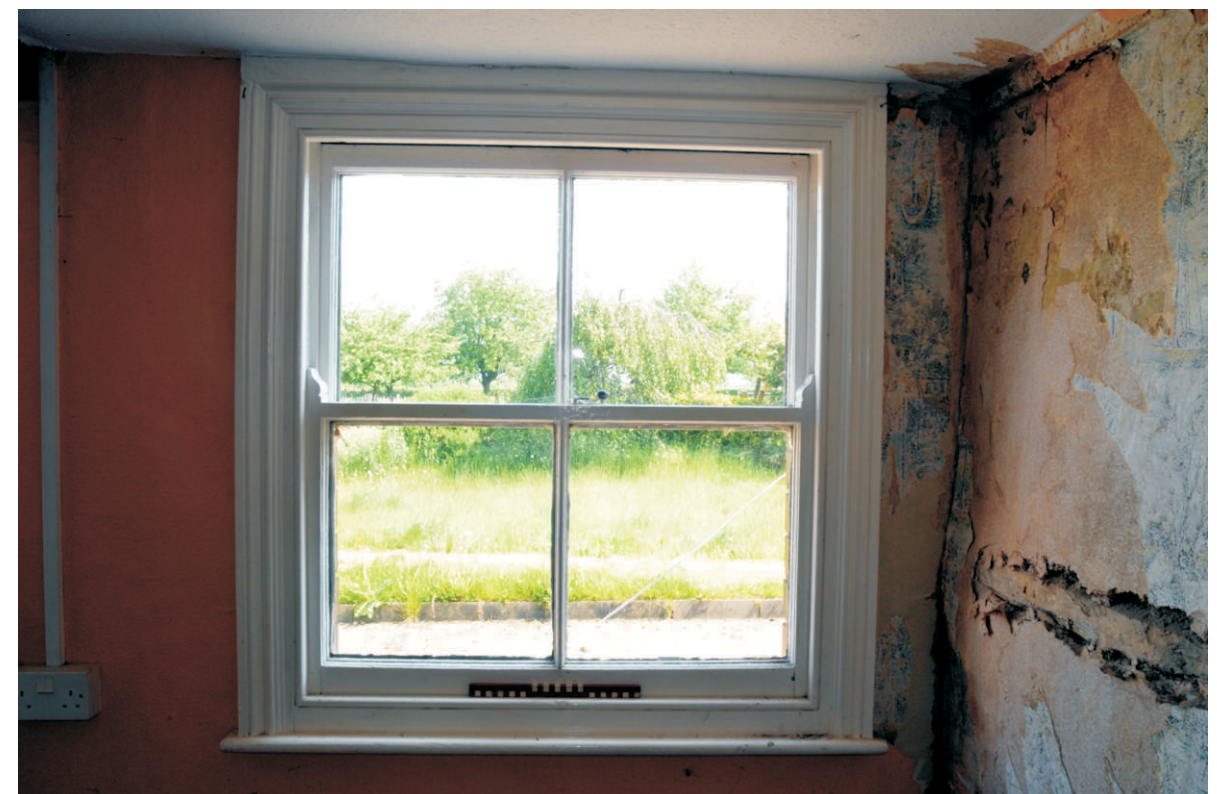
Detail of relocated late 19th C sash window

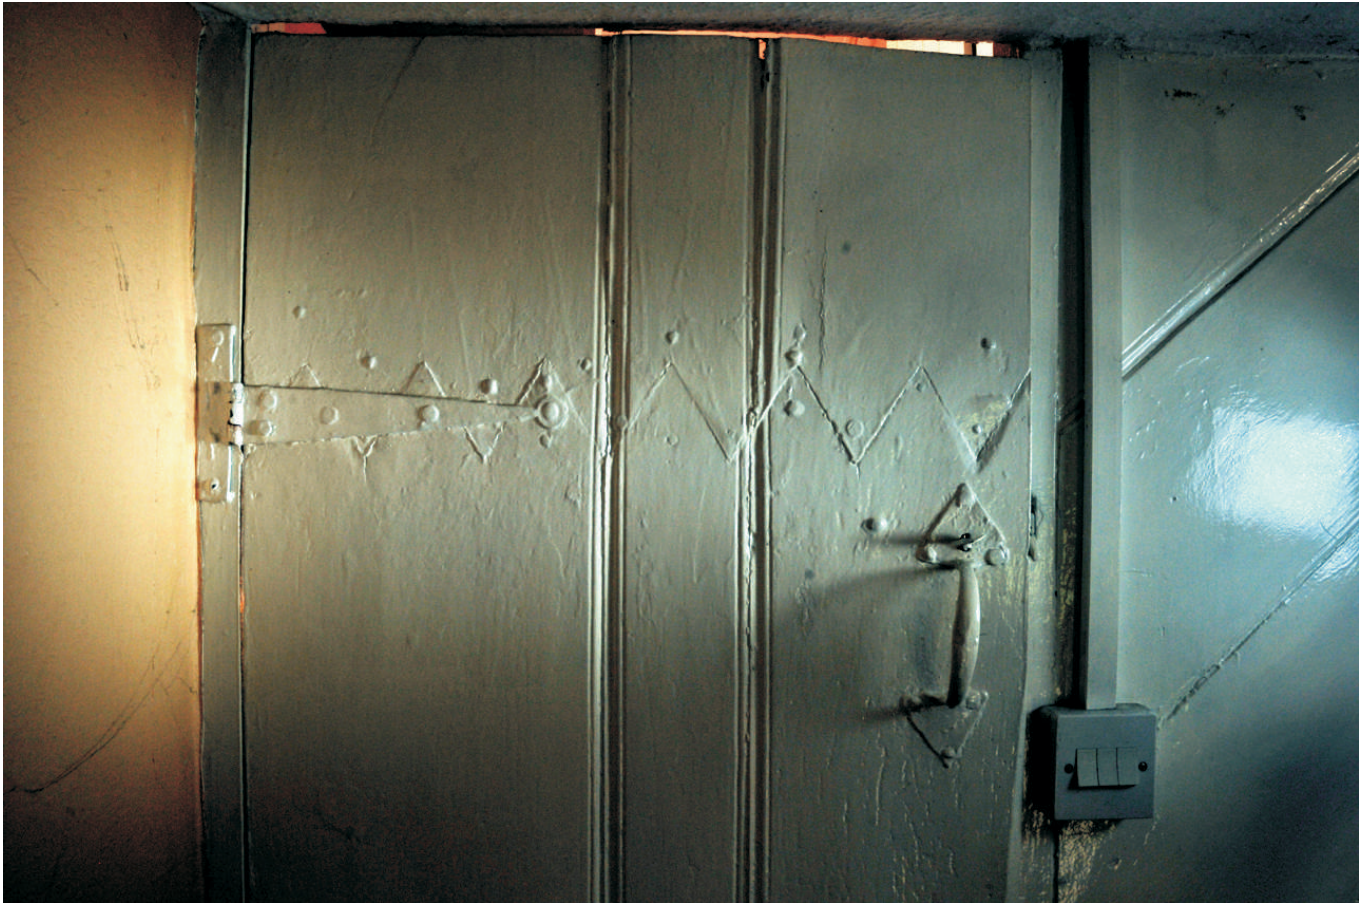
Details of door to stairwell - this appears to be re-used and is of mid 17th C date

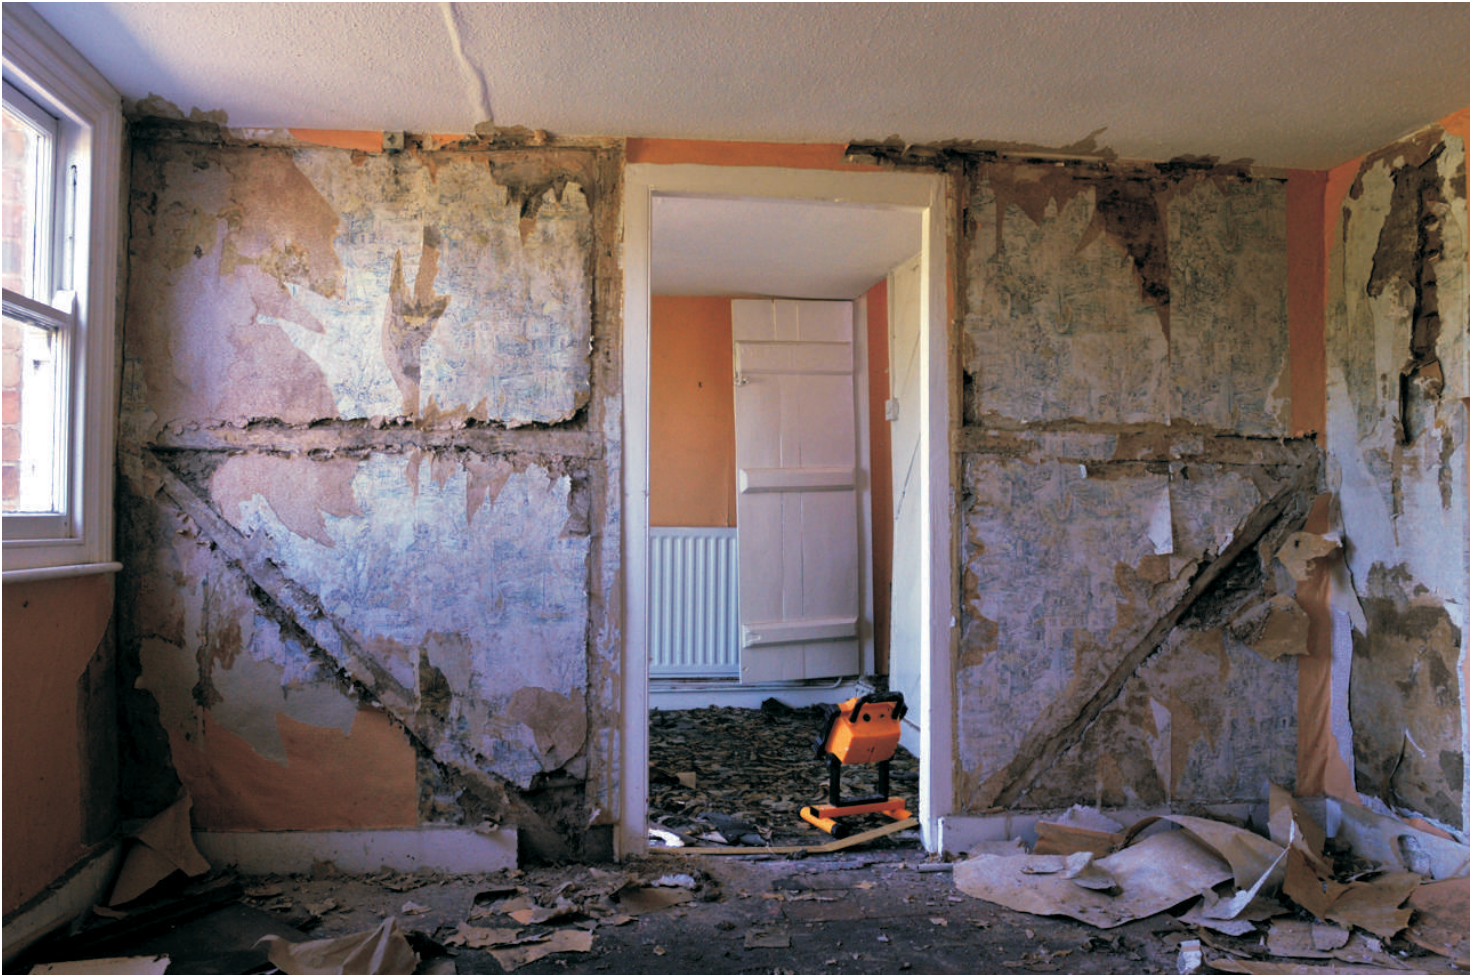
Exposed framing of partition between GF 4 and GF 5

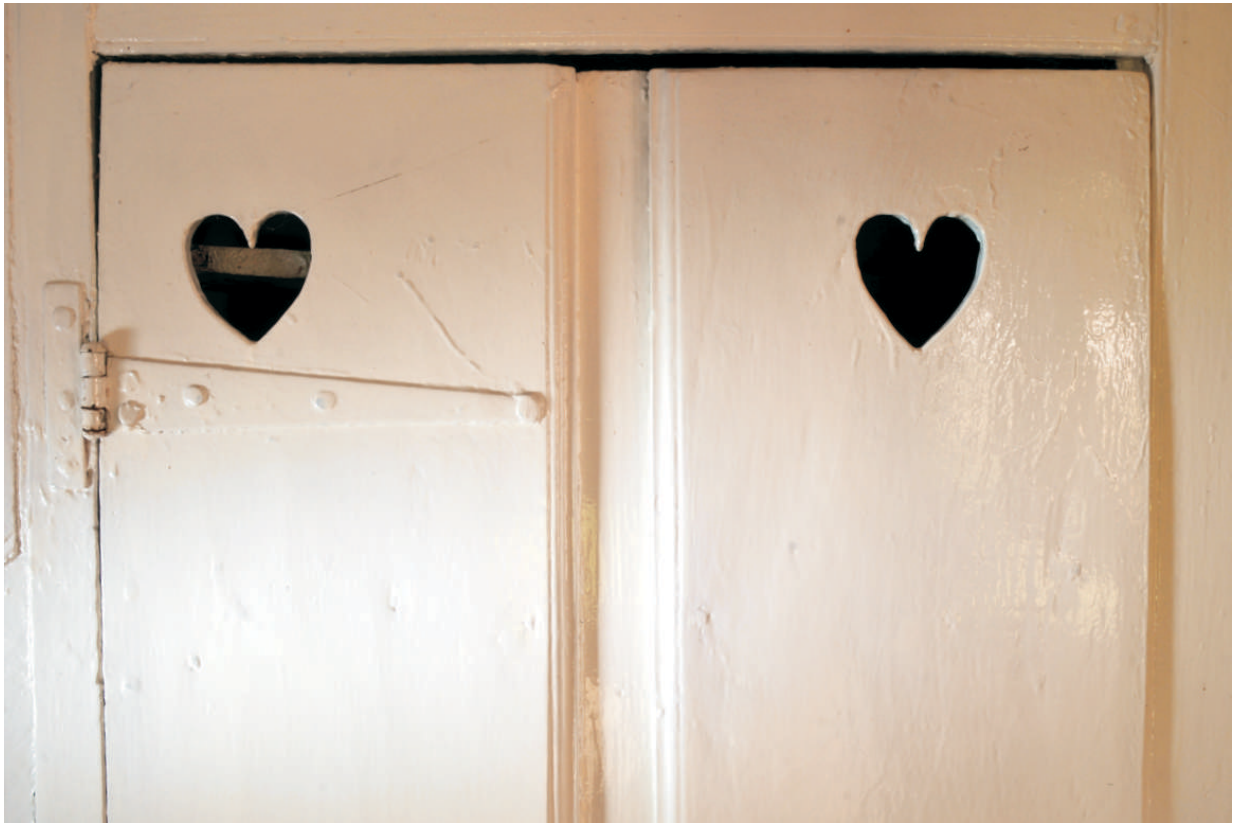
Detail of door to understairs cupboard, of mid 17th C date; hinge probably early 18th C

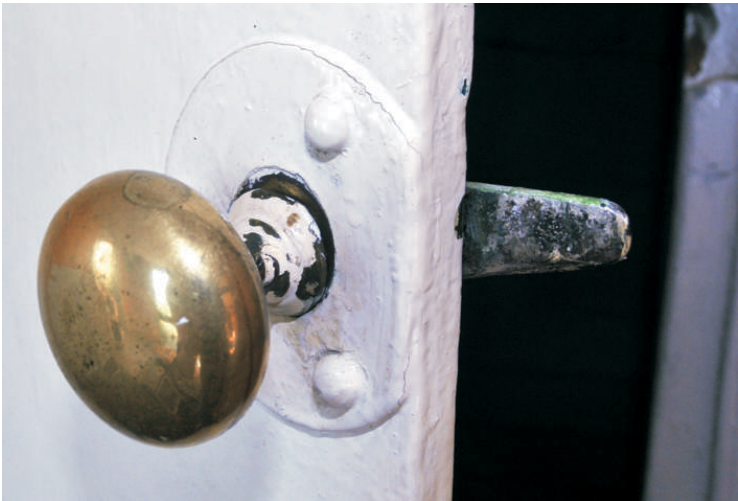
Detail of 19th C door turn latch on cupboard door

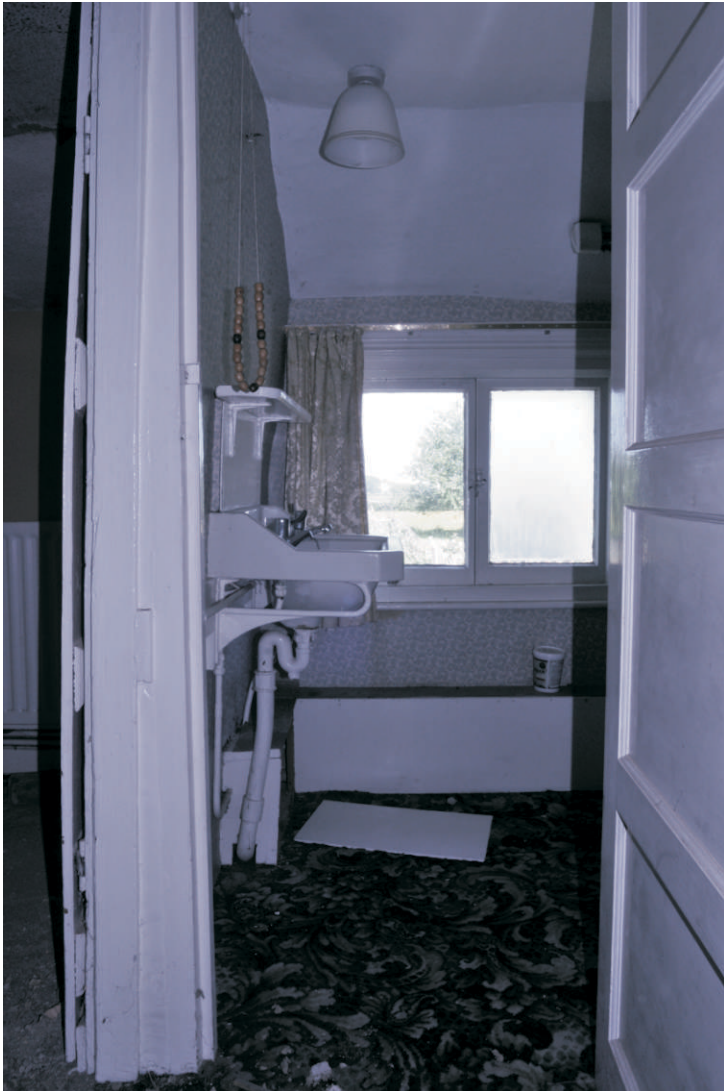
View of bathroom FF3 from landing FF2

- 9.4.8 At first floor level the stair arises in a small lobby area FF3. This area is divided from FF2 by a mid 20th C plywood and obscure glazed partition, probably dating to the mid 1950s-early 1960s. An inserted doorway leads into FF4 from part way up the stair-flight. The remainder of the southern bay is occupied by a bathroom (Figs 4 and 12). The bathroom (FF2) is furnished with mid 20th C fittings and has a mid 20th C door. A small window is provided at eaves level on the eastern elevation. The ceiling is of lath and plaster on joists that appear to be later 19th C – the ceiling appears to have been replaced when the eastern elevation was rebuilt, but has subsequently sagged significantly. The first floor is clad in mid-late 20th narrow softwood boarding. The plasterwork is generally of L18th-mid 19th C character, with localised later repairs. The structural partition at this level is partially infilled with wattle and daub, but the upper part of the partition appears to have been partially rebuilt, and this area has lath and plaster of late 19th C date. The elm framing of the partition shows signs of extreme distortion under load, and some elements have failed. The purlin loads are transmitted mainly by inserted studs and packing pieces, the collar having snapped at both ends. The roof load is effectively transmitted to the ground only by the door frames at first and second floor, both of which show signs of bowing under the weight. Lateral restraint against the spreading of the roof is provided by a wrought iron cranked tie of probably late 19th C date. The exterior walls have moved away from the structural partition, most noticeably at the western end. It is unclear if the walls were ever tied into the partition, but this seems unlikely. The two gable ends at this level appear to have been rebuilt in the mid-late 19th C,

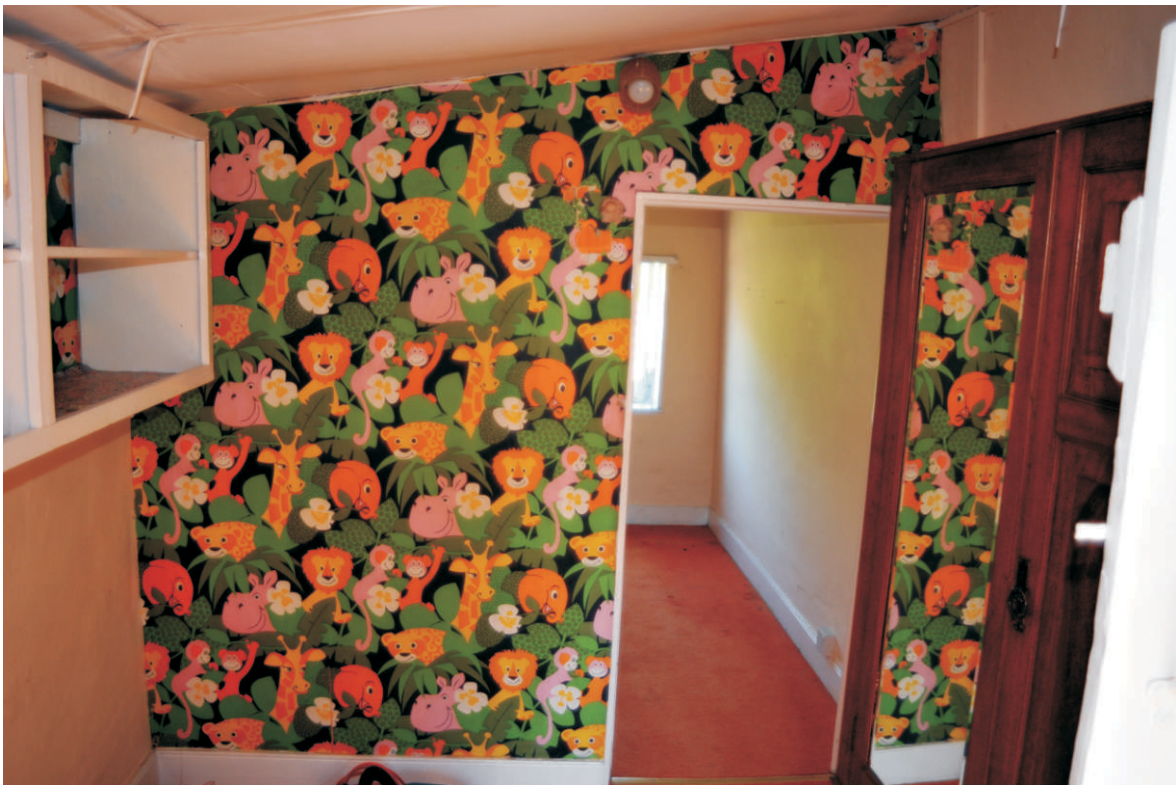
Rooms FF4 and FF5, view facing north

become 9" brick, the original walling at this level being only half brick thick. Room FF4 served as a through bedroom to FF 5, The slender partition wall between the two rooms appears to be of stud construction (not exposed). Doors to both rooms are of ledged plank construction, that from the stairwell to FF4 has been increased in width on the hinge edge, the other planks being beaded tongue and groove. The original door is probably mid-late 19th C in date, but re-used in the present position. The latch lifter handle is probably of similar date. The door to FF5 is also re-used (having again been widened). The original part of the door is beaded tongue and groove softwood, and the door furniture circa 1860s-70s, with a small square metal cased lock and wrought latch-lifter handle. The skirtings in both rooms are of a simple narrow design with a top bead; this type of skirting was popular in the 1860s-70s for lesser rooms. The ceiling is of hardboard panelling. It would appear likely that when the roof was raised the earlier doors were re-used in wider doorframes, and the partition re-constructed.

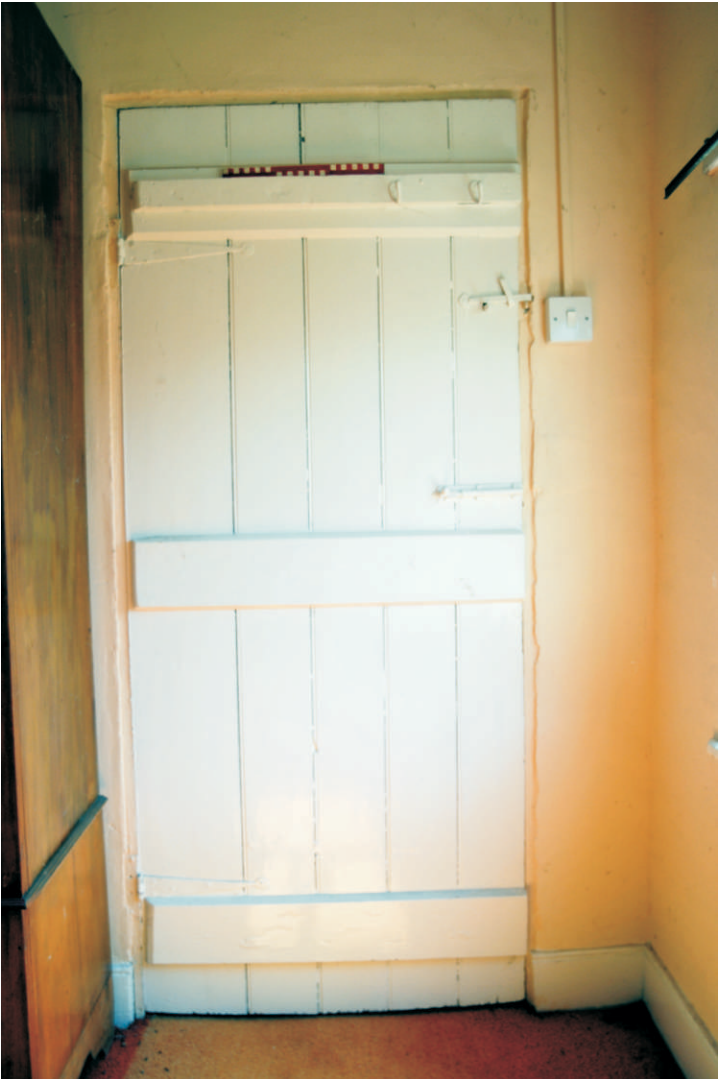
Reused and widened door of FF4

- 9.5.3 Room FF4 is accessed via an awkwardly placed doorway positioned over the turning steps of the staircase within the original cottage. The area of walling around the door has been rebuilt to
