ARCHAEOLOGICAL EVALUATION  
TRENCHING AT THURSTON COURT  
SEVERNSIDE SOUTH  
BEWDLEY  
WORCESTERSHIRE

# Archaeological Evaluation Trenching at Thurston Court, Sevenside South, Bewdley Worcestershire

21st September, 2021

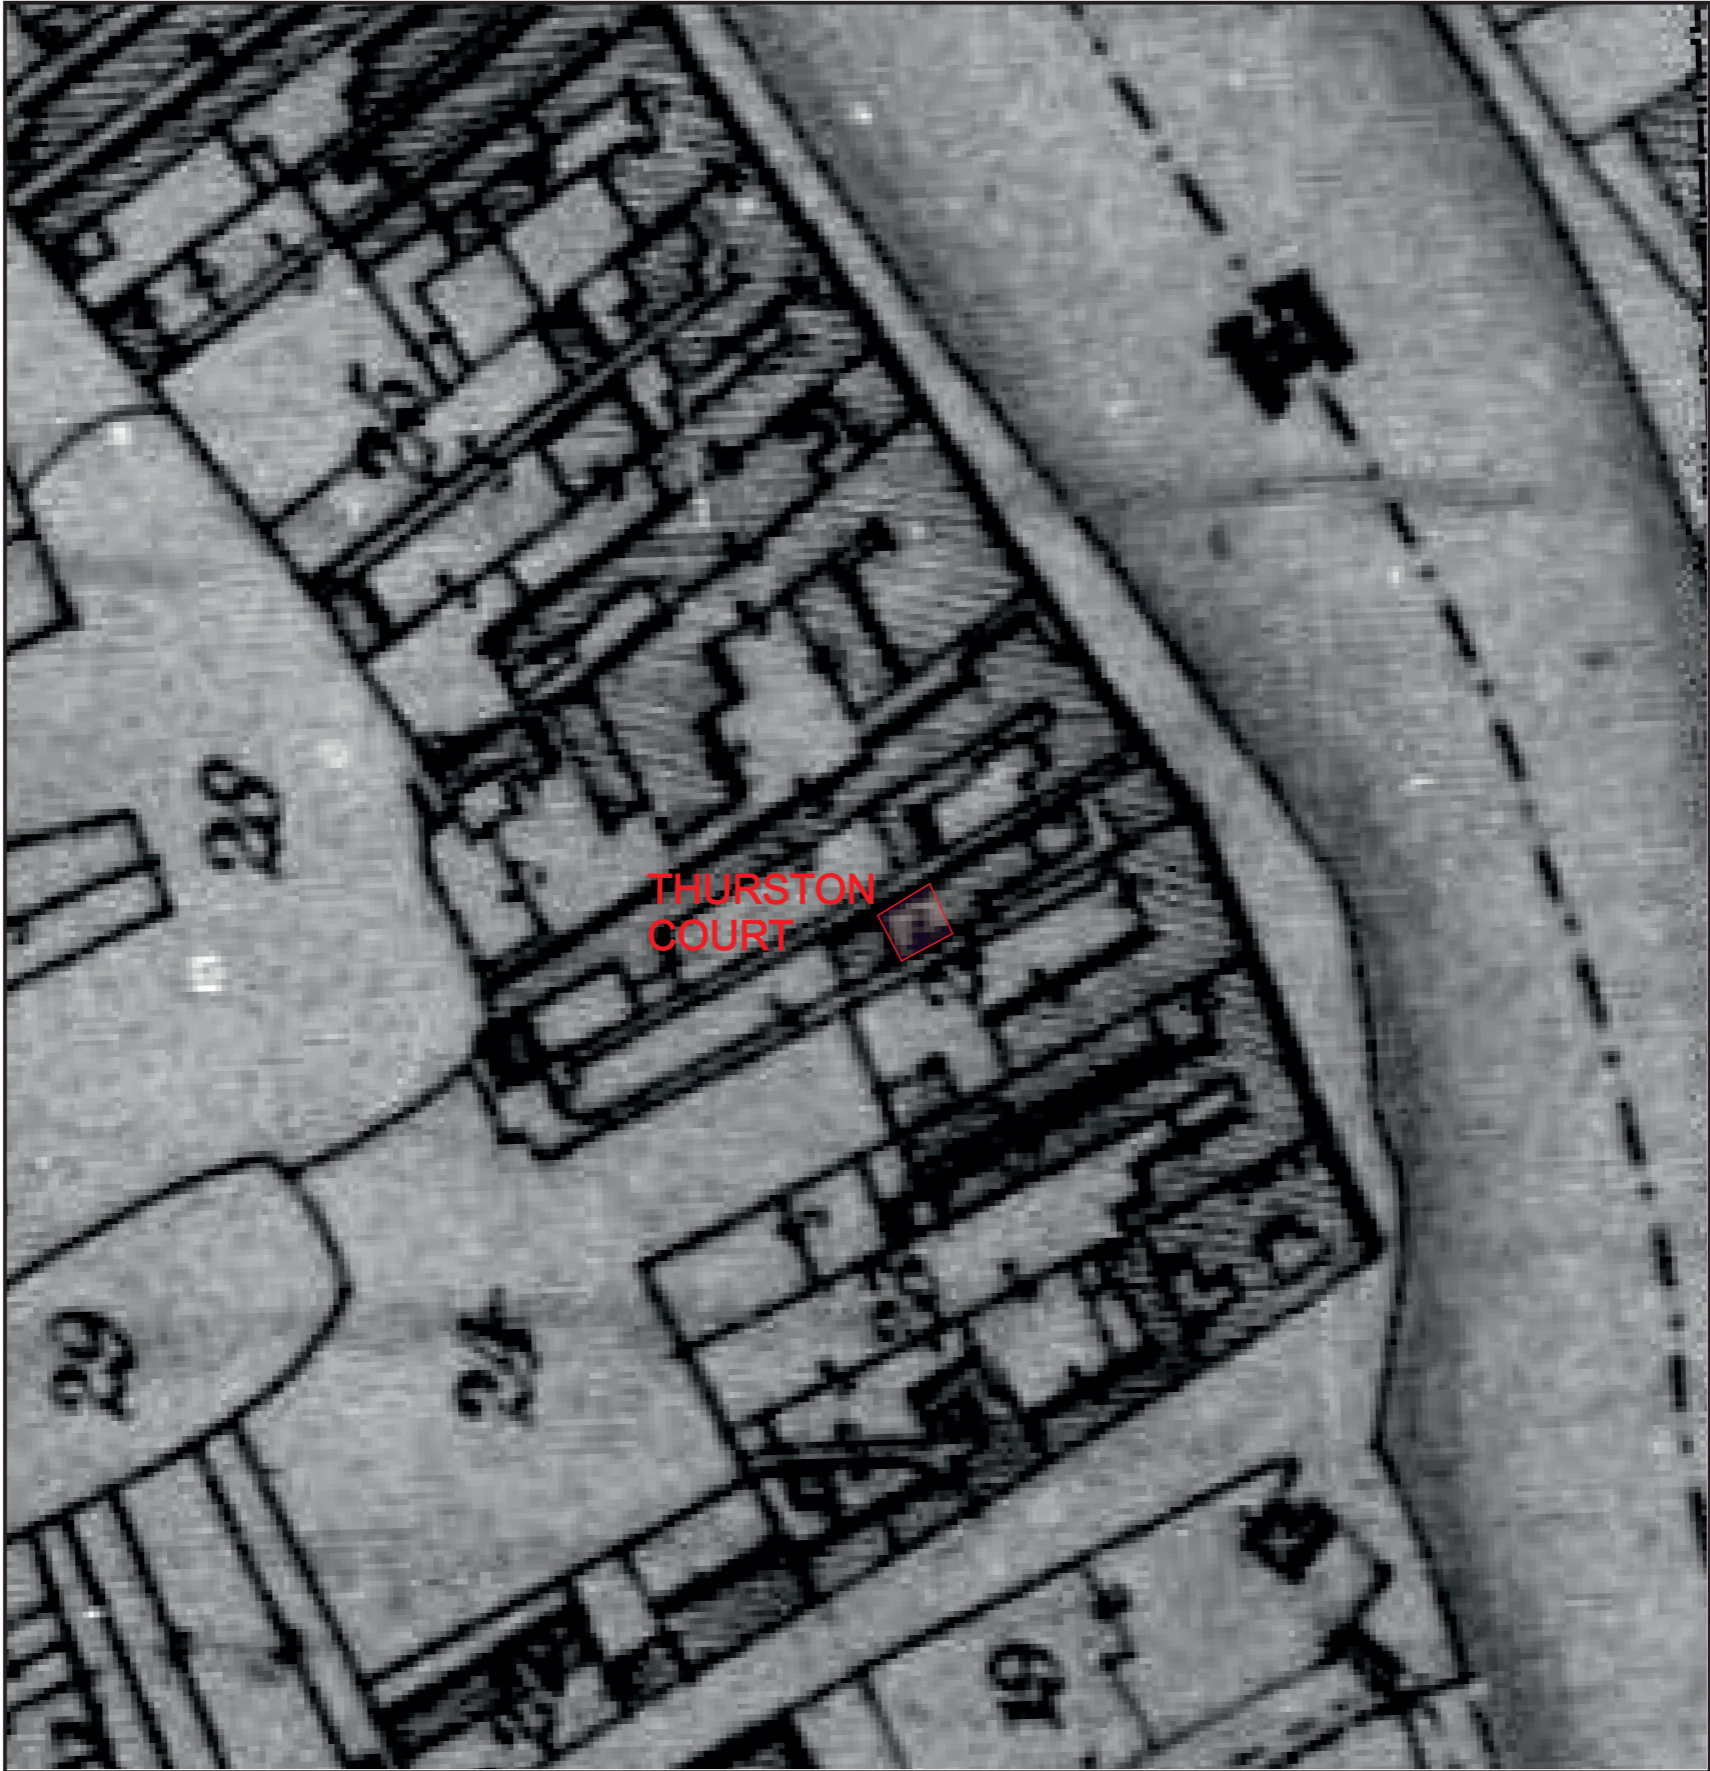
Figure 2: Tithe Awards plan

- 5.1 Unusually for a town of Bewdley's importance there is very little cartographic or pictorial evidence for the town before the 19th century. The 1843 Bewdley Tithe Awards Plan reveals that the presently proposed development area was, in the 1840s, largely occupied by buildings situated at the rear of two separate properties located on Severnside South. The plot of the presently proposed dwelling is shown as being built up by 1843. The later cartographic evidence adds little to the interpretation of the site – the present building footprint having been unaltered since the 1<sup>st</sup> Edition Ordnance Survey, other than enlargement of the street access in the early 20<sup>th</sup> Century and demolition of the single storey workshop (in the 1990s) recorded on recent mapping.

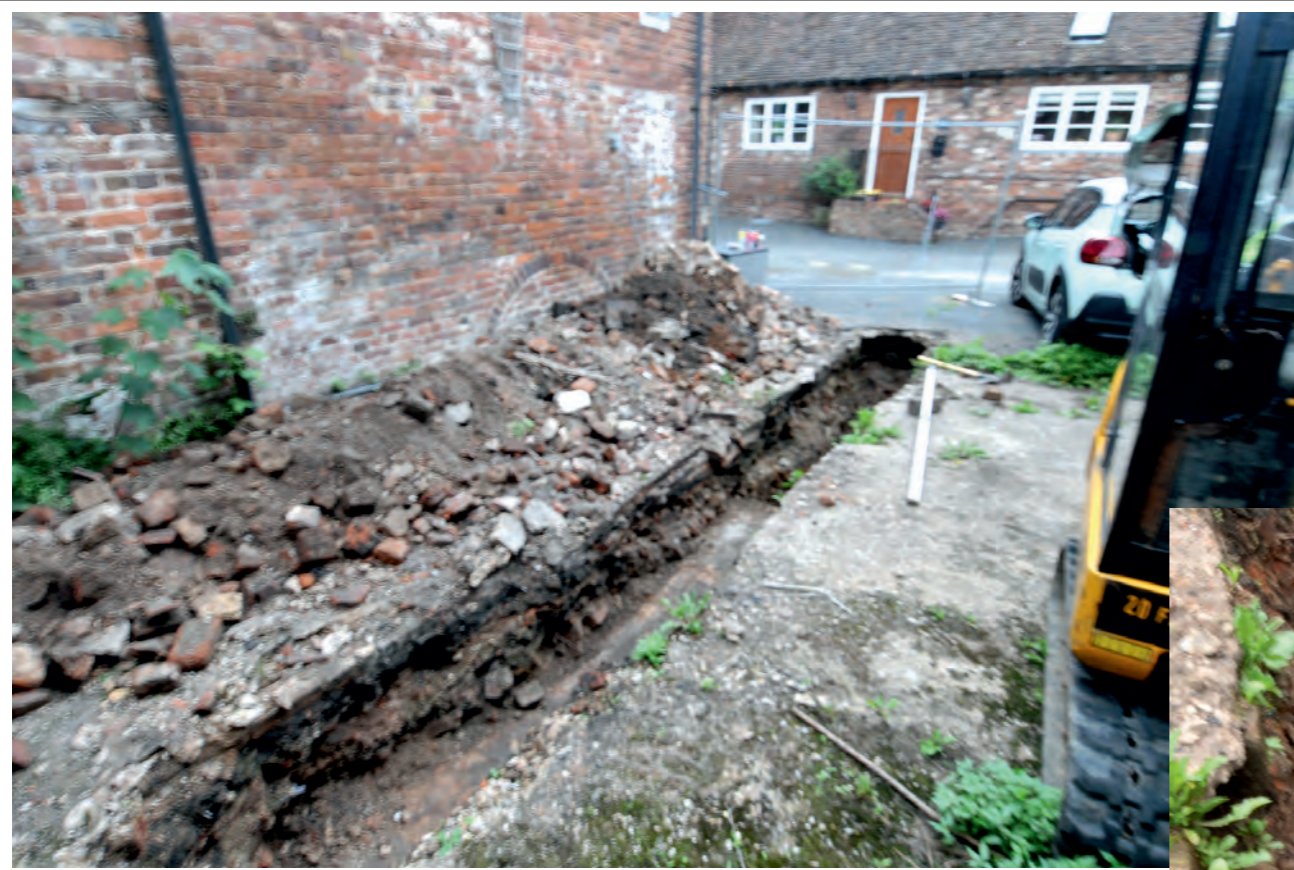
Trench location - facing south-east

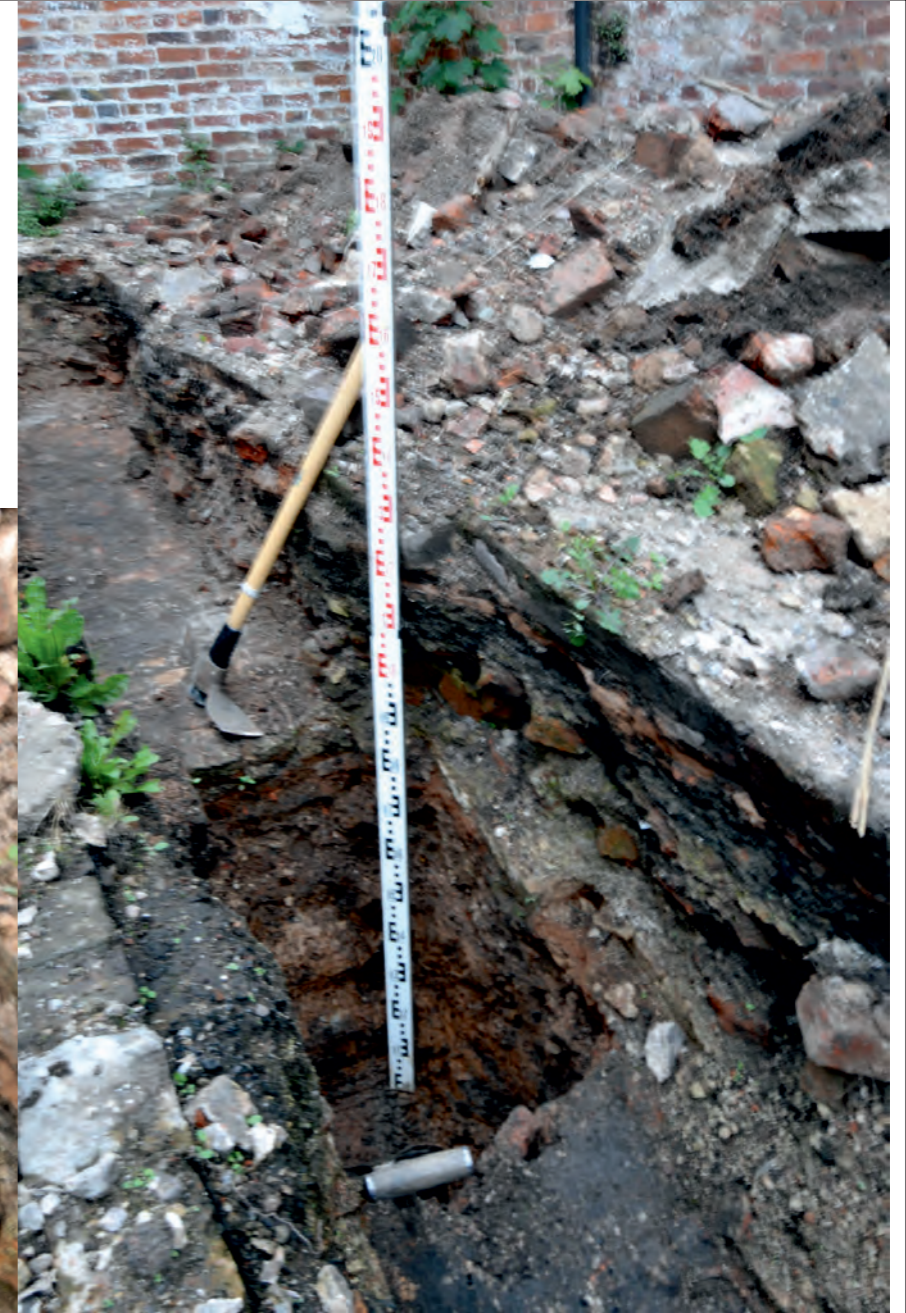
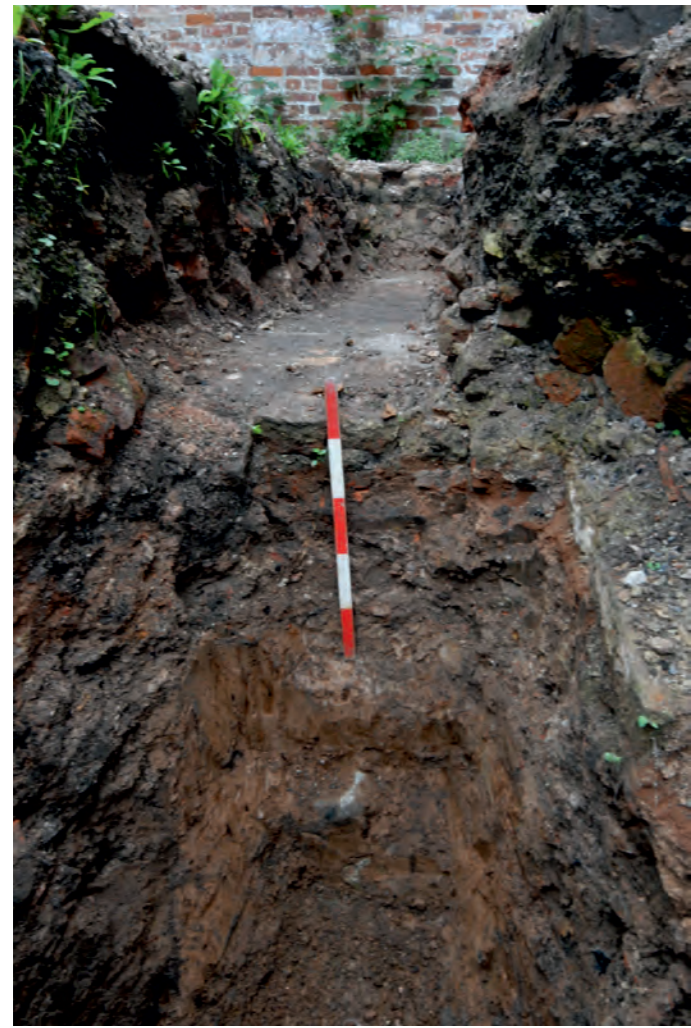
Figure 4: Evaluation trench

Deposits below 19th Century brick floor

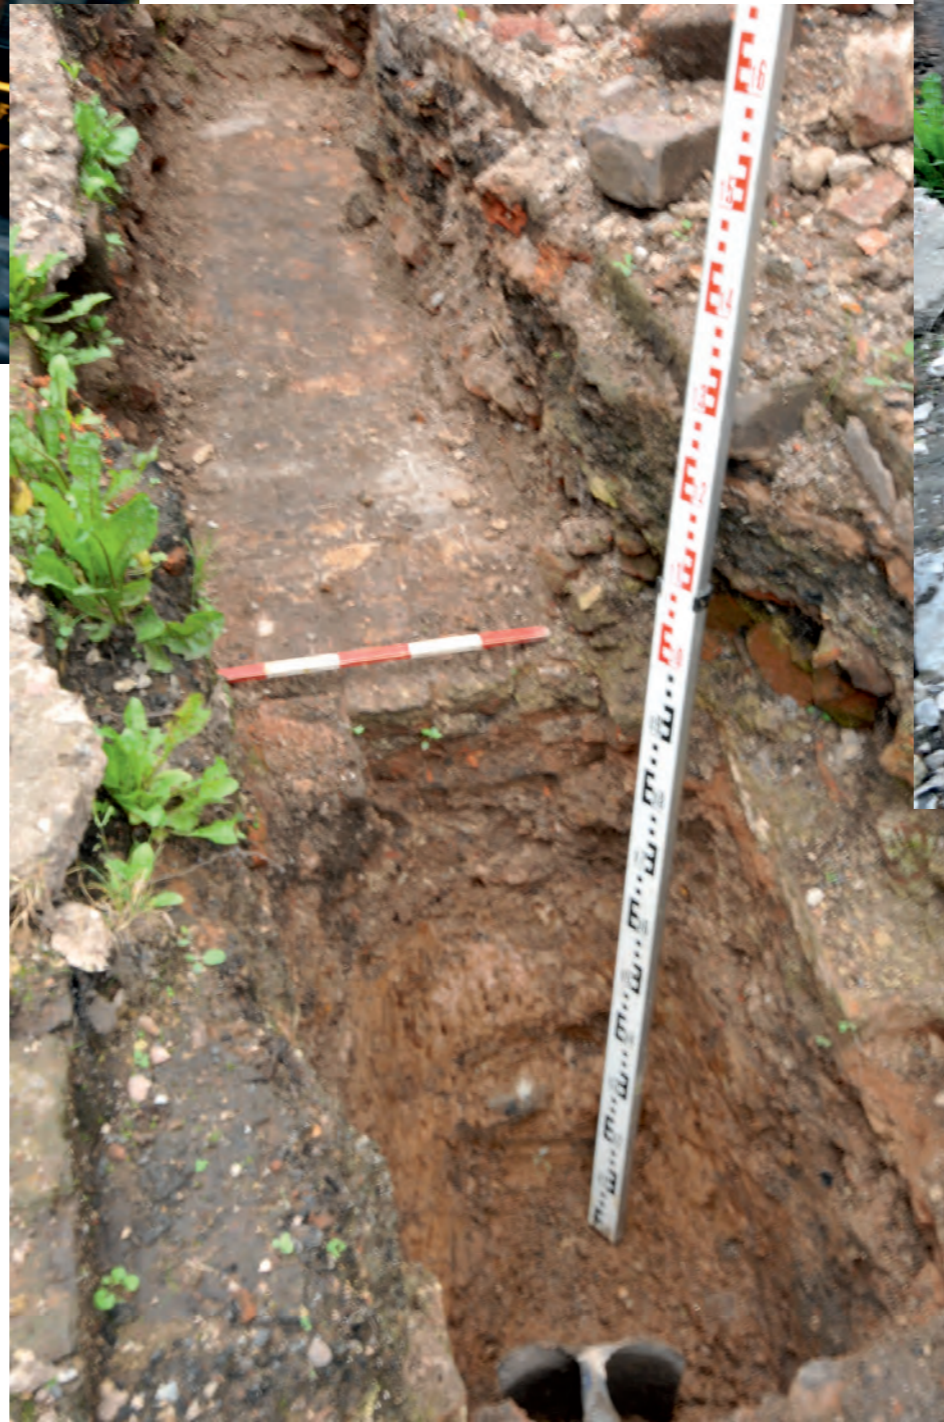
8.1 Natural deposits, context (100) consisting of a soft tan brown mottled sandy clay were encountered within 1m of current ground surface levels. The observed natural deposits towards the northern end of the trench were more gravelly and very compact. Natural deposits at the southern end of the trench were rather lower, but this section of trench had suffered some previous disturbance, so it is probable that the original natural horizon had been truncated (Fig 6).

Excavated trial pit into underlying natural deposits

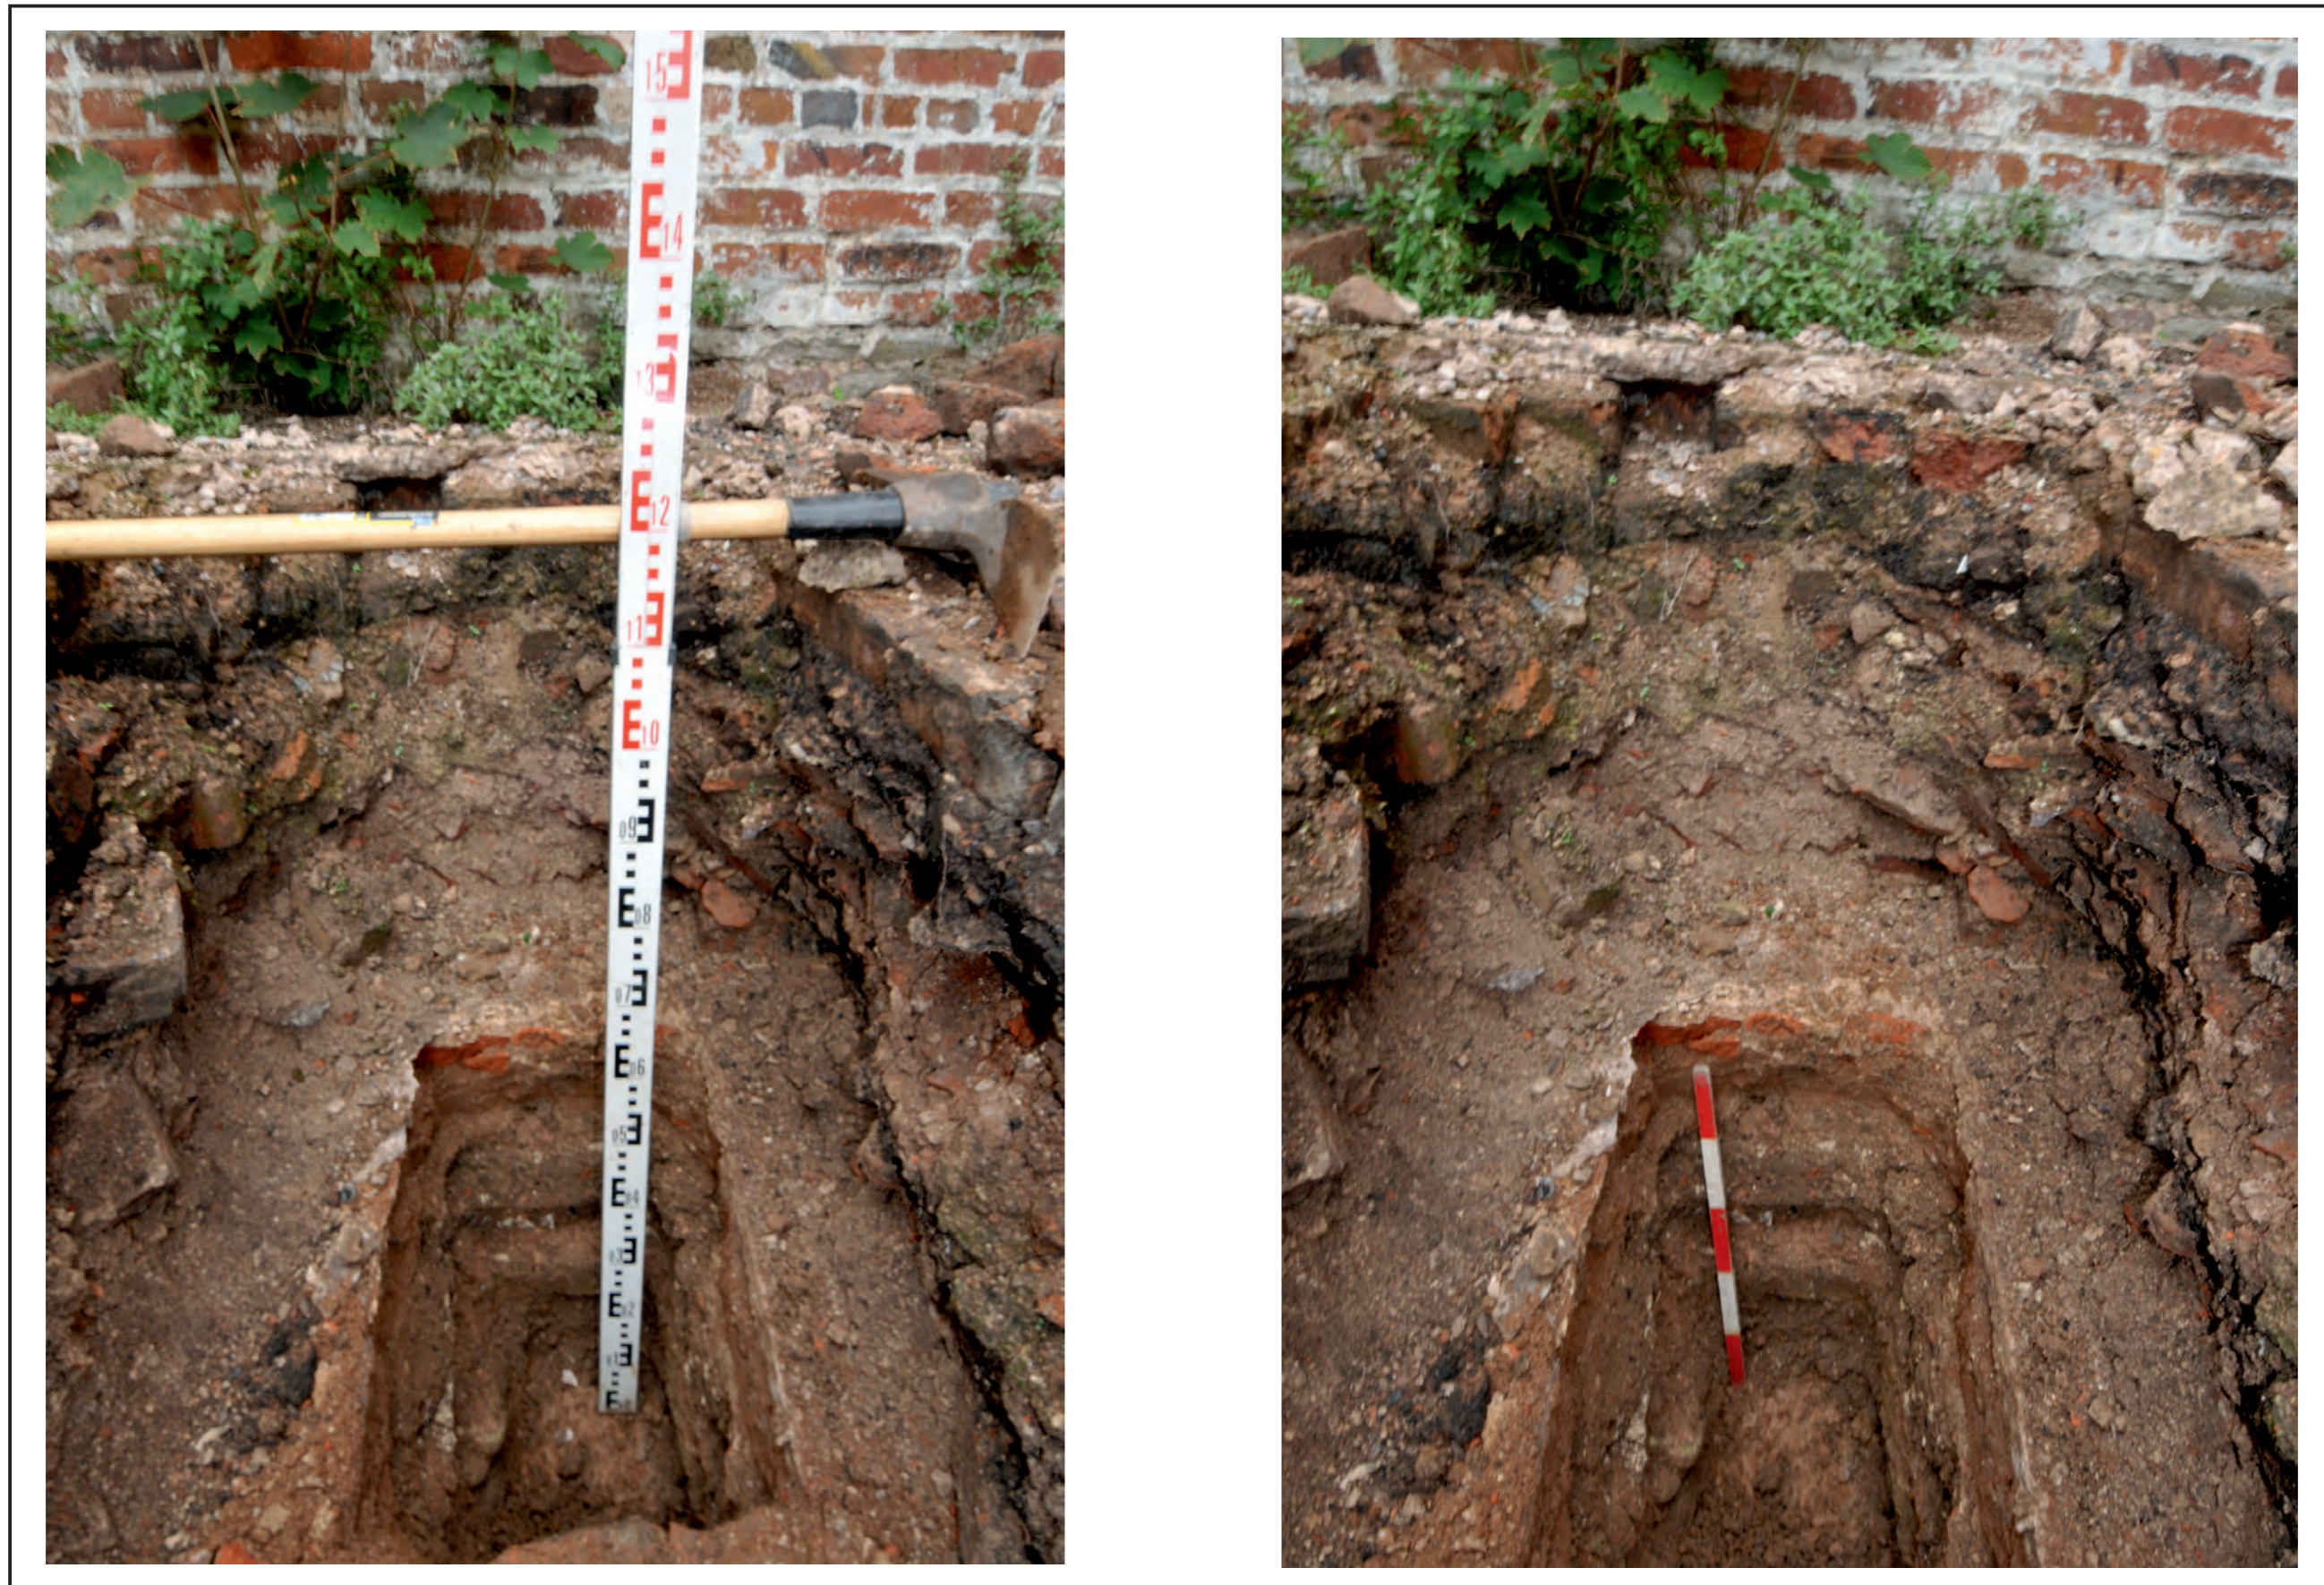
8.3 Layers of ashy material mixed with lime mortar, tile and brick fragments (102) appear to represent a construction or levelling episode. The presence of clay tobacco pipe stem, slate and small fragments of window and vessel glass indicate a late 18<sup>th</sup> Century or later date. It would appear probable that context (102) was deposited shortly before the laying of the overlying brick surface (103).

8.4 A continuous brick paved surface (103) was encountered across the northern three quarters of the trench area. The bricks were unfrogged soft red bricks of early 19<sup>th</sup> Century character. The paved area was rather un-even and had settled in places. The character of the surface might be that of a humble internal domestic floor, but more probably relates to a workshop or yard surface. The absence of any surface “trample” suggests that the floor weathered for some time before levels were raised in this area.

8.5 Deposits above the paved surface (104) consisted primarily of demolition debris of earl-mid 20<sup>th</sup> Century character. The material included window glass, plaster, lime mortar, slate and brick (18<sup>th</sup> C to mid 20<sup>th</sup> C. Towards the southern end of the trench there was a large area of loose loamy soils in an irregular feature that cut the brick paved surface (103) the disturbance appears to also cut the relatively recent material context (104).

Figure 5: 0.35m of made ground/make up beneath 19th C. brick floor - floor overlaid by demolition rubble of early 20th C date - northern end of trench
