ARCHAEOLOGICAL EVALUATION AND BUILDING RECORDING AT DOG LANE BEWDLEY (FORMER FIRE STATION AND MEDICAL CENTRE SITE)

Archaeological evaluation and building recording at Dog Lane Bewdley (former fire station and medical centre site)

1st July, 2021

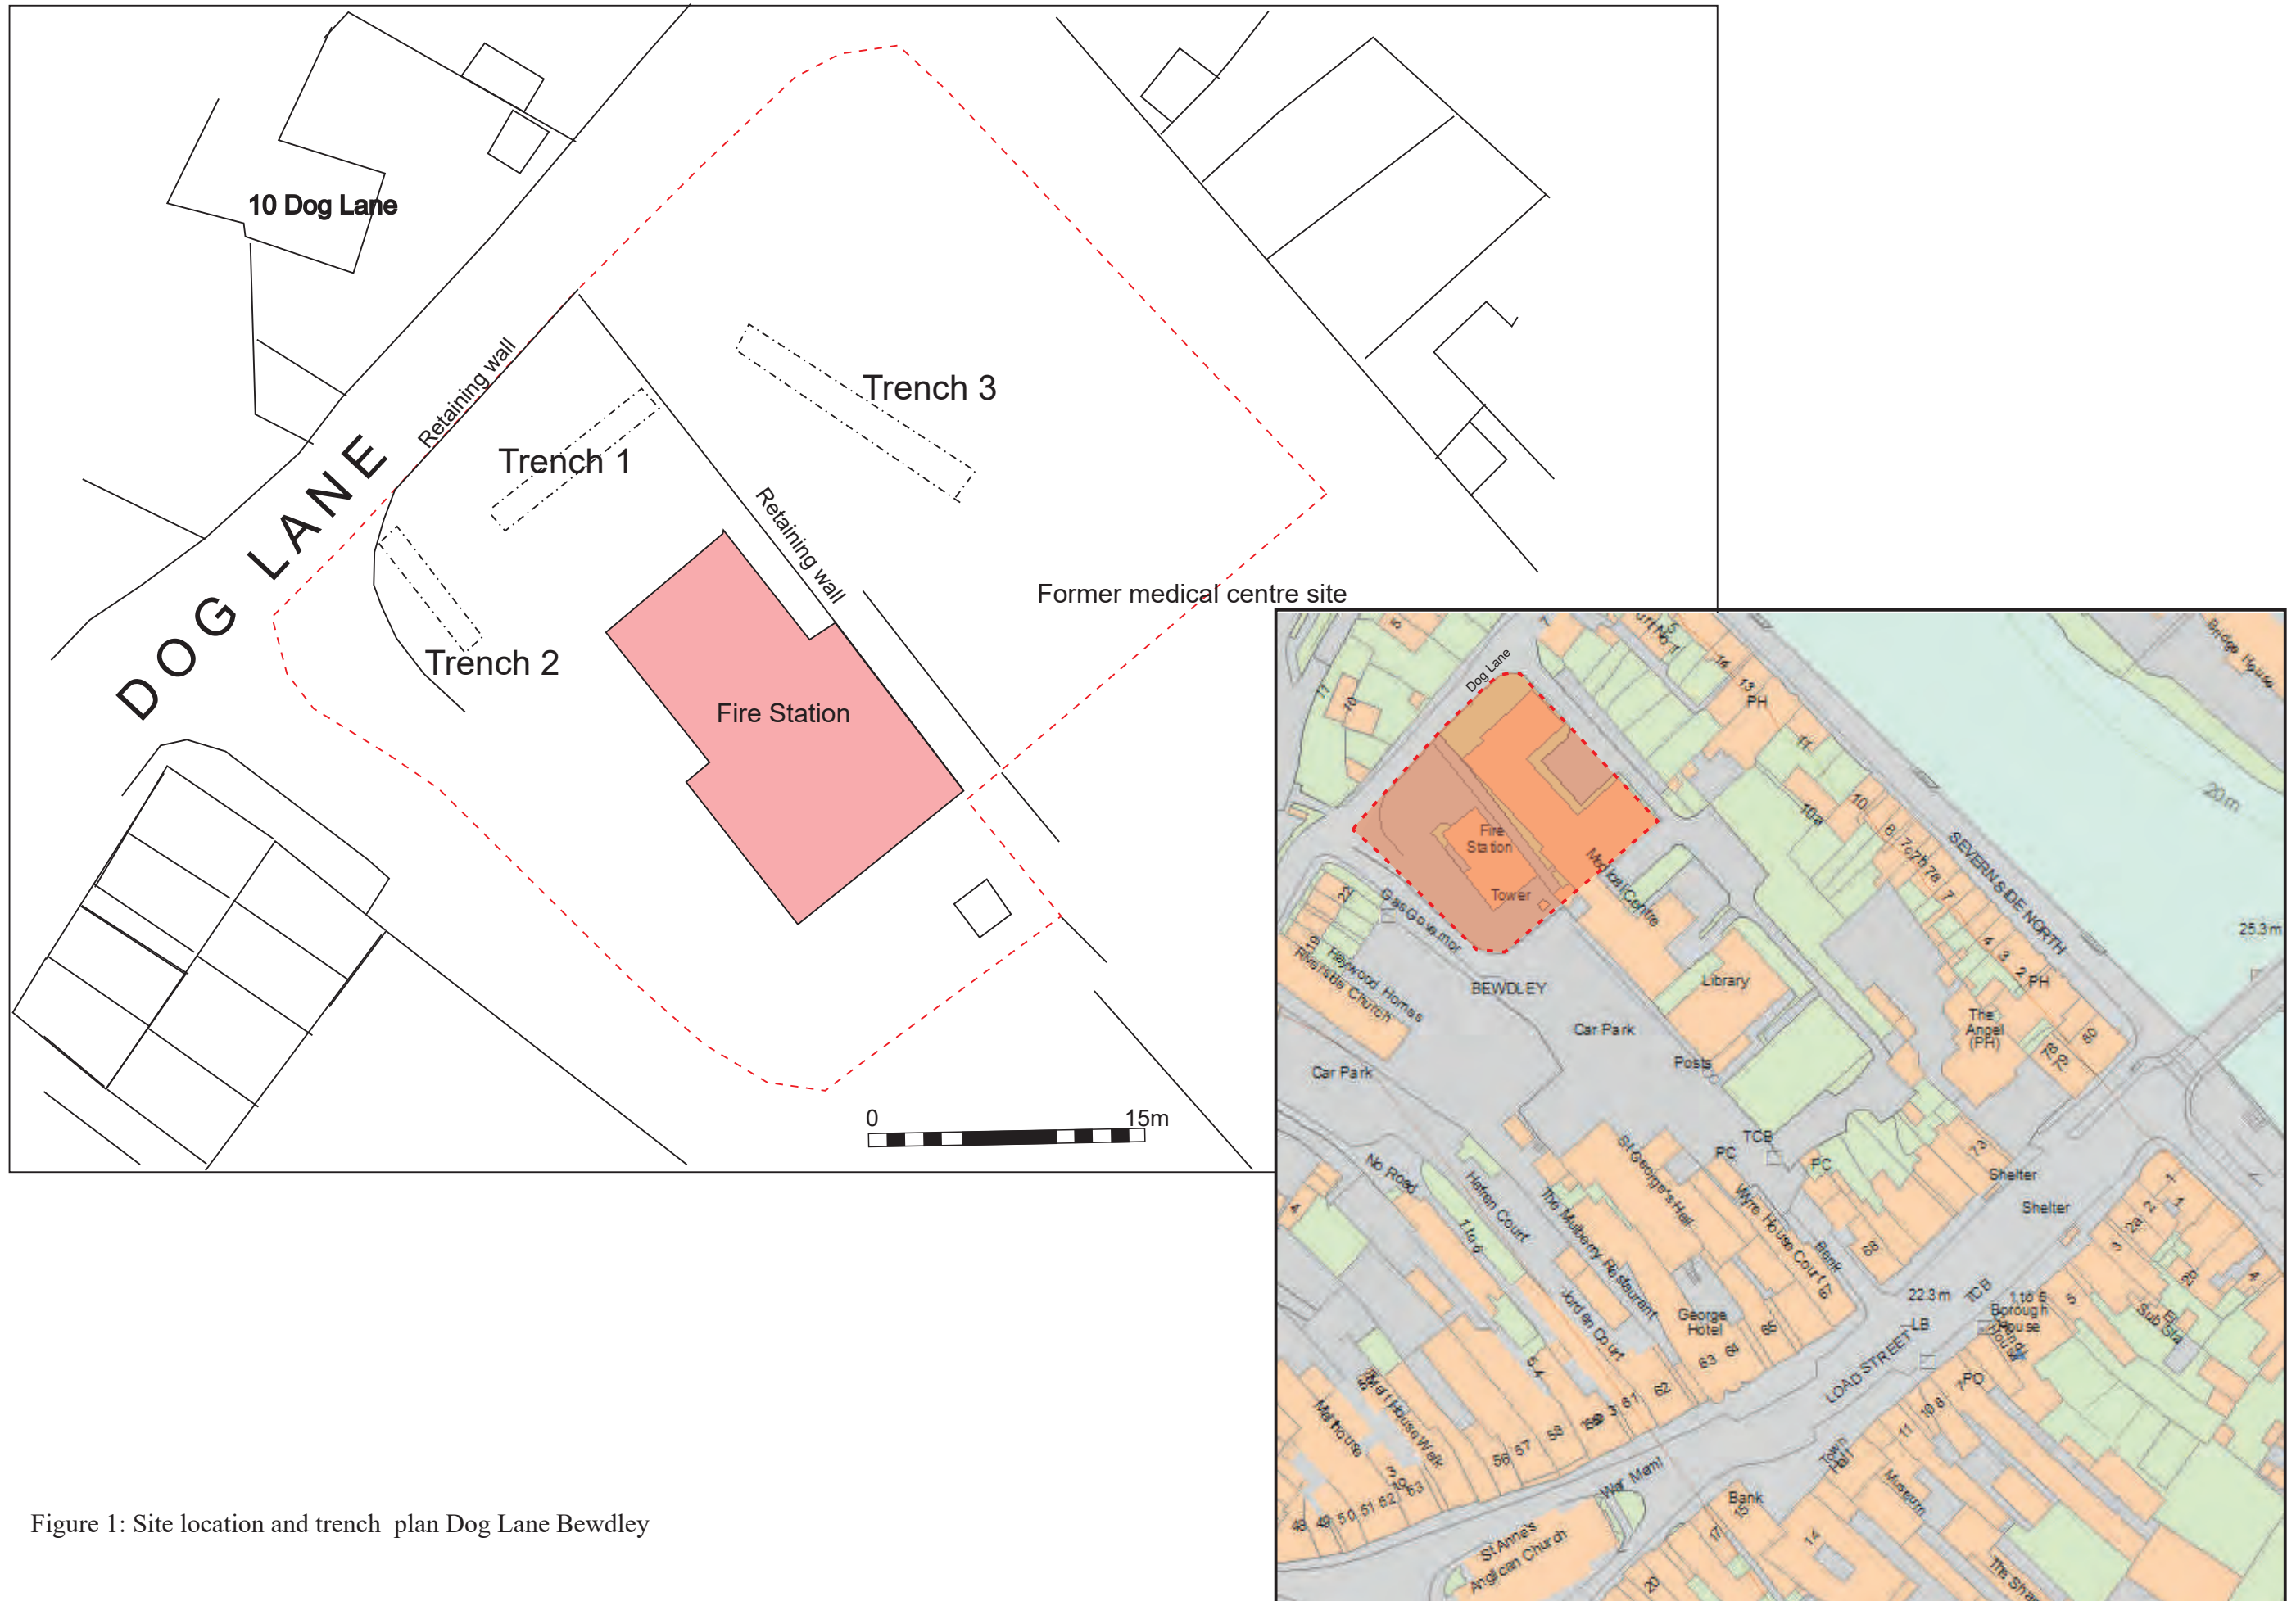
Figure 1: Site location and trench plan Dog Lane Bewdley

2.1 The present report repeats the relevant portions of background information from the 2020 desk top assessment and heritage statement for the site. Fieldwork for the archaeological evaluation was undertaken by 110 Archaeology during 1st-3rd June 2020. The planned two trenches were in the event split into three due to the presence of a live service run. These trenches (1 & 2) each measuring approx. 7.50m long and 1.60m wide were excavated on the southern, more elevated area of the site (Fig 1). The third trench 15m long and 1.60m wide was excavated on the lower eastern side of the site. Trenches were excavated using a mini-digger with toothless ditching bucket. Sections and the trench base were then hand cleaned prior to recording in plan and section (Figs 2 to 5). The trench locations were surveyed in relation to the site boundaries and existing building on the site.

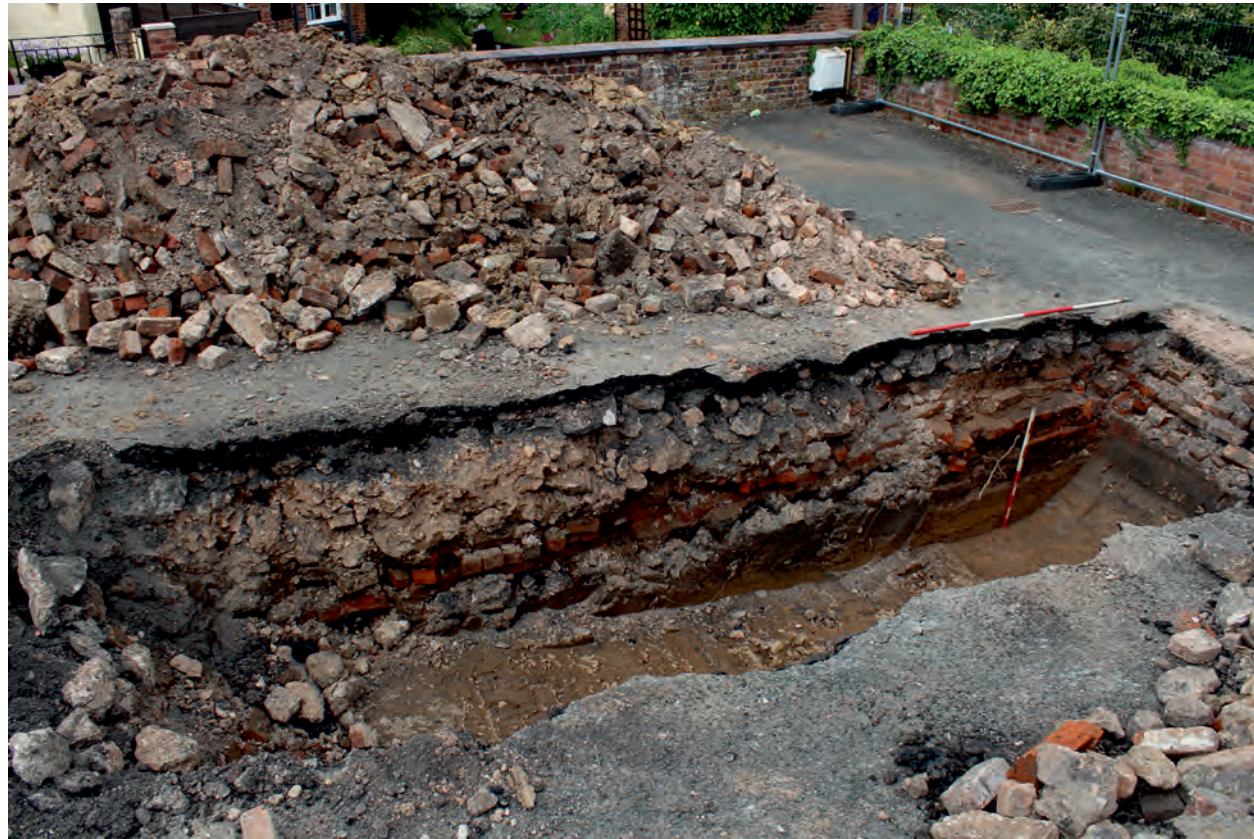
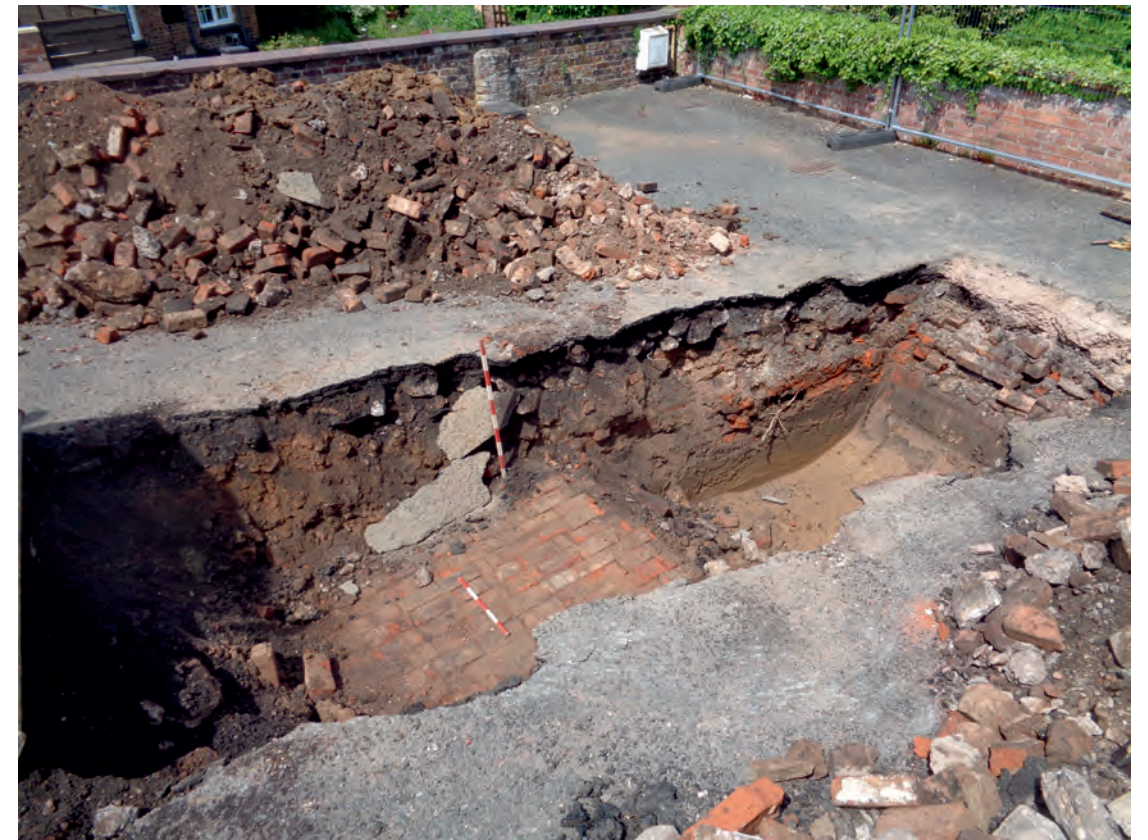
A single modern rectangular pit measuring at least 1.50m long and 0.60m wide with vertical sides was partially observed truncating the natural clay in the northeast corner of trench 2. A similar sequence to Trench 1 was recorded in Trench 2, the natural brown clay (at 21.39mAOD) being overlain by a cultivation/garden soil (202). Contexts (200) and (201) were tarmac and sub-base.

Trench 2 view facing north - prior to and after excavation of brick floor

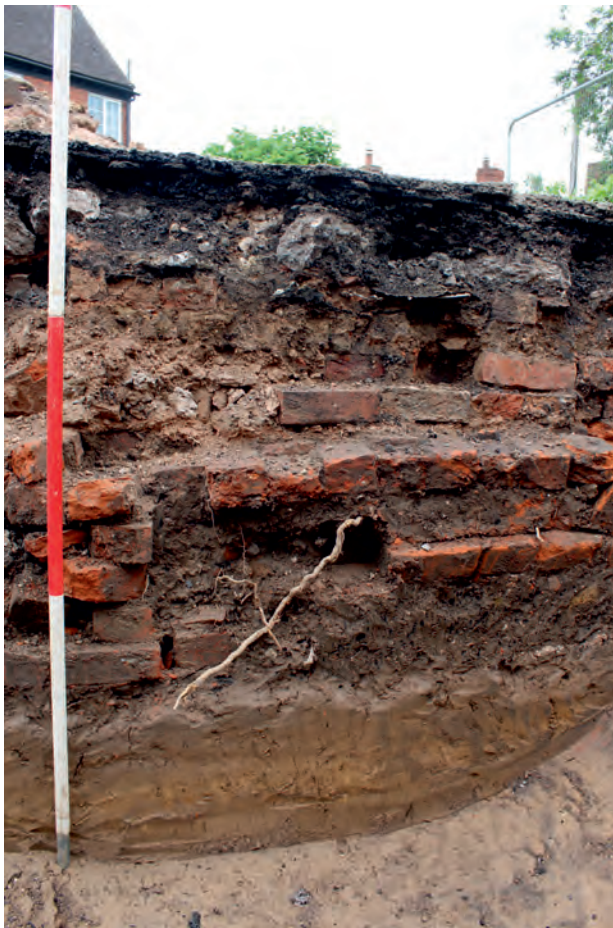
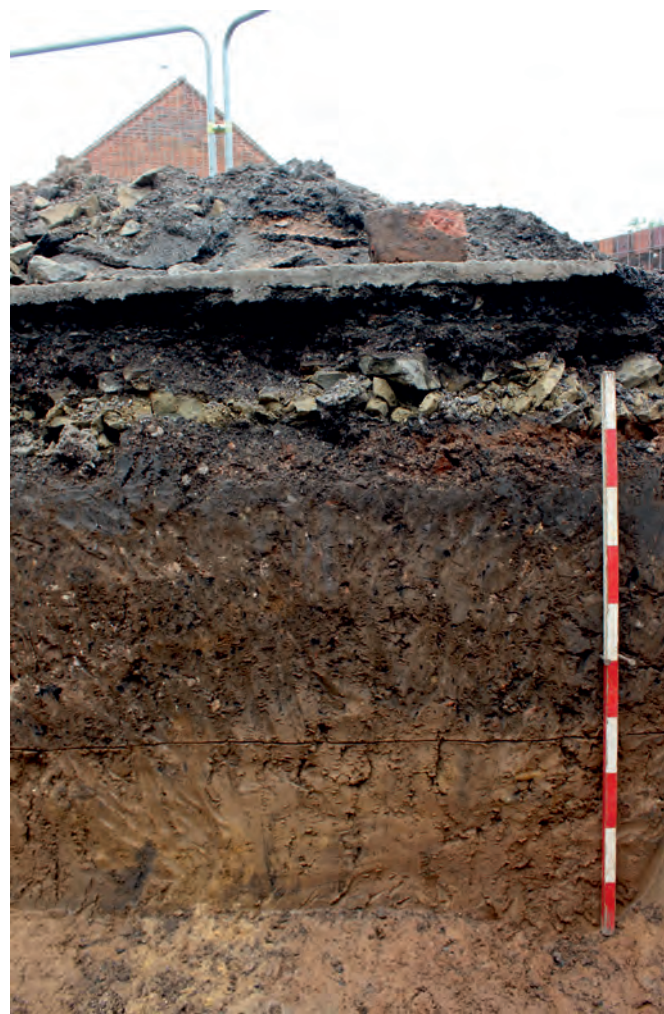
Trench 2
brick floor/footing detail

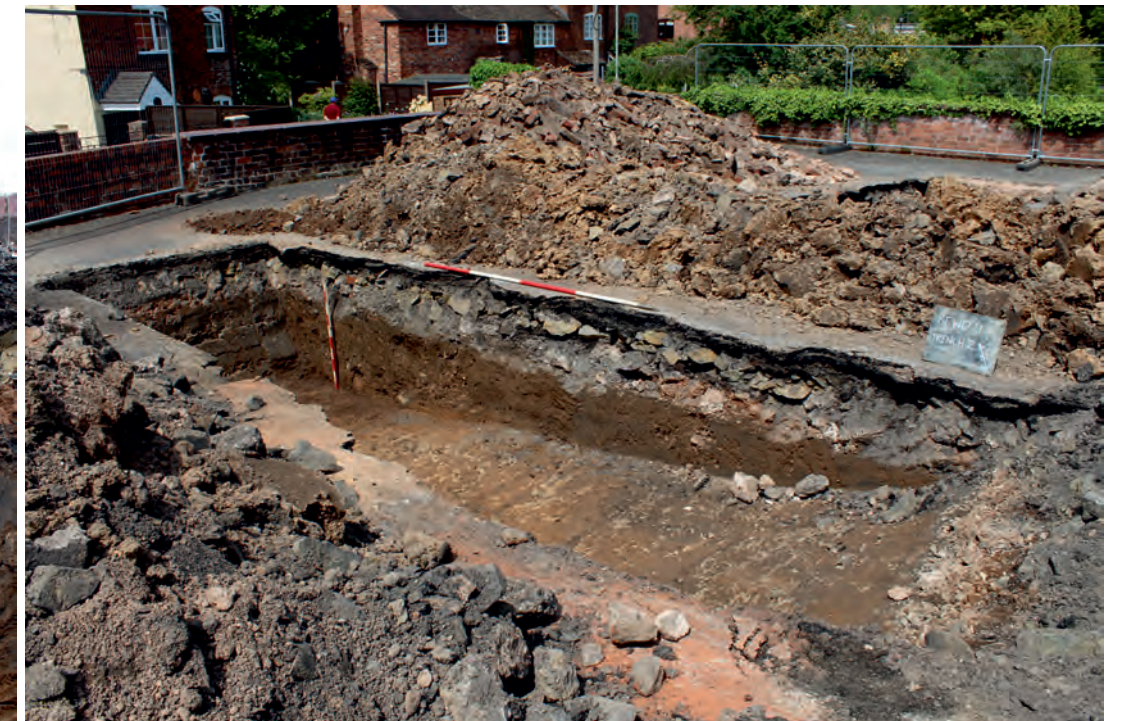
Contexts 100 and 101 consisted of tarmac carpark surface and a crushed concrete/roadstone sub-base. Most of the trench area covered a late 19th C or early 20th C. red brick surface or foundation layer of unmortared brick 3-4 courses deep. It is likely that this foundation/floor relates to the former “drill hall” marked on early- mid 20th C mapping. Context 103 was a mid-greyish-brown cultivation/garden soil, clayey silt frequent charcoal flecking and frequent crushed stone fragments. Context 104 was natural light brown clay.

Trench 1 view facing north with detail of deposition sequence (scale 1m)

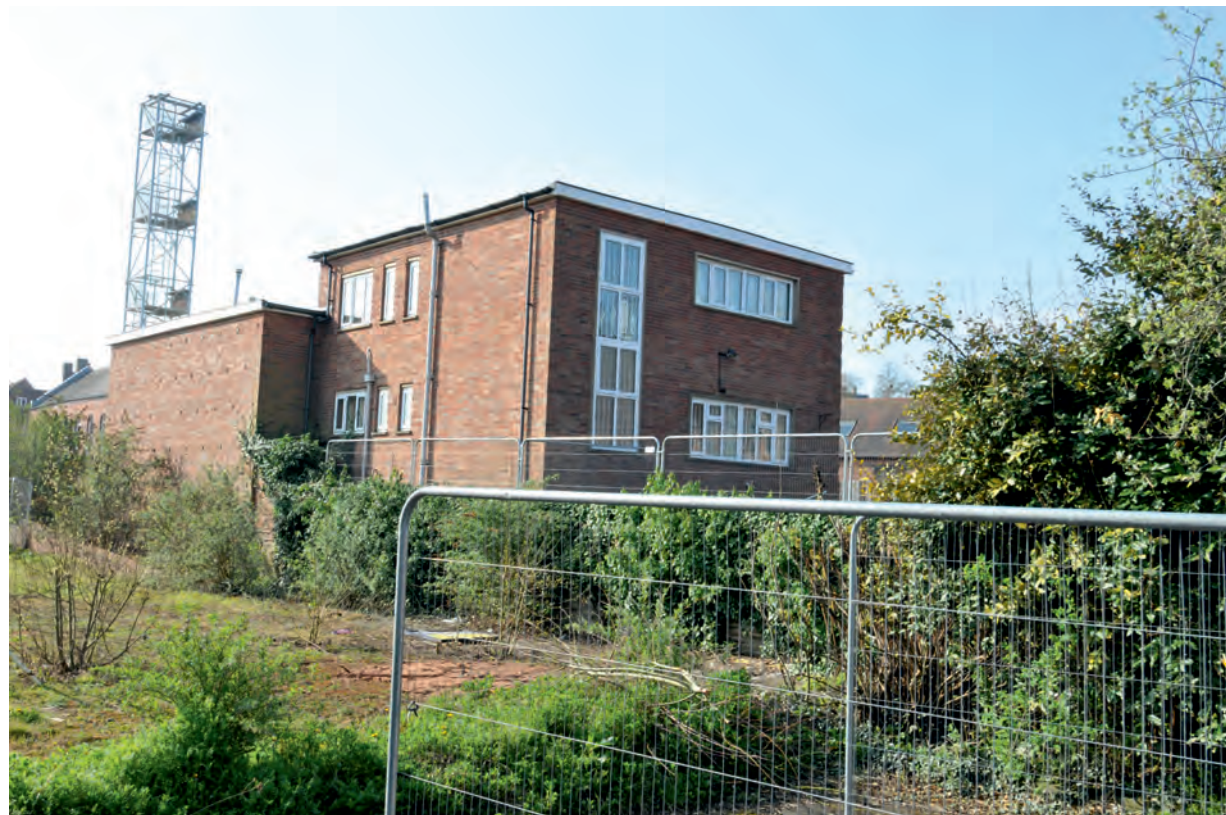
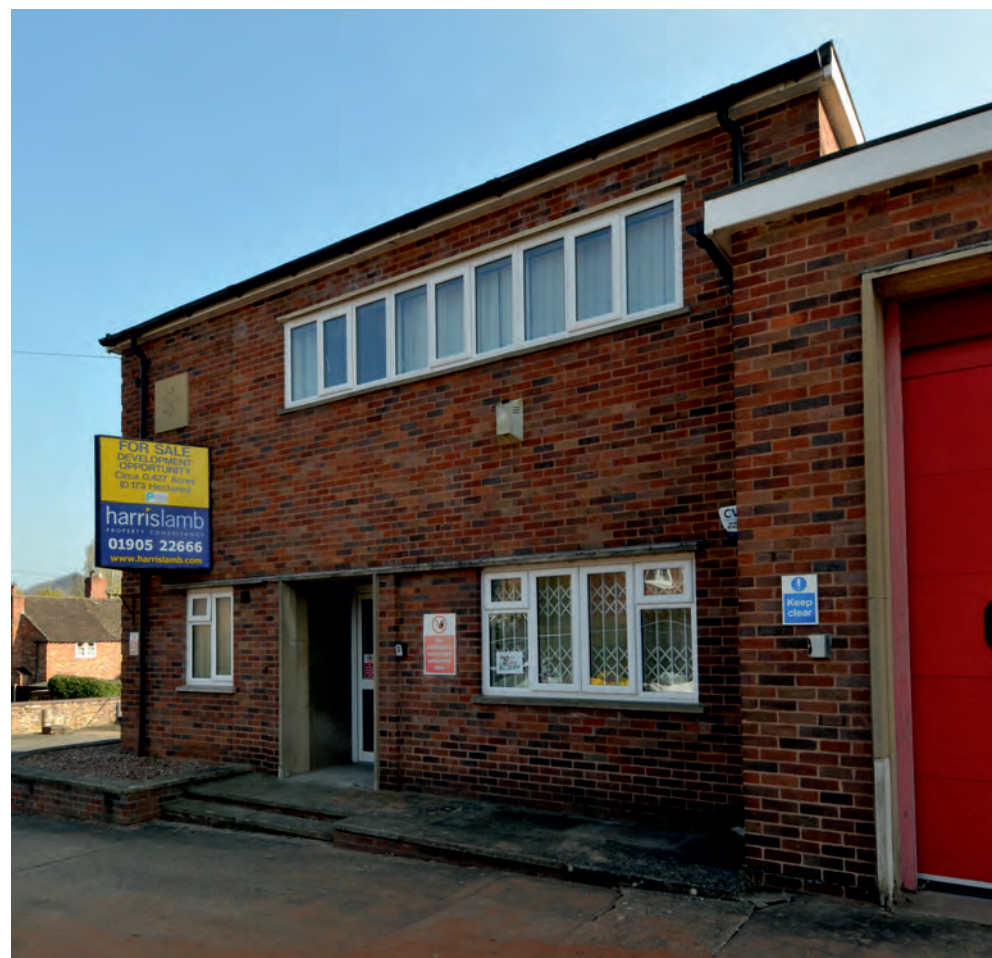
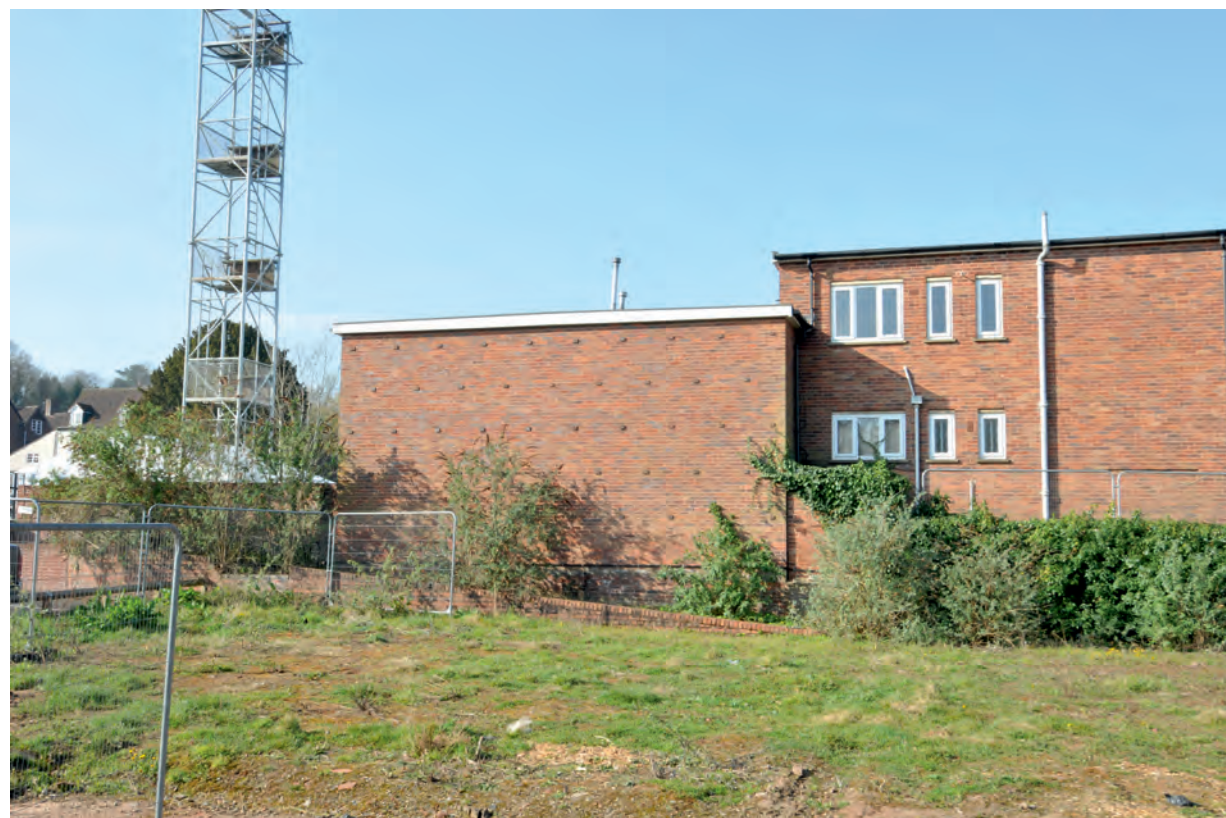
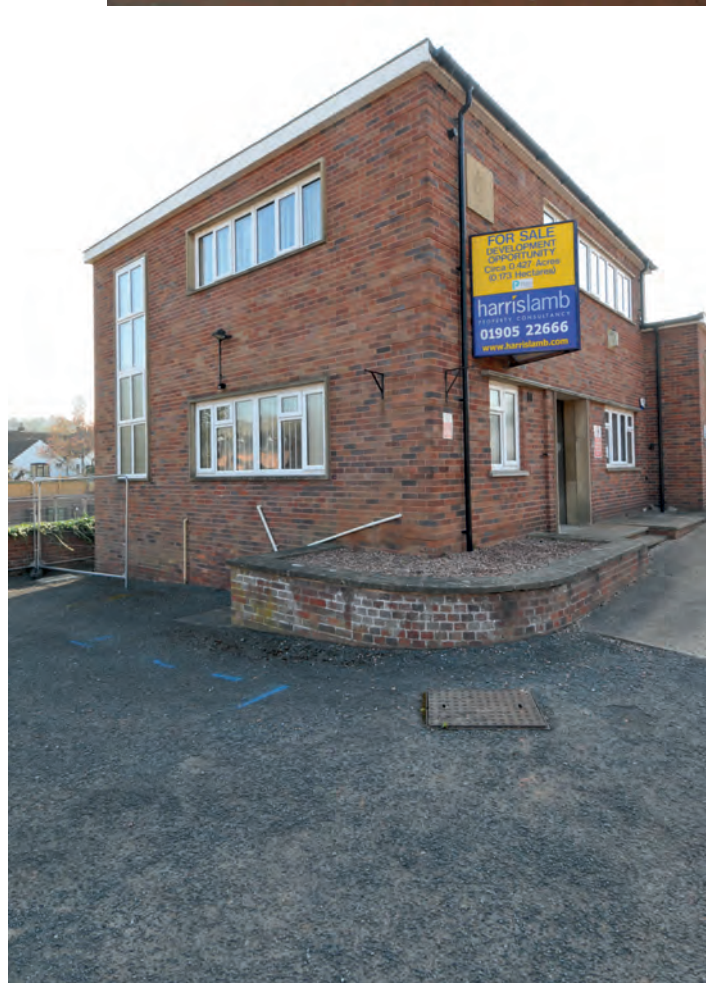
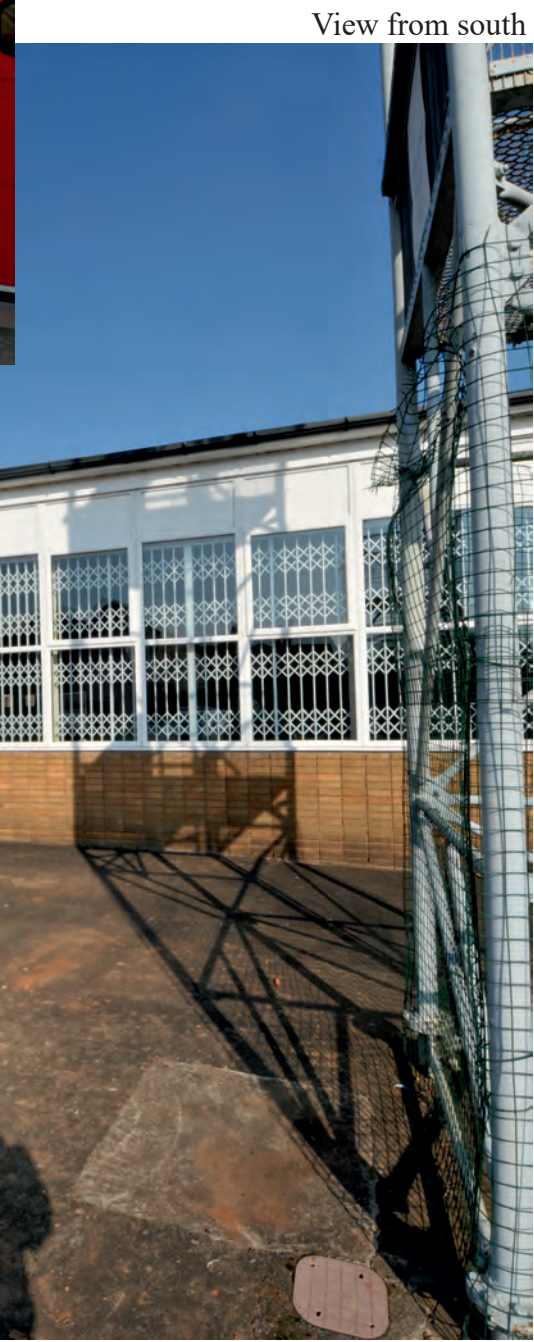
Figure 6: Details of exterior

A basic building record was made of the 1966 Fire Station building; the structure proved to be relatively unchanged other than replacement of the original garage doors with electronically operated roller shutter doors. The construction was unexceptional for its period.

2.3 The fire station building was recorded photographically internally and externally prior to proposed demolition – the building had very few features of specialist interest (Figs 6-11).

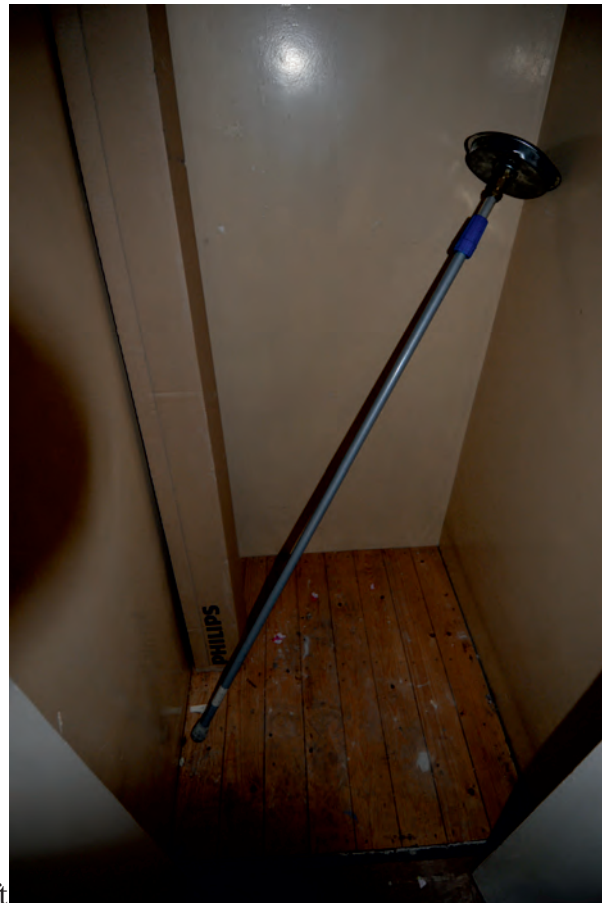
Former pole drop shaft
