Peterborough Cathedral

Interpretation Boards and Signs

A Report on a Programme of Archaeological Observation and Recording.

Scheduled Monument No: SM PE 140
SMC application Ref: S00160009
Associated Planning Reference Number: 15/00429/ADV
Archaeological contractor's Site Code: PCS17

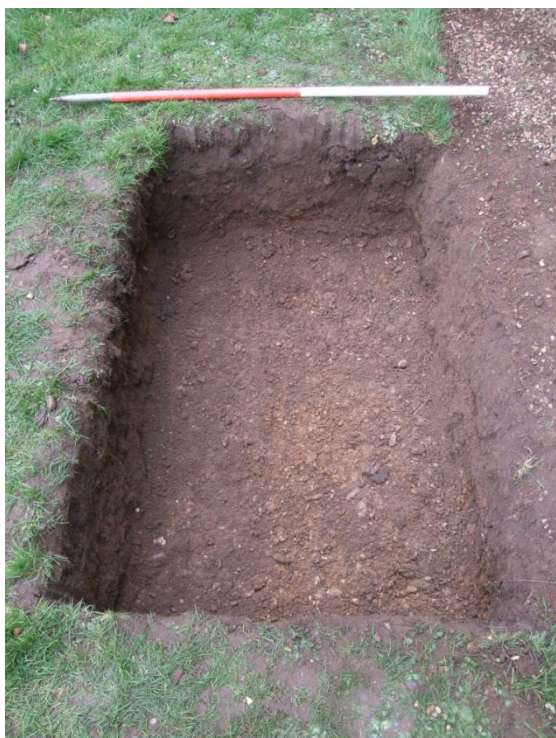
Plate 1

The trench for lectern-mounted board **G-ST-00** (Plate 1) was 1.26m (E/W) by 0.90m (N/S) by a maximum of 0.32m deep, measured from the adjacent gravel path surface (limit of excavation 7.795m OD). The trench was aligned on the fifth pilaster (counting from the west) and its north side was 3.40m south of the pilaster's plinth.

Cloister lectern G-ST-00: viewed from the east. Scale units 0.50m.

The exposed deposits were, at the limit of excavation, the southern edge of a layer of fine pea gravel, presumed to be part of an earlier path surface, and a substantial sealing layer of modern topsoil and turf.

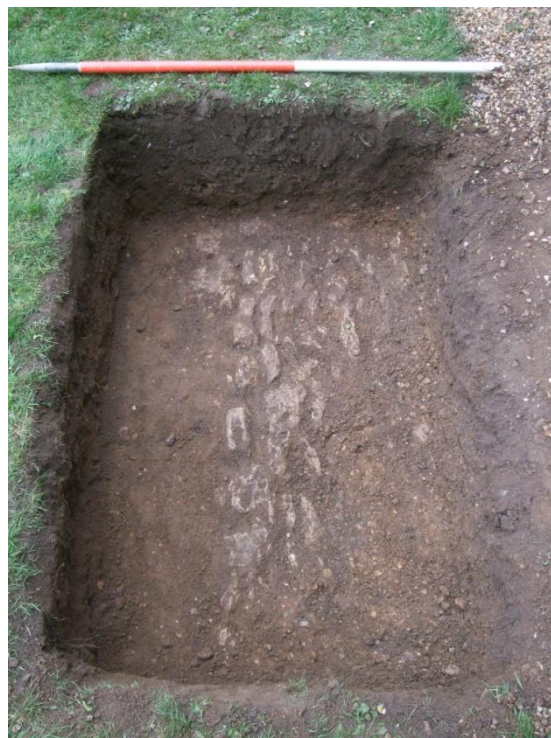
Plate 2

Cloister lectern G-ST-03: viewed from the east. Scale units 0.50m.

The trench for lectern-mounted board **G-ST-03** was 1.30m (E/W) by 0.86m (N/S) by a maximum of 0.31m deep, measured from the adjacent gravel path surface (limit of excavation 7.805m OD). The trench was aligned on the second pilaster (counting from the west) and its north side was 3.26m south of the pilaster's plinth.

The exposed deposits (Plate 2) were, at the limit of excavation, a pitched limestone rubble path surface lapped by a deposit of mid brown gritty, loamy clay. Overlying both deposits was the fine pea gravel observed in trench **G-ST-00** and the modern topsoil.

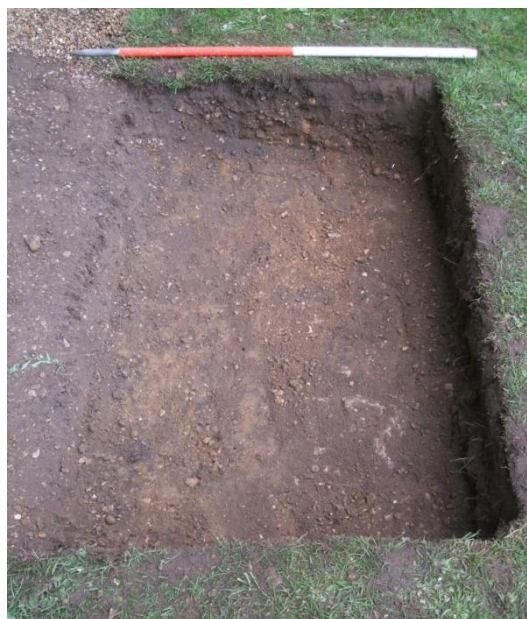
Plate 4
(Archive image: PCS 17 077)
Cloister lectern G-ST-02: viewed
from the south. Scale units 0.50m.
Photograph: Caroline Atkins

The exposed deposits were, at the limit of excavation (Plate 4), a layer of stone chippings, presumed to belong to an earlier and wider path surface, and the crown of a large stone (Plate 4, bottom right of trench) over which the stone chippings lapped. Overlying the presumed path surface and the large stone was a layer of stone chippings mixed with topsoil and above that the modern topsoil and turf. No artefacts were encountered. It is possible that the large stone is part of a buried structure.

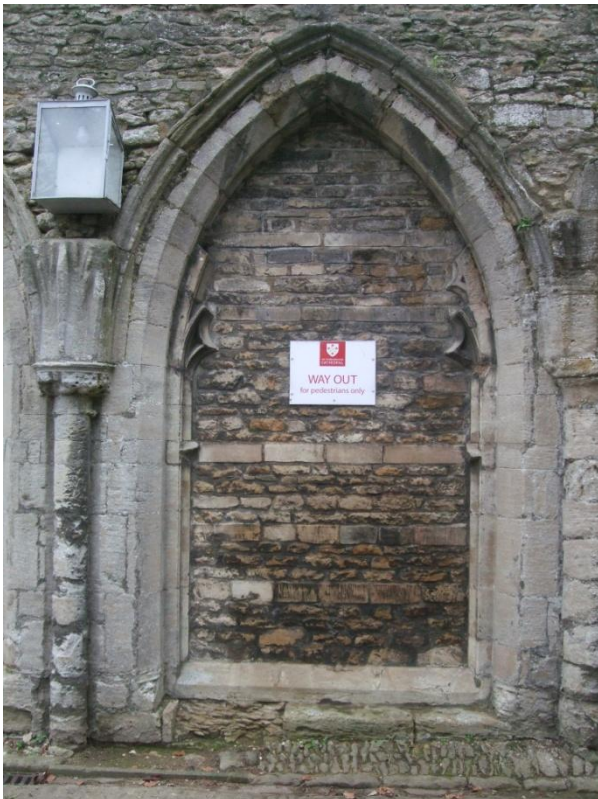
Plate 5
(Archive image: PCS 17 030)
Way finder sign G-WF-15: as existing
Photograph: Caroline Atkins

Two signs were replaced in Hostry Passage, within the scheduled area; one a way finder (Figure 2, **G-WF-15** and Plate 5) and the other an interpretation board (Figure 2, **G-ST-07** and Plate 6). By agreement, on condition that photographs of the exposed areas of wall face were supplied to the project archaeologist, both existing signs were removed and the new signs were installed without archaeological supervision. Both affected areas of wall face were unlikely to add significantly to the record since both the existing and replacement signs were relatively small, which was just as well, since the contractor failed to supply an acceptable photograph of the medieval wall behind **G-ST-07**.

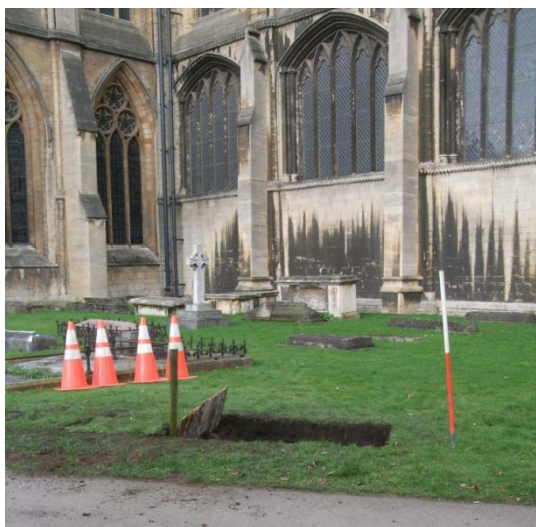
The trench for lectern-mounted board **G-ST-04** (Plate 7) was 1.30m (E/W) by 0.95m (N/S) by a maximum of 0.34m deep, measured from the adjacent, turfed, ground surface. The trench was aligned on the existing tarmac road with its centre approximately 13.50m south of the third buttress east of the south transept. The precise location is recorded in the site archive.

Plate 7
(Archive image: PCS 17 042)
Interpretation board G-ST-04: location
Photograph: Caroline Atkins

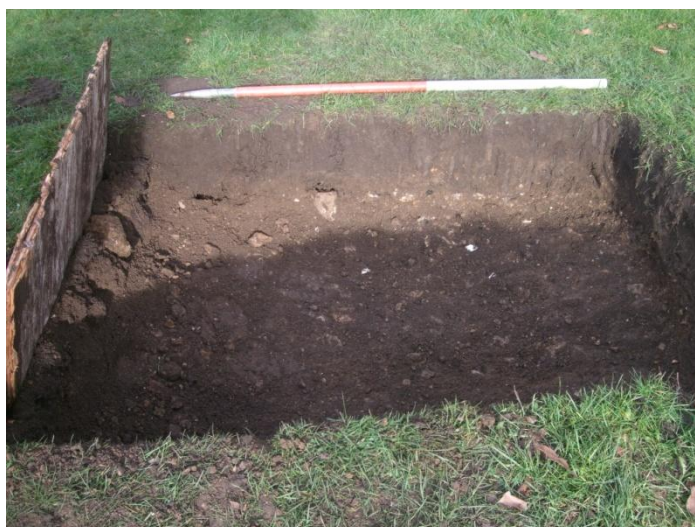
The two deposits exposed in the trench (Plate 8) were a light to mid brown gritty clay-loam mixed with small stones, fragments of limestone and brick, and the modern topsoil. Within the lower deposit were a few small sherds of white glazed china, which were noted but were not retained. The 50/50 ratio of loam to stone and brick fragments in the lower deposit suggests that it represents either part of an earlier track surface or a leveling deposit for the present one.

Plate 8
(Archive image: PCS 17 045)
Interpretation board G-ST-04: groundworks
Scale units : 0.5m
Photograph: Caroline Atkins

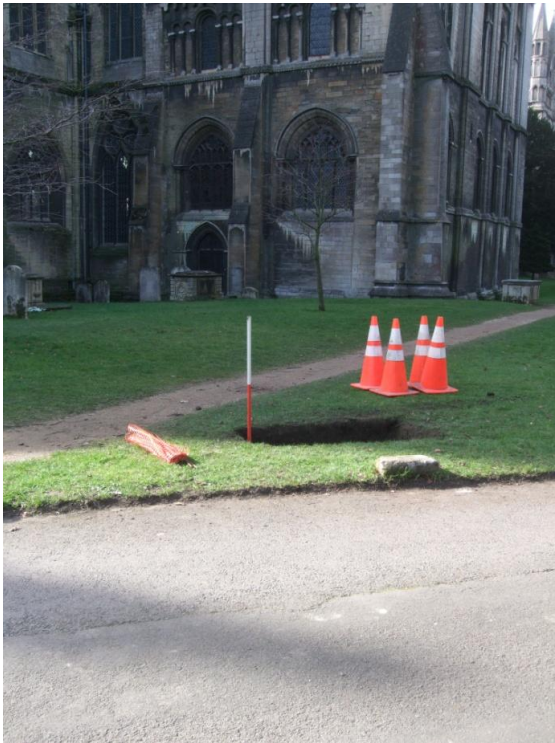
The trench for lectern-mounted board **G-ST-06** (Plate 9) was 1.30m (SE/NW) by 0.90m (NE/SW) by a maximum of 0.31m deep, measured from the adjacent, turfed, ground surface. The trench was aligned on the existing tarmac road with its centre approximately 22.50m north of the third buttress from the west end of the New Building. The precise location is recorded in the site archive.

Plate 9
(Archive image: PCS 17 057)
Interpretation board G-ST-06: location
Photograph: Caroline Atkins

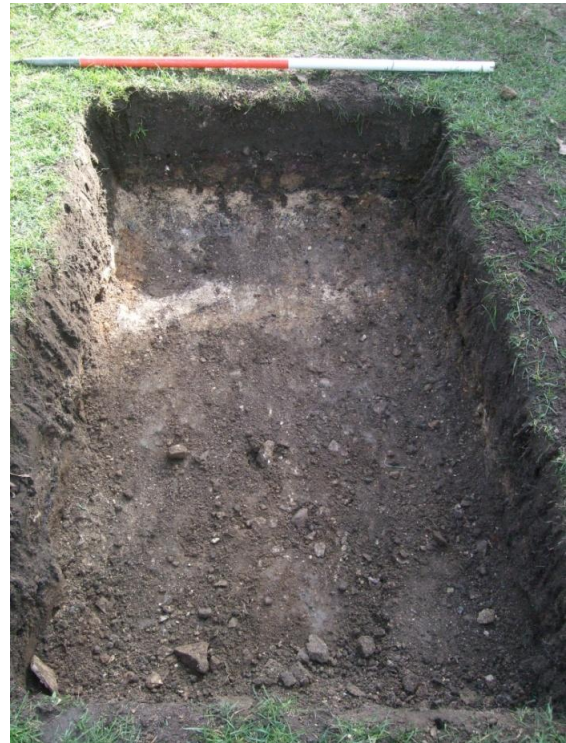
Three deposits were exposed in this trench (Plate 10), the earliest of which was a layer of crushed limestone, potentially an earlier path surface. Within this layer, at the SE end of the trench, were lenses of cleaner limestone fragments and pale sand. Separating this probable path surface and the modern topsoil and turf was a layer of gravel and small stones mixed with a mid brown clay-loam. No artefacts were encountered.

Plate 10
(Archive image: PCS 17 053)
Interpretation board G-ST-06: groundworks
Scale units : 0.5m
Photograph: Caroline Atkins

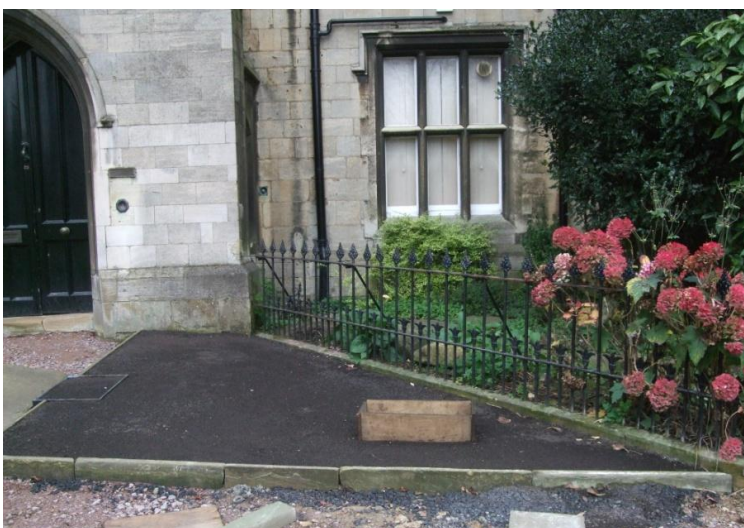
Plate 11
(Archive image: PCGC 402)
No. 25 Minster Precincts: the
location of the small monolith
sign **G-WF-03**
Photograph: Caroline Atkins

The groundworks associated with the installation of a small monolith sign outside the front door of No. 25 Minster Precincts (Plate 11) were carried out in November 2014, when the area outside the door was being reduced and resurfaced as part of the Galilee Court Landscaping Project. The small trench, 0.26m (N/S) by 0.65m (E/W), was excavated without archaeological supervision in an area already recorded and landscaped (Hall and Atkins, 2017).

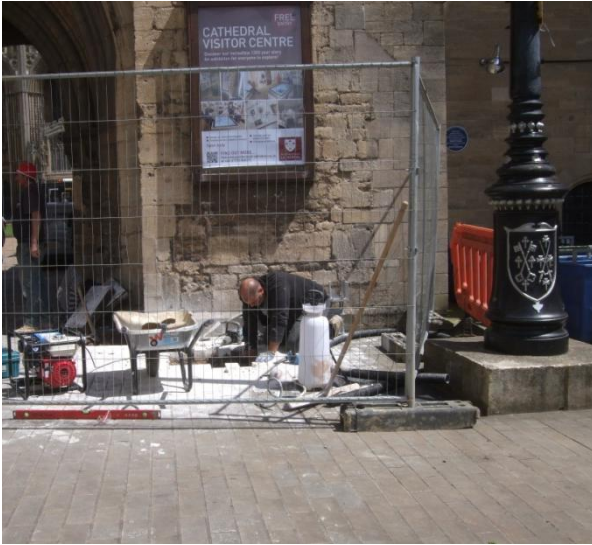
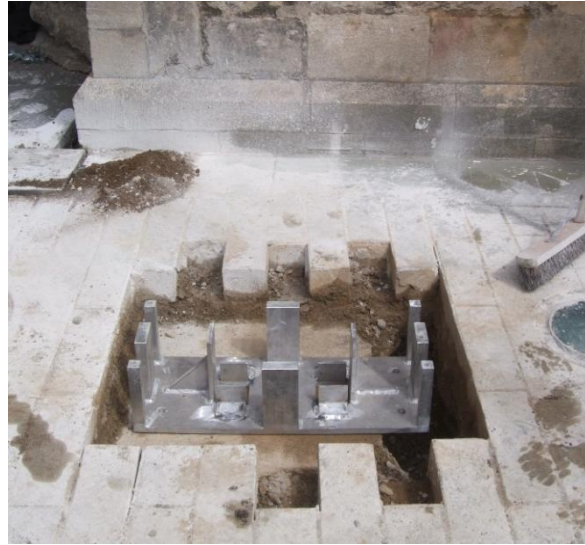
The trench for the large monolith sign, **G-WF-01** (Plates 12 and 13), was 0.79m (S/N) by 0.62m (E/W) by a maximum of 0.26m deep, measured from the adjacent paved surface. The trench was aligned on the west face of the west wall of the Gate, to the south of the gate passage, and an average of 0.68m distant from it. The precise location is recorded in the site archive.

The requirement that an archaeologist should be present during the excavation of this trench was included in the planning permission conditions because it was proposed that the trench would be in excess of 0.80m deep. What was not known at that time was that the stone paving of Cathedral Square had been set on a raft of almost un-dentable concrete, the likes of which the contractor (LMH (Civil Engineering) Ltd.) had rarely seen before. After lengthy attempts to cut through the concrete, it was agreed that the base plate for the monolith could be bolted to it. Consequently, nothing of archaeological interest was exposed by the groundworks.

Plate 12
(Archive image: PCS 17 081)
Interpretation board G-WF-01: location
Photograph: Caroline Atkins

Plate 13
(Archive image: PCS 17 083)
Interpretation board G-WF-01: groundworks
Photograph: Caroline Atkins

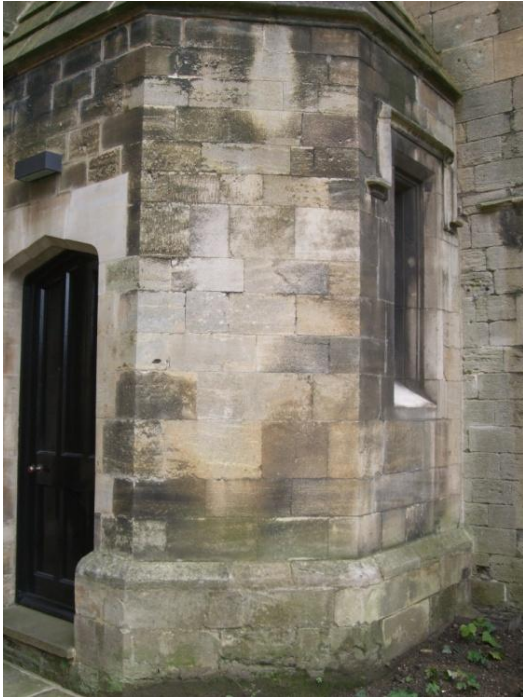
Plate 14
(Archive image: PCS 17 007)
Interpretation board G-WF-13: intended location on No. 25 Minster Precincts.
Photograph: Caroline Atkins

Excluding the two signs installed in Hostry Passage (see Section 2.4), a total of 15 signs have been mounted on a gate, a post, a door and assorted walls. The majority of these have been installed without supervision because the supporting structures were either already exposed and available for photographic recording (eg. Plates 14 and 15, signs **G-WF-13** and **G-WF-14**) or were of little or no archaeological interest. The sites included in the latter group (ie. **G-WF-02**, **G-WF-05**, **G-WF-06**, **G-WF-08**, **G-WF-09**, **G-WF-10**, **G-WF-11**, **G-WF-12**, **G-WF-16**, **G-WF-17**, **G-WF-18**, **G-ST-01**, **G-ST-05**) were left to the installation contractor to record photographically after removing the existing sign and cleaning the area before fixing the new sign in its place (eg. Plates 16 and 17).
