# **MOGGERHANGER HOUSE**

## **Emergency Recording of Trussed Floor Beams and Historic Fabric**

March 2013

Document No: TJC2013.12

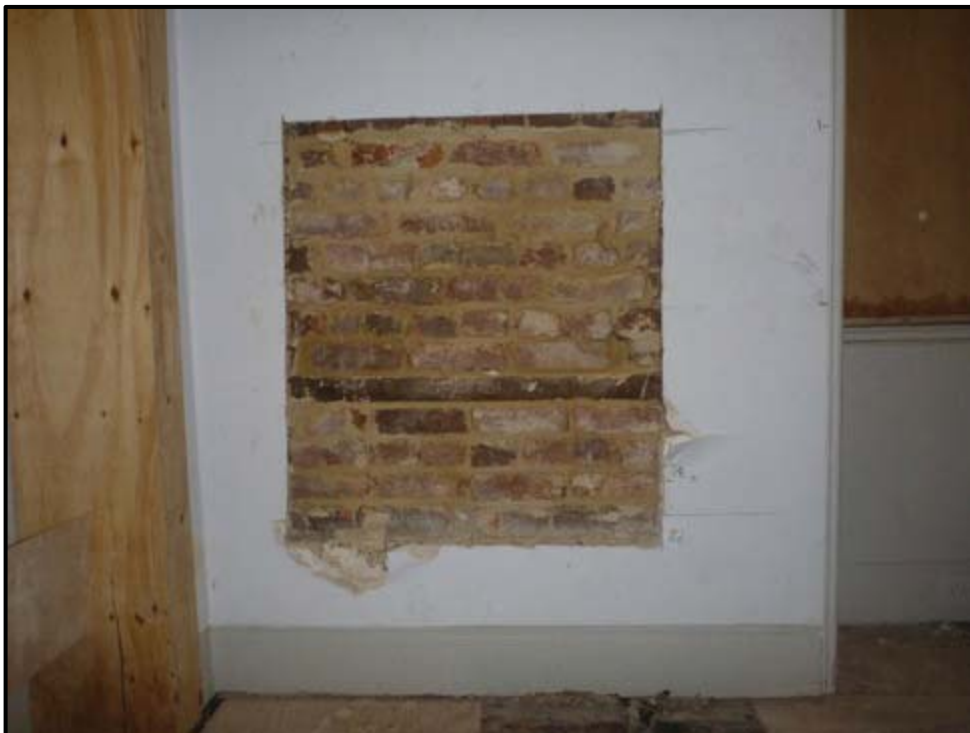
A section of plaster measuring 0.82m was removed from the south wall of F5. The coursed brickwork forming the core fabric of the external wall of the building was exposed. The walling contained horizontal timbers for vertical batons for a lath and plaster finish (**Appendix 2.1**). The bricks measured 6cm (2 $\frac{3}{8}$ " ) x 11cm (4 $\frac{3}{8}$ " ) x 22cm (8 $\frac{5}{8}$ " ).

**OB1:** View looking south of exposed structural brickwork in south wall, F5.

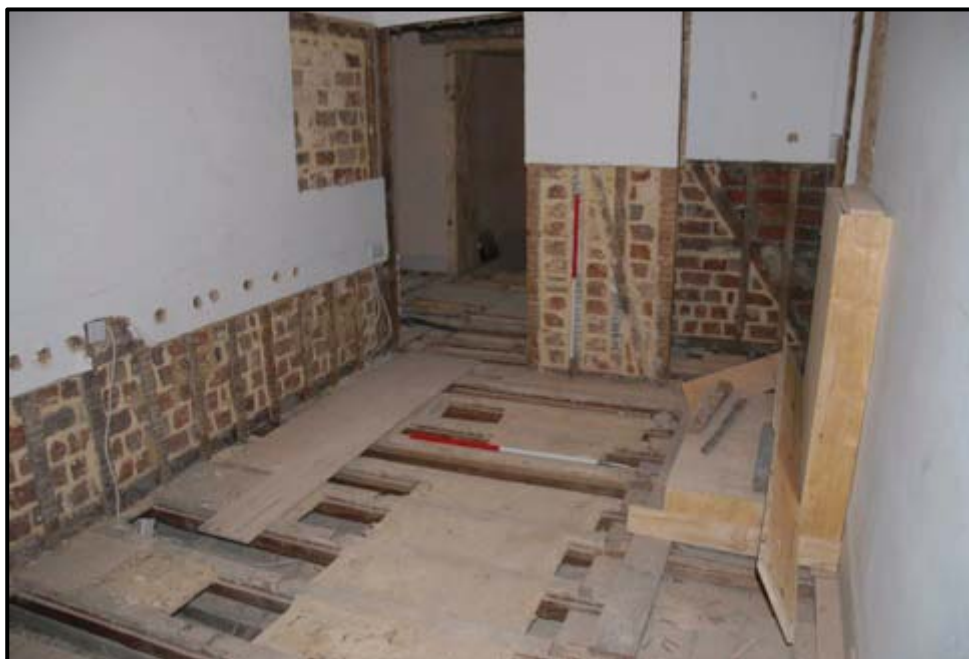
Sections of plaster had been removed from the west wall of F5 that formed a dividing wall to F6 (**Appendix 2.2**). The internal framing was exposed, which comprised of horizontal timbers tenoned into end posts at heights of 0.65m (2ft 1 $\frac{1}{2}$ " ) and 2.1m (6ft 10 $\frac{3}{4}$ " ) above the floor and measuring 6cm (2 $\frac{3}{8}$ " ) x 11cm (4 $\frac{3}{8}$ " ). Vertical batons were nailed onto these timbers and the soleplate. Filling the spaces between each of the horizontal timbers were bricks laid on their side; the bricks measured 6cm (2 $\frac{3}{8}$ " ) x 11cm (4 $\frac{3}{8}$ " ) x 22cm (8 $\frac{5}{8}$ " ). Riven laths and lime plaster formed the final surface finish.

**OB2:** View looking north-west of exposed studwork and brick infill of west wall, F5.

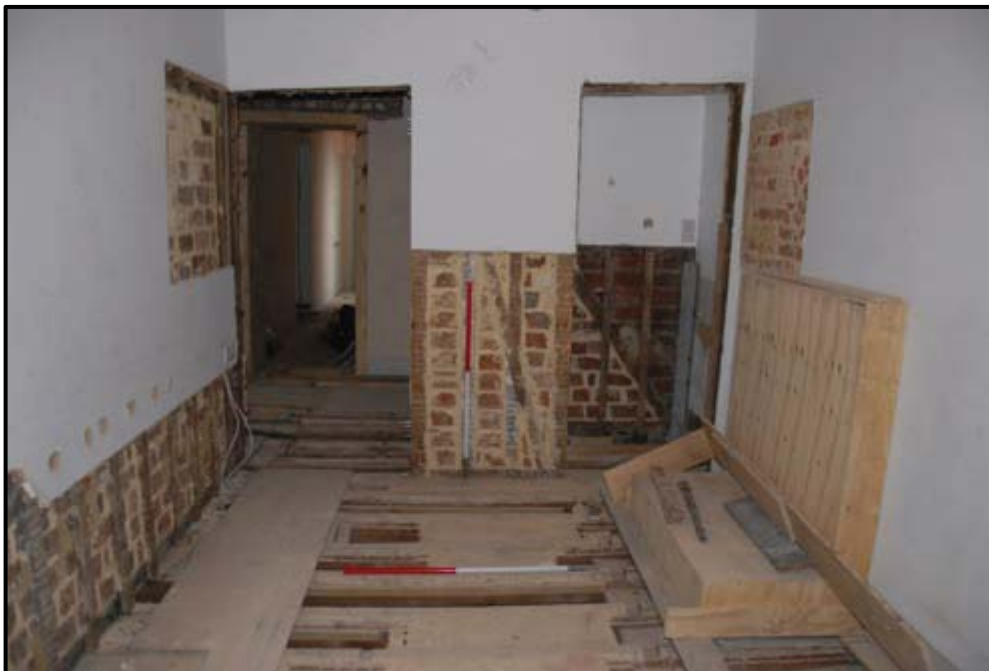
There are two doorways in the north wall of F5, between which is a short section of walling (**Appendix 2.3**). The plaster from the lower half of this wall was removed, exposing the timber framing beneath. The wall was formed from vertical timbers with a diagonal strut and each panel was infilled with bricks laid on their side. The bricks measured 6cm (2 $\frac{3}{8}$ " ) x 11cm (4 $\frac{3}{8}$ " ) x 22cm (8 $\frac{5}{8}$ " ). The lime plaster was attached to riven laths nailed to the vertical timbers.

The east doorway in the north wall of F5 opens into a small walk-in cupboard. The lower section of plaster was removed exposing the timber framing, which was an identical form of construction to OB3. A few of the timbers had redundant joints and mortices indicating reuse (**Appendix 2.3**).

**OB3, OB4:** View looking north of exposed studwork and brick infill of north wall, F5.

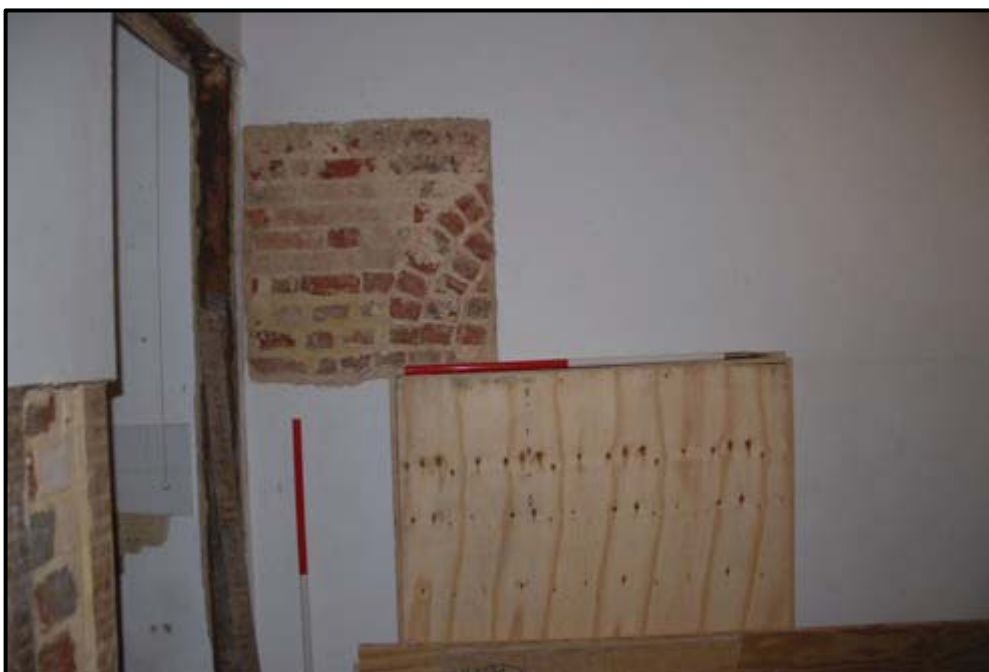
A square section of removed plaster in the north-east corner of F5 exposed the brick walling fabric (**Appendix 2.4**). The plaster was applied directly to the brickwork, without the use of laths. Part of a brick arch comprising three courses of header bricks was also exposed, with bricks measuring 6cm (2 $\frac{3}{8}$ " ) x 11cm (4 $\frac{3}{8}$ " ) x 22cm (8 $\frac{5}{8}$ " ). The spring of the arch was c.1.37m (4 $\frac{1}{2}$ ft) above the floor, with the apex at 1.88m (6ft 2"). This feature coincides with a fireplace and hearth and is interpreted as a relieving structure associated with the construction of the flue. It confirms that this location of a fireplace is contemporary with the construction of the east wall of the room that is a principal spine wall continuing on all floors throughout the building. Beneath the fireplace a partial brick vault was observed spanning between the principal floor joists, c.2.72m (8ft 11 $\frac{1}{4}$ " ) apart, and which would have supported the hearth stone.

**OB5:** Detail of exposed relieving arch above fireplace in north-east corner of F5, looking east.

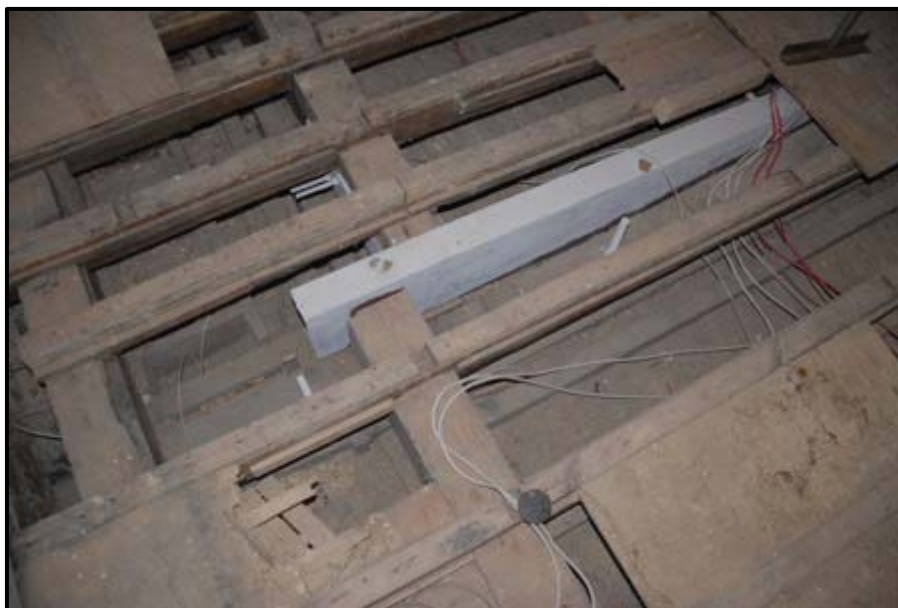
OB6: Detail of exposed double floor structure within F5; note pugin still *in-situ*.

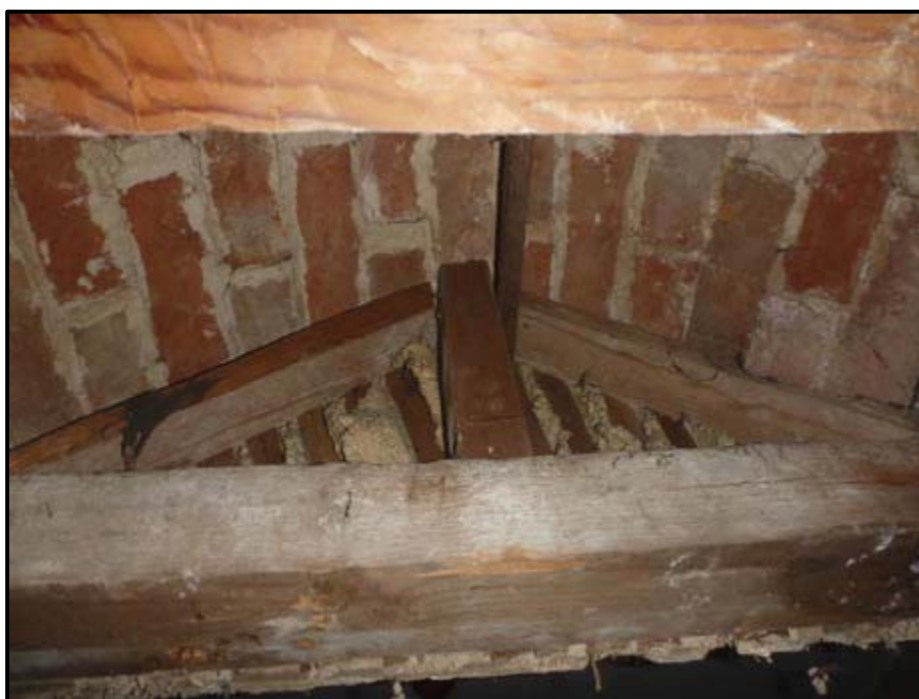
OB7: View of arched door-head between F12 and F13; note timber framework and lath and plaster.

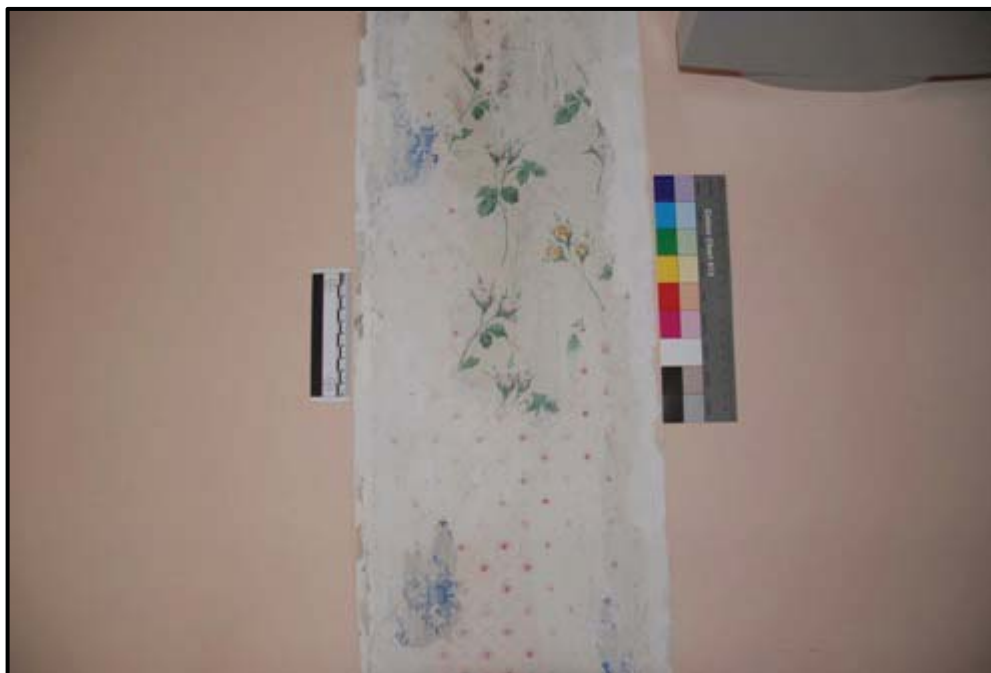
A preserved strip of wallpaper on the east wall of corridor F8 was recorded; although it should be noted that it had initially been exposed in an earlier phase of restoration works at Moggerhanger House (**Appendix 2.7**). Three layers of paper were recorded. The uppermost layer was a design with yellow and pink roses; the middle layer comprised pink flowers in a geometric pattern; and the lowest (earliest) layer was a blue block print with squares and parallel stripes.

**OB8:** Detail of preserved strip of wallpaper on east wall of corridor F8.

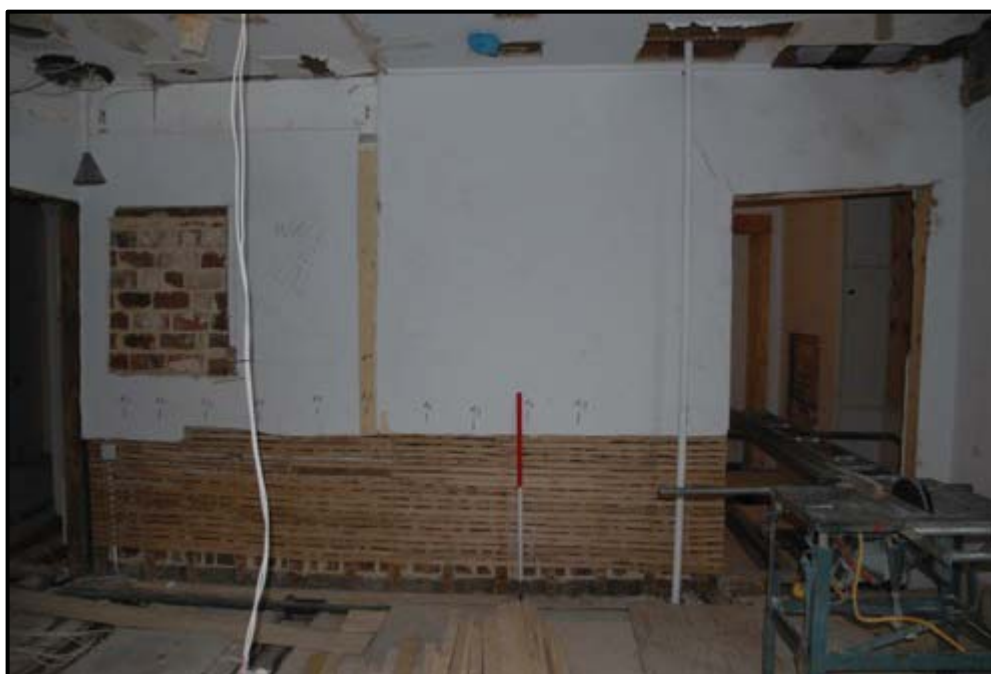
**OB9:** General view of east wall of F6; note timber studwork and brick infill.

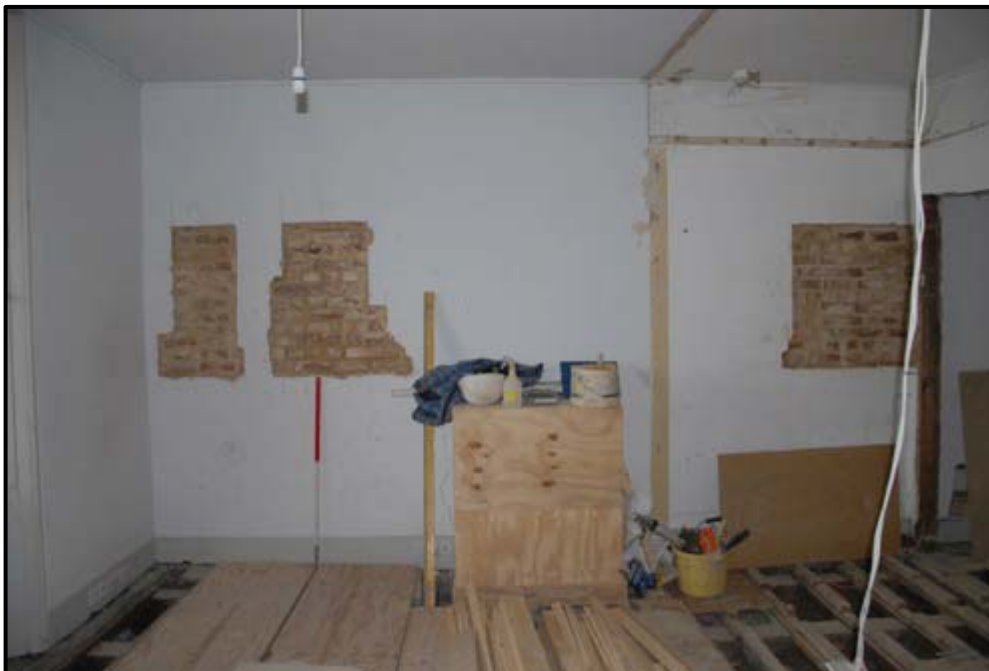
**OB10:** General view of west wall of F6 with areas of exposed brickwork.

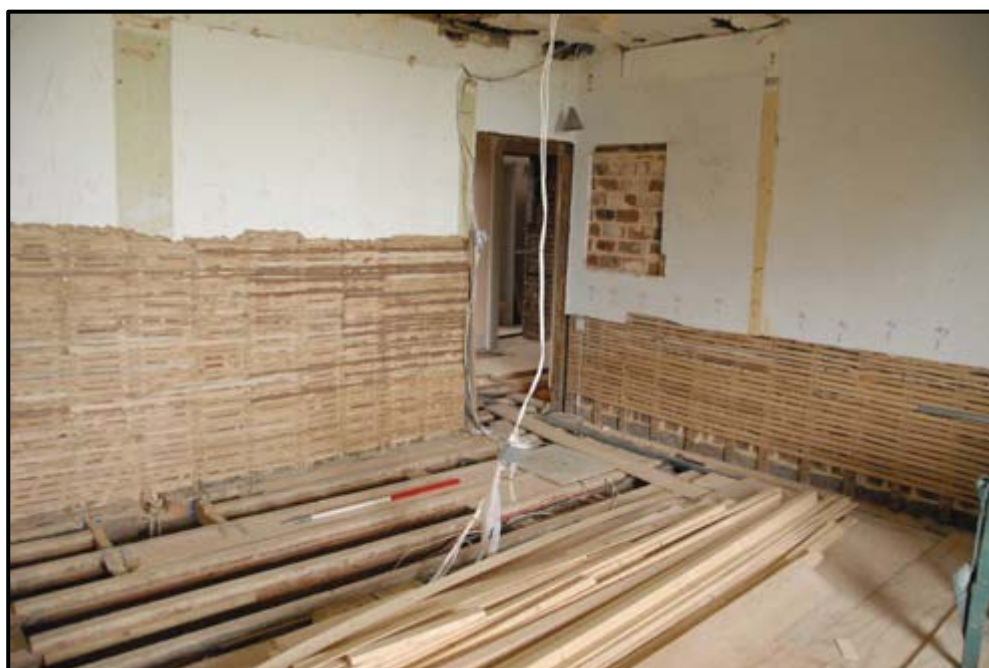
**OB11:** General view of north wall of F6; note stud construction.

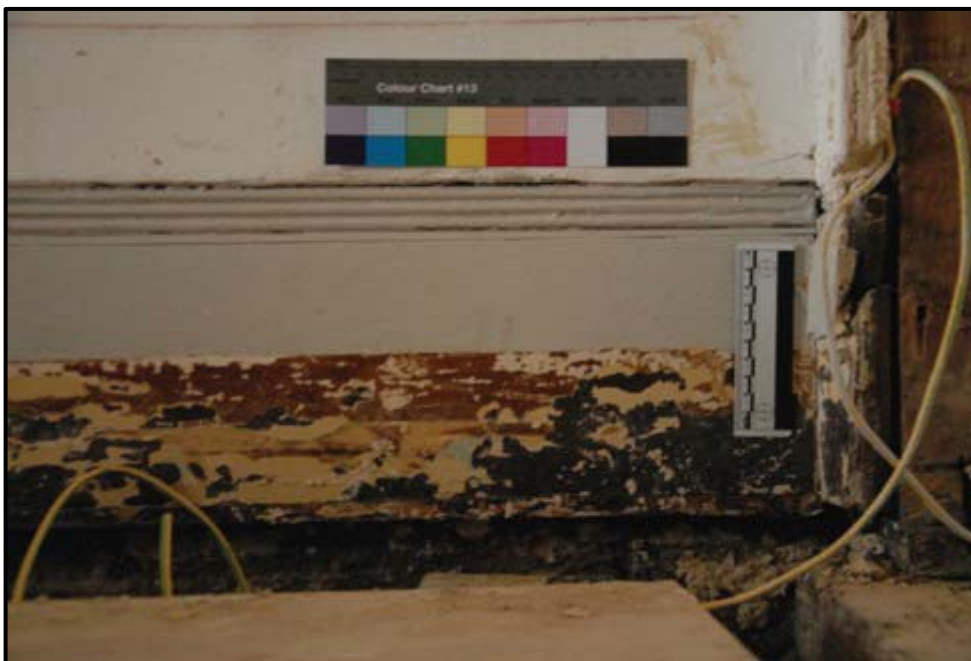
A section of the wooden skirting along the west wall of F6 was found to have multiple layers of painted decoration (**Appendix 2.11**). This paint had previously been examined in a earlier stage of restoration at Moggerhanger House. The paint sequence comprised, in part, the following colours: pale grey (modern top coat); translucent toffee brown; cream; ochre; duck egg blue; dark chocolate brown.

**OB12:** Detail of painted skirting board in north-west corner of F6.

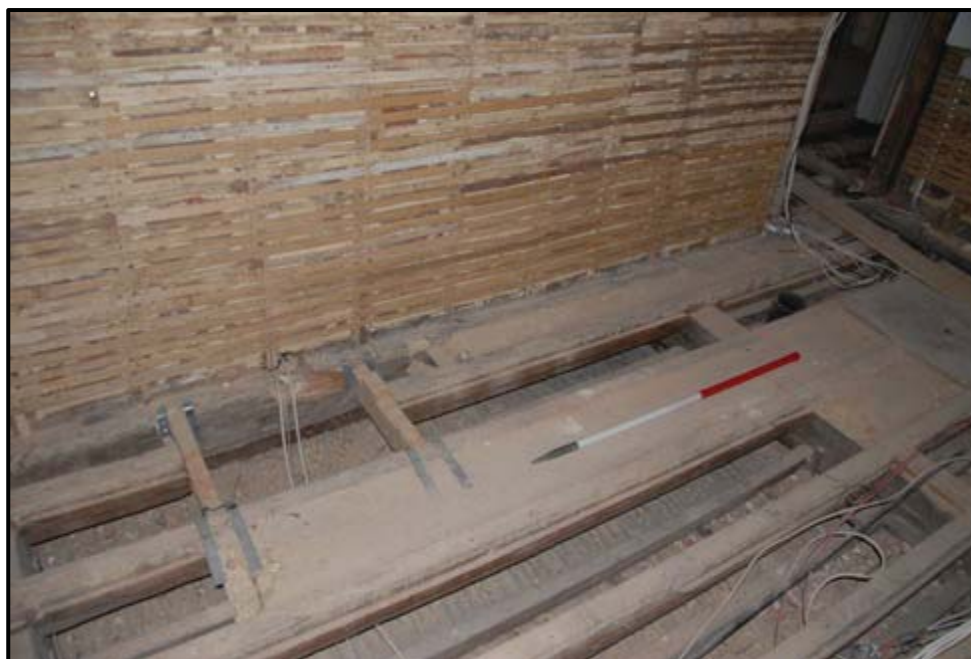
**OB13:** Detail of floor structure in F6, looking north-east.

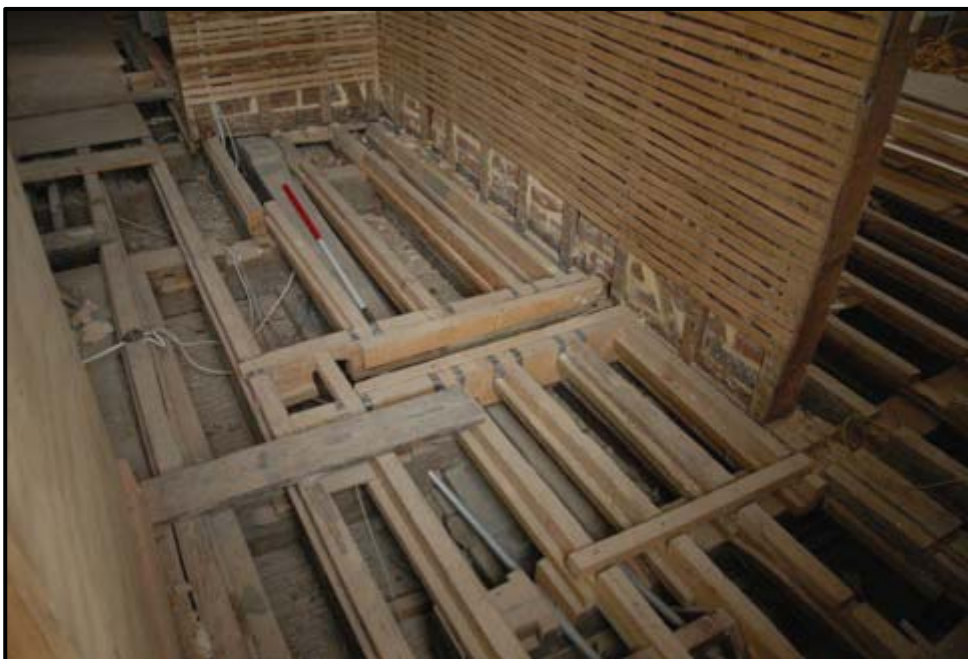
Following the removal of the floorboards, the floor structure of F7 was found to be identical to F5 and F6, forming a single large floor, upon which various timber partitions had been inserted. Against the north wall of F7 a section of a brick arch was exposed (**Appendix 2.15**), which formed a support to a fireplace. The brick arch was damaged, however it appeared to be identical in form to another beneath the fireplace in F5, and recorded as OB5.

**OB14, OB15:** View of floor structure in F7, and exposed stud walls to the south and east.

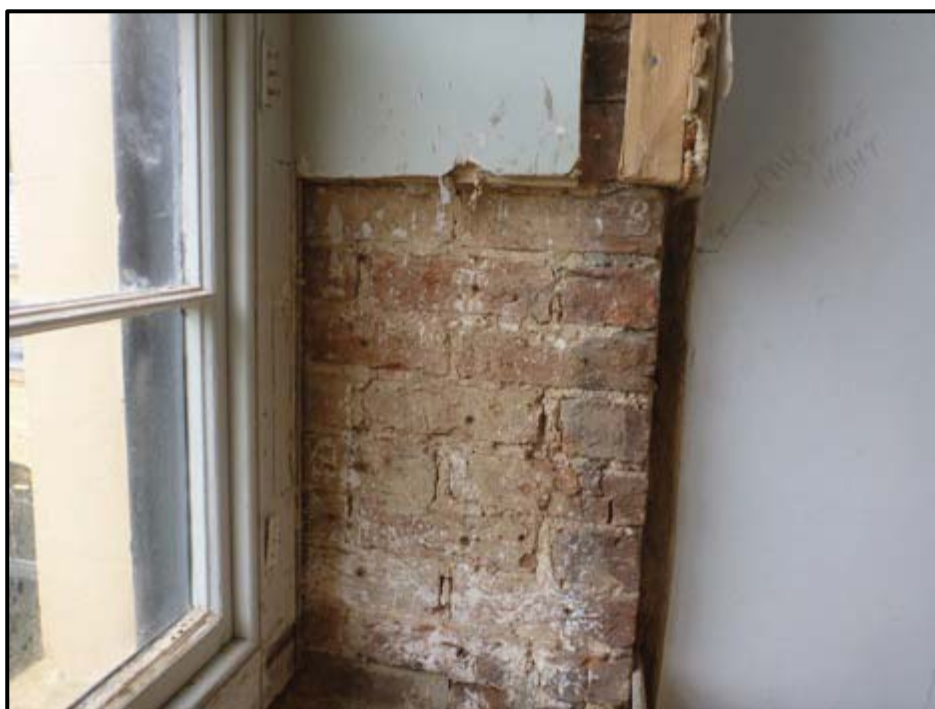
The plaster had been partially removed from the reveals of the window in the west wall of F7 (**Appendix 2.14**). The brick work that formed the external west wall of the building was exposed, and found to be identical to that along the south wall noted in OB1. The bricks measured 6cm (2 $\frac{3}{8}$ " ) x 10.5cm (4 $\frac{1}{8}$ " ) x 22cm (8 $\frac{5}{8}$ " ). Horizontal timbers had been set into the brick work, for attaching batons and laths for the plaster finish.

**OB16:** Detail of exposed brick reveal in west wall of F7, looking north-west.

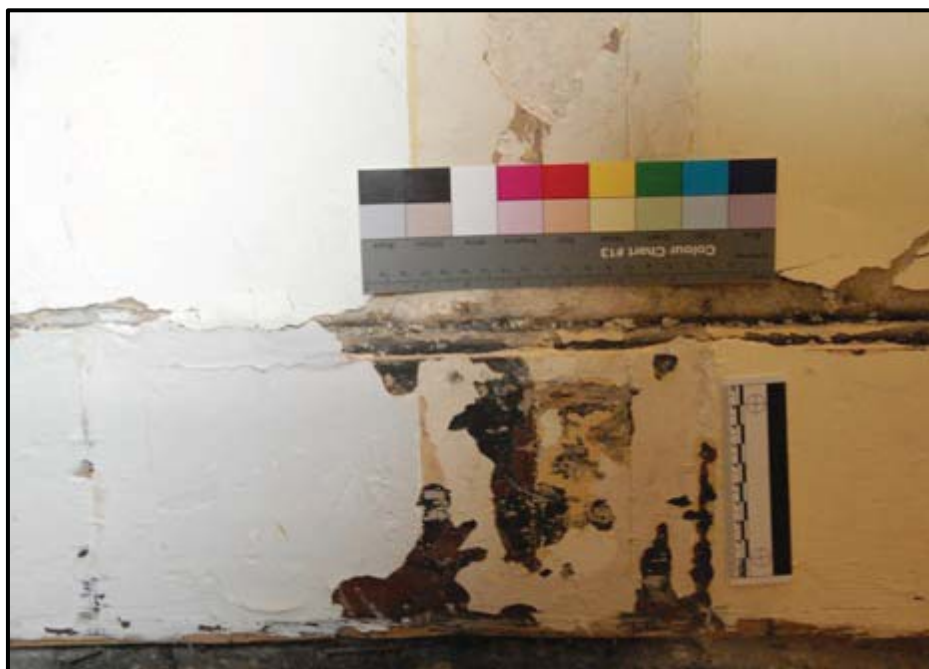
A section of the wooden skirting along the south wall of S11 was found to have multiple layers of painted decoration (**Appendix 2.11**). This paint had initially been examined in a previous stage of restoration at Moggerhanger House by Inskip & Jenkins Architects, however the sequence observed appeared to comprise the following colours: grey (modern top coat); translucent toffee brown; cream; ochre; dark chocolate brown.

**OB18:** Detail of exposed section of painted skirting board, in south-east corner of S11.

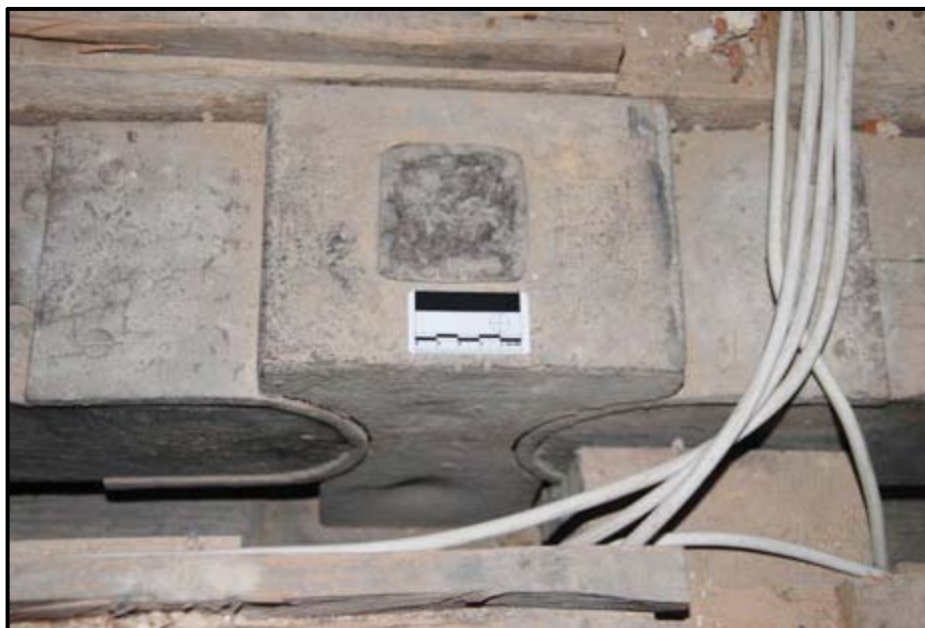
**2.21).** The truss was supported by two cast iron queen bolts, spaced 54cm (21¼") apart in the center of the beam (**Appendices 2.19 to 2.21**). These castings were substantial items, measuring 15cm (6") x 20cm (8") at the head, and diminishing to 13cm (5⅛") x 15cm (6") at the interface with the lower timber of the beam. It is suggested that they were secured in position with a square nut, although the lower face of the beam was observed by plasterwork at the time of survey. Beneath the head, the queen post had curved recesses on either side which housed the upper sections of the truss, each of which had metal bands screwed onto the ends to form a secure fit with the queen bolts, that would also have allowed a certain degree of movement (**Appendix 2.19**).

**OB19:** Detail of east cast iron post forming beam **F1**; note wooden timbers with metal collars forming joints with cast iron post.

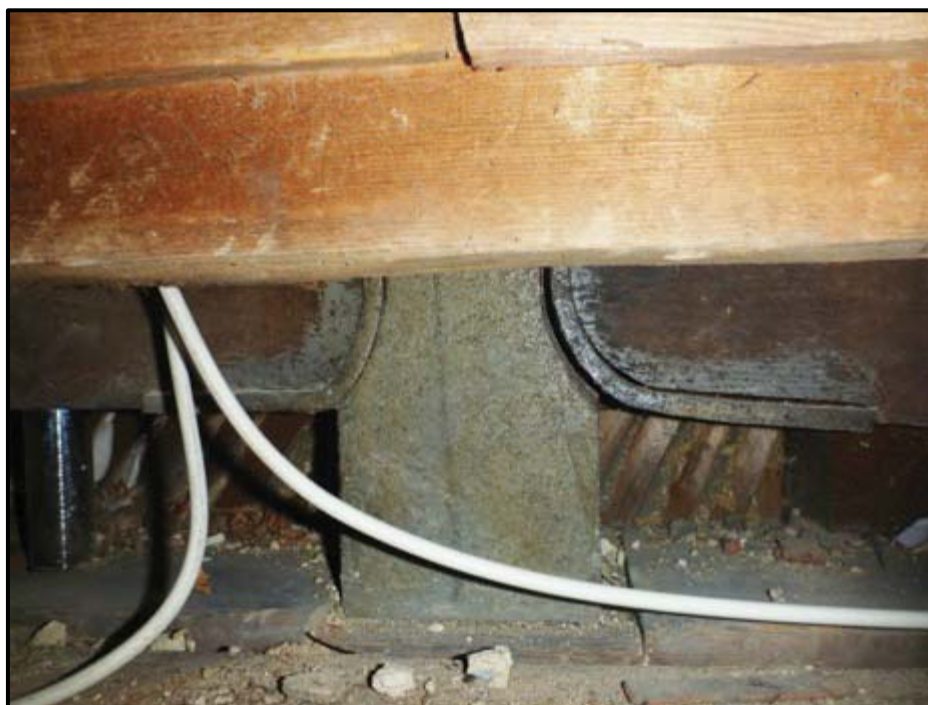
**OB19:** Detail of base of cast iron post at interface with lower timber forming beam **F1**; note traces of bluish paint on metalwork.

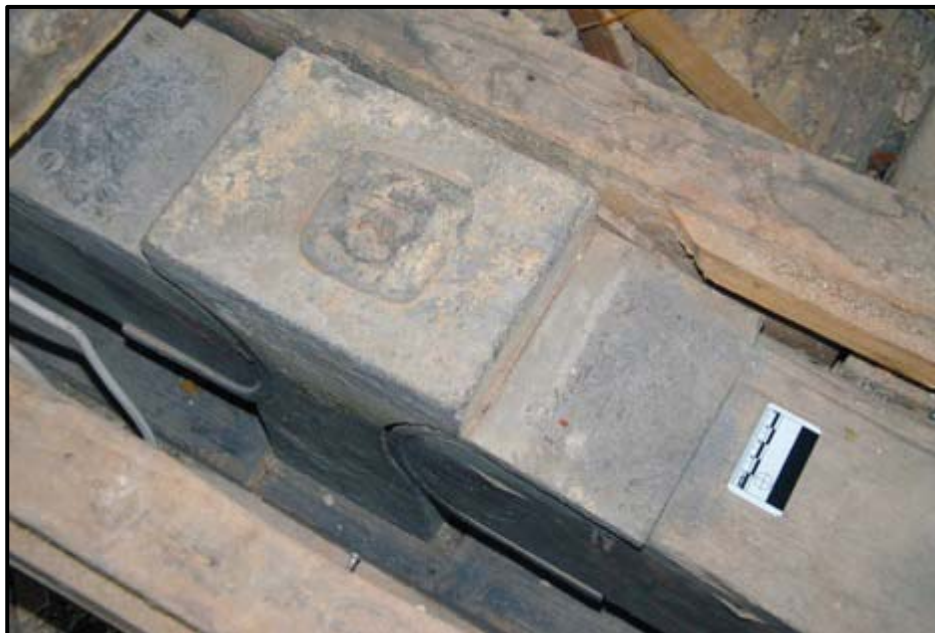
**OB19:** Detail of east cast iron post forming beam **F1**; note slot headed screws used to secure metal hoops onto the end of the timber joints.

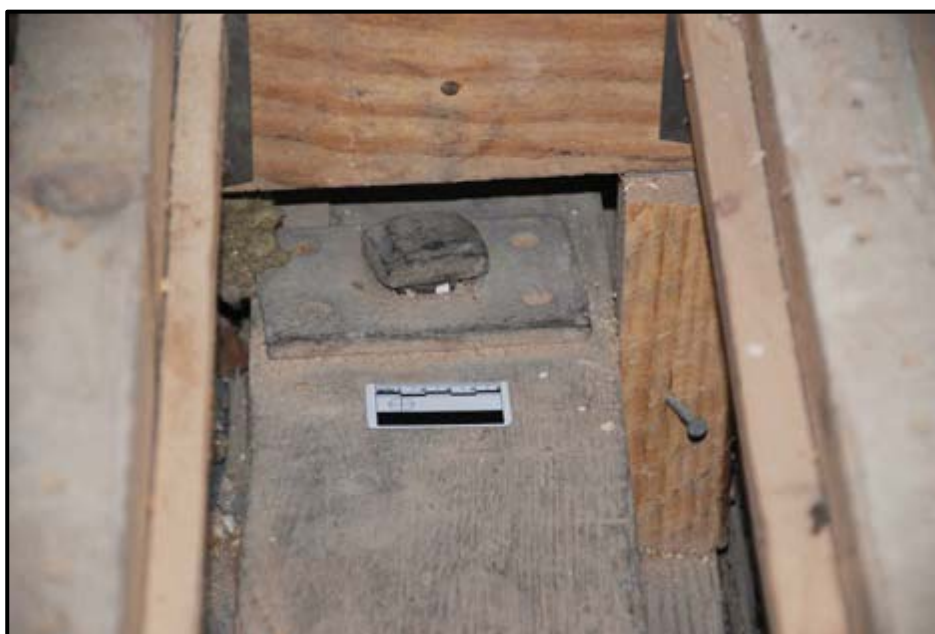
**OB19:** Detail of square head of bolt and rectangular plate (spacer) securing together components of beam **F1**.

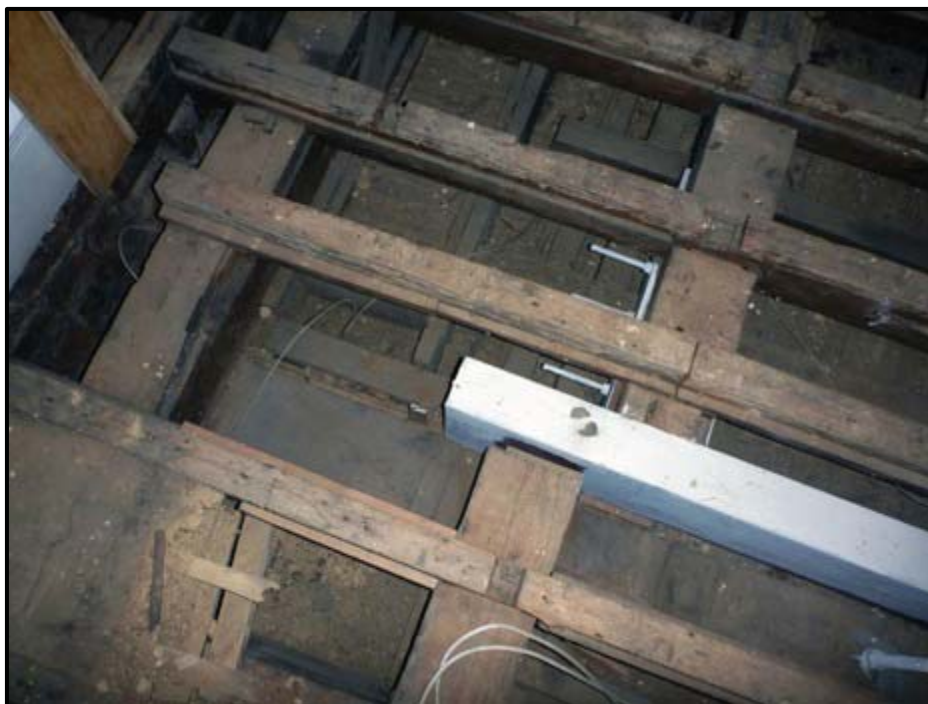
**OB19:** General view of east end of beam **F2**; note iron strap and square bolt head and spacer.

No secondary alterations were recorded on either of beams **F1** and **F2**, apart from the recent repairs in the form of the steel plates to provide both additional strength and lateral stiffness (**Appendix 2.23**).

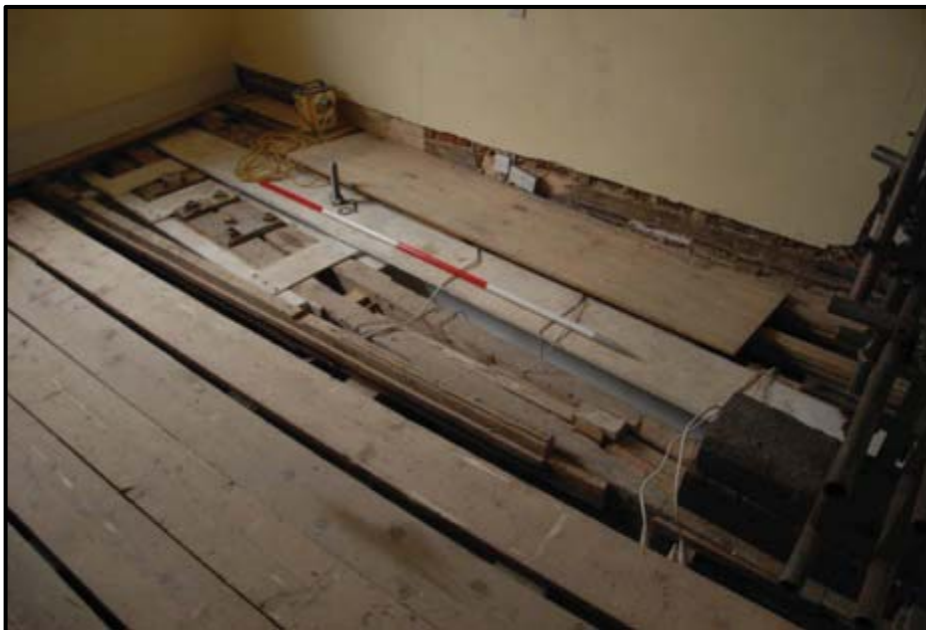
**OB20:** General view of south end of beam **S1**; note proximity of structure to underside of floorboards.

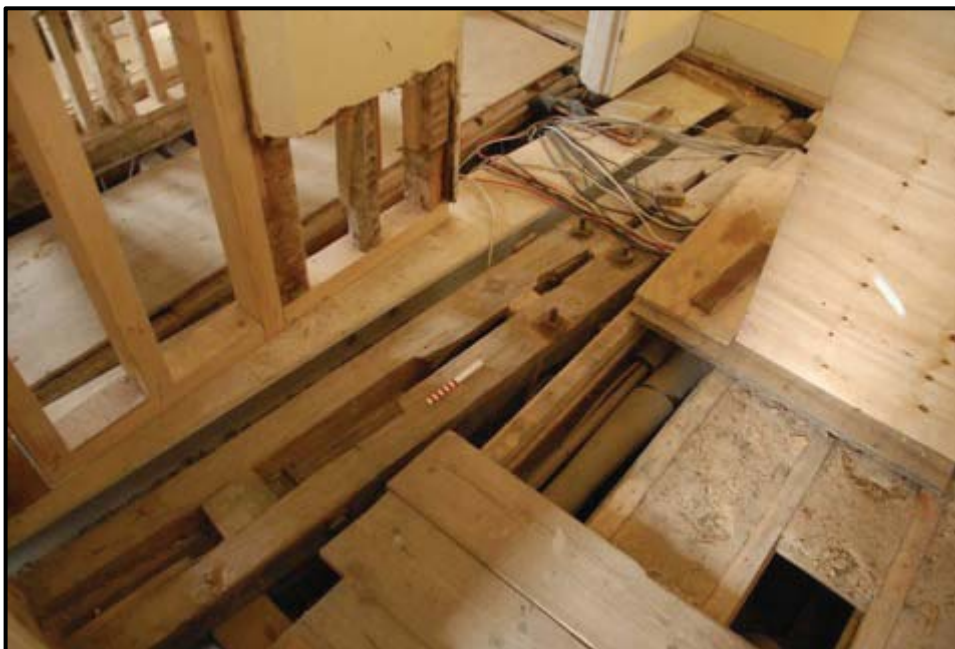
**OB20:** General view of north end of beam **S1**; note central slot.

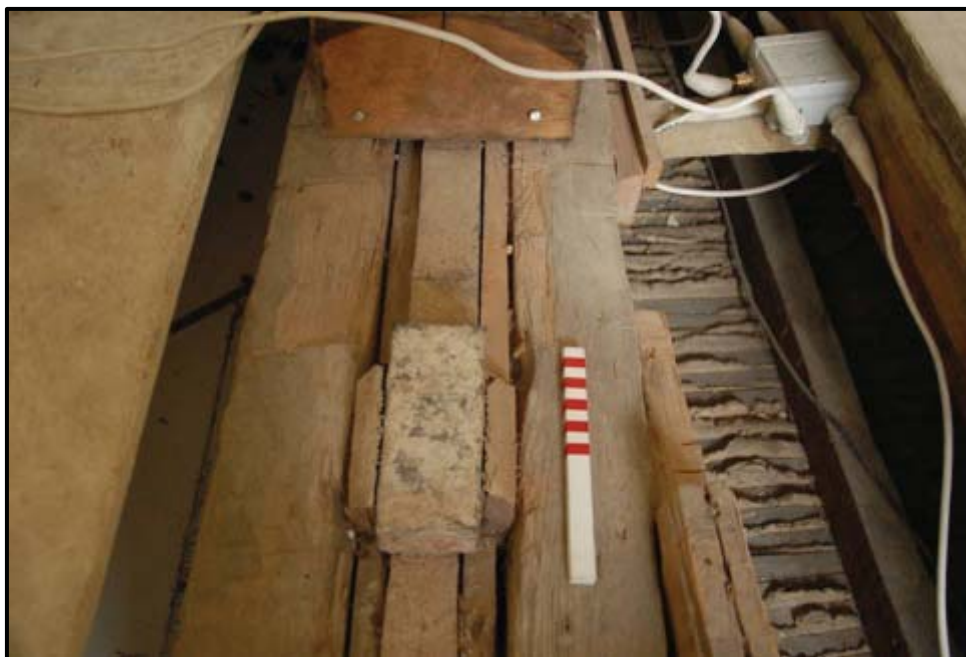
**OB20:** Detail of central section of beam **S1**; note head of cast iron post sandwiched between timber beams **S1.1** and **S1.2**.

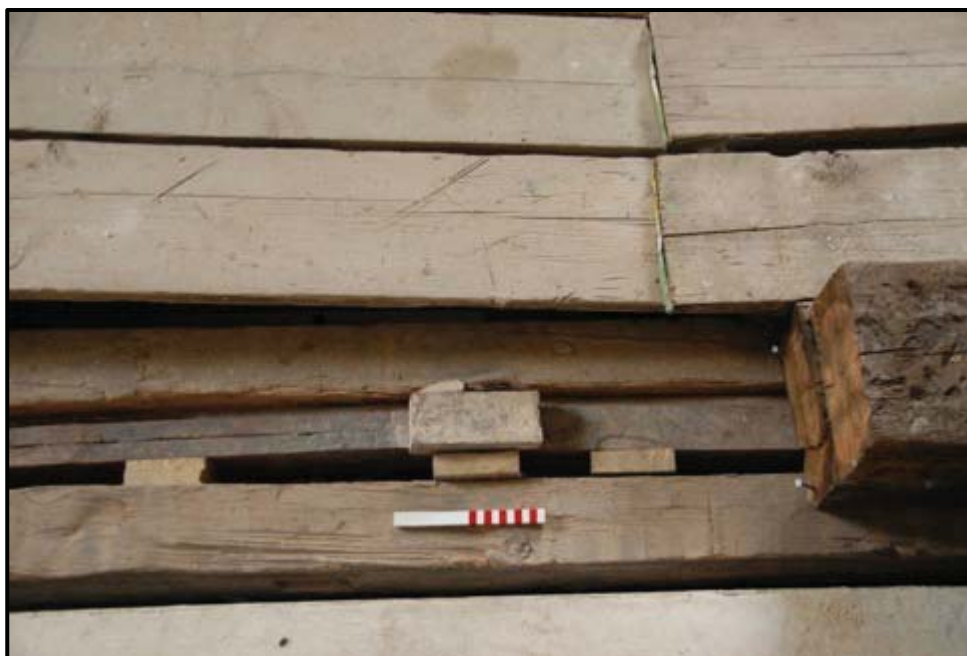
**OB20:** Detail of central section of beam **S2**; note head of cast iron post and metal bars projecting on either side sandwiched between timber beams.

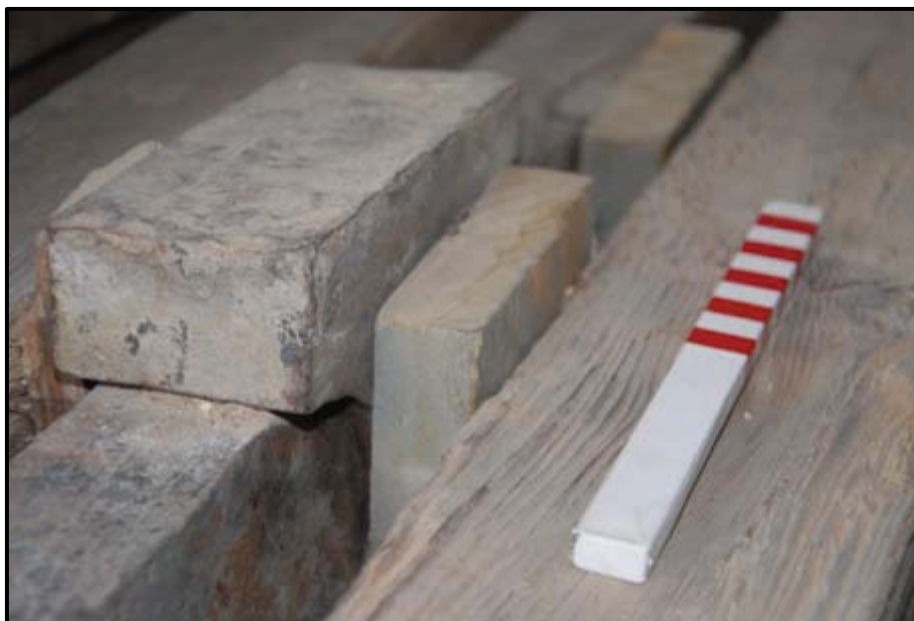
Two different types of metal bar, or trusses, were observed. In the center of each beam between the two queen bolts, a thick bar with rounded ends formed the middle element of the truss. This bar measured 63cm (2ft ¾") in length, 10cm (4") in height and had a thickness of 6.5cm (2½"). The additional elements of the truss comprised two angled metal bars that were located within the chased grooves on the inner face of each timber forming the beam. They were angled downwards from the top of each queen bolt (**Appendix 2.33**) and secured by the horizontal bolts and end stops (see below). These bars were comprised

**OB20:** Detail of cast iron post in central section of beam **S2**; note rounded end of central cast iron bar.

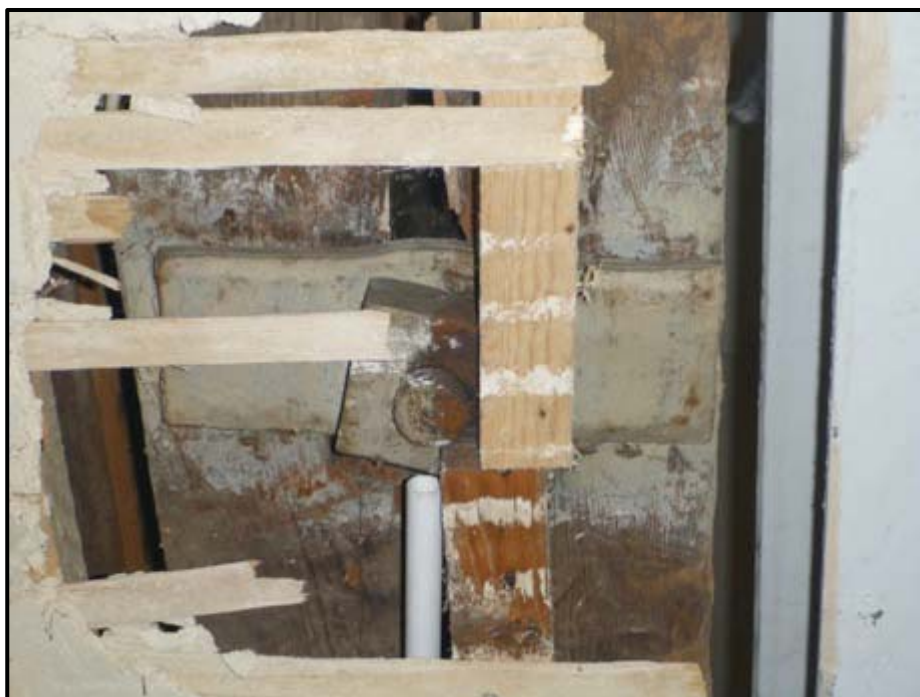
**OB20:** Detail of lower end of cast iron post of beam **S1**; note expanded rectangular plate and square nut.

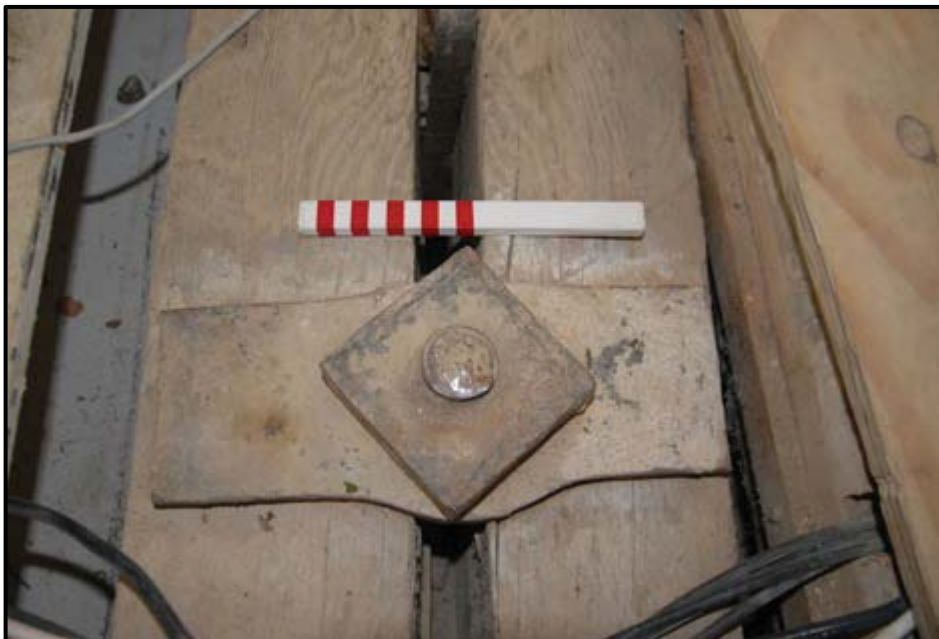
**OB20:** Detail of upper surface of end bolt of beam **S1**; note expanded rectangular plate and square nut.

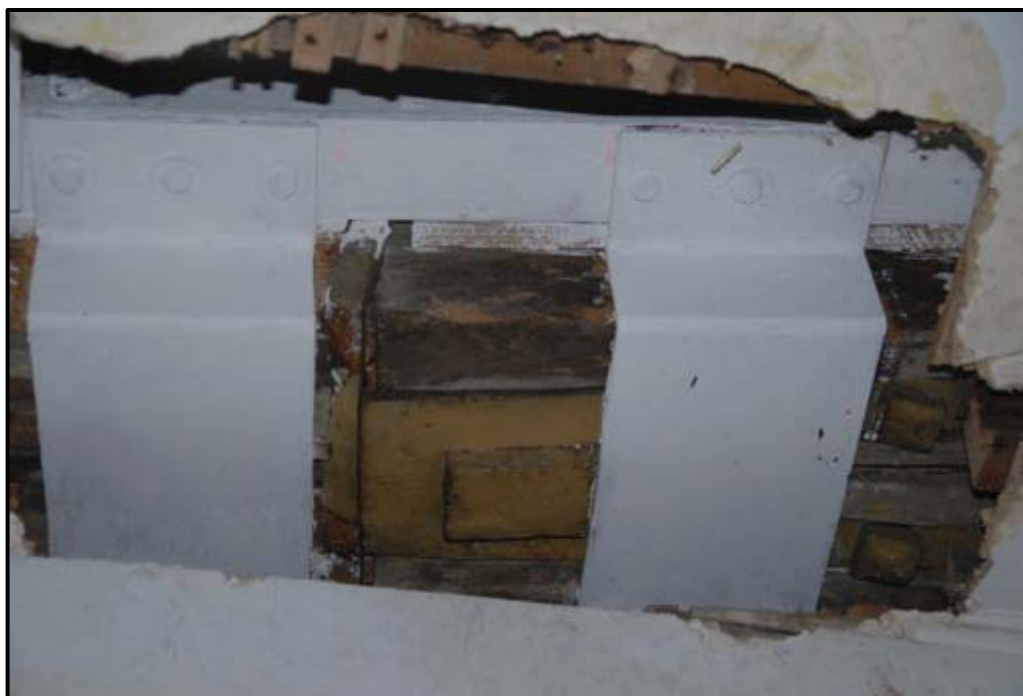
**OB20:** Detail of rectangular head of end bolt of beam **S1** from below; note U-shaped strap and extended straps with square headed bolts.

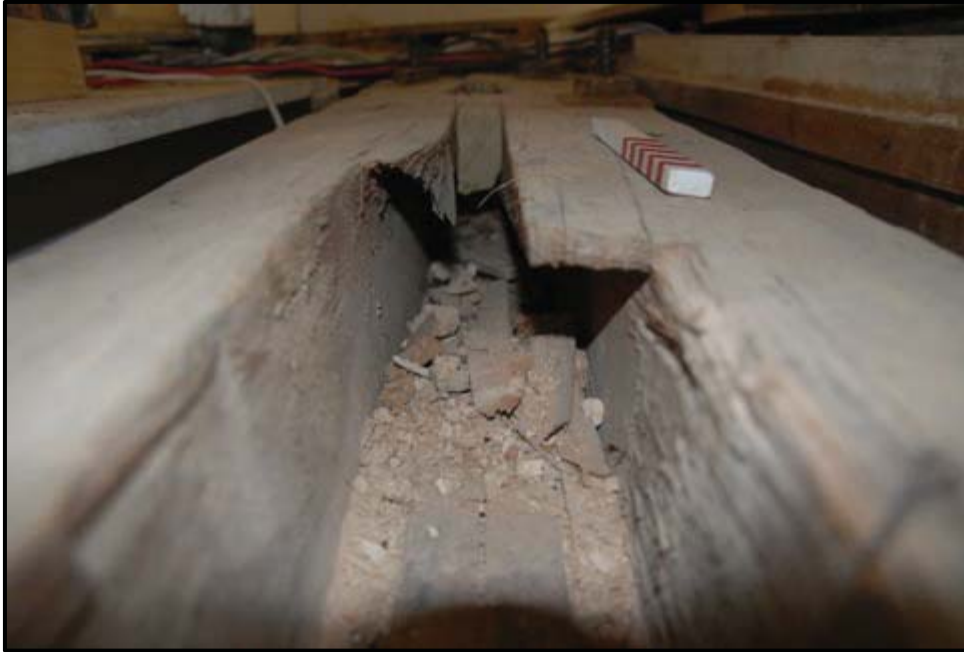
**OB20:** Detail of central groove at north end of beam **S1**; note angled alignment and paired bars at base forming internal truss.

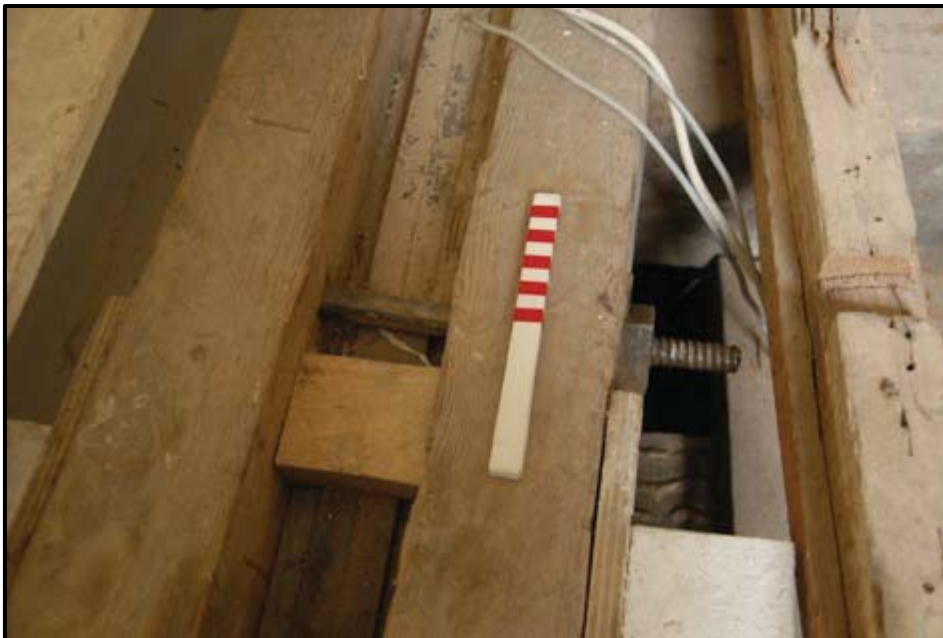
**OB20:** Detail of central groove at of beam **S1**; note paired bars forming internal truss secured in place by horizontal bolt with threaded end and square nut.

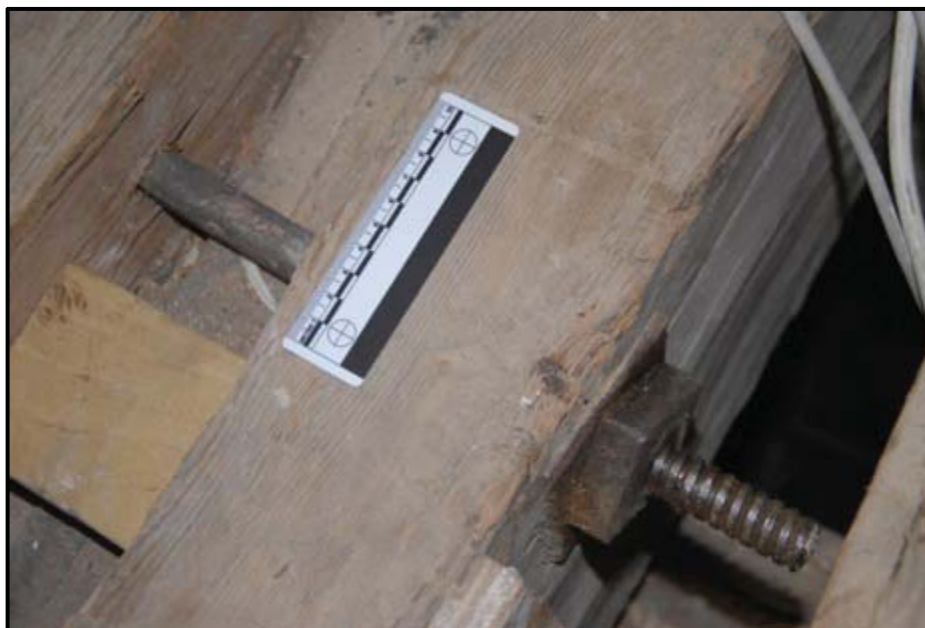
**OB20:** Detail of horizontal bolt with threaded end and square nut.

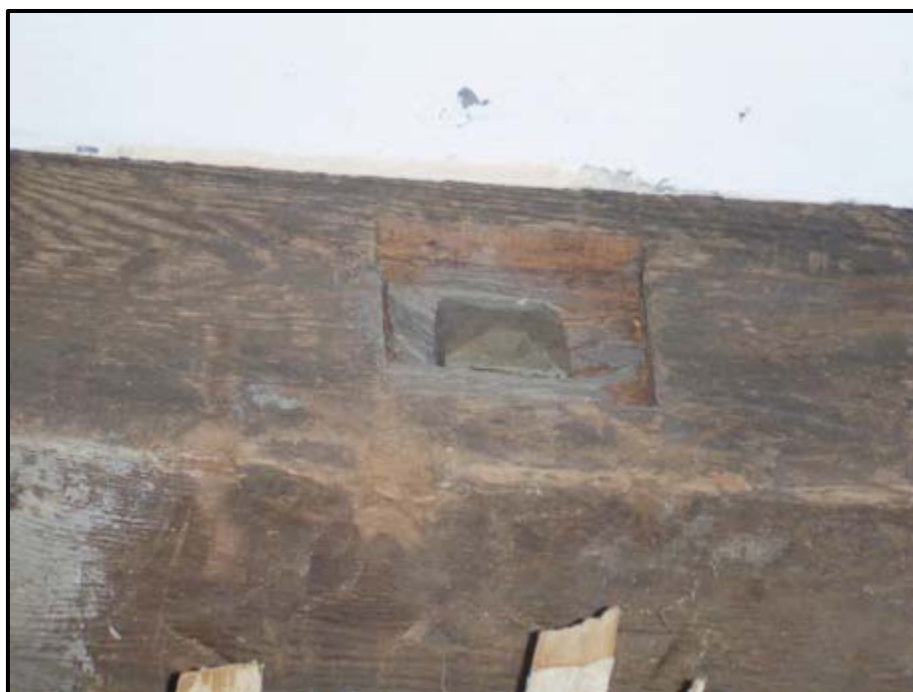
**OB20:** Detail of cut recess in side face of beam **S1** to house head of horizontal bolt; note crushed surface of wood due to excessive tightening and missing washer.
