# **MOGGERHANGER HOUSE**

## **Emergency Recording of Trussed Floor Beams and Historic Fabric**

March 2013

Document No: TJC2013.12

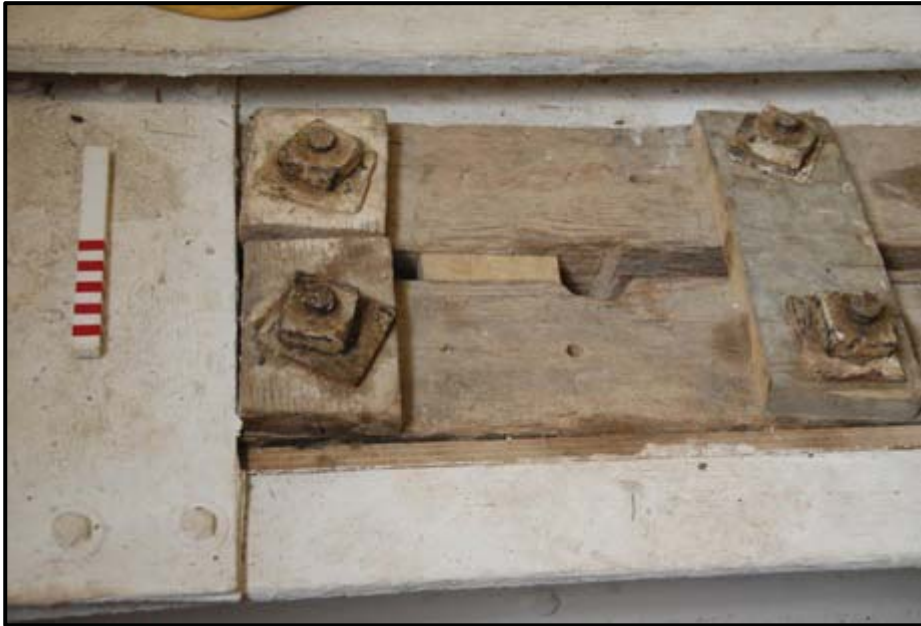
**OB20:** Detail of nuts securing vertical bolts at south end of beam **S1**; note use of wooden pieces below metal washers and redundant hole in center of groove.

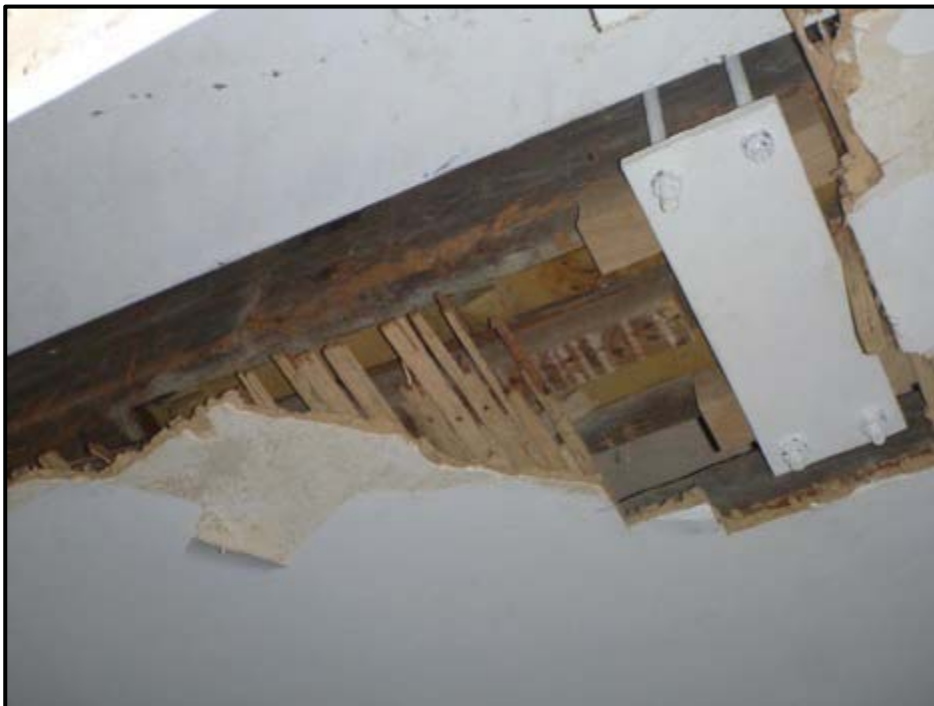
**OB20:** Detail of longitudinal straps set in chased grooves in underside of south end of beam **S1**; note square headed ends of vertical bolts securing straps in place.
