ASHFORD-IN-THE-WATER MILL

DERBYSHIRE

Archaeological Evaluation (Trial Holes)

Document No: TJC2014.61

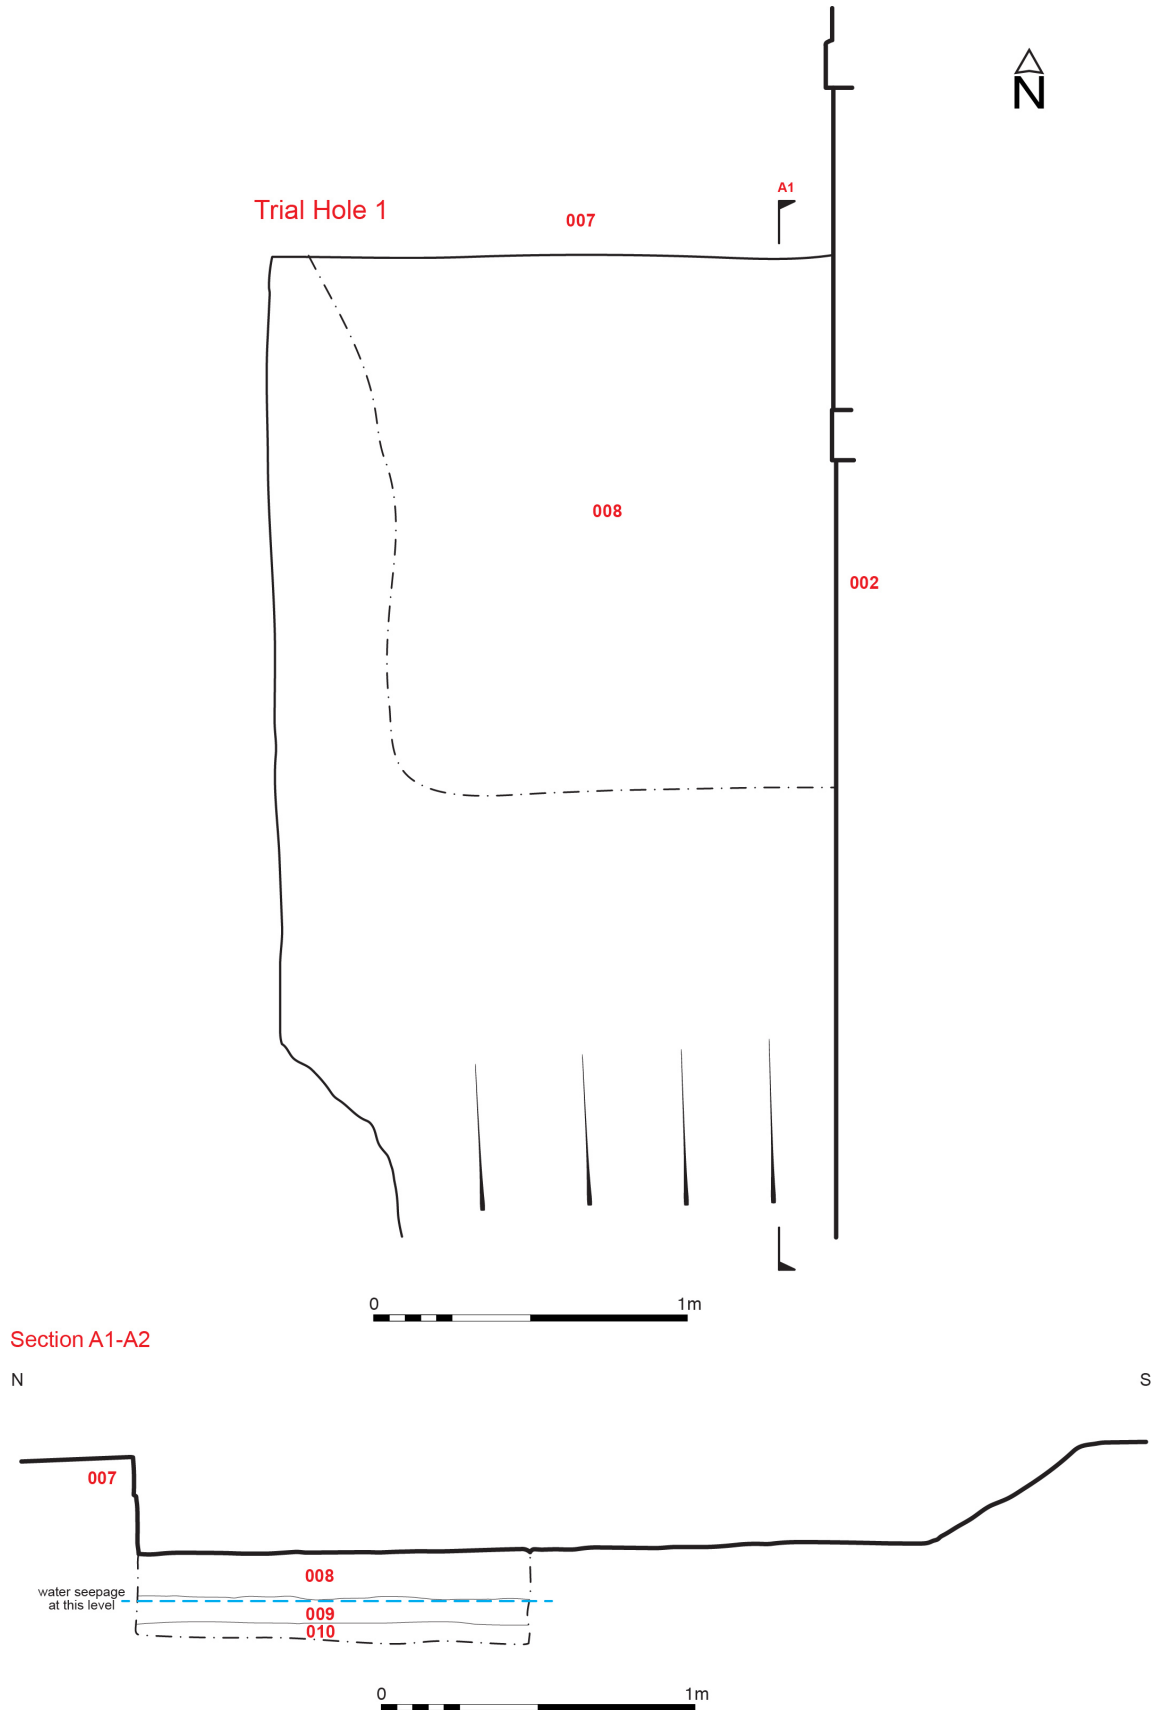
Appendix 2.1: Excavation plan and cross-section, Trial Hole 1.

Trial hole 1 (**Figure 3**) was located against the east wall of the West Wing of the Mill (**Appendix 3.1**). It was set within a lowered area **007** that had been adapted for a former weighing machine (**Appendix 2.1**). The ground surface comprised of a concrete slab **008** that was 0.14m in thickness. The slab comprised of a mixture of re-used concrete kerb stones with a layer of concrete poured over the top. The kerb stones were laid on a layer of hardcore chippings **009**, which overlay a layer of sand and mortar **110** at a depth of 0.24m below the base of **007**. The water table was encountered immediately beneath the concrete slab **008** (**Appendix 3.2**).

The use of concrete kerb stones to construct the sunken feature **007** was clearly intended to support a heavy load, such as the weighing machine. No natural ground was encountered in the base of the trial hole.

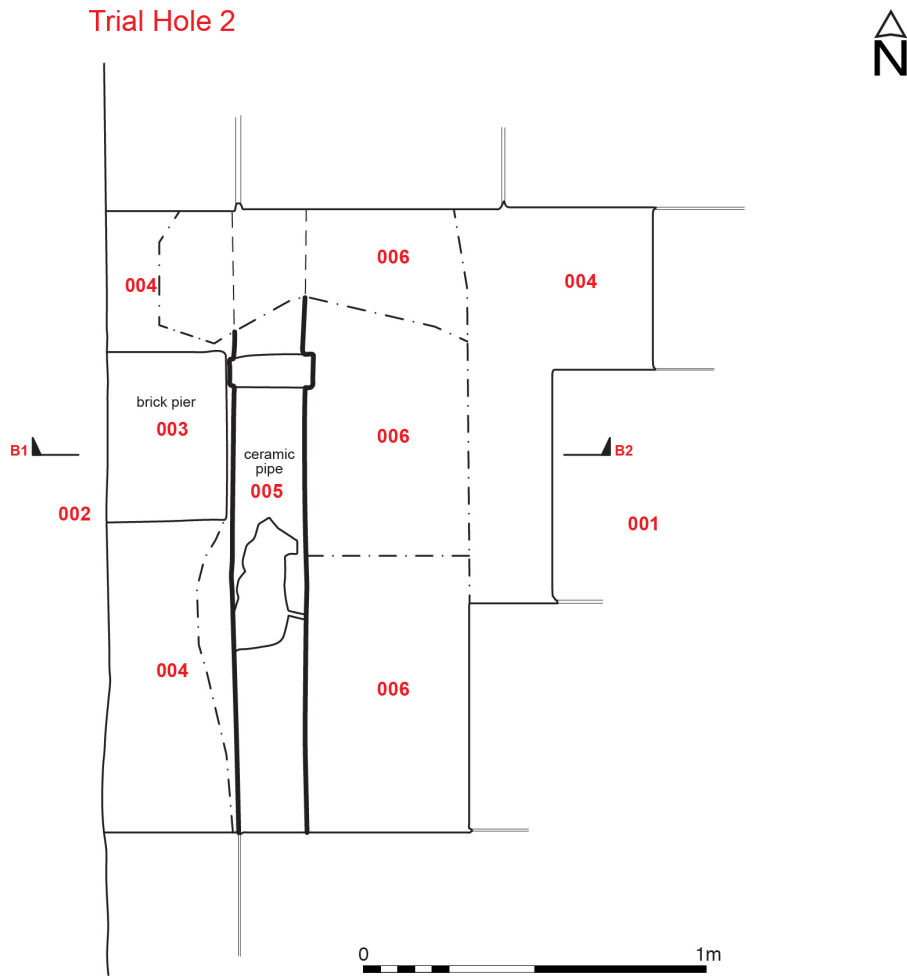
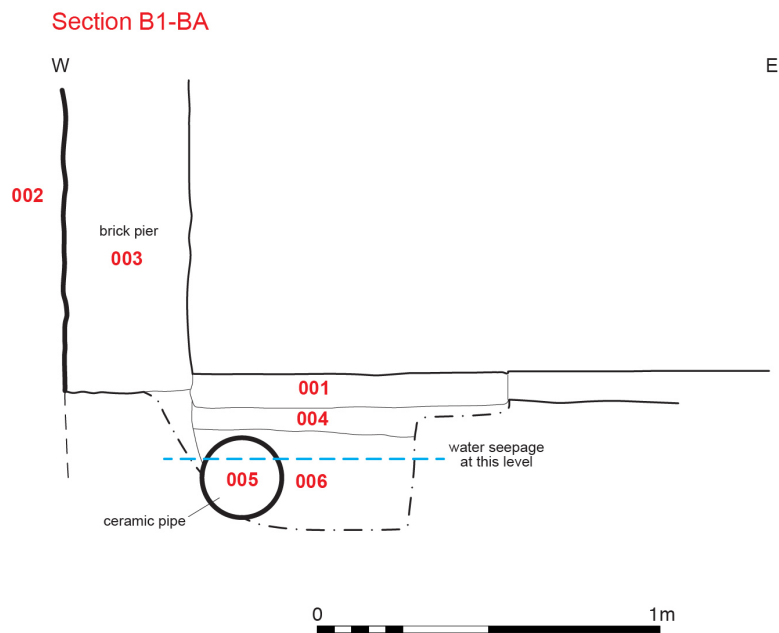
Appendix 2.2: Excavation plan and cross-section, Trial Hole 2.

Trial hole 2 (**Figure 3**) was originally intended to be two separate holes against the west wall of the mill **002**, however once the flagstone flooring (**Appendix 3.3**) had been lifted, it was found that a single hole was more appropriate (**Appendix 3.4**). The hole had an irregular form, but the maximum dimensions were 1.8m x 1.1m (**Appendix 2.2**). The flagstones **001** were 0.08-0.1m in thickness and cut in rectangular slabs. They were bedded on a bed of compacted lime mortar **004**. There is a series of brick piers along the west wall **002**, one of which was located within the edge of the trial hole. This pier **003** measured 0.34m x 0.46m and was built with machine made bricks (7cm x 11cm x 23cm) and bedded in a cement mortar. The pier is a secondary insertion, which was cut through the flagstones, although it sat directly upon **006**.

Beneath **004** was a layer of stone fragments and chippings **006**. The upper surface of this layer was a very compacted upper surface, although at a depth of 0.3m below the ground surface the water table was encountered and the chippings became loose with numerous voids. Within

this layer was a large salt glazed pipe **005** that was parallel to the west wall **002**. The pipe had a diameter of 0.2m and had a large fracture with a folded fragment of tin sheet over the top; presumably representing a historic repair perhaps when the brick pier **003** was inserted. Fragments of ceramic and glass were recovered from **006**.

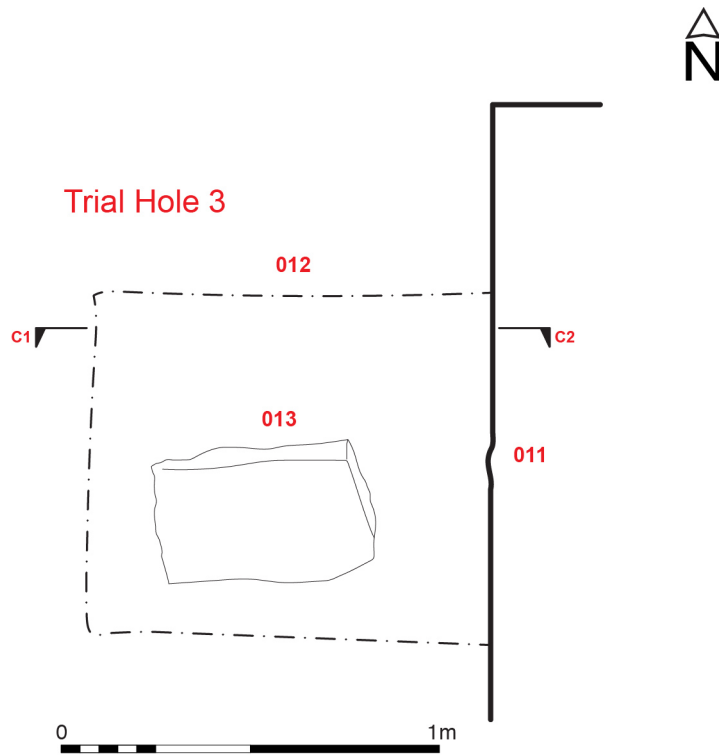
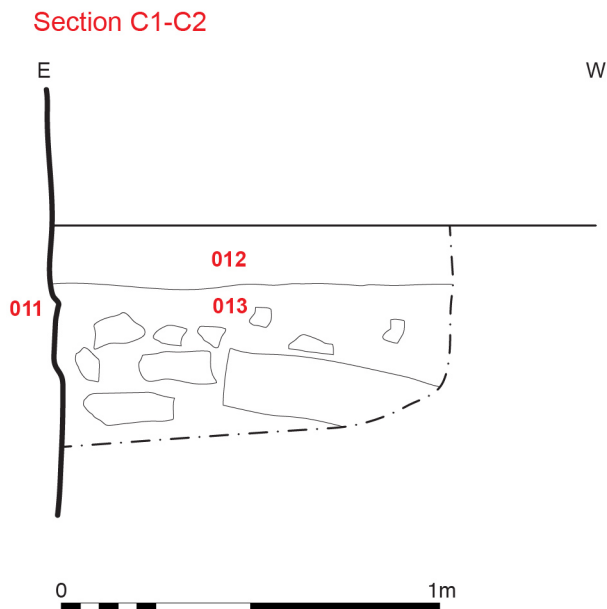
Appendix 2.3: Excavation plan and cross-section, Trial Hole 3.

Against the east wall **011** of room **G2A (Figure 3)** trial hole 3 was excavated by machine (**Appendix 3.5**). This hole measured 0.9m x 1.05m (**Appendix 2.3**), with a maximum depth of 0.6m. The concrete slab **012** was 0.16m in thickness and overlay a loose sub-base of medium sized angular fragments of Ashford stone **013**. This layer of loose stone was dry and contained many voids and had been backfilled against the inner face of **011 (Appendix 3.6)**, which represents one side of the corn drying kiln that was inserted in the 19th century.

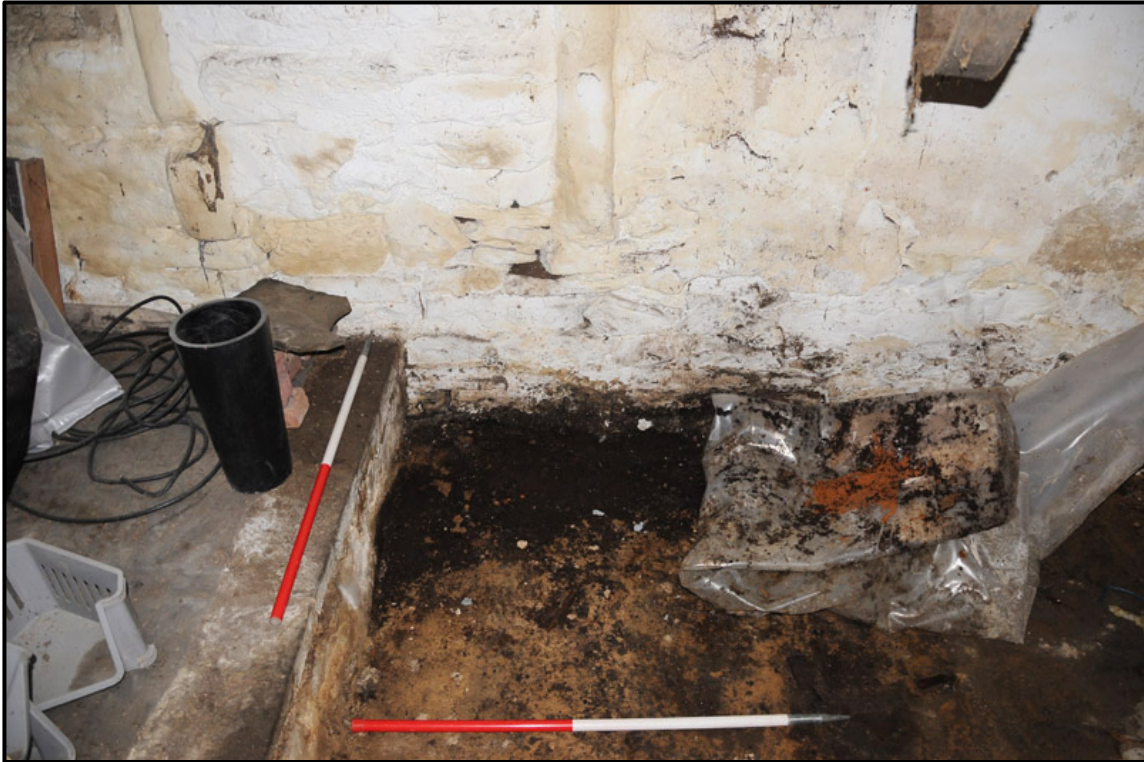
Appendix 3.1: General view of Trial Hole 1 before excavation, looking east (1m scale).

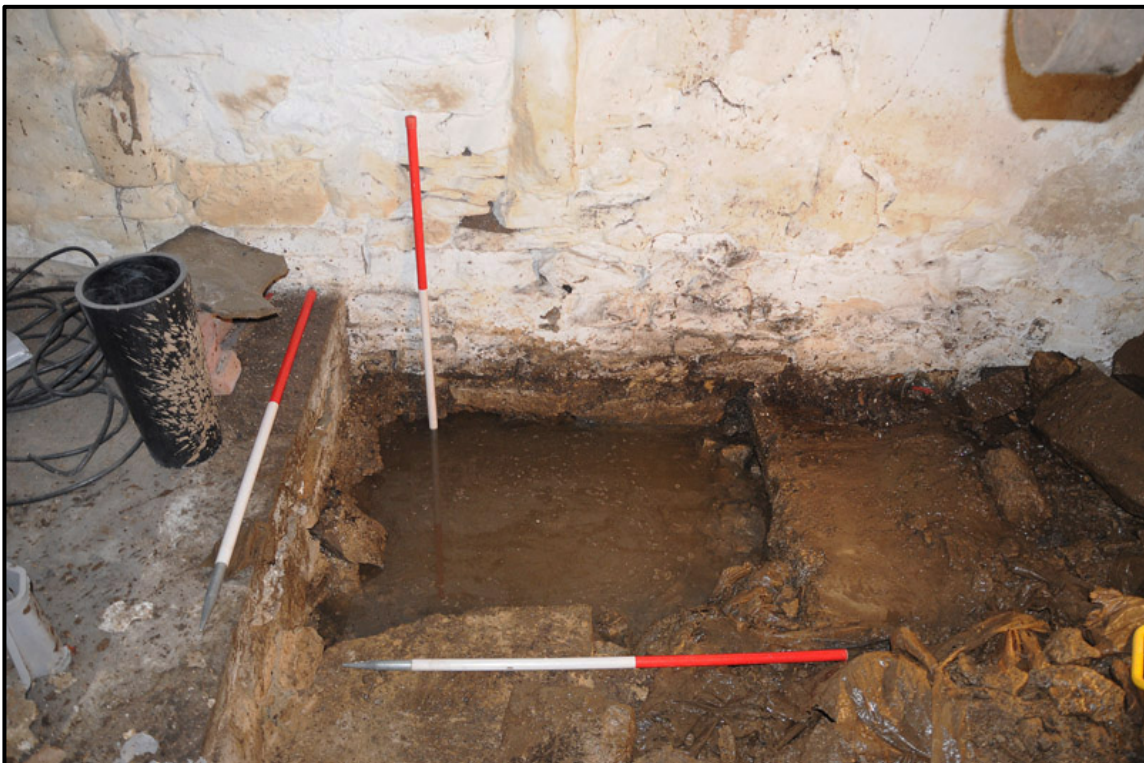
Appendix 3.2: General view of Trial Hole 1 after excavation, looking east (1m scale).

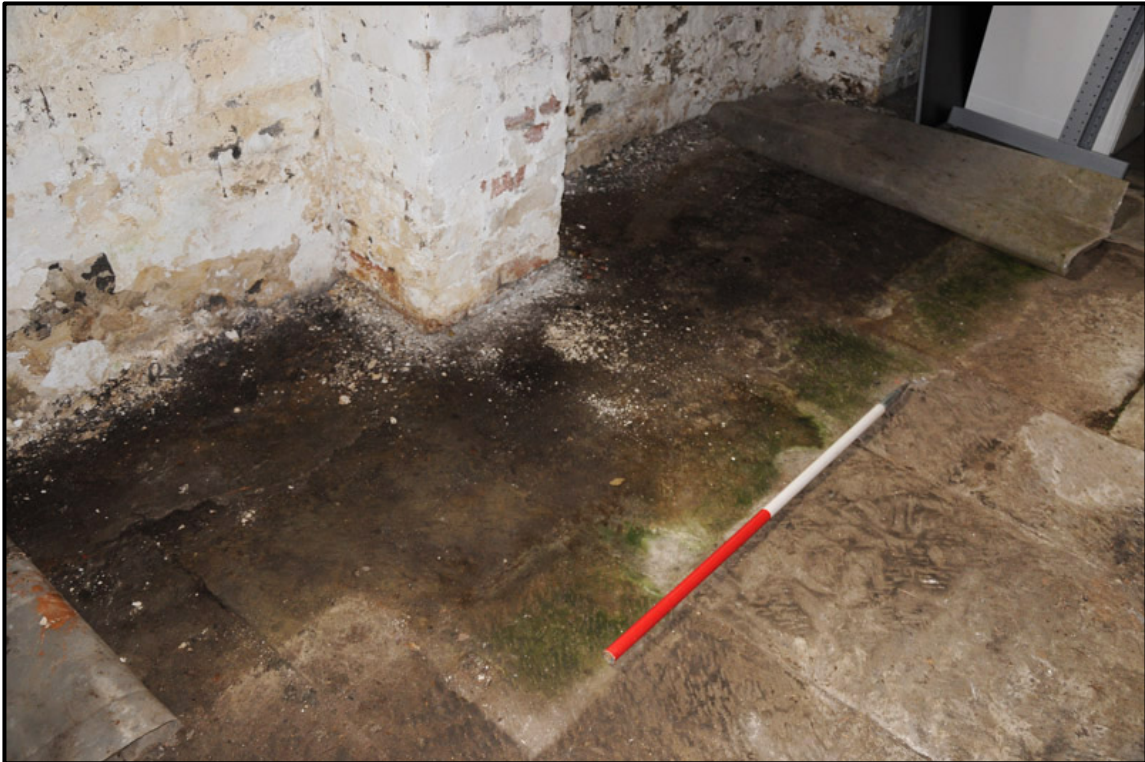
Appendix 3.3: General view of Trial Hole 2 before excavation, looking northwest (1m scale).

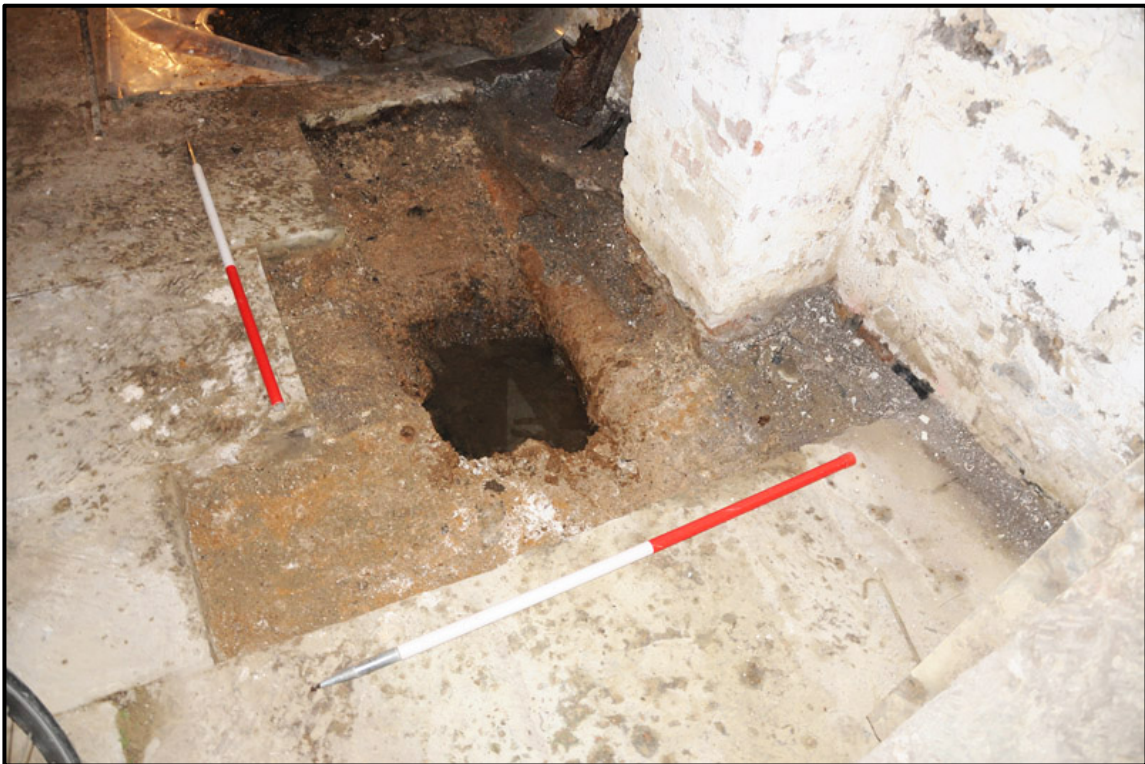
Appendix 3.4: General view of Trial Hole 2 after excavation looking south; note ceramic pipe (1m scale).

No natural ground was encountered in the base of the trial hole (**Appendix 3.4**).

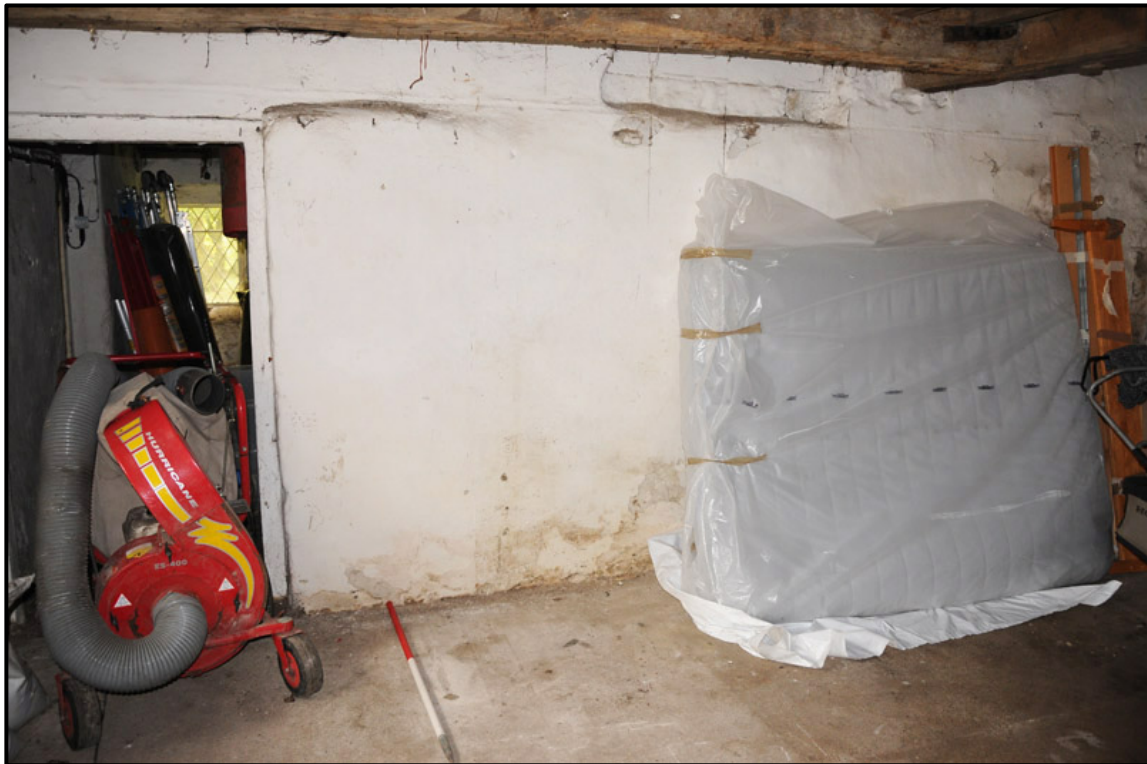
Appendix 3.5: General view of Trial Hole 3 before excavation, looking east (1m scale).

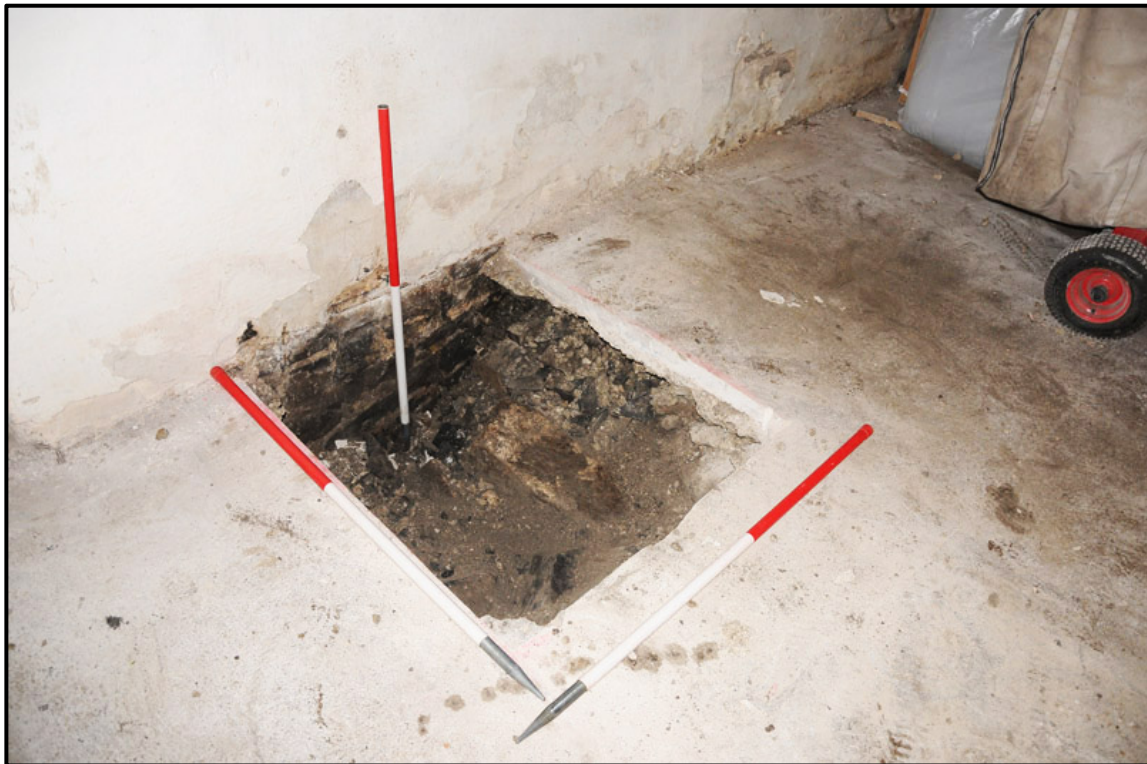
Appendix 3.6: Trial Hole 3 after excavation looking southeast; note wall face continues downwards (1m scale).

No natural ground was encountered in the base of the trial hole.
