Heathcote, Ilkley, West yorkshire

Historic Building and Photographic Survey

The JESSOP Consultancy and ArchHeritage
February 2016

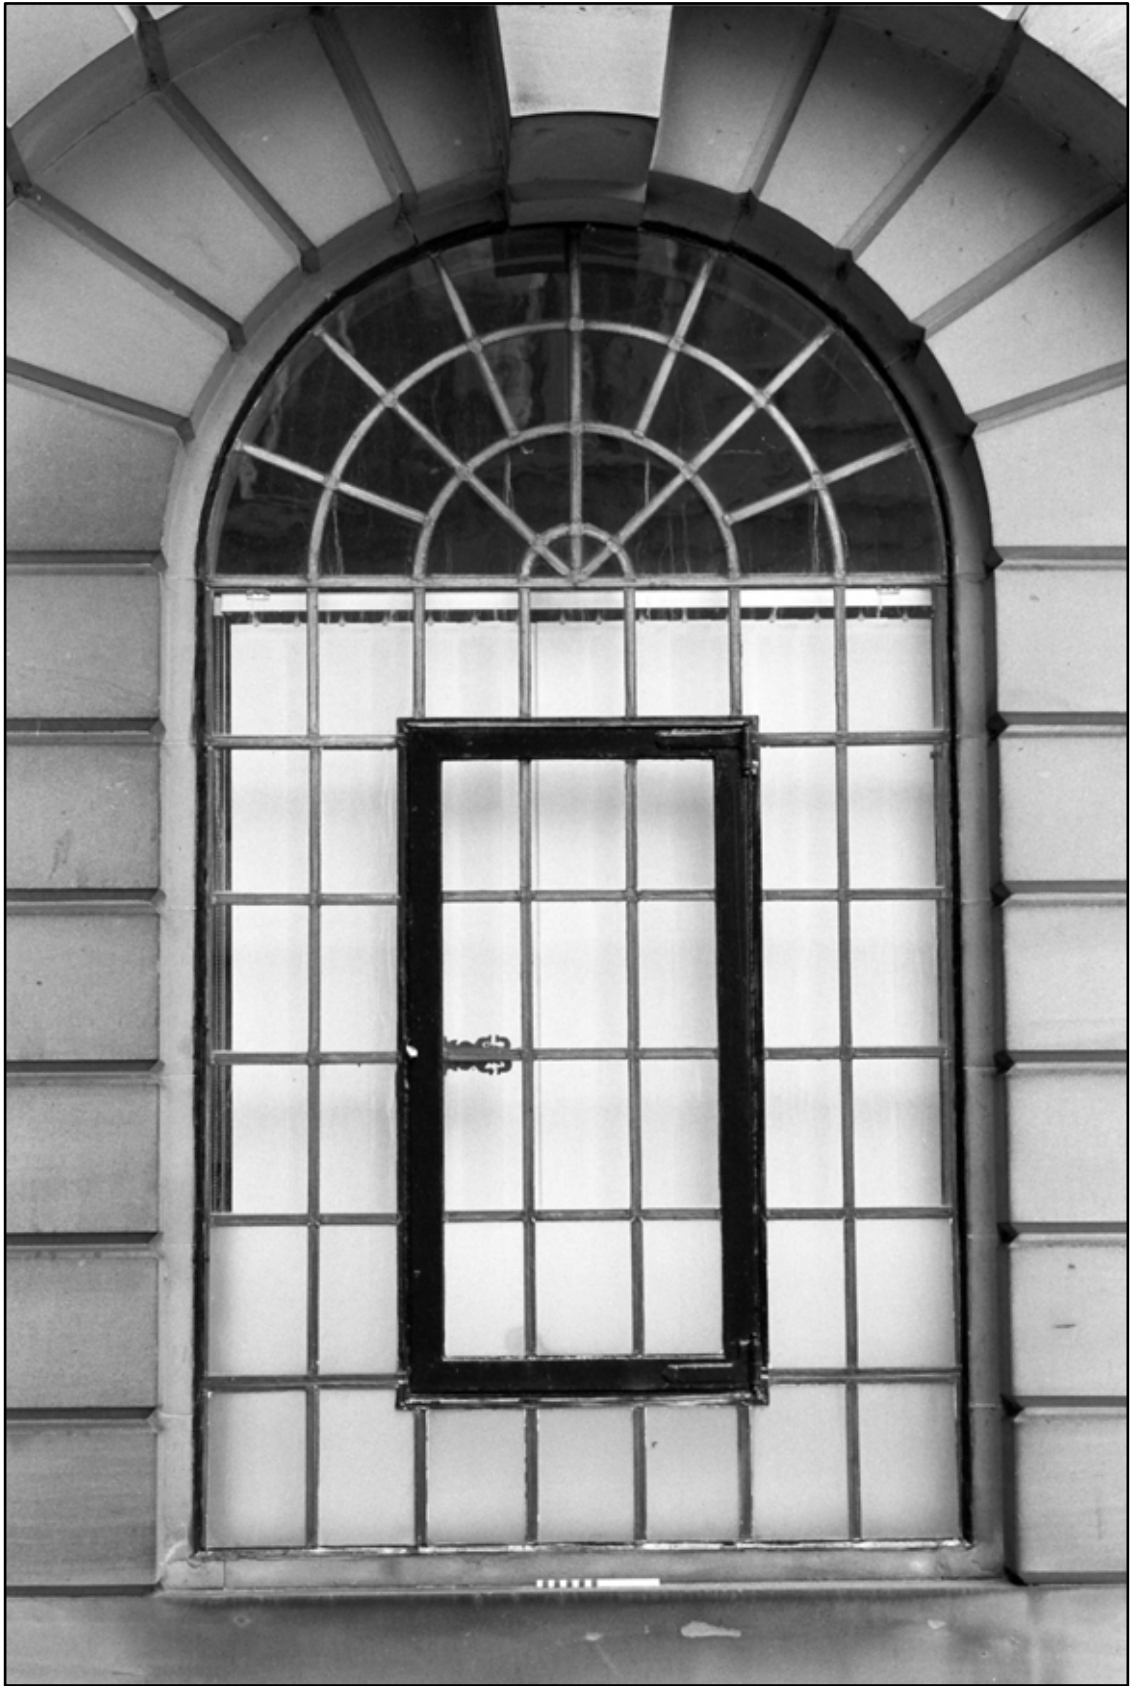
Appendix 5.54: Detail of window in north elevation of house (20cm scale) (Film 32.09)

The north, main entrance elevation (Appendix 5.51) has ashlar quoining to the three-storey central block and the projecting two-storey pavilions with banded rustication on the ground floor. Between the ground and first floors (Appendix 5.47) is a moulded, ashlar band with blind panels. The eaves level of the two-storey pavilions is continued across the front of the central block with a shallow roof of pitched pantiles. The ground floor of the central block has three round-headed, blind arches with stepped voussoirs and giant keystones, and the single return bays of the pavilions have similar arches (Appendix 5.54).

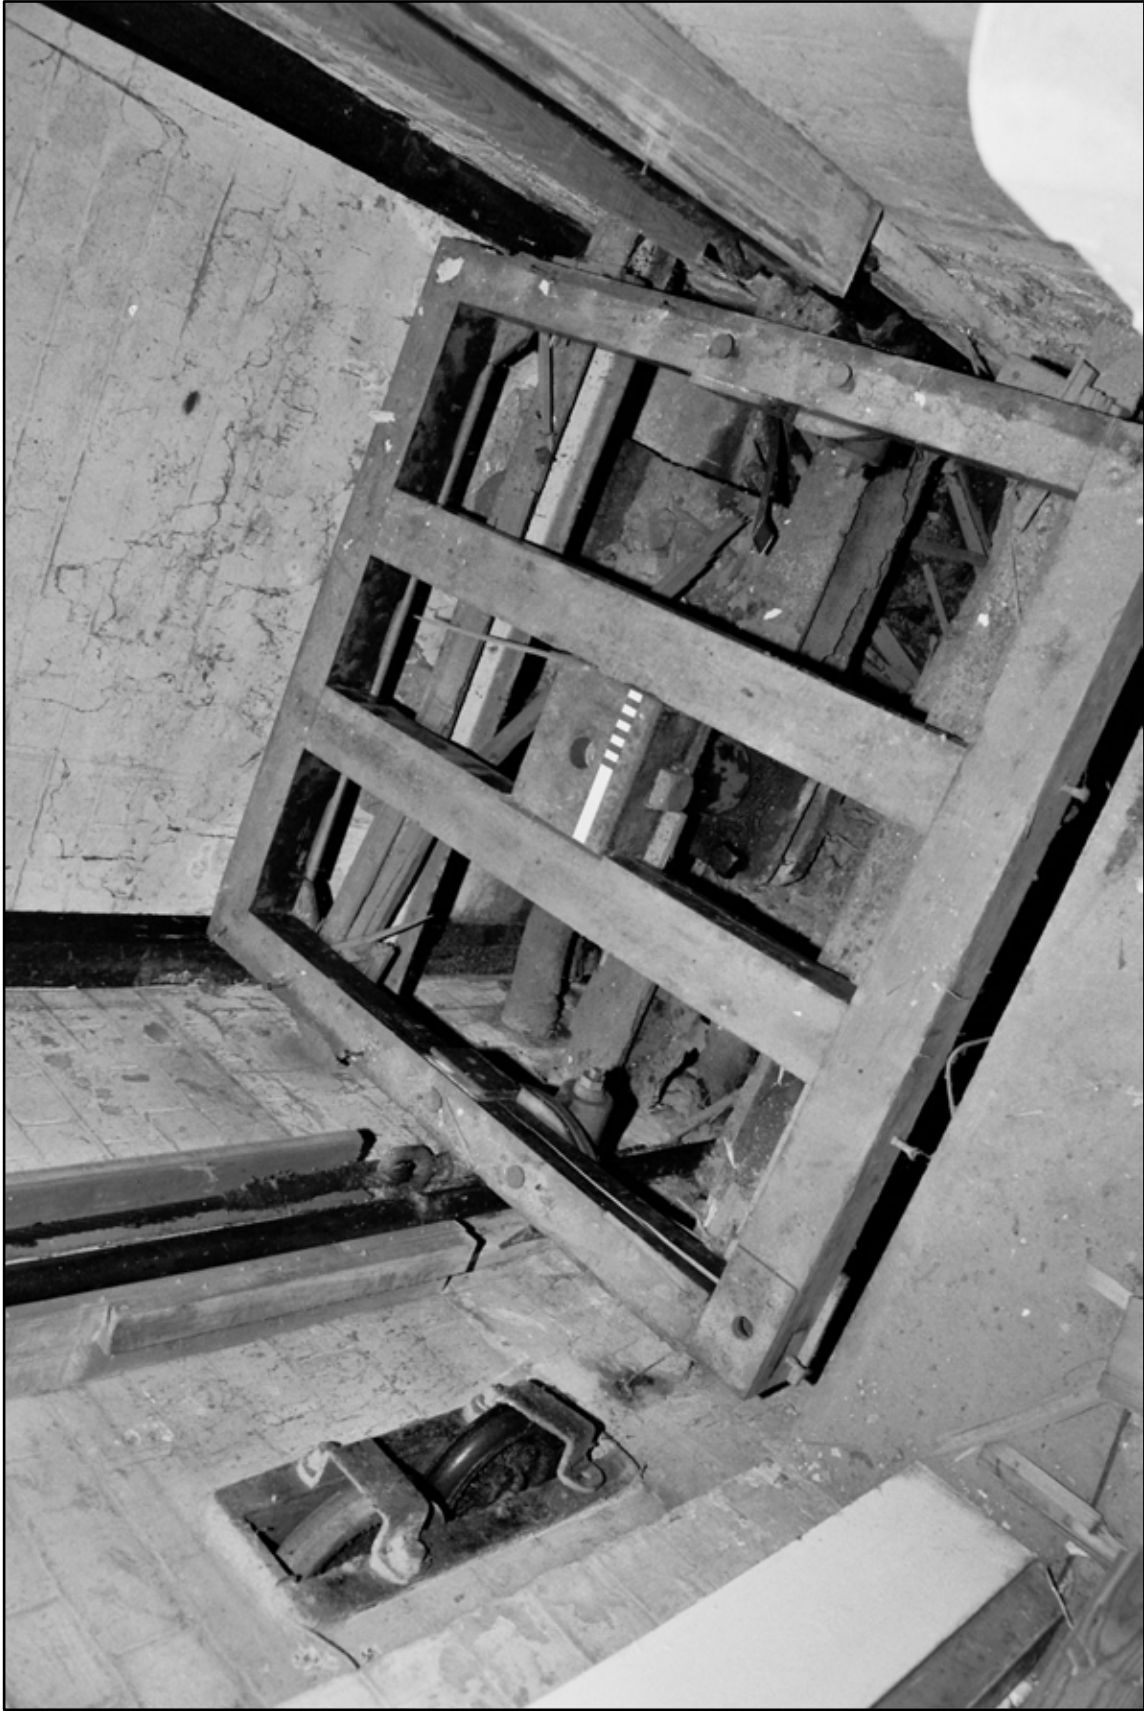
Appendix 5.108: Detail of remains of lift car in basement (20cm scale) (Film 33.34)

33.33		B9	Detail of base of lift shaft	20cm	NE	28.05.15
33.34	5.108	B8	Detail of hydraulic machinery	20cm	SE	28.05.15
33.35	5.105	B8	Detail of H.FROST'S water meter		E	28.05.15

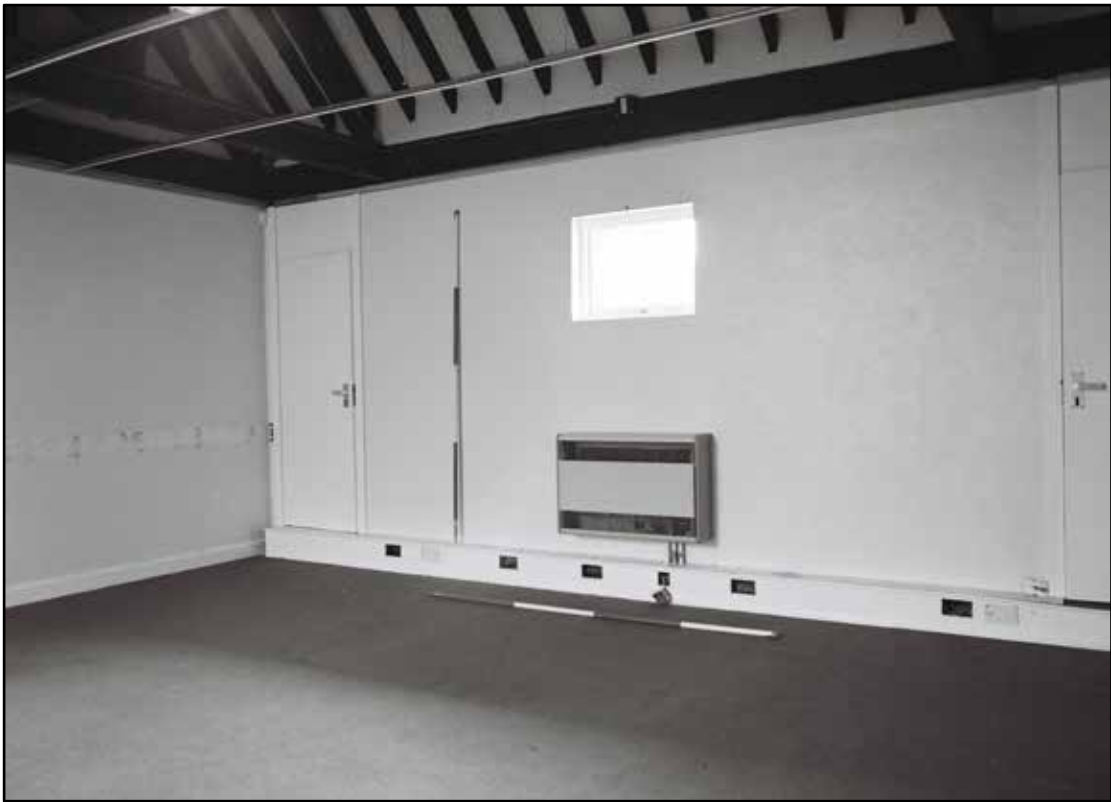
Appendix 5.216: General view of S5, looking south; note high level window (2m scale) (Film 12.04)

Along the south side of S9 were three rooms, two of which remain largely intact. The large square central room S5 (Appendix 5.217) appears to have been used as a box-room. It has a single high level window (Appendix 5.216), but has an exposed and fake timber framed roof (Appendix 5.215), which comprised of staining the roof timbers black to imitate a closely-spaced common rafter structure with king-post trusses and side purlins. Access into S5 was via an inserted stair from the north wall, although this appears to have replaced an original door in the northwest corner (see Figure 5). The floor of S5 is c.1m above the level of the central corridor S9 and the 1920s floor plan illustrates a set of double opening doors in the location of the existing glazed doorway. This detail is likely to represent a waist level hatch, which opened level with the floor of S5, thus strengthening the possibility that this room was principally intended for storage as it was unheated and poorly lit.
