# BOILER HOUSE WALL: WINDING ENGINE HOUSE, MIDDLETON TOP, DERBYSHIRE

## Archaeological Building Survey

October 2016

Document No: TJC2016.40  
Planning Application No: n/a  
OASIS No: thejessop-263195

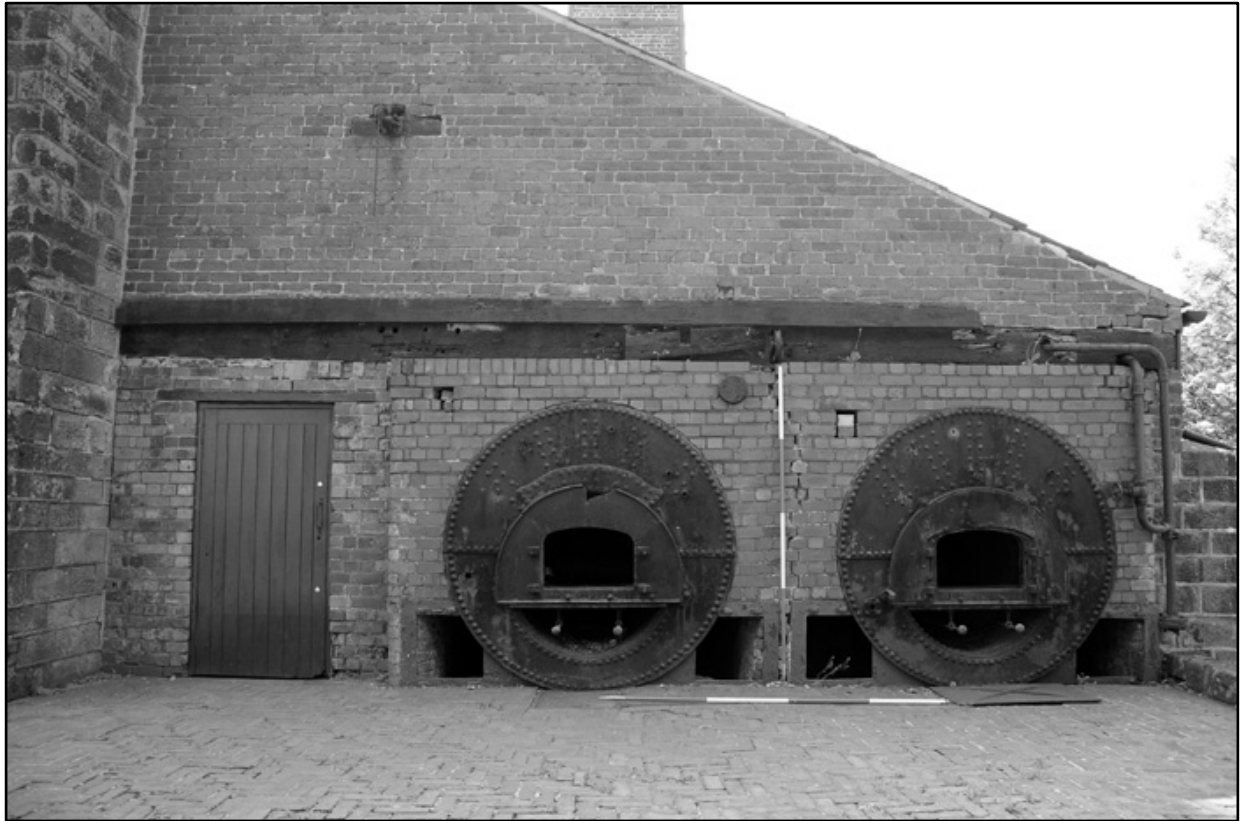
Between the boilers is a section of brickwork that has a central crack 1.2cm in width (**Appendix 2.8**). This brickwork is made from alternative courses of headers and stretchers, with bricks that measure 22-23cm x 10.65cm x 7cm. This brickwork is built up to the underside of the horizontal lintel and stands proud of the upper wall face by c.10cm (see **Appendix 2.12**), indicating that it is a later insertion. This is further confirmed by two staggered vertical joints at either end of the brickwork, where bricks with rounded corners have been used. The walling represents the final phase of inspection of the boilers which occurred every six years, presumably c.1950s in date as the boilers were decommissioned in 1957.

Appendix 2.8: Detail of north elevation, looking south; note structural crack and timber lintel. Film 1.23.

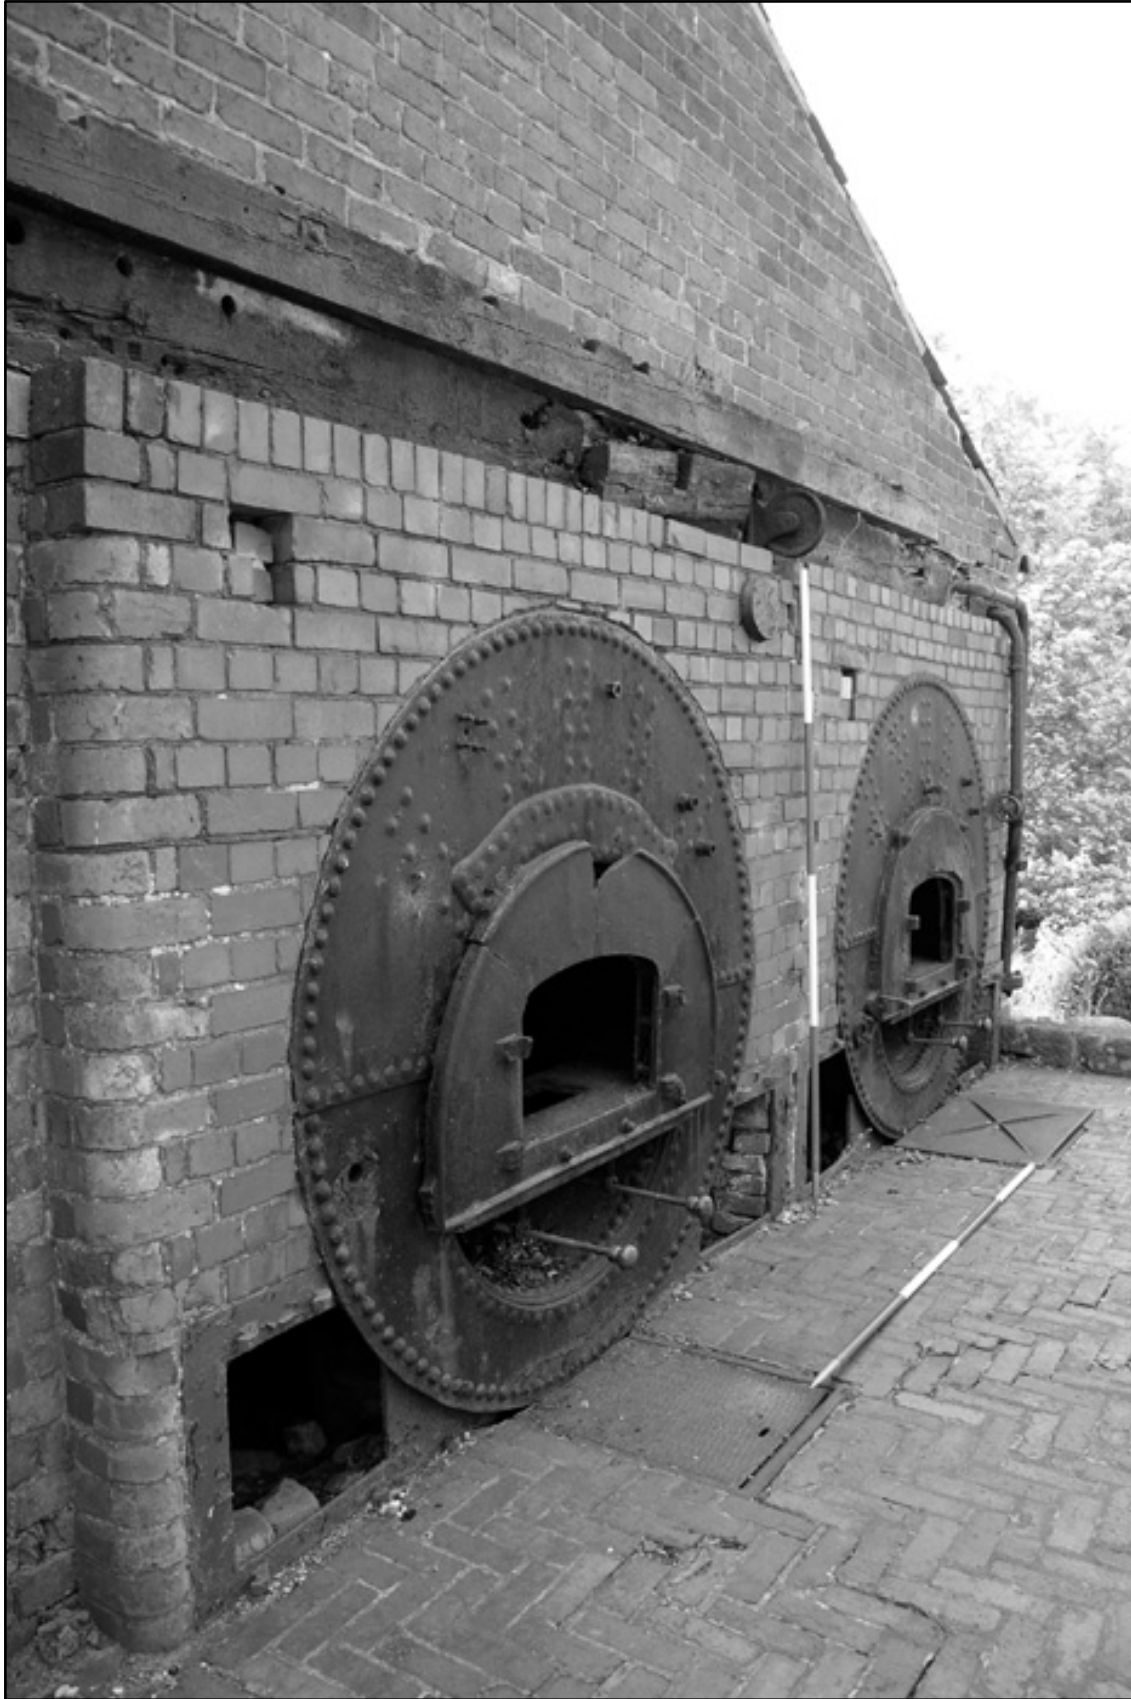
Above the horizontal lintel is a secondary timber that is directly attached to the brickwork above (**Appendix 2.10**). This timber is secured with large nails driven into the mortar joints. The upper edge of the timber (**Appendix 2.13**) has a series of irregularly spaced empty mortices, which are interpreted as once housing angled timbers forming rafters to support a lean-to roof (see **Appendix 1.9**). Between the mortices are projecting nails that would have supported a corrugated metal roof.

The upper brick walling is supported upon a long horizontal timber lintel, which effectively formed a large self supported opening above the two boilers (**Appendix 2.10**). This was necessary to allow for the periodic (every six years) inspection of the boilers for repair and maintenance. The opening was then bricked up, which may explain the large structural crack within this brickwork as it was never intended to last for a significant length of time.

Appendix 2.10: Detail of north elevation, looking southwest; note boilers with brick walling (2m scale). Film 1.27.

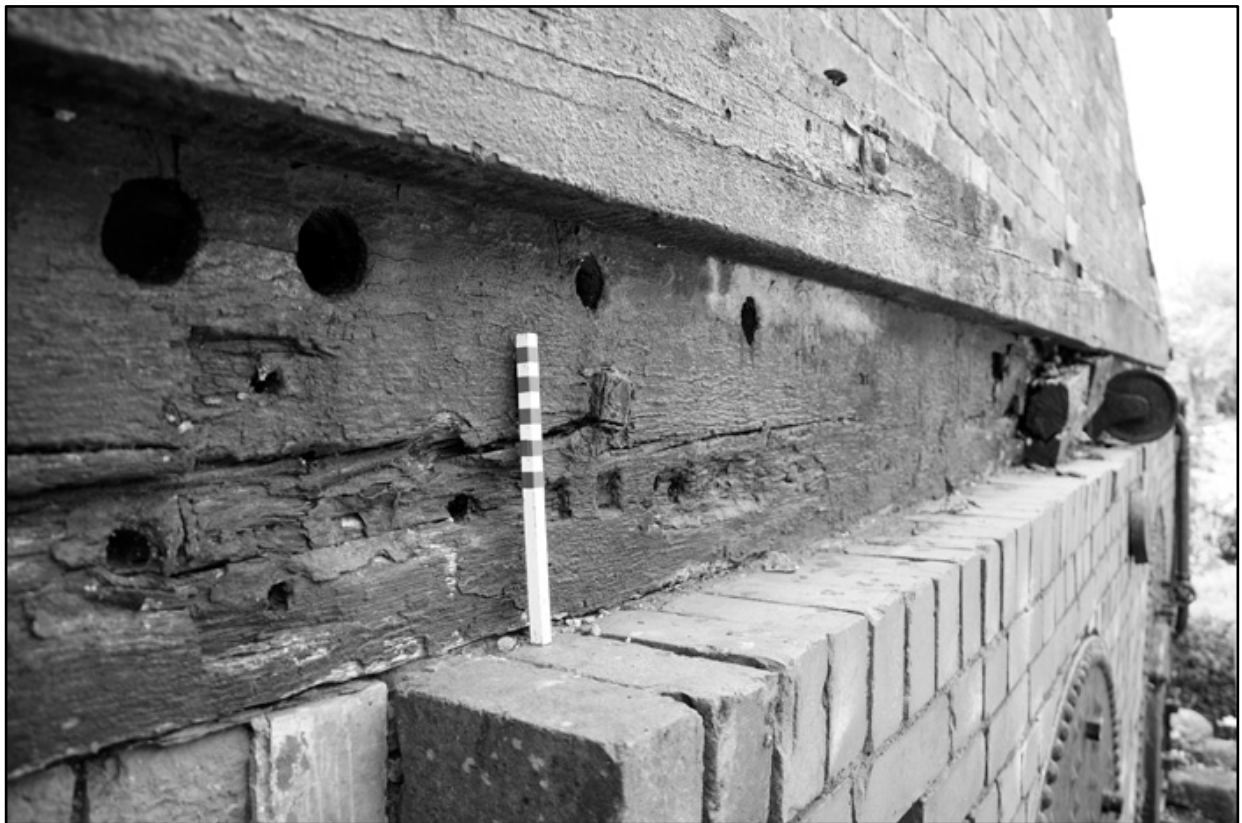
Within the external face of the horizontal lintel are numerous compression scars from bolts, brackets, holes and fixings that have largely been removed (**Appendix 2.12**), but presumably once associated with external pipes and attachments necessary to operate the boilers. At the east end of the elevation two metal steam pipes are attached to the exterior (**Appendix 2.8**), however they have been sealed off. The pipework has been crudely inserted through the horizontal lintel and it is suggested that they are a later addition, most likely being associated with the external stationary locomotive engine that was installed in 1957 following the decommissioning of the boilers. These pipes continue along the internal face of the boiler house and would have powered the winding engine during the final years of the operation of the railway.

Appendix 2.12: Detail of timber beam along north elevation; note compression scars and bolt holes (20cm scale). Film 1.30.

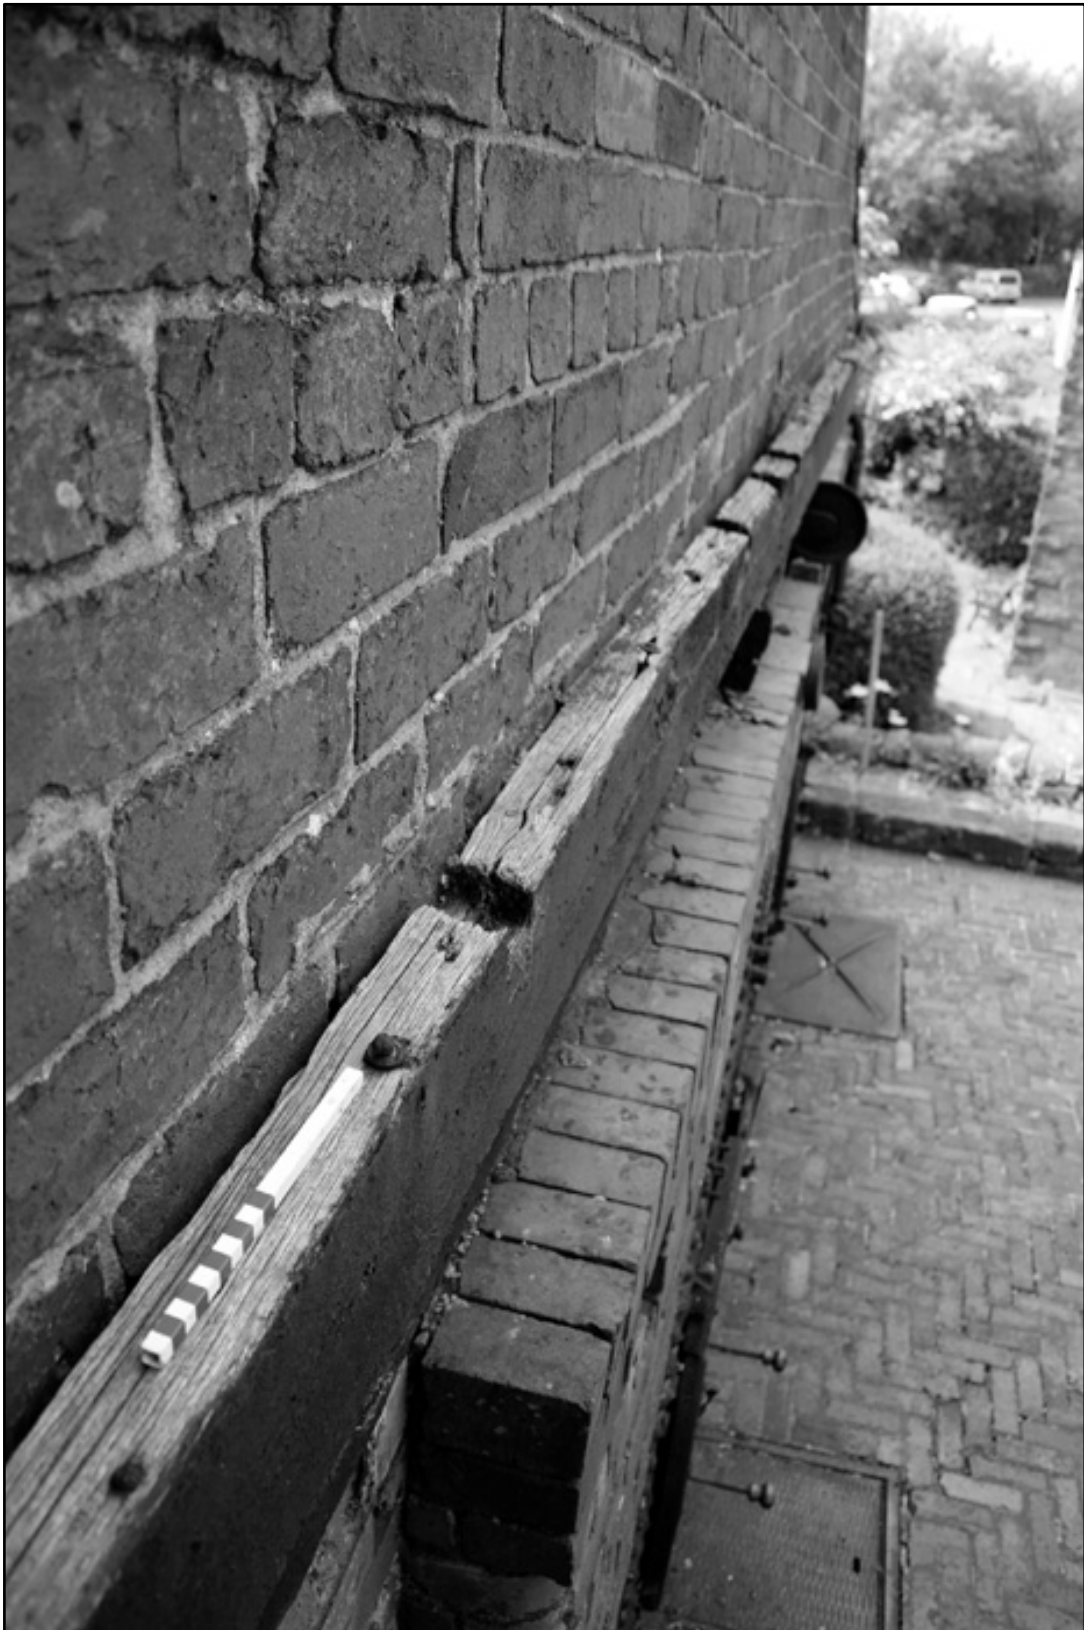
Appendix 2.13: Detail of timber beam along north elevation from above; note empty slots for roof joists (20cm scale). Film I.29.

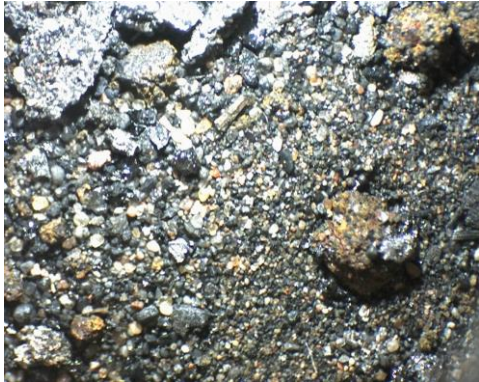
<p><b>Summary of Results and Comments:</b></p>	<p><b>The aggregate:</b> is a fine - medium grained black-brown iron slag material with up to 40% white/milky/clear mostly rounded/sub rounded quartz grains:</p>

<p style="text-align: center;"><b>Aggregate, mag. x 10</b></p> <p><b>The binder:</b> is an O.P.C. (Portland cement), with extra strength offered by the blast furnace iron slag material, which has a pozzolanic reaction with the free lime in the cement.</p> <p><b>The mortar:</b> The black-grey colour of the mortar is a result of the black-grey coloured aggregate.</p> <p><b>The Mix Ratio by Volume:</b> is 2.36 : 1 (aggregate : Binder).</p> <p><b>Replication Mix:</b></p>

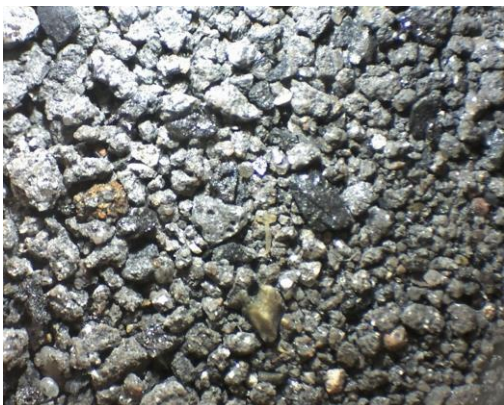
<p><b>Summary of Results and Comments:</b></p>	<p><b>The aggregate:</b> is a fine - medium grained black-brown iron slag material similar to that in sample 1, but with negligible off-white ash material and less white/milky/clear mostly rounded/sub rounded quartz grains (20 – 30%).</p>

<p style="text-align: center;"><b>Aggregate, mag. x 10</b></p> <p><b>The binder:</b> is an O.P.C. (Portland cement), with extra strength offered by the blast furnace iron slag material, which has a pozzolanic reaction with the free lime in the cement.</p> <p><b>The mortar:</b> The black-grey colour of the mortar is a result of the black-grey coloured aggregate.</p> <p><b>The Mix Ratio by Volume:</b> is 1.75 : 1 (aggregate : Binder).</p> <p><b>Replication Mix:</b></p>

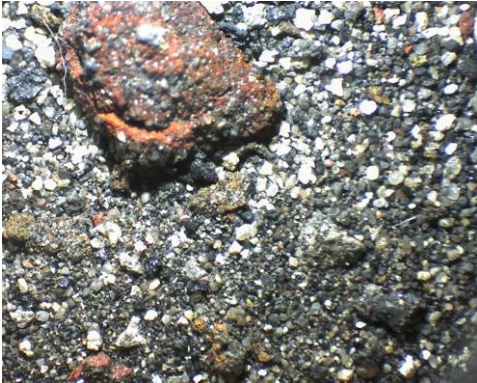
<p><b>Summary of Results and Comments:</b></p>	<p><b>The aggregate:</b> is an iron slag material consisting of black-grey coke, black-brown iron oxides (some magnetite with black metallic lustre), sub rounded white/milky clear quartz grains + ,unlike in samples 1 and 2, up to 50% off-white/reddish purple ash material:</p>

<p style="text-align: center;"><b>Aggregate, mag. x 10</b></p> <p><b>The binder:</b> is an O.P.C. (Portland cement), with extra strength offered by the blast furnace iron slag material, which has a pozzolanic reaction with the free lime in the cement.</p> <p><b>The mortar:</b> The black-grey colour of the mortar is a result of the black-grey coloured aggregate.</p> <p><b>The Mix Ratio by Volume:</b> is 1.86 : 1 (aggregate : Binder).</p> <p><b>Replication Mix:</b></p>

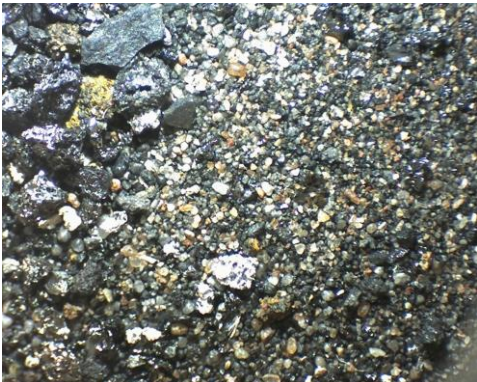
<p><b>Summary of Results and Comments:</b></p>	<p><b>The aggregate:</b> is a fine - medium grained black-brown iron slag material with up to 40% white/milky/clear mostly rounded/sub rounded quartz grains similar to that in samples 1 and 4:</p>

<p style="text-align: center;"><b>Aggregate, mag. x 10</b></p> <p><b>The binder:</b> is an O.P.C. (Portland cement), with extra strength offered by the blast furnace iron slag material, which has a pozzolanic reaction with the free lime in the cement.</p> <p><b>The mortar:</b> The black-grey colour of the mortar is a result of the black-grey coloured aggregate.</p> <p><b>The Mix Ratio by Volume:</b> is 1.9 : 1 (aggregate : Binder).</p> <p><b>Replication Mix:</b></p>

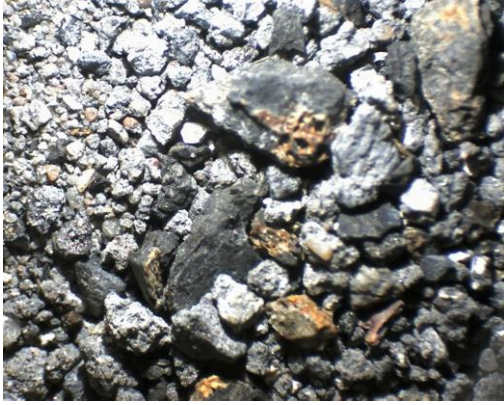
<p><b>Summary of Results and Comments:</b></p>	<p><b>The aggregate:</b> is a fine - medium grained black-brown iron slag material with up to 40% white/milky/clear mostly rounded/sub rounded quartz grains, similar to that in samples 1, 4 and 7:</p>

<p style="text-align: center;"><b>Aggregate, mag. x 10</b></p> <p><b>The binder:</b> is an O.P.C. (Portland cement), with extra strength offered by the blast furnace iron slag material, which has a pozzolanic reaction with the free lime in the cement.</p> <p><b>The mortar:</b> The black-grey colour of the mortar is a result of the black-grey coloured aggregate.</p> <p><b>The Mix Ratio by Volume:</b> is 2.2 : 1 (aggregate : Binder).</p> <p><b>Replication Mix:</b></p>
