# STANTON OLD HALL, CONGREAVE, STANTON IN PEAK, DERBYSHIRE

## Heritage Statement

August 2018  
Final

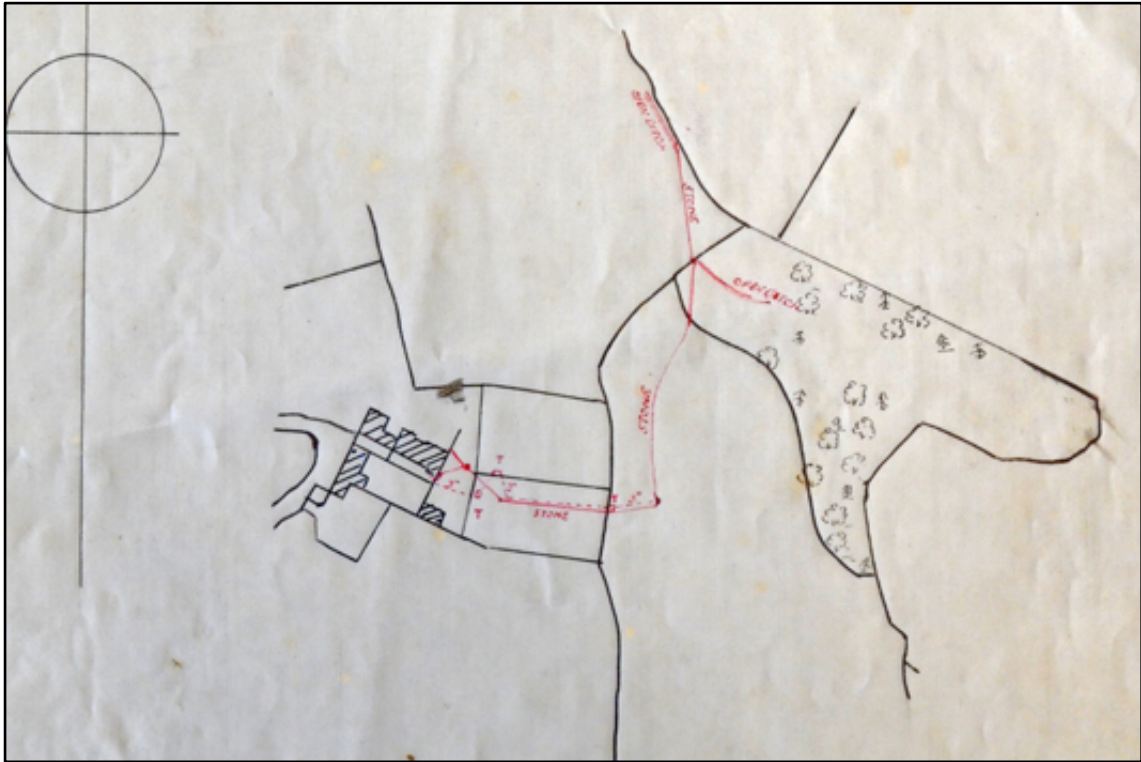
Appendix I.9 Plan of drains at Stanton Old hall, c.1937  
 © Haddon Estate. Reproduced with permission

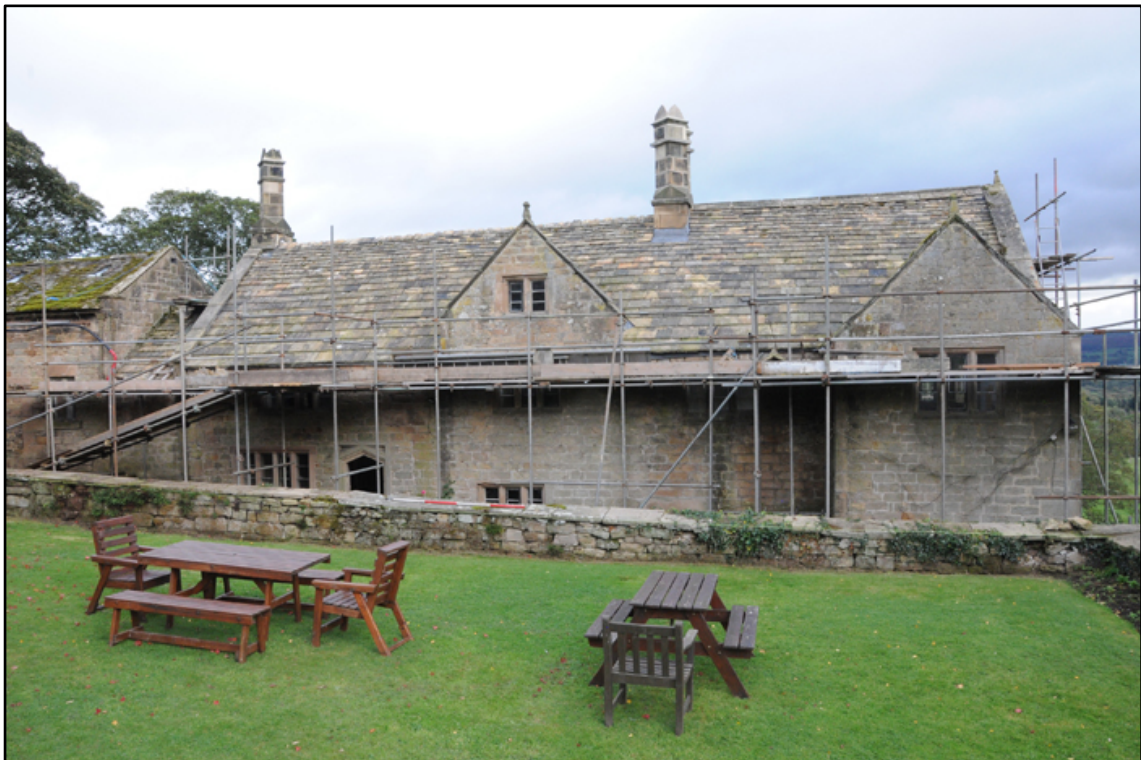
**Appendix 5.2:** General view of south elevation of Hall, looking north (2m scale)

The principle façade of the building is assumed to have been the south elevation (**Appendix 5.2**), with the main entrance door leading into **G2** (**Appendix 5.9**). The location of doorway directly in front of the central hearth and chimney stack is commonly known as a baffle entry, and lead to the south into a large room that formed the kitchen, or housebody. There is a horizontal beam slot built into the wall behind the doorway which is likely to have been used to house a security drawbar. This room was well lit with windows to the east (**Appendix 5.23**), northwest corner and in a short southern projection (**Appendix 5.21**) where a small window (now blocked see **Appendix 5.25**) originally looked up the entrance walkway to the west (**Appendix 5.5**). The floor in this room is flagged, elements of which are assumed to relate to this original phase of construction and use. There is a large chimney stack and open fronted hearth in the west wall (**Appendix 5.20**), although the large timber bressumer beam and associated walling above is interpreted as being later, dating to phase 7. In the north wall is a doorway leading into the former demolished north wing, which may have been re-set or altered in the phase 7 period of alterations (**Appendix 5.36**).

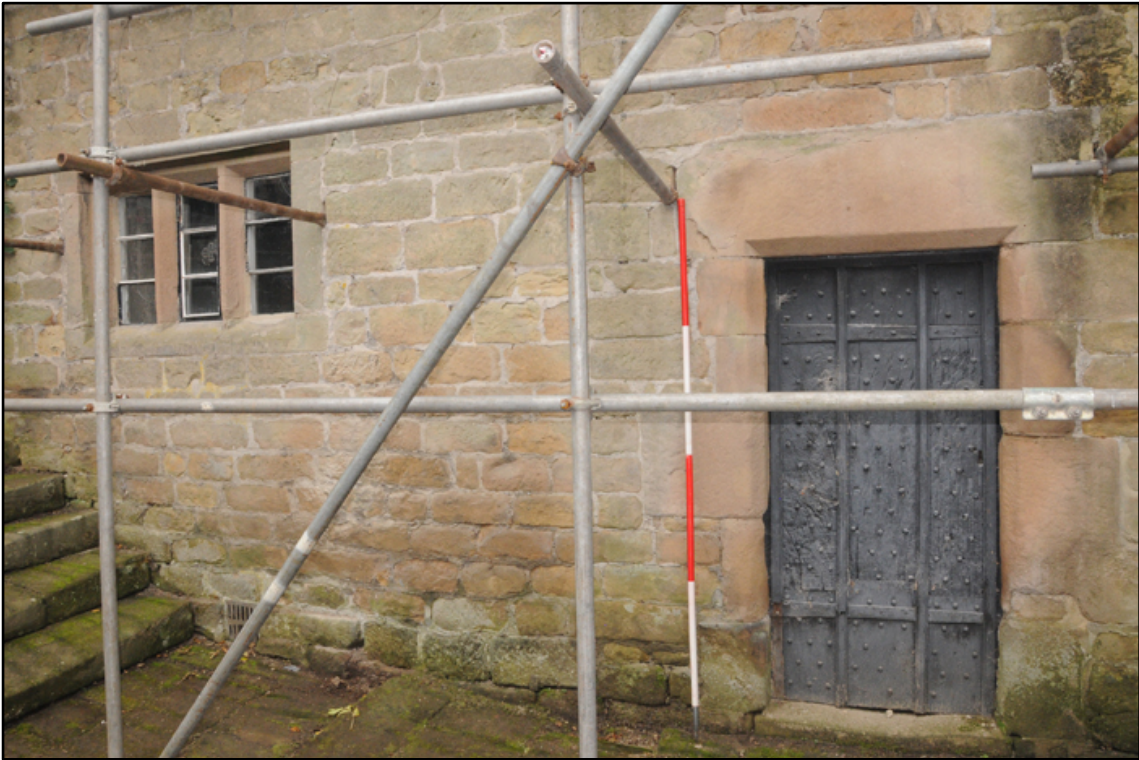
**Appendix 5.9:** Detail of doorway (phase 1) into room **G1** (2m scale)

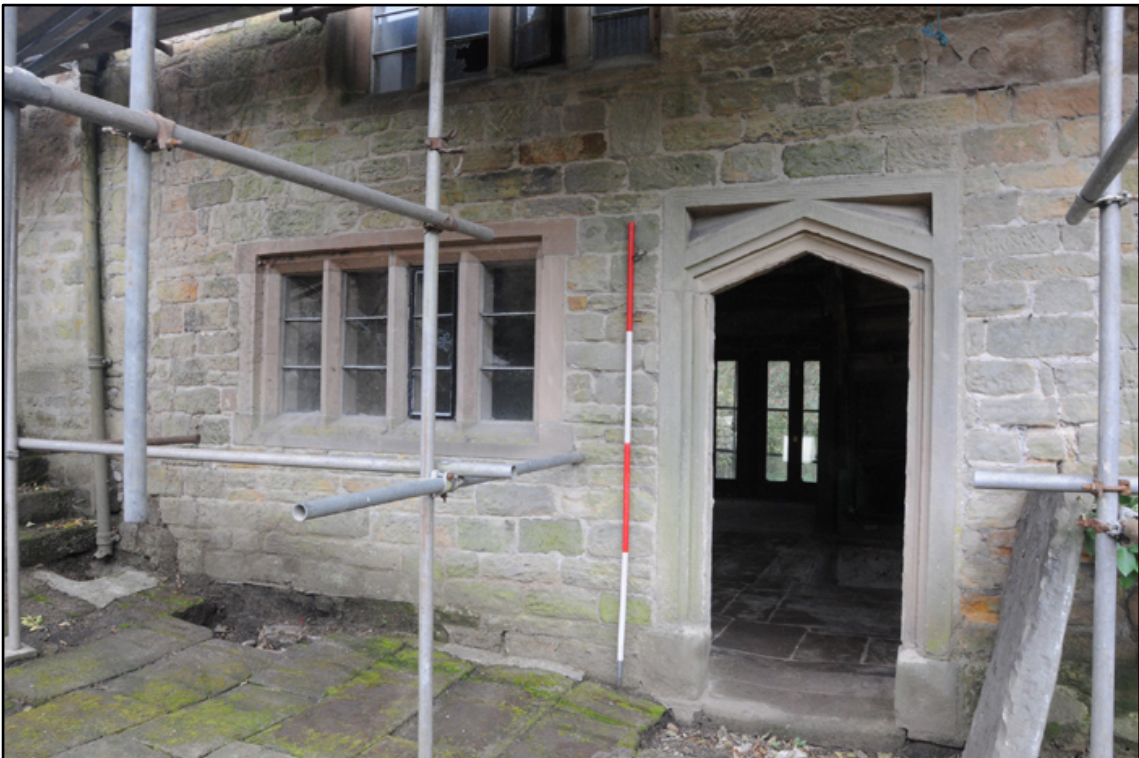
**Appendix 5.10:** Detail of inserted doorway (phase 7) into room **G3** (2m scale)

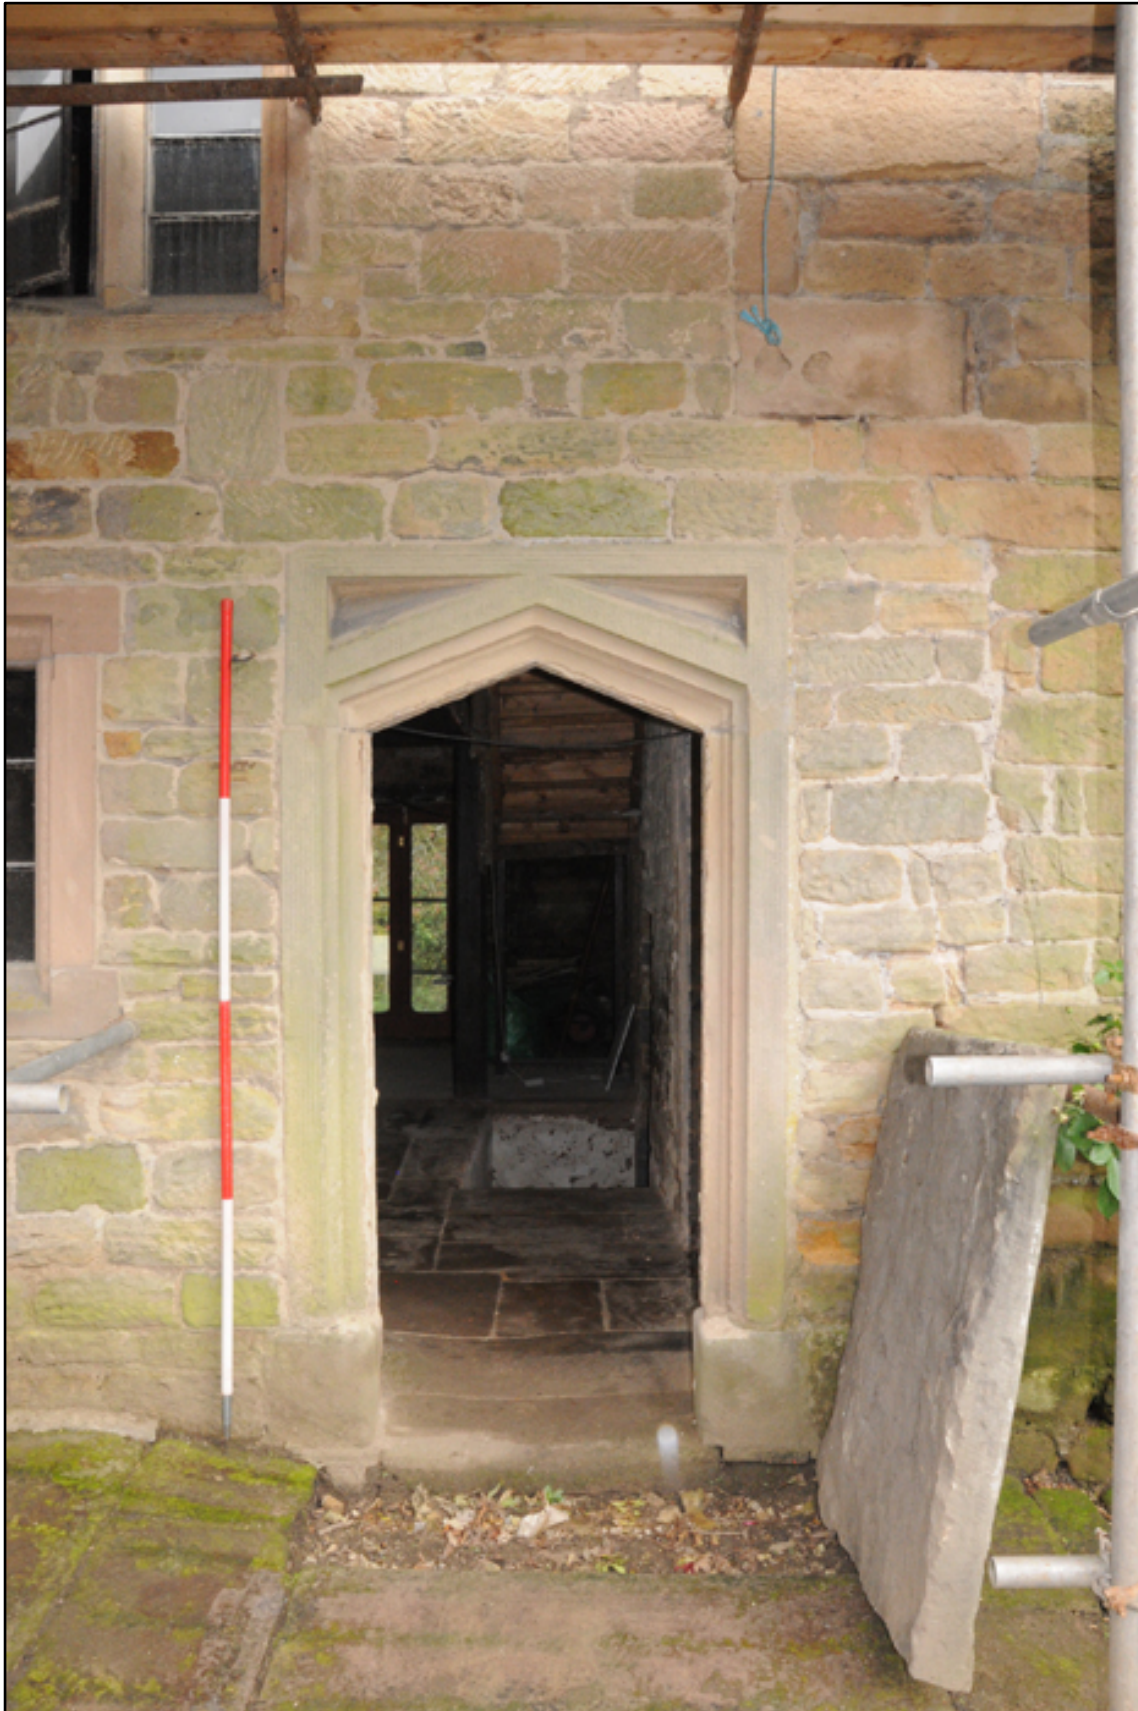
Appendix 5.11: Detail of doorway into room G1; note truncated quoins from phase I house (2m scale)

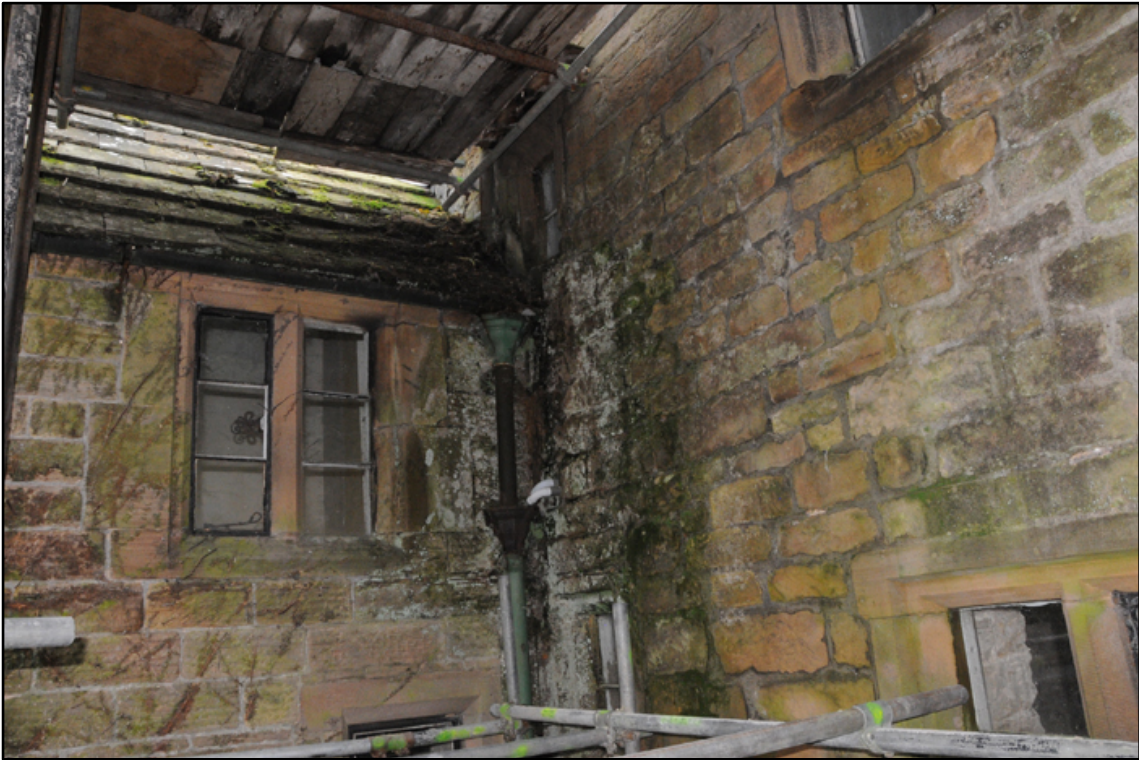
**Appendix 5.14:** Detail of external junction of F4 and F6; note change in coursing and size of window

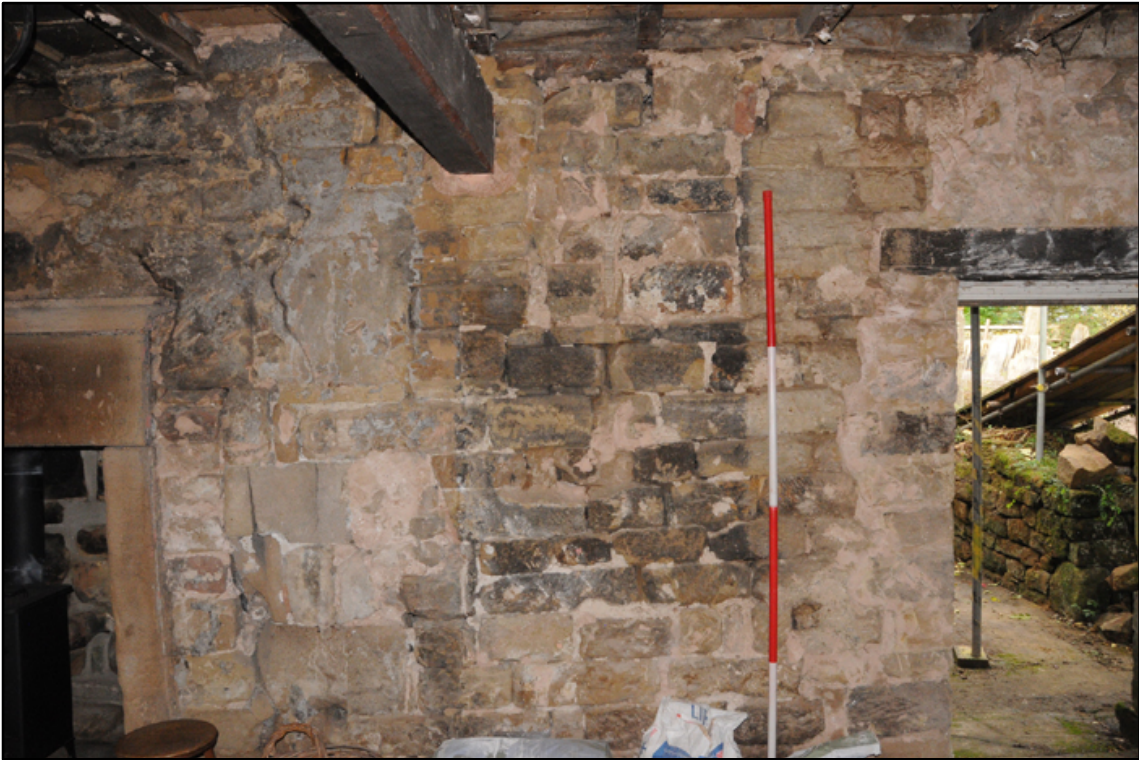
Appendix 5.30: Detail of blocked high level window in west wall of **G3** (possibly reused?); note inserted door (2m scale)

In phase 2 the hall was enlarged by the addition of a single bay extension to the west. This created a U-shaped building, which butted against the northwest corner of **G1** and was built into the southwest corner by the partial removal of the lower quoins at this location. It should be noted however, that the original access into this extension is unclear due to secondary alterations. At ground floor level in **G3** there may have been a door in the southeast corner into **G1**, evidenced by a possible door reveal in the former west gable of the phase 1 house. There was a large fireplace in the west wall and a possible oven to the southwest where a large sandstone lintel has been broken by the insertion of a modern doorway (phase 9). There are single light windows in the northeast corner and to the north of the fireplace (blocked, see **Appendix 5.30**).

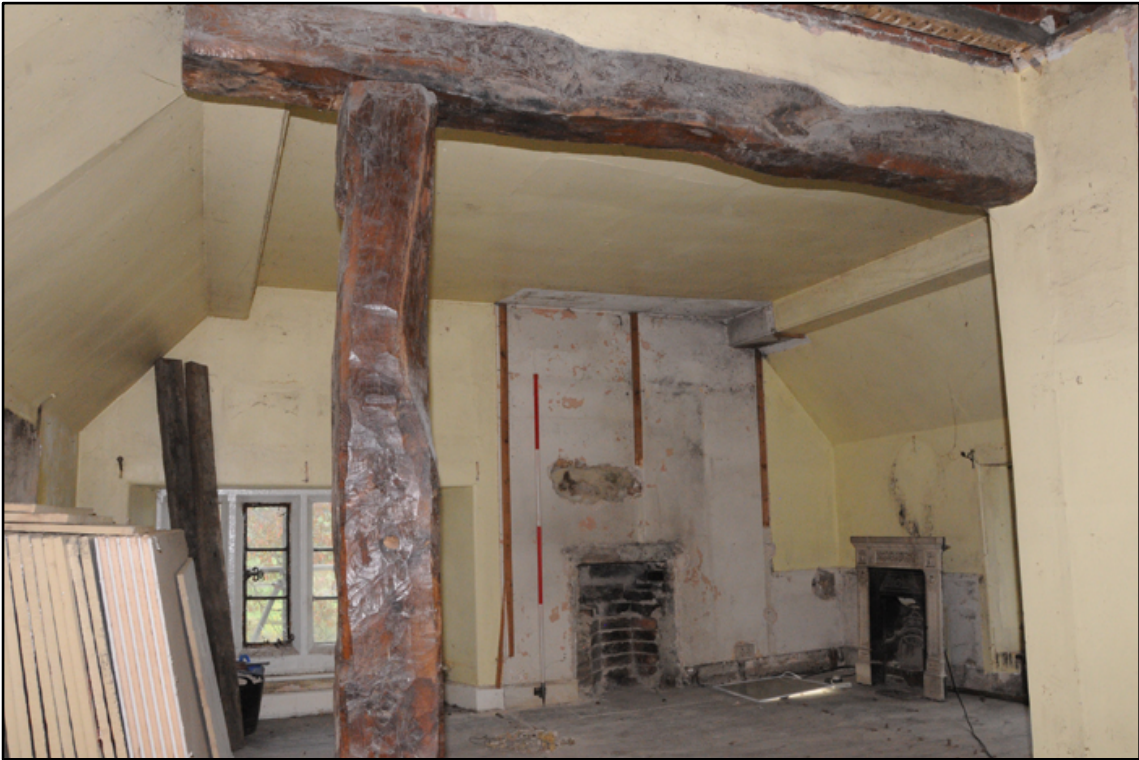
Appendix 5.44: General view of F6, looking north; note inserted timber beam (phase 7) (2m scale)

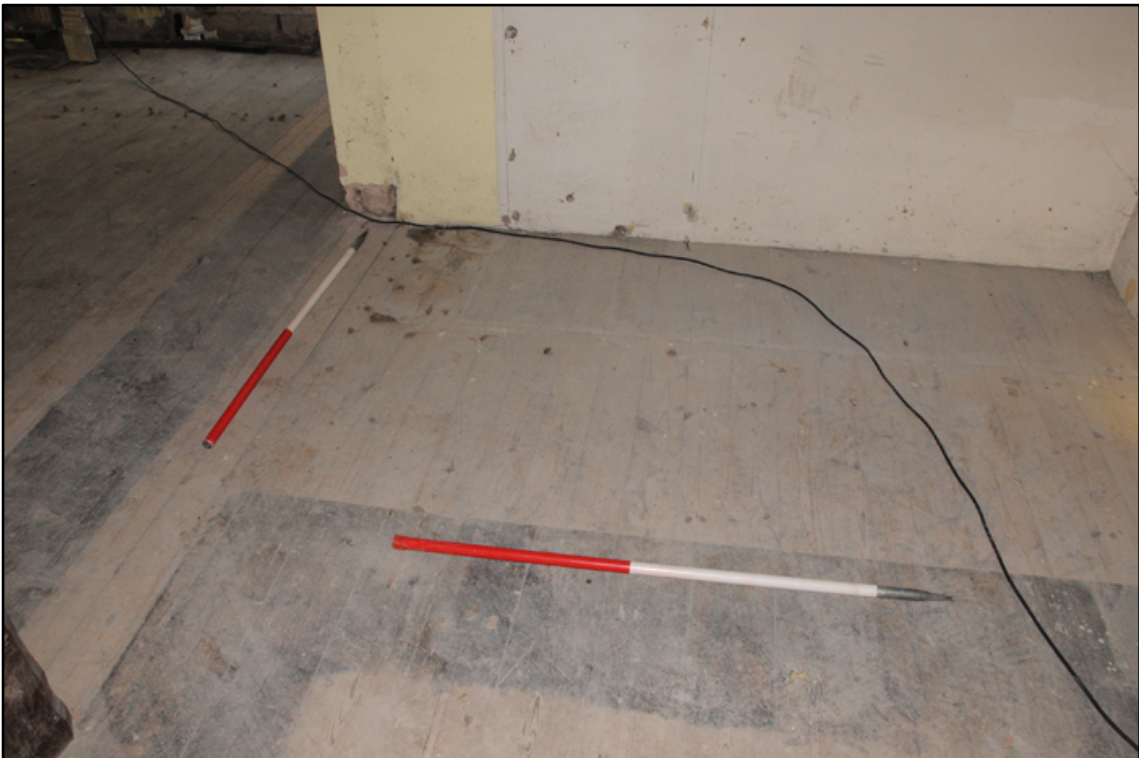
Appendix 5.45: Detail of floor staining in F6, and scar for removed (phase 9) open-well staircase (2m scale)

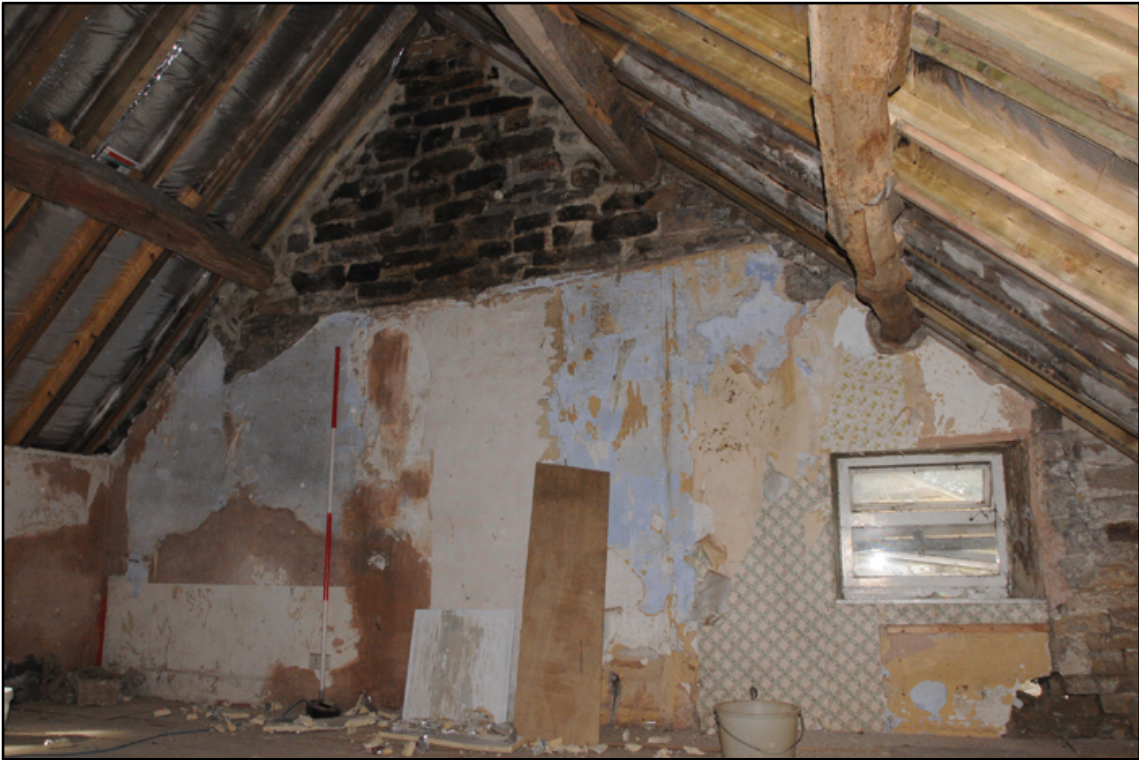
Appendix 5.48: General view of west wall of F3; note blocked doorway behind ranging pole (2m scale)

At first floor level in **F3** little evidence remains that help explain the use of the room, apart from a very high open span roof (**Appendix 5.48**) supported only by purlins and a blocked doorway in the southwest wall. There is a mullioned window in the south wall. The blocked doorway was originally accessed via an external flight of steps (removed in phase 8), which suggests that the upper floor may have always been intended for an ancillary use, perhaps for storage or as a workshop.

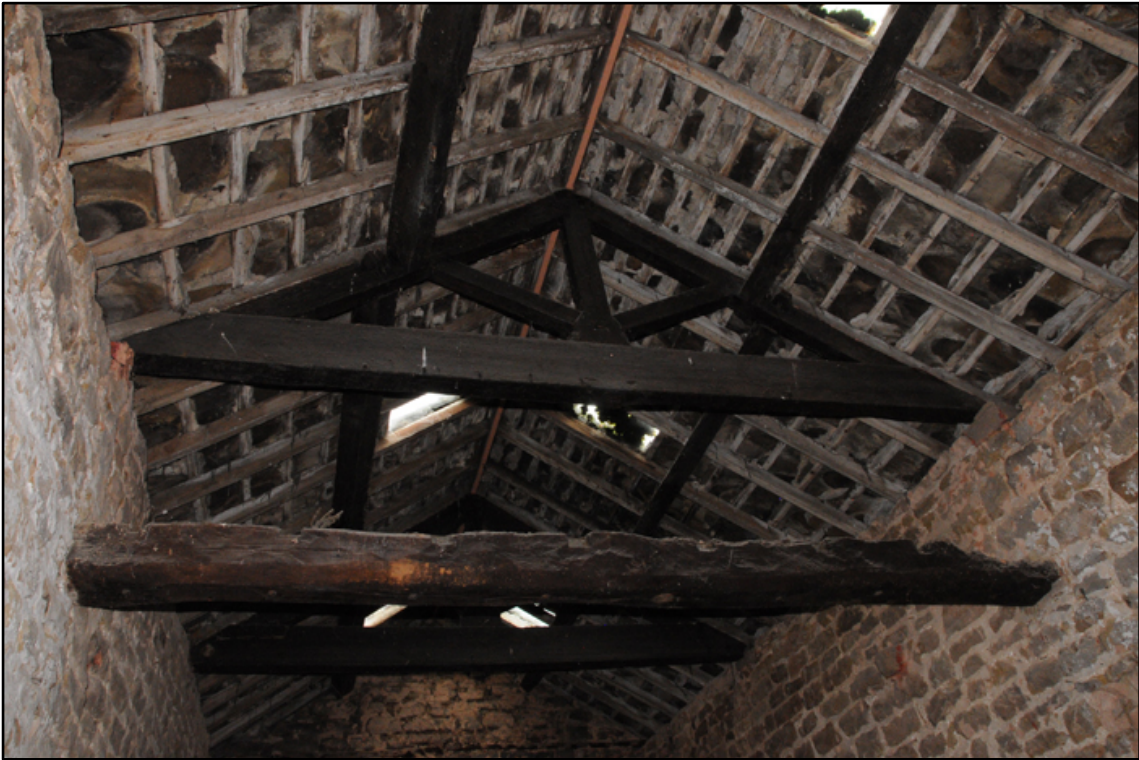
Appendix 5.62: General view inserted beam and roof trusses in F5, looking west

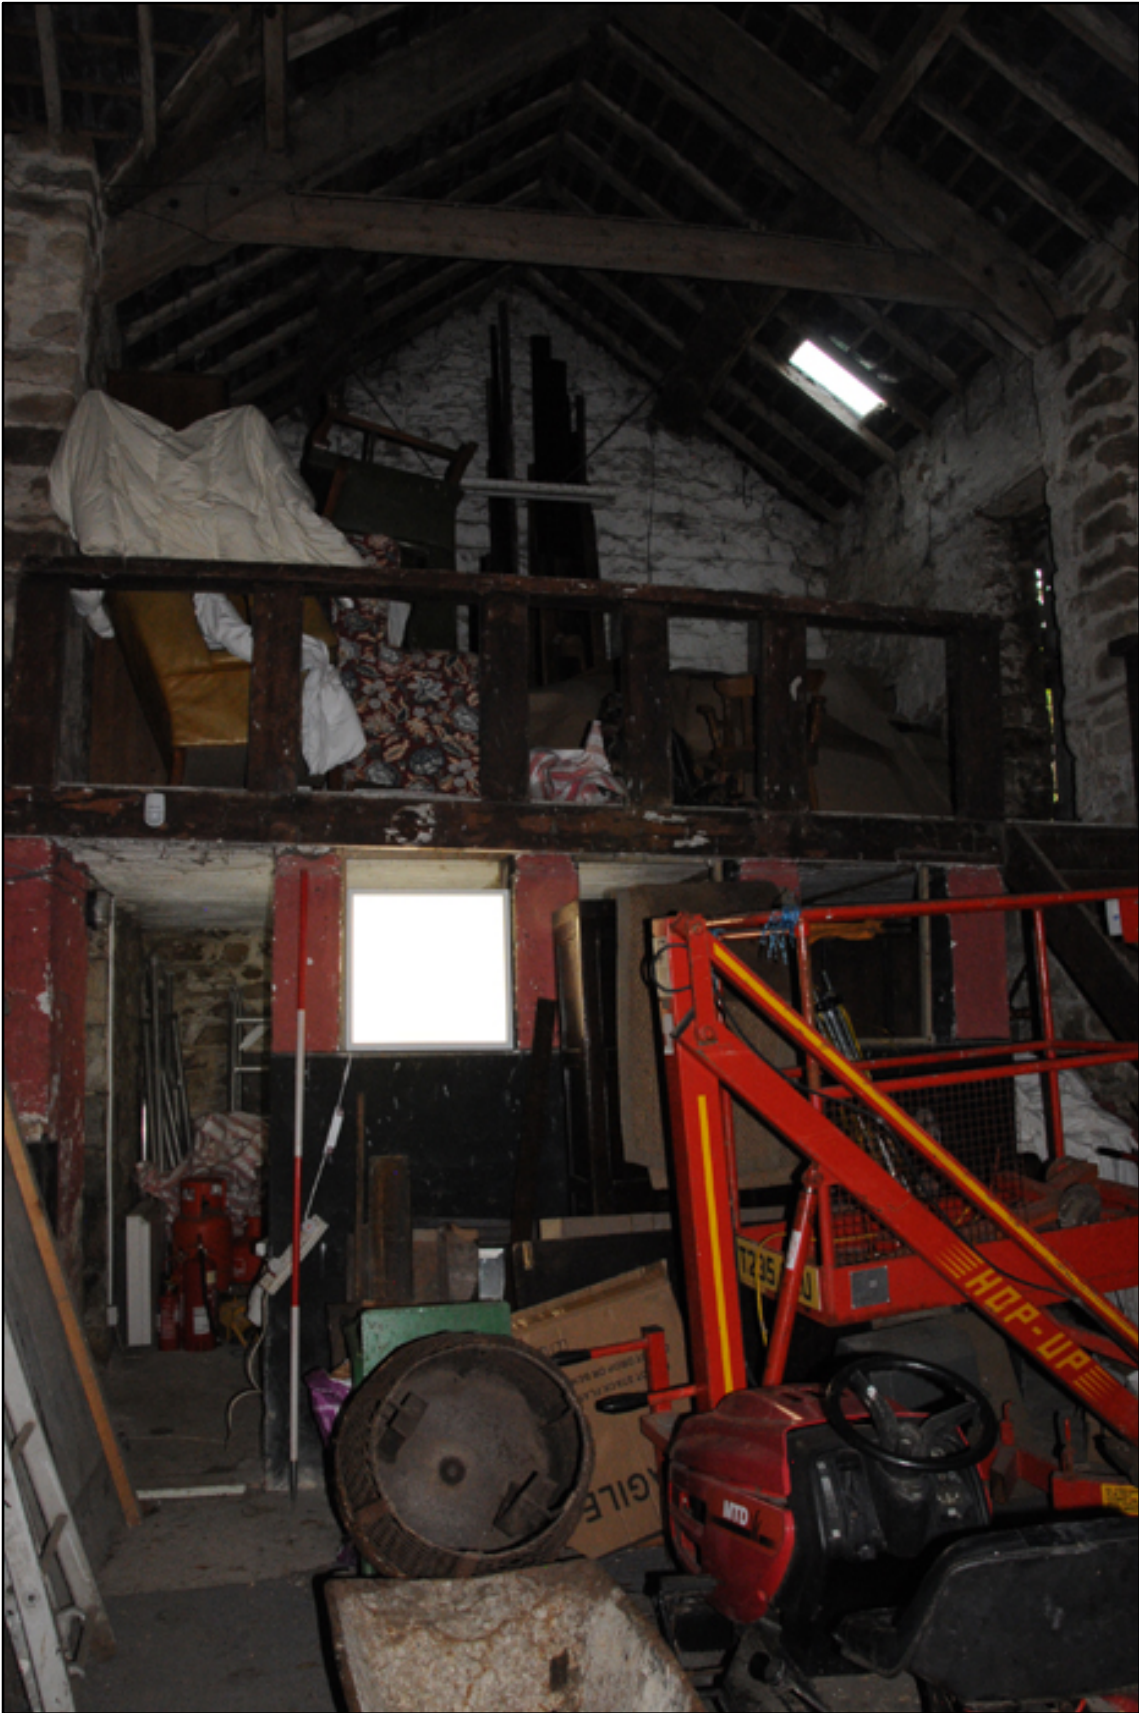
Appendix 5.74: General view of south end of T-shaped barn; note inserted concrete floor for upper level (2m scale)
