# GROVE HOUSE, 1 WHARF STREET, BAWTRY, SOUTH YORKSHIRE

## Archaeological Building Recording during structural alterations

April 2018

Document No: TJC2018.24

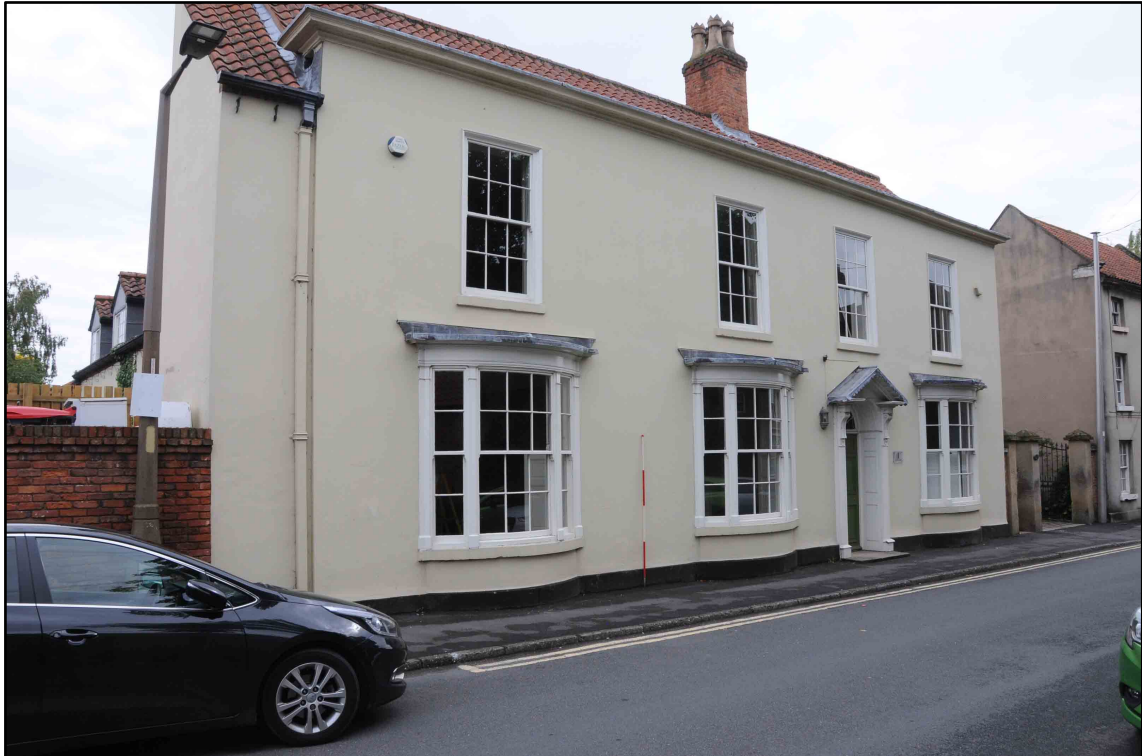
Grove House is located at 1 Wharf Street (**Appendix 1.1**) in the south-east of Bawtry in South Yorkshire (**Figure 2**). It has an L-shaped plan with a linear extension to the rear (**Appendix 1.2**). The building sits on the north side of Wharf Street. The west boundary is formed by Granby House and a Public House. Grove Coach House and The Poplars form the eastern boundary while the northern boundary is formed by the gardens to Grove Coach House.

The origins of Grove House are unknown, although it is likely that it was built in the 17th century for one of the wealthy merchants in Bawtry. The previous heritage statement (Wells 2016, 27) suggests that it was built as a double pile property facing the street (**Appendix I.1**), however it is more likely that the form of the original building was a linear structure two-storeys in height, one room deep and three rooms in length with a cellar – c.5.9m x 16m (see **Figure 3**).

Appendix I.1: General view of front elevation of Grove House looking east (2m scale).

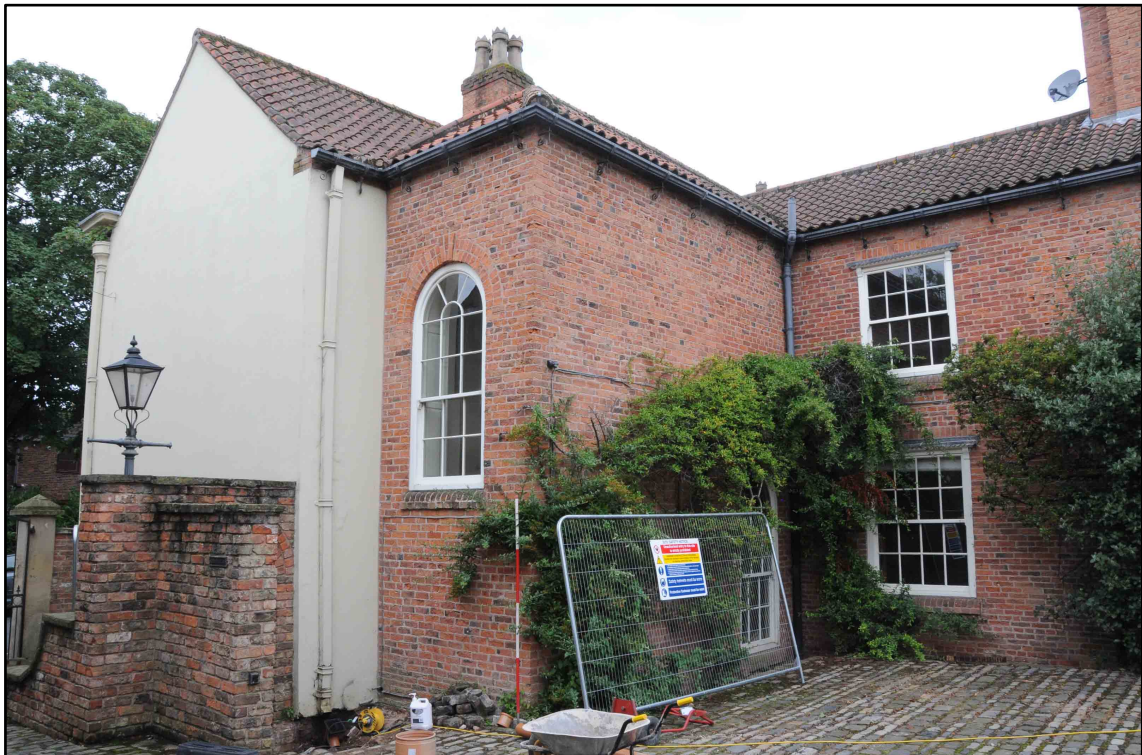
The second phase of the building comprised of a large rectangular extension to the rear c.8.5m x 10.5m (**Appendix I.4**). This effectively doubled the size of the building and represents a considerable investment in upgrading the interior plan form and circulation routes within the building. This included the addition of a large curved staircase in the south-east corner (**Appendix I.3**), with a secondary ancillary staircase to the north-west for domestic service staff. It is likely that the façade was enhanced at this date by the addition of bowed bay windows and the door-case was altered. From cartographic sources, this second phase of work is assumed to have been undertaken in the 1840s (Wells 2016, 30).

**Appendix I.4:** General view of exterior of staircase with round headed window (2m scale).

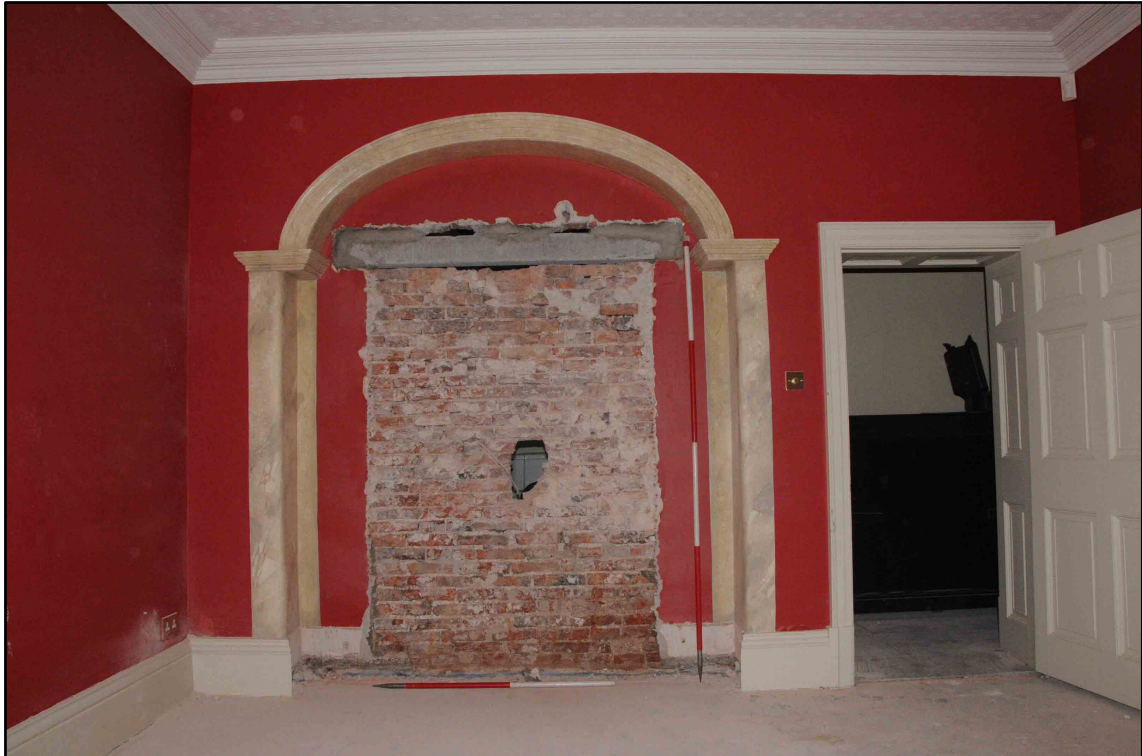
A new opening was made in the north wall of **G3** (**Appendix I.5**) to allow direct access in to **G4** to the north (**Appendix I.6**), the first stage of which comprised the removal of the existing wall plaster coving an area of c.1.42m wide by 2.3m high. The north wall of **G3** comprised of a recessed arch forming a vaulted niche.

It was also observed that the wall itself was only one brick thick and comprising of irregular courses of stretch and headers, however the headers actually represent cut back whole bricks. This is an odd detail as the walling on either side of the arch is wider. One explanation is that the wall was built as a standard width, but when the building was extended in phase 2, the recessed niche in **G3** was formed by partially removing the inner skin of the bricks within the room and any projecting headers were cut back to their current thickness (**Appendix I.5**).

Appendix I.5: Detail of north wall of G3 with plaster removed (1 m/2m scale).

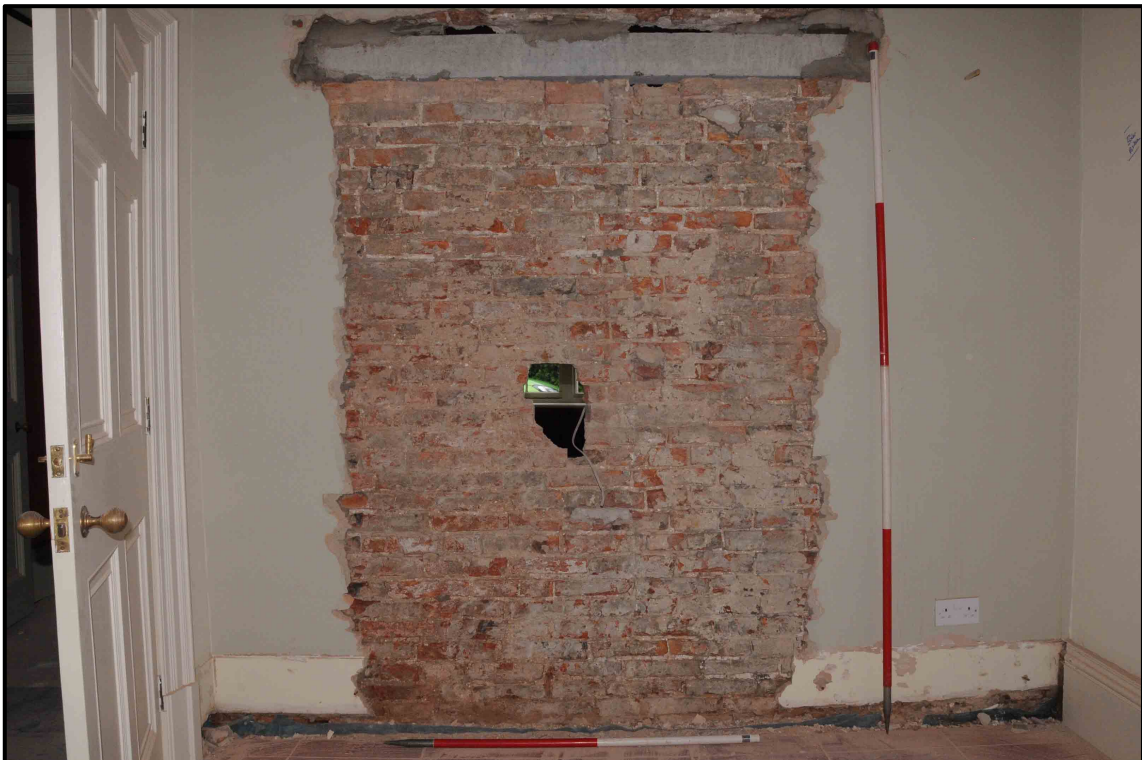
Appendix I.6: Detail of south wall of G4 with plaster removed (1 m/2m scale).

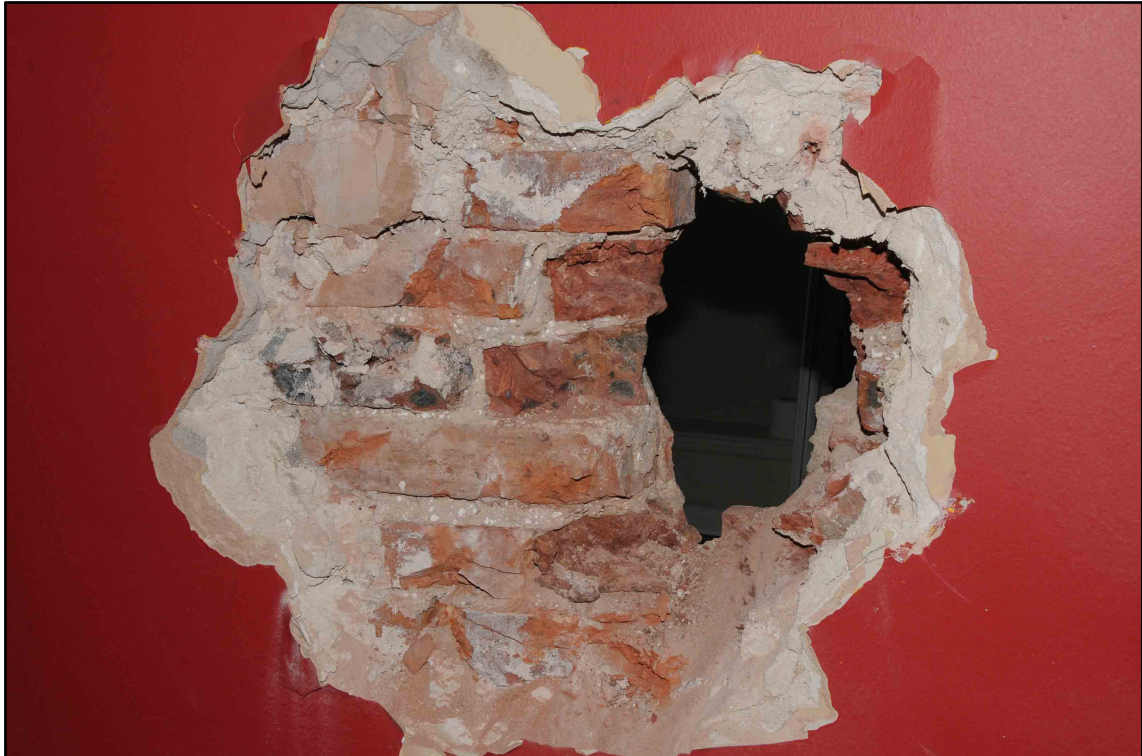
During the removal of the brickwork it was noted that the treatment of the pointing varied, with the joints in **G4** having a struck finish (**Appendix I.7**), whilst in **G3** they were unstruck (**Appendix I.8**). This evidence is indicative that the wall face exposed in **G4** was originally an external wall, which helps confirm the phased development of the front section of the building. The bricks were of an orange/red handmade fabric with no frog and measured 5.5cm x 12cm x 24.5cm.

Appendix I.7: Detail of brick wall between **G3** and **G4**; note single brick thickness.

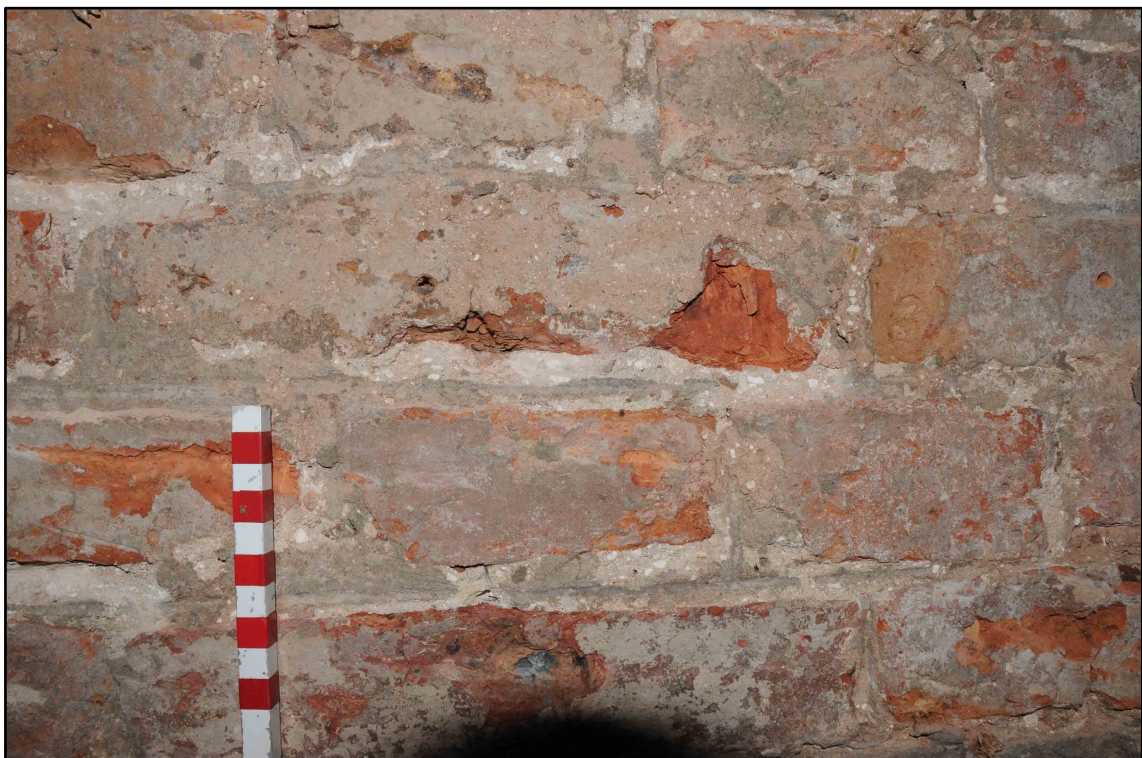
Appendix I.8: Detail of south wall of **G4**; note struck pointing suggestive of being external (10cm scale).

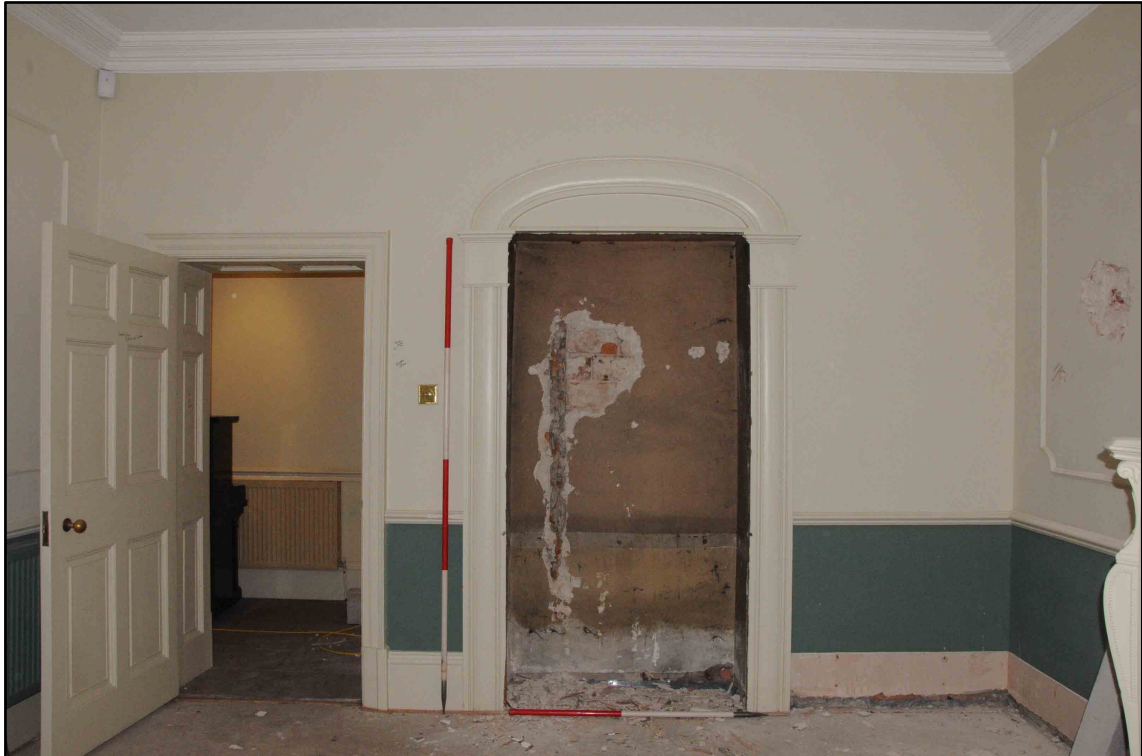
In the north wall of **G2** there is a doorway to the west and a recessed cupboard set slightly off-center (**Appendix I.9**). Both the door and cupboard have deeply moulded architraves typical of a mid 18<sup>th</sup> century style, although there is a curved arch set above a flat lintel above the cupboard, reminiscent of the recess in **G3** (**Appendix I.5**) and presumably contemporary in date forming part of the phase 2 remodeling.

**Appendix I.9:** General view of north wall in **G2** (1m/2m scale).

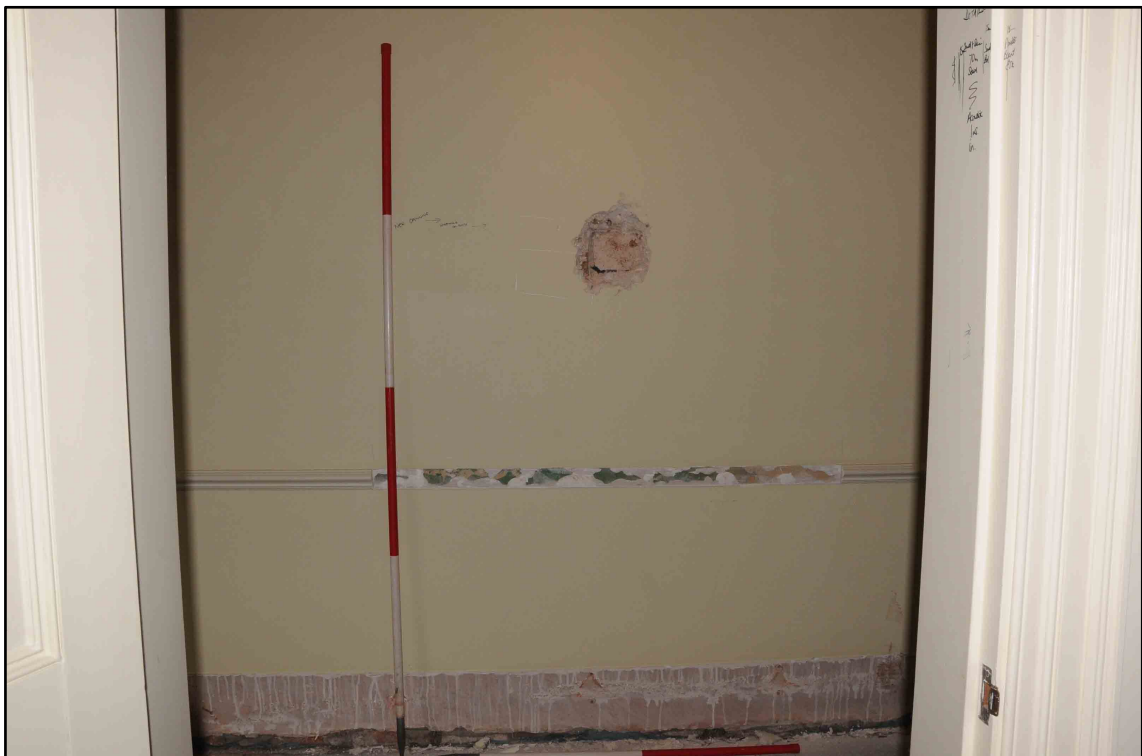
The cupboard measured 0.4m x 1.12m and was internally plastered with a lime mix with coarse brown animal hair, c.2.5m thick. The interior was painted a dark ochre colour, with 5x horizontal scars (**Appendix I.10**) indicating the location of former shelves of differing heights.

The north wall of the corridor **G5** on the opposite side of the new opening that as being created was also plastered with a slightly thicker layer of plaster, c.3cm, but on top of the lime and hair mix was a skim of modern gypsym plaster.

**Appendix I.10:** General view of south wall of corridor **G5** (1m/2m scale).

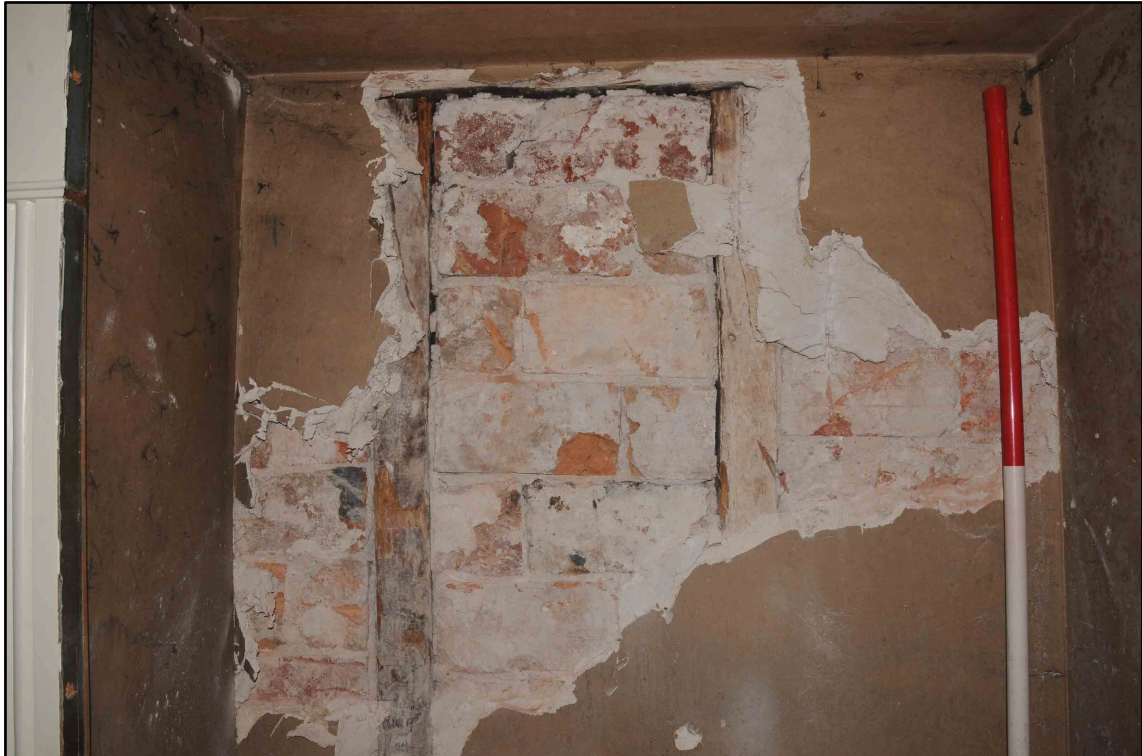
During the removal of the plaster in the recessed cupboard two timber posts were exposed (**Appendix I.11**). These measured 6cm x 7cm in scantling and were nailed into a horizontal timber at the top (**Appendix I.12**) with hand forged nails. Between the timber posts, or studs, bricks had been inserted and set on their side in an offset pattern. The bricks were of an orange handmade fabric with no frog and measured 6cm x 12cm x 24cm. The wall and plaster on either face measured 11.5cm in thickness.

**Appendix I.11:** Detail of exposed timber studs and brick fill in cupboard in **G2** (0.5m scale).

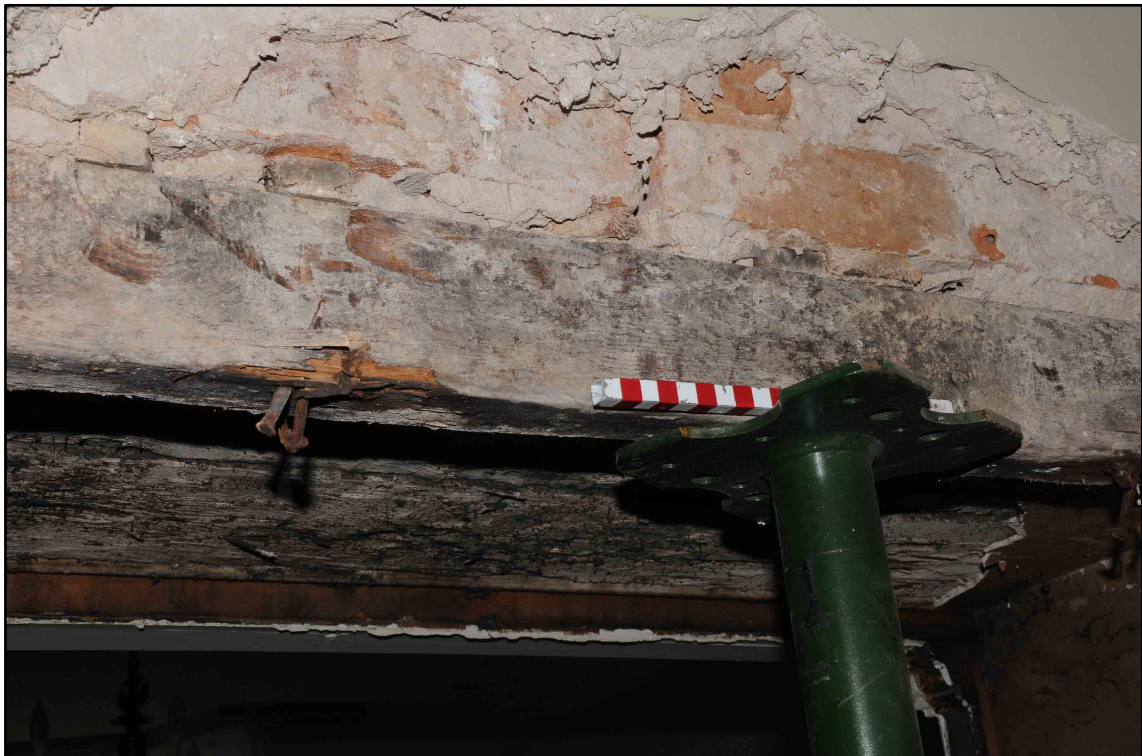
An interesting feature of the horizontal timber that formed a lintel above the inserted studs was a row of small timber wedges immediately above it (**Appendix I.12**). This detail may indicate that the lintel was a secondary insertion into the wall fabric, and the wedges were used to pack up the void at the top to prevent the bricks in the wall above from dropping. It is however suggested that the inserted wall at the rear of the cupboard in **G2** is secondary insertion into an earlier doorway opening as part of the phase 2 alterations. The formation of this blocking therefore comprised of both the vertical studs and the horizontal timber, which is not large enough to have functioned as a lintel and must have been removed.

**Appendix I.12:** Detail of re-used timber forming lintel in south wall of corridor **G5** (10cm scale).

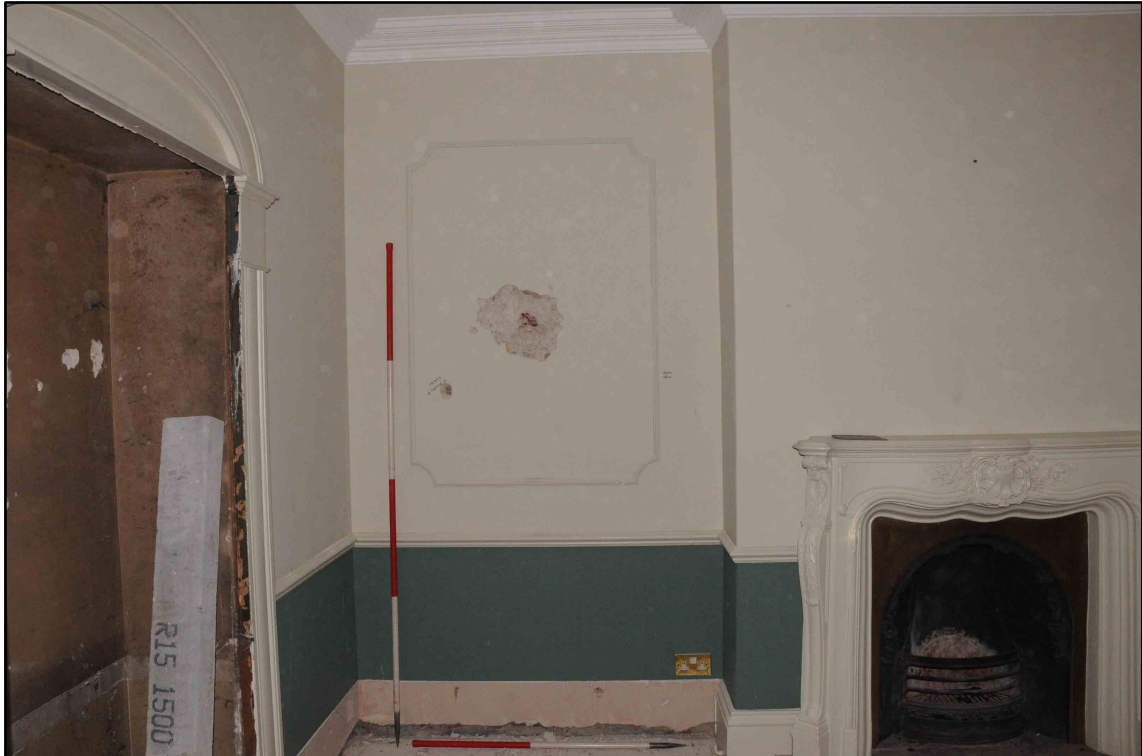
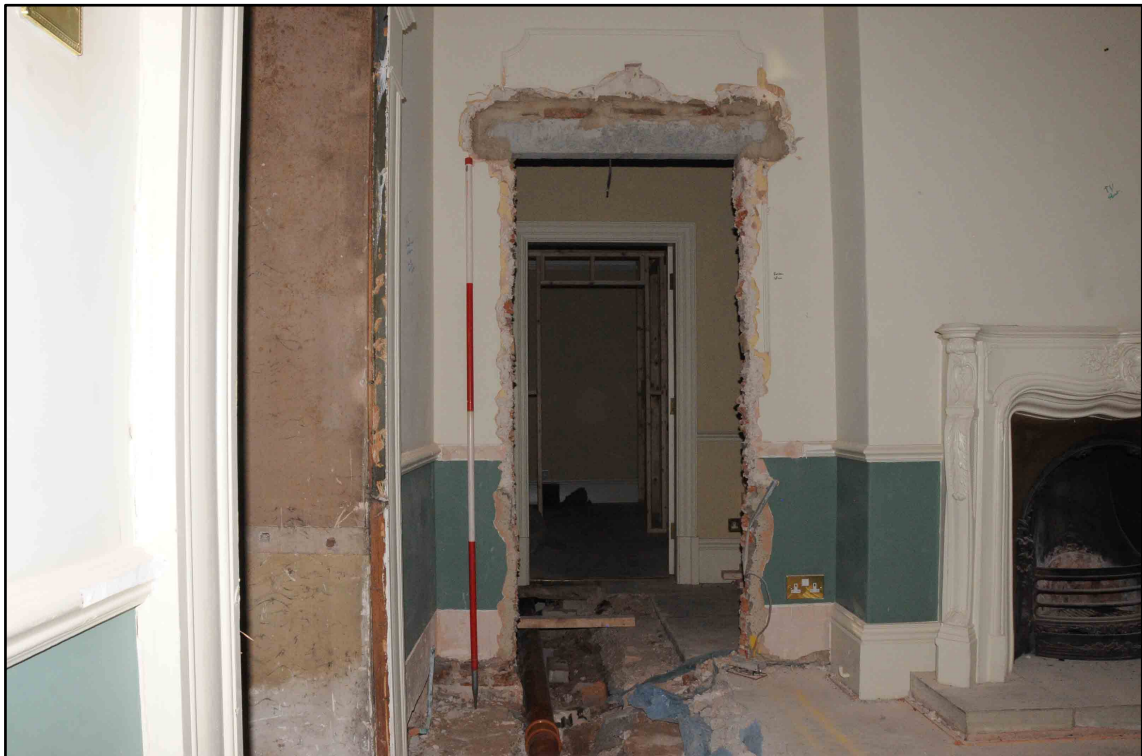
A new doorway was formed in the entrance corridor **G7** into **G2** (**Appendices I.13, I.14**) and was directly opposite the existing doorway in **G1**. The plaster on both wall faces was found to be a lime mix with added animal hair c.3cm thick with a modern skim of gypsum plaster. The wall core was a single skin of brick (**Appendix I.12**) measuring 12cm in width. Exposed within the center of the wall at a height of 1.27m above the timber floorboards in **G7** was a horizontal softwood timber (see **Appendices I.15, I.16**). This appeared to be reused and contained 3-4 redundant peg holes, but it did not appear to represent an *in-situ* timber frame. A second block of timber measuring 7cm x 12cm was located at a height of 0.72m above the floor (**Appendix I.15**) and may have been used to act as a nail fixing point for panelling, or a low dado rail.

Appendix I.13: General view of north-east corner of **G2** (1m/2m scale).

Appendix I.14: General view of north-east corner of **G2** following removal of bricks (2m scale).

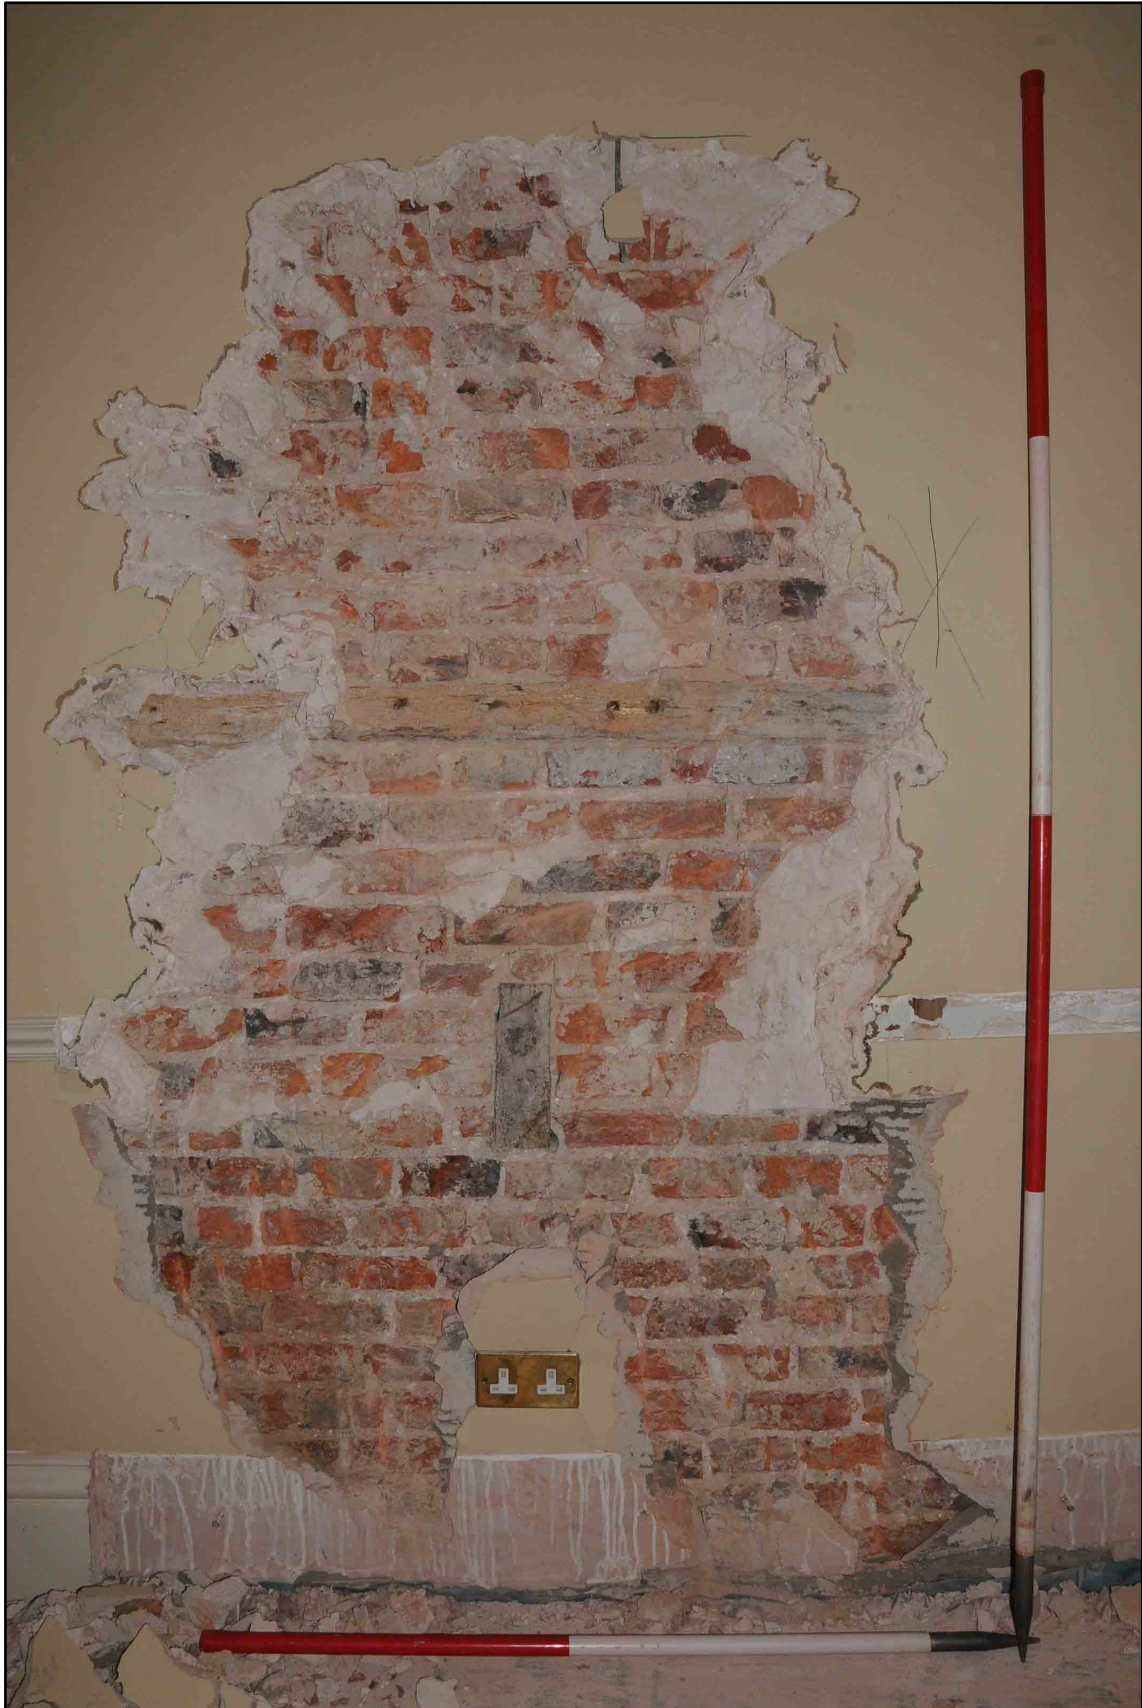
Appendix I.15: General view of north wall in G7, note inset timbers (1m/2m scale).

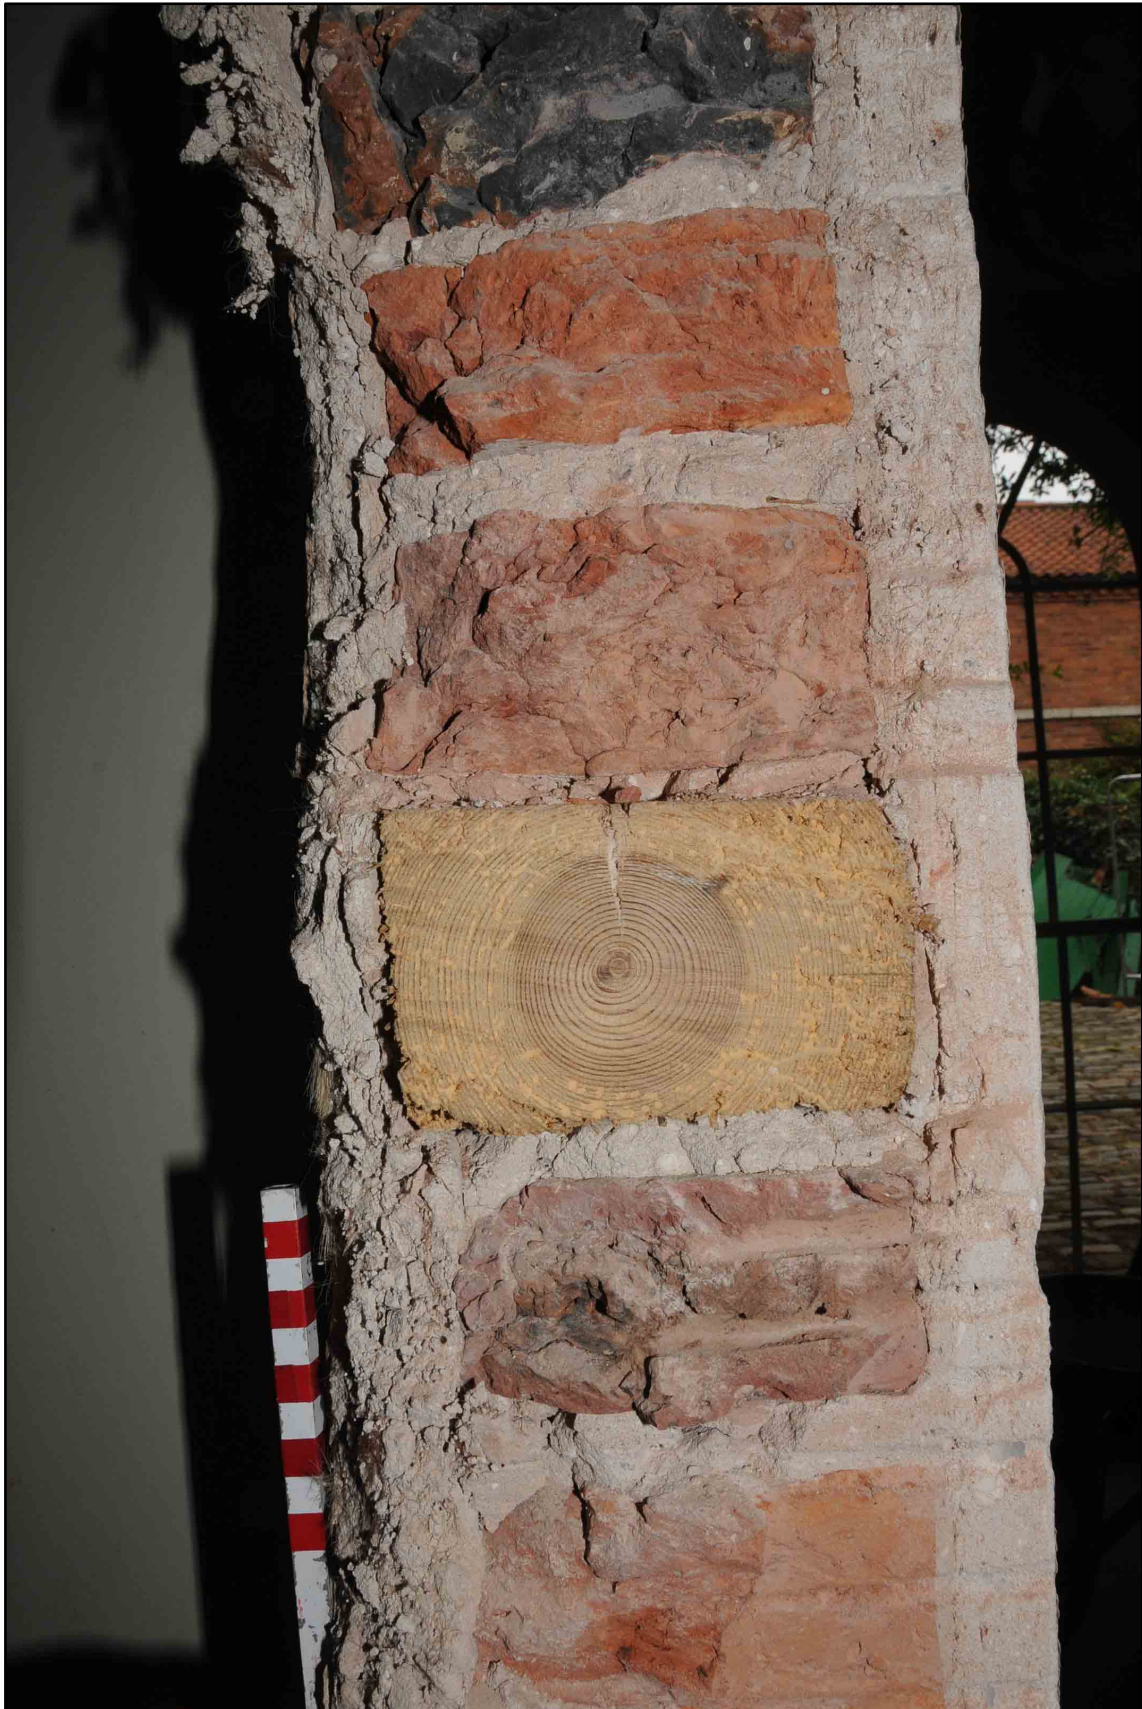
The walling bricks were an orange handmade fabric with no frog and measuring 5.5-6cm x 12cm x 24cm. No additional features were noted in this section of brickwork.

Appendix I.16: Detail of inset timber in wall between **G2** and **G7**; note single brick thick (10cm scale).
