NORBURY OLD MANOR

Norbury Hollow, Norbury, Derbyshire

Historic Building Survey on behalf of the National Trust

Volume I: Description of Fabric and Analysis

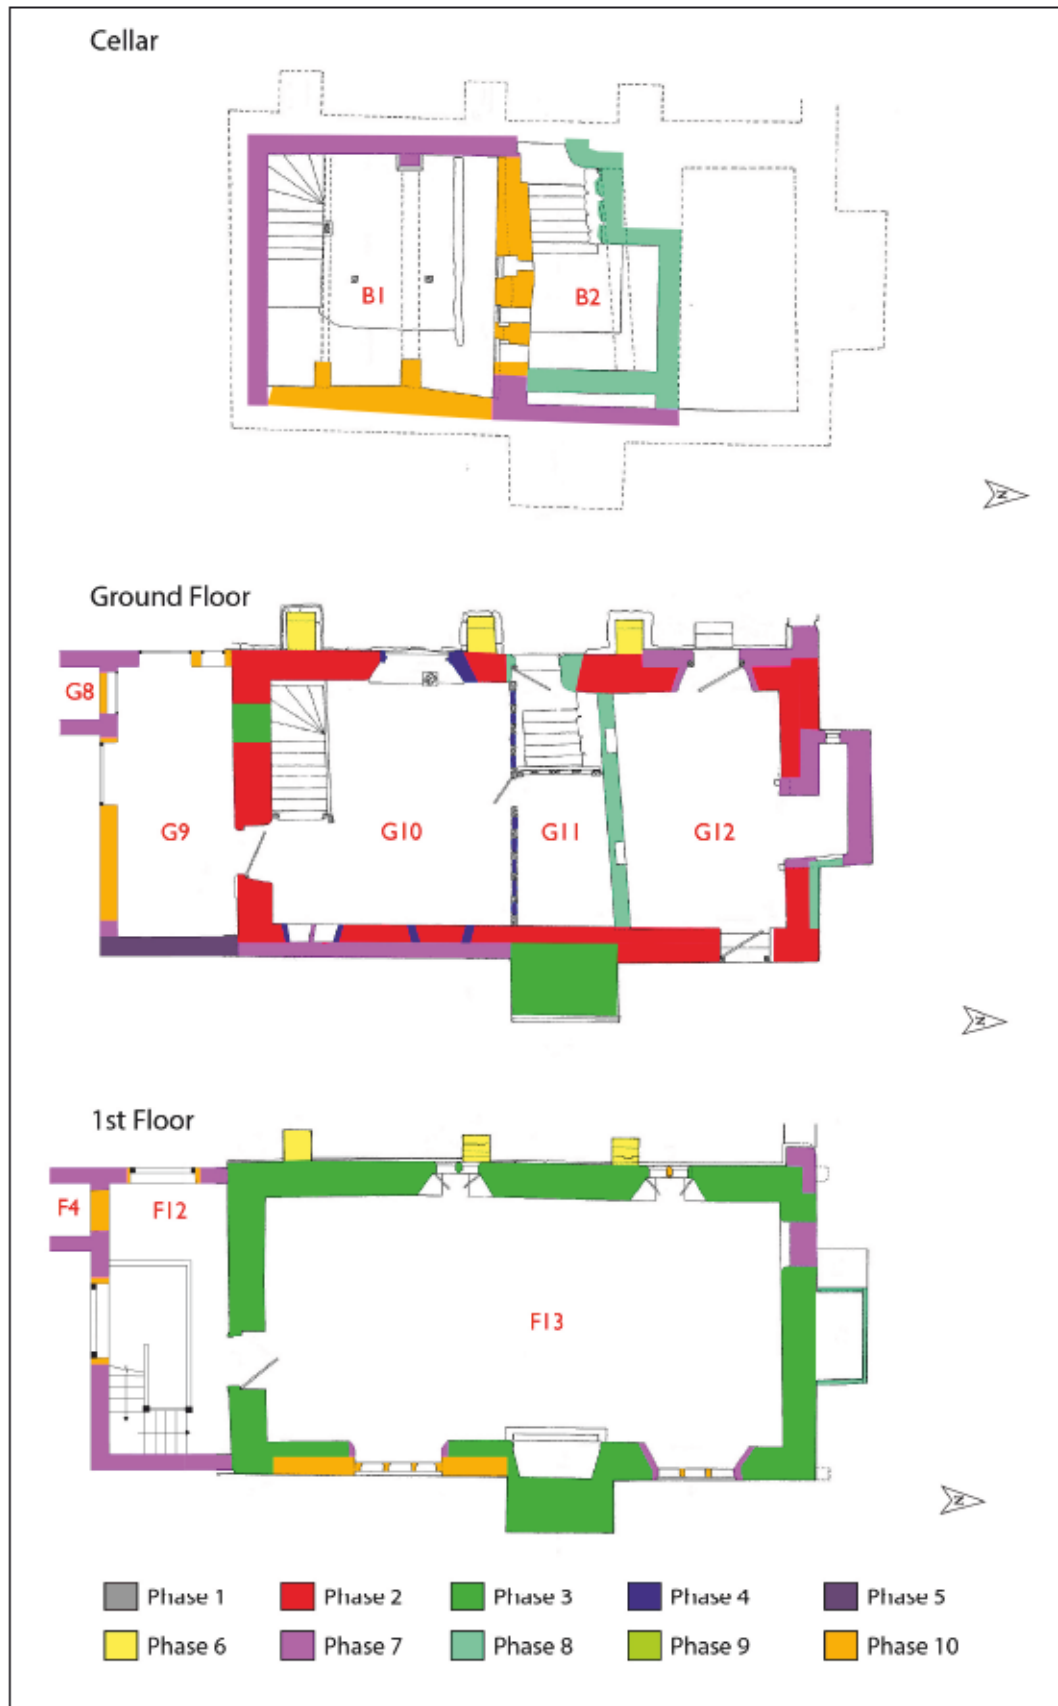
Figure 4: Phased floor plans of Building 2

(based on a building survey by Franklin, 2002)

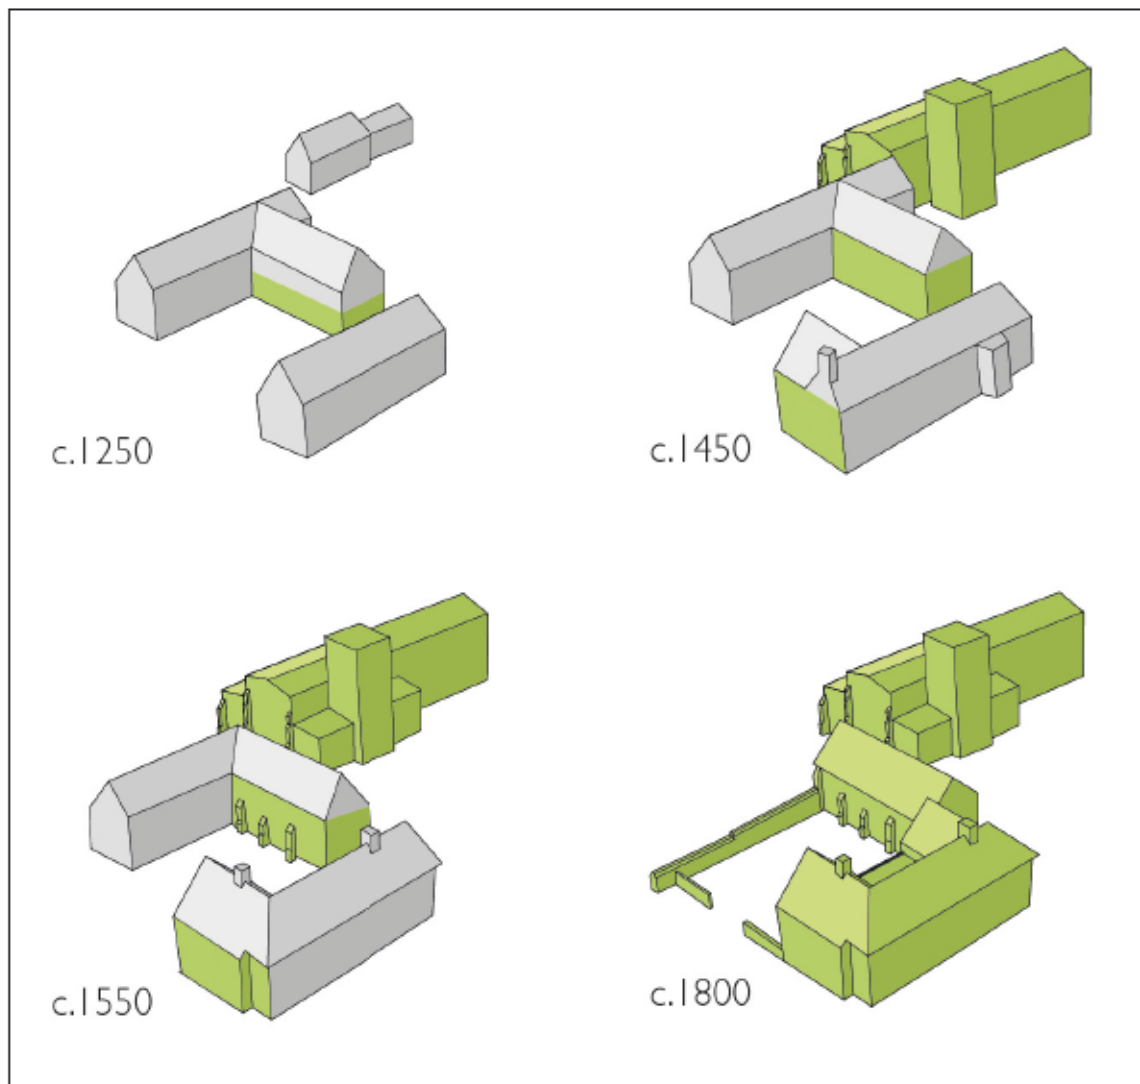
Figure 5: Block phase plan (Green = surviving fabric, and Grey = conjectured elements)

The earliest phase of Norbury Old Manor has been attributed to the 12th to 13th century, when William Fitzherbert acquired the estate from Tetbury Priory. Very little is known of the extent and form of this manor, although it has been determined that the ground floor of **Building 2** most likely dates to this period (**Figure 5**).
