HOLLY BUSH FARM

Pikehall, Derbyshire

Archaeological Watching Brief

September 2018
Final

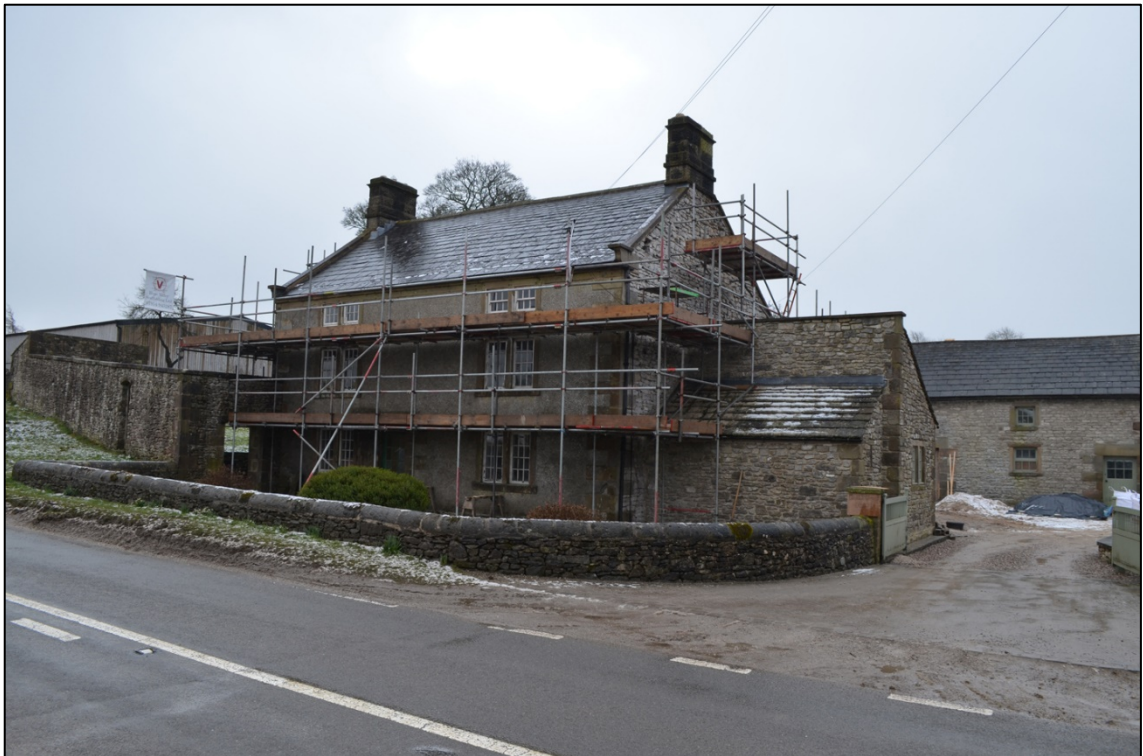
Appendix 2.1: Holly Bush Farmhouse, looking south-east

The cellar is located beneath the northwest corner of Holly Bush Farm (**Appendix 2.1**) and is accessed via a stairwell along the exterior of its southern wall (**Appendix 2.2**). Internally, the cellar measures 4.2 x 3.5m, formed with limewashed rubble-built walls and refaced at the western end of the room in blockwork (**Appendices 2.3-2.4**). The entrance to the stairwell is situated within the southwest of the room, whilst a secondary opening in the centre of the west wall had been converted to a doorway for new access.
