# CHURCH FARM

Oxton, Nottinghamshire

## Heritage Statement

OCTOBER 2018  
FINAL

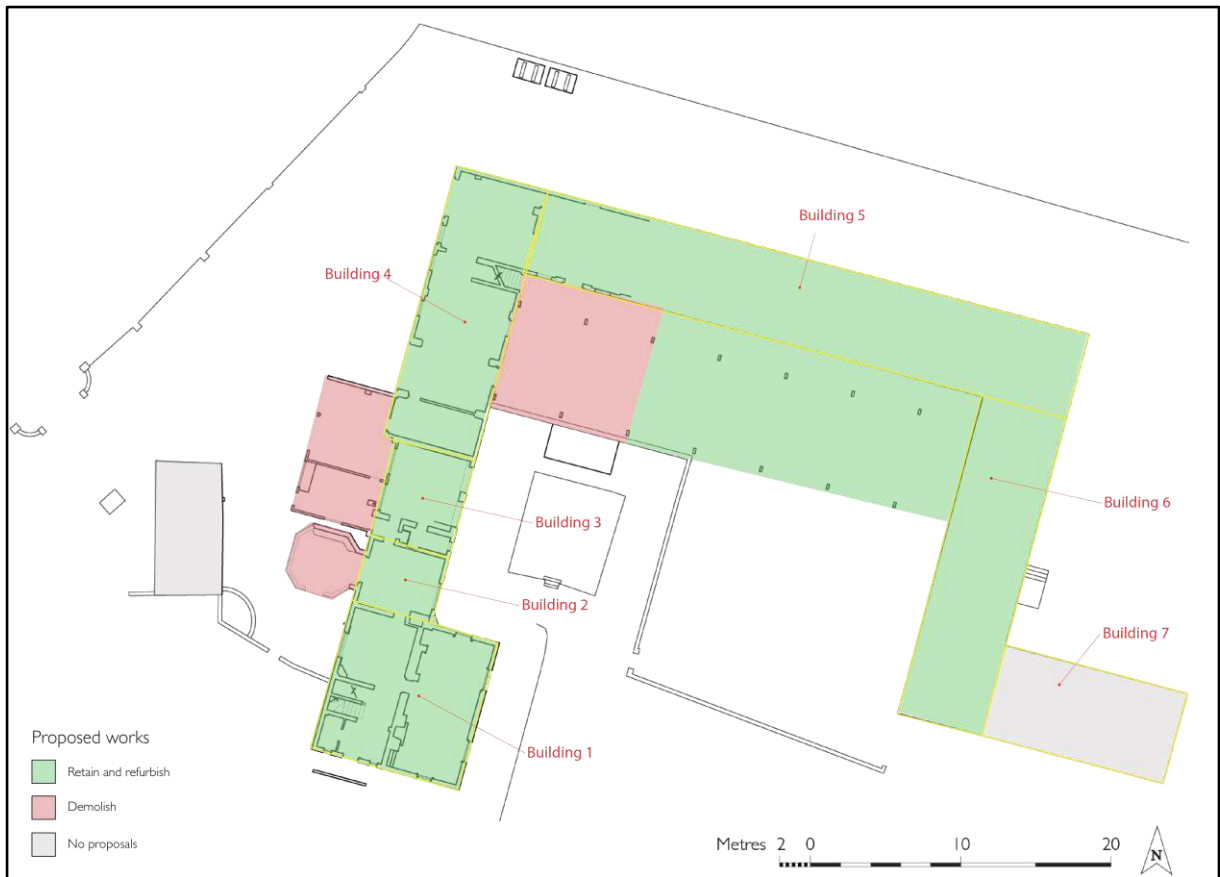
Figure 2: Site layout outlining stages of proposed works

The buildings within the site (**Figure 2**) essentially form three sides of a regular courtyard plan. The western side of the courtyard is bounded by the three-storey house (**Building 1**), two storey northern wing of the house (**Building 2**), a single storey bay (**Building 3**) and a two-storey agricultural range (**Building 4**). To the north is a single storey long linear range (**Building 5**), which extends south to form the eastern side of the courtyard (**Building 6**). Extending east from the southern end of Building 6 is single bay open sided cart shed (**Building 7**).

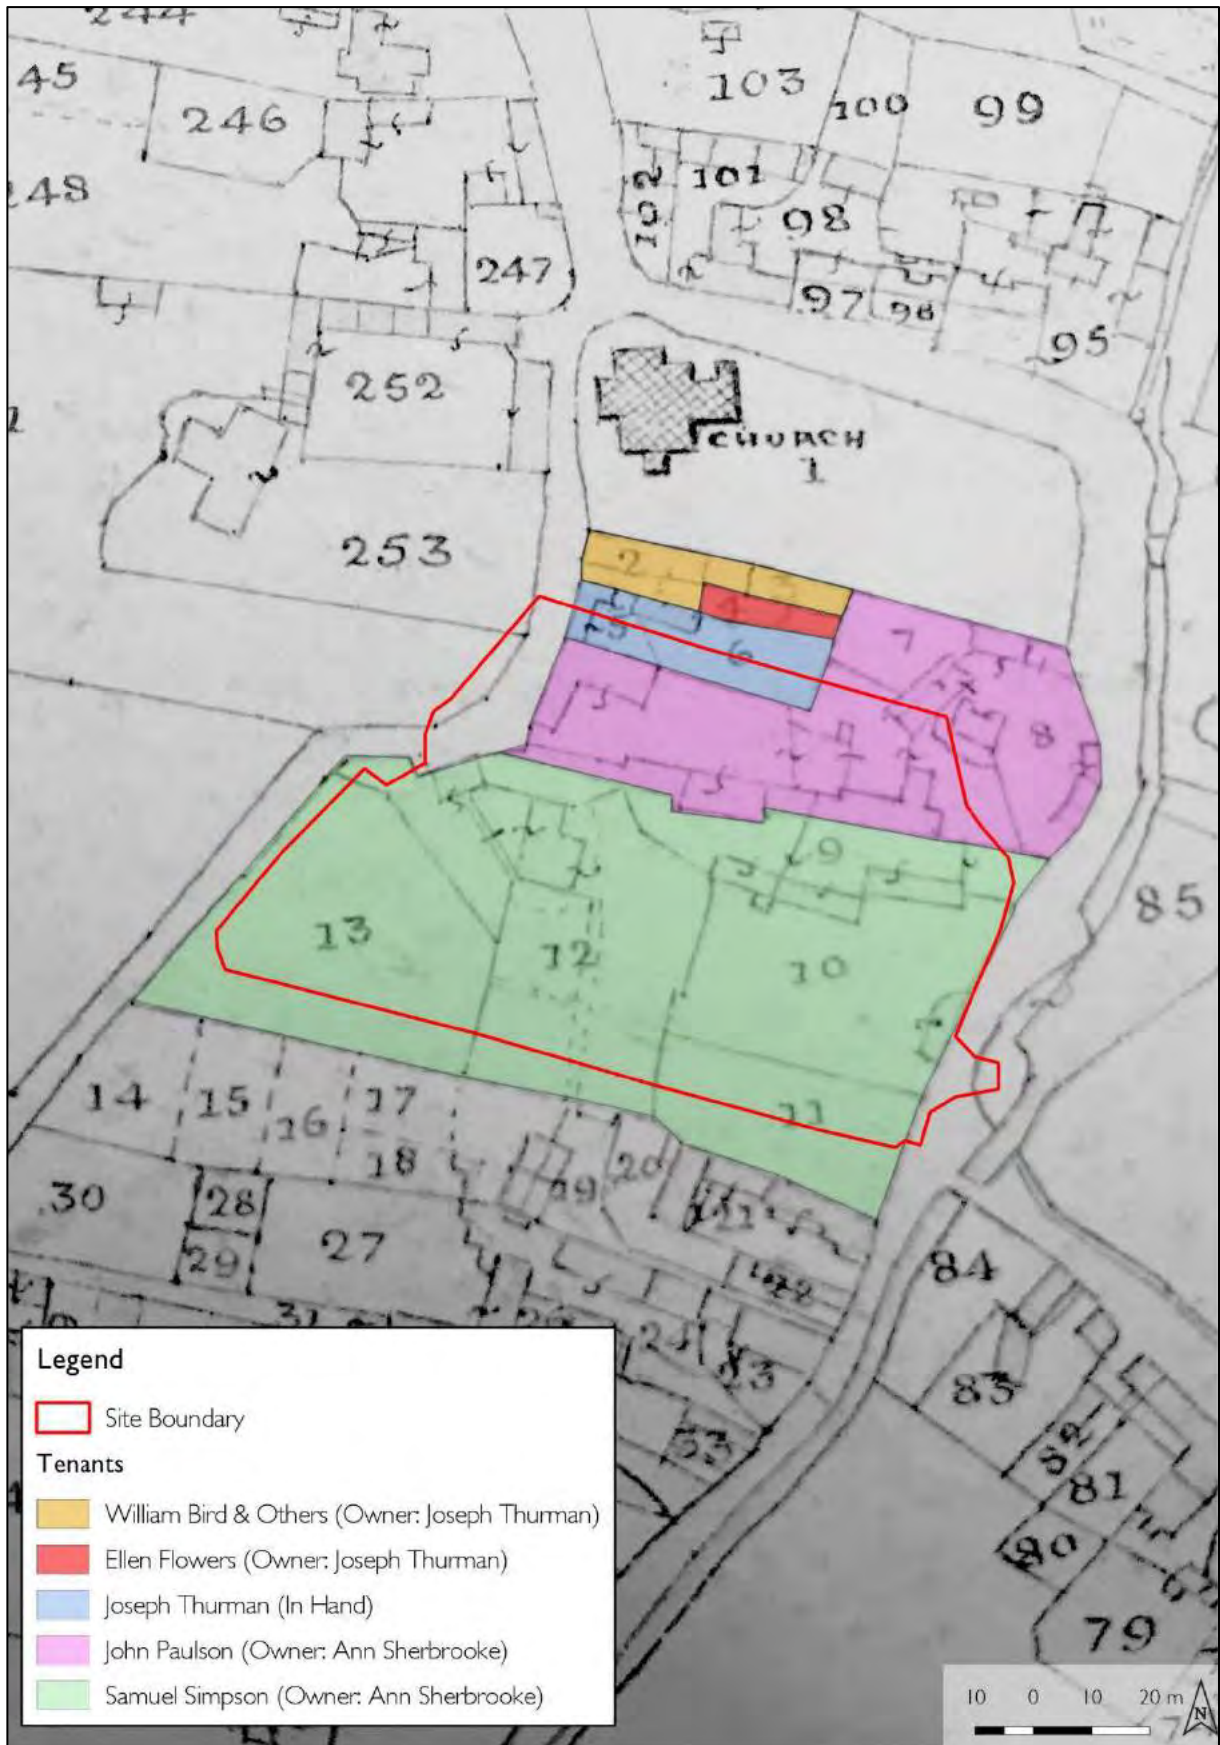
Appendix I.I: 1842 Oxton Parish tithe map

The earliest detailed record we have of the site is from a tithe survey of Oxton Parish produced in 1842 (**Appendix I.1**). The site was shown to be divided between 9 plots, occupied under three principal tenants:

The plan illustrates that **Building 1 and 2** were in existence by this period. Whilst an L-shaped range is also shown on the approximate site of **Building 4** and the existing adjoining north range, the physical evidence (see section 6) indicates this structure dates from the later 19<sup>th</sup> century. A significant number of other buildings are shown across the northern part of the site, none of which now survive.

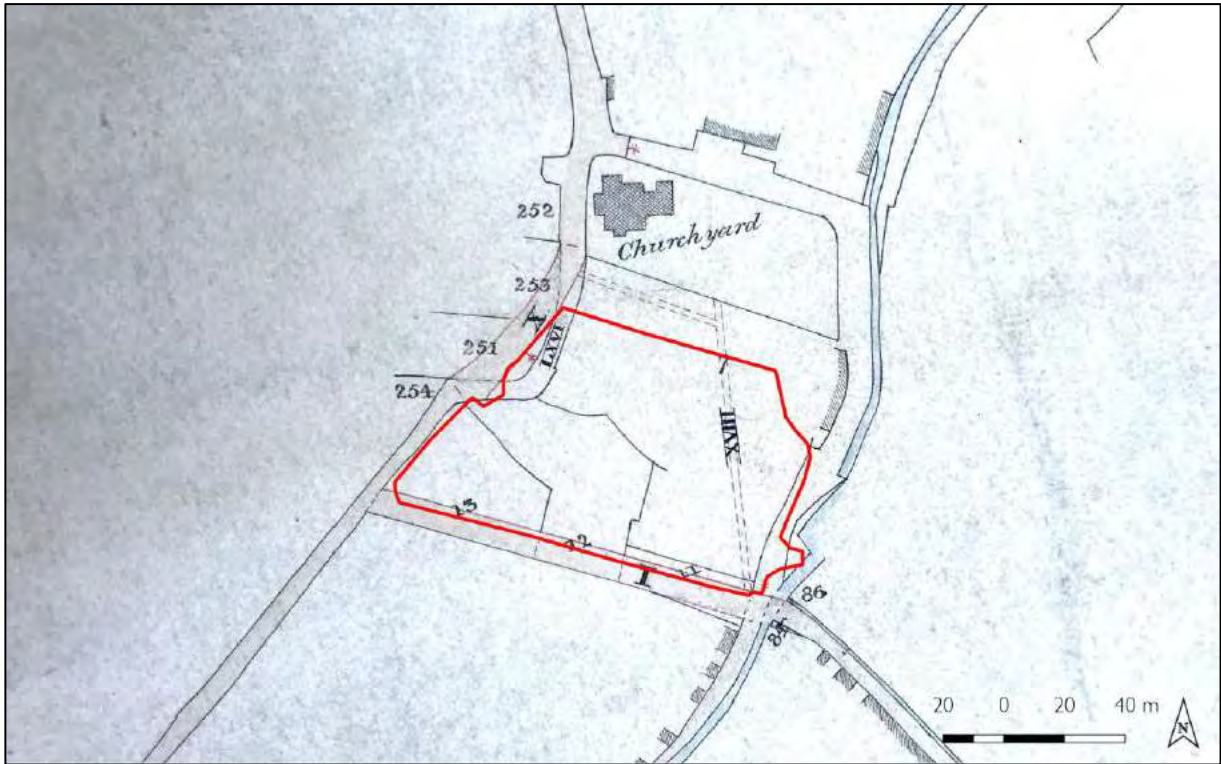
Appendix I.2: 1850 Oxton enclosure map showing road realignment at the site

The enclosure of commons in Oxton in 1850 included the realignment of Main Street, with a plan produced at the time illustrating the original alignment as shown in 1842, and the proposed alignment as it lies today (**Appendix I.2**). Also shown is the addition of New Street. These road realignments extended the western boundary and truncated the southern boundary of the earlier plots within the site.
