# PASTURE MINE

Eyam, Derbyshire

## Historic Building Record

SEPTEMBER 2018  
FINAL

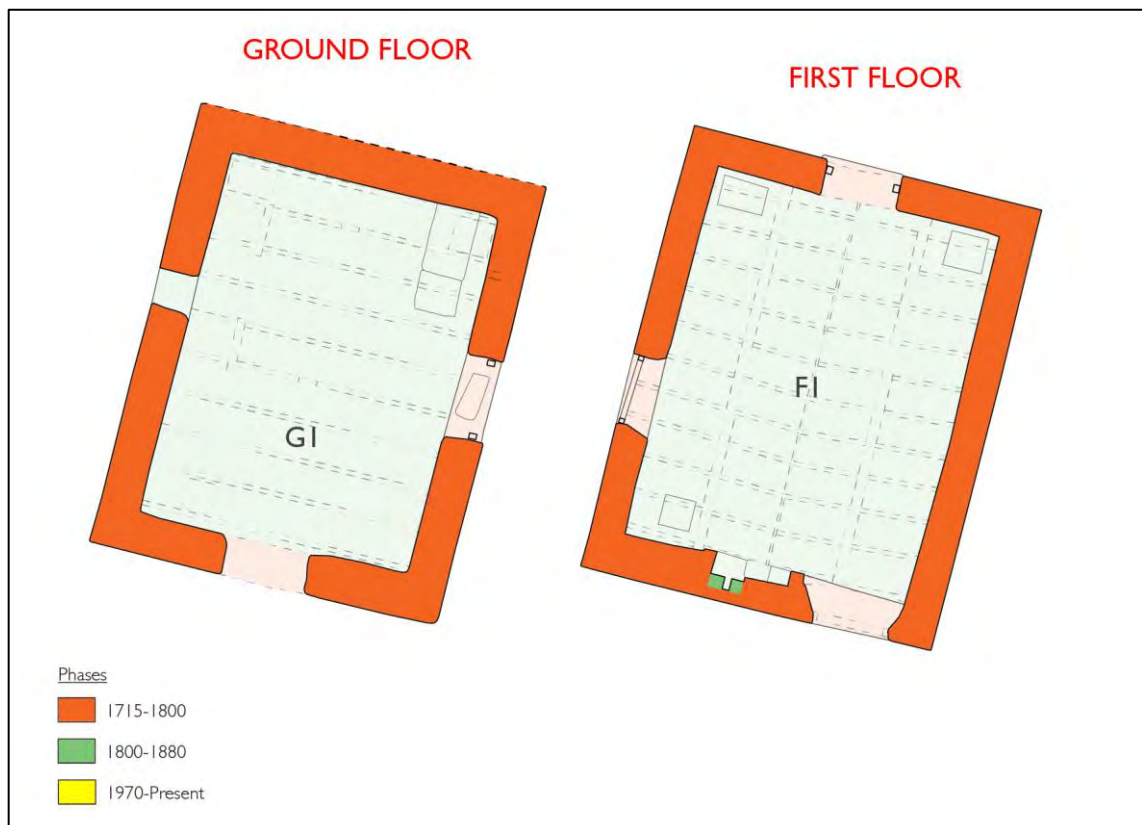
Figure 3: Phased site plan

The investigation of the building identified three principal phases of development which have been attributed to the following periods (**Figure 3**):

Phase 1: 1715-1800	Construction
Phase 2: 1800-1880	Refurbishment
Phase 3: 1970-Present	Re-roofing

The roof on the structure has been entirely replaced. The date of the replacement is unknown but given its good condition a relatively recent date is most likely.

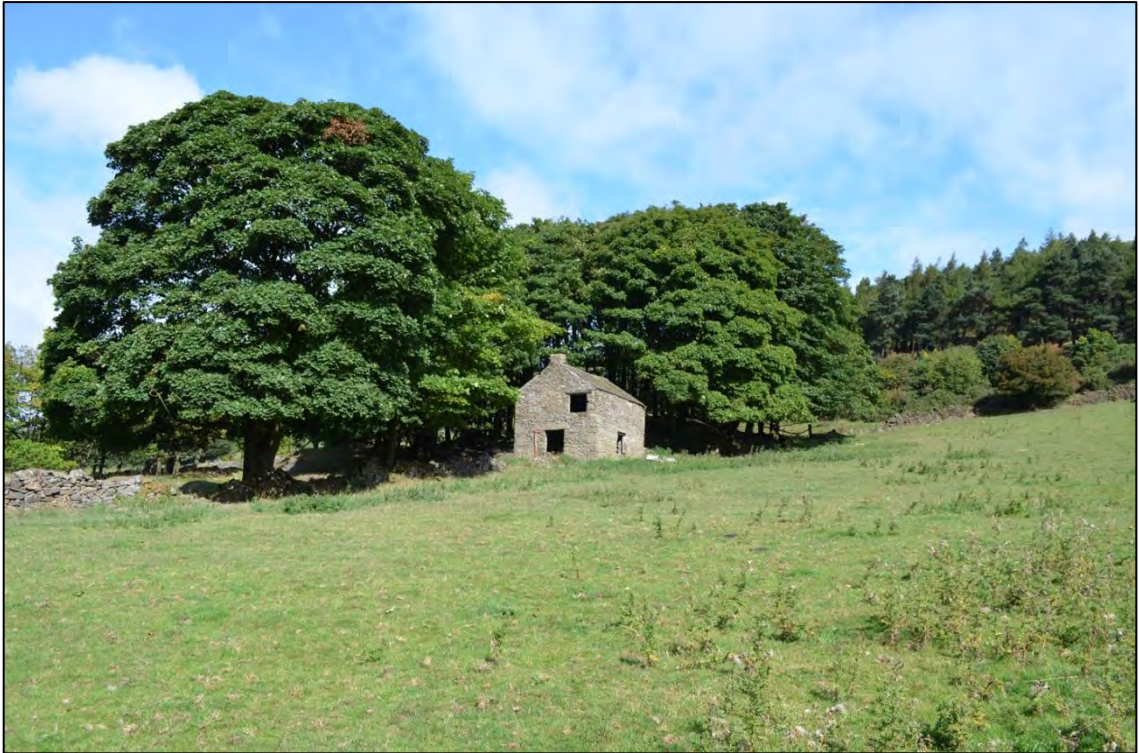
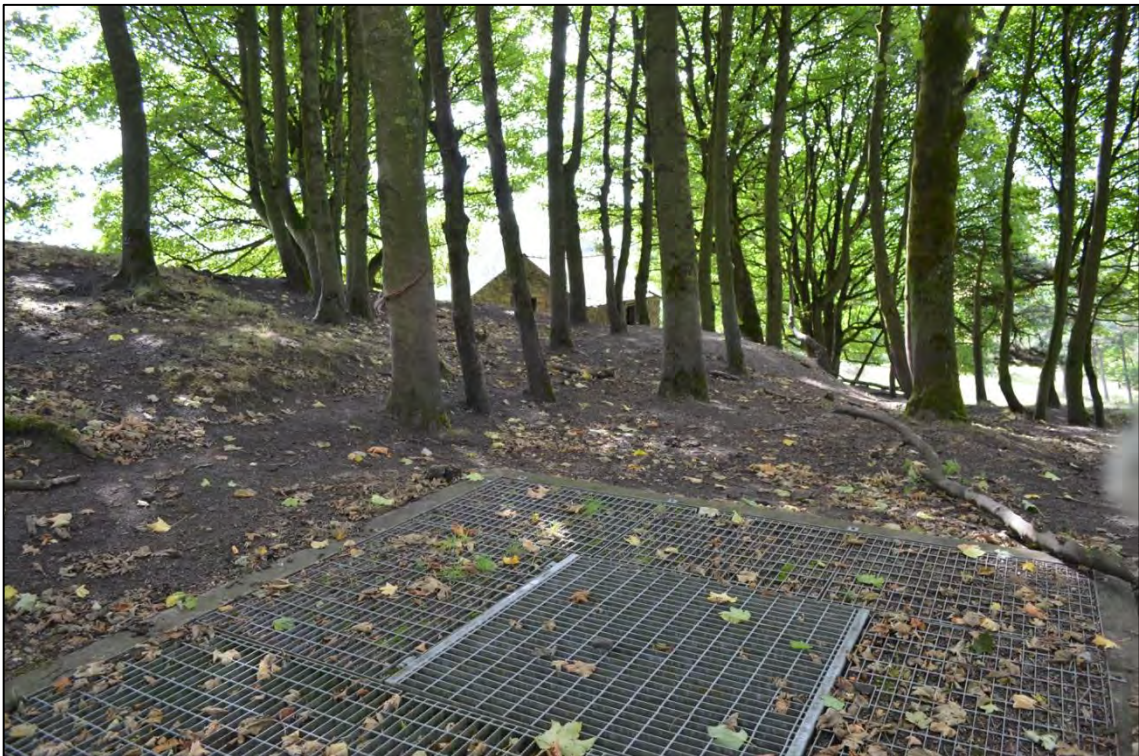
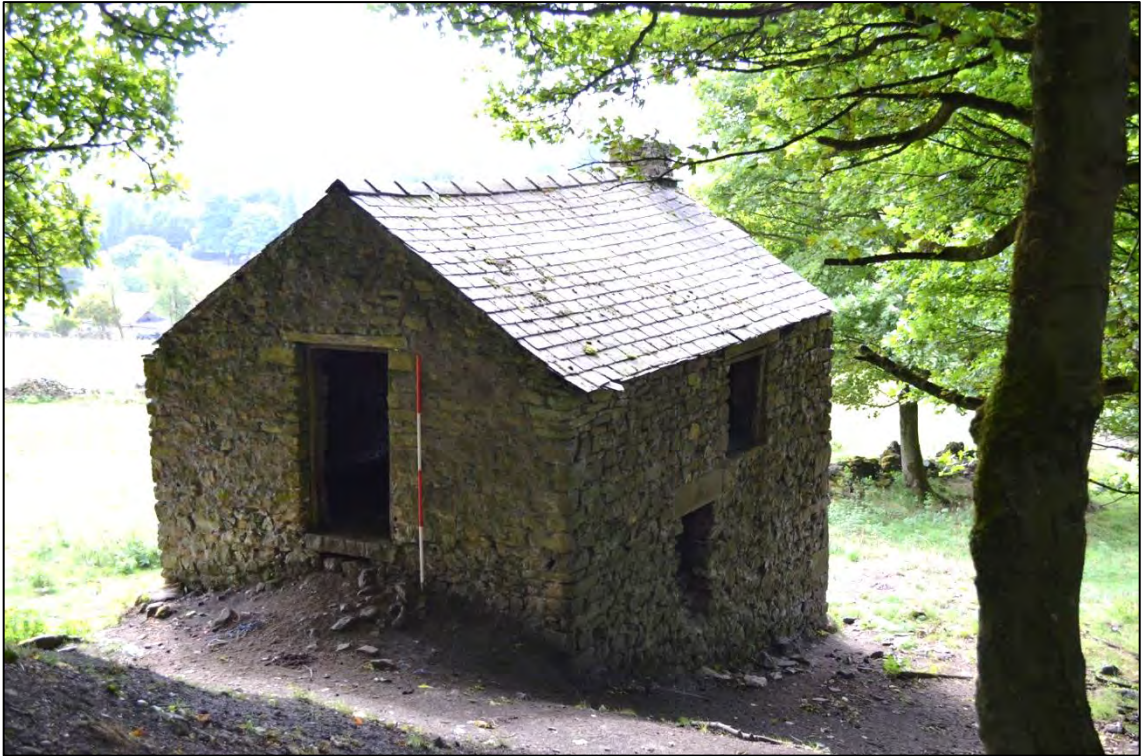
The building at Pasture Mines (**Appendices 2.1-3**) is a two-storey structure, measuring 4.7 × 6.0 m (15 ½ × 20 ft), built from coursed sandstone rubble. The roof of the building is pitched with slate with ceramic ridge tiles. A short stone-built chimney emerges from the southern gable.

Appendix 2.1: General view of the site, looking north-west (scale: 2m)

Appendix 2.2: General view of the site, looking south-east over the covered mine shaft

Appendix 2.3: General view of the site, looking south-east (scale: 2m)

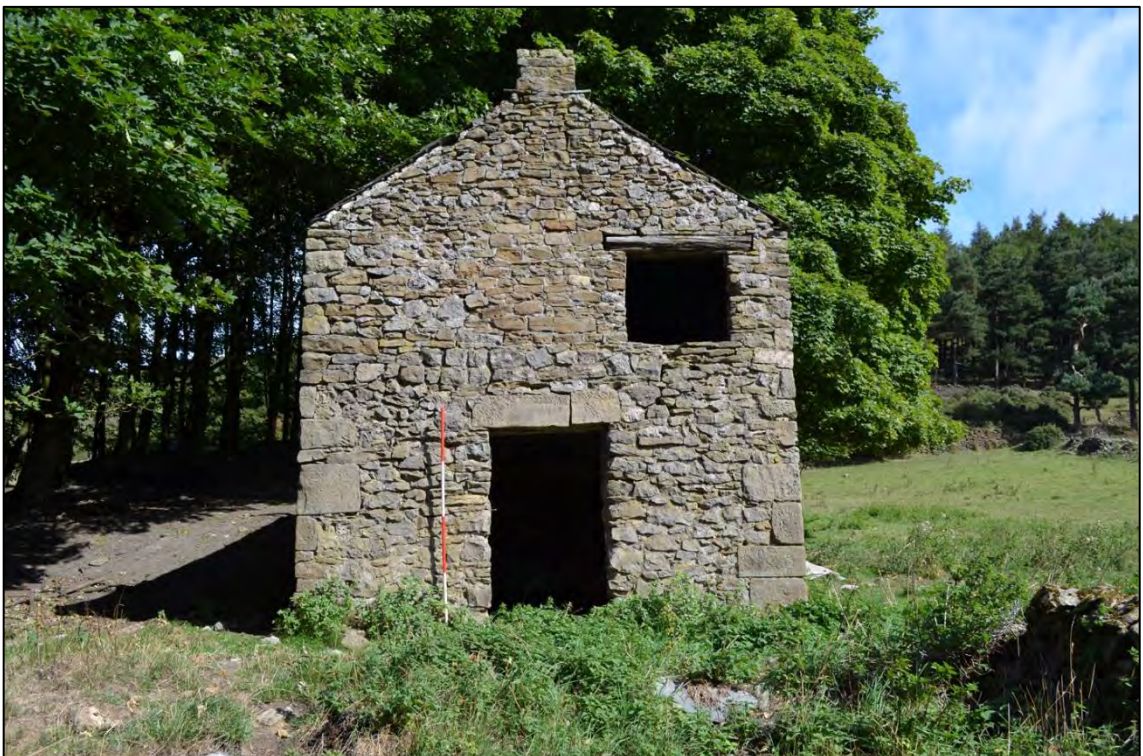
The south elevation (**Appendix 2.4; Figure 6**) contains a single central doorway at ground floor level with rough stone jambs and sandstone lintel (broken) with irregular rough tooling. Mortar scars in the jambs of the doorway indicate the former presence of a doorcase. A window is offset above to the right side of the elevation with rough stone jambs, timber lintel and no sill.

There quoins at either side of the elevation comprise large dressed sandstone blocks at ground floor level, changing to roughly squared rubble above. This change coincides with a horizontal break in fabric between ground floor and first floor level marked by a double course of square stone blocks. A slight change in the colour of stone between these parts of the elevation would suggest that these represent different phase of construction. The brickwork within the centre of the first-floor elevation is slightly discoloured, reflecting the location of the fireplace and flue.

Appendix 2.4: South elevation (scale: 2m)

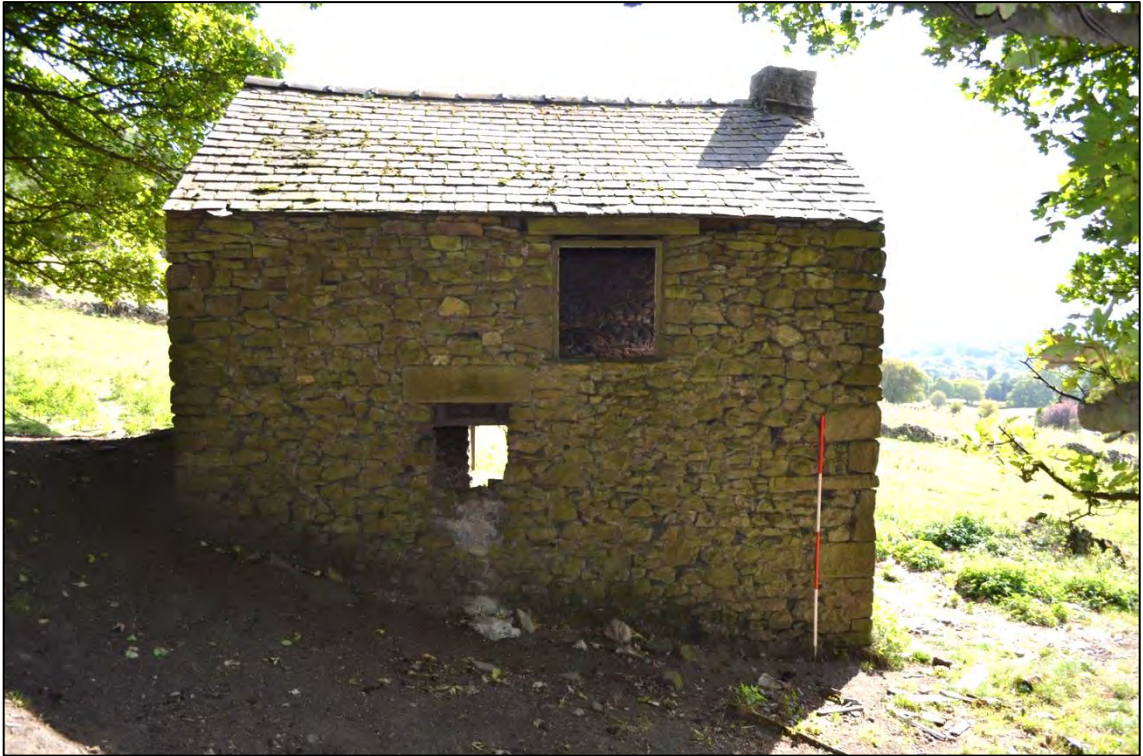
The west elevation (**Appendix 2.5; Figure 7**) contains a central small square window at ground floor level, with dressed stone lintel and no sill. The jambs of this opening appear to comprise rubble and has partially collapsed on its northern side. This, and its correlation with brackets associated with a 19<sup>th</sup> century floor internally, suggests the window is inserted. A second window is situated above at first floor, with rough squared stone jambs, timber lintel and stone sill. A timber frame partially survives, with scars from a removed central rail and two fillets.

The horizontal break in fabric observed in the southern elevation legibly continues along this elevation.

Appendix 2.5: West elevation (scale: 2m)

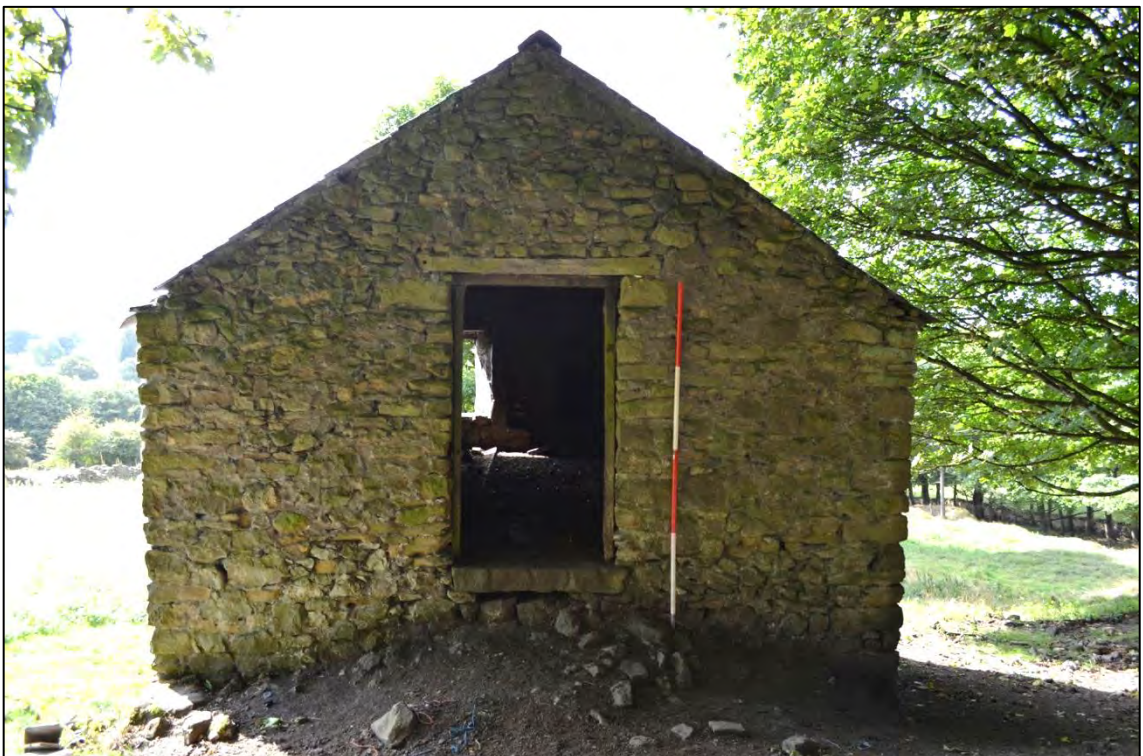
Ground level rises around the structure such that the first-floor level of the north elevation (**Appendix 2.6; Figure 7**) is at ground level. Within the centre of the elevation is a doorway with reused timber lintel and stone threshold. A door retains a plain timber doorcase, but no door.

Appendix 2.6: North elevation (scale: 2m)

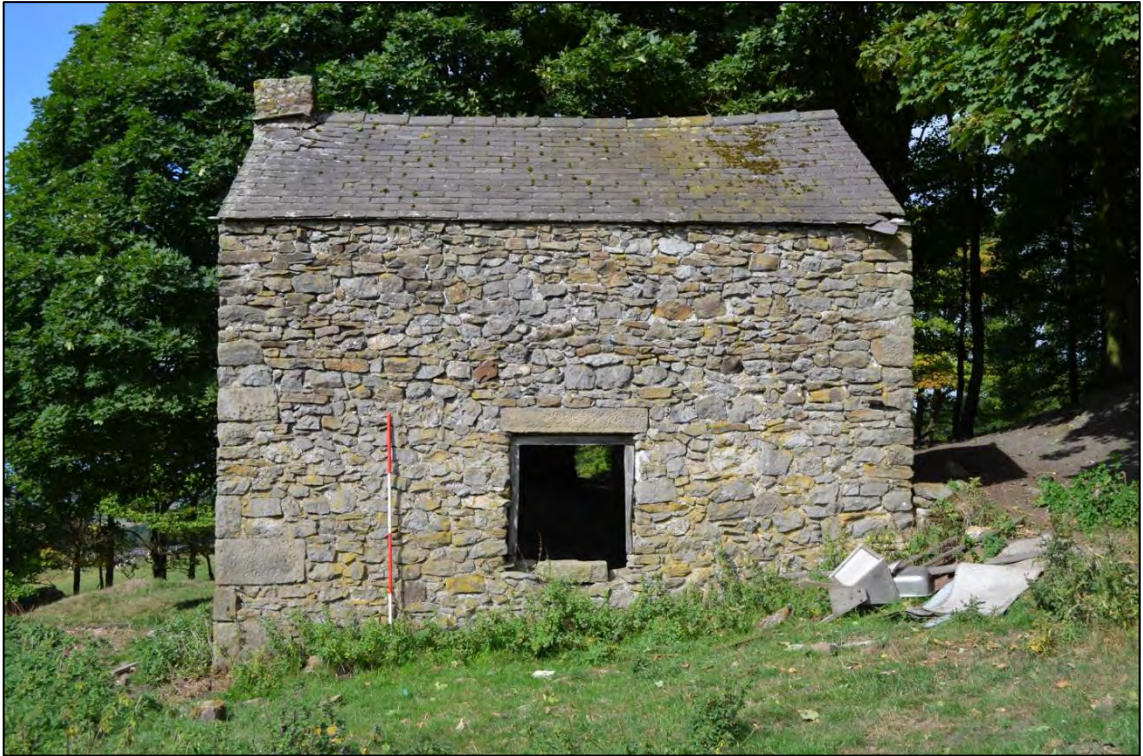
The east elevation (**Appendix 2.7; Figure 6**) contains a single central square window with rough stone jambs and dressed stone lintel. No sill survives. The posts and top rail of a timber framed window survives in situ.

The horizontal break in fabric observed in the southern elevation legibly continues along this elevation.

Appendix 2.7: East elevation (scale: 2m)

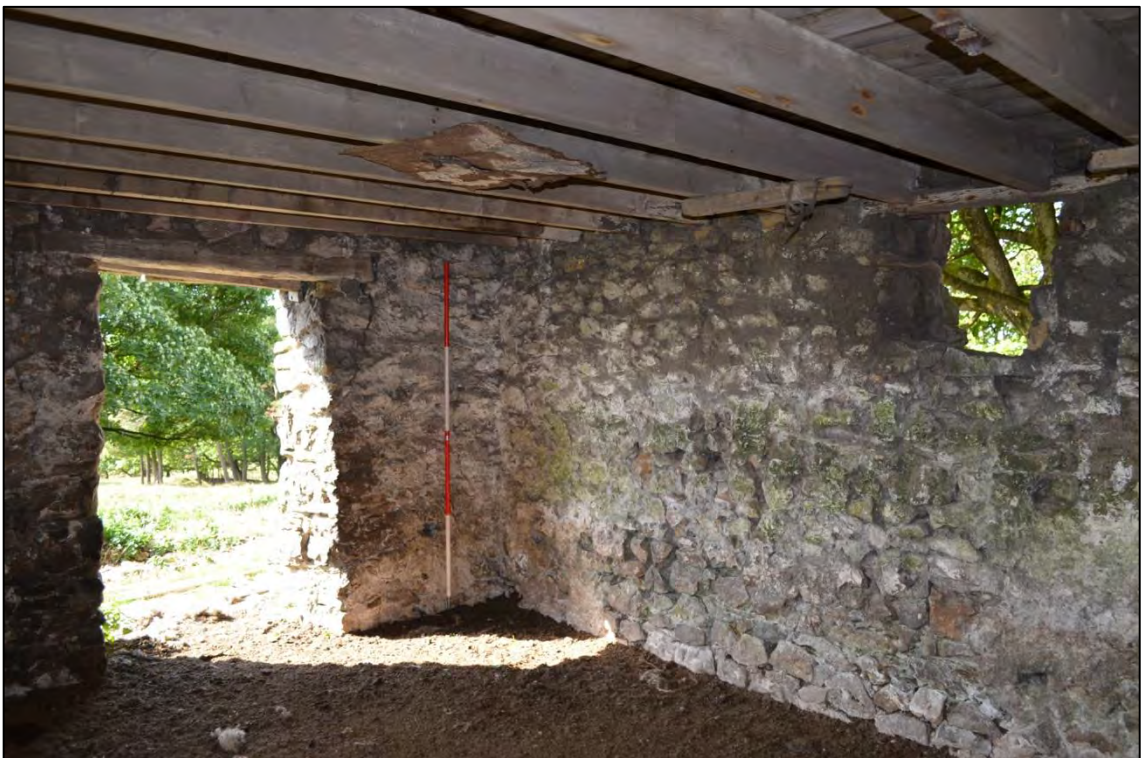
The ground floor comprises a single space (**Appendix 2.8**) with an earthen floor, thinly limewashed rubble walls, and ceiling of exposed floor joists. A small area of stone flags was observed in the north-east corner of the room. A small diameter low pipe was situated adjacent to this paving in the east elevation.

The wall within the south-east corner of the room had been painted black to dado level, although this colouration had substantially decayed. No evidence of colouration was observed elsewhere within the building.

Appendix 2.8: General view of GI (scale: 2m)

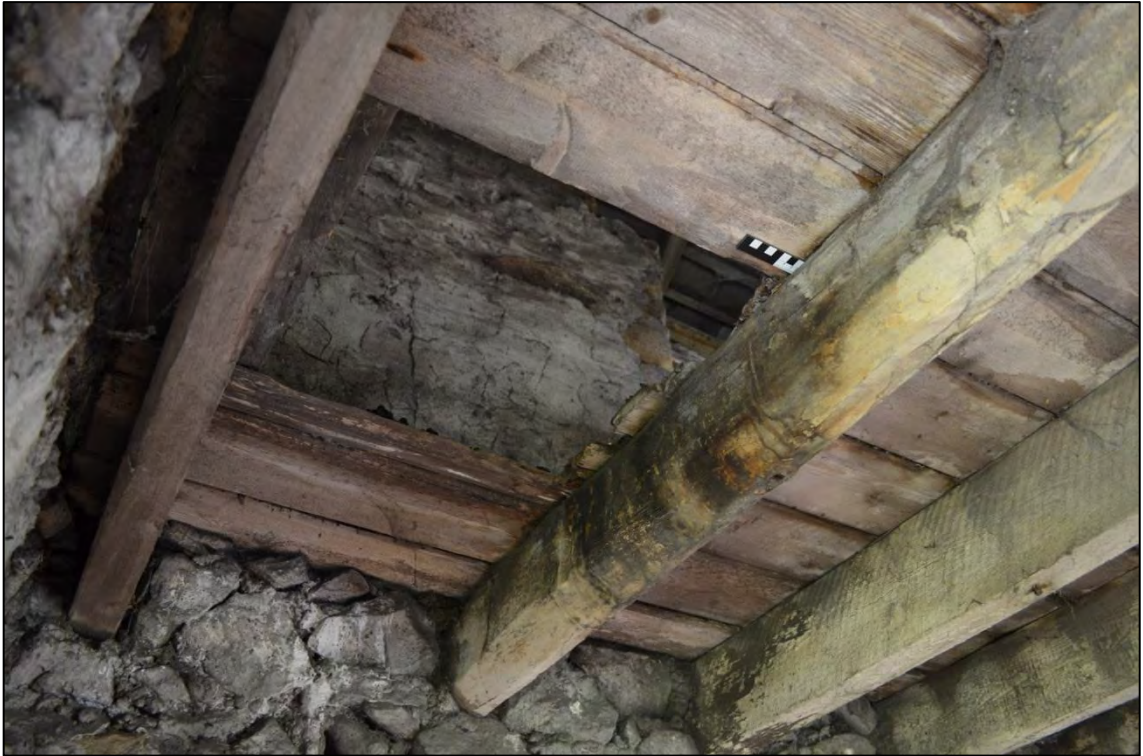
A series of brackets were identified within the ceiling of the room, comprising two iron brackets centrally within the roof, and two wooden battens supported either side of the opening in the centre of the west wall (**Appendix 2.10**). The character of these brackets was undiagnostic but were suggestive of some form of power transmission or cable/rope system. A hole in the ceiling in the south-west corner of the room had evidently had ropes or materials pulled through frequently resulting in an adjacent becoming heavily worn (**Appendix 2.9**).

Appendix 2.9: Detail of worn joist and hole in ceiling in southwest corner of **GI** (scale: 1cm intervals)

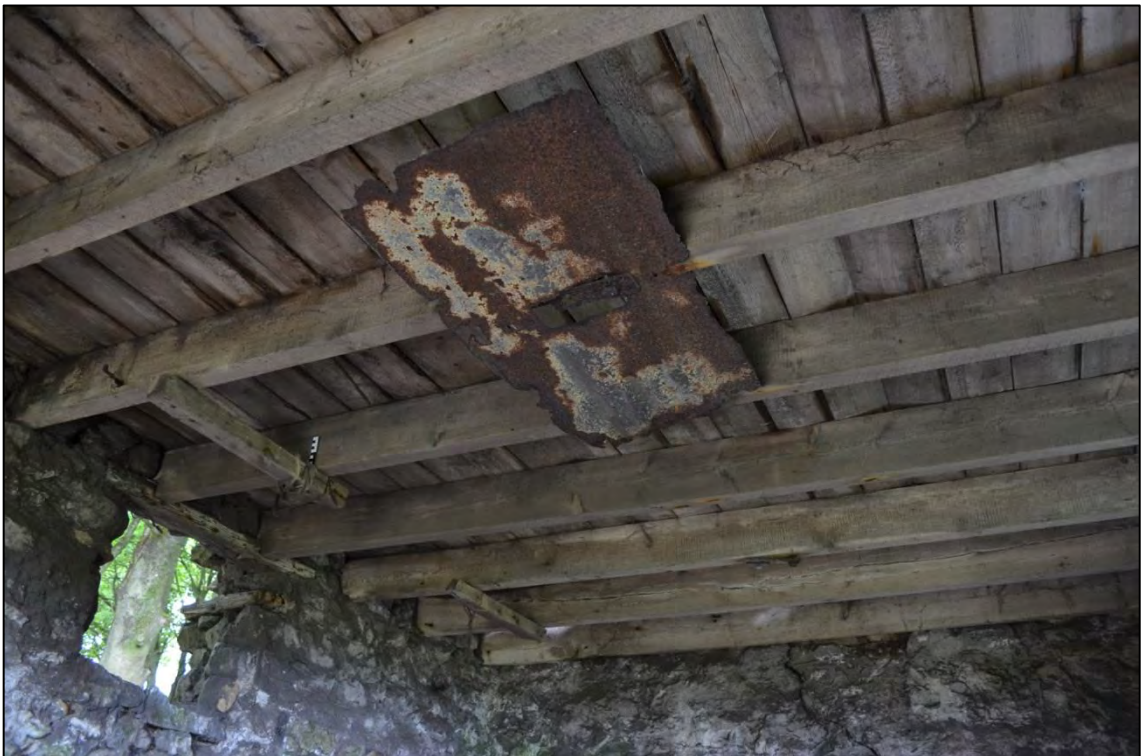
The presence of brackets on the ceiling within the ground floor correspond suggest that some machinery may have been installed within the building during this period. Whilst nothing remains to illustrate the form of function of the machinery, the brackets suggest that line shafting or, more likely, a rope/cable pulley system may have been transferred into the building through the hole in the west elevation, possibly suspended from the brackets on the ceiling. The stone slabs identified in the floor in the northeast corner of the room could represent a machine base.

Appendix 2.10: Detail of brackets on ceiling of **GI**, centred on west window (scale: 10cm)

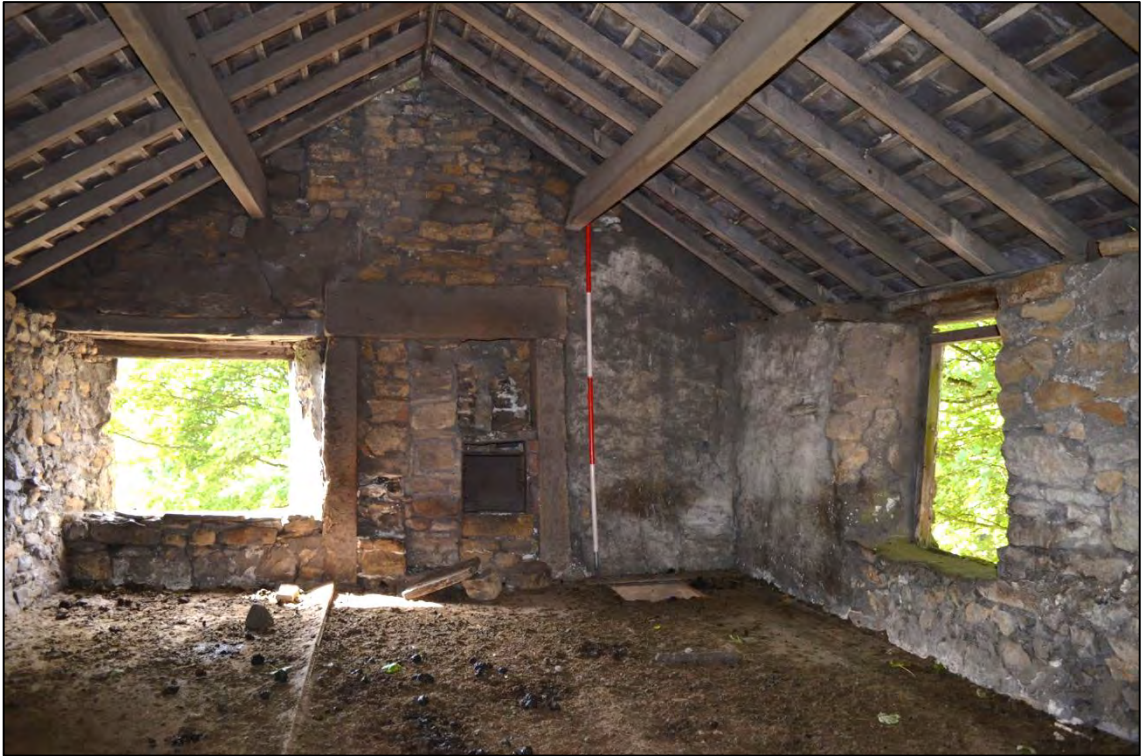
The first floor similarly comprises as single space (**Appendix 2.11**) with a wooden boarded floor, largely bare stone walls, and a ceiling open to the rafters. A fireplace is situated in the centre of the southern wall (**Appendix 2.12**) formed within a plain stone fire surround with narrow vertical posts and broader flat lintel. The fireback was of rough stone, with some evidence of phasing including a blocked central stone lined hole (**Appendix 2.13**; possibly a flue) and inserted shelves to either side of a small central hearth that would have supported a range, the oven box of which survives.

Appendix 2.11: General view of FI, looking south (scale: 2m)

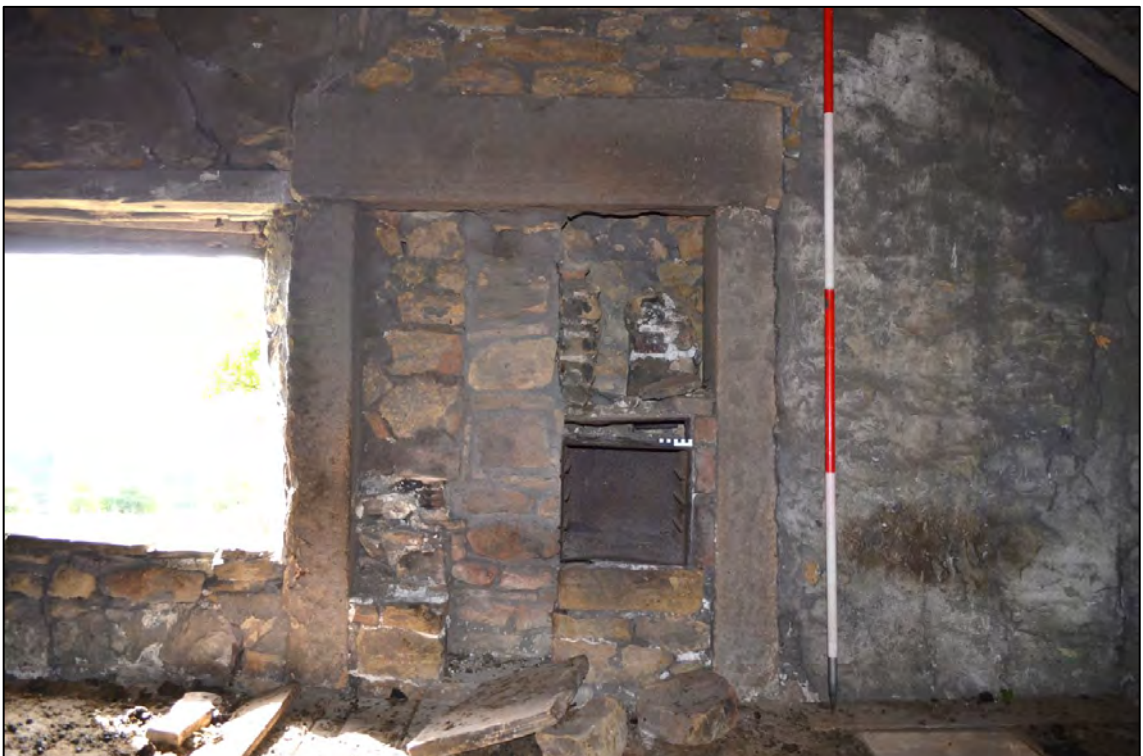
Although the building itself retains few diagnostic architectural features, the stone surround around the fireplace on the first floor is of a style commonly associated with the 18<sup>th</sup> century, although a late adoption of the style, or reuse, in the 19<sup>th</sup> century cannot be ruled out.

The fireplace in the first-floor room also shows signs of alteration, potentially to facilitate the installation of a cast iron open-hearth range, of which part of the oven still survives. The range would have most-likely included a water boiler on the left side of the central fire. Such ranges were invented in the late 18<sup>th</sup> century but remained in use well into the late 19<sup>th</sup> century.

Appendix 2.12: Detail of fire place in FI (scales: 2m & 10cm)

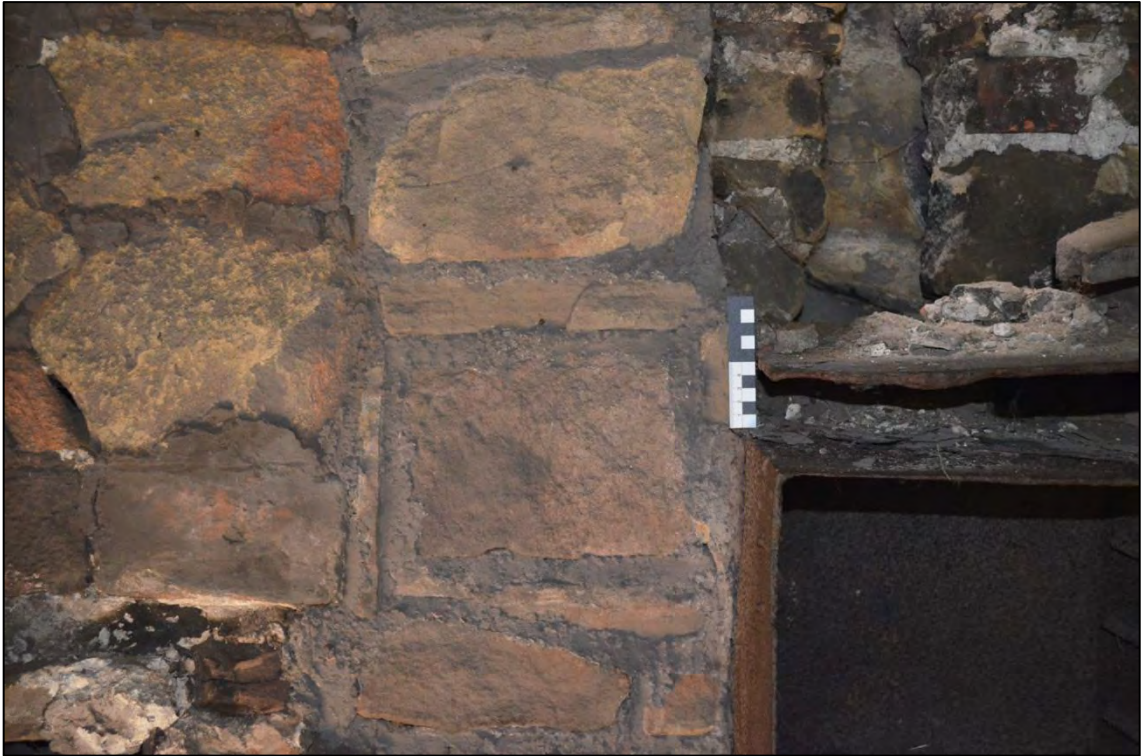
Appendix 2.13: Detail of blocking in back of fireplace (scale: 10cm)

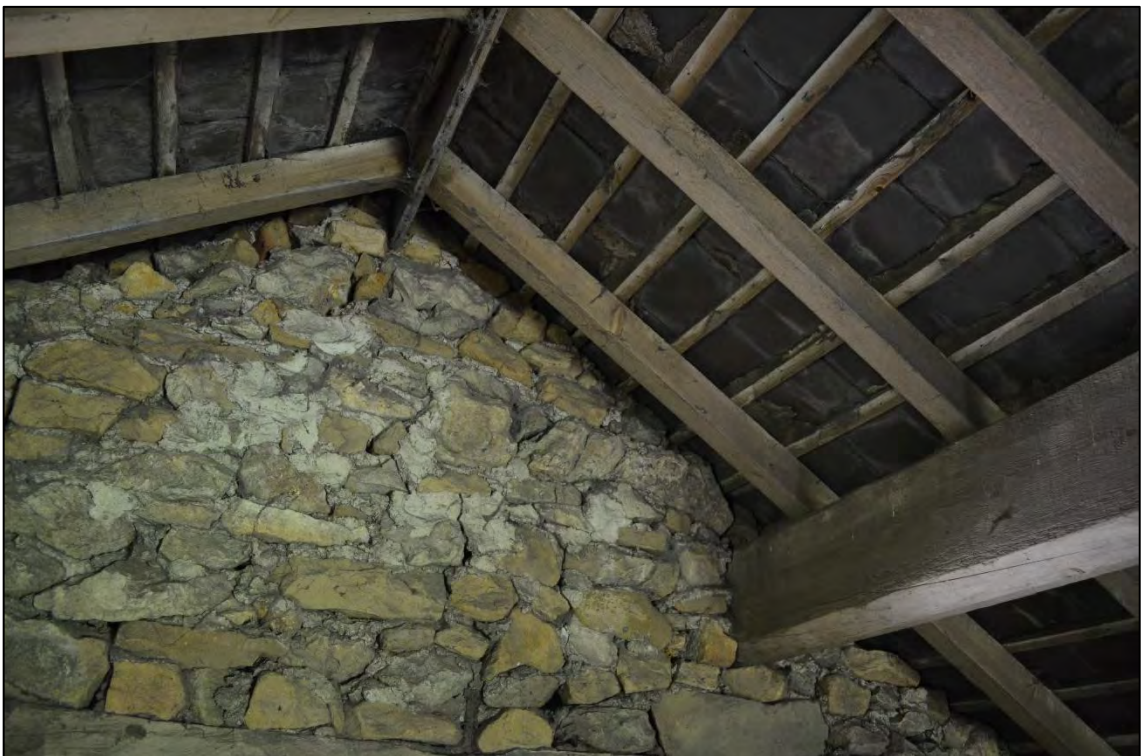
Appendix 2.14: Detail of replaced roof structure above FI
