HOOTON PAGNELL HALL

STRUCTURAL WATCHING BRIEF DURING ALTERATIONS TO THE LIBRARY FLAT

March 2020

Document No: TJC2020.12
Planning Application No: 19/02682/LBC (Condition 5)
OASIS No: thejesso1-380659

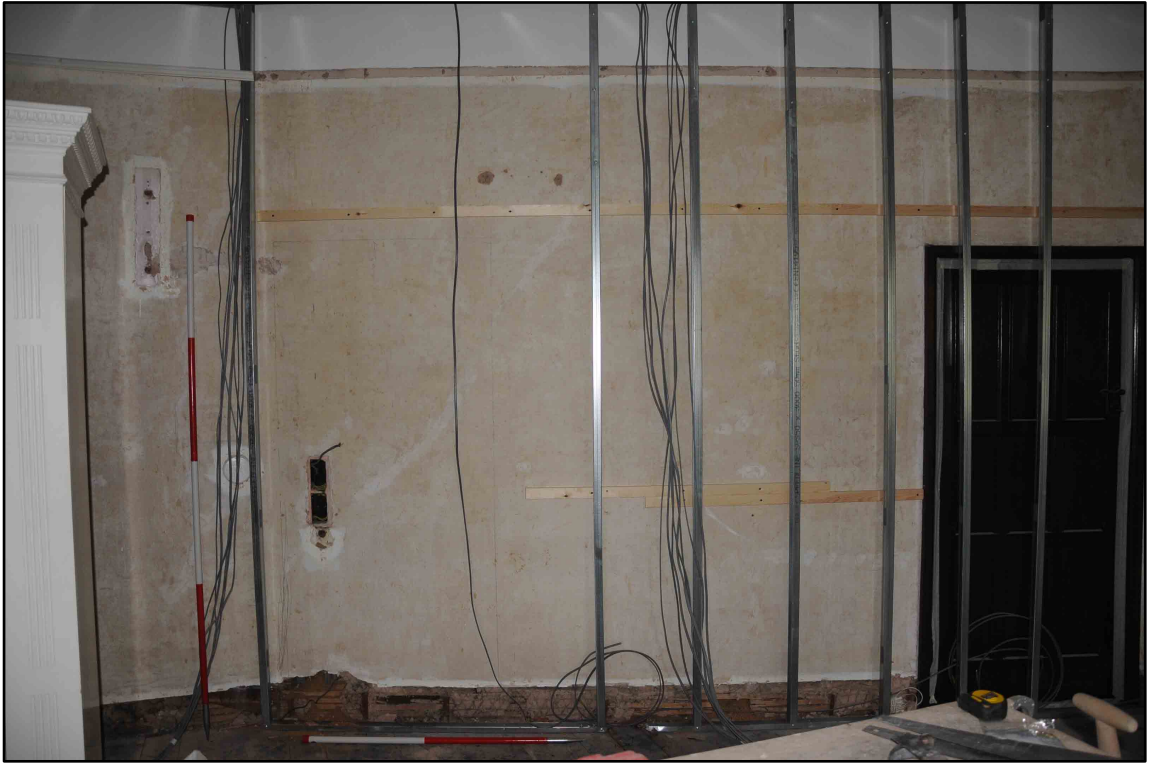
The north-west section of walling where the new doorway opening was formed was a timber stud construction with a lath and plaster surface finish (**Appendix 2.5**). The studs were machine sawn softwood measuring 6cm × 8cm and set at 36-38cm centers (**Appendix 2.16**). Integral to the primary phase of construction of the studwork were two rows of diagonal softwood noggins (**Appendices 2.15, 2.17**), arranged at 0.8 and 2.1m above the floor. Unusually there was no soleplate to the stud wall, and the individual studs were notched at the lower end and housed above a horizontal baton secured to the floor (**Appendix 2.18**).

Appendix 2.5: Detail of west wall of **Bedroom 4** prior to works (1m/2m scale; b/w Film I.6)

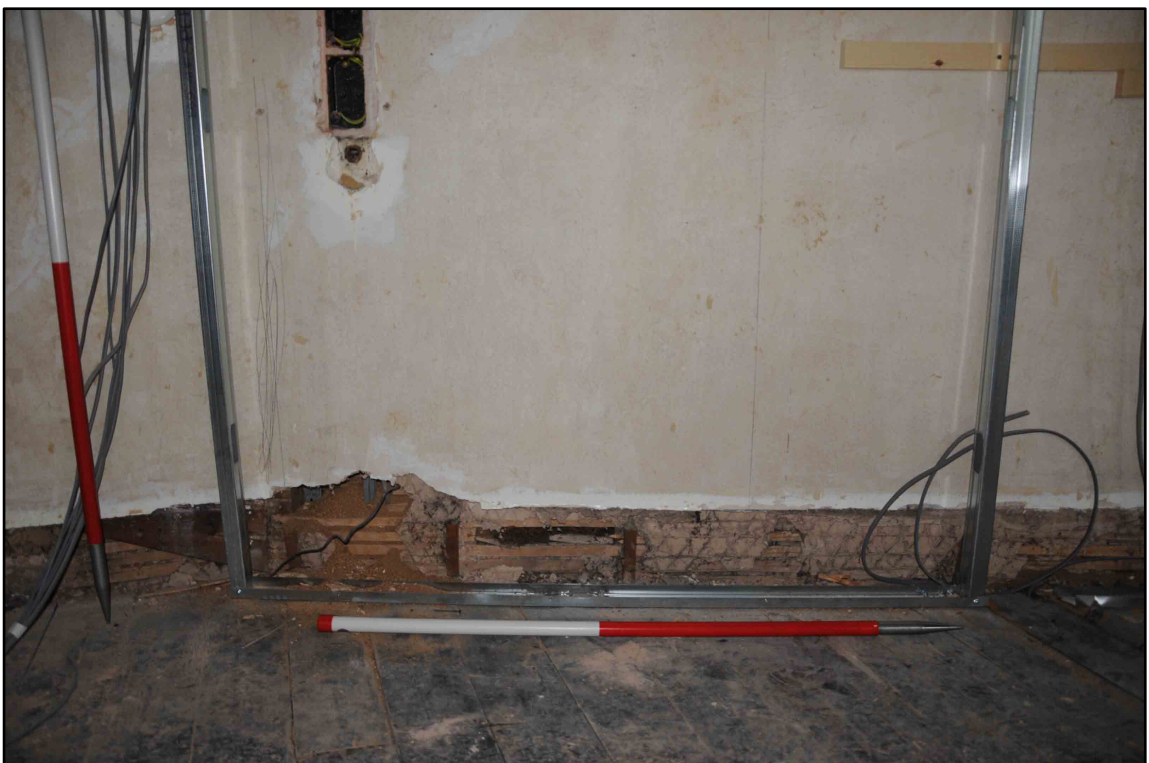
Secured to the studs were riven laths, most likely chestnut, fixed with hand cut nails (**Appendix 2.11**). The laths were arranged in irregular offset blocks of varying lengths up to 1.08m (**Appendix 2.9**). Nailed onto the top of the laths were short 12cm vertical strips of timber 12cm onto which the skirting board was attached (**Appendices 2.6, 2.20**).

Appendix 2.6: Detail behind skirting in **Bedroom 4** prior to works (1m scale; b/w Film I.10)

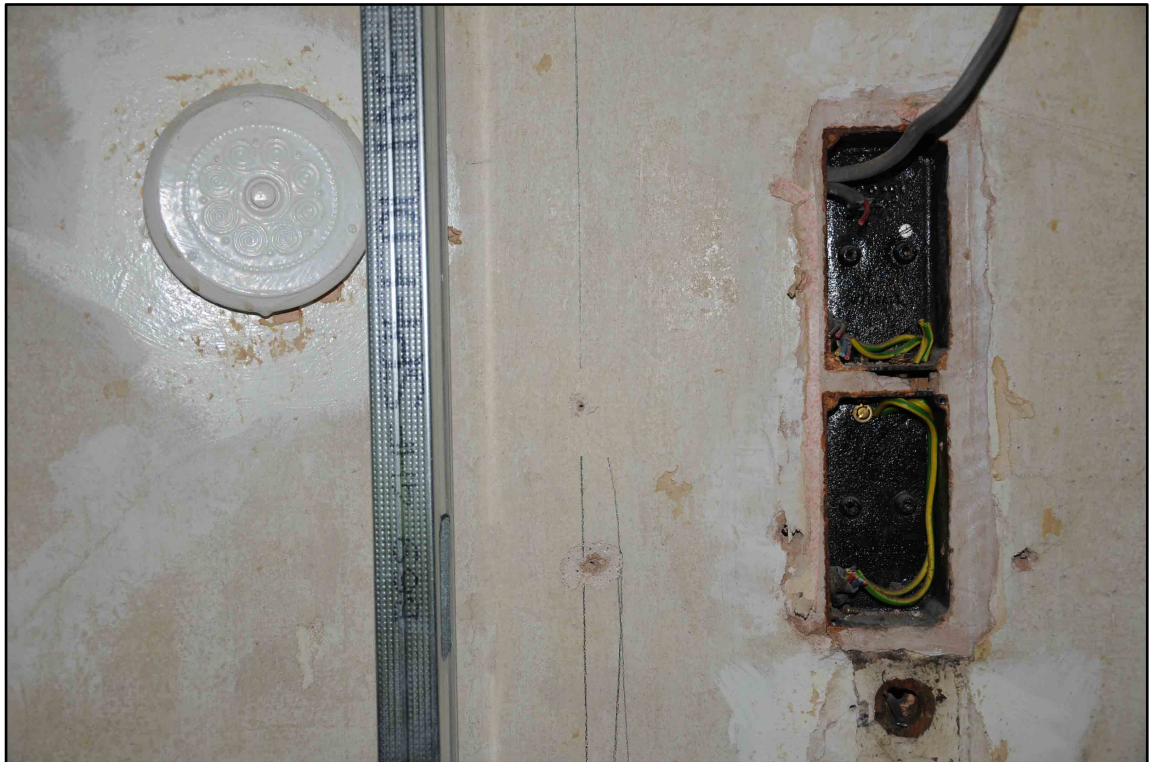
The room underwent changes to the wiring in May 1979 where two metal housings for light switches were inserted breaking the laths, c.0.9m above the floor (**Appendix 2.7**). Associated with this was a new push light switch at a height of 0.7m with an embossed metal design in the shape of

Appendix 2.7: Detail of push switch and housing in **Bedroom 4** prior to works (b/w Film I.12)

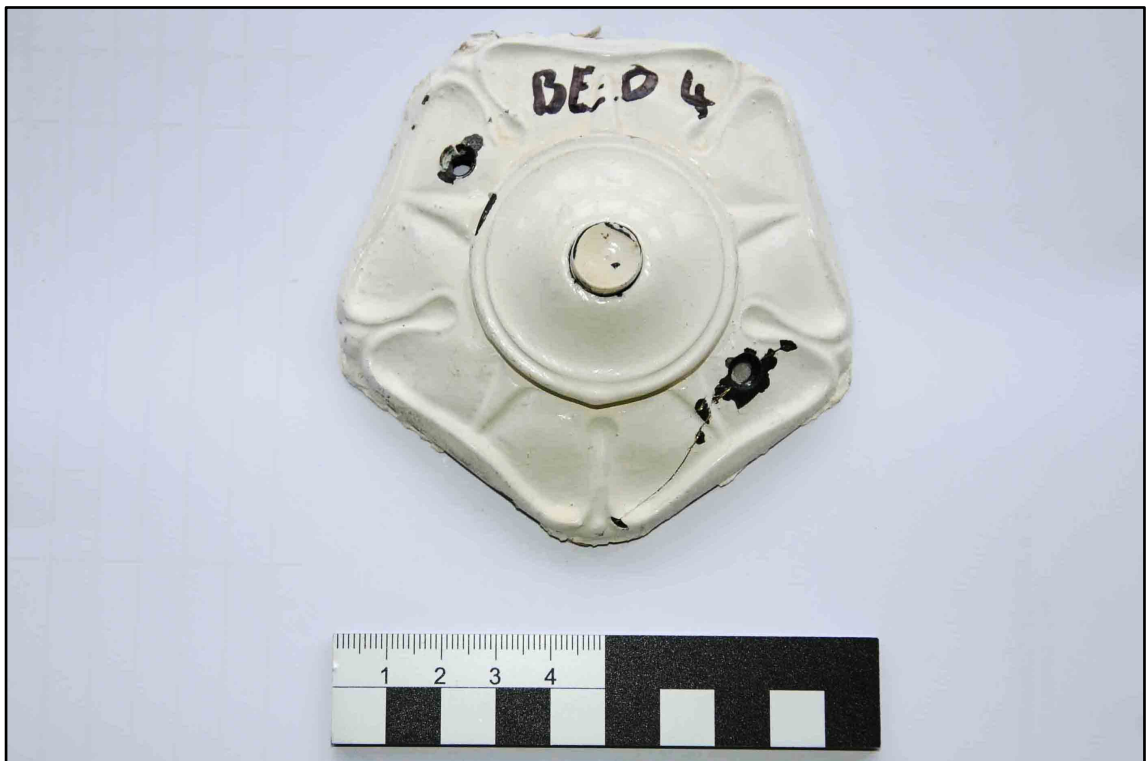
a Tudor rose (**Appendix 2.8**). Packed behind the inserted wiring was a fragment from a Daily Mail newspaper dated 22nd May 1979 (**Appendix 2.10**), which provides a timeframe for when the work was undertaken.

Appendix 2.8: Detail of push switch cover in west wall in **Bedroom 4** (10cm scale; b/w Film I.15)

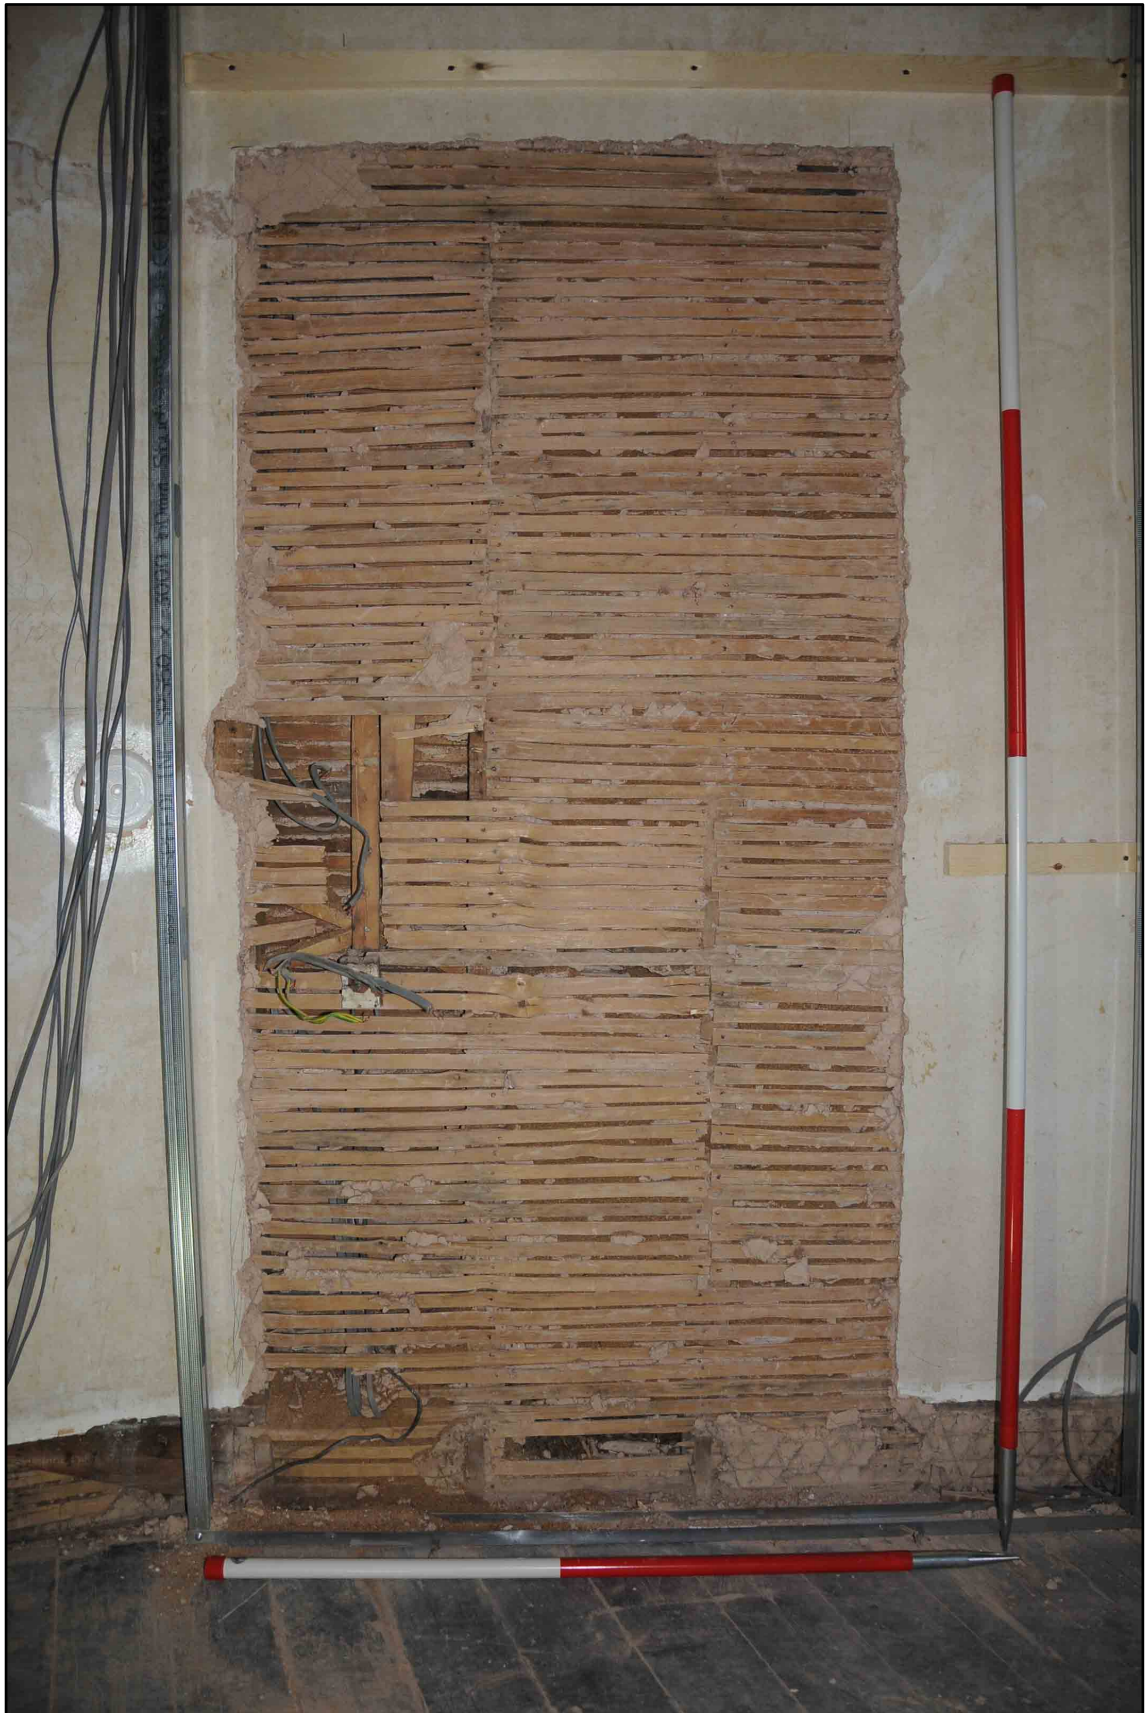
Appendix 2.9: West wall of **Bedroom 4** following plaster removal (1m/2m scale; b/w Film 1.24)

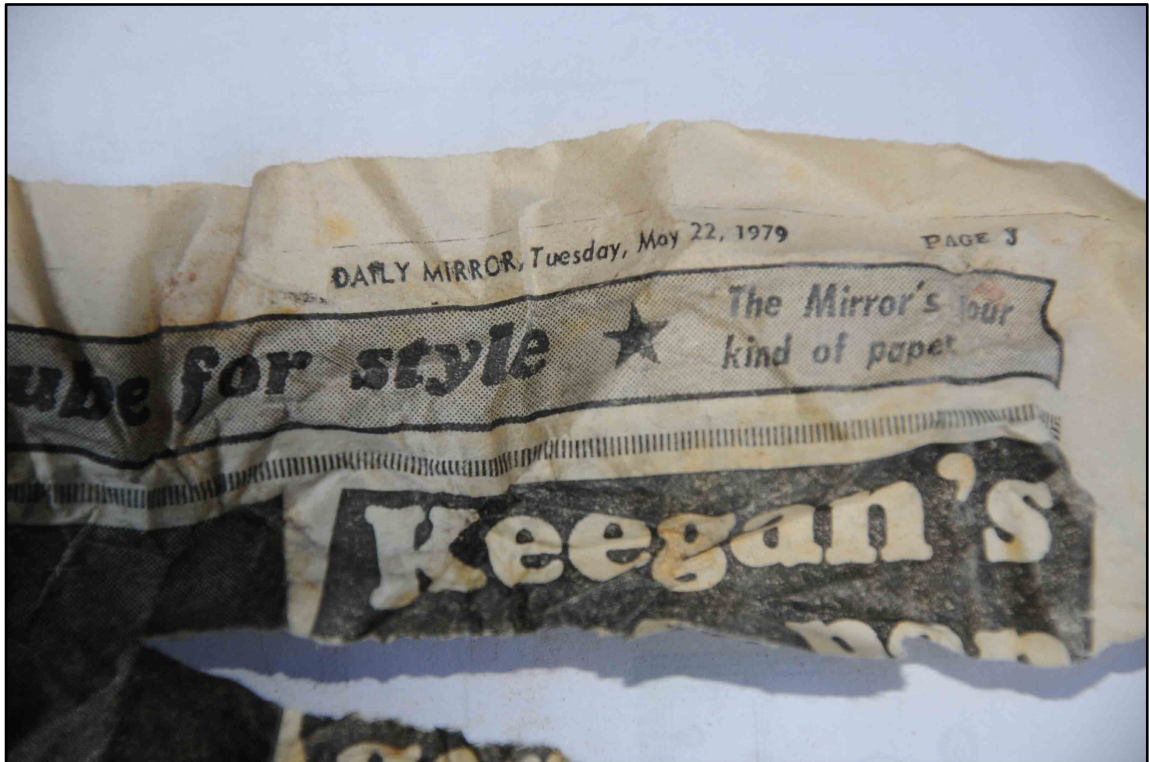
Appendix 2.10: Detail of newspaper behind switch housing – 22nd May 1979 (b/w Film 1.22)

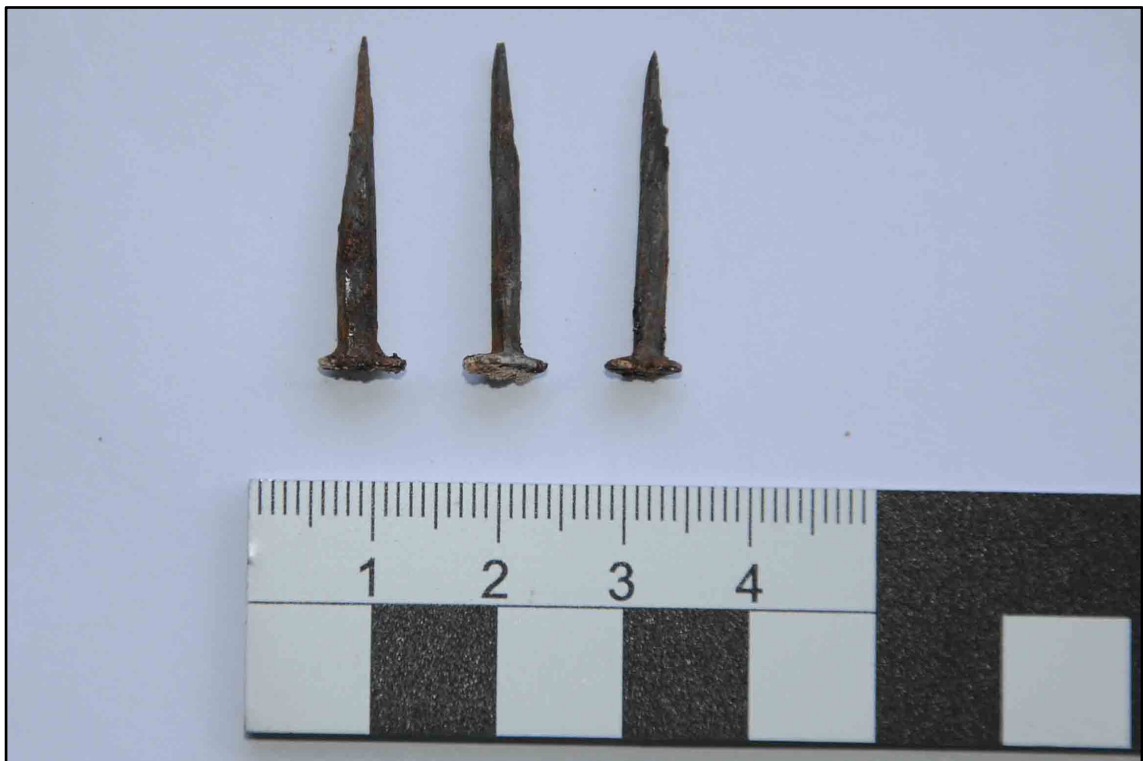
Appendix 2.11: Detail of nails used to secure laths for wall plaster (5cm scale)

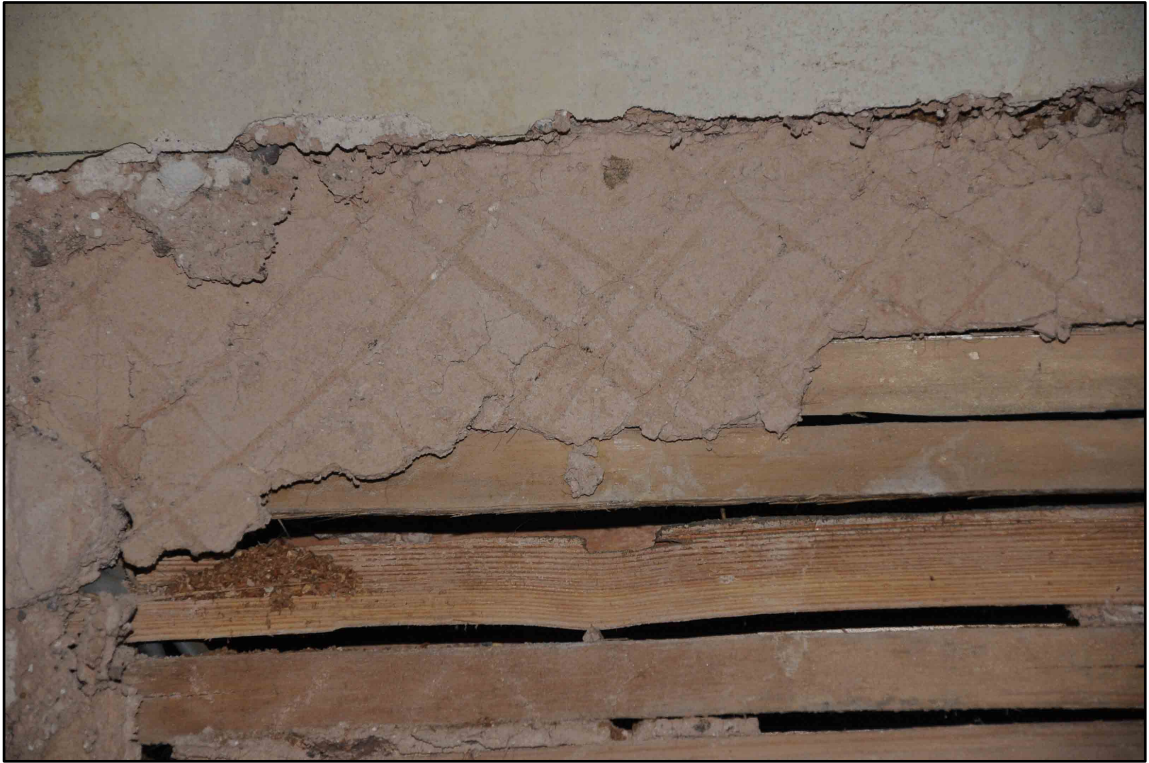
The plaster attached to the laths comprised of two layers, the lowest being a scored scratch coat (**Appendix 2.12**) acting as a key for the smooth surface finish. It was noted that the lime mix varied on the two sides of the wall, with a pink mix used for **Bedroom 4**, whilst in the **Corridor** a white lime mixture was used. The reason for the variety in the plaster mixes is unclear, however does suggest that the individual rooms may have been plastered in stages using different sources of sand and lime.

Appendix 2.12: Detail of scratch coat plaster in west wall of **Bedroom 4** (b/w Film 1.23)

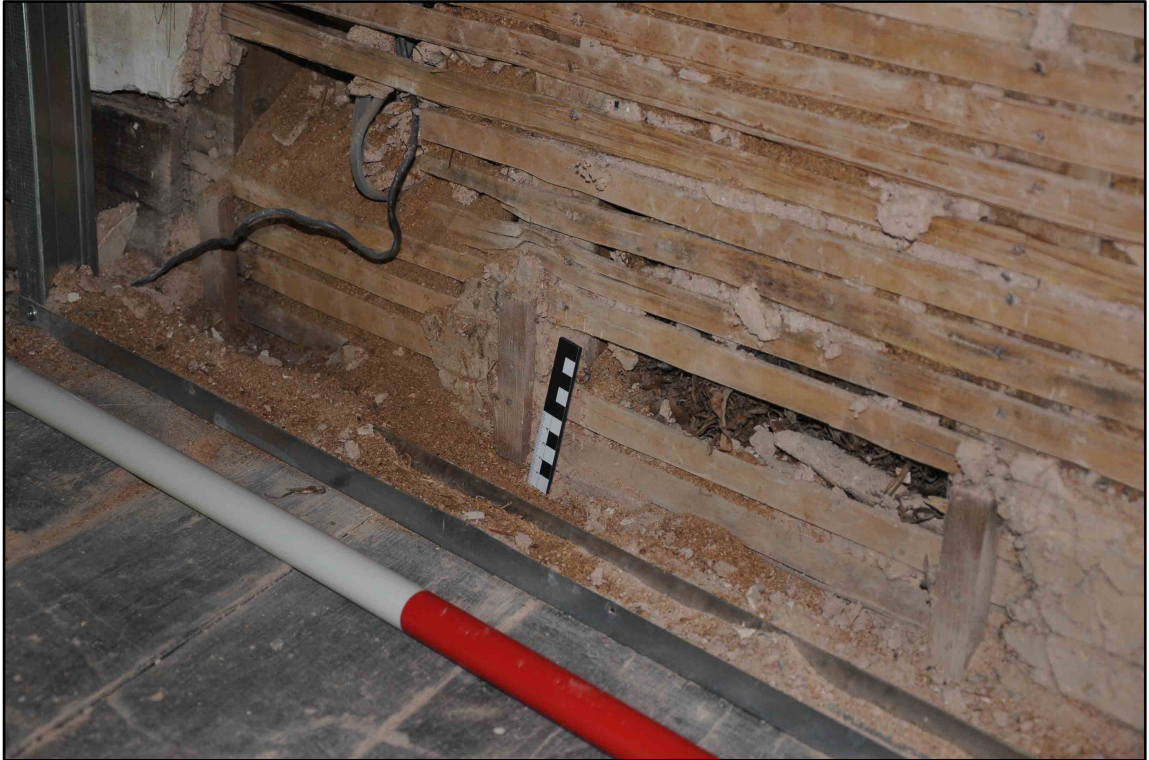
Appendix 2.13: Detail of batons to secure skirting in west wall (10cm scale; b/w Film 1.26)

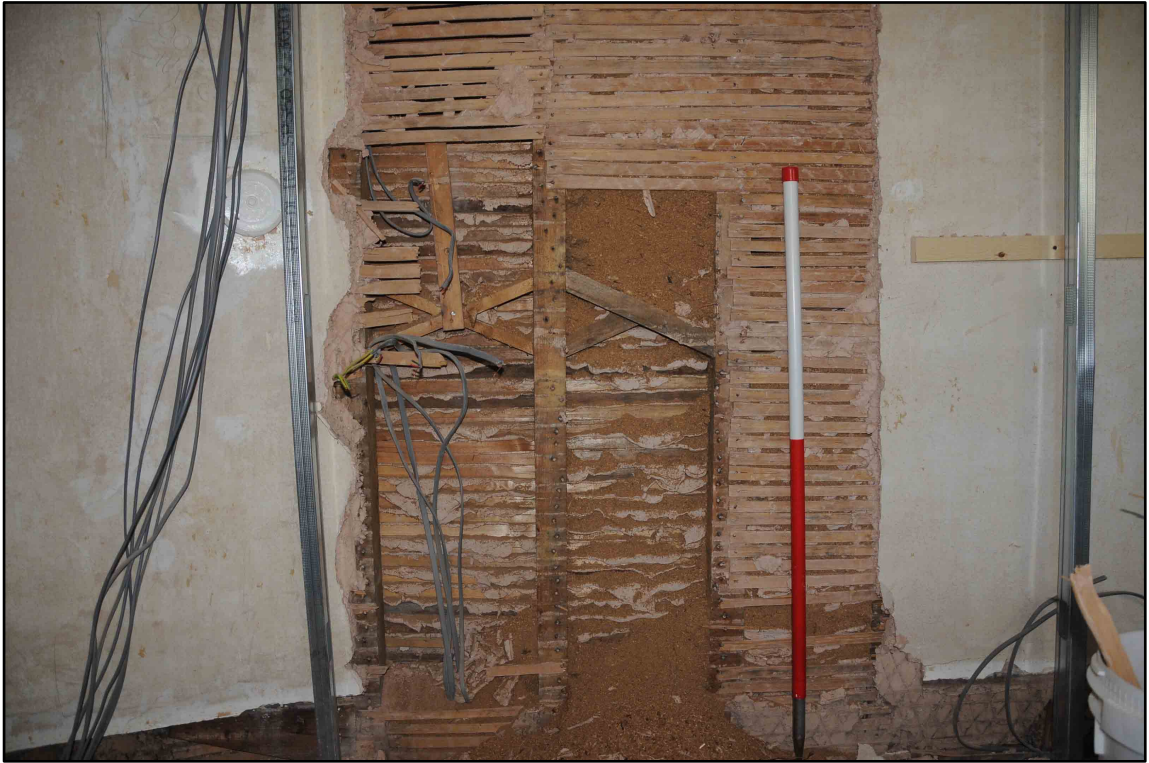
One curious aspect of the stud walling is that the voids between the studs were filled with a fine sawdust (**Appendix 2.24**), which may have been an attempt to introduce sound proofing and a greater thermal efficiency of the wall similar to the effect of using pugging below the floorboards.

Appendix 2.14: West wall of **Bedroom 4** during of laths; note sawdust (1m scale; b/w Film I.28)

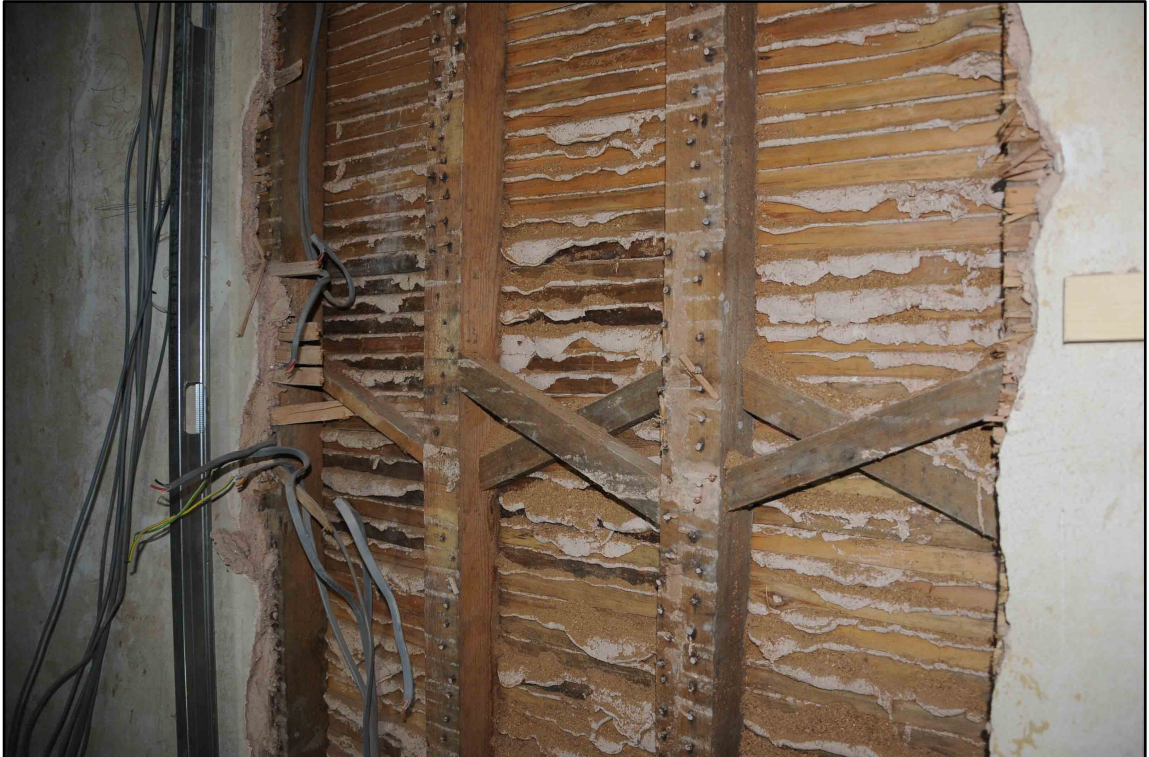
Appendix 2.15: Detail of timber noggins in **Bedroom 4** following removal of laths (b/w Film I.32)

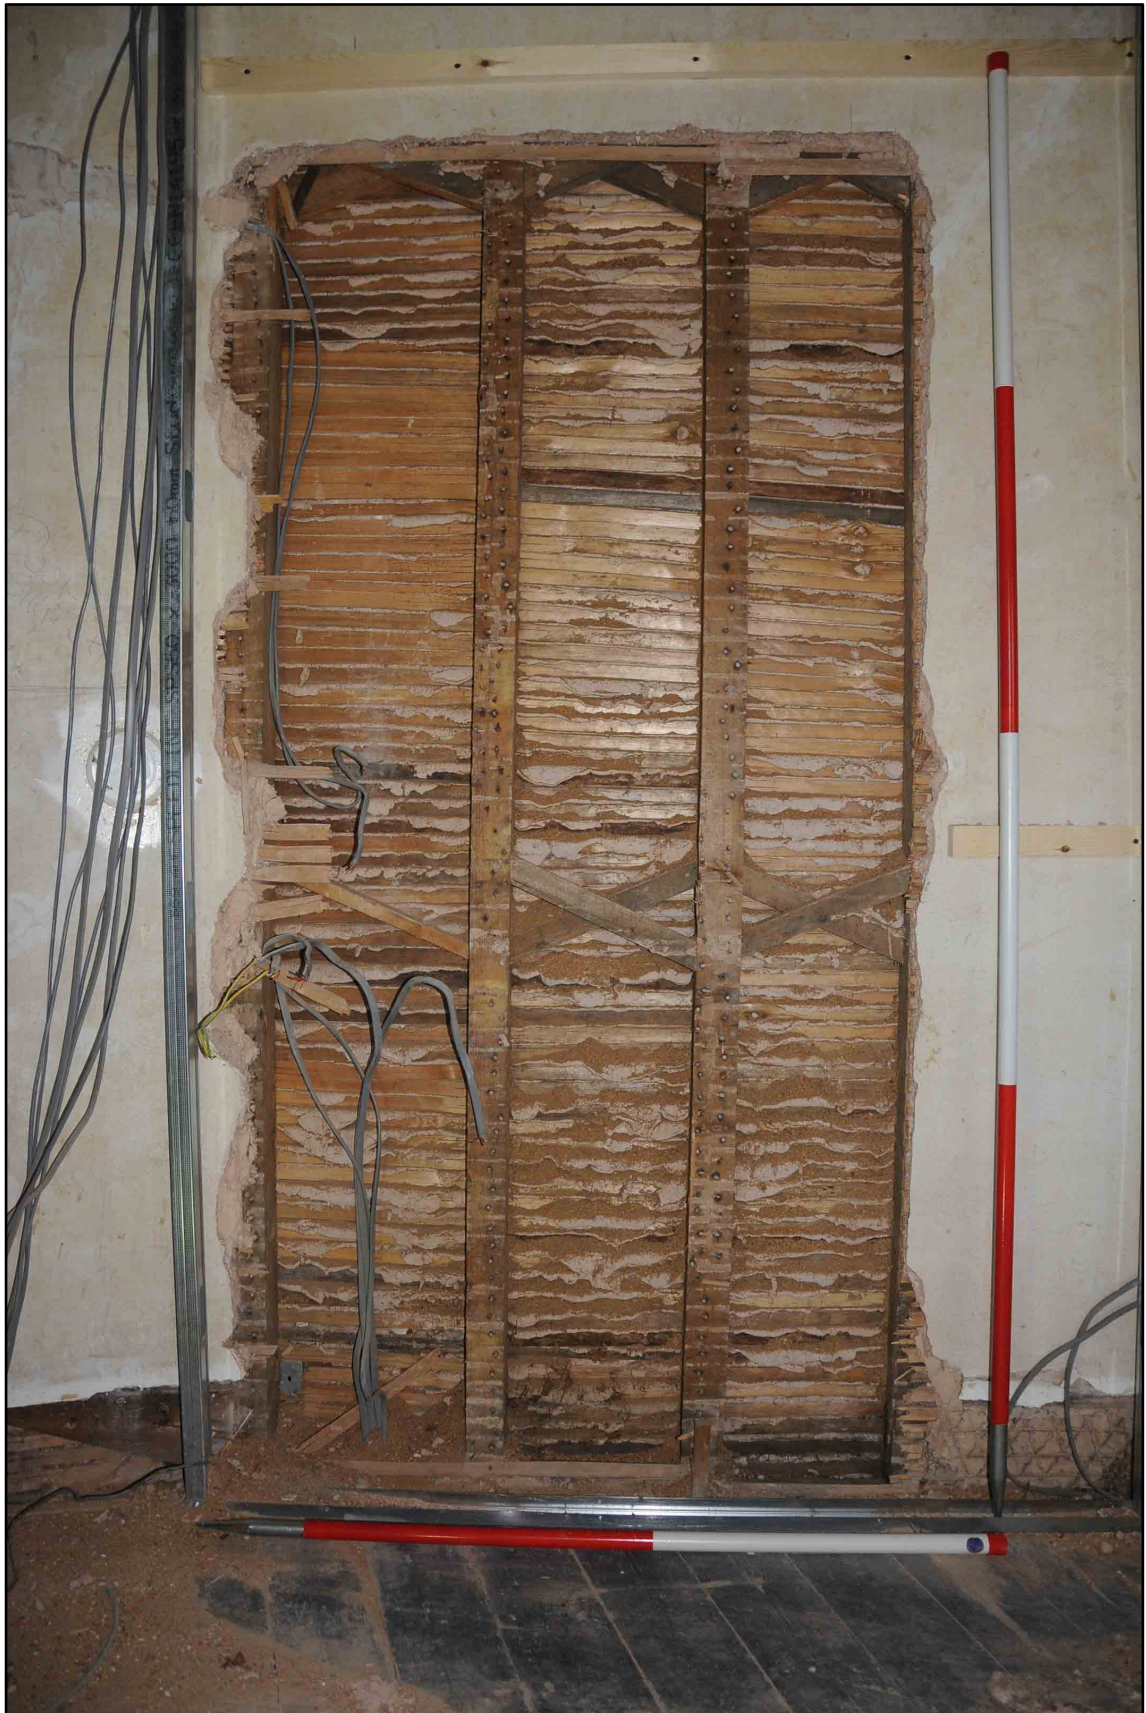
Appendix 2.16: West wall of **Bedroom 4** following lath removal (1m/2m scale; b/w Film 1.30)

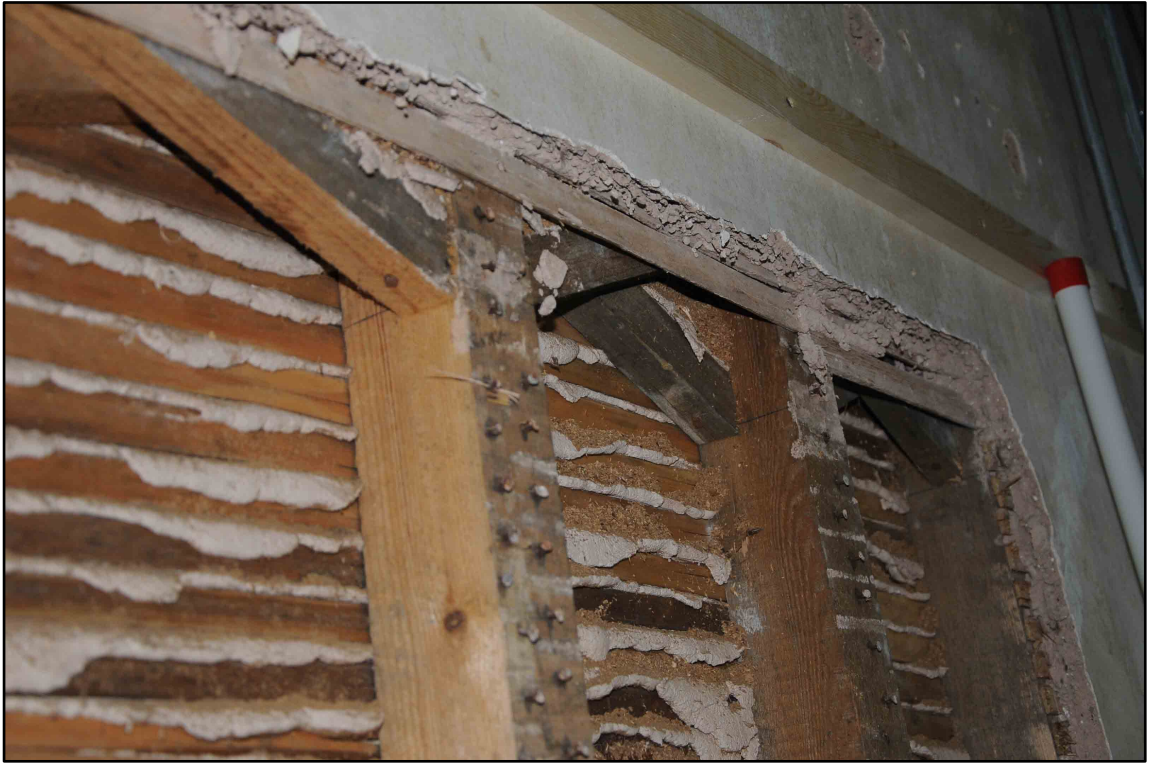
Appendix 2.17: Detail of timber noggin in **Bedroom 4** following removal of laths (b/w Film 1.33)

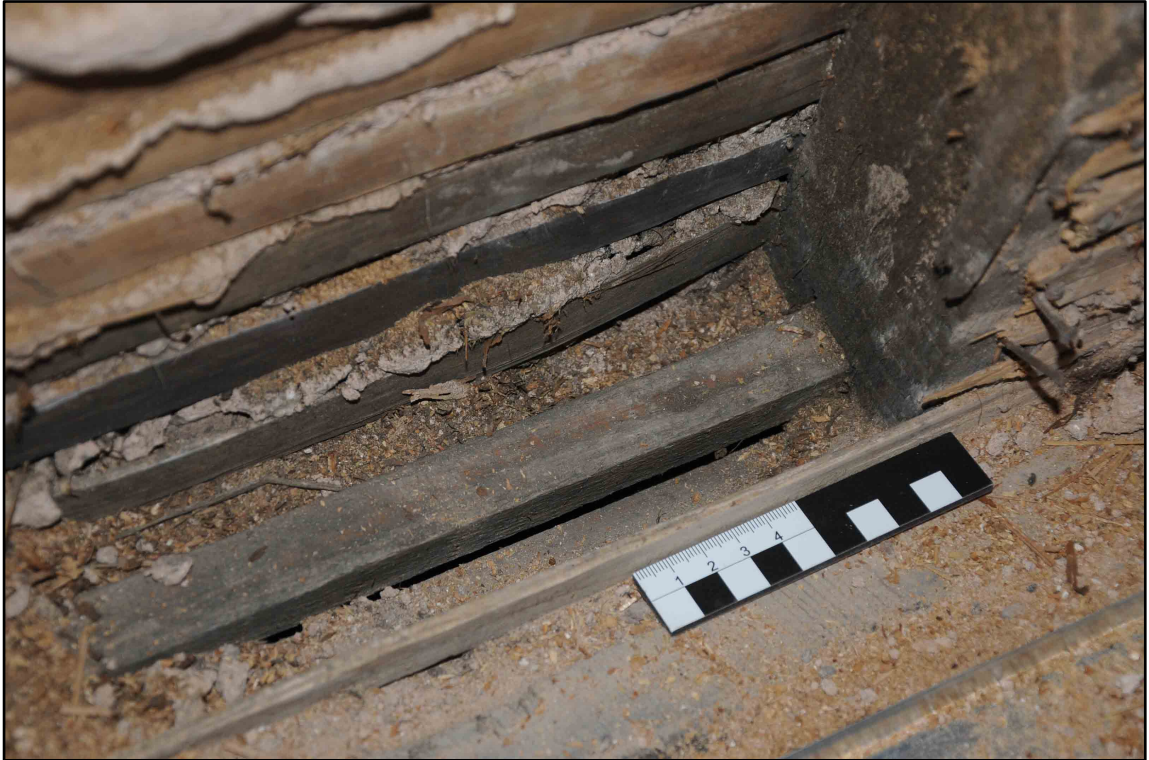
Appendix 2.18: Detail of notch at base of wall studs in **Bedroom 4** (10cm scale; b/w Film 1.34)

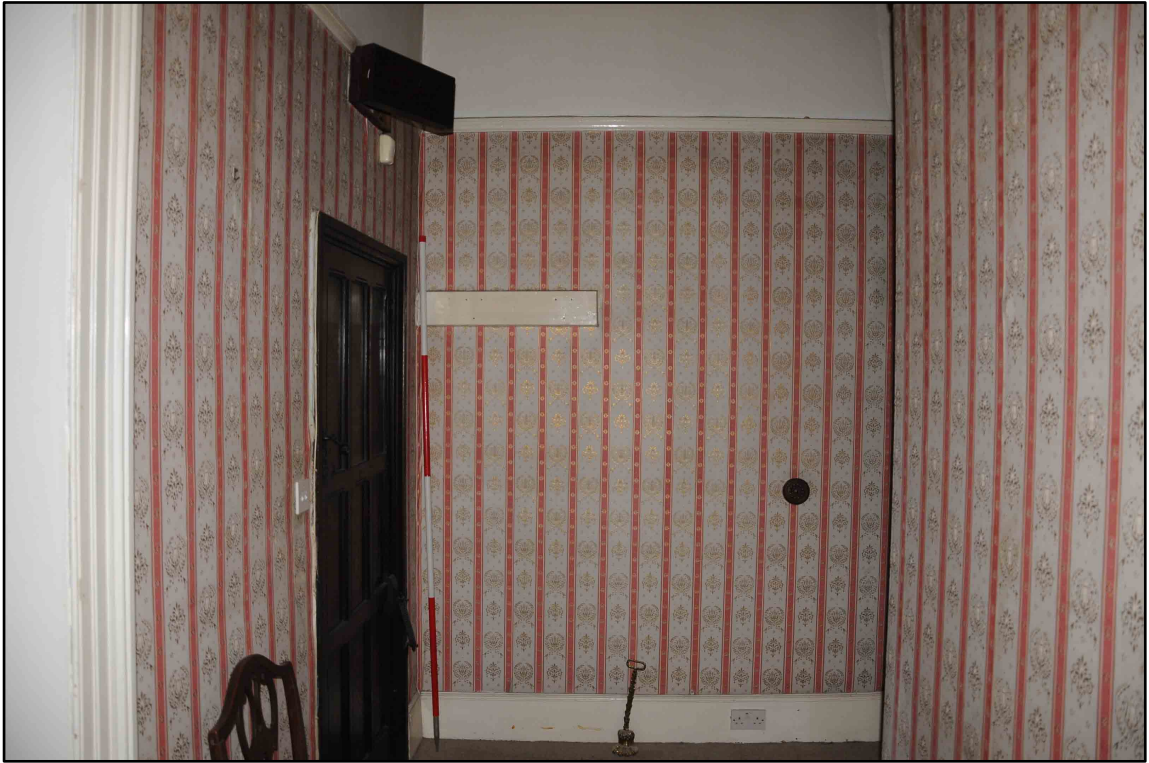
Appendix 2.19: View of position of new door in **Corridor 2** (2m scale; b/w Film 1.16)

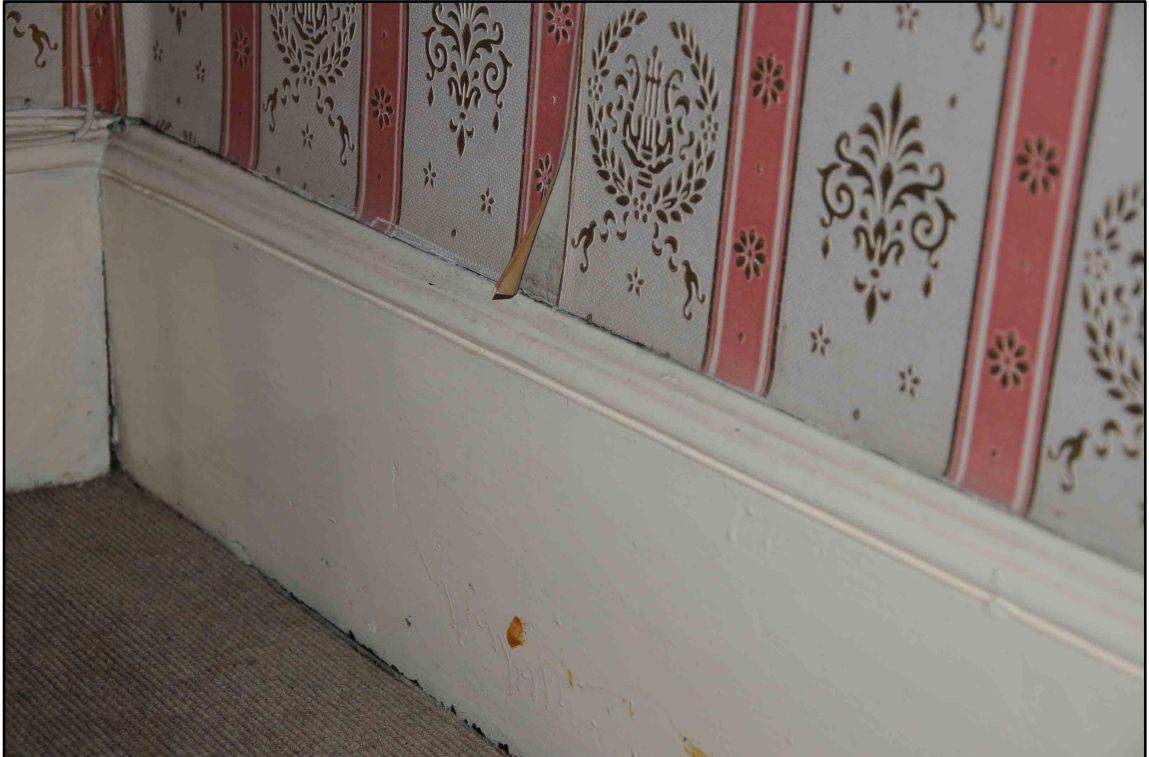
The corridor forms a connection between rooms in the Main House and the Library Flat dating to the 1894-1904 phase of alterations. There is a high timber skirting with a typical profile common at the end of the 19th Century (**Appendix 2.20**) and a simple picture rail 2.7m above the floor. The wall covering is a slightly embossed machine printed wallpaper (**Appendix 2.19**). The watching brief noted no new features of archaeological significance exposed within this part of the building, apart from the use of a white plaster mix (see section above).

Appendix 2.20: Detail of skirting in **Corridor 2** (b/w Film 1.19)

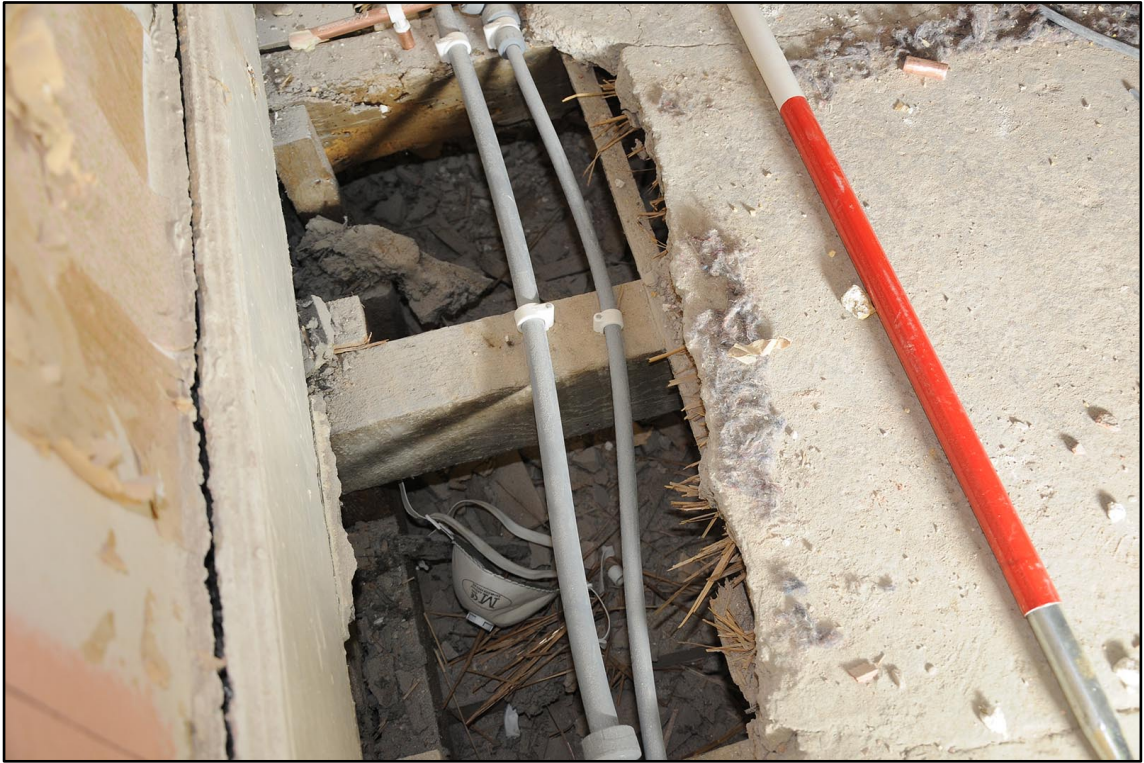
- The flooring in the adjacent room to the south-east and along the central corridor was a lime ash construction laid on reeds (**Appendix 2.21**);
- The roof space above the Hall Cottages was supported on king-post trusses with evidence of a white paint, or limewash (**Appendix 2.22**);
- Traces of 19th Century wallpaper were noted in the window reveals of the room to the north-west of the staircase (**Appendix 2.23**).

Appendix 2.21: Lime-ash floor in adjacent room to the south-east of **Bedroom 4** (0.5m scale)

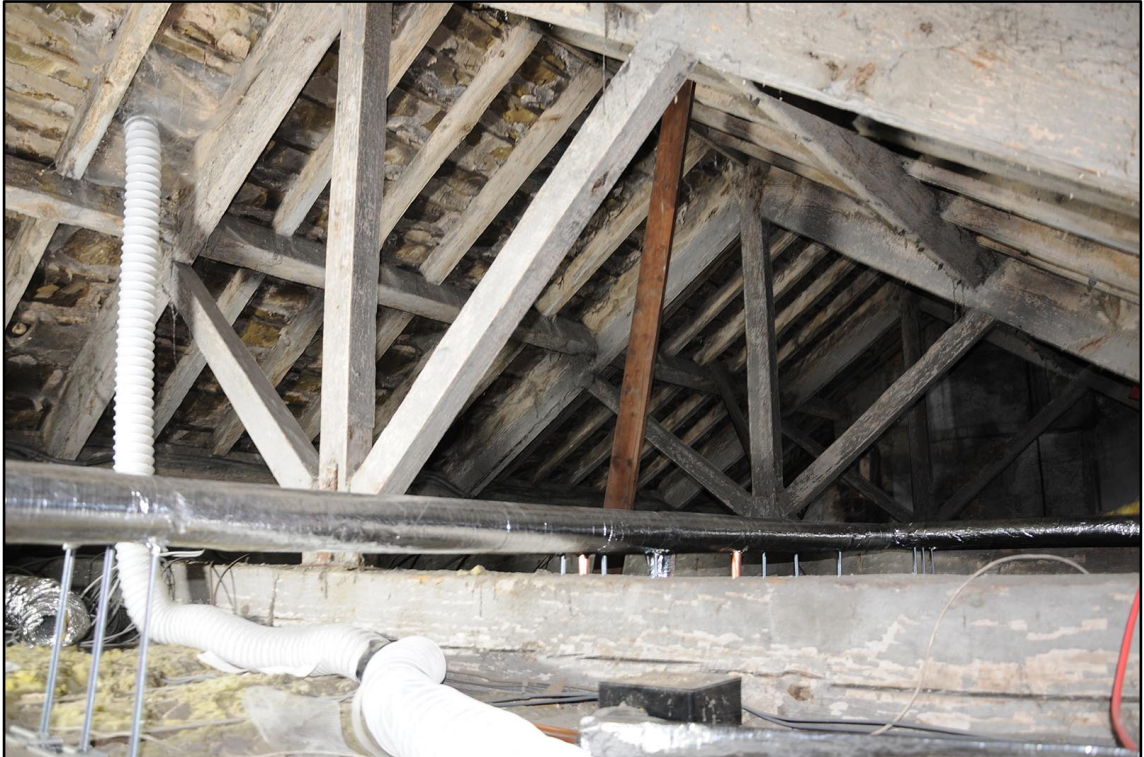
Appendix 2.22: Detail of roof structure above **Hall Cottages**, looking south-east

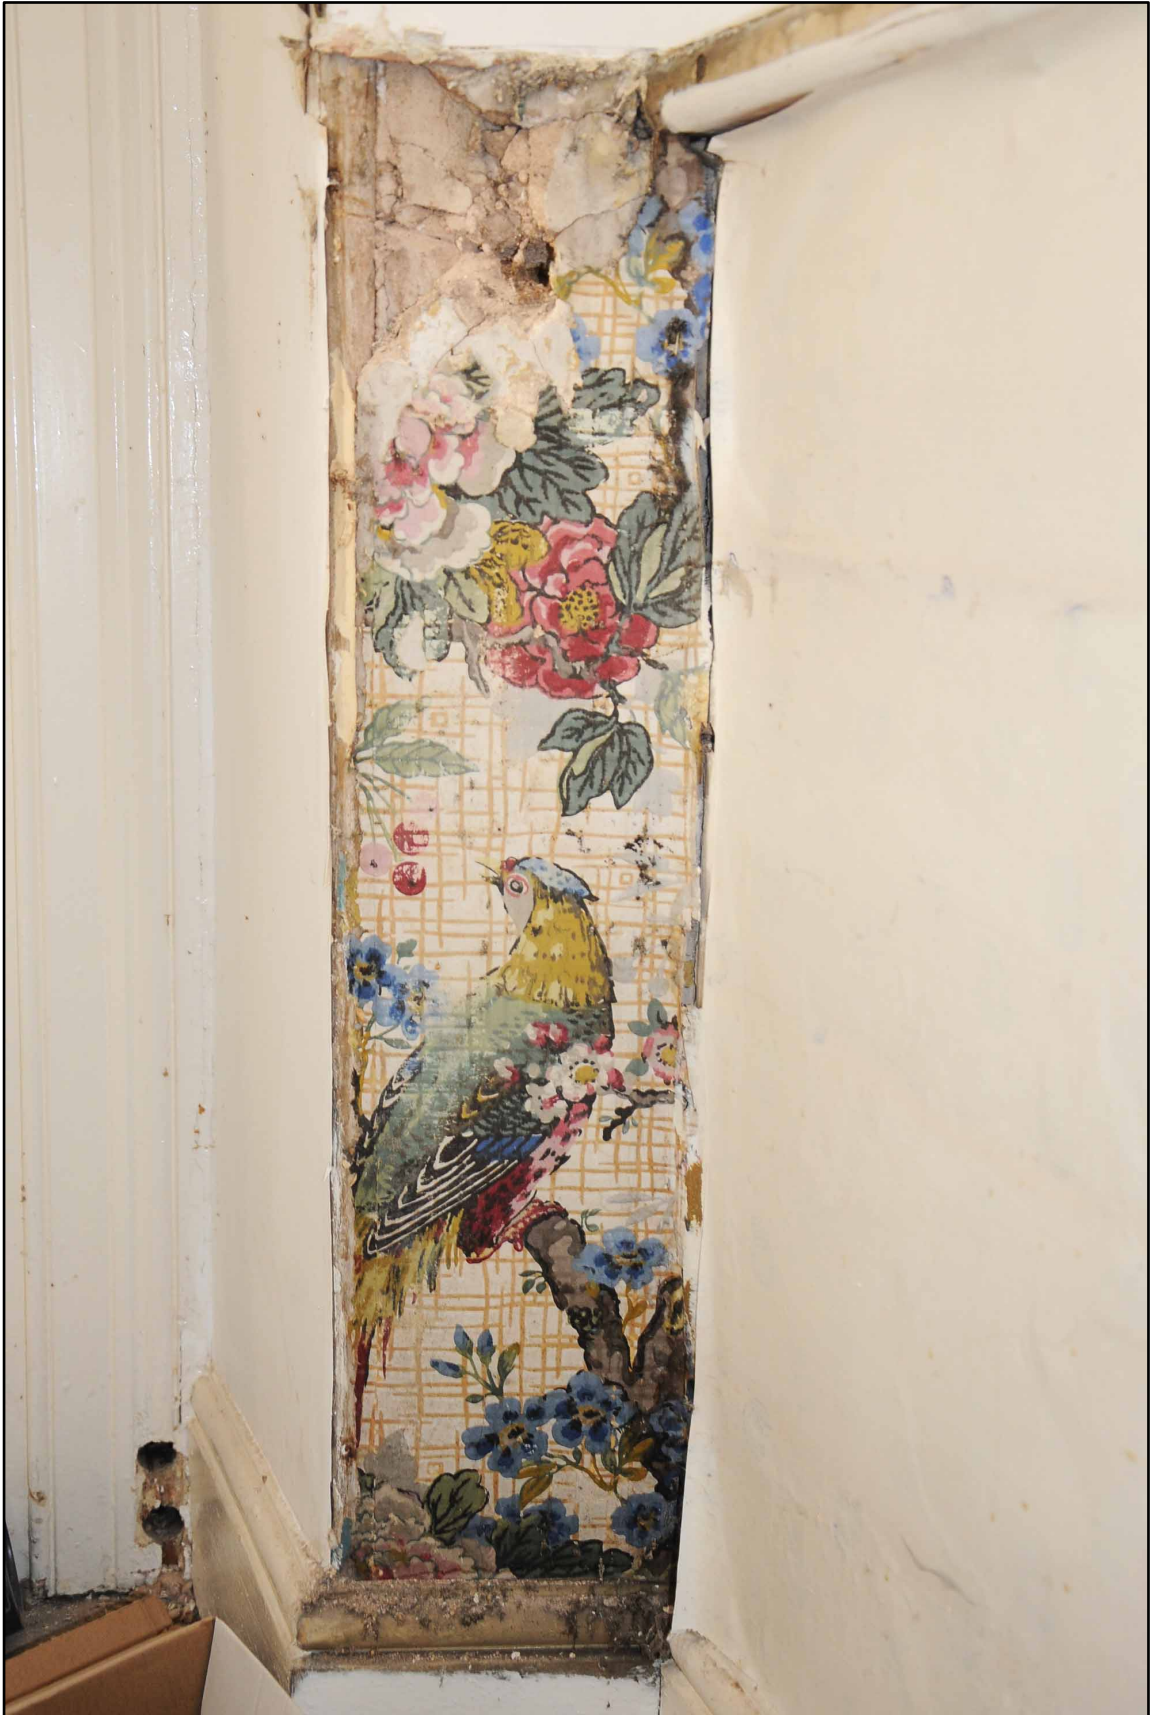
Appendix 2.23: Detail of wallpaper in window reveal in room to the north-west of the staircase
