# LOWER EASTFIELD FARM

Thurgoland, South Yorkshire

## Historic Building Record

April 2020  
Final

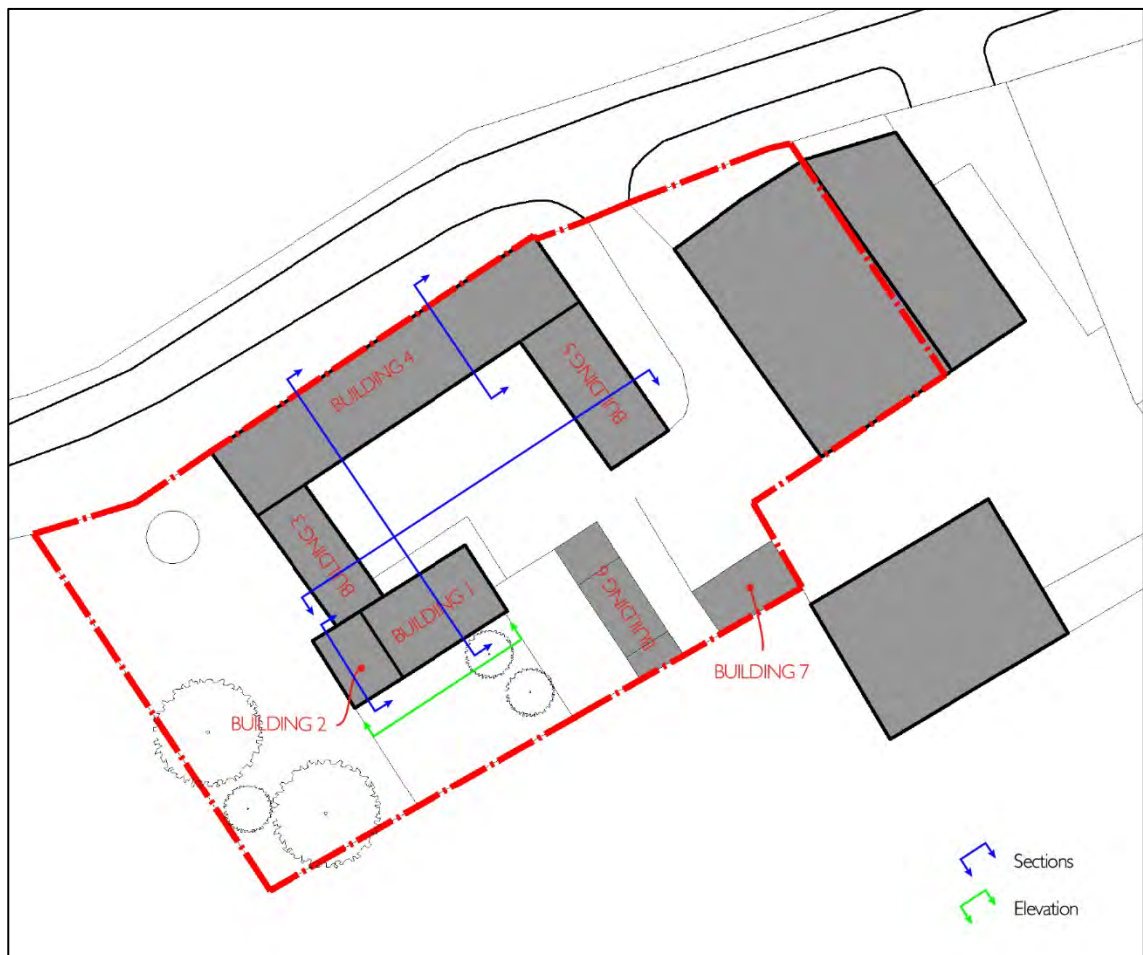
Figure 2: Site Layout showing proposed section and elevation drawings

The farm comprises a collection of agricultural buildings and a farmhouse (**Figure 2**), principally arranged around a regular courtyard plan with detached buildings to the south-east and larger modern sheds beyond the site boundary to the south-east and east.

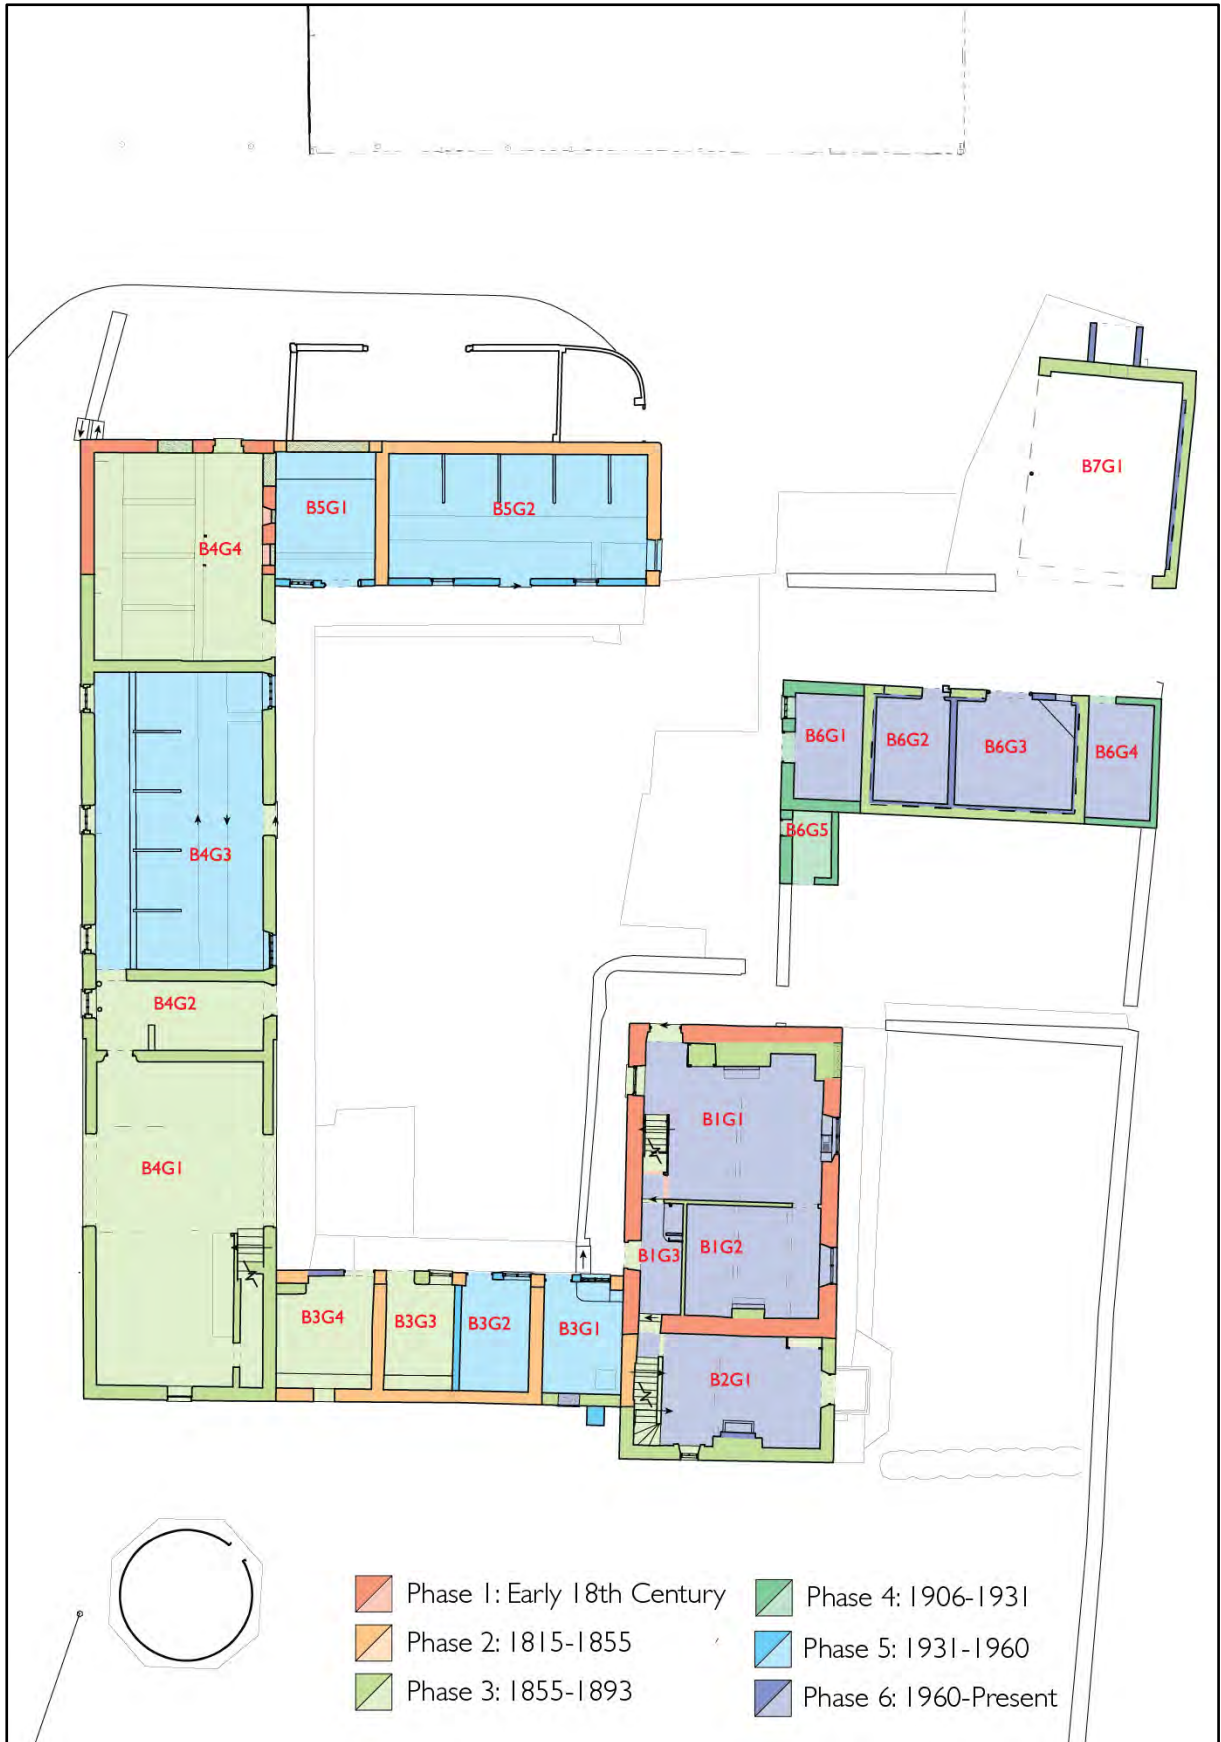
Figure 3: Phased ground floor plan

<b>Phase 1:</b> Early 18 <sup>th</sup> Century	Foundation of the farm including the construction of <b>Building 1</b> , and elements of <b>Building 4</b> .
<b>Phase 2:</b> 1815-1855	Construction of <b>Building 3 &amp; 5</b> .
<b>Phase 3:</b> 1855-1893	Construction of <b>Buildings 2, 4, 6 &amp; 7</b>
<b>Phase 4:</b> 1906-1931	Extension of <b>Building 6</b>
<b>Phase 5:</b> 1931-1960	Infilling of arches to <b>Building 3</b> and reconfiguration of <b>Buildings 4 &amp; 5</b> .
<b>Phase 6:</b> 1960-Present	Repairs to <b>Building 6</b> .

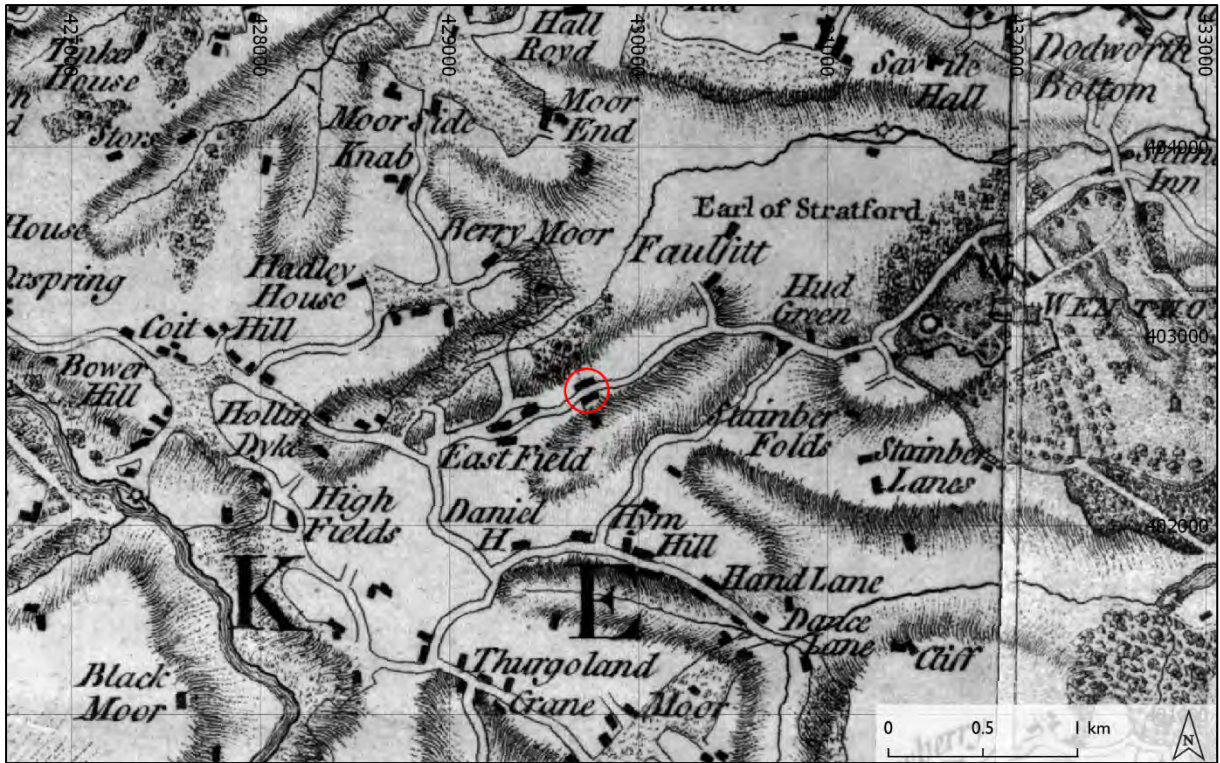
Appendix I.1 1771 Thomas Jeffrey's map of the West Riding of Yorkshire (site circled)

Whilst the origins of Lower Eastfield Farm are not documented, the farm is shown on Thomas Jeffrey's map of 1771 (**Appendix I.1**), where two buildings are shown within the approximate vicinity of the site, either side of Eastfield Lane. An additional building is shown to the south, on the side of a small valley.

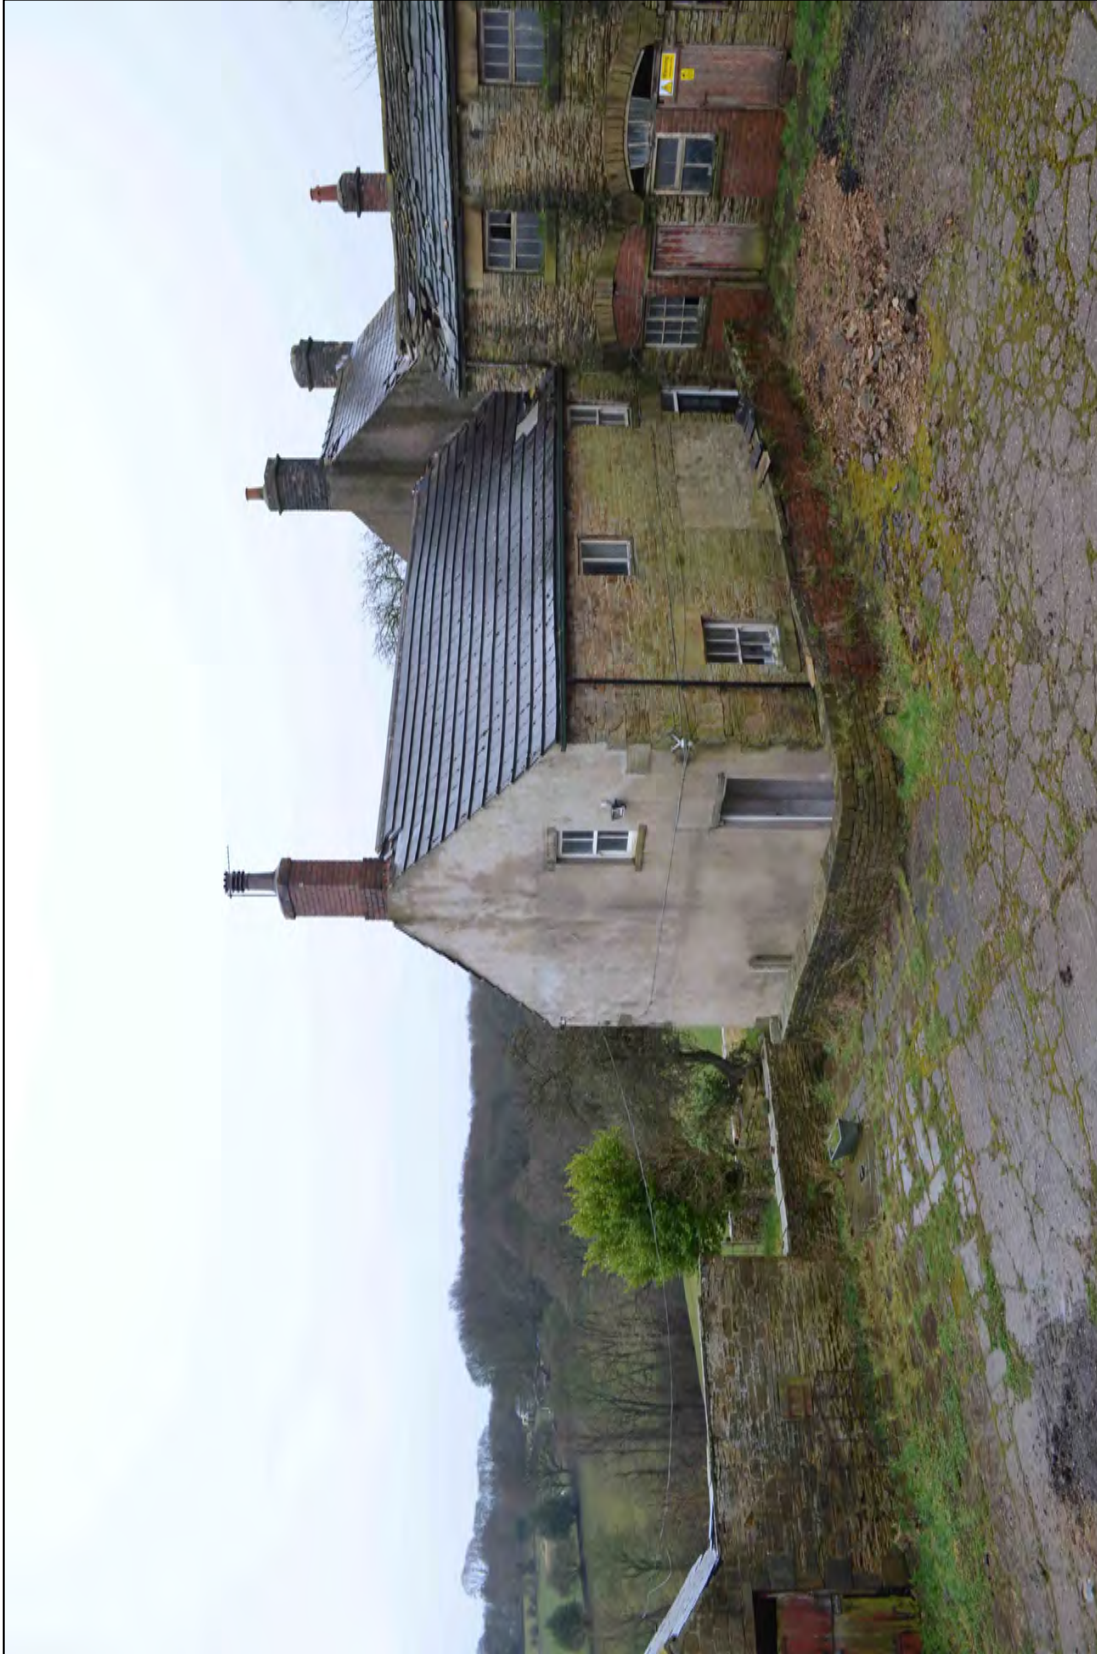
**Appendix 2.4** General view of Building 1, looking south-west (film no. 3.10)

Whilst much altered, it is possible that **Building 1** represents an early 18<sup>th</sup> Century building. This interpretation is based on the presence of a blocked door adjacent to the fireplace in the south elevation of the building and the strap reinforced extension to the ceiling beam towards its junction with the chimney breast in **BIG1**. Such evidence is suggestive of an earlier end-lobby entrance plan, where the doorway entered a small lobby to the side of a wide fireplace with a smoke hood above. This date is potentially corroborated by several panelled doors and numerous wrought iron strap hinges (one set in situ, others potentially reused) throughout the property. The latter include expanded end and rounded end varieties with wide rectangular base plates (**Appendices 2.36-27**) which are of a type dated elsewhere to the 18<sup>th</sup> Century (Alcock & Hall, 1994).

The expected internal arrangement would have been for a main hall, with a pantry and parlour to one side and chambers above, however, no further evidence survives from this phase, with external windows all showing signs of alteration or insertion, and changes in floor levels at the first-floor indicative of later replacement.

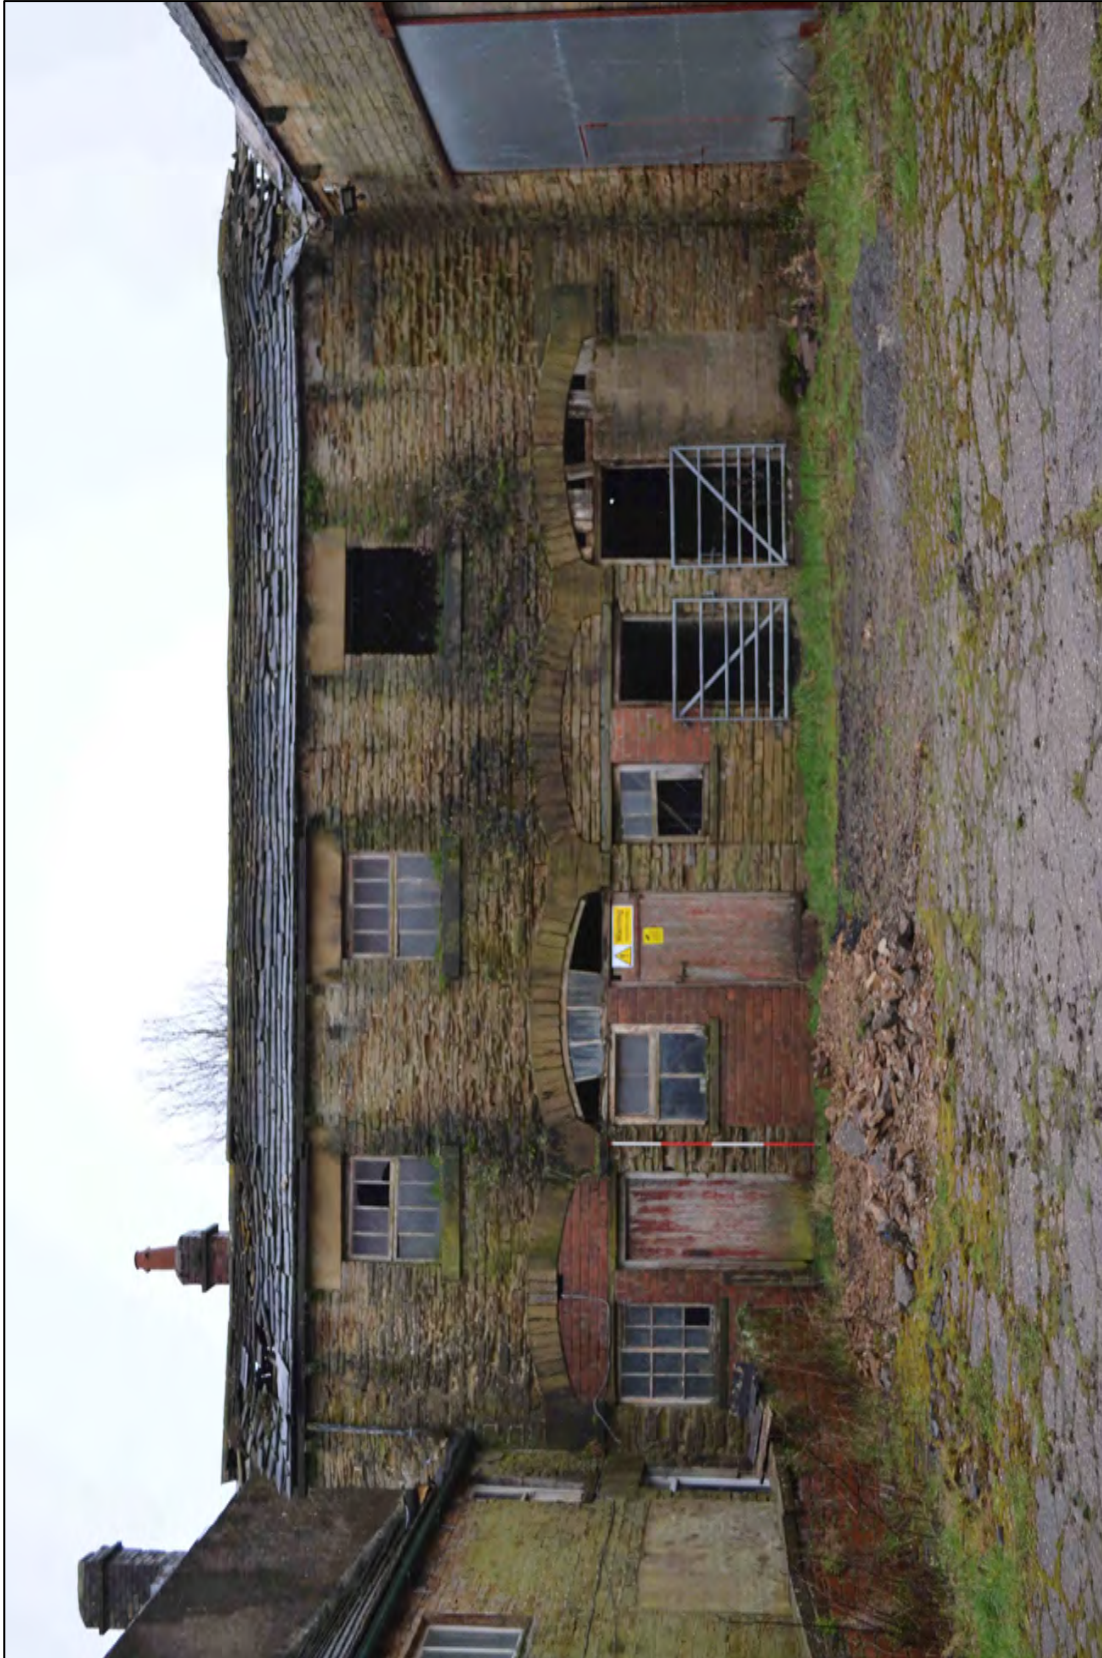
Appendix 2.38 General view of Building 3, looking west (film no. 1.2)

Cartographic evidence shows the drift through **Building 3** was closed off in this period, potentially also indicating that this was when the arched openings had also been infilled and subdivided into their present arrangement, adding loose boxes and a potential new dairy.

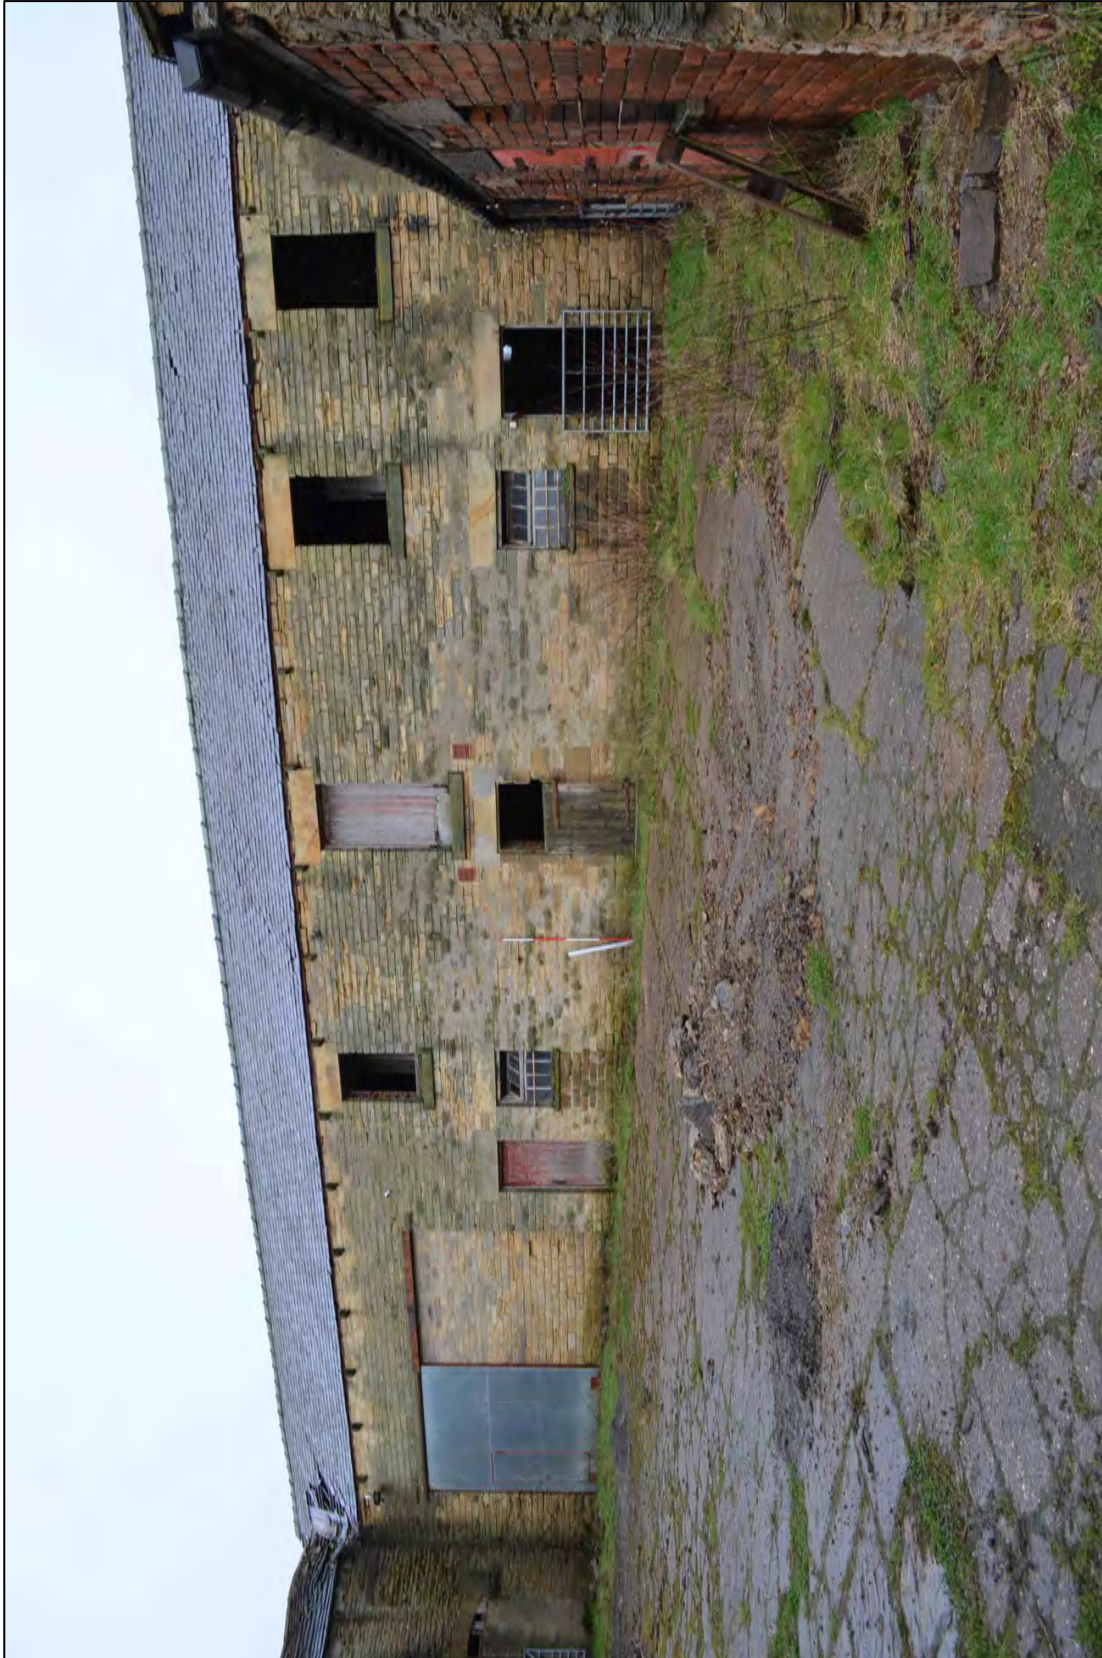
**Appendix 2.53** General view of Building 4, looking north-west (2m scale; /lm no. 1.5)

The cow stalls in Building 4 were rearranged during this period, bringing them into line with current cowhouse design and the health regulations for dairy farms in this period. This involved realigning the stalls parallel with the building and reforming the dividers and floor in concrete with wide drain, and a concrete skim to the lower part of the walls and the enclosure of the ceiling. These features were all intended to enable thorough cleaning and reduce contamination of milk. Two earlier doors were also replaced with windows, improving light and ventilation.

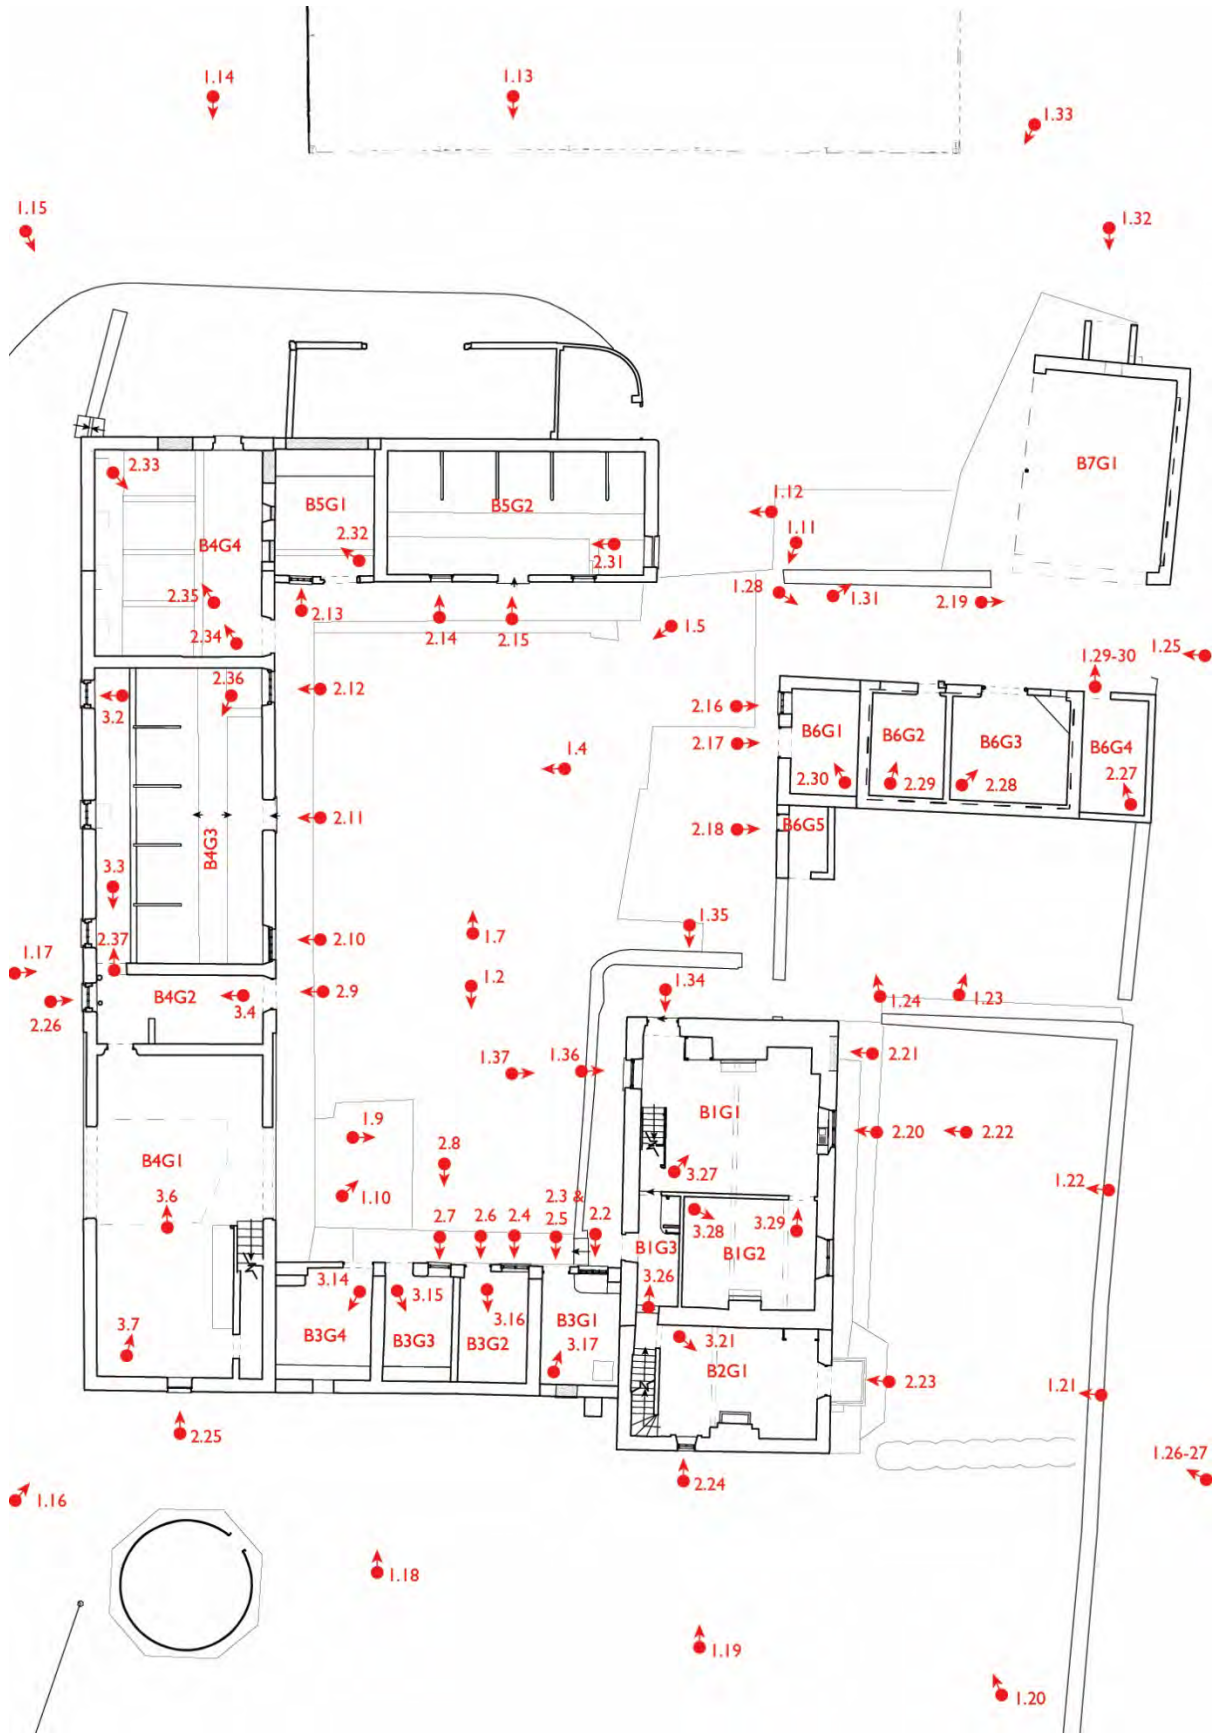
Appendix 2.102: Ground floor photo location plan

(numbers relate to film and frame, see Appendix 2.104)

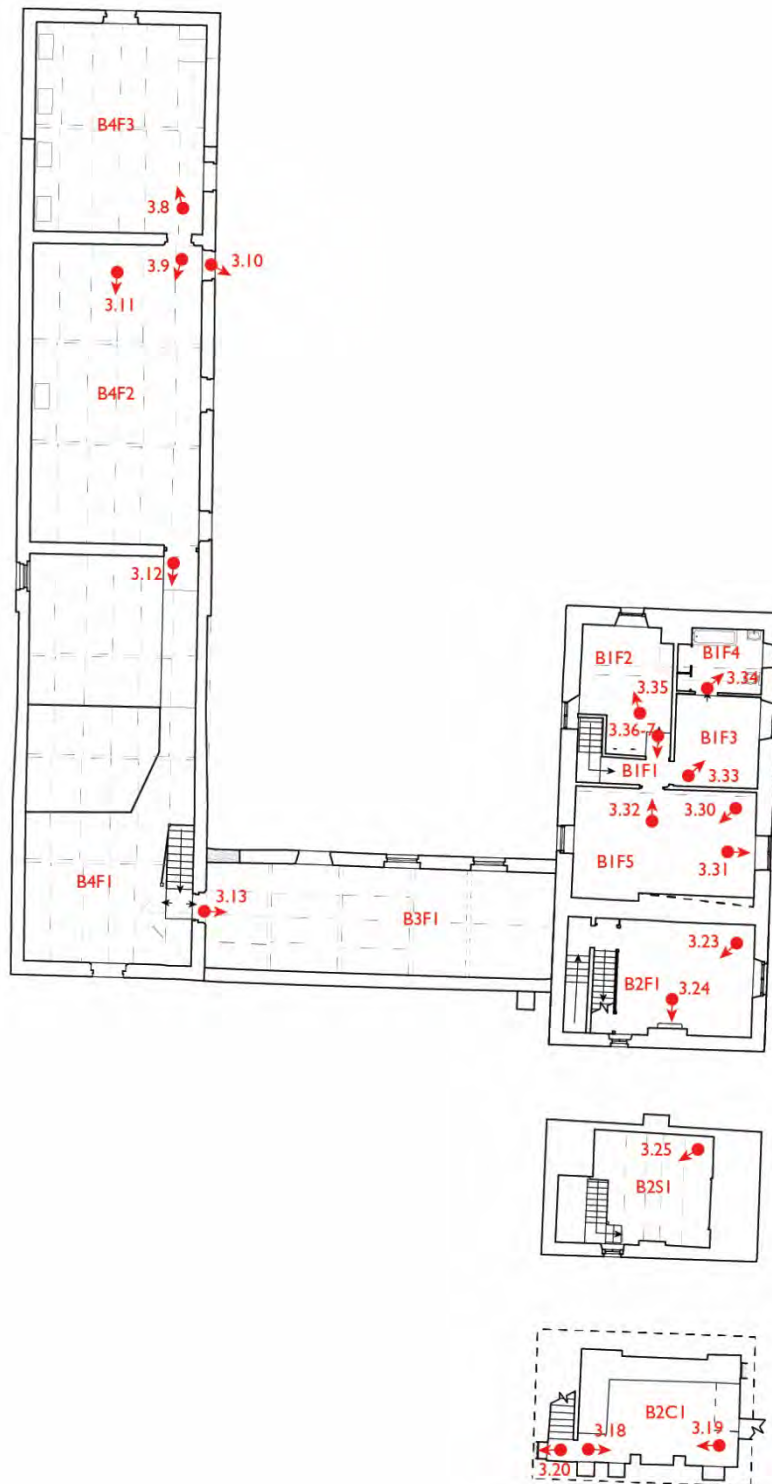
Appendix 2.102: First floor photo location plan

(numbers relate to film and frame, see Appendix 2.104)
