# HAWKSHEAD FARM

| The Nook, Bolton Le Sands, Lancashire

## Historic Building Record

**Document No:** TJC2020.75

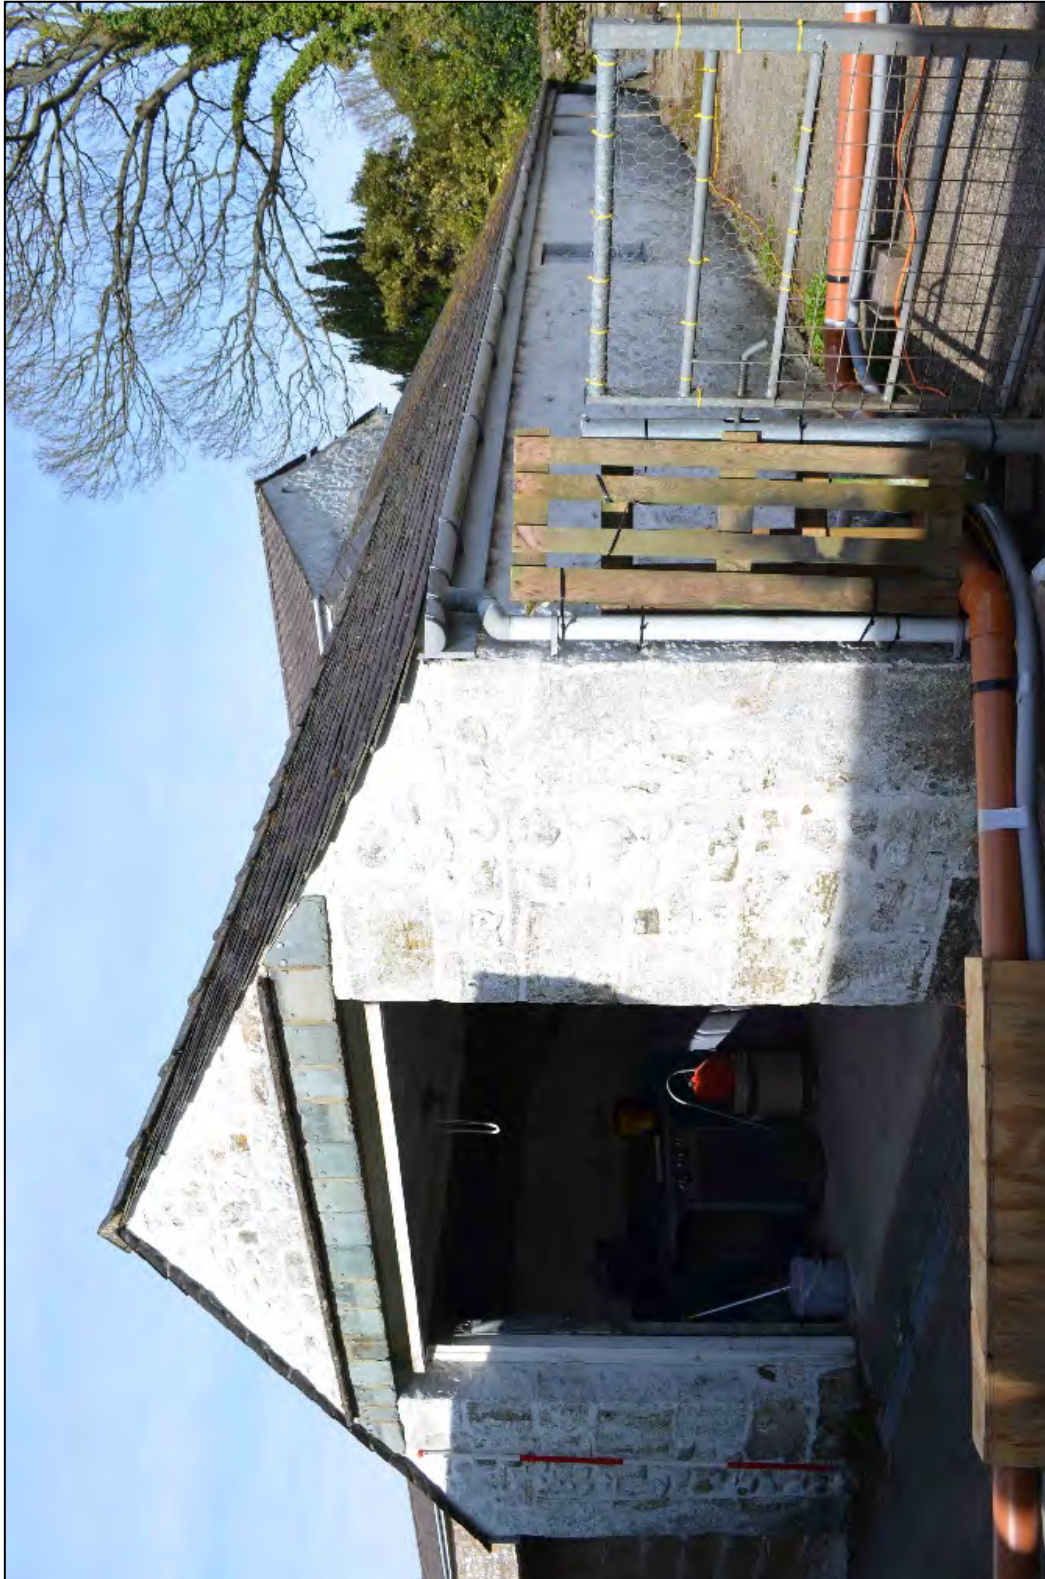
Appendix 2.13: Building 1, looking north

The south elevation (**Appendix 2.13**) has a wide central opening with garage door, the walls to either side rebuilt in blockwork clad externally in stone, including reused quoins around the door jambs. Towards either edge of the gable are straight joints corresponding to the location of two former doorways.

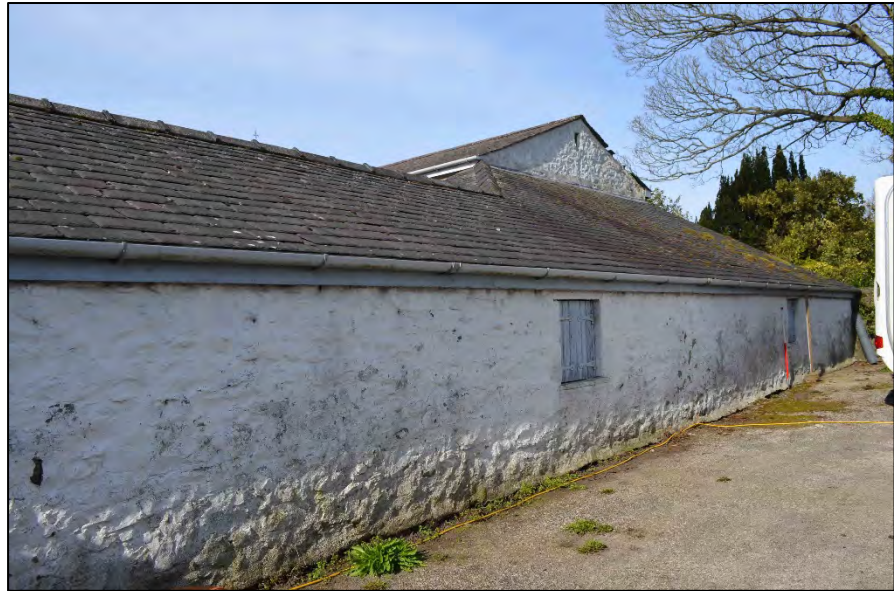
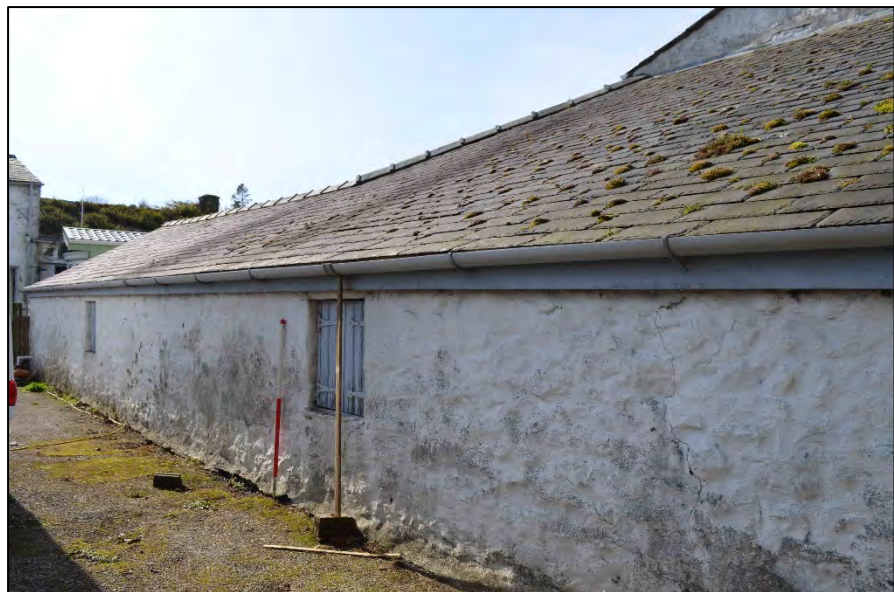
**Appendix 2.14:**  
East elevation of  
Building 1, looking  
north-west

The east elevation (**Appendices 2.14-2.15**) has two square windows with dressed stone lintels and thin stone sills, fitted with external shutters of narrow vertical timber boards with cast iron spear-head strap hinges with rectangular hinge plate (**Appendix 2.16**), and internal shutters of wide timber boards with quirk and bead detail to joints and wrought iron tapered end strap hinges on pintles and iron draw bar (**Appendix 2.17**).

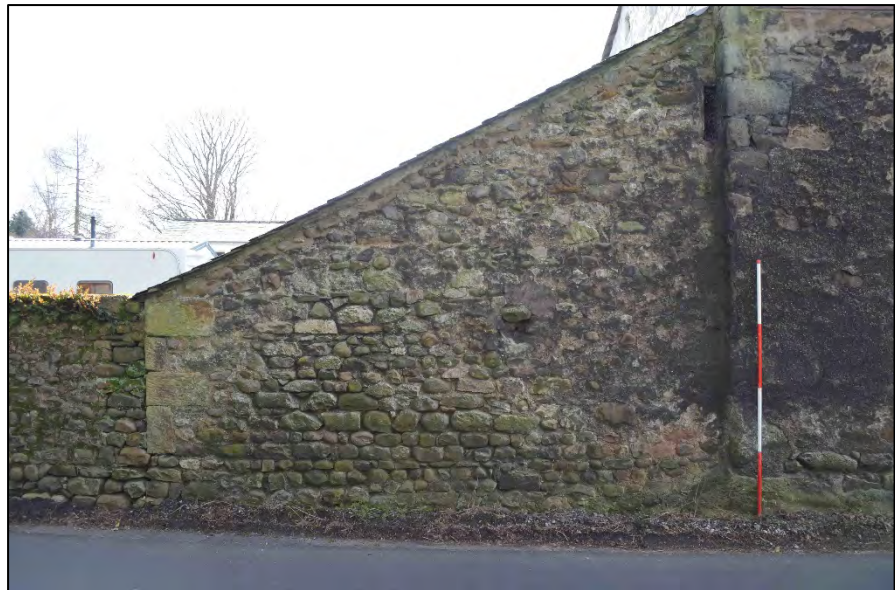
**Appendix 2.18:**  
North elevation of  
Building I

The north elevation (**Appendix 2.18**) is not whitewashed, exposing the rubble fabric, which has been roughly repointed. Towards the upper right side of the elevation is a narrow slit which could have been intended as a ventilation slot.

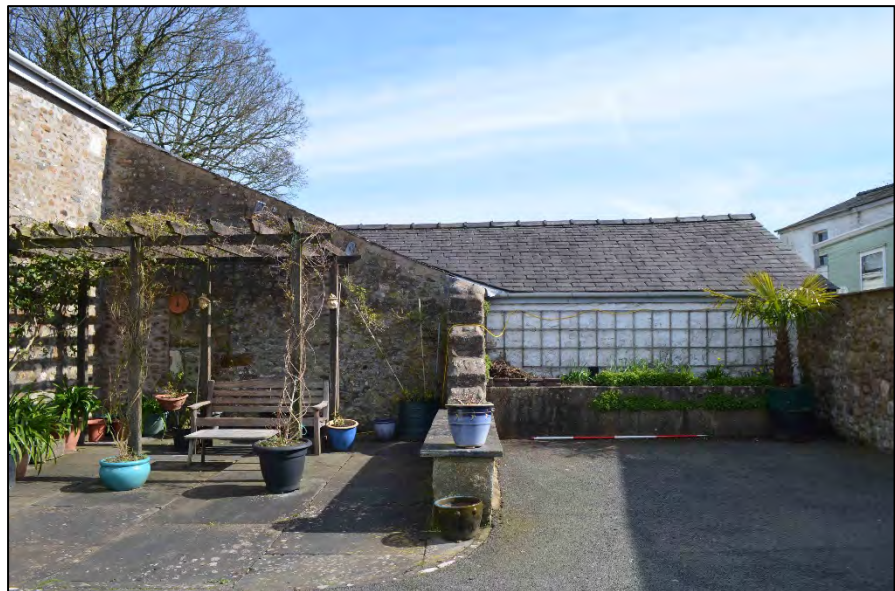
**Appendix 2.19:**  
West elevation of  
Building I

To the west the building abuts the north barn, and where it projects beyond it there is a section of exposed masonry (**Appendix 2.19**), previously part of a lean-to extension along the south elevation of the barn containing a blocked door with dressed stone architrave and timber lintel, and a small high level window with rubble jambs and timber lintel. Cartographic evidence suggests the lean-to post-dates **Building I**, although the degree to which it extended or rebuilt existing fabric is unclear as no vertical or horizontal joints are evidence.

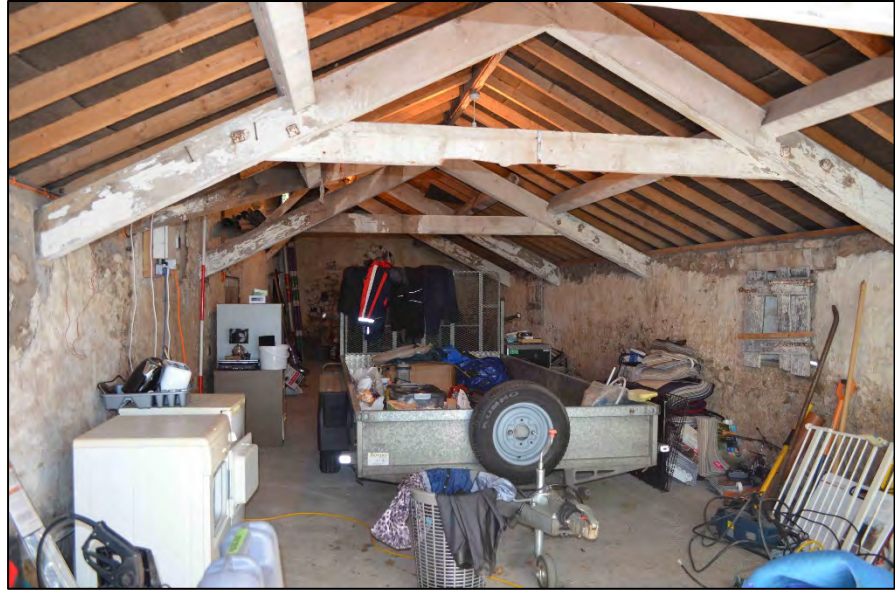
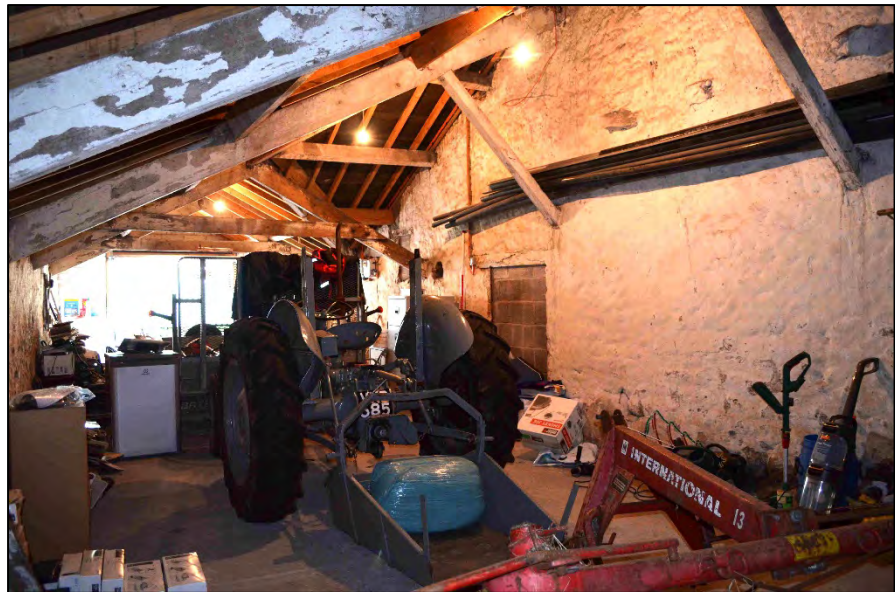
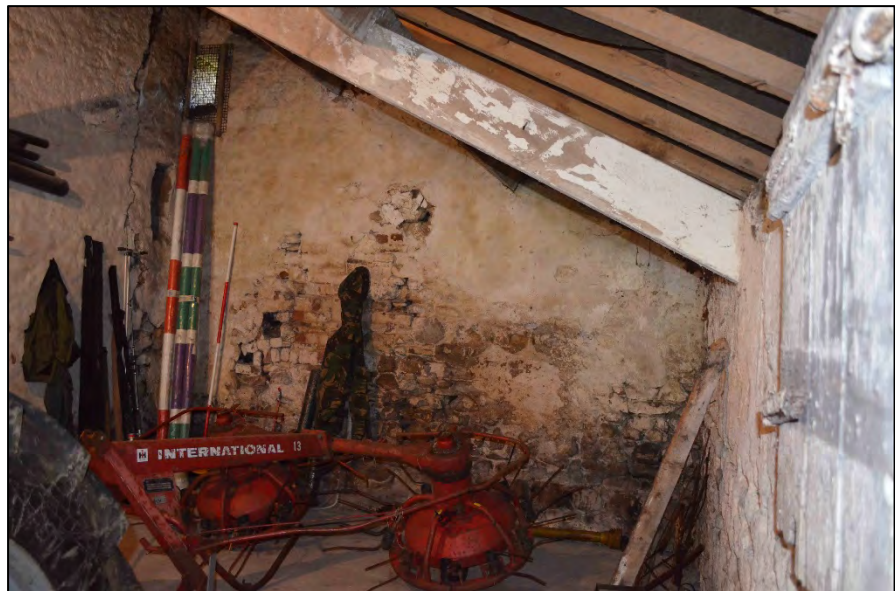
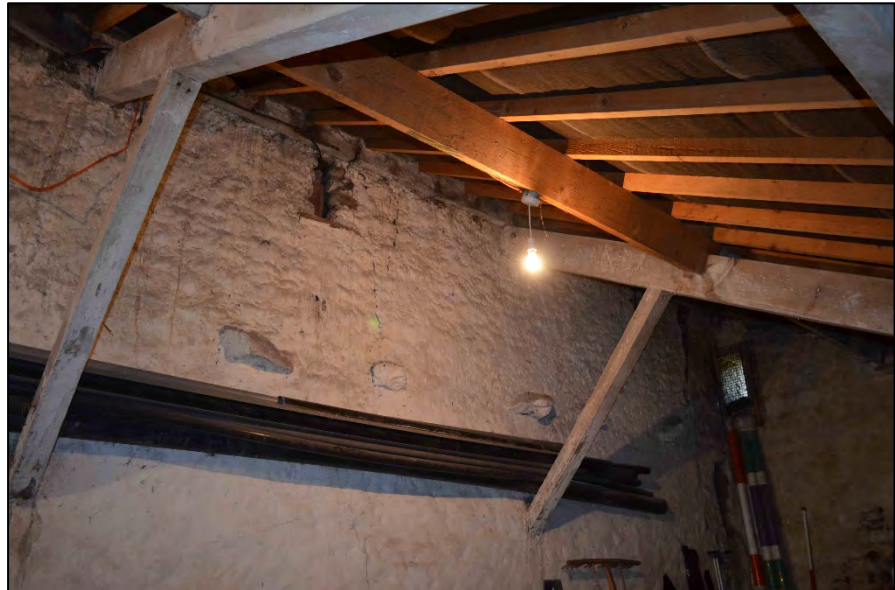
**Appendix 2.20:**  
Interior of BIG1,  
looking north

The interior of **Building 1** (**Appendices 2.20-2.24**) comprises a single open space with a concrete floor, lime washed rubble walls and open to the rafters. No historic fixtures or fittings survived relating to its previous use as a cow house. The floor retained no scars of removed stalls and likely dates to its conversion to a garage. A patch of brick repairs in the north wall potentially relates to where a trough had previously joined the wall, although this was inconclusive.

The northern part of the west wall comprises the former east gable of the north barn with a projecting row of through stones mid-way up the elevation, and a ventilation slot towards the apex of the gable (**Appendix 2.23**). The wall is heavily whitewashed, obscuring evidence of blockings or structural phases, although inspection of the west side of the wall revealed a probable blocked window at its southern edge. A narrow slot has been inserted between the north barn and **Building 1** at the northern edge of the west elevation, set at a slight angle in its vertical plane that could suggest it was for the transmission of line-shafting or electrical services, although fixing plates or grease stains were observed to confirm this.

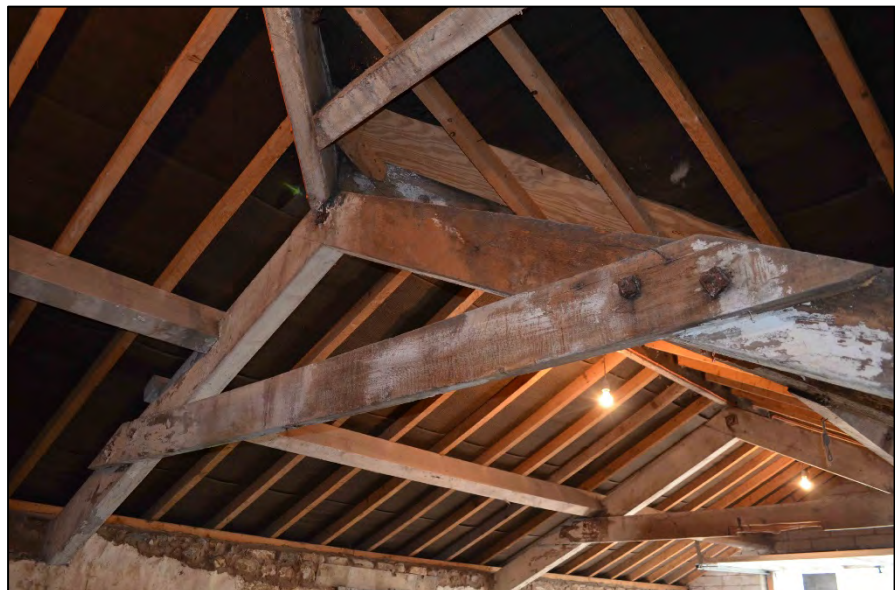
**Appendix 2.24:**  
Detail of truss in  
BIGI

The roof to **Building 1**, with its circular sawn regular roof timbers with square headed bolts reinforcing joints appears late 19<sup>th</sup> Century in character, suggesting it was reroofed during this period.

The roof of the building transitions from a lean-to roof where it abuts the north barn to its west, and a pitched roof where it projects beyond it to the south. The roof is covered with slate and supported on raised tie-trusses of regular circular sawn timbers with square bolted joints (**Appendix 2.24**).

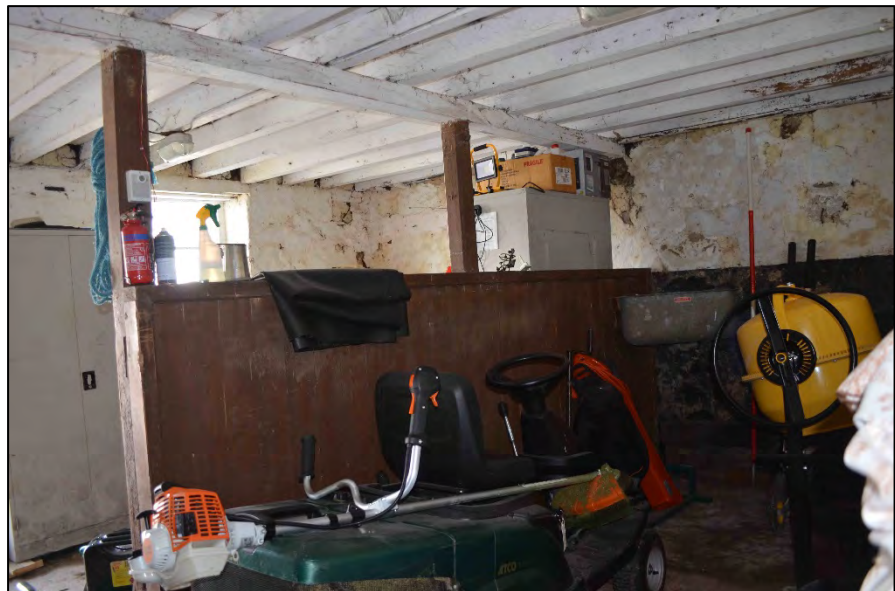
**Appendix 2.36:**  
General view of  
interior of B2G1,  
looking south-east

Room **B2G1 (Appendices 2.36-37)**, within the eastern end of the building, has a concrete floor and lime washed rubble walls. The ceiling has exposed floor joists of circular sawn timber with 8" tongue and groove floorboards (across which a concrete floor has been cast). Internally the room is divided into two stalls by a timber partition of vertical timber planks within an ovolo-moulded frame supported against two vertical chamfered posts (**Appendix 2.39**). The posts carry a transverse spinal beam (**Appendix 2.38**). A single iron tethering ring was noted on the east post (**Appendix 2.40**). A steel triangular trough is present within the southern stall, with a maker's plate reading "MABBOTTS of MANCHESTER / MANUFACTURERS – EST. 1901 / STABLE AND SADDLE ROOM FITTINGS" (**Appendix 2.41**).

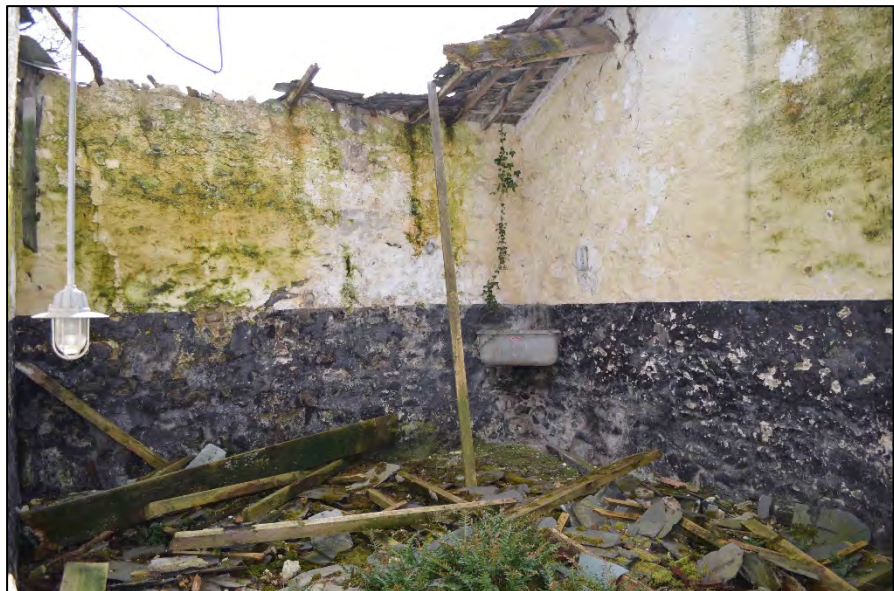
**Appendix 2.58:**  
General view of  
B3G4, looking  
south-west

Room **B3G4** (**Appendix 2.58**) was not fully accessed due to the precarious condition of the roof which had partially collapsed. The room has a concrete floor, limewashed walls and ceiling open to the rafters. There is steel Mabbots trough in the south-west corner.

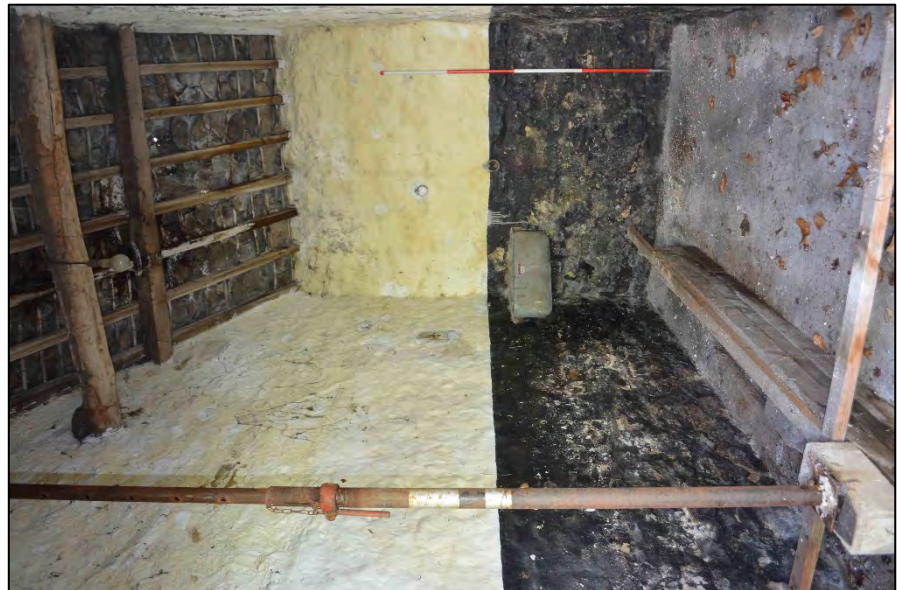
**Appendix 2.62:** General view of B3G3, looking south-east  
(2m scale; Film no. 2.11)

Room **B3G3** (**Appendix 2.62**) comprises a narrow room, and may originally have functioned as a storage space, possibly a tack room, rather than for livestock. Such a use would commonly have a fireplace to help maintain leather, and although none was observed there is a chimney above the room and whilst a blocked fireplace could be hidden behind lime washing the former presence of stove would appear more likely. The room has a concrete floor cast over earlier cobbles, limewashed walls and is open to the rafters. There is steel Mabbots trough and ferrous tethering rings in the south wall.
