The Grambla

Trewoofe, Lamorna, TR19 6PA

Historic Building Recording

July 2022

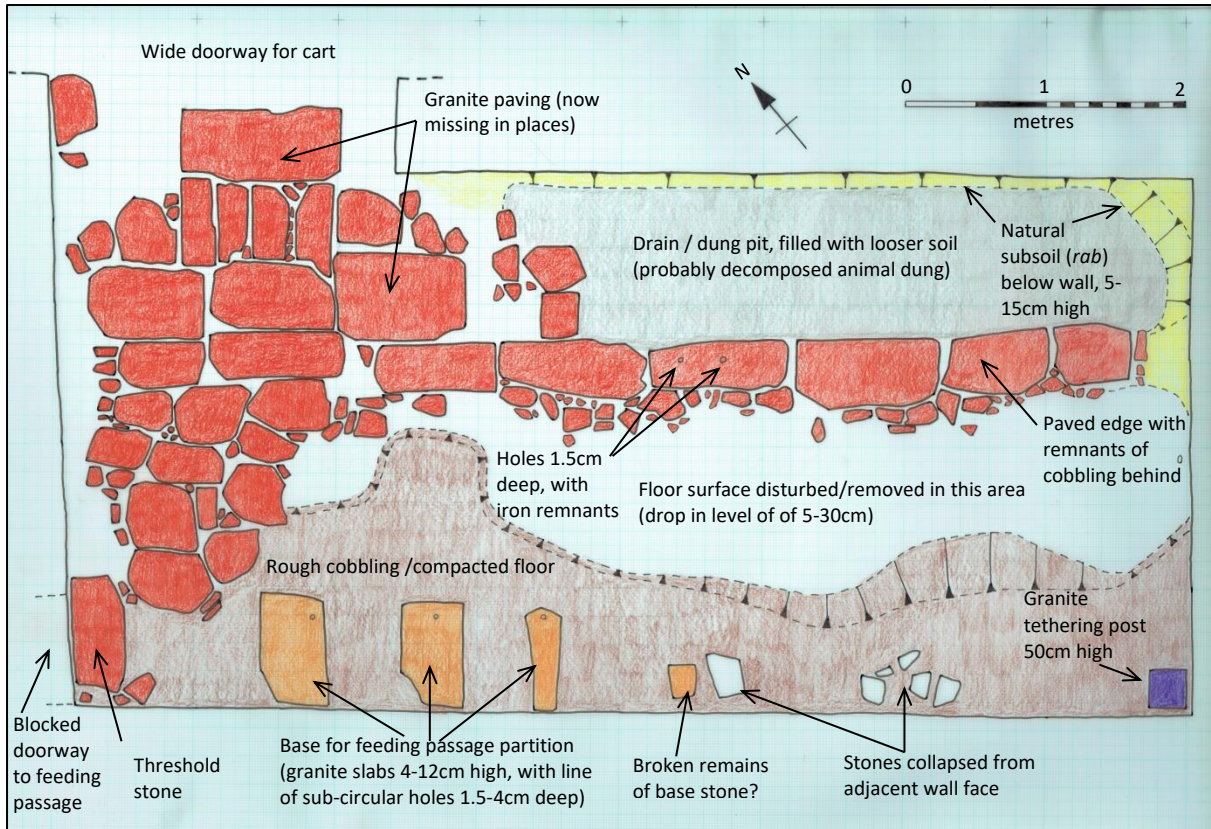
26: Detailed plan of the cartshed floor (existing)

The cartshed floor was planned at 1:20 scale using a tape and offsets and an inked and coloured-up version has been included in this report (Figure 23)

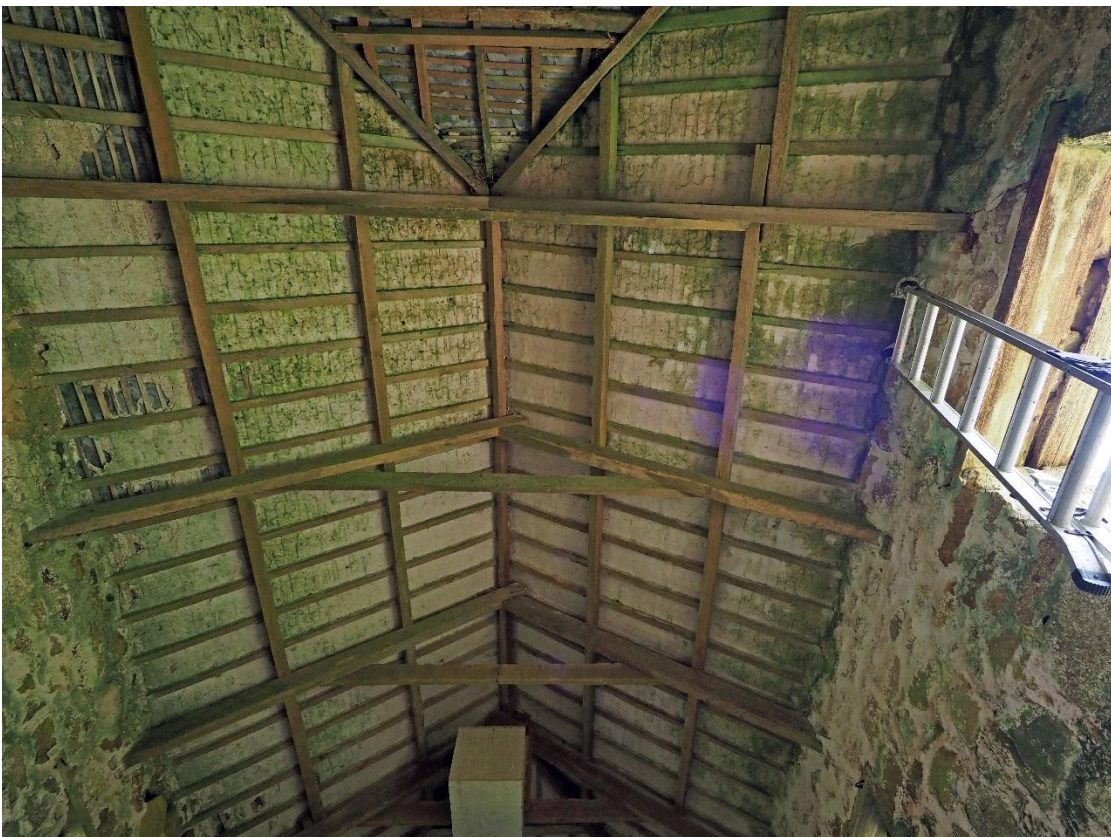
Figure 35: Barn roof

The floor surface within the cowhouse is compacted earth and small stones, with a large natural boulder at the north end. The floor above the cowhouse has slender joists and remains of a planked floor, now in poor condition. The barn's 4-bay roof structure has collar trusses, purlins, and common rafters.

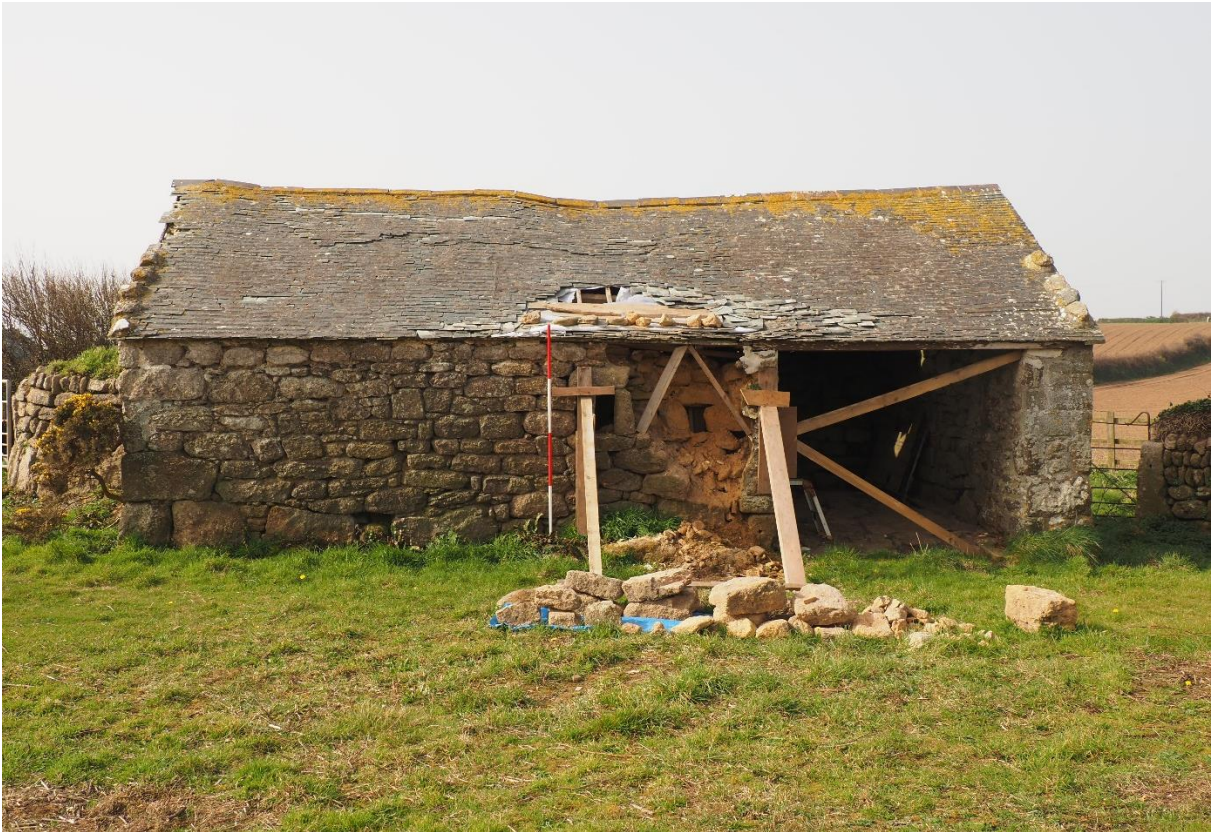
Figure 40: Cartshed from NE since partial collapse

Recently, there has been a collapse of masonry to the left-hand side of the original wide doorway. At the other side of the doorway the jamb masonry was partly rebuilt to NW side of doorway inscribed: SJH 8:5:1986. In the SE wall near the SW end there is an inscription in a mortar repair: EOO 2002.

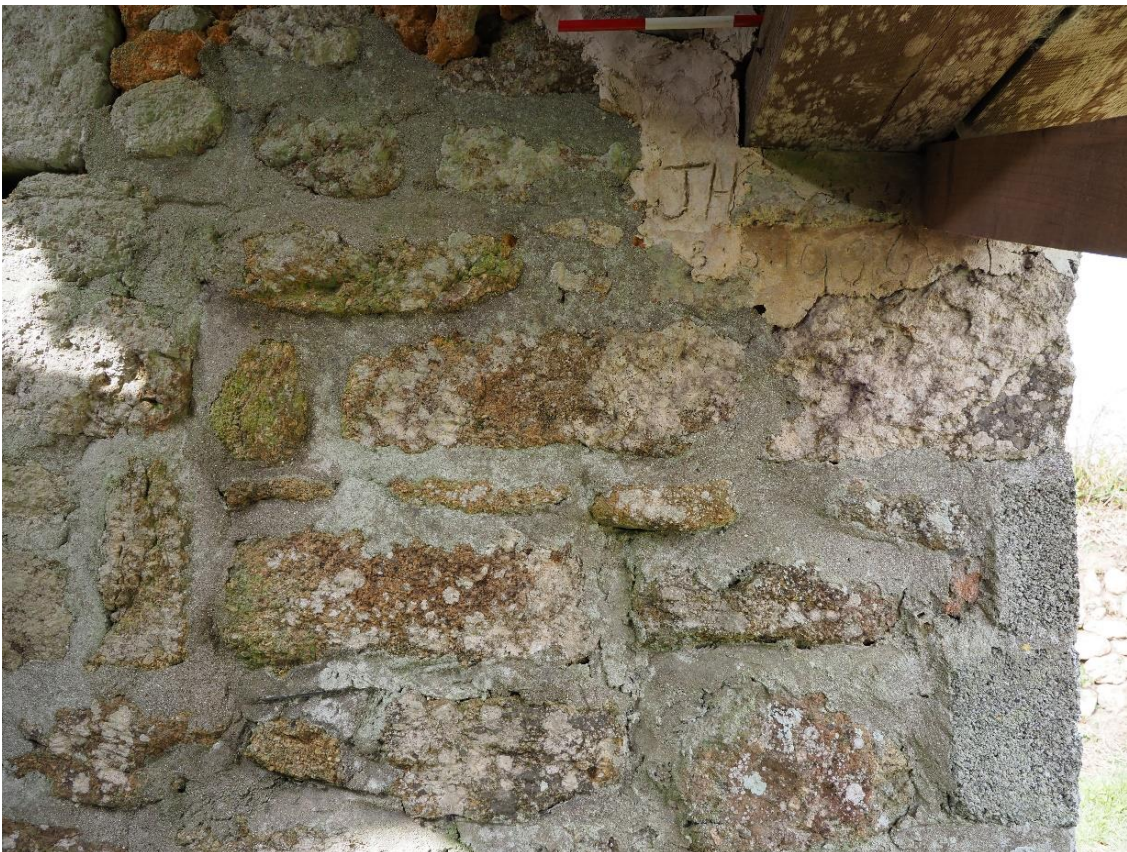
Figure 51: Cartshed: rebuilt masonry to NW side of doorway inscribed: SJH 8:5:1986

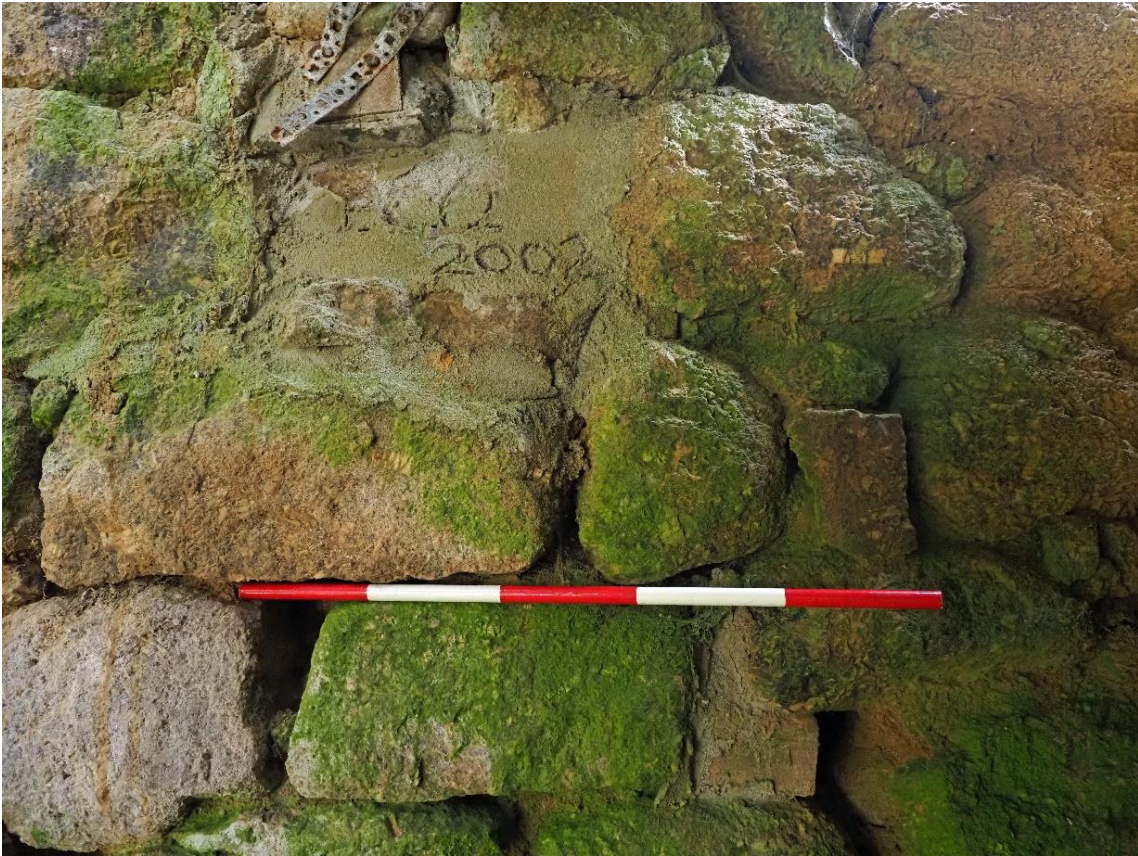
Figure 52: Cartshed SE wall: inscription in mortar repair: EOO 2002

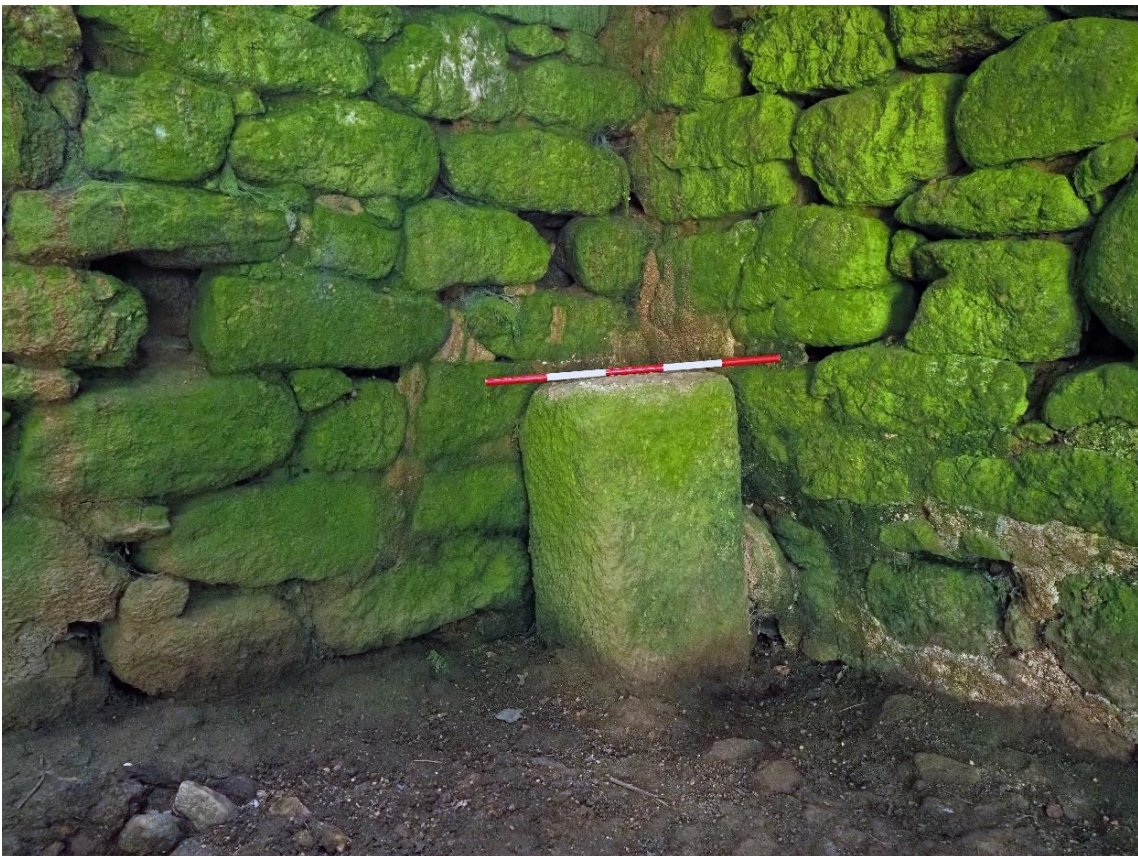
Figure 53: Cartshed south corner: probable tether stone

The building's original function, characterised by its wide doorway, was probably a cartshed at its north-west end, plus workshop/store at the south-east end. This central part was later adapted to become a small cowhouse or stabling with a feeding passage at its south-west side and an open drain/dung pit to the opposite side. A narrow doorway cut into the south-west end of the north-west wall was clearly for access to the feeding passage. This doorway was later blocked. The south-east end was last used as a probable loose box, possibly for a horse, possibly for a bull. Standing in the south corner is a vertical dressed granite monolith, possibly a tether stone, which also suggests use as a slaughterhouse.

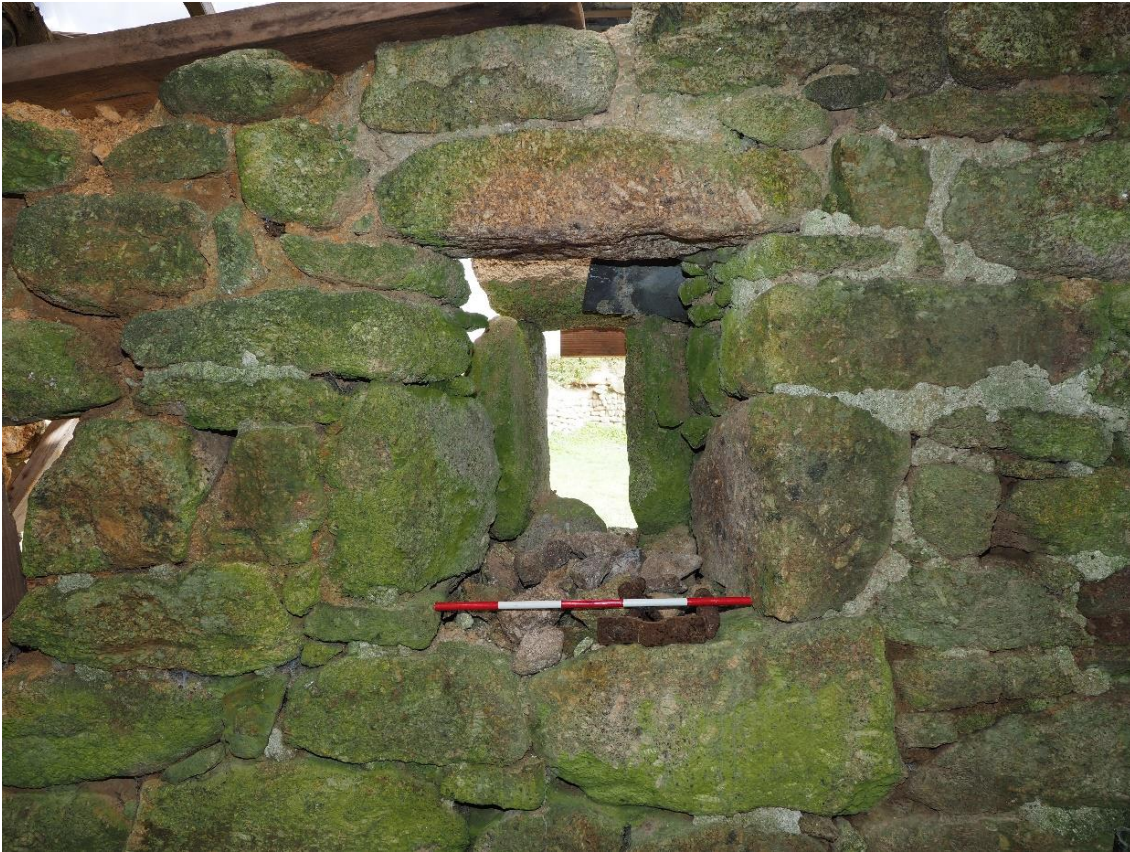
Figure 54: Cartshed: vent to centre of NE wall

There is a slit ventilator to the north-east, south-east and south-west walls. The present roof is not the original roof as there is clear evidence that the eaves level has been raised to the north-east side. Close examination of the south-east gable end shows similar evidence. The present 5-bay tie-beam roof structure incorporates some reused timbers. Scantle slate roof covering survives to the north-east side albeit in poor condition. The roof covering has been replaced with corrugated bitumen to the south-west side, now in terrible condition.

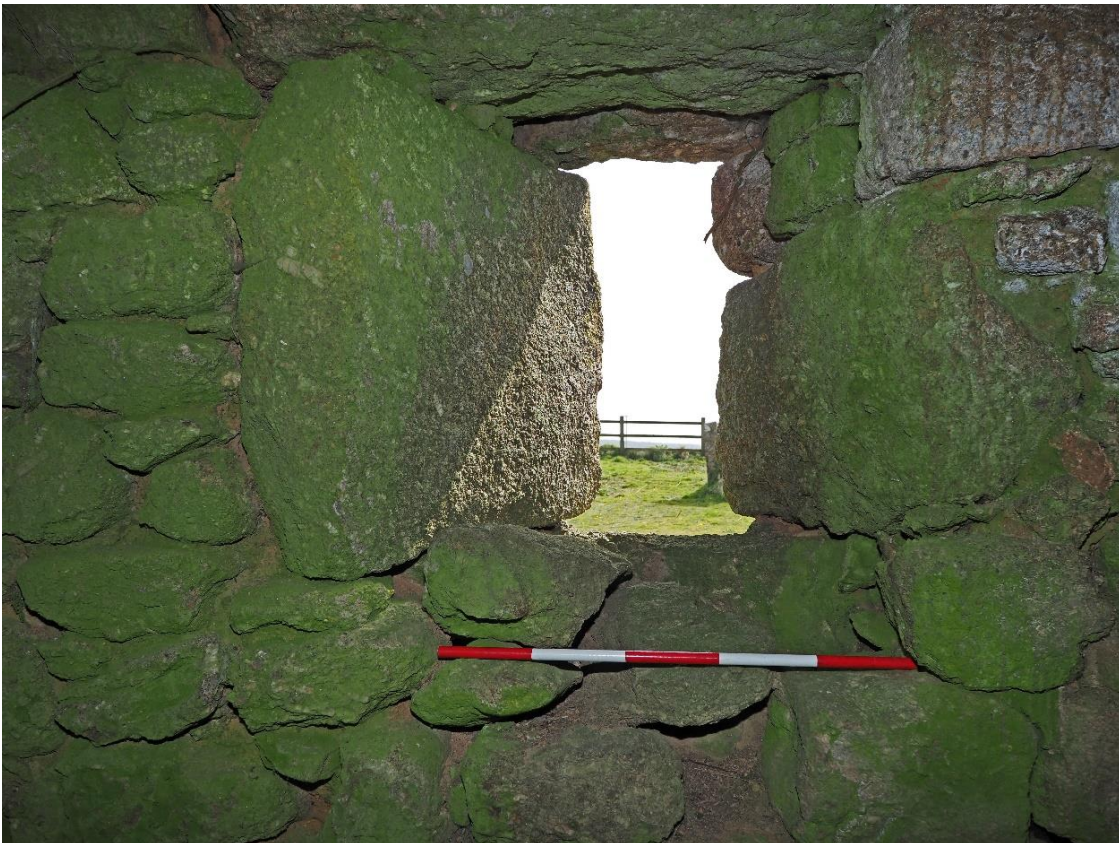
Figure 55: Cartshed: vent to SE gable end

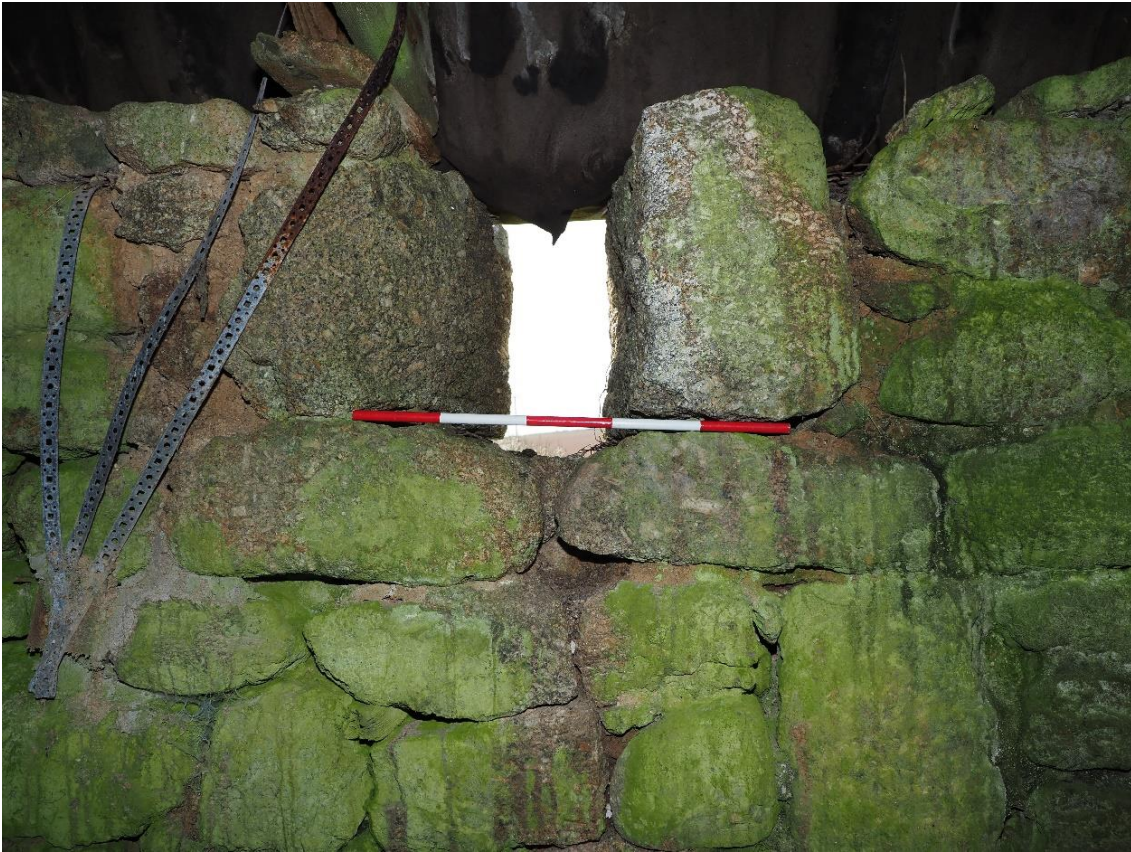
Figure 56: Cartshed: vent central to SW wall

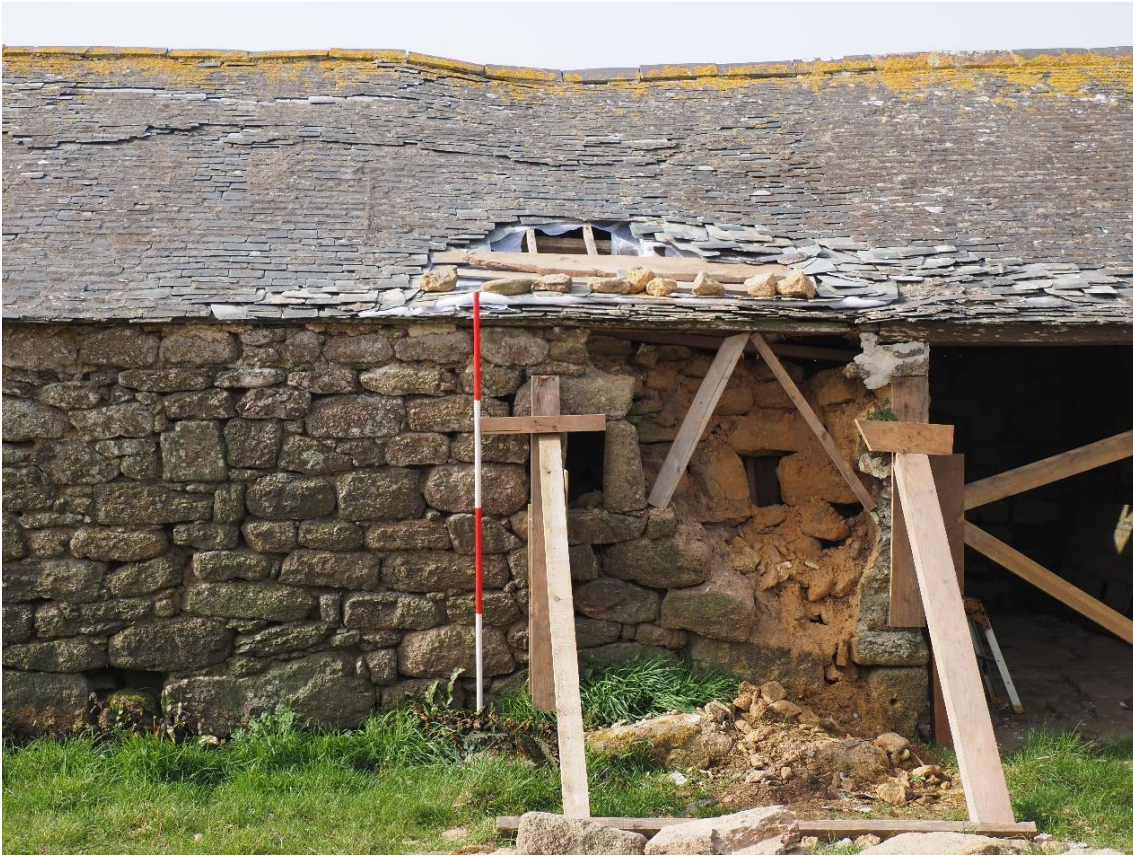
Figure 58: Cartshed NE wall showing collapsed section

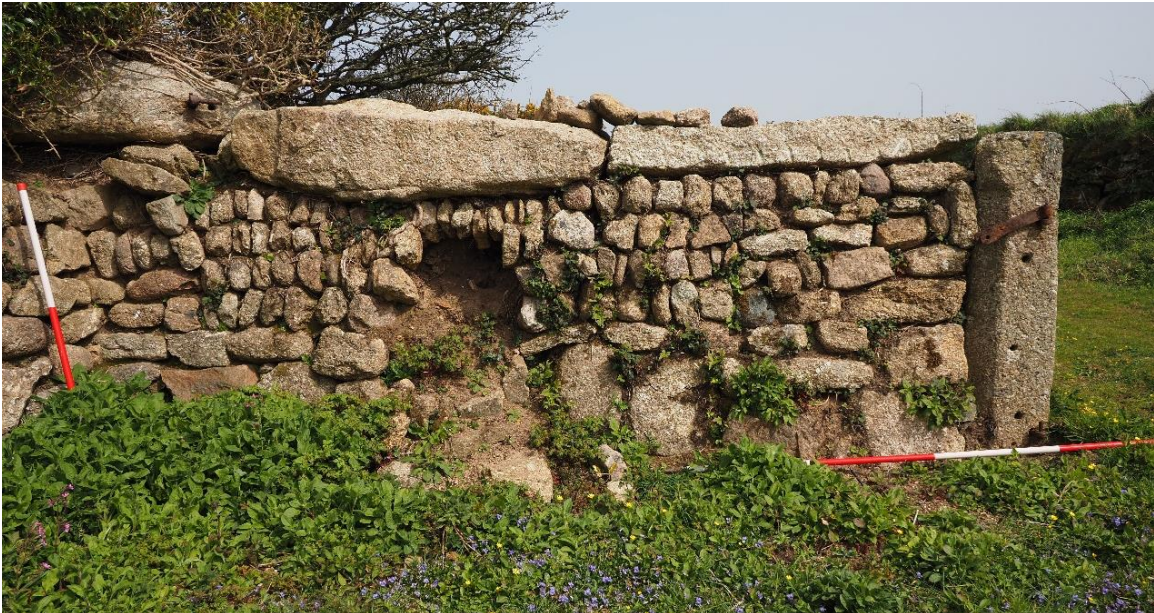
Figure 60: Cornish hedge north of barn, incorporating reused C17 probable fireplace lintel

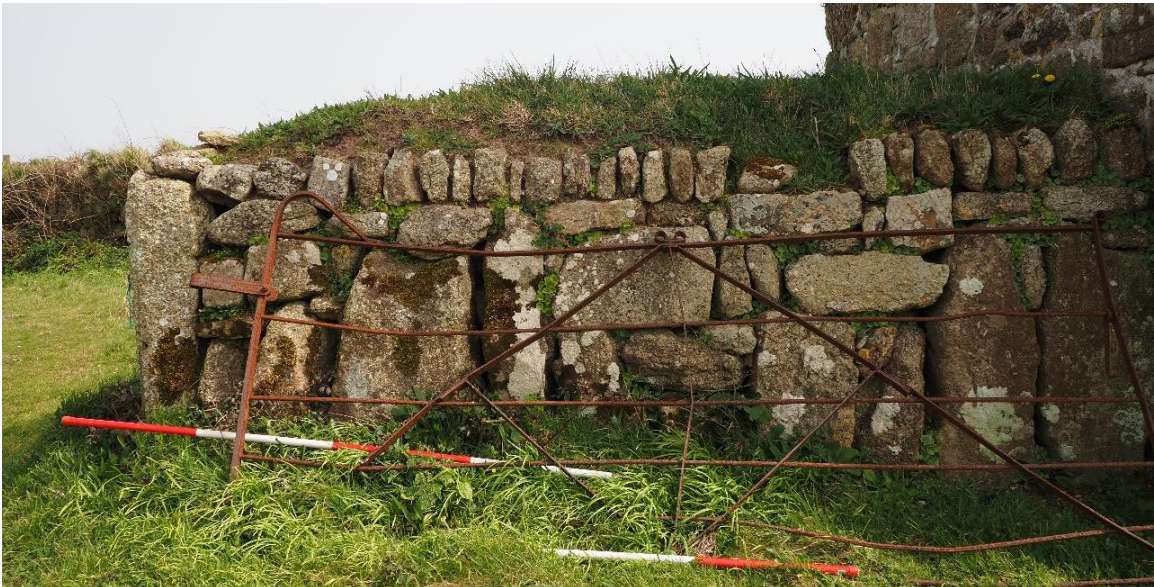
Figure 61: Cornish hedge adjoining north side of barn with reused probable jamb-stone (left), plus C19 wrought-iron field gate

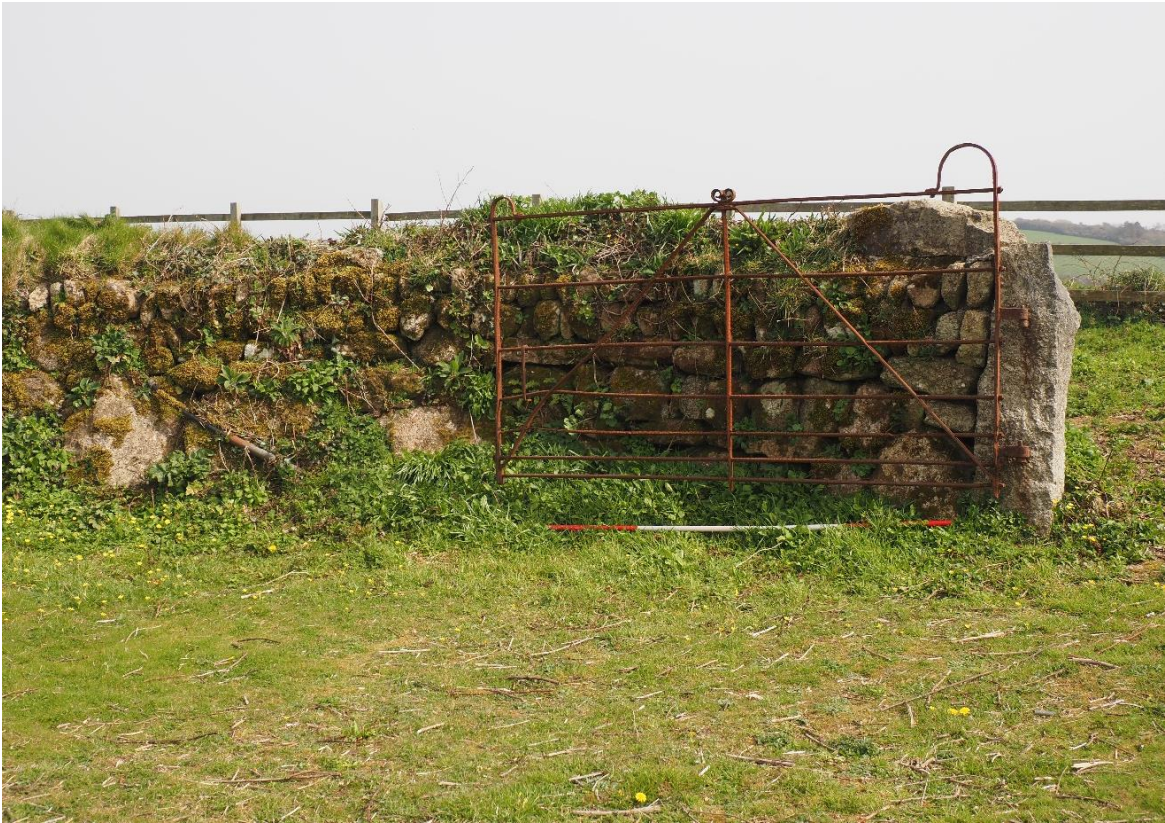
Figure 64: Context Cornish hedge south of Barn, with rare C19 wrought-iron field gate

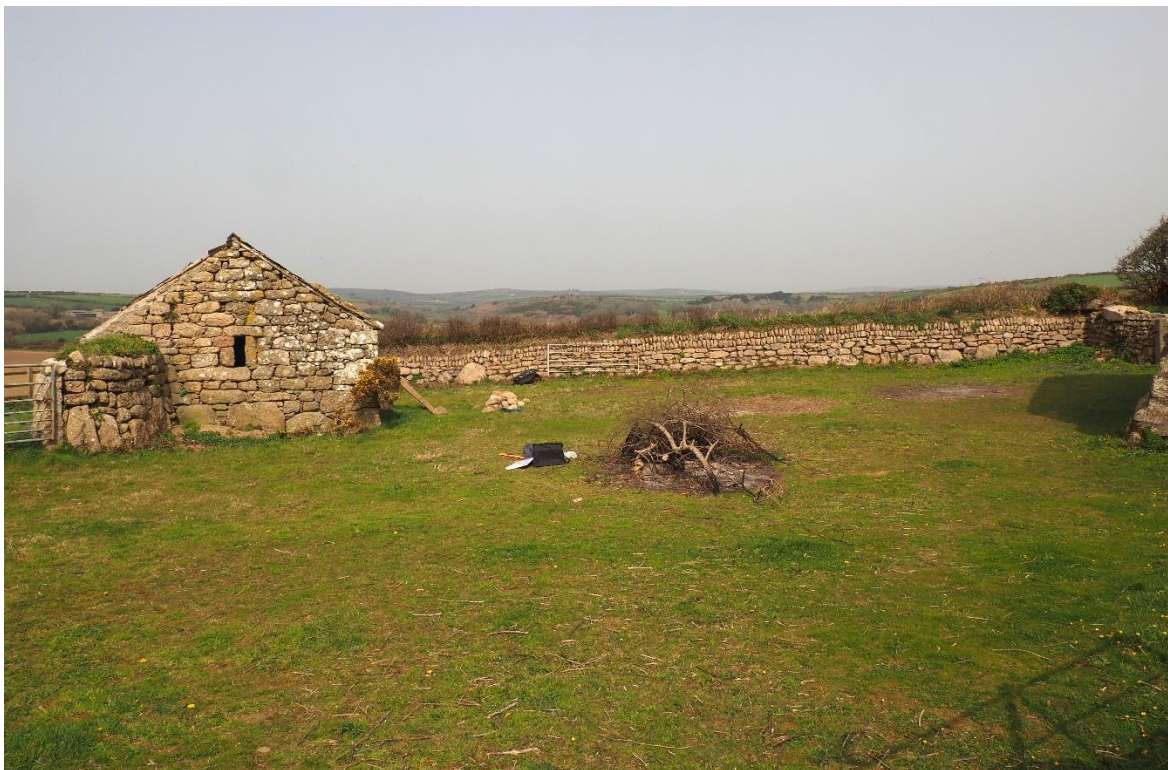
Figure 67: Context: Farmstead from SE: Cartshed, left, boundary hedge of farmyard beyond, located on site of probable former farmhouse
