YORK CASTLE MUSEUM CONCOURSE.

REPORT ON AN ARCHAEOLOGICAL WATCHING BRIEF
OSA REPORT No: OSA10WB02.

June 2010.

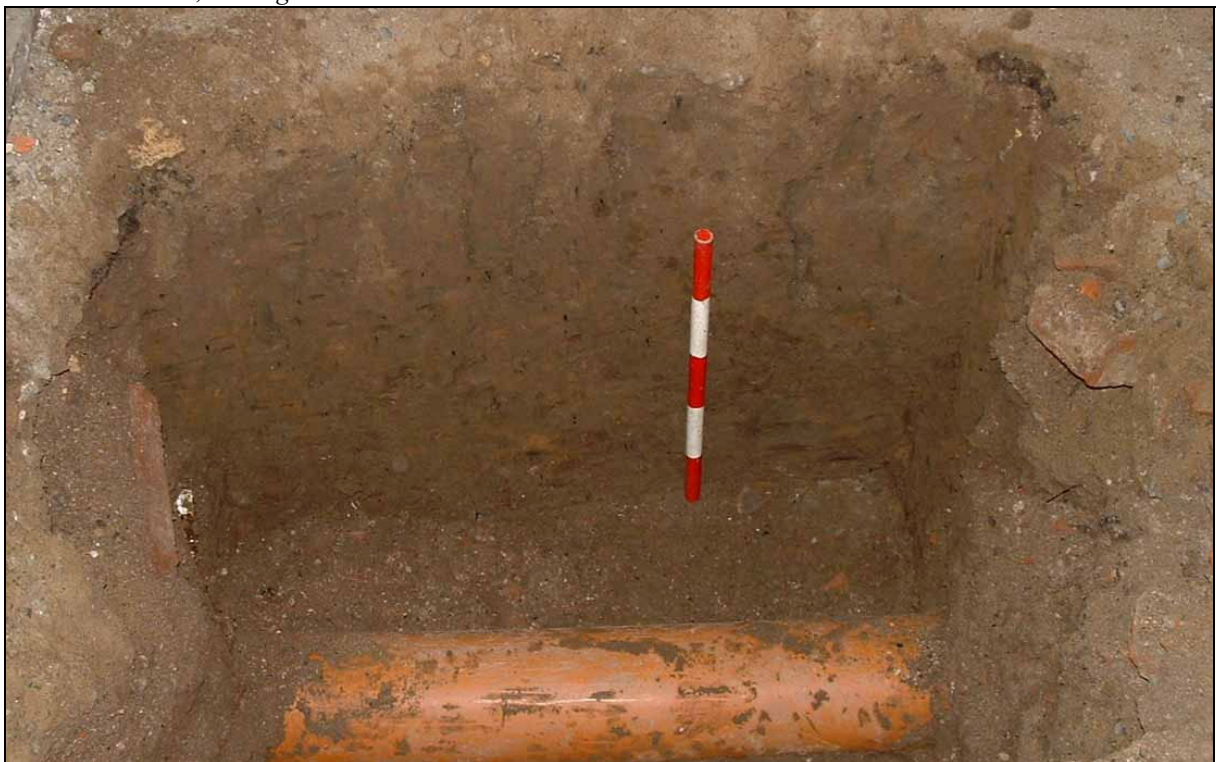
Plate 2. Trench 1, deposit (104) looking southwest

The earliest deposit encountered was a firm mid reddish brown silty clay (104), which contained occasional small pebbles and fragments of animal bone, but no other inclusions or datable artefacts (Plate 2). This deposit was recorded from the base of the trench, with a maximum thickness of 0.75m, so its upper surface was recorded at a depth of only 0.10m below the modern ground level. It was sealed by a thin (0.05m) layer of loose, pale yellow sand (103), which formed a bedding layer for the flagged floor (100) within this room. Although the floor appeared to be a single continuous layer it had clearly been lifted at some point in the recent past for the insertion of the existing drain (101)/[102]. The drain clearly cut the floor bedding layer (103) and its backfill was sealed by the stone flags. The existing drain is a 9-inch plastic pipe and therefore dates to the later 20th century.

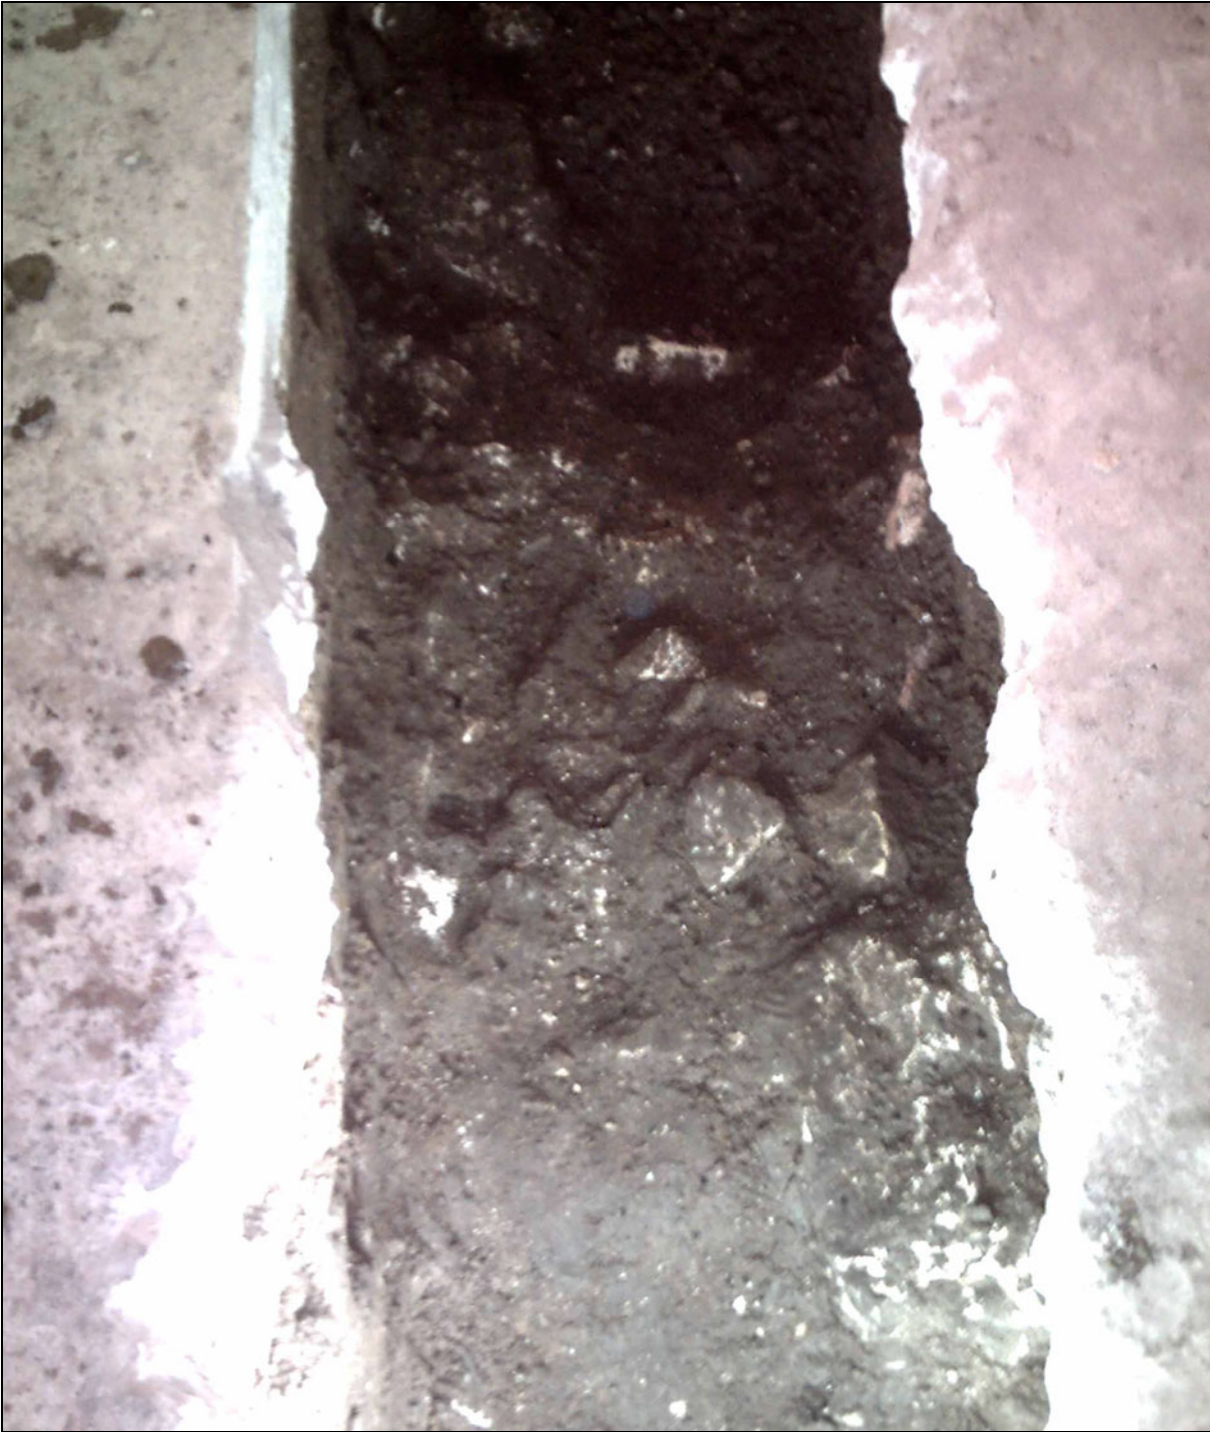
Plate 3. Trench 2, foundation (204)

The earliest archaeological features recorded were only exposed in the base of the trench, at a depth of 0.60m below the modern ground level. These comprised a possible occupation layer and a wall foundation (see Figure 2 for the location of this foundation). The foundation (204) consisted of unbonded, rough limestone rubble, a maximum of 200mm across. This appeared to cross the full width of the trench on an approximately north south alignment (Plate 3). To either side of the foundation was a layer of mid reddish brown sandy silt (203) containing flecks of mortar and charcoal.

Trench 2 also revealed remains that pre-date this soil horizon. The wall foundation is of particular interest, as its alignment is clearly different to the organisation of the castle buildings at the start of the 18th century. Although only a very small segment of the foundation was exposed it is likely to represent a building within the castle, either dating to the medieval, or post-medieval period. The lack of any dating evidence again precludes more conclusive interpretation. It is significant to note that the remains of buildings pre-dating the early 18th century survive within 0.60m of the current internal floor level. Any future intrusive groundworks, of similarly shallow depth, either within the castle or in the immediate vicinity may therefore expose further remains.

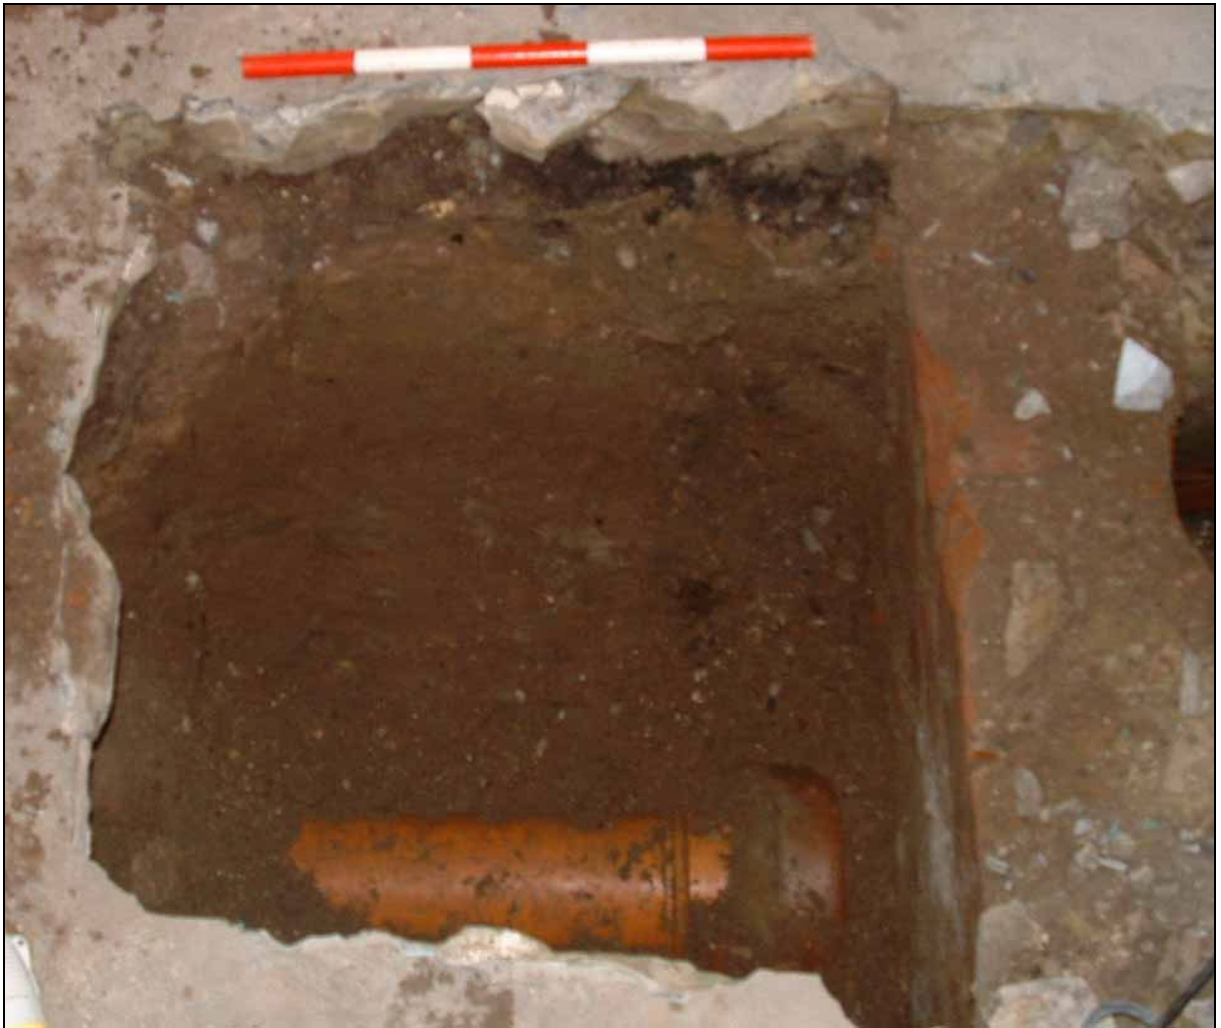
Plate 4. Trench 3, looking southwest

existing blocked drain. A sequence of earlier deposits was recorded in the southwest edge of the trench (Plate 4).

The earliest deposit recorded was a dark reddish brown clay with occasional flecks of charcoal (306), which was a total of 0.30m thick and extended below the basal limit of excavation. This was sealed by 0.40m thickness of dark brown clay sand silt (305) with occasional small pebbles and flecks of charcoal. This deposit survived to within 0.20m of the modern floor surface from which level the extant brick manhole (304) had been constructed. The manhole and drain backfill (303) were sealed by the bedding (302) for the current stone flagged floor (301).
