THE LODGE, HOWDEN SECONDARY SCHOOL,
DERWENT ROAD, HOWDEN.
EAST RIDING OF YORKSHIRE.

REPORT ON AN ARCHAEOLOGICAL WATCHING BRIEF
OSA REPORT No: OSA10WB14.

June 2010.

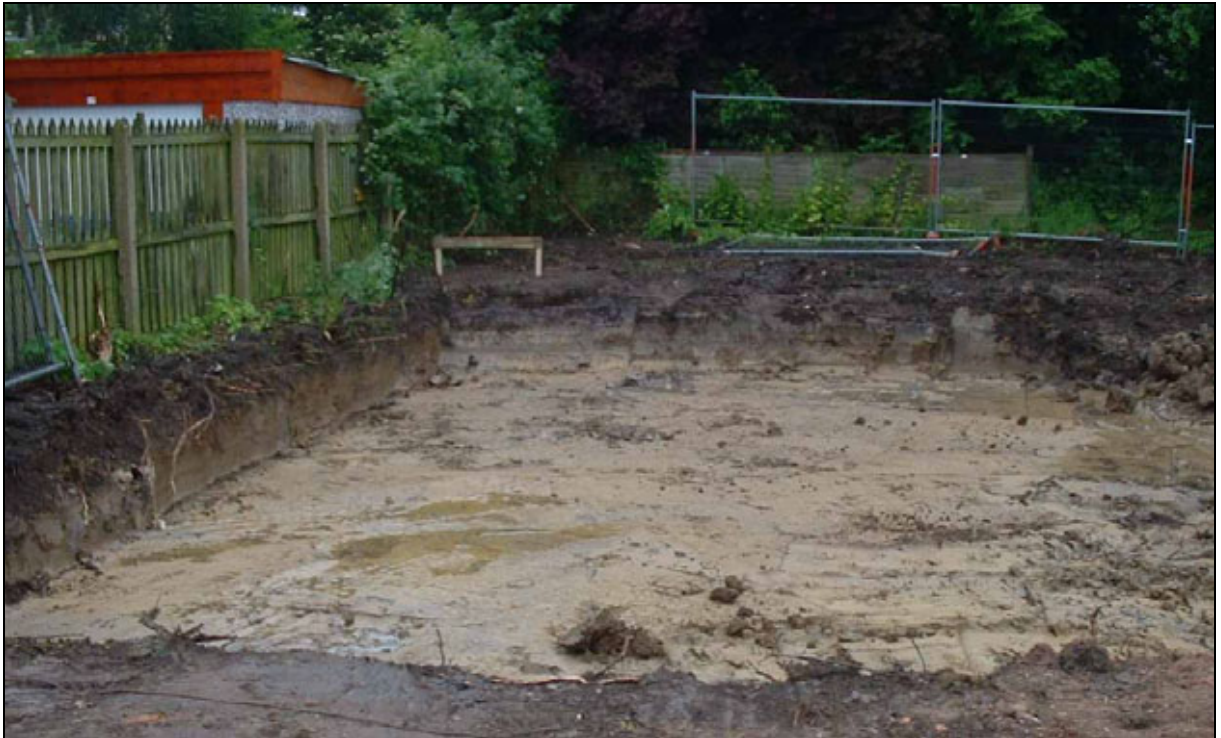
Plate 1. General view of site looking south

The earliest deposit encountered was (102) the mid yellow clay natural. This was encountered at an average depth of 0.40m below the existing ground level (around 3.55m AOD) (see Plate 1). The natural was overlain by a subsoil deposit (101) of mid reddish brown silty clay, 0.10m to 0.15m thick, from which a single sherd of heavily abraded medieval green glazed pottery was recovered. The uppermost deposit present was (100) the recent mid grey clay silt topsoil, which was a maximum of 0.30m thick (see Plate 2).

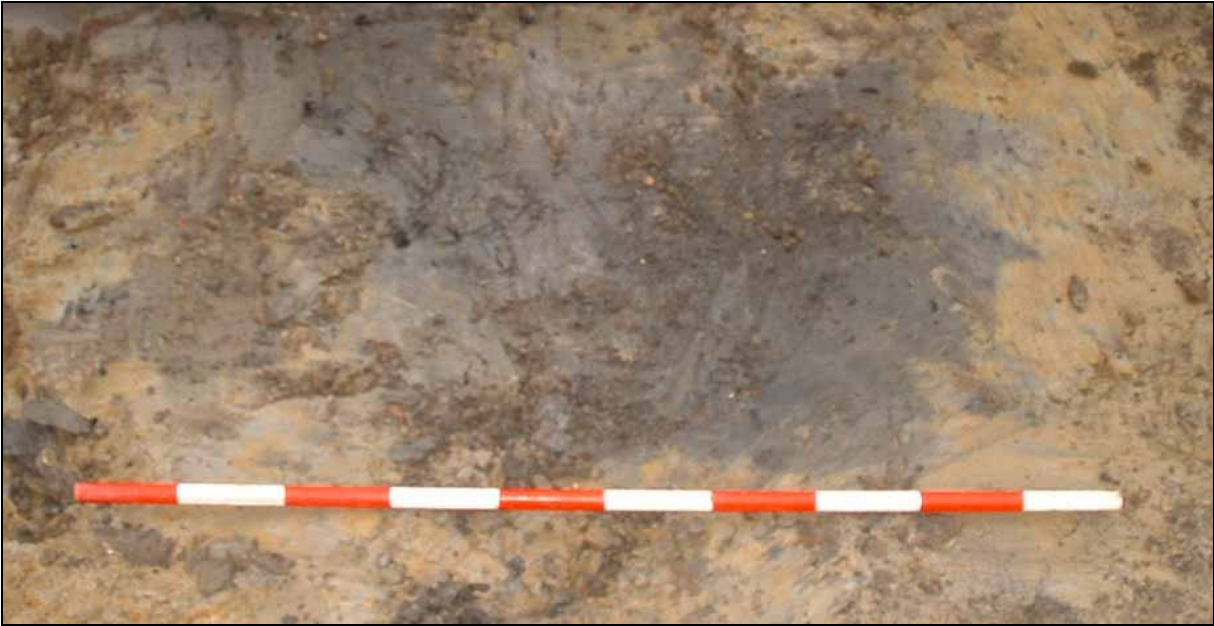
Plate 3. (103) prior to excavation looking north

Close to the northern edge of the excavated area a possible archaeological feature [104] was observed cutting into the natural. This was approximately oval, with a maximum diameter of 1.00m and up to 0.15m deep. The sides were very irregular, including several offshoots, that

almost certainly represent rotted out roots. The fill (103) of mid grey clay silt contained occasional flecks of Ceramic Building Material (CBM), but no other artefacts. The similarity of this fill with the modern topsoil suggests that this feature is of recent date, and its irregular nature indicates that it is either formed by a tree root, or if it was originally a cut archaeological feature, it has subsequently been very heavily disturbed by root action.
