COVERHAM ABBEY, MIDDLEHAM.

ARCHAEOLOGICAL INVESTIGATIONS 1995-2015
OSA REPORT No: OSA14WB48

July 2015

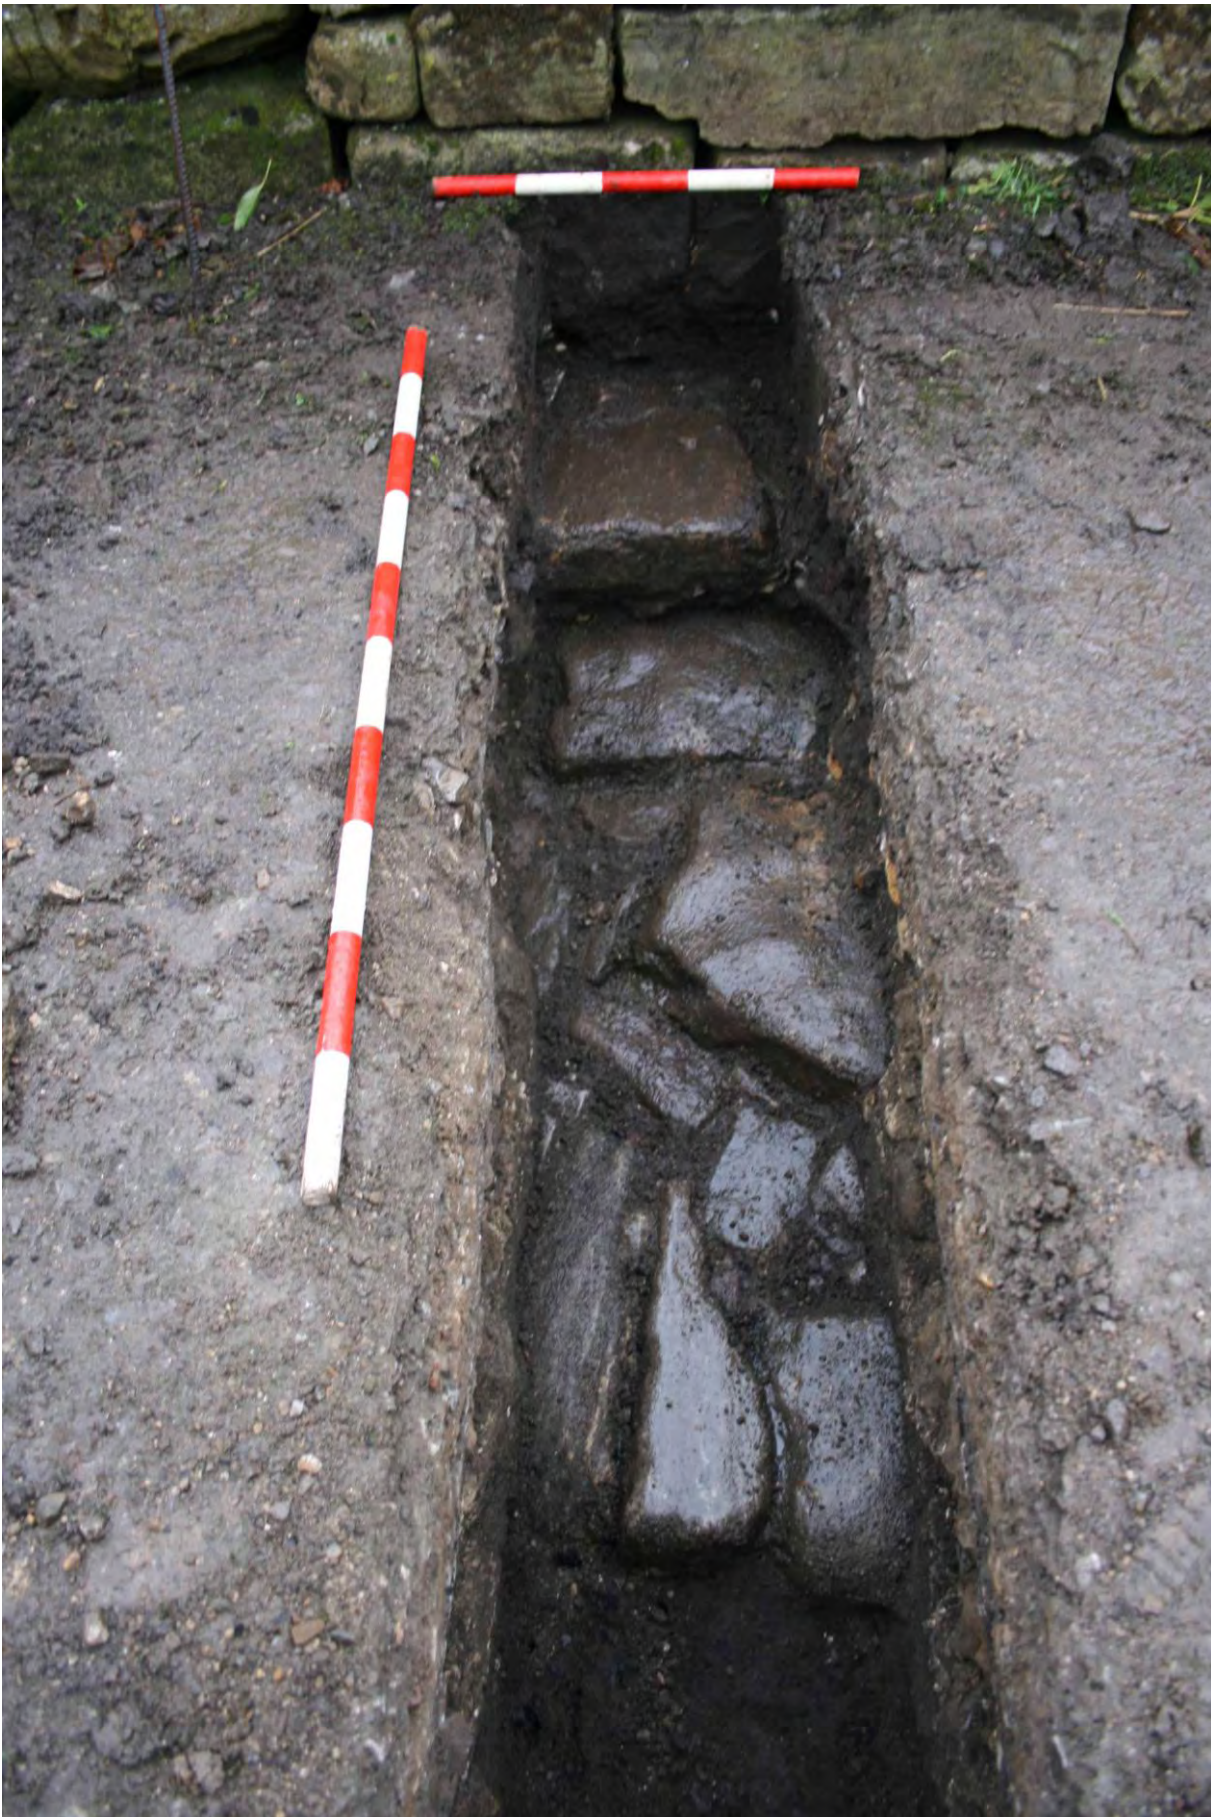
Plate 2. Track Area, masonry (206) in Trench 2 looking northwest

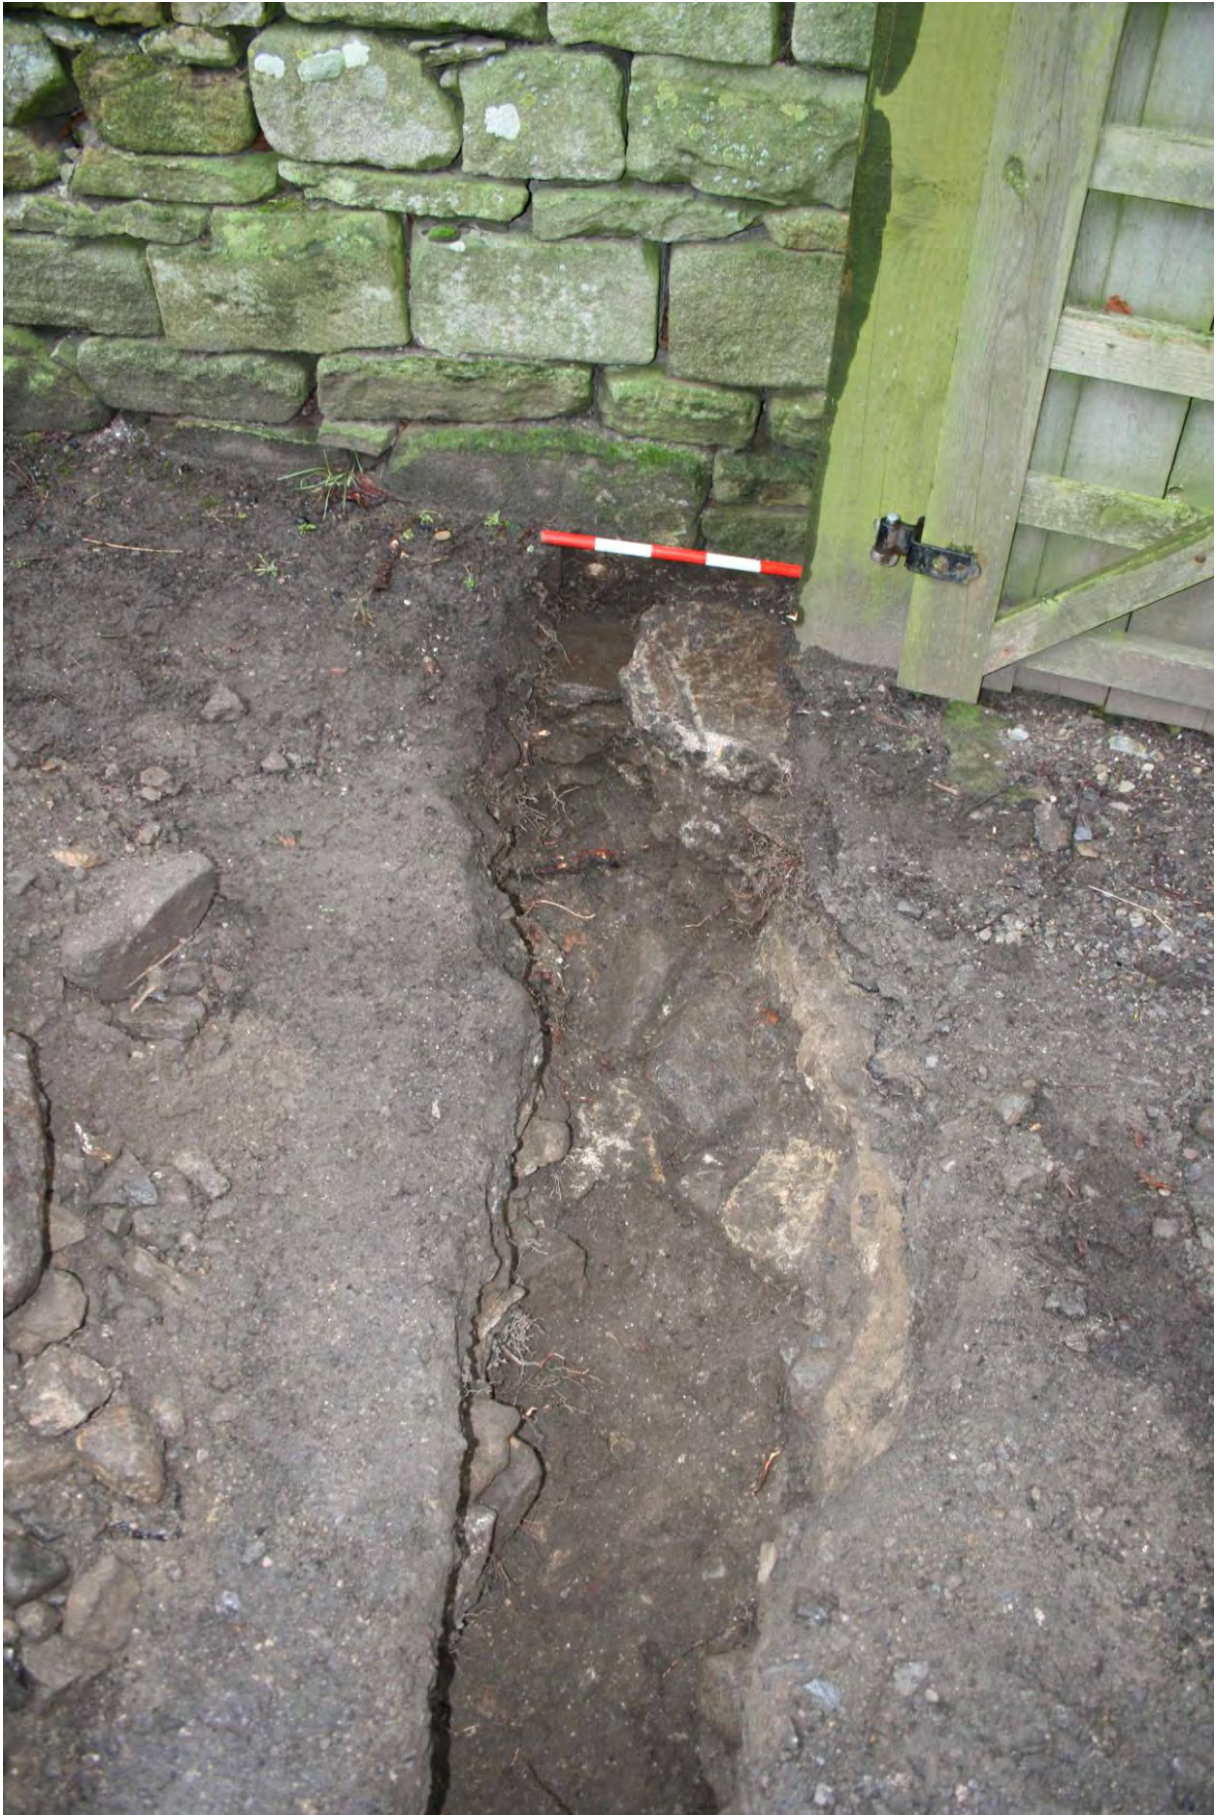
Plate 3. Track Area, masonry (305) and (306) looking northwest

Evaluation Trench 3 was located at the northeast end of the track, adjacent to the standing remains of the former abbey church. As in Trench 2, to the north were the remains of a stone surface (306) in the base of the trench, together with a taller element of masonry (305) at the end of the trench although the actual surface was less complete than in Trench 2 and had been truncated by the insertion of a modern concrete gatepost foundation (Plate 3). The deposit in

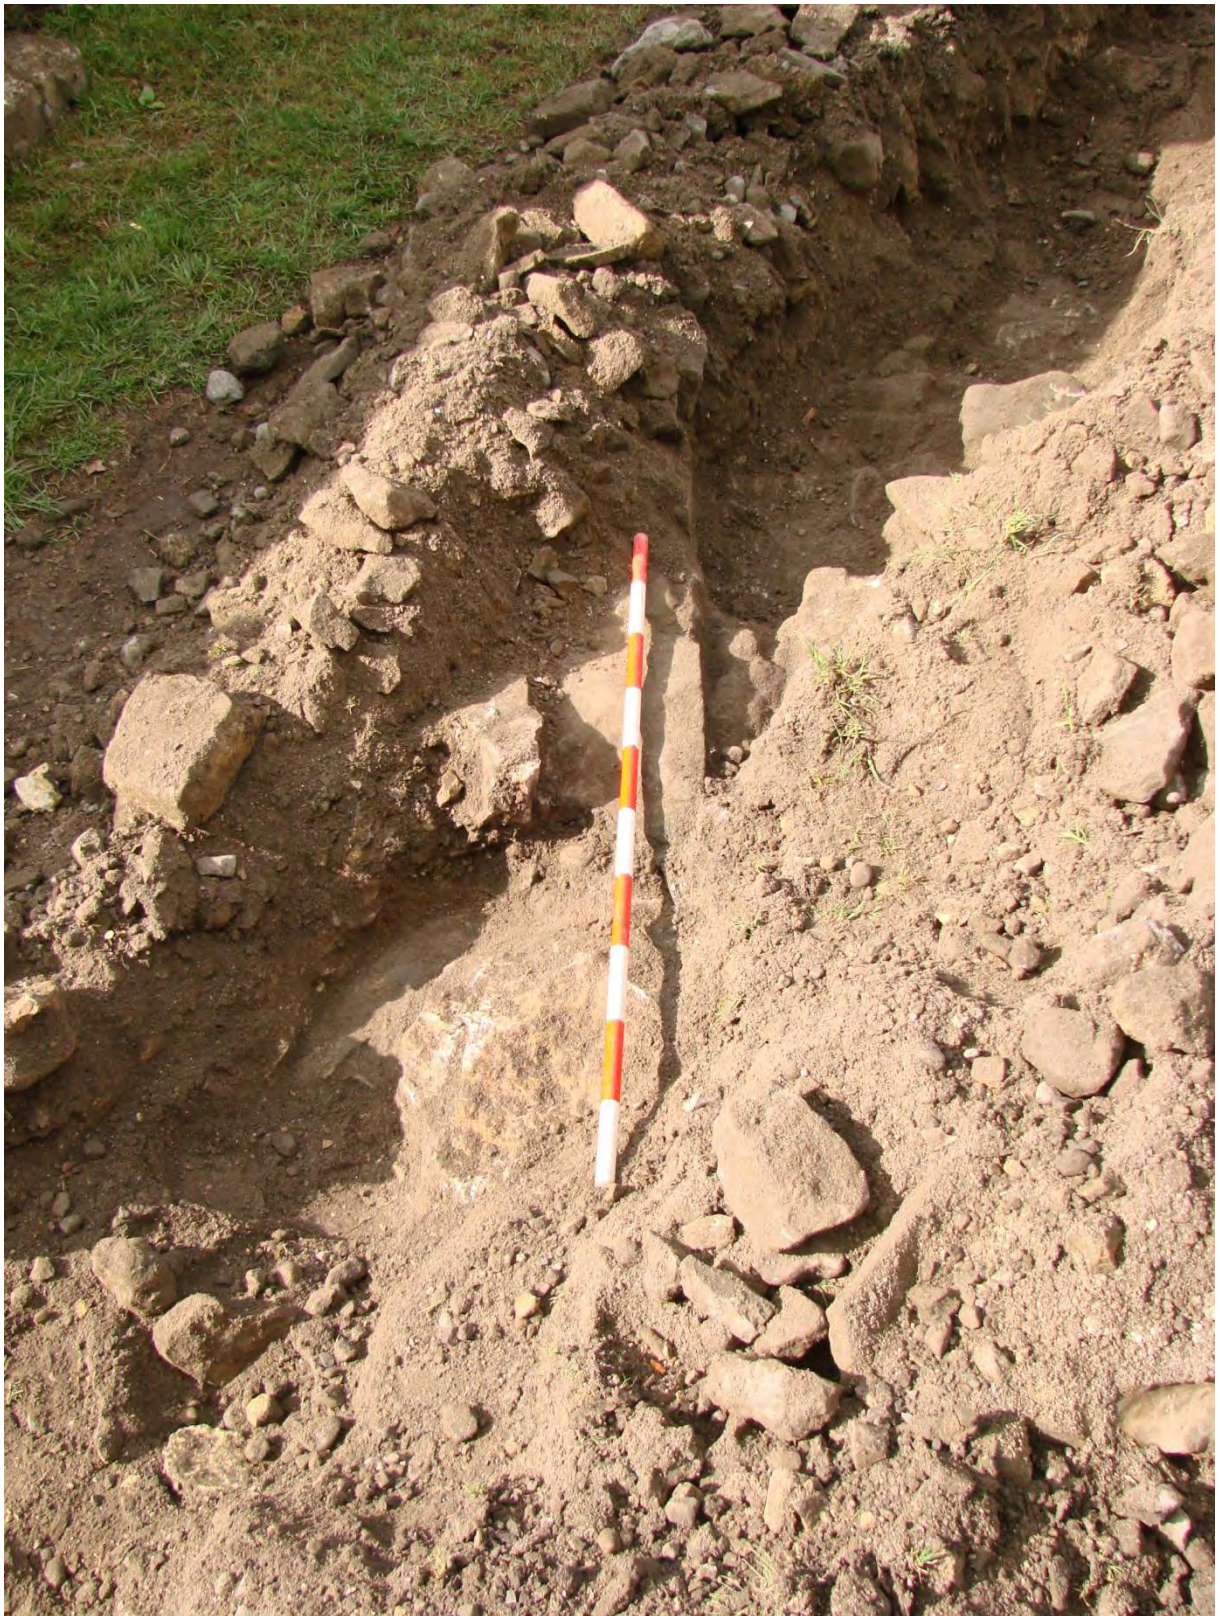
Plate 5. Track Area, box drain in Trench 5 looking south

The example found during the watching brief in the Track Area lay just to the north of the projected line of the north elevation of the nave of the monastic church. It ran approximately north-northeast to south-southwest (subject to the caveat that only a tiny part of the feature was seen in the cable trench) and while the orientation was clearly not in line with that of the church building, it also does not match the orientation of the later buildings on the site. It is a possibility that the drain would have run below the church itself, thus potentially dating to the earliest monastic settlement of the site. The drain uncovered in a trial trench at the southwest corner of Coverham Abbey House had a similar alignment and it too makes little sense in the context of the later buildings on the site. This too is likely to have been a medieval feature.

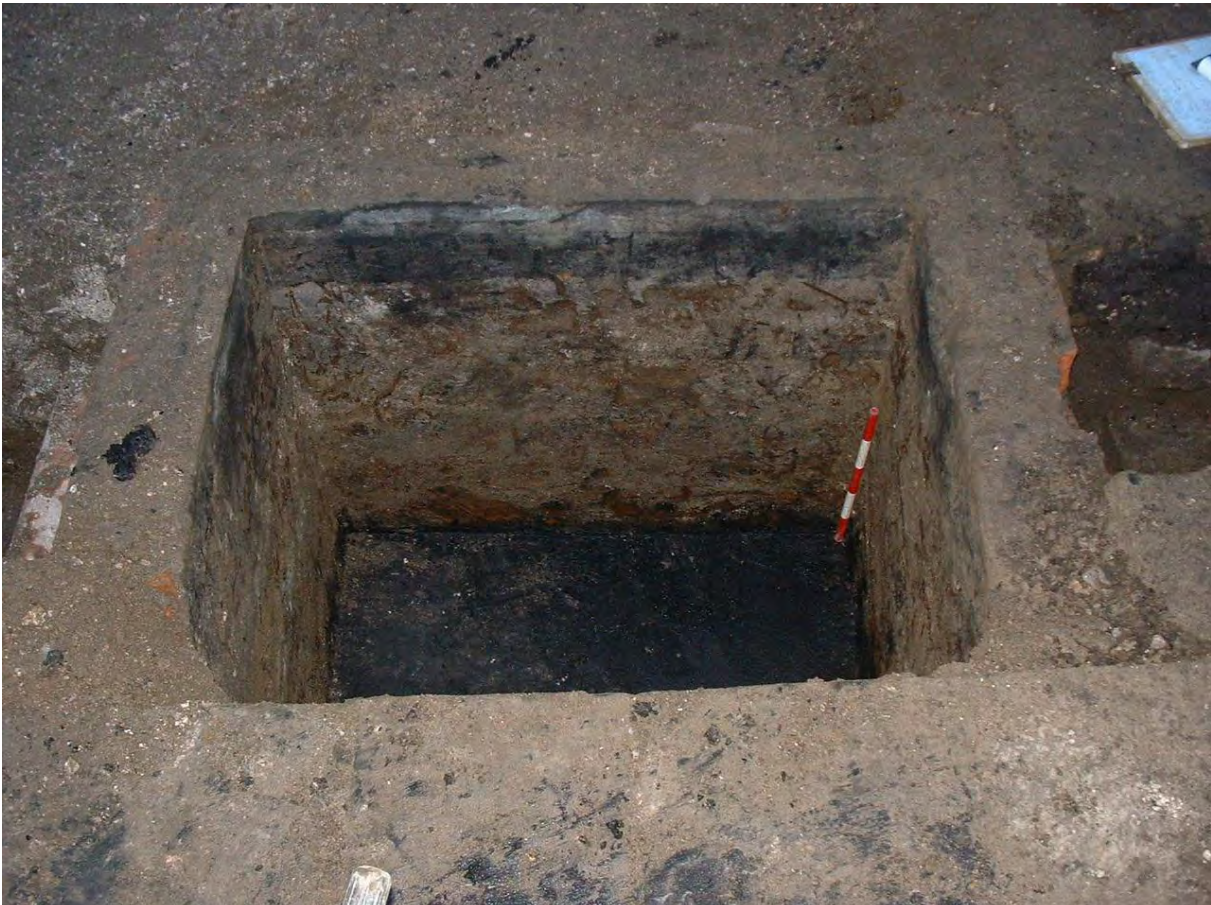
Plate 11. Porch Area early modern cistern(?) looking west

cess pit (Plate 11). Rusted cast iron pipes visible in the backfill of the unexcavated part of the feature may have been pipework for a pump.

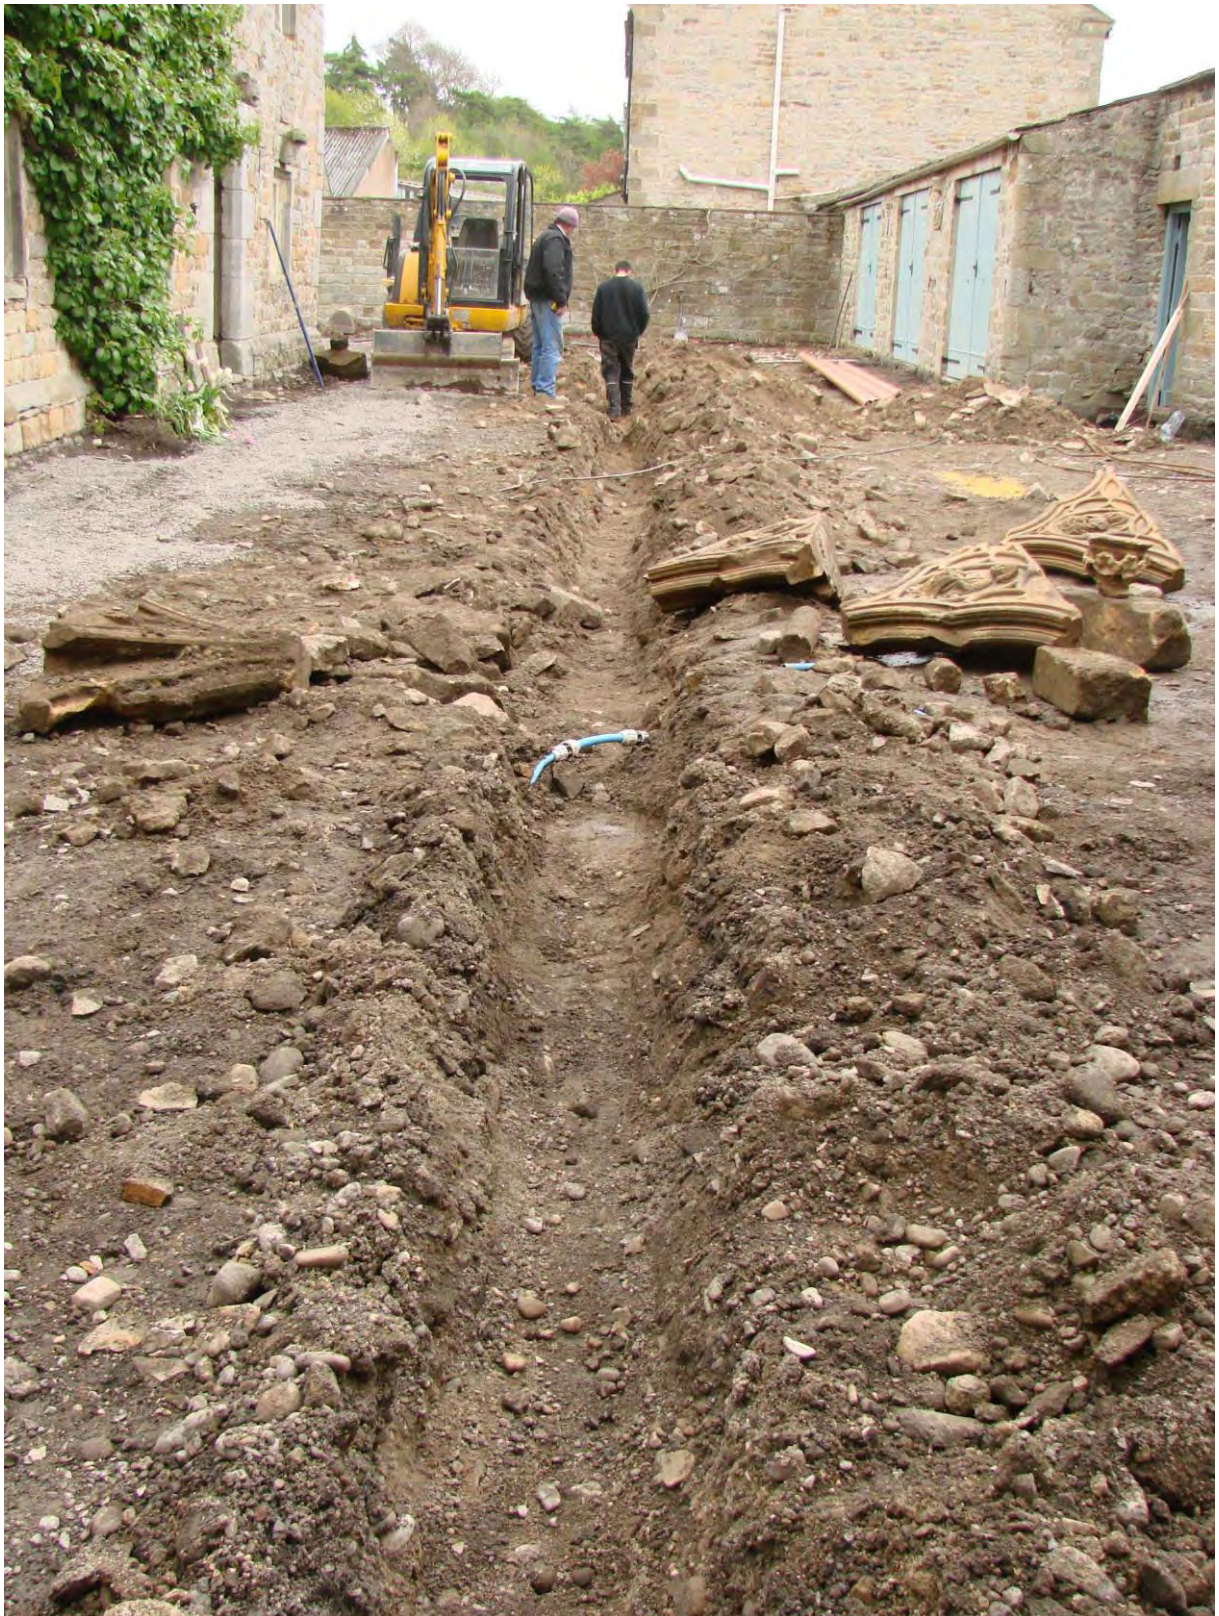
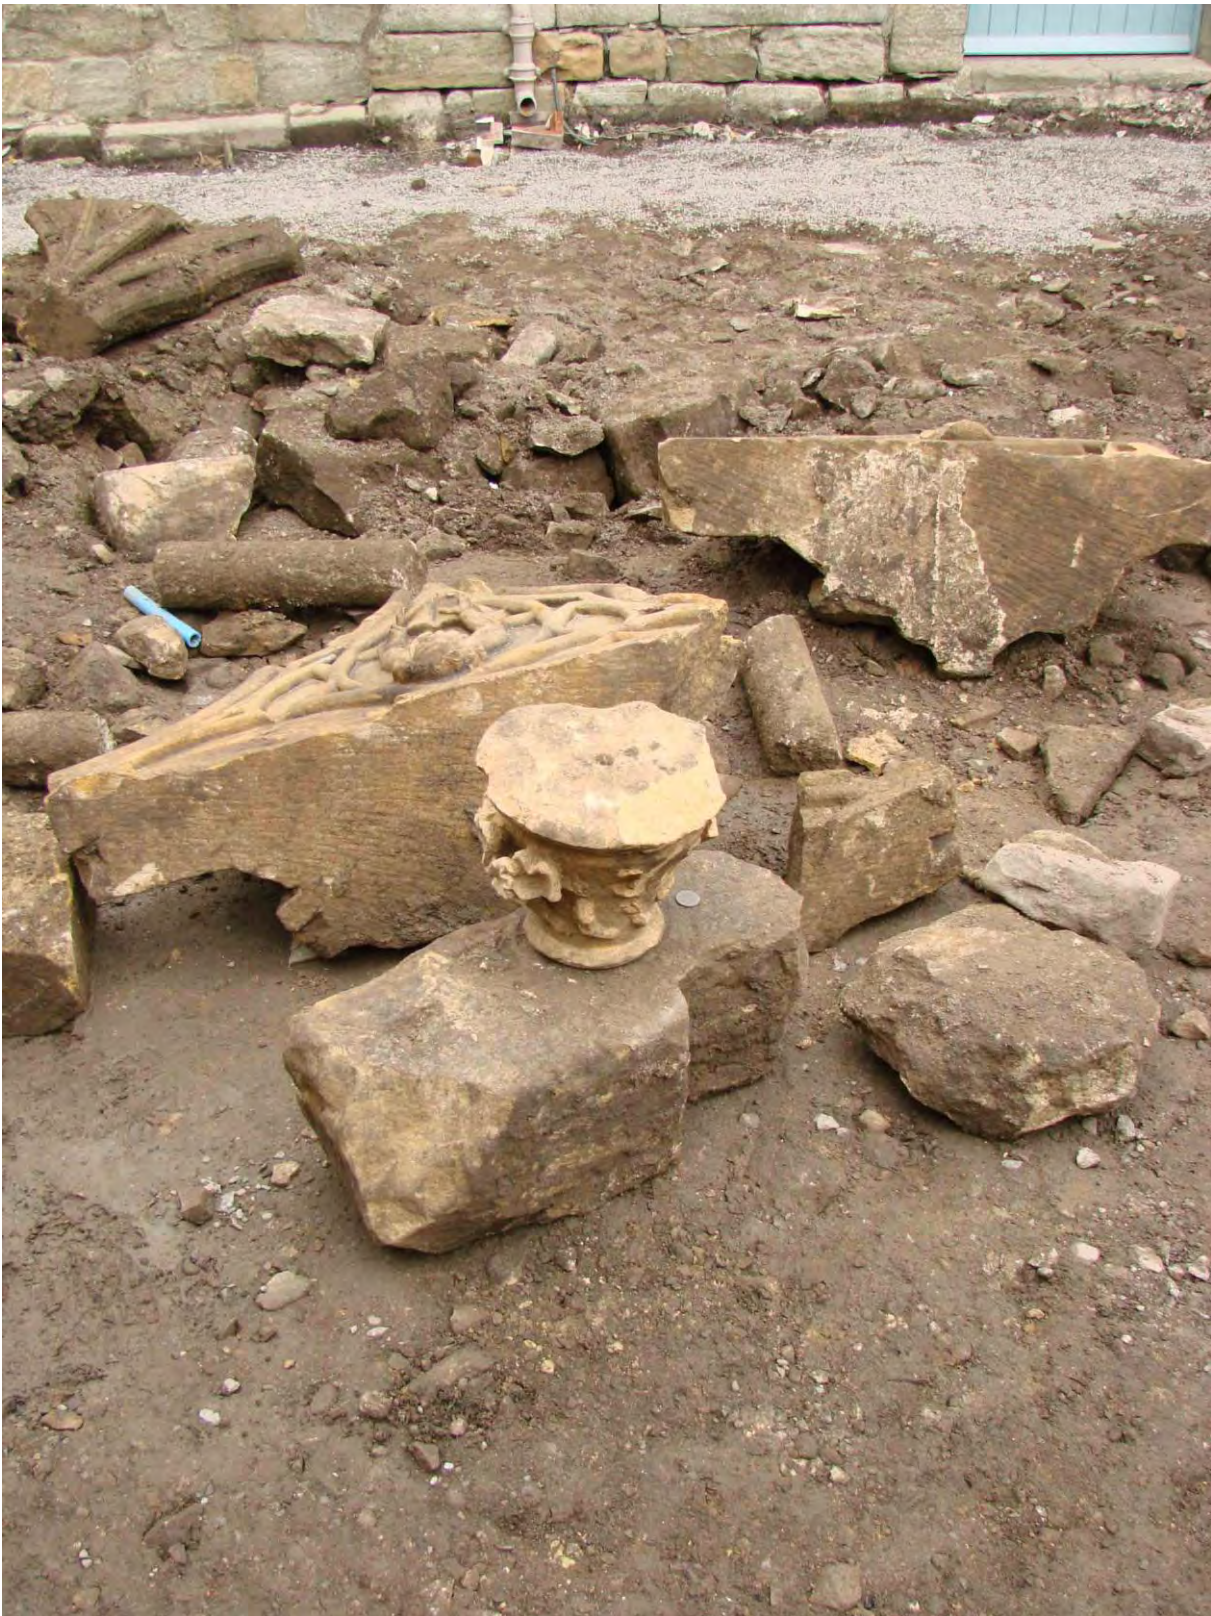
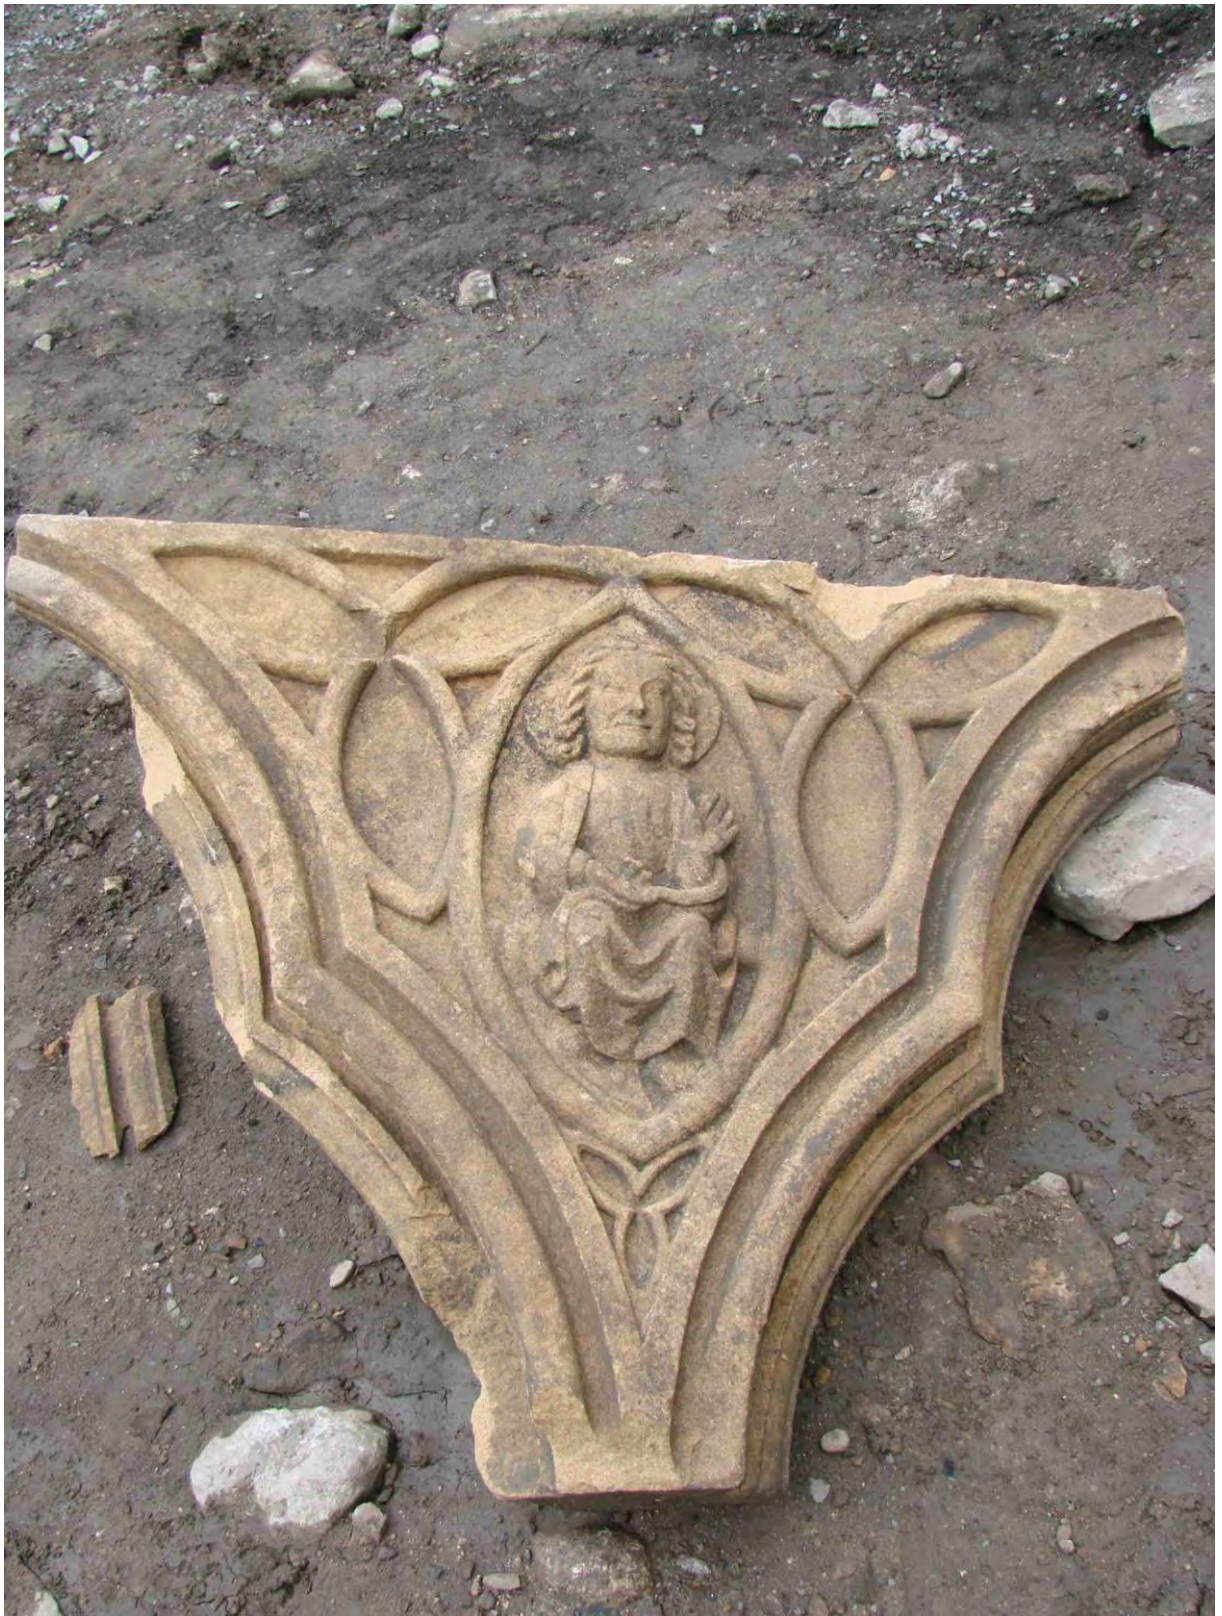
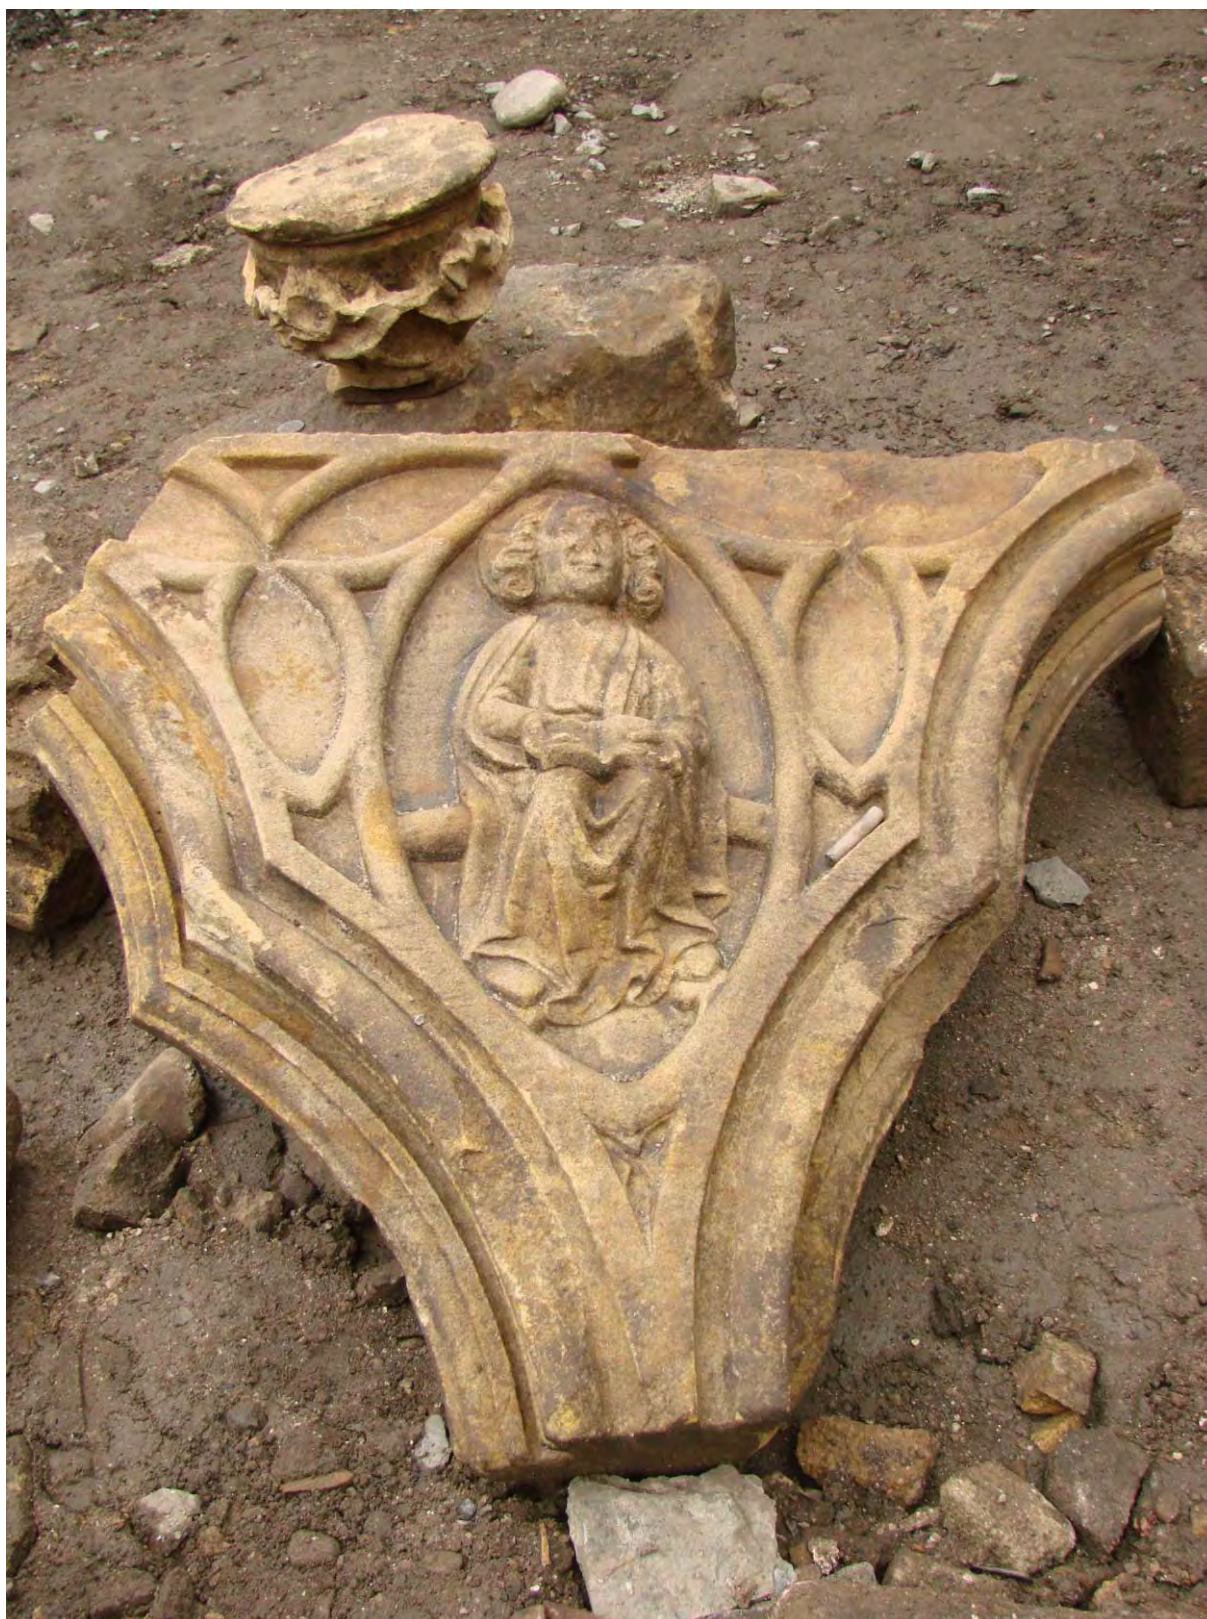
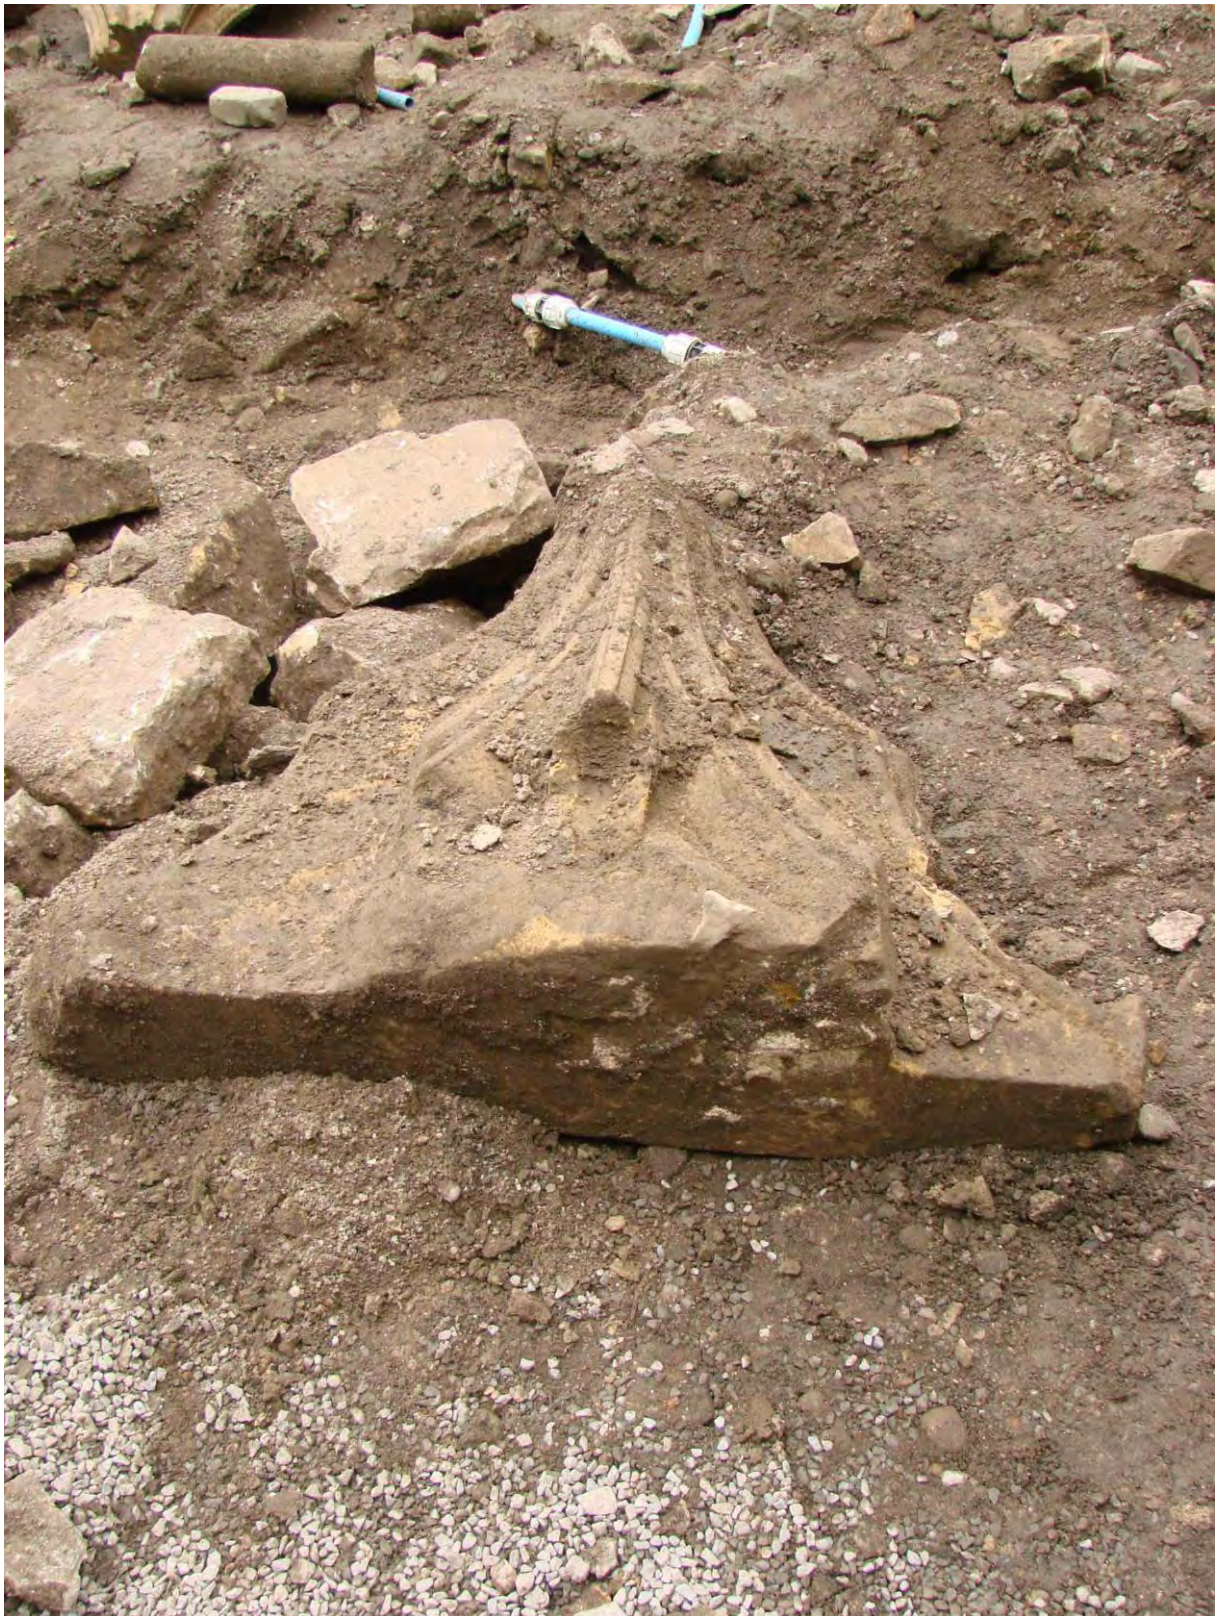
Plate 14. Yard Area spandrels and drain trench

Plate 15. Yard Area spandrels and decorative masonry

Plate 16. Yard Area example of spandrel

Plate 17. Yard Area example of spandrel

Plate 18. Yard Area rear of spandrel showing springer

trench (4003). This included four intricately carved spandrels, each measuring almost a metre across their tops (Plates 14 to 19). Each of the four had springers on the rear suggesting they attached to vaulting ribs. Three of the four were broadly similar in their working. Each contained a *vesica piscis* set between two trefoils containing a seated figure. Each figure was represented with a halo. The fourth spandrel had a blank front. Found with the spandrels were an intricate capital and several fragments of cylindrical shaft. These cylindrical pieces may have formed the columns for the spandrels although at just 105mm in diameter they would have been slender in proportion to the spandrels they supported. The investigation was limited to an examination of the excavated sides of the drain trench, which did not reveal any stratigraphic relationships. An explanation for the apparently linear, east-west deposition of the fragments may be that they were the backfill of a 'robber trench' for the extraction of building stone from a putative former wall. However, this is speculative and no physical evidence for such a robber feature was found.

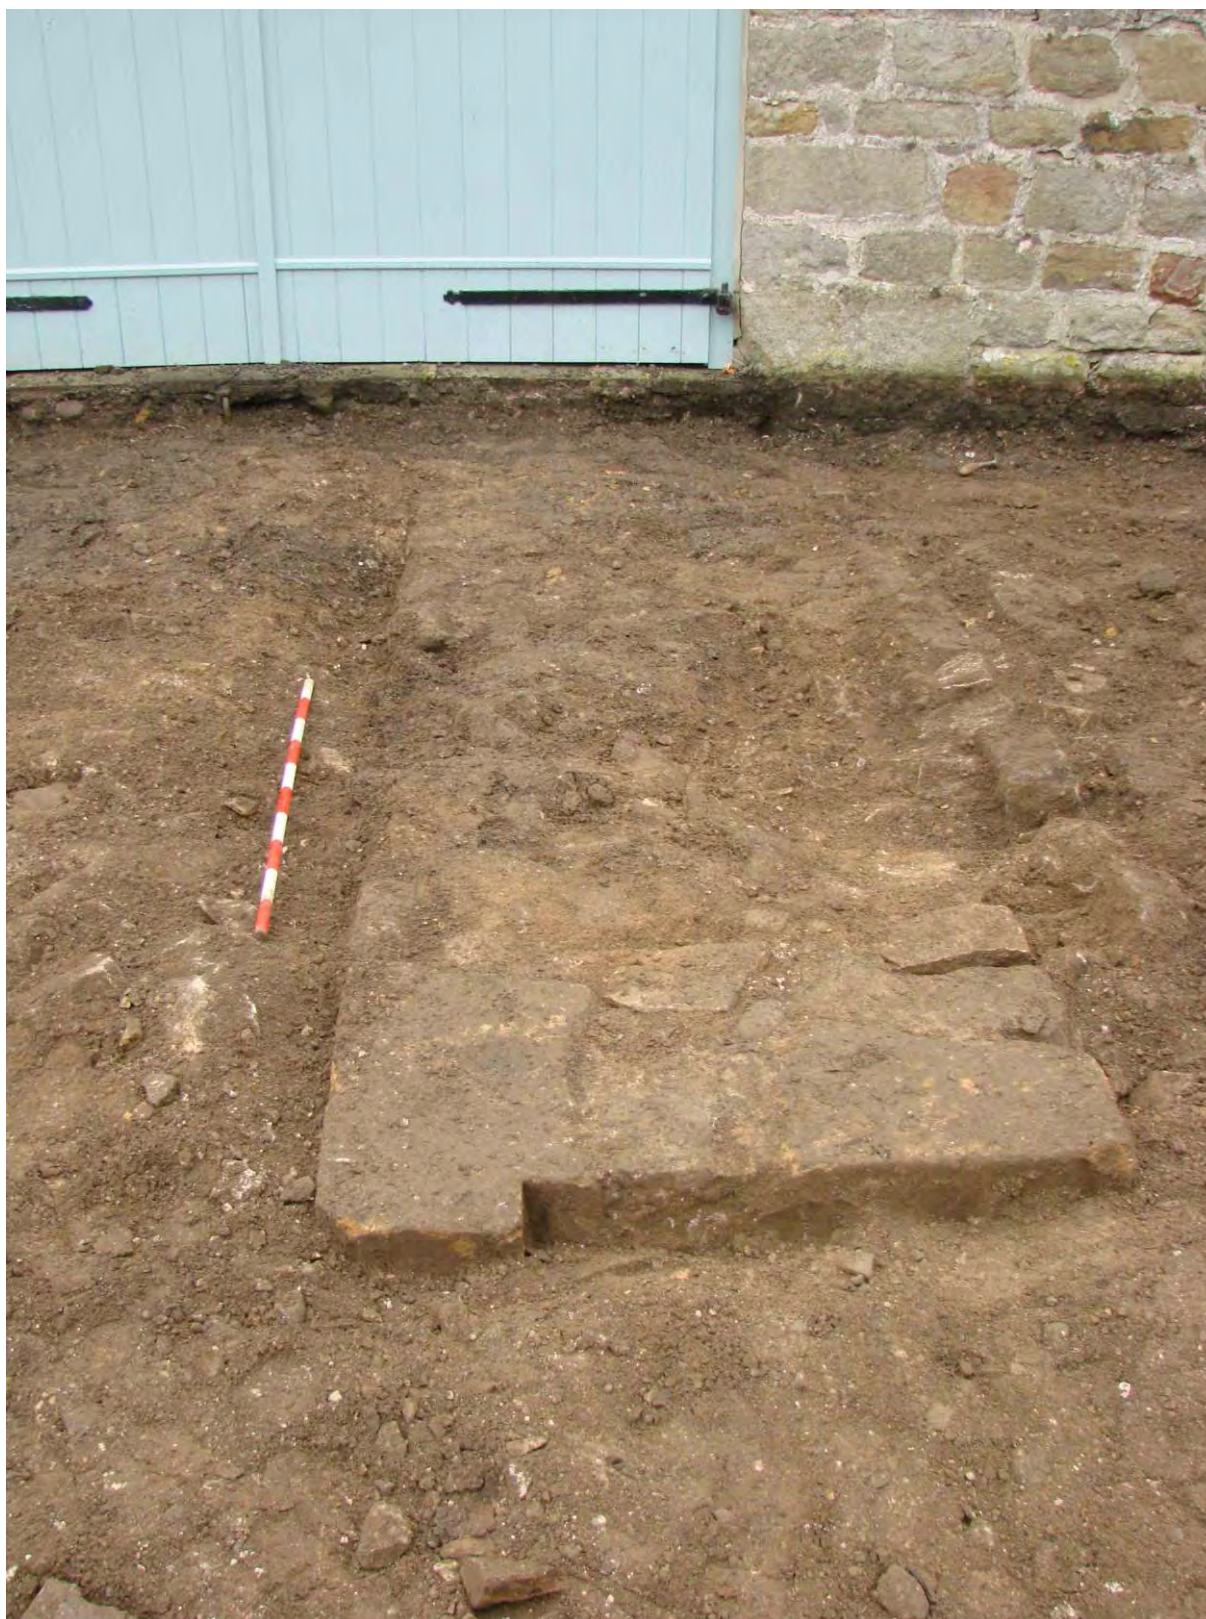
Plate 20. Yard Area foundation (4022) showing door jamb

Approximately 5.5m to the east a second example of a substantial north-south wall (4022) was found, running parallel to the first (Plate 20). It too had a rebated block at its northern end for containing a door, identical in form to the block to the west. Both examples were for separate doors (that would have been orientated north-south when closed). This foundation was 1.45m wide and 3.5m was exposed, although it clearly continued to the south beneath the existing garages and it was also bonded with lime mortar.

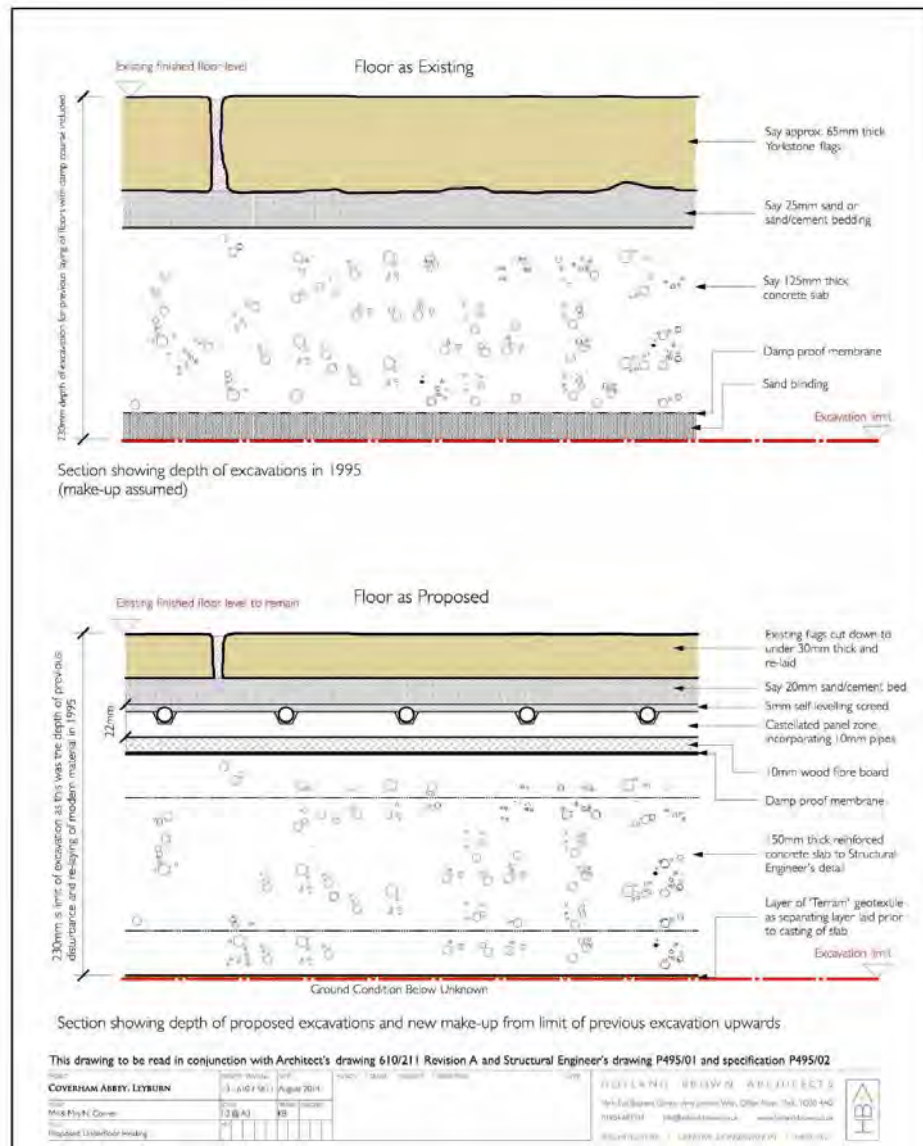
Figure 4. Indicative sections through floors as existing, and as proposed.
