TENTERCROFT STREET, LINCOLN.

ARCHAEOLOGICAL EVALUATION  
BY BOREHOLES AND TEST-PITTING  
OSA REPORT No.: OSA17EV10

April 2017

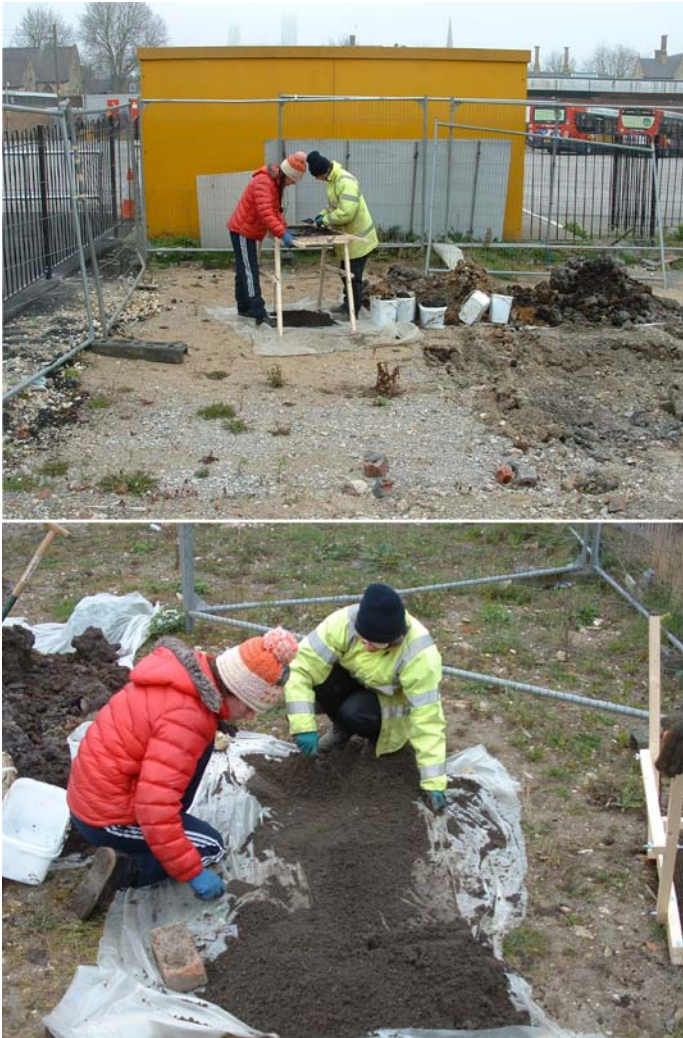
Figure 4. Sieving and hand sorting the sieved residue

A sample of 100 litres of the target deposit in each of the six test pits was examined using a combination of dry-sieving and manual disaggregation. A total of 600 litres of target deposit was examined across the site. Because of the consolidated nature of the deposits (particularly the buried soil A-horizon, which was extremely dense degraded peat with a highly coherent structure) a relatively coarse 9mm mesh was used. As it was possible that the smallest flint artefacts would pass through the mesh, the sieved residue was also sorted through by hand to search for small artefacts (**Figure 4**).

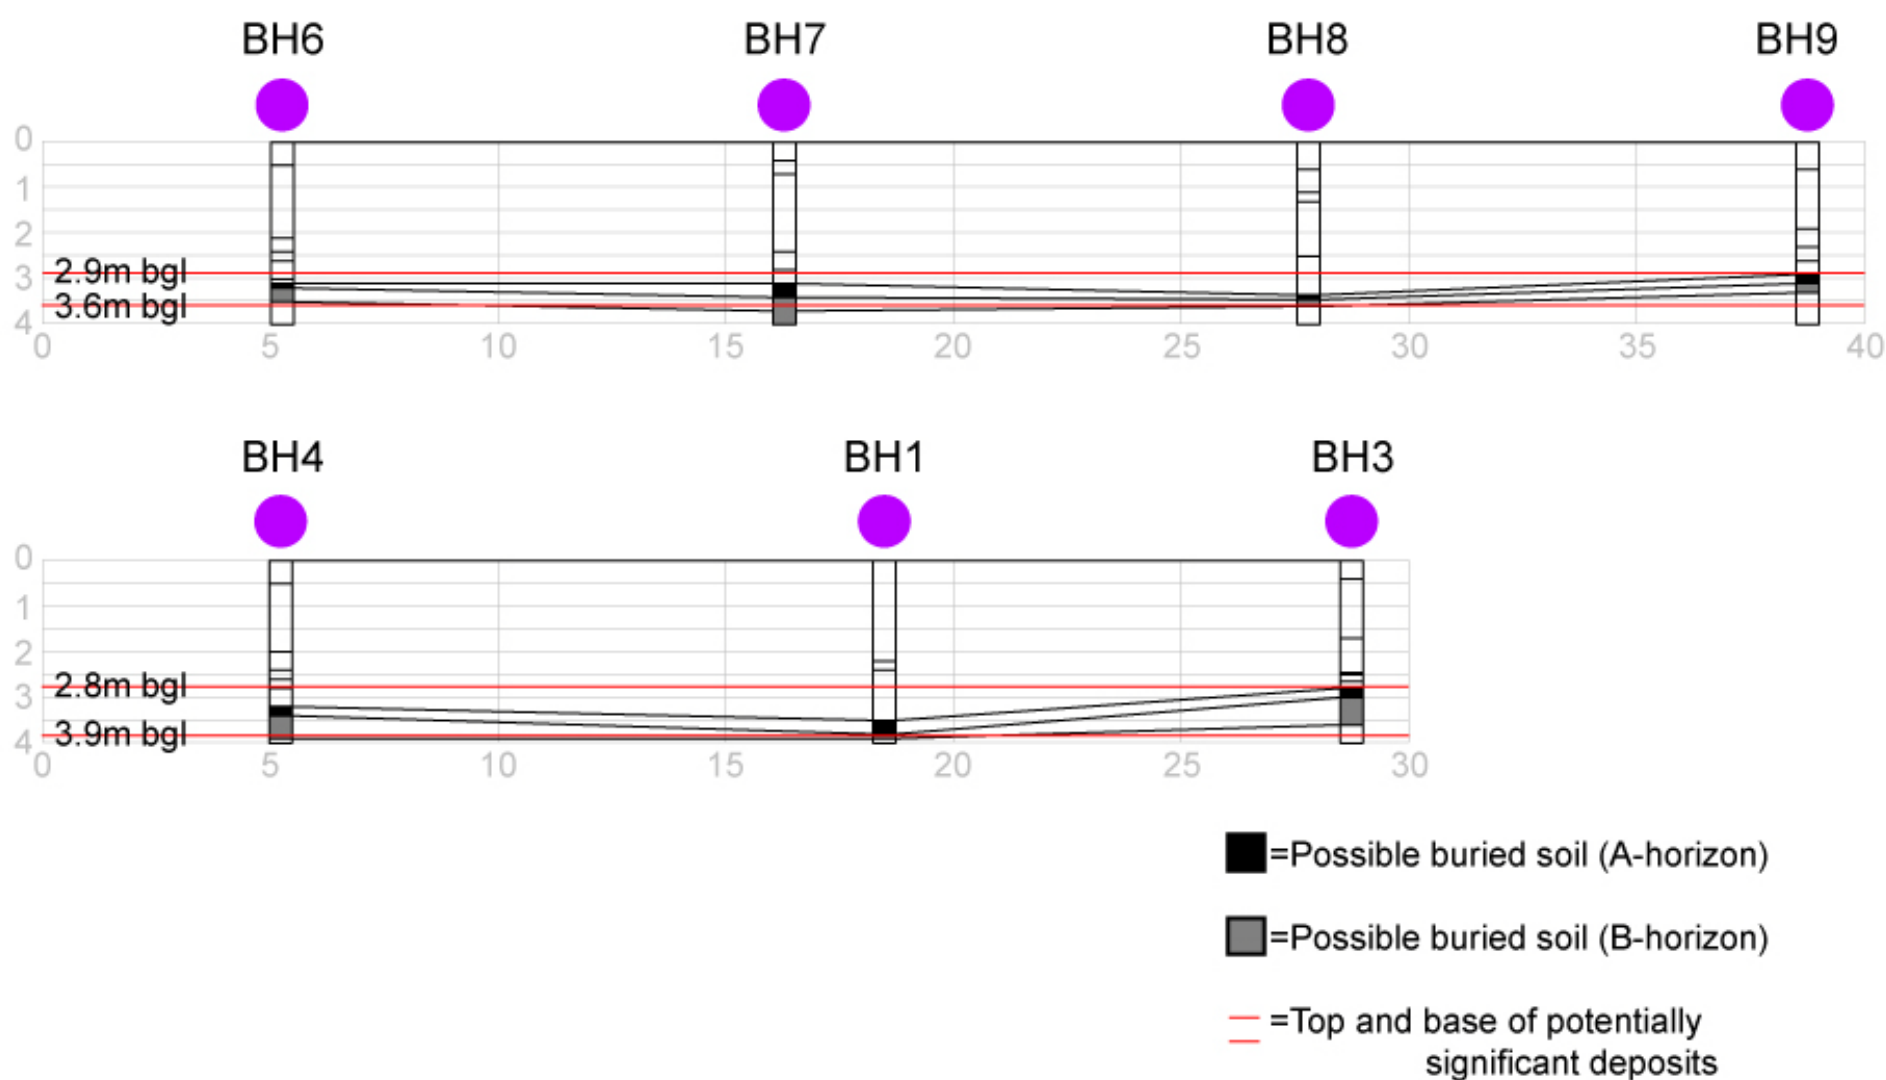
Figure 5. Borehole locations, results and deposit model

A full record of the boreholes is given in Appendix 1, but the main findings are as follows. The borehole locations and a deposit model are shown in **Figure 5**.

Undisturbed natural geology, consisting of firm orange-brown sand, was found at a consistent level of between 3.5m (BH6) and 3.9m (BH1). Above this was a probable buried soil deposit consisting of a B-horizon of grey sand and a former A-horizon of consolidated black silt.
