CAYTHORPE COURT, CAYTHORPE HEATH LANE,  
CAYTHORPE, LINCOLNSHIRE.

REPORT ON AN ARCHAEOLOGICAL WATCHING BRIEF

OSA Report No: OSA17WB54

May 2018

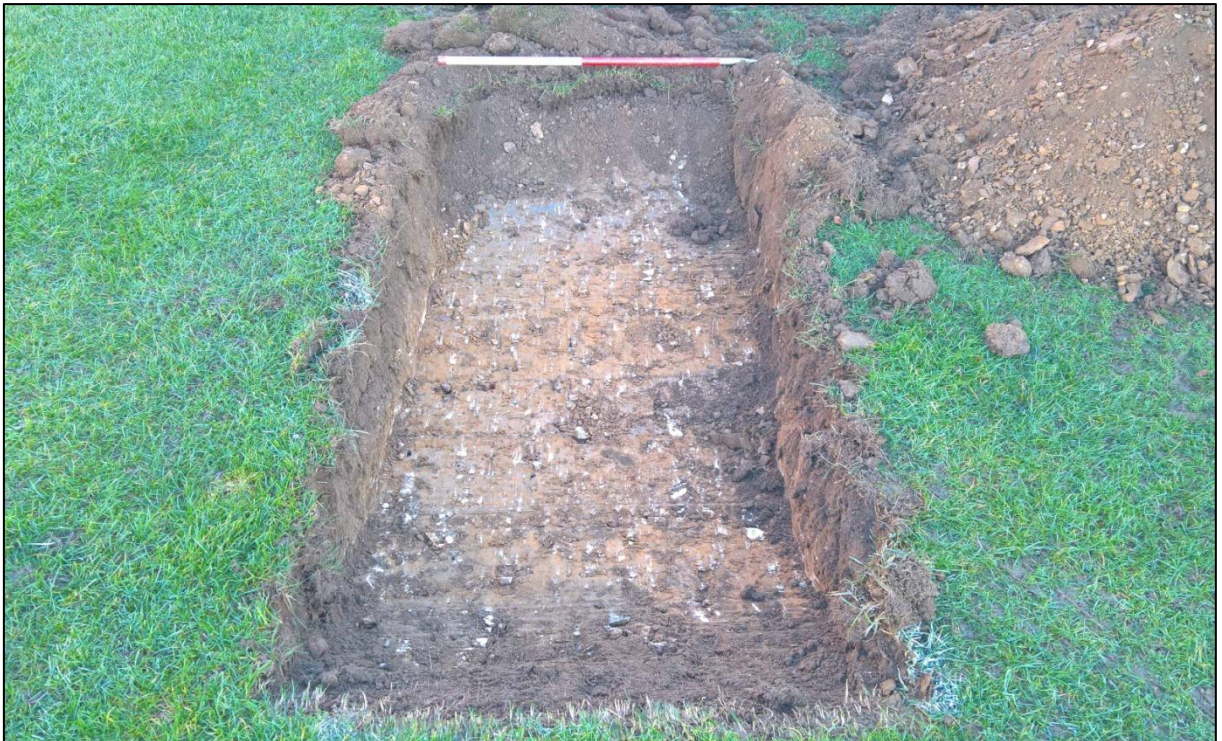
*Plate 2. Typical test pit.*

No archaeological features or deposits were revealed in the geotechnical test pits. Observed deposits were limited to modern topsoil, subsoil, comprising mid brown sandy silty clay, and natural limestone brash (Plate 2).
