Sillenhurst Moated Site and Fishpond, Woore, Shropshire
Scheduled Monument No. 32304

Archaeological Investigation Report
SLR Ref: 410.04169.00001

November 2013

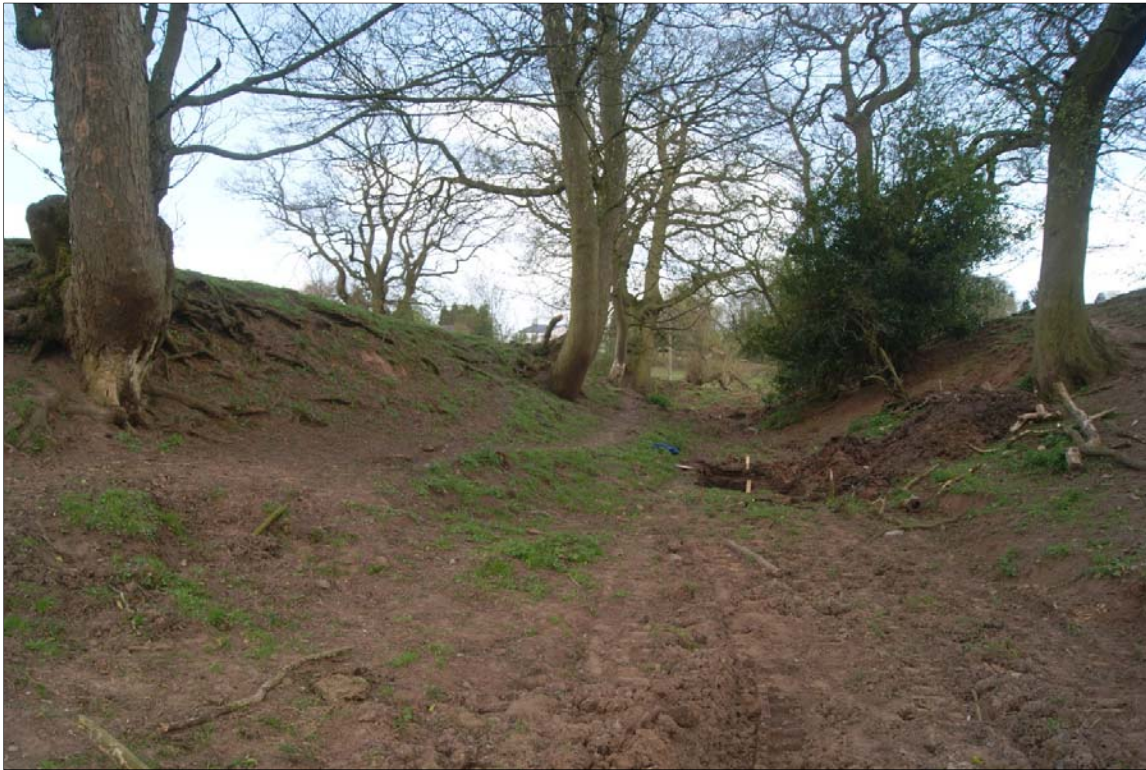
Figure 4: View south along western moat arm

By contrast the western arm of the moat is approximately 15-16m wide measured from the top of slope, and between 2.7m deep (southern end) and 3.75m deep (northern end), narrowing to a base that is barely 2.5m wide. This may suggest historic erosion of the moat sides, possibly exacerbated by the presence of large deciduous trees rooted into the moat sides, though these are likely to have subsequently aided its stabilisation. Some damage to the moat sides due to livestock movement, particularly around the north west corner of the platform, was noted, and animal burrows were observed in the western side of the moat.

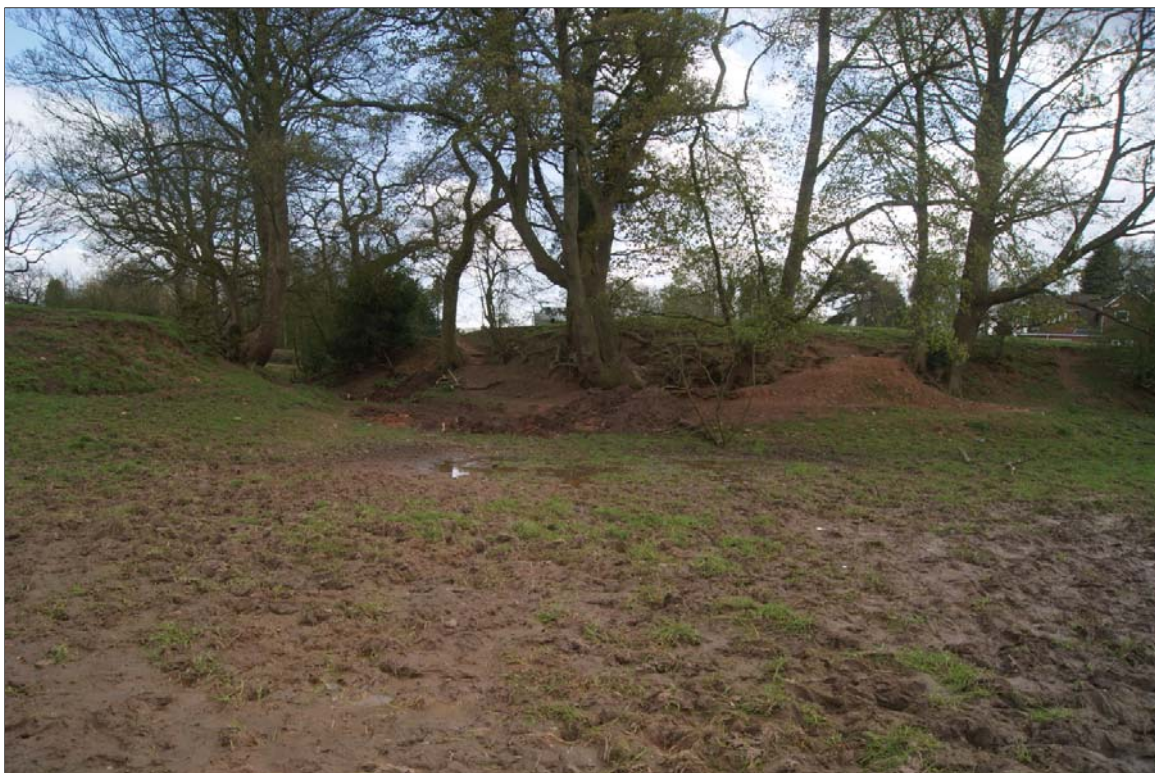
Figure 5: View south across waterlogged and trampled central area of fish pond, towards western moat arm

northern embankment towards its eastern end associated with drainage works, and the base of the pond has been disturbed by trample from cattle movement.

The base of the monument has suffered from trample caused by a combination of seasonal waterlogging and cattle movements along the moat arms and base of the fish pond. In all trenches an upper layer of trampled and disturbed ground was visible to the naked eye, but assessment of samples taken from the lower fills indicates that this disturbance extended to the base of the monument, indicating recent deposition and reworking.

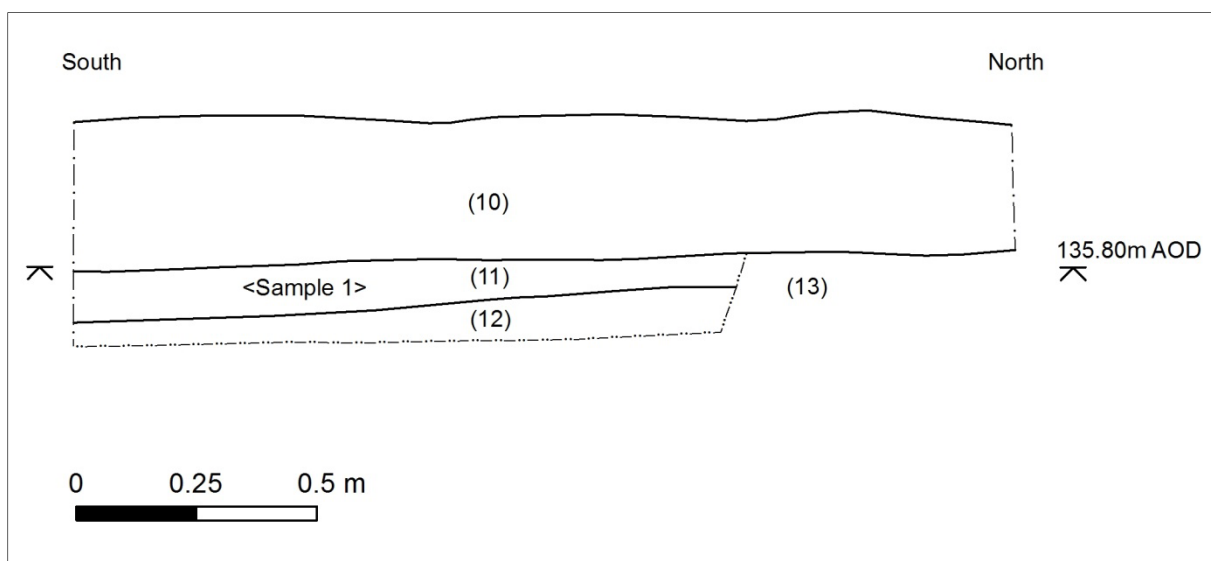
The existing ground level stood at approximately 136.30m AOD, and was very soft, containing root disturbance and leaf litter from the adjacent trees, and had been heavily trampled by cattle moving along the base of the moat. The trench was excavated to a maximum depth of 0.74m, equating to a basal depth of 135.56m AOD.

Figure 7: Plan of Trench 1

Figure 8: Trench 1, north east facing section

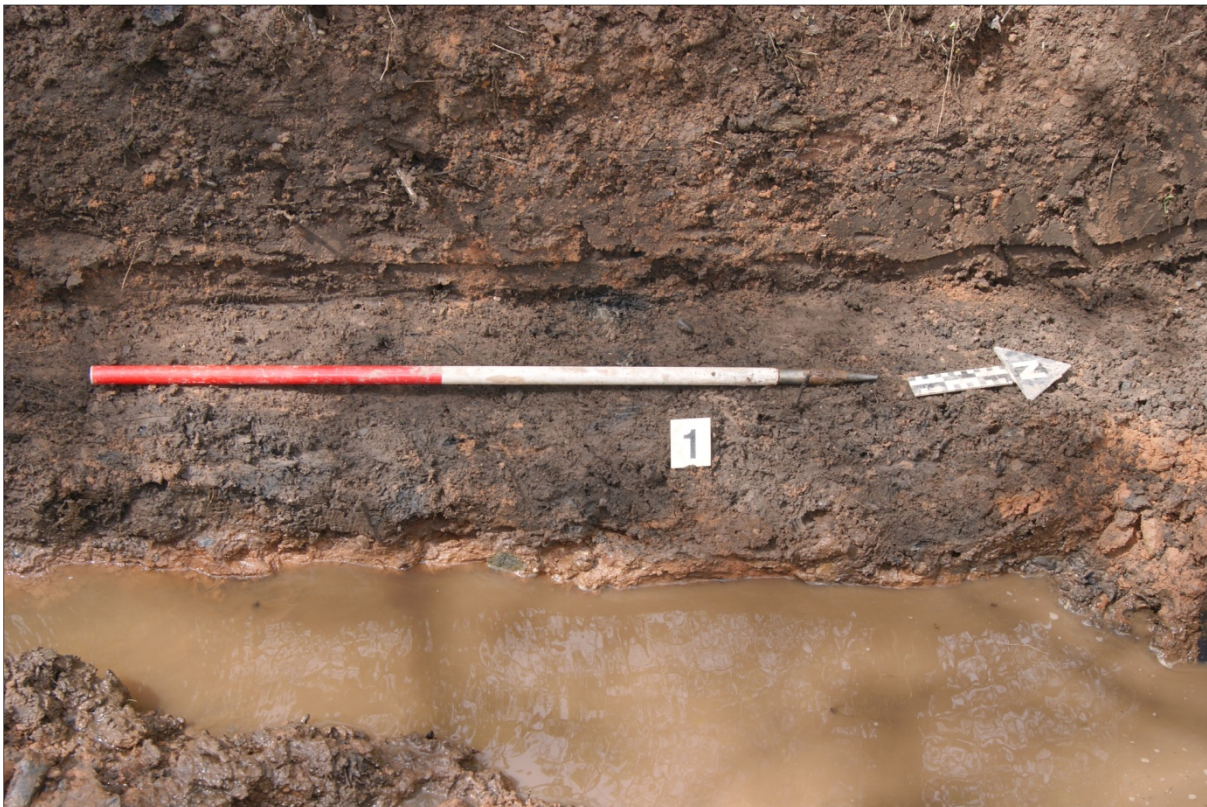
In the base of the trench the natural slightly clayey sand was noted at a depth of 135.62m AOD (Context 12). This material was sealed by a deposit of dark grey/brown clayey silt (Context 10) interpreted as the basal fill of the moat. This layer was up to 0.16m thick and contained frequent twig, branch and root fragments, and had a strong organic odour. A sample of this deposit was recovered for palaeoenvironmental analysis (Sample 1).

Figure 9: Trench 1, view to west of basal moat fill

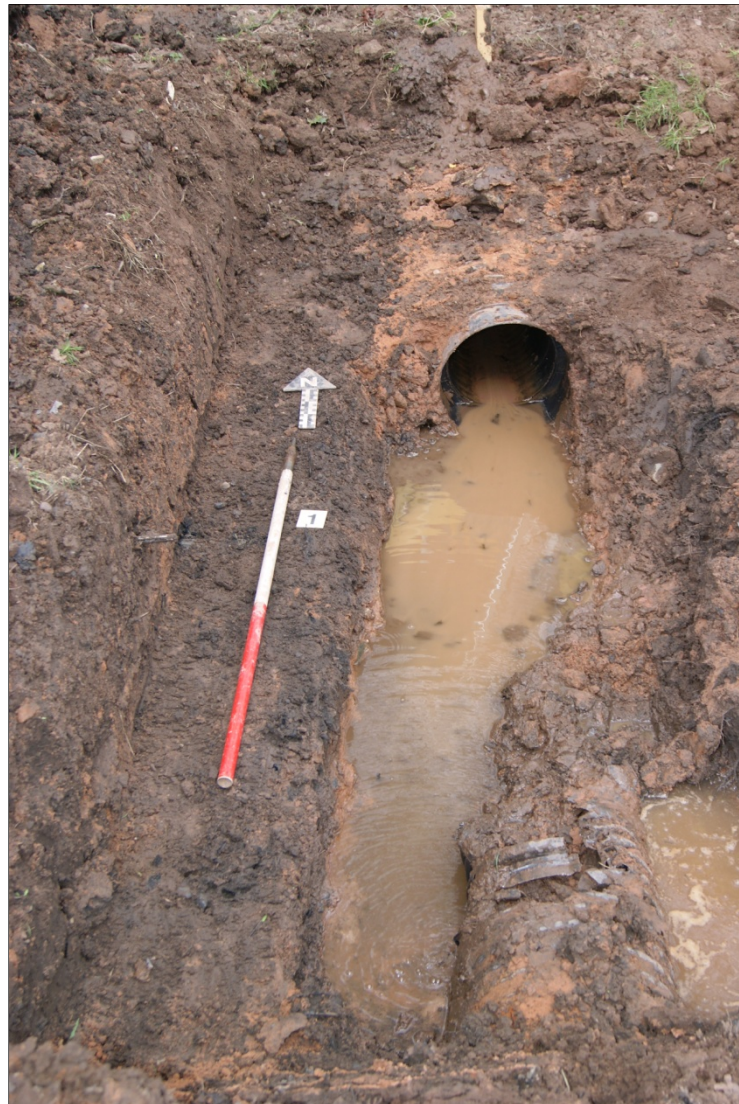
The fills of the moat had been cut by the machine excavated drainage trench [42], which was 0.9m wide and 0.76m deep with vertical sides. A plastic drain 0.3m in diameter had been laid within the cut (upper surface standing at between 135.89-135.95m AOD) and the cut then backfilled with a mixed dark brown organic clayey silt and red sand (Context 13).

Figure 10: Trench 1 facing north showing drain cut through moat fill

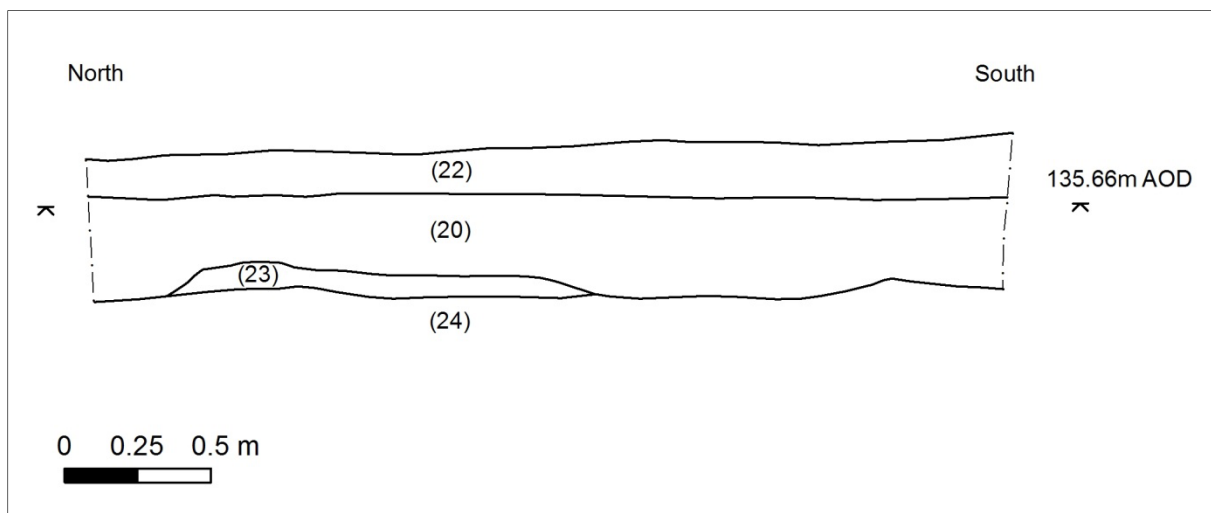
The existing ground level stood at around 135.82m AOD, and was heavily disturbed by root action from the adjacent trees and trample by cattle. The trench was excavated to a maximum depth of 135.28m AOD.

Figure 11: Plan of Trench 2

Figure 12: Trench 2 south west facing section

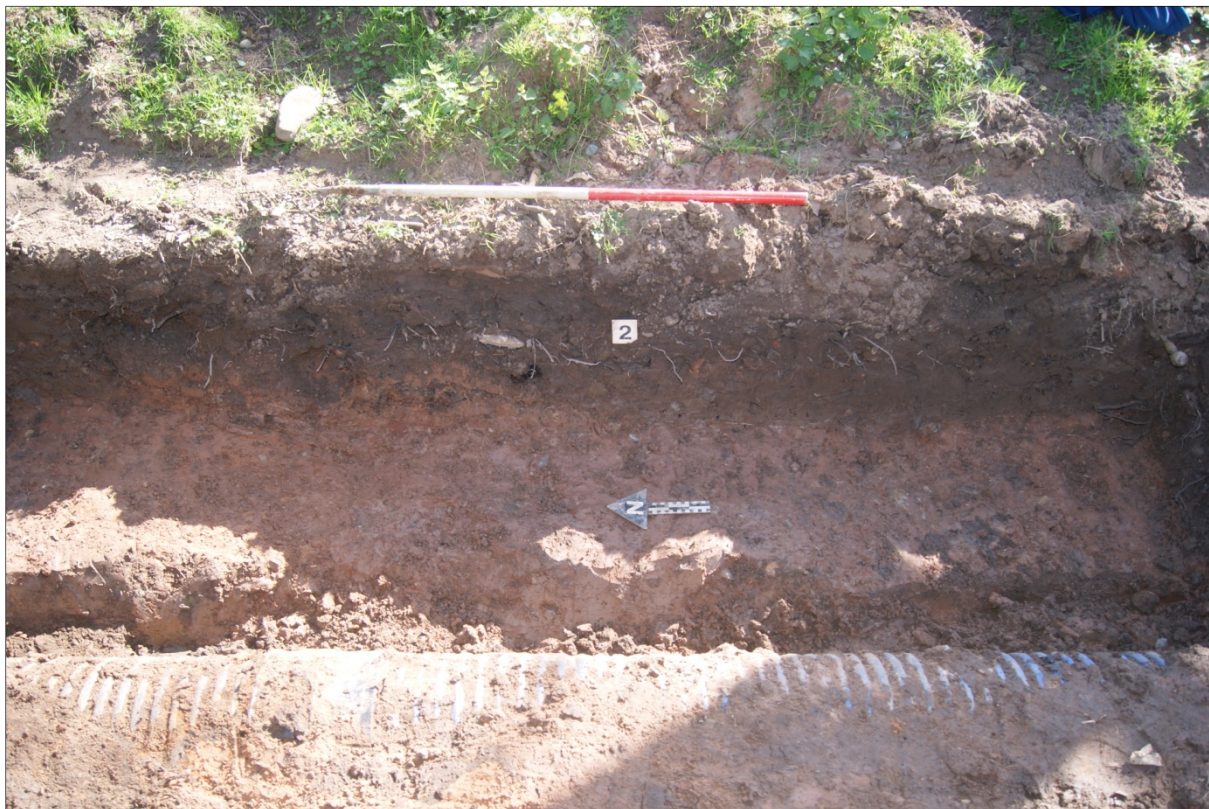
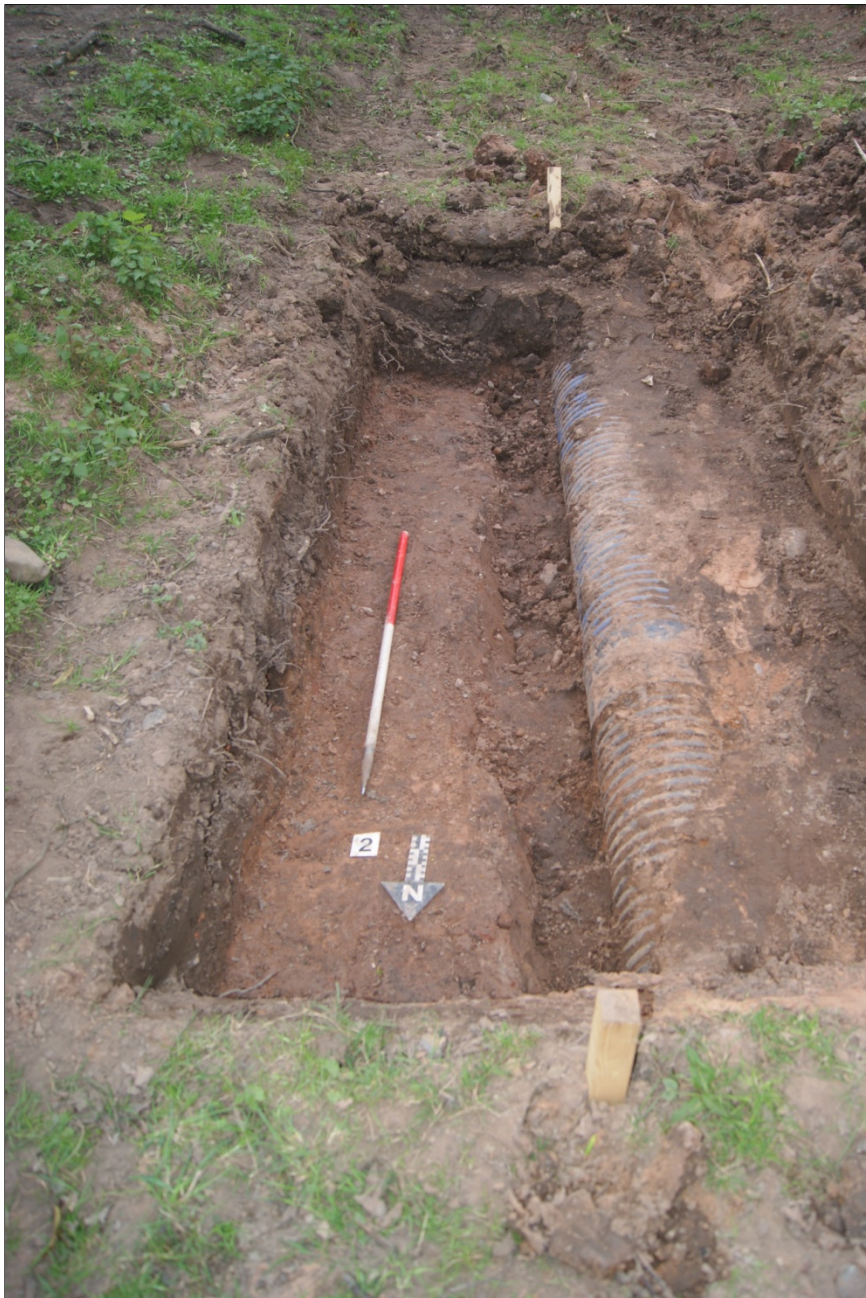
The fills of the moat had been cut by the machine excavated drainage trench [42], aligned north west to south east. The cut was 0.9m wide and 0.7m deep with vertical sides. A plastic drain 0.3m in diameter had been laid within the cut (upper surface standing at between 135.48-135.44m AOD) and the cut then backfilled with a mixed dark brown organic clayey silt and red sand blinding (Context 21).

Figure 13: Trench 2 west facing section

Figure 14: Trench 2 facing south

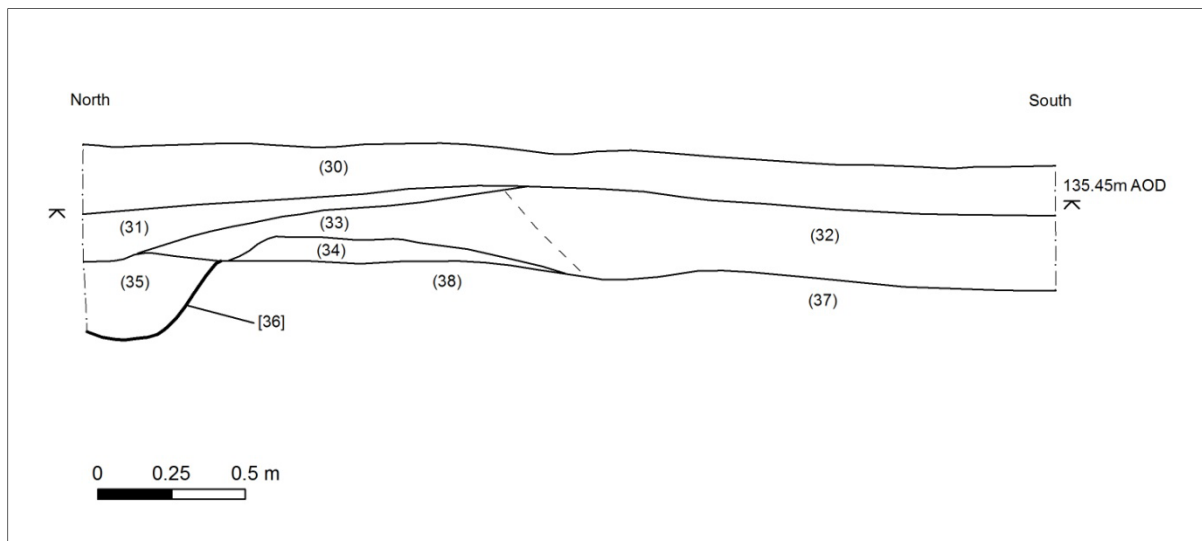
The existing ground level stood at approximately 135.61m AOD, and had been heavily trampled by cattle. The trench was excavated to a maximum depth of 0.46m, equating to 135.15m AOD.

Figure 15: Plan of Trench 3

Figure 16: Trench 3 west facing section

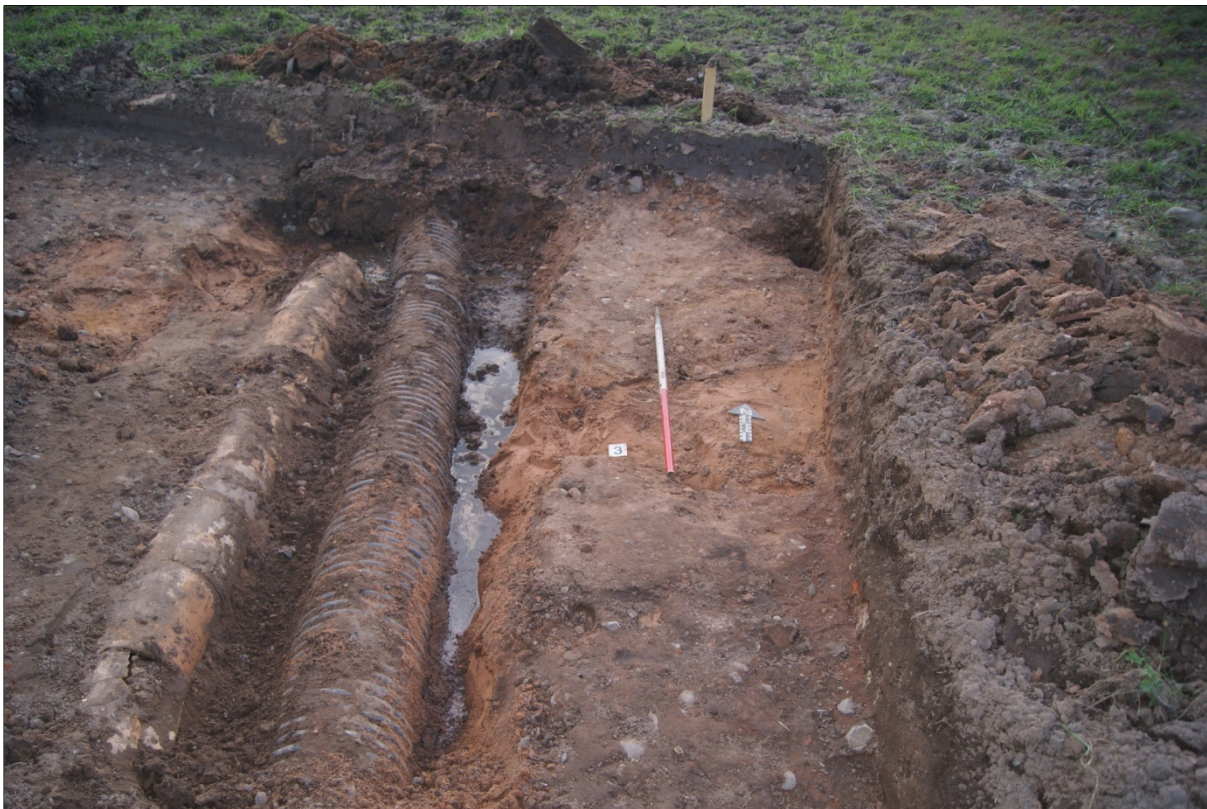
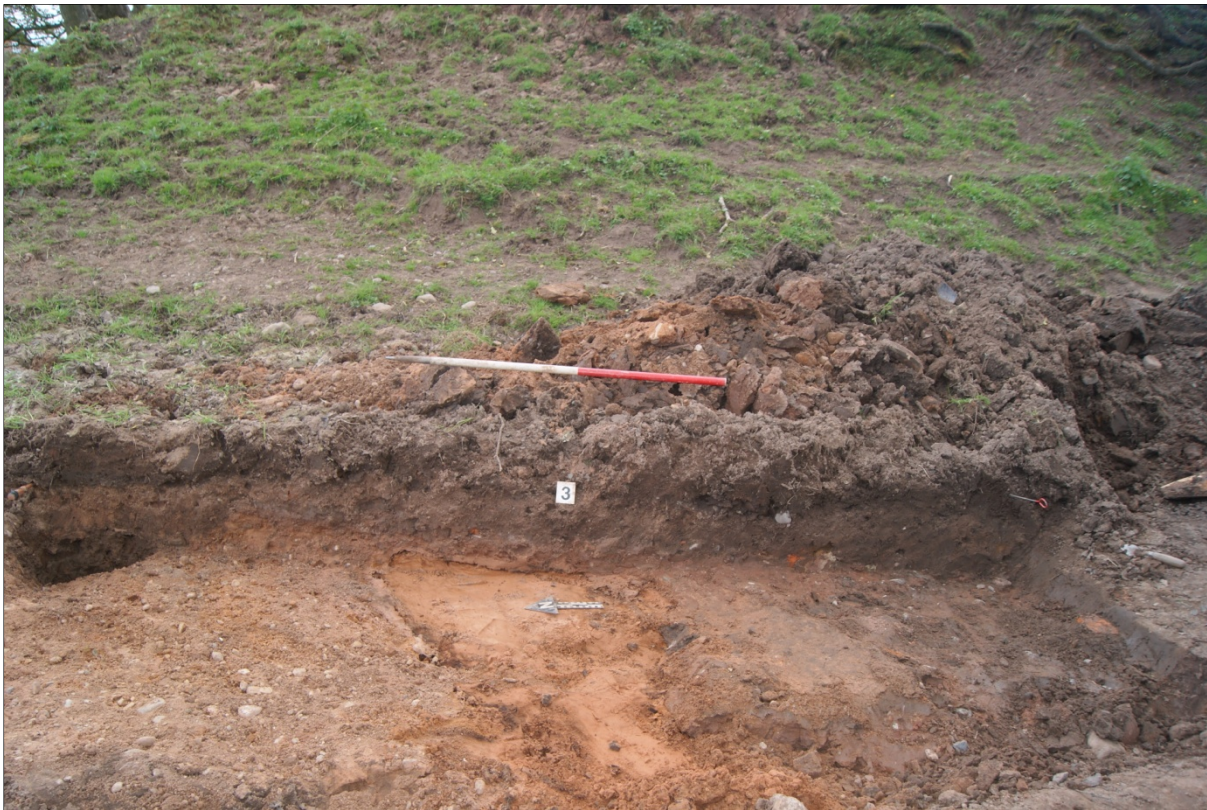
Towards the north east corner of the trench was a circular cut (context [36]), assumed to be either a removed post setting or an animal burrow. The feature cut into the underlying natural sand and was 0.36m in diameter with steep sides. The maximum exposed depth was 0.28m, though the feature extended beyond the eastern limit of the trench and was therefore not fully exposed. The fill (Context 35) was a dark grey silty clay from which animal bone and a single pottery fragment were found, though these were noted to be stratigraphically insecure (see Section 6 below).

A trampled and homogenised dark brown topsoil (Context 30) covered the trench to a depth of 0.22m. This had been cut through by the machine-excavated drainage trench [42]. The cut was wider than seen in Trenches 1 or 2 (up to 2.08m), as it had exposed an earlier ceramic drain on the western side, and had apparently been widened to allow the new plastic drain to be laid to the east. The cut extended below the level of the adjacent natural sand, and had vertical sides. The base was not exposed due to the incursion of water from wet ground to the north of the trench. The drain had then been backfilled with mixed clay, sand and brown clayey silt (Context 39).

Figure 17: Trench 3 facing north

Figure 18: Trench 3 west facing section

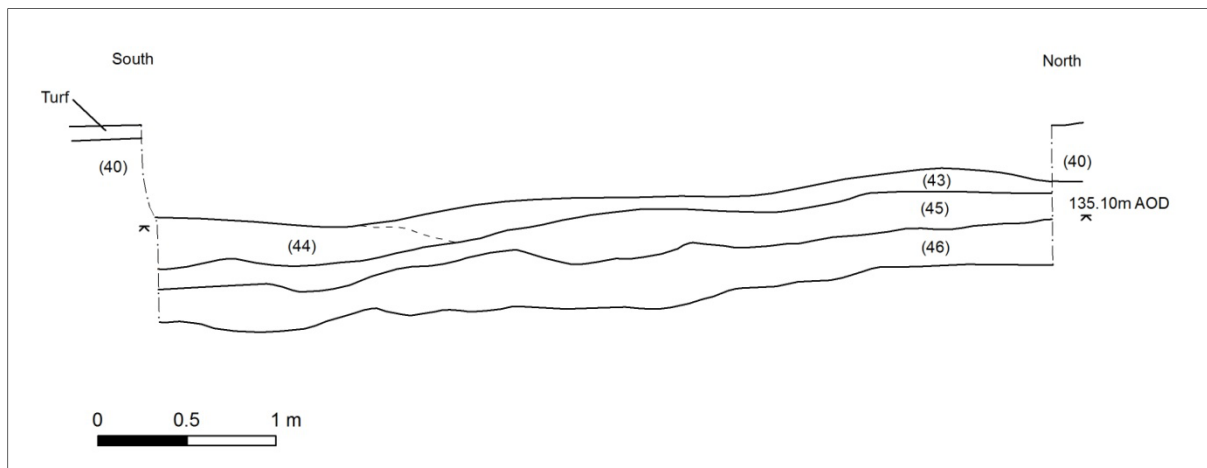
The existing ground level stood at around 135.68m AOD, immediately to the north of an area of boggy waterlogged ground and trample from cattle movement. The trench was excavated to a depth of up to 1.21m, equating to 134.47m AOD.

Figure 19: Plan of Trench 4

Figure 20: Trench 4 east facing section

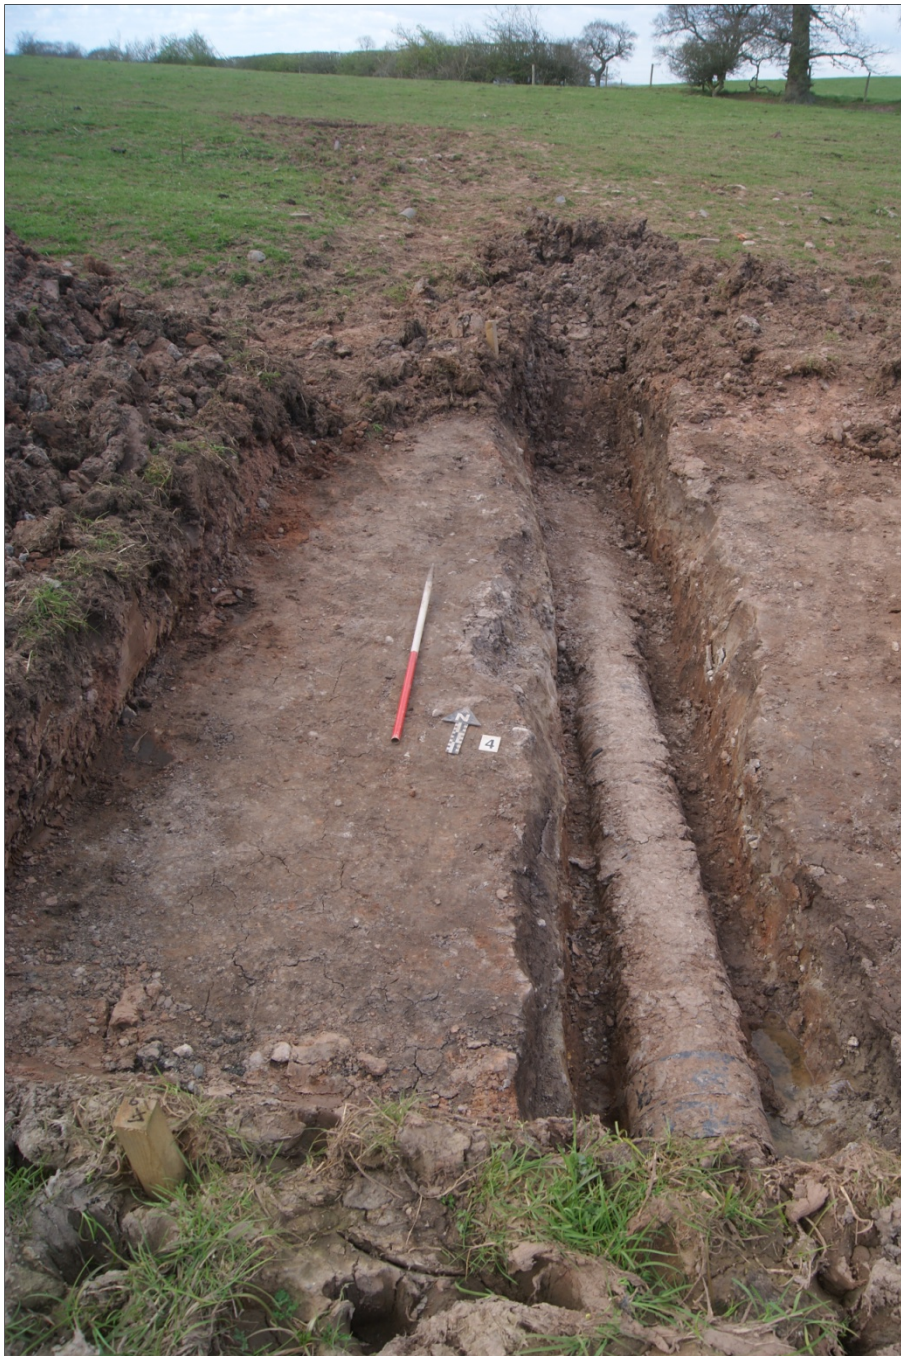
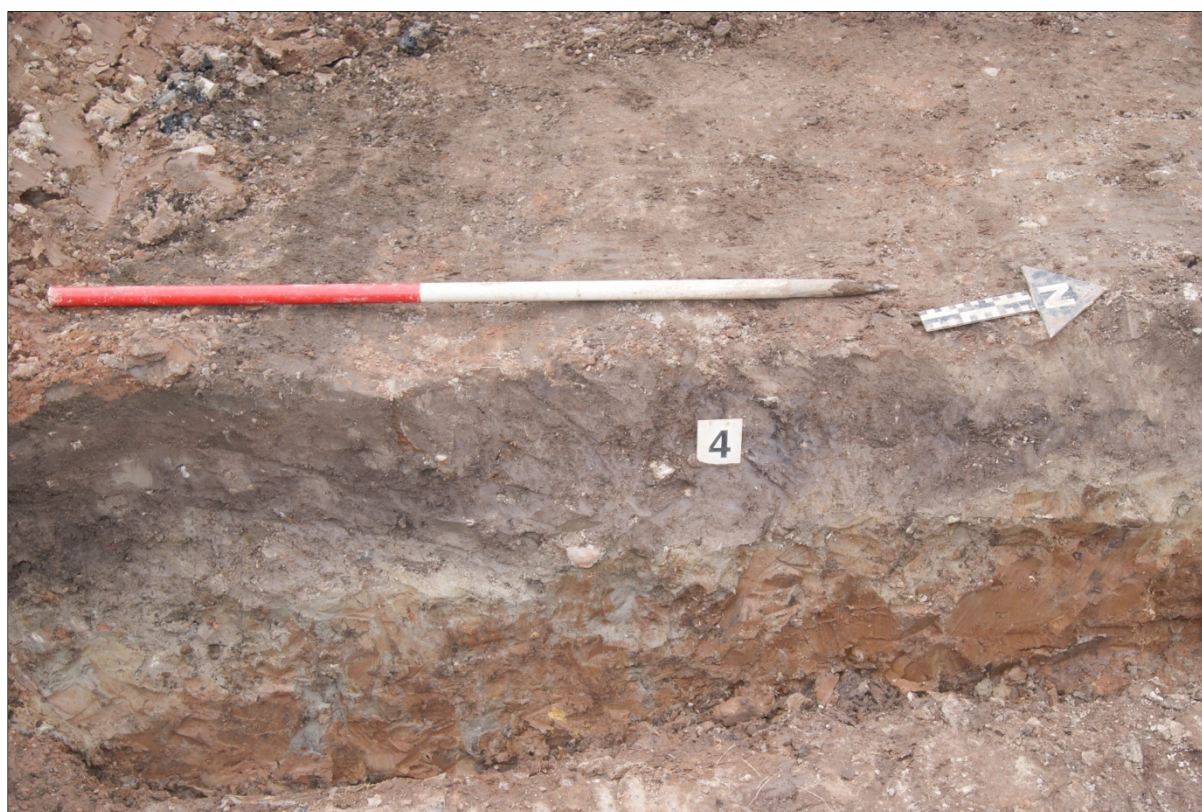
The natural geology in this trench comprised orange/pink boulder clay (Context 46) and overlying clayey sand (45). The upper surface of the geology was recorded at a height of between 135.2m AOD at the northern end, dipping to 134.72m AOD at the southern end (i.e.

falling towards the centre of the fish pond). This may reflect the original excavated level of the pond base.

The cut for the modern drain (context [42]) ran through the trench on a north-south alignment and was 0.7-0.85m wide with vertical sides. The cut truncated the fills of the pond and passed into the underlying natural clay, excavated to a depth of 134.47m AOD. The plastic drain was laid in the base of the cut (level on the upper surface of 134.75m AOD) and backfilled with redeposited clay and earth (Context 41). The backfill of the drain contained fragments of broken ceramic pipe suggesting the new drain followed the old alignment at this location.

Figure 21: Trench 4 facing north

Figure 22: Detail of pond fill (44), Trench 4 east facing section

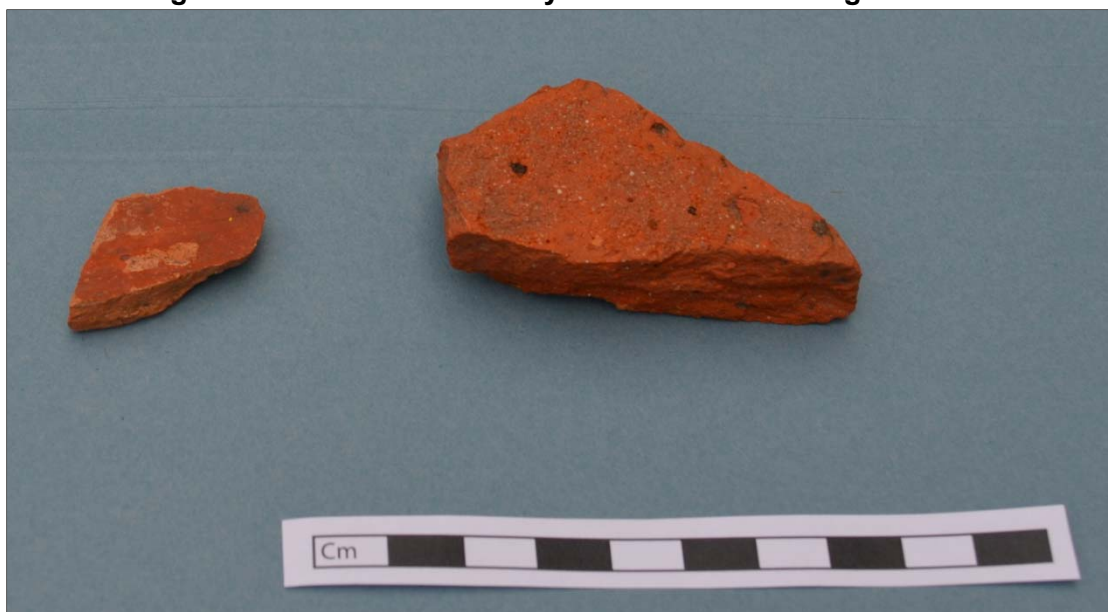
Two sherds of early post medieval red ware pottery were recovered from context 10 (Trench 1) and context 35 (Trench 3). These were both well fired wheel-thrown vessels decorated on one side with red slip. The sherd from context 10 was heavily abraded with one missing surface and was not diagnostic of form, however the sherd from context 35, while also heavily abraded, can be identified as the rim of a bowl or dish with an internal dark red/brown glaze. Typologically these domestic vessels are dated to the late medieval or very early post medieval period, commonly attributed to the late-15th to 16th century.

Figure 23: Context 10. Pottery and ceramic building material

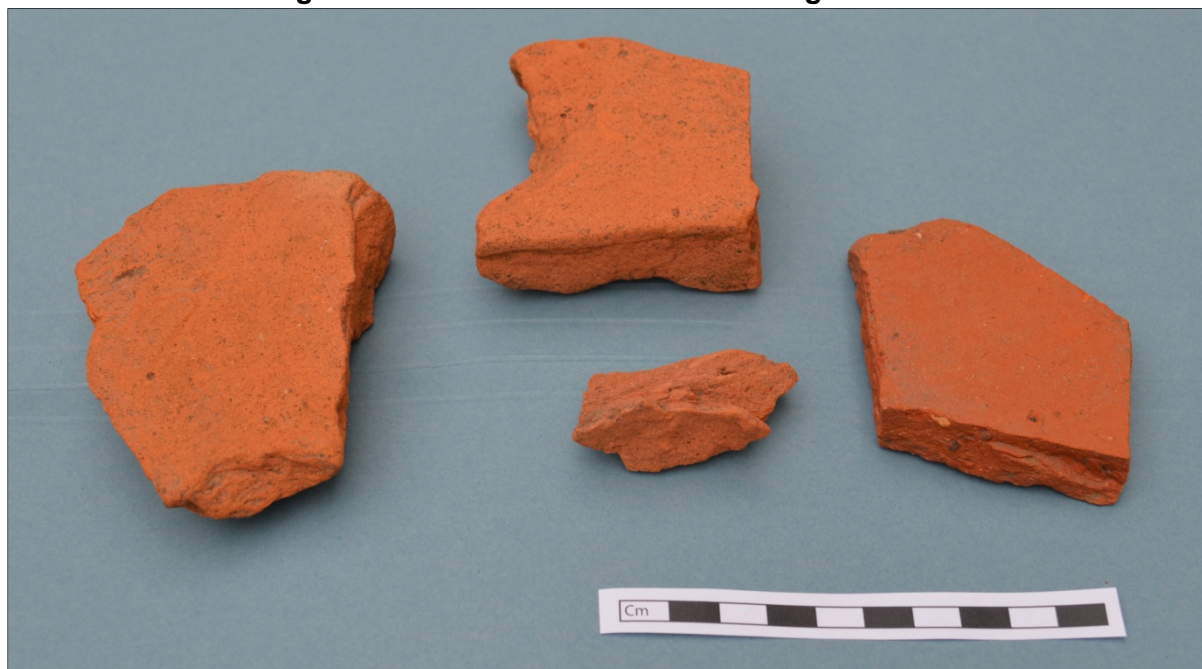
The coarse fabric was noted in single fragments from context 10 (Trench 1) and 20 (Trench 2), with broadly uniform thickness between 12mm and 14mm. The notable similarity of the fabric and surface finish of the material in these two test pits suggests it is likely to have derived from the same source.

The condition and characteristics of the material recovered in context 20 is reflected by the material observed in the residue from Sample 2 (also context 20), in which intrusion or mixing of the deposit with evidence of water rolling was noted.

Figure 24: Context 20. Ceramic building material

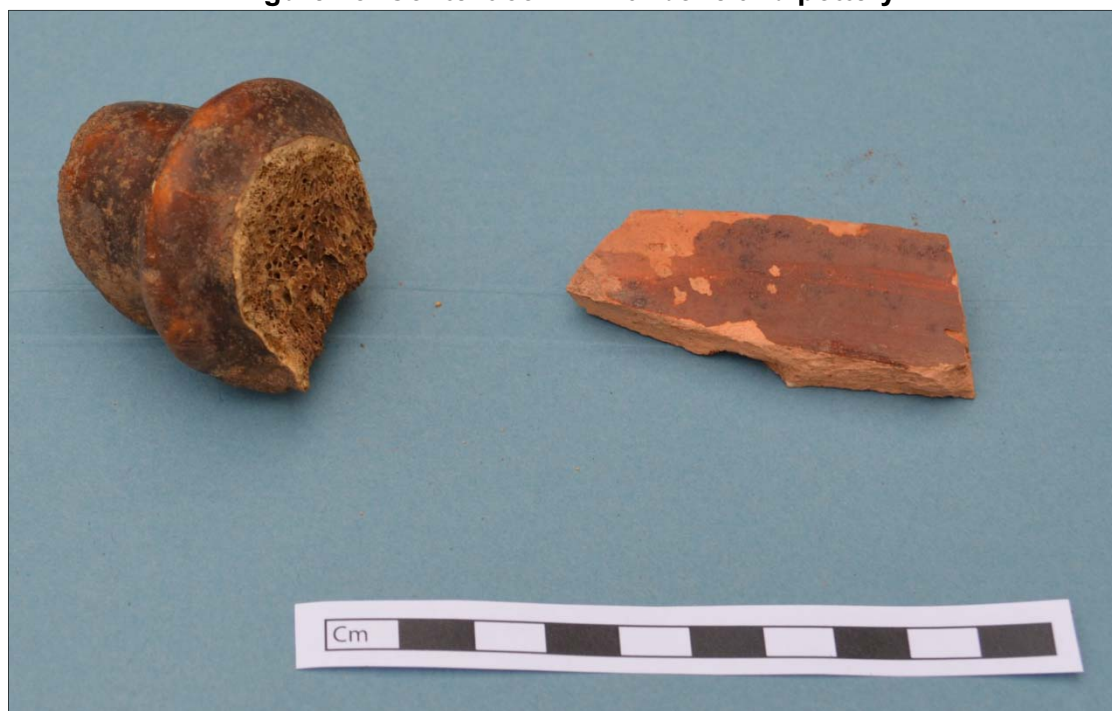
A single fragment of cattle metacarpal was recovered from context 35 in Trench 3. The bone was broken and abraded with no evidence of gnawing or butchery marks, however the exterior colouration suggests partial (lower temperature) fire damage.

Figure 25: Context 35. Animal bone and pottery

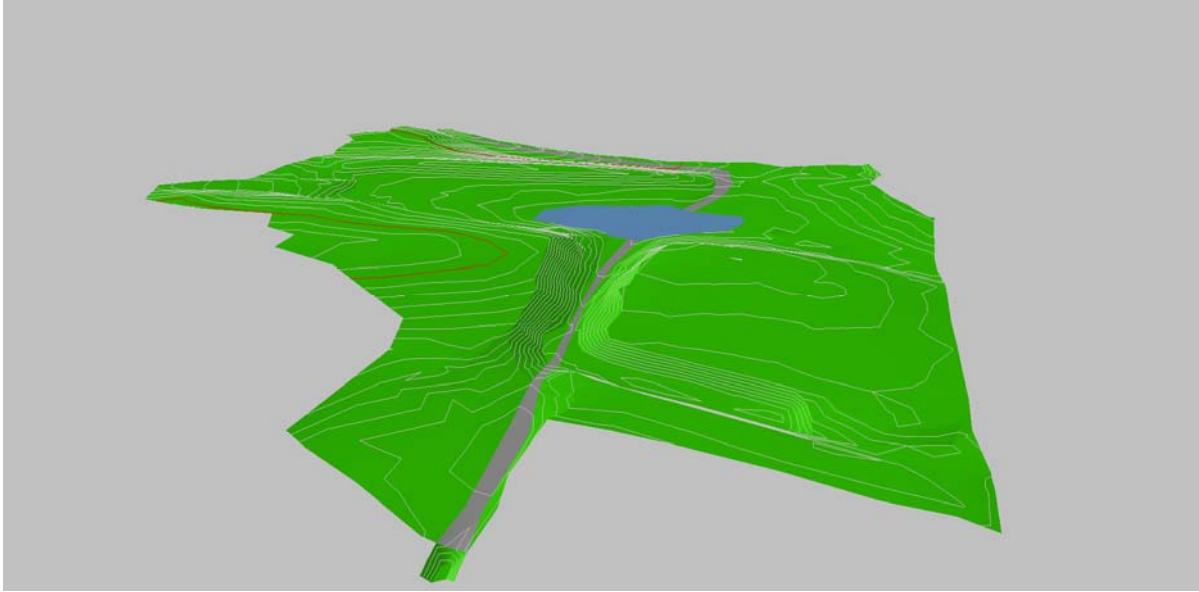
Plate 1: 3D rendering of Sillenhurst Moated Site facing north west along western moat arm. Unauthorised drainage trench is shaded grey.

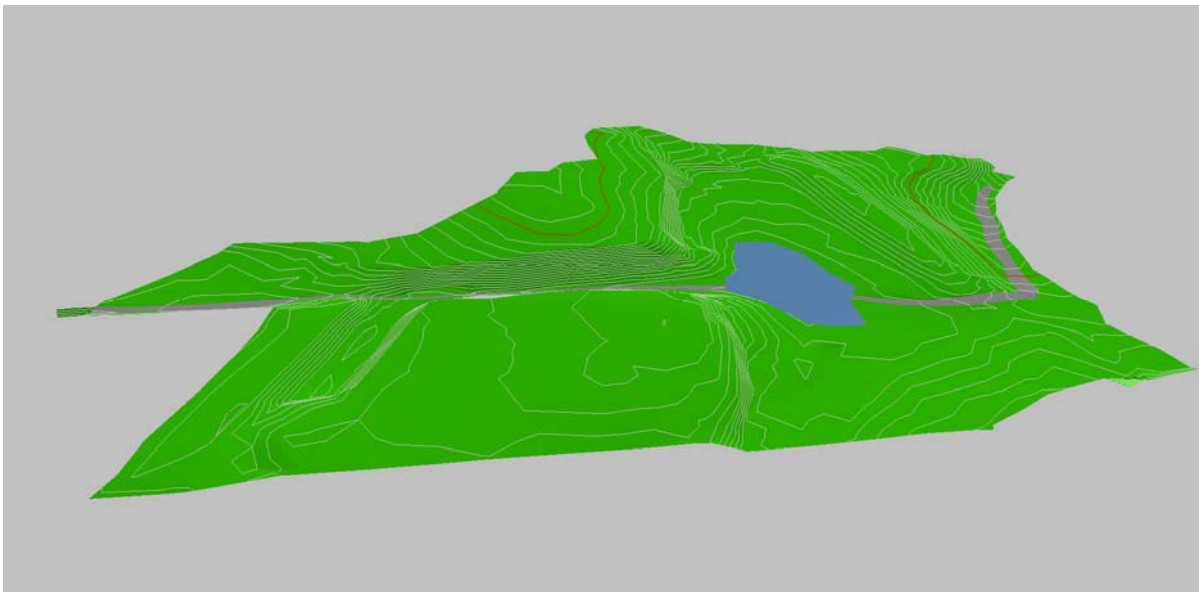
Plate 2: 3D rendering facing south west across fishpond.

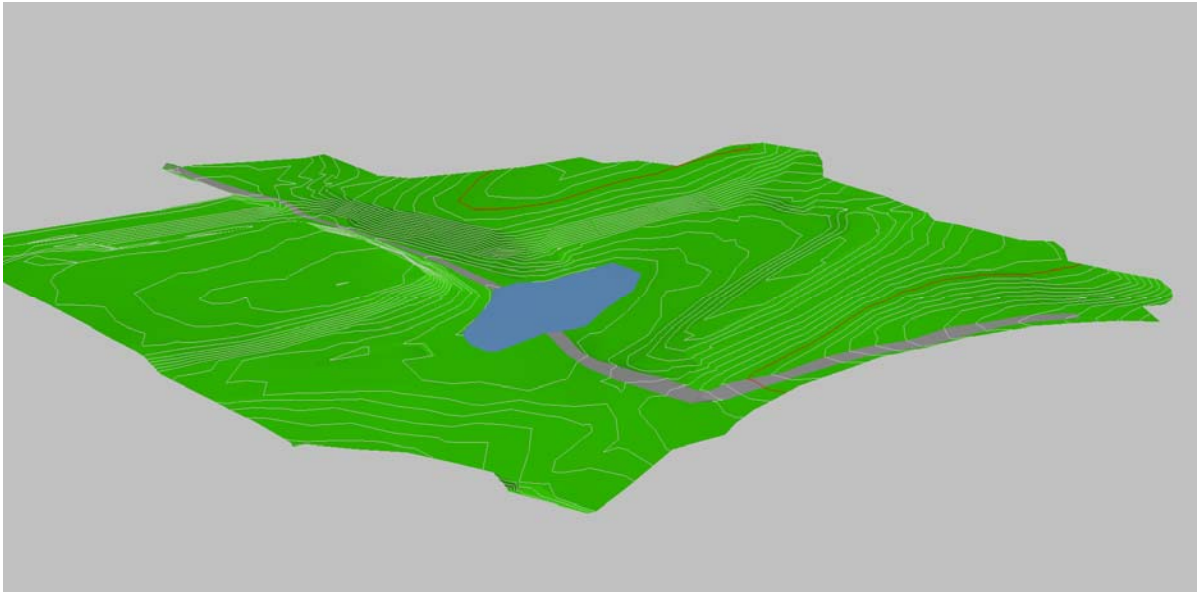
Plate 3: 3D rendering facing south-south west across fishpond.

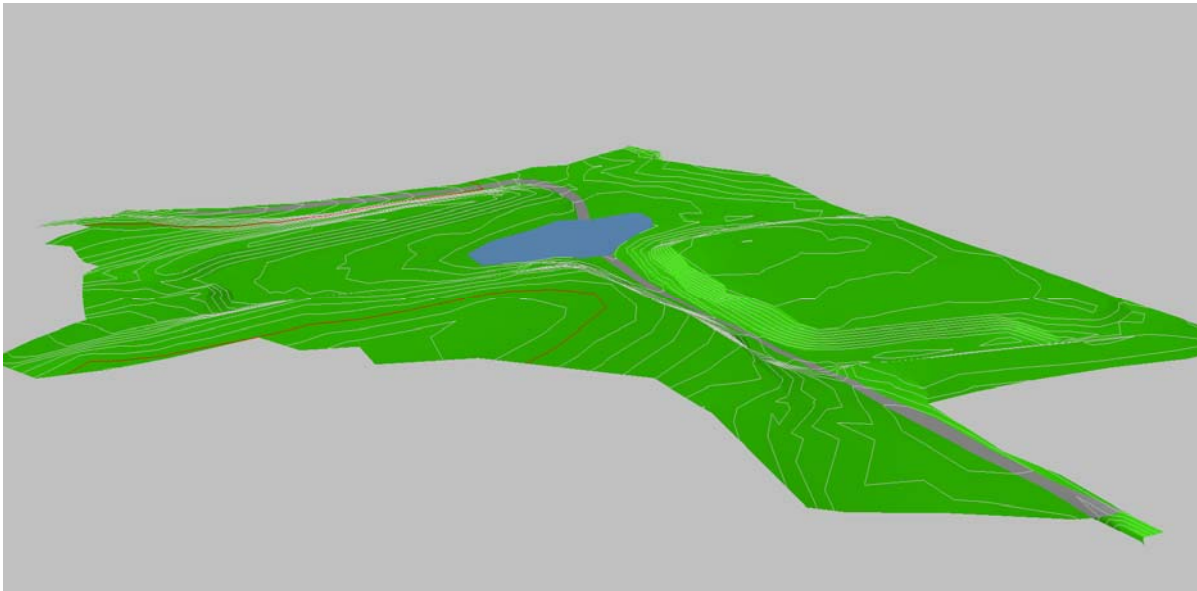
Plate 4: 3D rendering facing north.
