The Butter Cross, Market Place, Newport, Shropshire
(NGR SJ 7451 1914)

Archaeological Investigations
SLR Ref: 406.00203.00005

September 2012

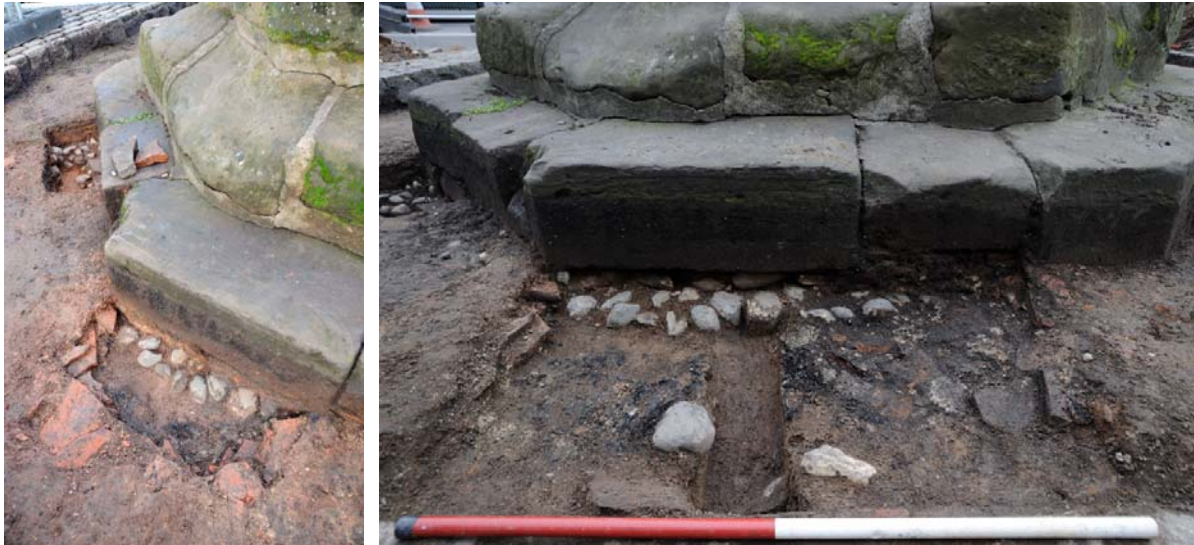
Figure 9 Section drawings, plans and photographs Sondages 1 & 2 of sandstone blocks forming plinth base and deposits beneath Cross

Sondages 1 and 2 shown on left and note demolition deposit 104, overlying ash and charcoal layer 139, and cobbles 141. In the right hand photograph these deposits are shown after removal of 104 in Sondage 2 (compare to plan 5 in Figure 9 above)

Beneath the Cross and above the buried soil Context 167, a layer of cobblestones was found (Context 141) which did not extend far beyond the Cross (Plate 5 and Figure 9). A layer of mortared and unmortared sandstone blocks and smaller fragments (Contexts 146 and 147) was found between the cobbles and the plinth, probably resulting from working the plinth when it was positioned in place beneath the cross (see sections 4, 6, 7 and 8 in Figure 9). A small area of 146 was overlain by a dark sandy deposit with bones in it (Context 145), and tile debris above which formed additional material to level the underneath of the plinth.

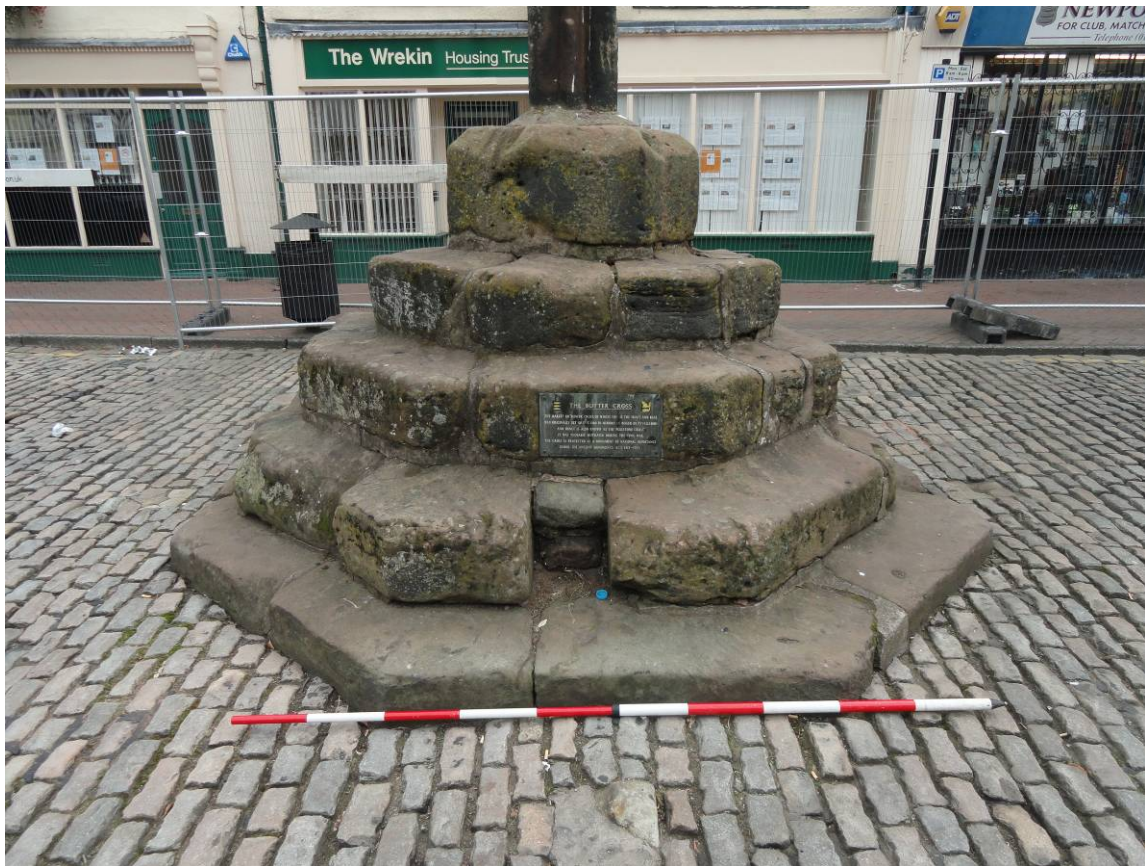
Plate 1. Detail of the base coursing and the bronze plaque, looking east

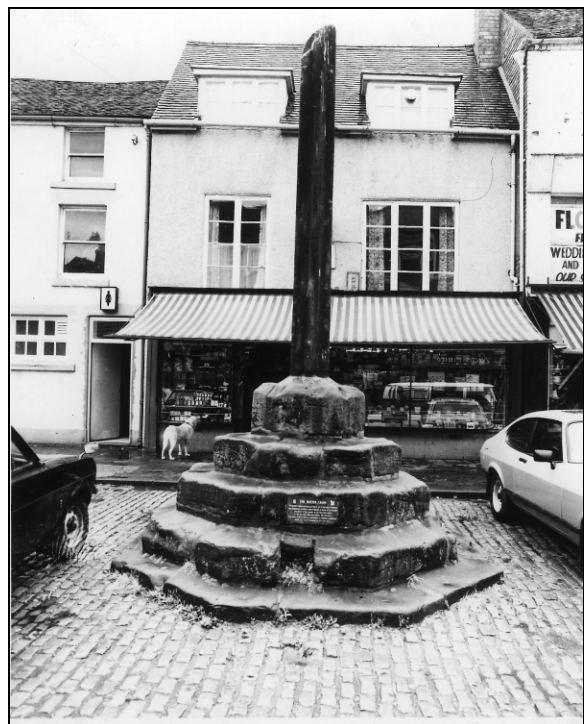
Plate 2. The Butter Cross enclosed by iron rails and trees at cardinal points, dated c. 1910
(Courtesy of the Newport History Society SNAP Project)

118	Brick wall, measuring 2.50 by 0.23m and orientated NE-SW, west of Wall (117) may represent the eastern elevation of the NW building. This structural element is constructed differently to other wall sections within the northern terrace. Truncated by later cuts [119] and [111].
119	N-S wall located at the eastern end of the northern terrace, representing a possible external gable wall, measuring 3.10 x 0.24m. Brick measurement: 24.5 x 10.5 x 0.06 m.
	AREA AROUND THE BUTTERCROSS
120	Cut of an E-W linear concrete-lined service trench, running along the northern foundations of the Butter Market (106).
121	Four oval features each measuring 1.0 x 0.75m, representing a former trench for an ornamental tree (see Plate 2). Trees were planted around the cross c. 1900. These

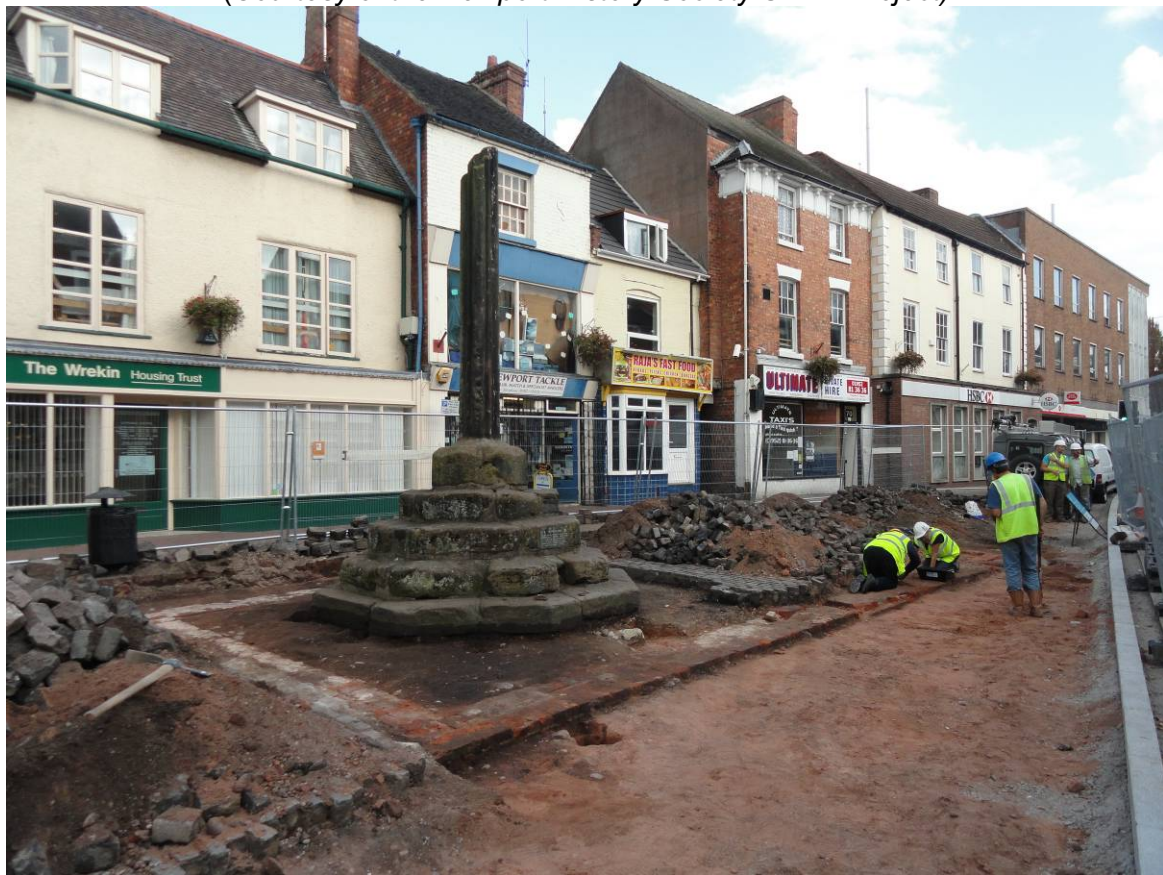
Plate 4. Archaeological excavation around the Butter Cross exposing the foundations of the 16th century Butter Market (Context 106)

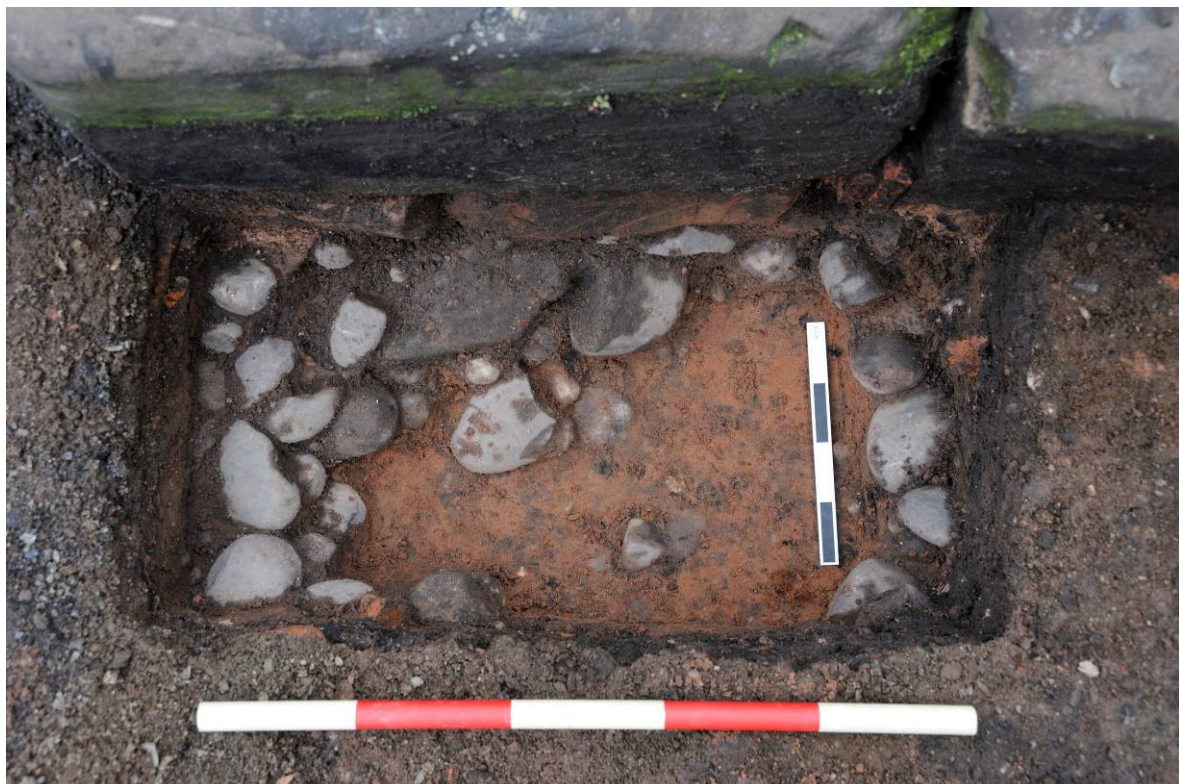
Plate 5. Exploratory slot exposing cobblestones Context 141 in Sondage 1

140	Unused Context number
141	Probable remains of a cobblestone street surface that extends to areas around the cross (see Plate 5).
142	Re-deposited sand, possibly associated with the levelling of the surface in and around the Butter Cross.
143	Underlying Context (139) was a further foundation layer associated with the levelling of the Butter Cross.
144	Unused Context number
145	Repair and support episode to the lower section (sub-surface) of the Butter Cross that includes the insertion of stone and tile underneath the first stone blocking course of the cross base.
146	Foundation material for the base of the cross that includes soil and sandstone rubble - possibly associated with Context (147).
147	Probable foundation material for the cross, 17 th century in date. Foundation material includes mortared bonded stone. Evidence of later successive repairs, prior to modern burial of the lower base with abutting stone sets etc.

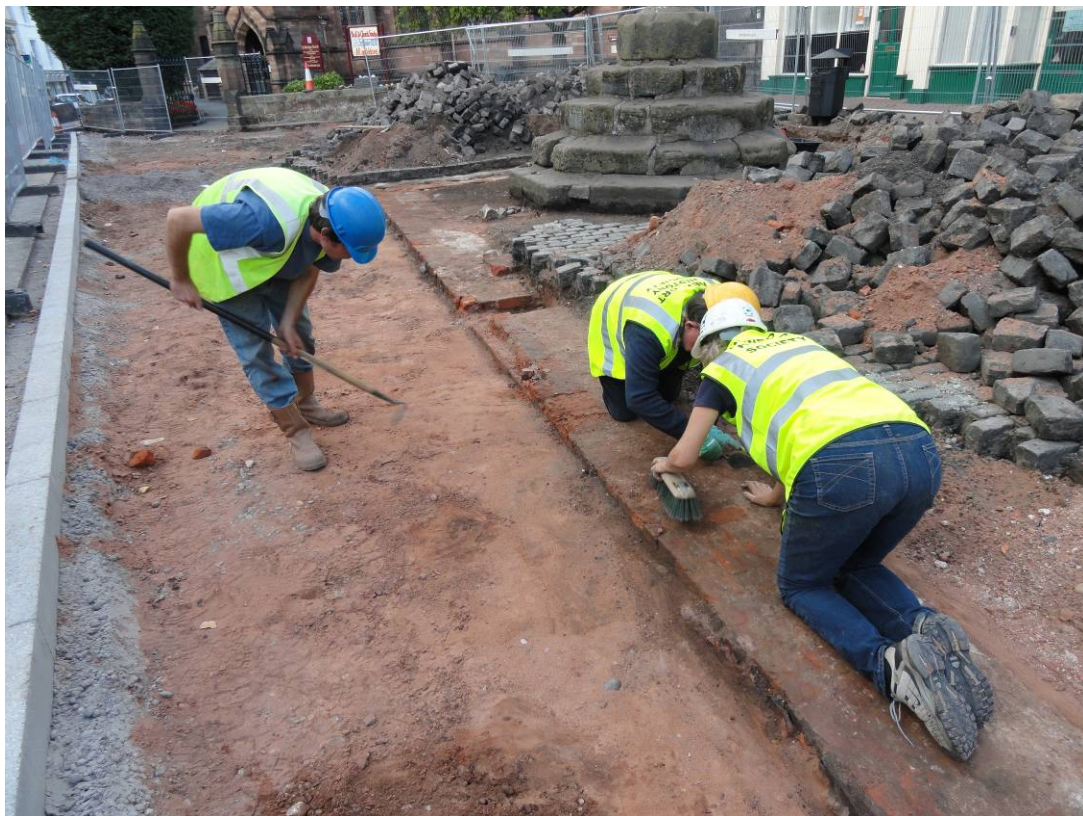
Plate 6. SLR Archaeologist and two members of the Newport History Society exposing the western wall of the Butter Market (Context 106), looking north

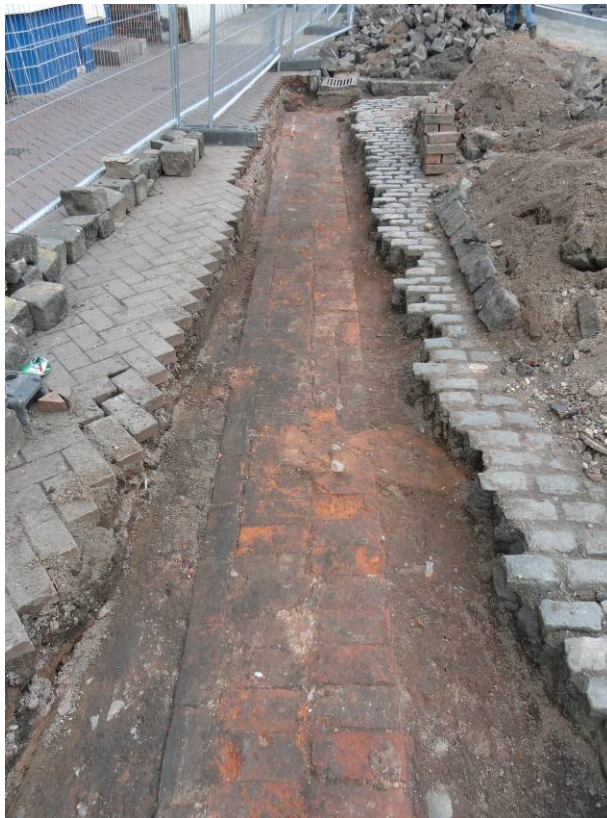
Plate 7. Exposing the 16th century brick foundations of the Butter Market, looking north

Context No.	Description
101	Stone sets extending across the surface of the site, laid and set in sand and bitumen around the latter part of the 20 th century.
102	Tarmacadam surface located around the southern gate area of St Nicholas church.
103	Underlying contexts (101) and (102) was a bedding material comprising gravel.
104	Loosely compacted deposit of silt and building debris associated with demolition of the Butter Market in 1866, underlies Contexts (123), (125), (127), (129), (131) & (133).
105	Post-medieval demolition deposit – similar to Context 104, associated with former buildings to the north of the site.
106	Rectangular-shaped brick foundation representing the former Butter Market building, measuring 12.30 x 5.50 m (see Plate 10). This structure, extending c. 0.42m below the present ground level comprises three courses of unfrogged 19 th century bonded brick (brick dimensions 0.24 x 0.11 x 0.07m). See Plates 6, 7 & 8.

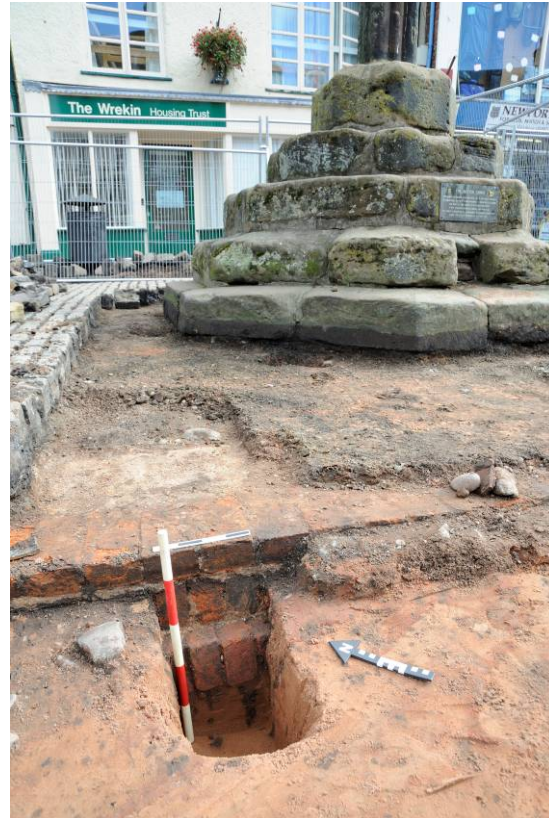
Plate 8. Small slot exposing the depth of the foundations of the former Butter Market building

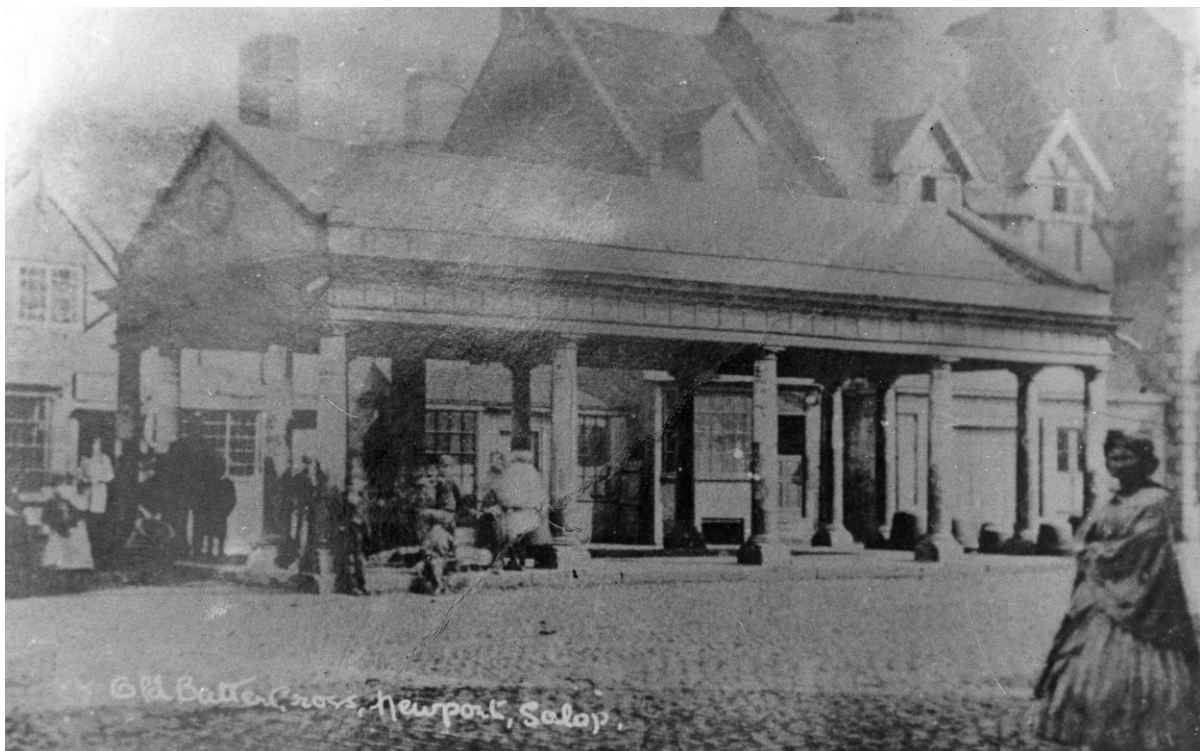
Plate 10. A mid to late 19th century view of the Butter Market [enclosing the Butter Cross at the northern end] (Courtesy of the Newport History Society SNAP Project)

maps. The foundations of these buildings, apparently constructed of 18th century brick were revealed during the watching brief. The footprints of buildings that form the double row (back-to-back) terrace located east and south-east of the Butter Cross appear to remain intact. Inspection of several of these buildings, especially those fronting St Mary's Street possesses timber-framing elements that clearly date the row to the late medieval or early post-medieval periods. Apart from the demolition of the northern terrace there appears to have been little change to the immediate area (Figures 4, 5 & 6). The 1st edition Ordnance Survey map of 1881 shows the Butter Cross standing in isolation. However, according to pictorial evidence, the cross was housed within a building known as the [Old] Butter Market which was demolished in 1866 and would not have featured on any early OS mapping (see Plate 10).

This open-sided civic building comprised twelve stone columns (arranged into five along each elevation and an additional column on each gable) that sat on a brick plinth and supported a pitched roof. The brick plinth is known through SLR'S recent archaeological investigations. It is probable and based on archaeological evidence that the surface within the Butter Market comprised a cobblestone floor; however, the photograph of the building suggests a flagged floor may be visible (Plate 10). The cross was probably located at the northern end of this structure (shown as a dark vertical shadow within the photograph of 1860 [Plate 10]).

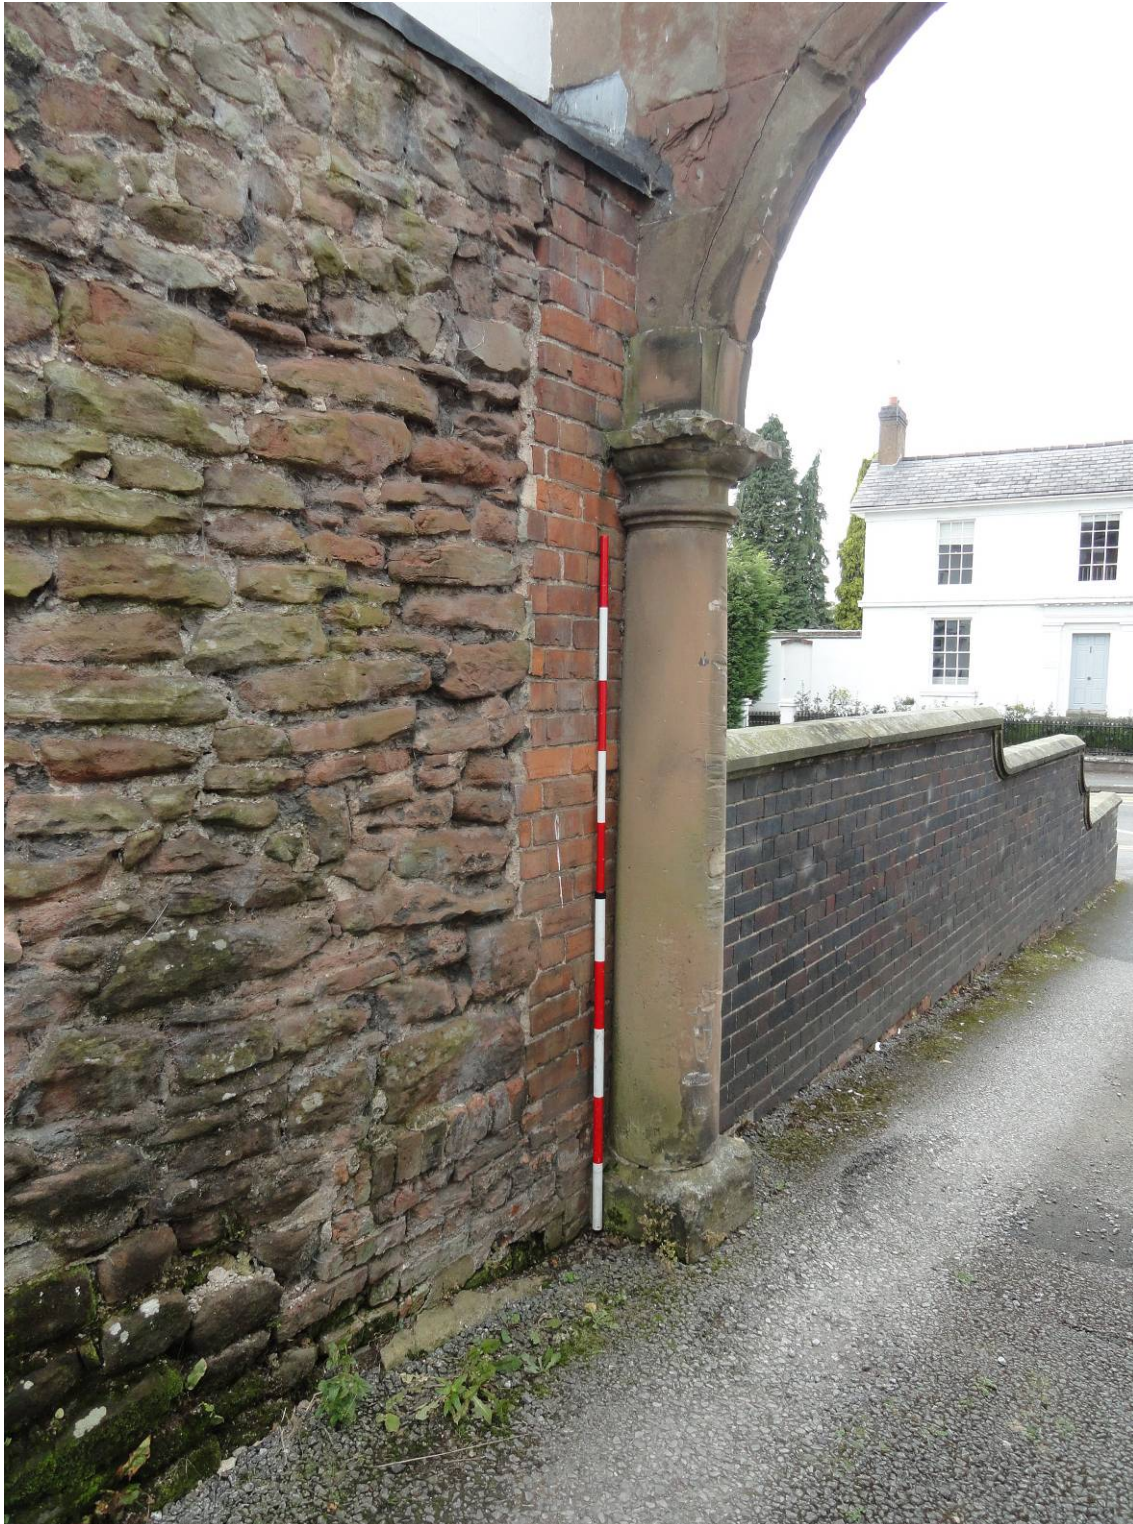
Plate 11. One of 12 stone columns belonging to the Butter Market (see Plate 10), now forming part of an archway to Castle House School, Newport

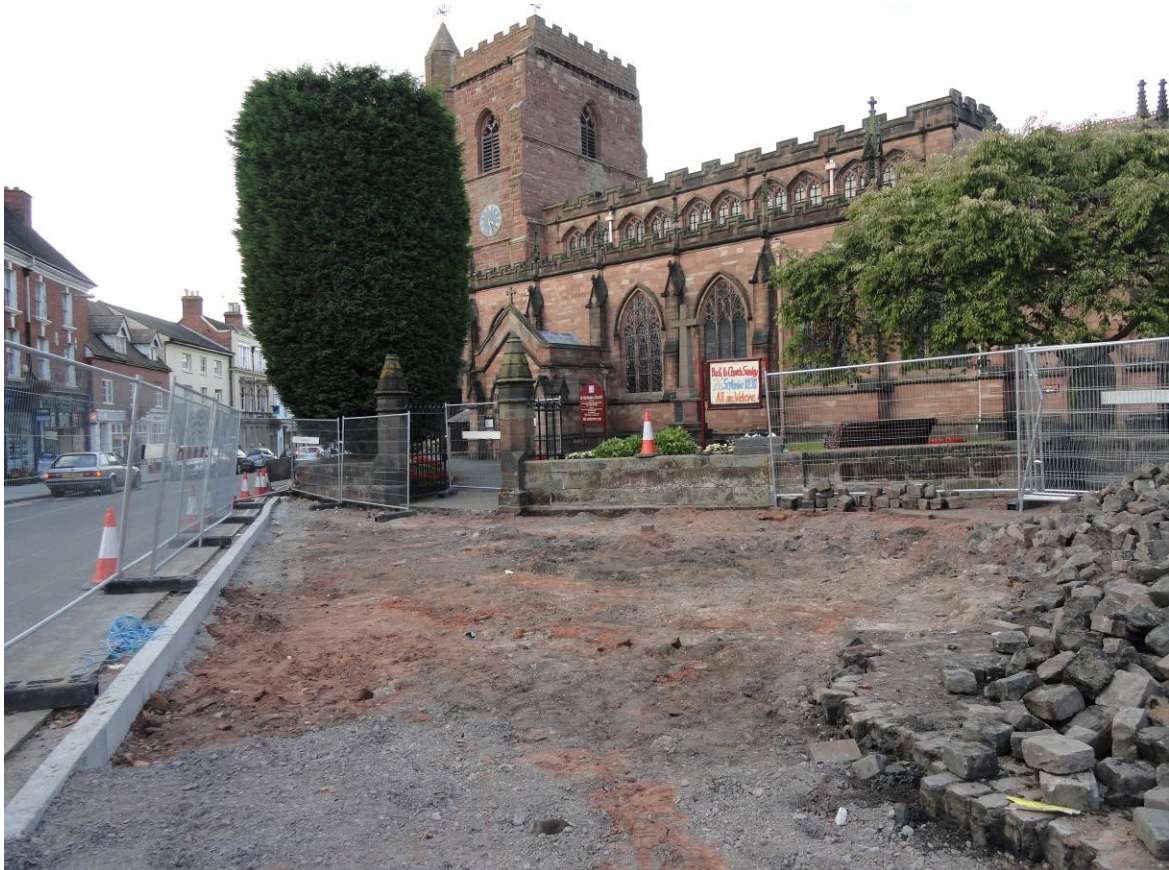
Plate 12. Cleaned area to the north of the Butter Cross showing the foundations of the northern terrace of Middle Row (demolished c. 1900)

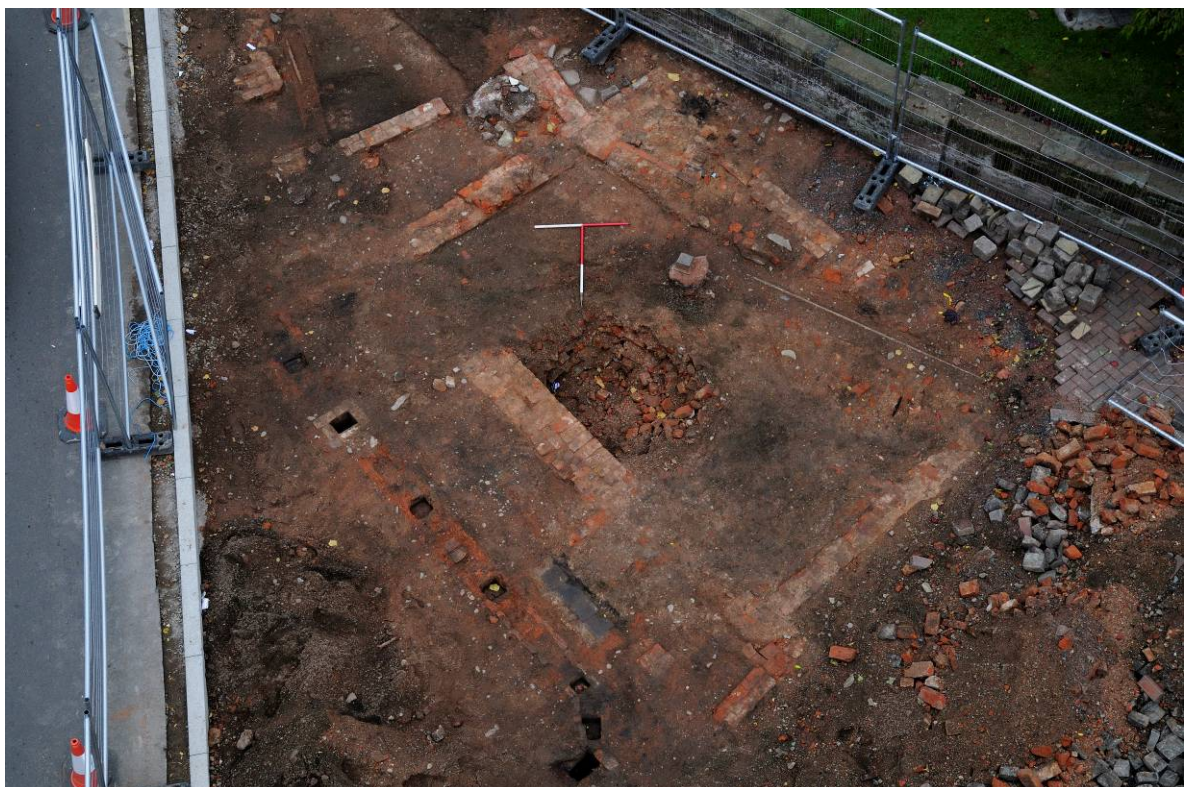
Plate 13. Aerial view of the northern section of the site showing the brick foundations of the northern terrace

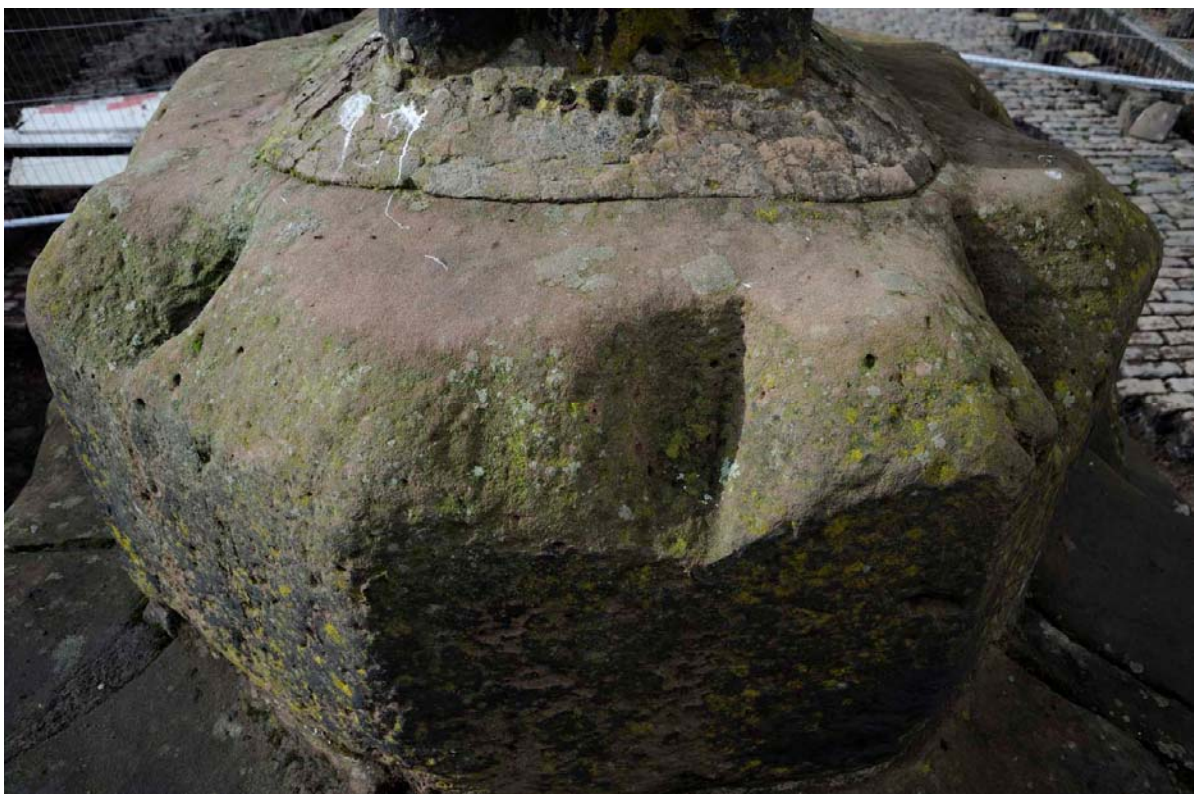
Plate 15. View of socket stone for Cross shaft, chamfered and with grooves evident

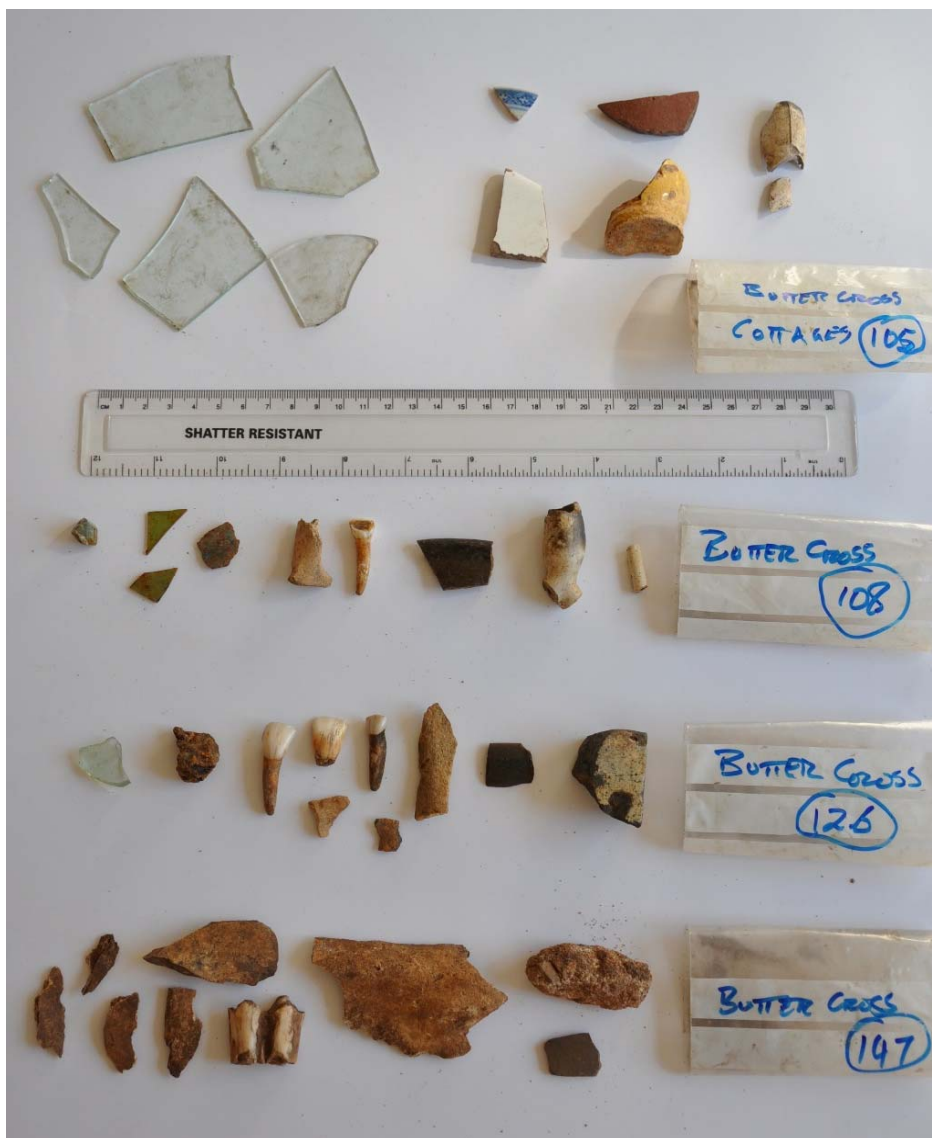
5 x clear window glass fragments 2mm thick, 1 ceramic rim fragment glazed blue and white, 1 fragment modern (?) white wall tile, 1 fragment ceramic vessel (salt-glazed stoneware?), 1 near complete base of yellow glazed vessel approx 3cm diameter (mid 17th century Midland yellow ware, lead glaze?), 1 clay pipe bowl (probably 17th century but not convincingly identified), 1 clay pipe stem fragment (see photo below)

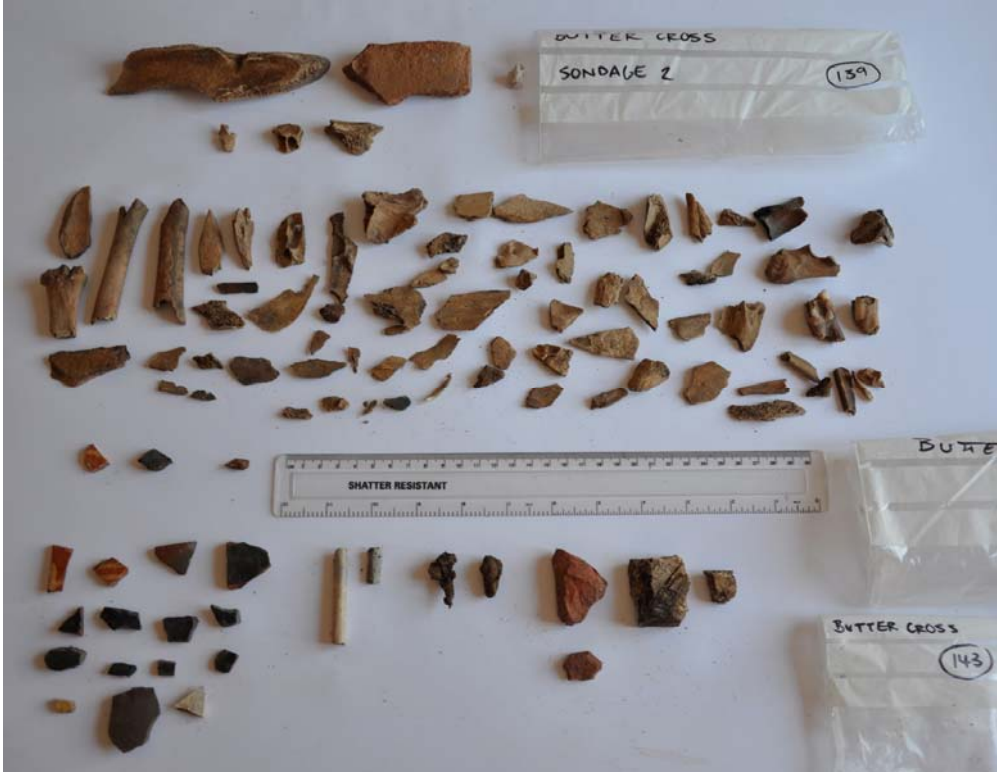
<p>126</p>	<p>1 glass fragment from vessel, 1 unidentified iron object, 6 animal bone fragments including 3 teeth, 1 ceramic rim sherd, 1 fragment glazed floor tile (see photograph above under 105)</p>
<p>139 Sondage 2: black ash & charcoal thin deposit</p>	<p>1 brick/tile fragment, 4 animal bone fragments, 1 base of clay pipe bowl fragment (unidentifiable) (see photograph below after 143)</p>
<p>140</p>	<p>1 oxidized glass fragment, 3 fragments ceramic vessel bases, 1 iron object, 2 animal teeth, 2 oyster shell fragments</p>
<p>141 cobblestones surface around Cross</p>	<p>2 iron glazed stoneware fragments</p>
<p>143 Foundation deposit for Cross Pottery 17th century, probably pre- 1620 (McCarthy & Brooks 1988, p.474)</p>	<p>70 animal bone fragments inc 2 teeth, 17 very small pot fragments including 1 red stoneware rim sherd (3mm thick) and 4 very small sherds glazed Staffordshire ware orange with yellow decoration, 10 iron-glazed wares, 1 Midland Purple ware (ribbed 5mm thick x 2cm), 1 white sherd, 2 clay pipe stems, 2 iron nails, 2 brick/tile fragments, 2 mortar fragments (see photograph below)</p>

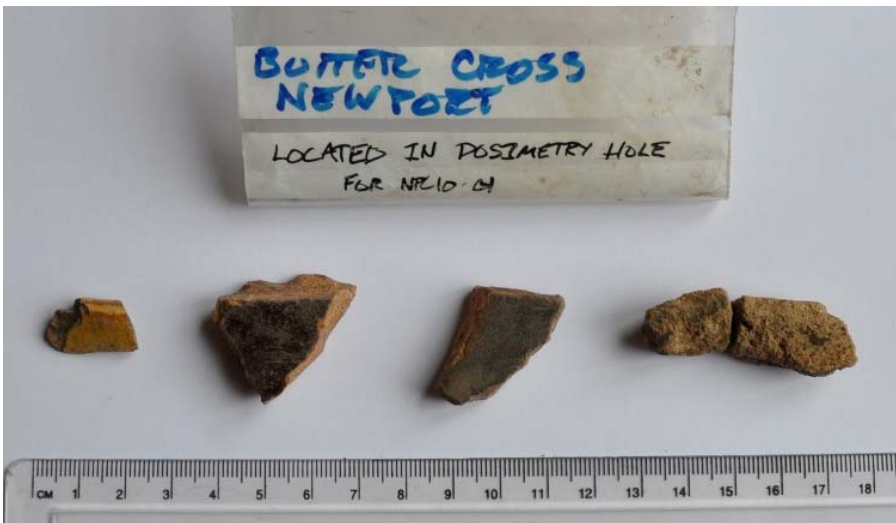
<p>147 Foundation deposit for Cross</p>	<p>7 animal bone fragments including 1 tooth, 1 unglazed oxidised ceramic body sherd (3mm thick x 1.5cm), 1 lump mortar (see photograph above under 105). 7 large lumps of mortar (bigger than fist size) not photographed.</p>
<p>167 (OSL dosimetry hole) from beneath Cross, probably 17th century (Draper 2001)</p>	<p>3 hard-fired ceramic fragments of which: 1 rim sherd glazed yellow and orange, 1 body sherd with black/dark brown shiny glaze on one side and red slip on external face; 1 body sherd with black/dark brown on one side – not shiny. 2 soft mortar fragments that join together</p>
