**Edgbaston House
Walker Street, Wellington, Telford**

Report on an Archaeological Site Investigation

**406.0203.00004
February 2010**

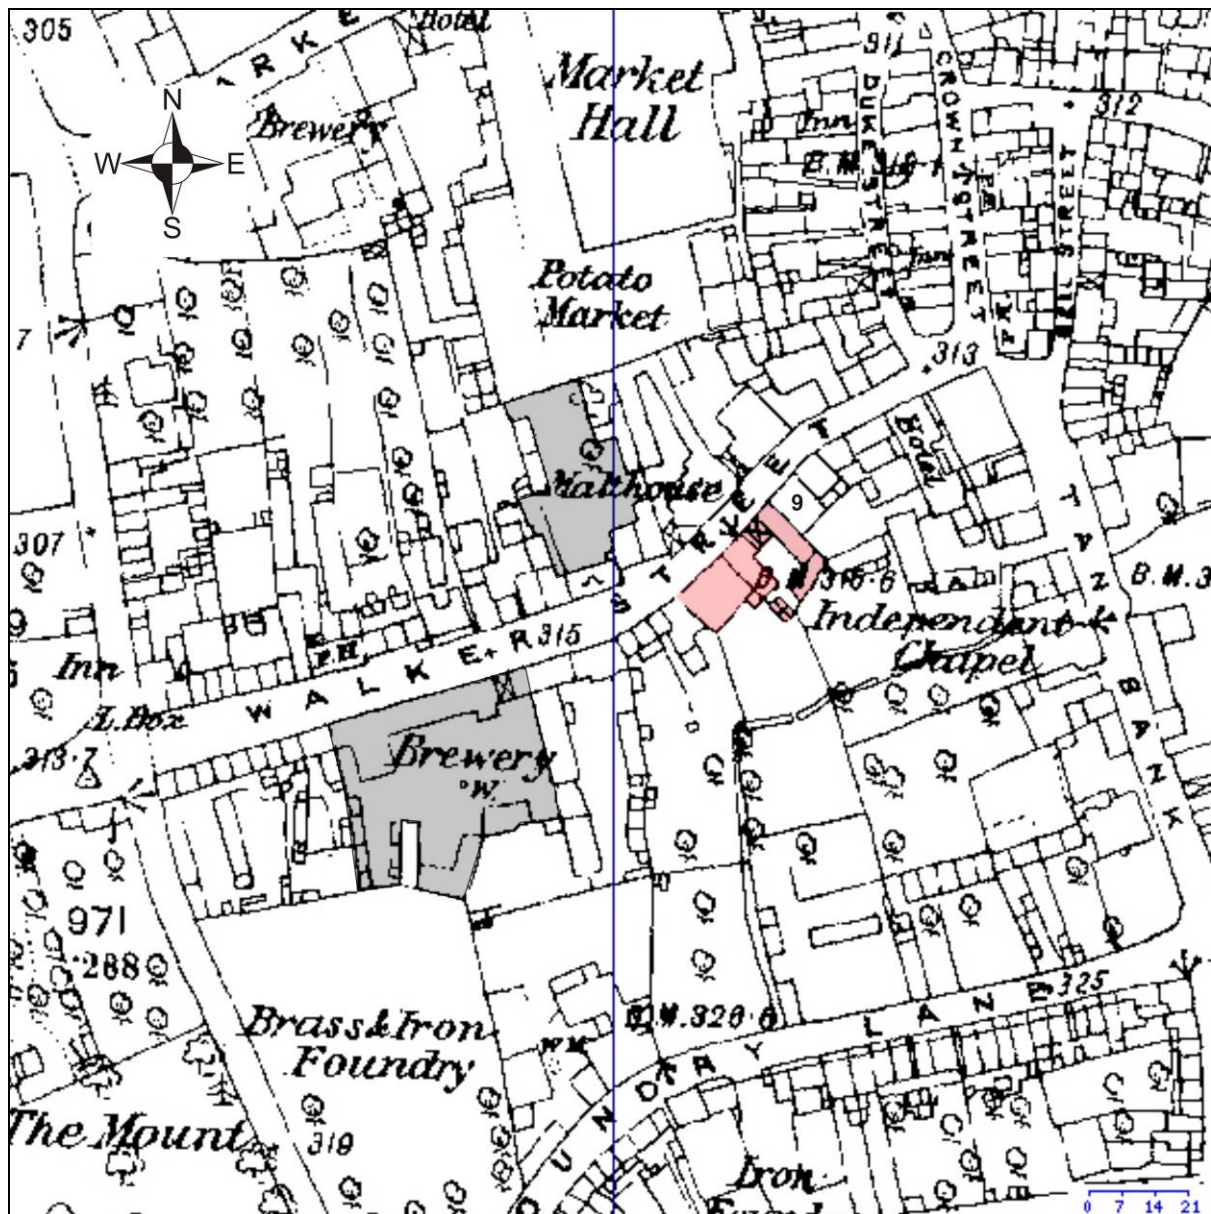
Figure 5: 1st edition Ordnance Survey map of 1882

showing Walker Street and the south-western corner of the medieval town form

Later maps show very little change to the line of Walker Street, although there are some radical changes to the building stock either side of the street such as a brewery replacing the work house, and these include structural changes to Nos. 9 and 11 Walker Street. On the 1st Edition Ordnance Survey map of 1882, No. 11 Walker Street has been expanded considerably to the rear; however, the form and use of the building extension is unclear. New businesses marked on this map include a brewery (with well) which is located and incorporating the building range of the former Union Work House, and a malthouse, located opposite Edgbaston House (belonging to the Wrekin Brewery). To the rear (north) of the malthouse is the main Market Hall and Potato Market, and both survive today (Figure 5).

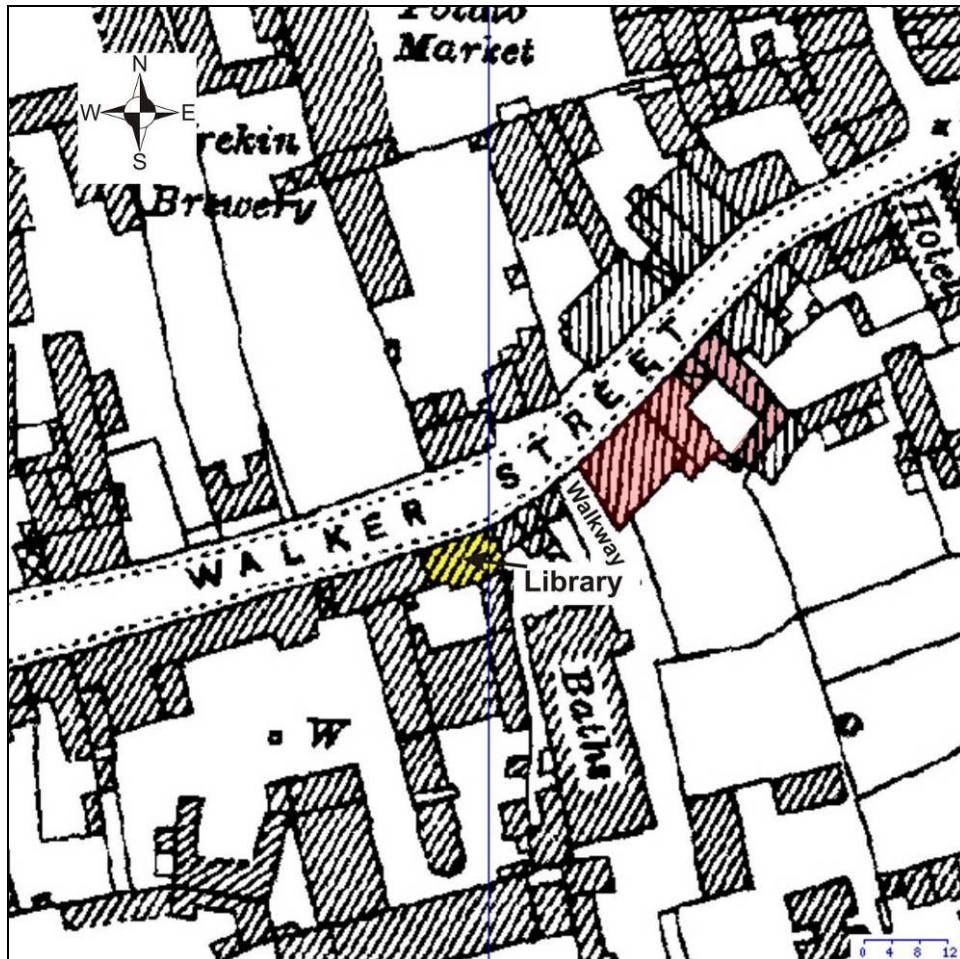
Figure 6: 4th edition OS map of 1927
showing walkway and library building immediately west of Edgbaston House

During the 20th century the form of the rear plot belonging to Edgbaston House and the courtyard to the rear of No. 11 Walker Street remains largely unchanged (Figure 6). The Ordnance Survey maps of 1927 and 1937 (scale 1: 2500) show little or no change to the building lines within Walker Street. However, one addition marked on both maps is a library building (constructed c. 1910) located west of Edgbaston House. Between Edgbaston House and the library building and during this period is a newly formed walkway which leads to a public bathhouse. This building replaced a series of buildings that were located along the boundary of a former burgrave plot.

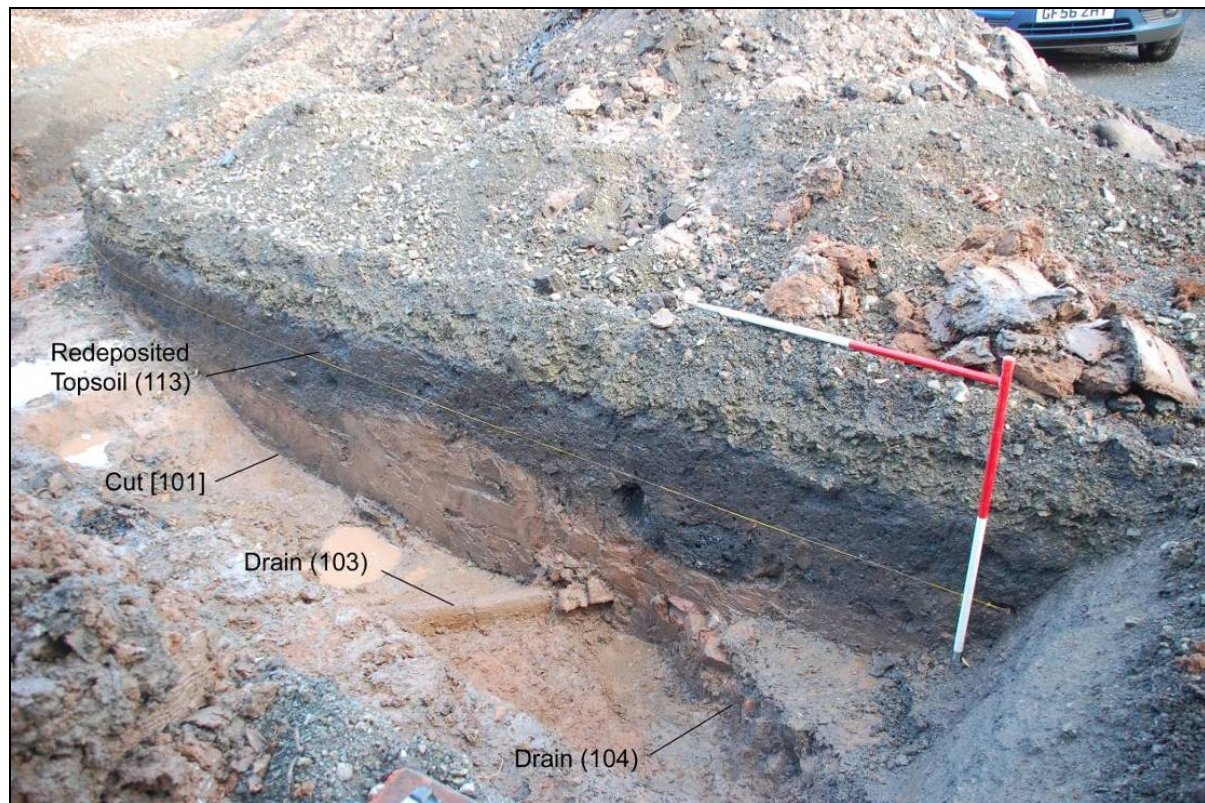
The base of cut [101] housed two post-medieval/modern drains. The first, (103), comprised a ceramic pipe encased in brick rubble and ran on a northwest-southeast alignment. At the eastern edge of the trench this drain converged with a second (104), also of brick rubble construction, running on a southwest-northeast alignment.

Figure 10: Trench 1a facing northeast showing drains in base of cut [101]

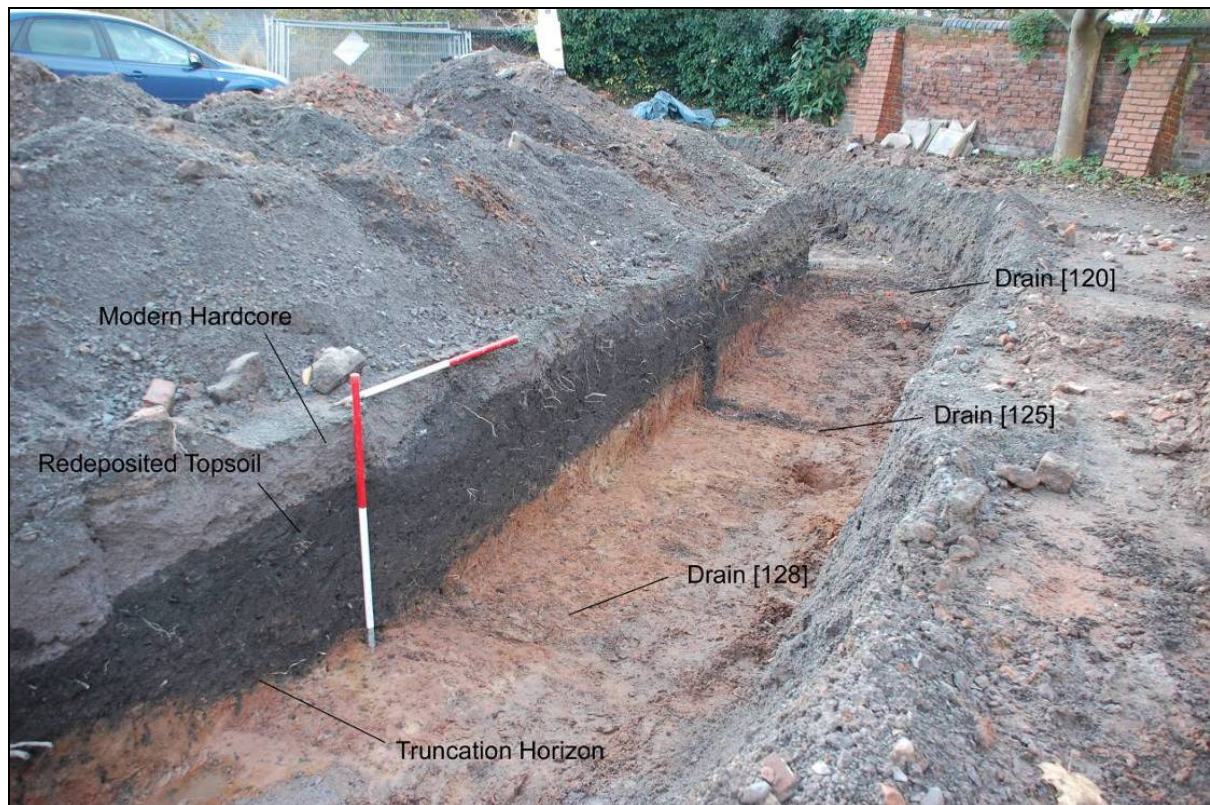
The base of the trench was excavated to a depth of around 96m AOD, 1m below the existing ground level. The upper surface of the natural geology was encountered at a maximum height of 96.37m AOD, comprising a clean buff/orange sand containing pockets of coarser gravels and pebbles. A small hand-excavated sondage was cut into the natural to confirm its identification, reaching a depth of 95.84m AOD.

Figure 12: Trench 1b facing southwest (note sharp interface at truncation horizon)

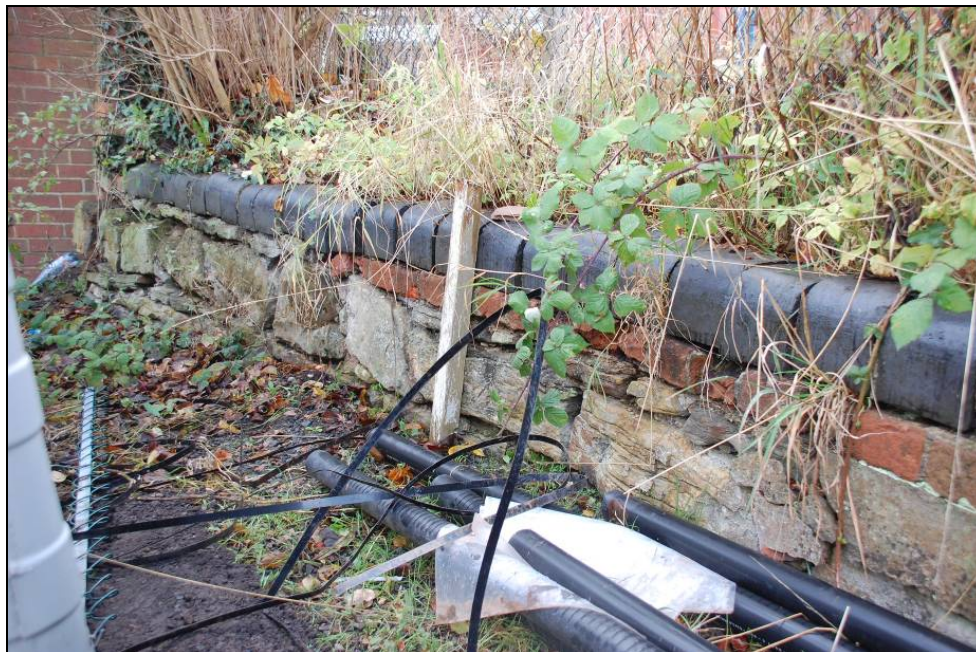
Figure 18: View of southern perimeter wall- note sandstone basal courses

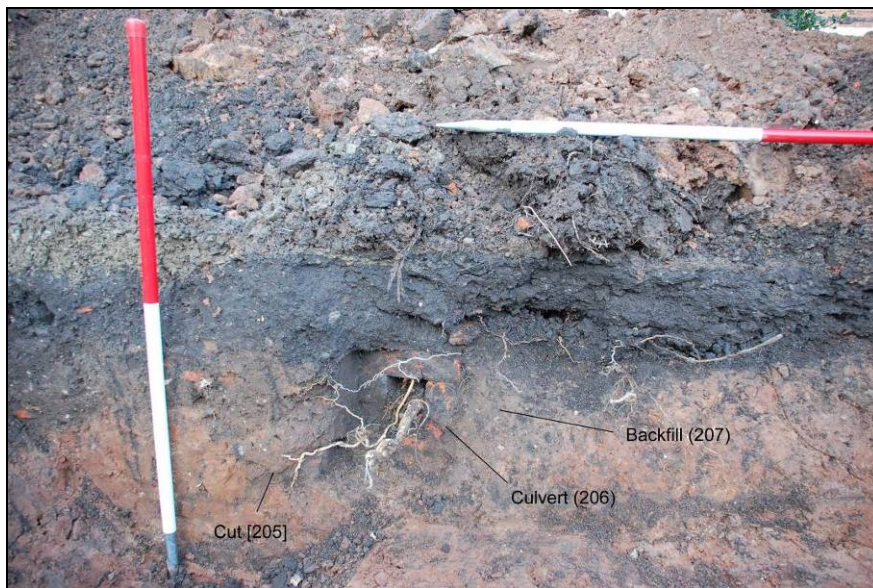
A brick-lined culvert was situated 0.3m to the west of the wall footing, following the same north-south alignment. The cut [205] was 0.75m wide and 0.55m deep with steep sides and a flat base. The culvert was constructed from un-bonded bricks (206), with a single course laid stretcher-to-stretcher along the base, bricks laid on their edge forming the culvert walls and a further course of capping bricks. The cut was backfilled with mixed brown clay-loam (207), again probably redeposited garden soil. The culvert did not appear to function as it was dry and choked with roots from nearby trees.

Figure 19: Culvert at western end of Trench 2 facing north

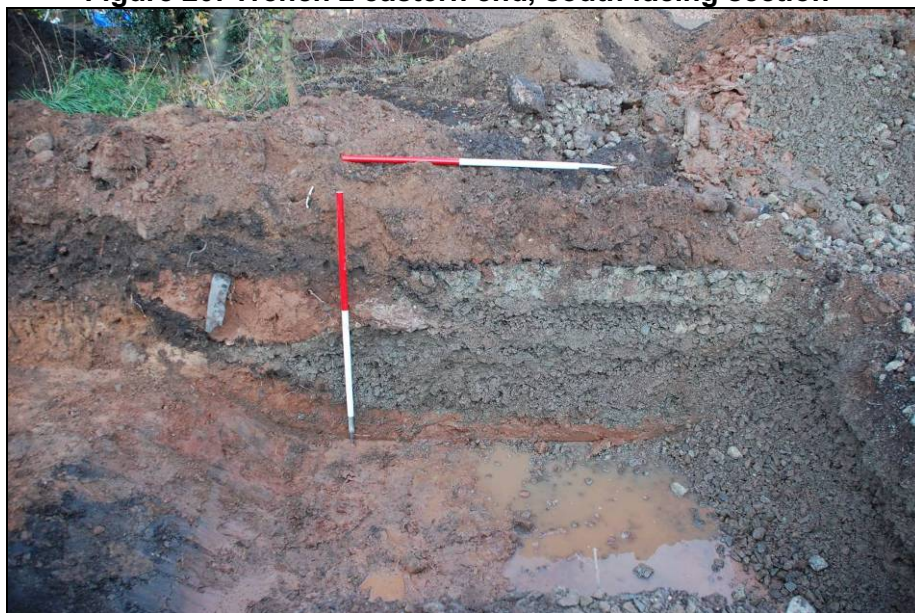
At the eastern end of the trench all earlier deposits had been completely truncated by the construction of a second car park. The ground below the car park was reduced to 96.37m AOD, 0.85m below the current ground level and 0.55m lower than the undisturbed surface of the natural sand to the west. The cut [209] had a vertical western face and gradual break of slope to a flat base. 0.7m of aggregate had been laid in the base (210), topped by a 20mm thick layer of tarmac (212). At the western edge of the car park a kerb had been set on a concrete base within a sand filled cut (Figure 20 below).

Figure 20: Trench 2 eastern end, south facing section

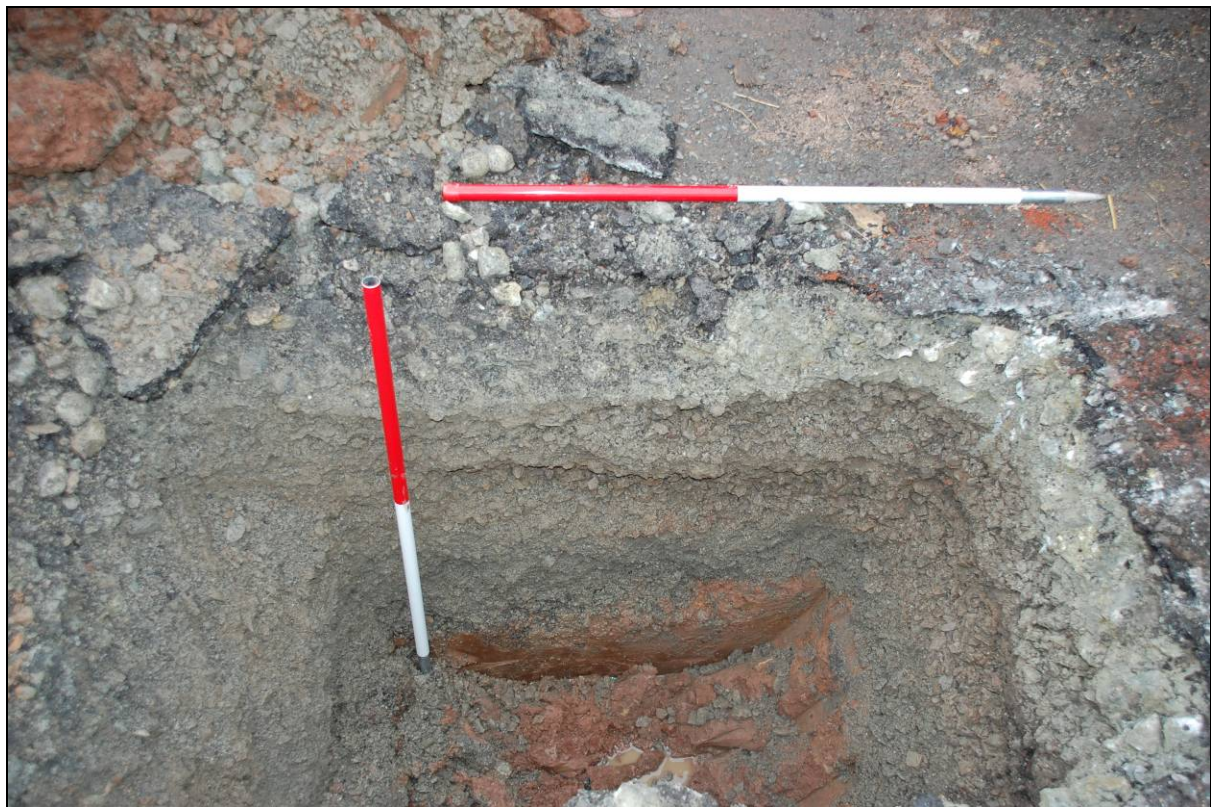
The sequence of deposits at the eastern end of Trenches 2 and 7 was confirmed. Natural sand was observed at a depth of 0.7m below the existing ground level (equivalent to 96.29m AOD), overlain with 0.5m of dark grey aggregate and 0.15m of pale grey hardcore topped with 50mm of tarmac. No archaeological features were observed, and it is likely the ground reduction for the car park's construction will have removed any former ground surface and shallow cut features.

Figure 21: Trench 3 facing northwest

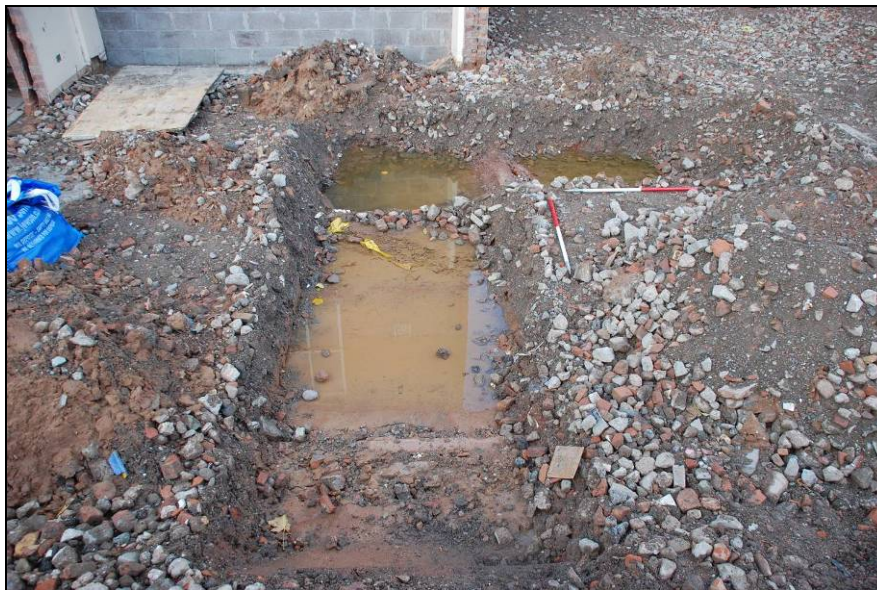
No archaeological remains were encountered in this trench. Natural waterlogged sandy clay was encountered at a depth of 95.6m AOD. This had been cut by two brick-built foundations marking the south-eastern corner of the modern buildings. To the northwest the ground had been disturbed to a depth of 95.38m AOD by modern drains.

Figure 22: Trench 4 facing north

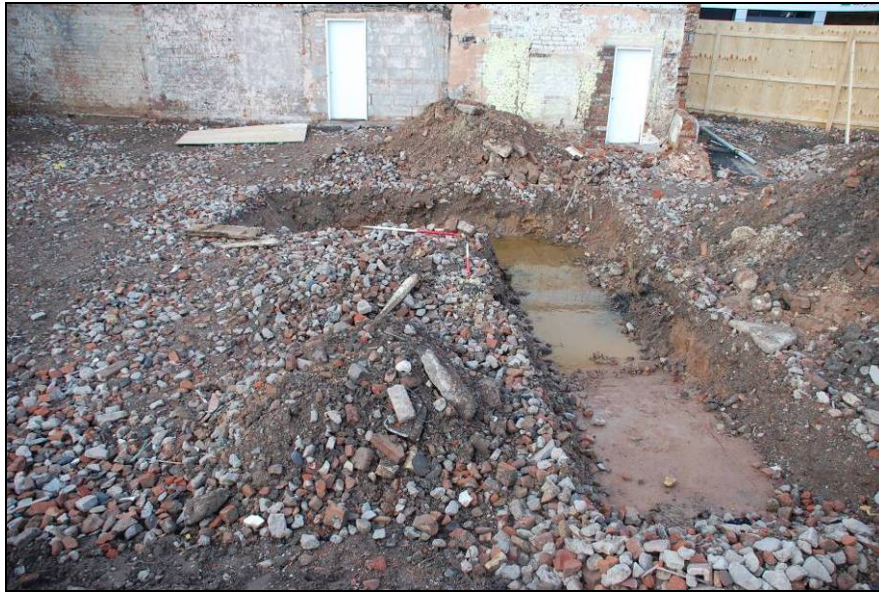
No archaeological remains were encountered in this trench. Natural waterlogged sandy clay was encountered at a depth of 95.31m AOD at the northern end of the trench, rising to 95.72m AOD in the south. The demolition works carried out shortly before the site investigation had completely removed modern foundations in this area. There was no indication of any earlier construction below these.

Figure 23: Trench 5 facing north

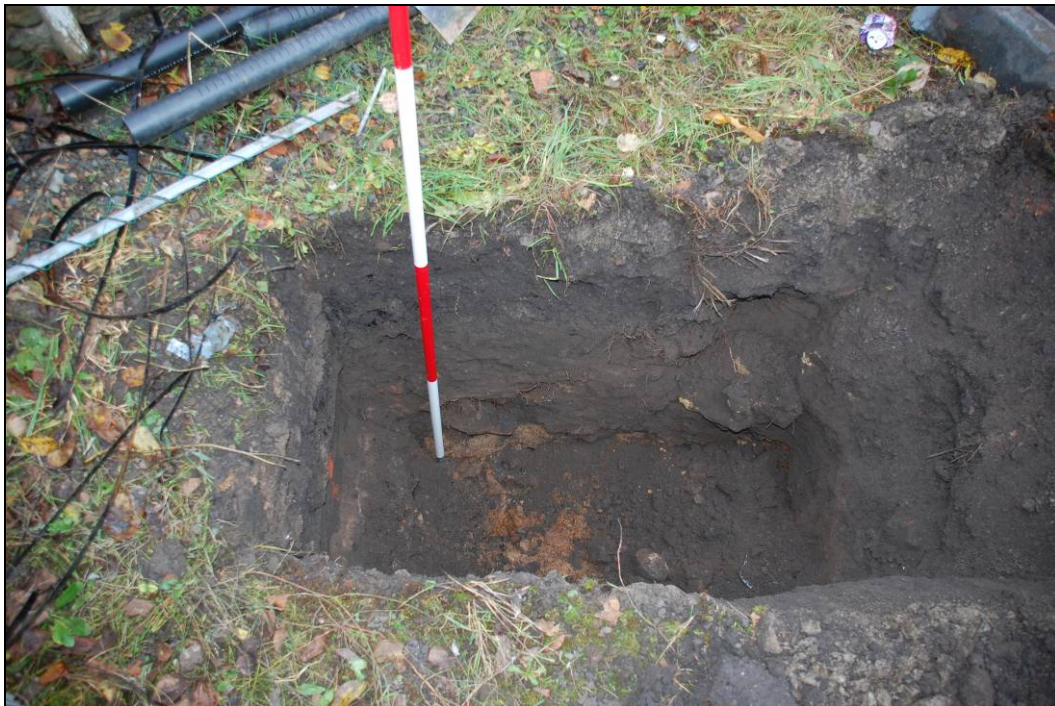
Natural sand was encountered in the base of the trench at a depth of 1.15m below the existing ground level (96.35m AOD). The sand was sealed by a deposit of clean brown loamy soil 0.3m deep containing natural (?) fragments of sandstone, overlain by a lens of clean buff sand 0.1m deep. This was in turn sealed by 0.4m of dark brown sandy loam containing brick rubble and 0.35m of loose friable topsoil. The ground surface was recorded at 97.5m AOD.

Figure 24: Trench 6 facing southwest

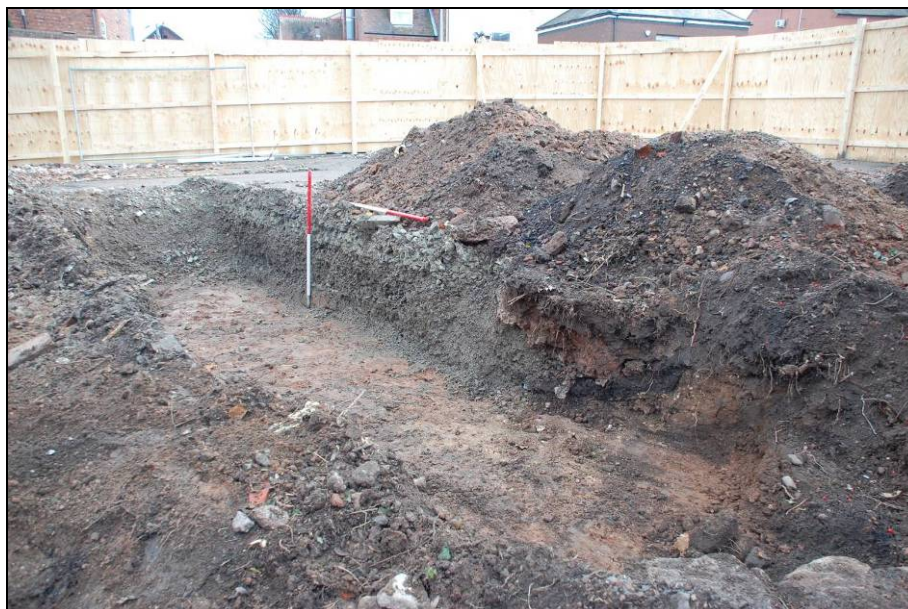
Figure 26: Trench 7 facing southeast showing deep truncation by car park deposits

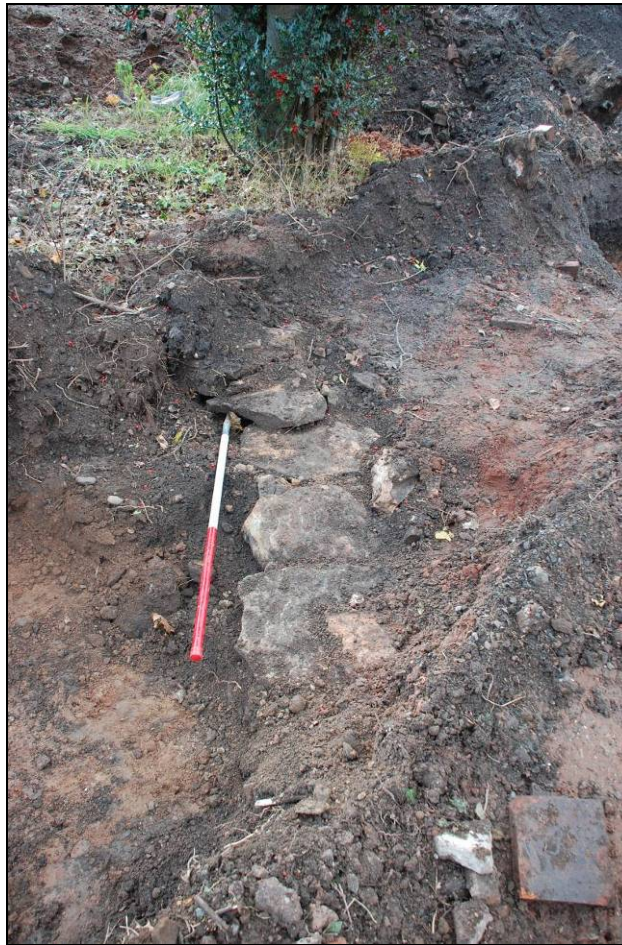
Figure 27: Wall footing [701] at western end of Trench 7 facing southwest

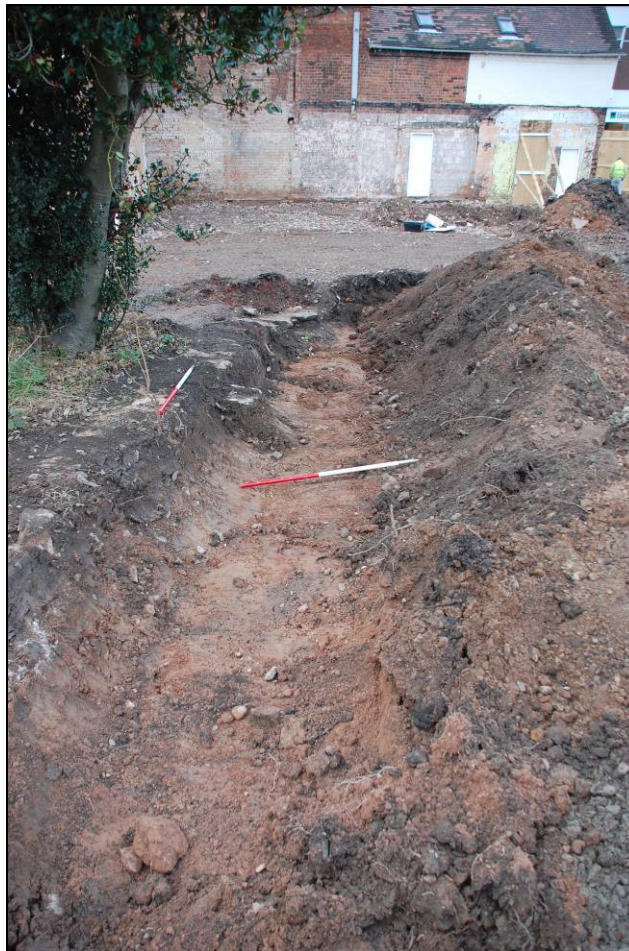
Following the first phase of site investigation the line of wall (702) was traced southwards to Trench 2, and the ground cleared to either side. This exposed a narrow strip of undisturbed garden soil that had been unaffected by the construction of the car parks. No significant archaeological material was encountered (either as cut features or stray artefacts in the soil) which may indicate a general lack of activity in this area, though as a sample excavation the area was too small to draw meaningful conclusions.

Figure 29: View to north along wall (702)

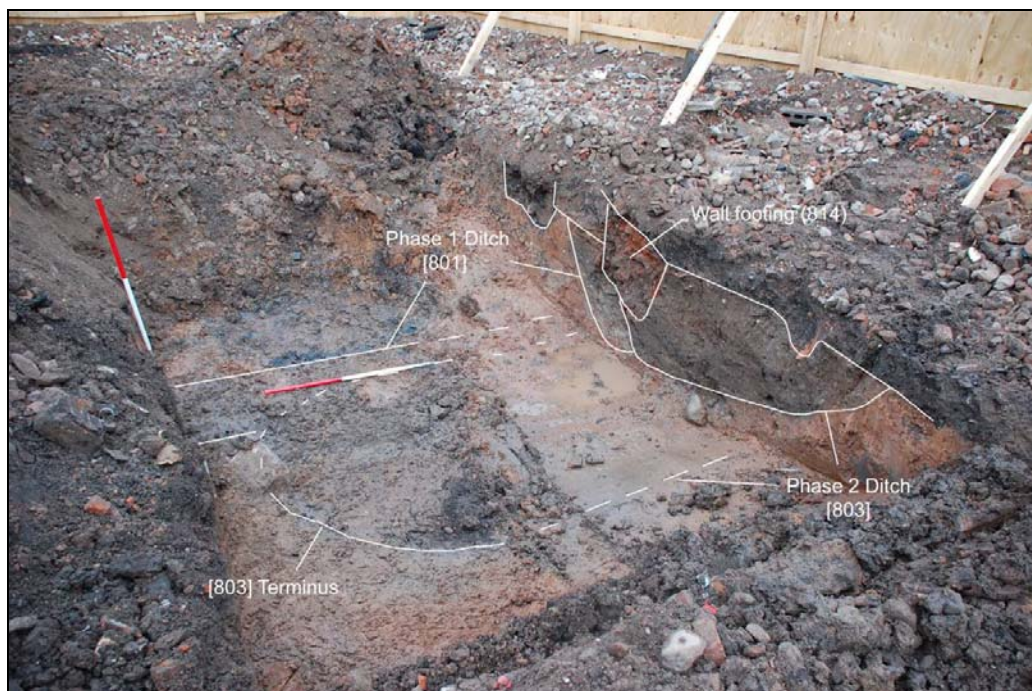
Figure 32: Northern end of Trench 8 facing north showing principal features

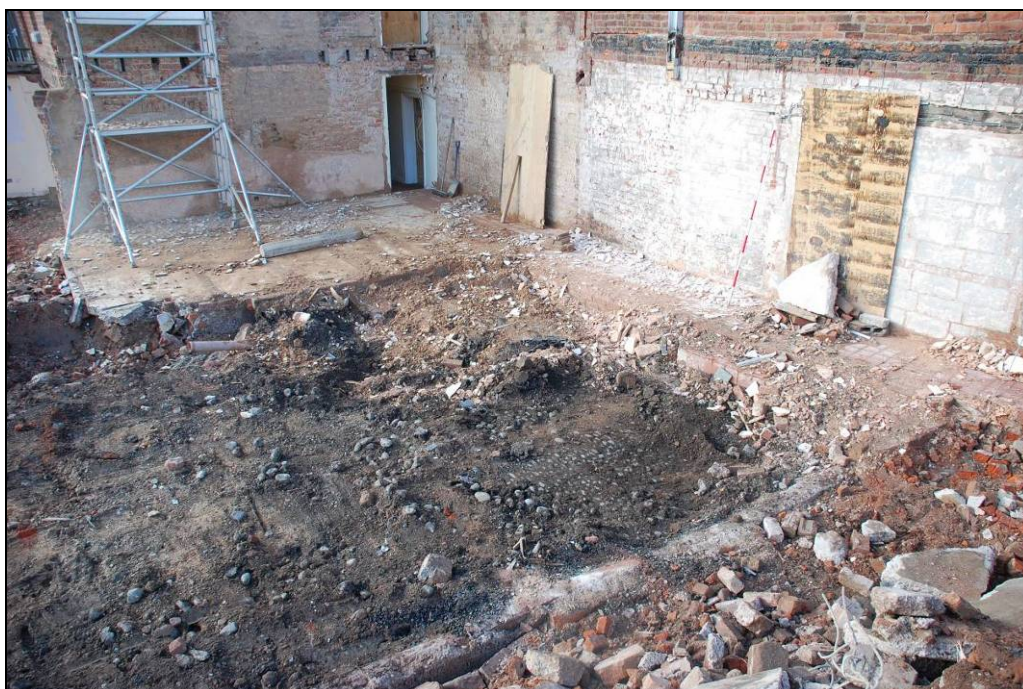
Within the footprint of the 20th century buildings all traces of earlier ground surfaces and structures had been removed, leaving only natural geology. The exception was in the courtyard area, where a 30mm thick layer of tarmac was stripped back to reveal a cobbled surface. The cobbles were up to 120mm in diameter and had been set on a thin make-up layer of ashy soil. The surface had been badly damaged by the insertion of services across the area in later periods and some of the cobbling had been deliberately removed, but the approximate dimensions of the yard surface were c 7.75m north-south and 5m east-west (Figures 37 and 38). The courtyard would originally have been accessed via a passageway through No 11 Walker Street.

Figure 37: View of cobbled courtyard facing northwest

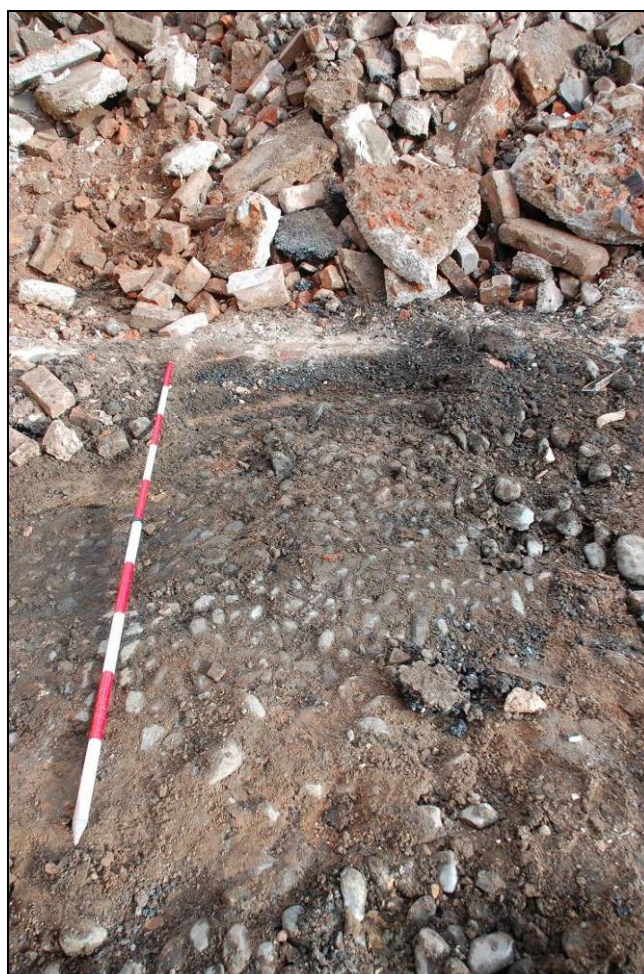
Figure 38: Detail of cobbled courtyard surface, facing east
