Muller Dairy North,
Market Drayton

Archaeological Site Investigation: Trial Trenching

SLR Ref : 403-00396-00011

January 2014

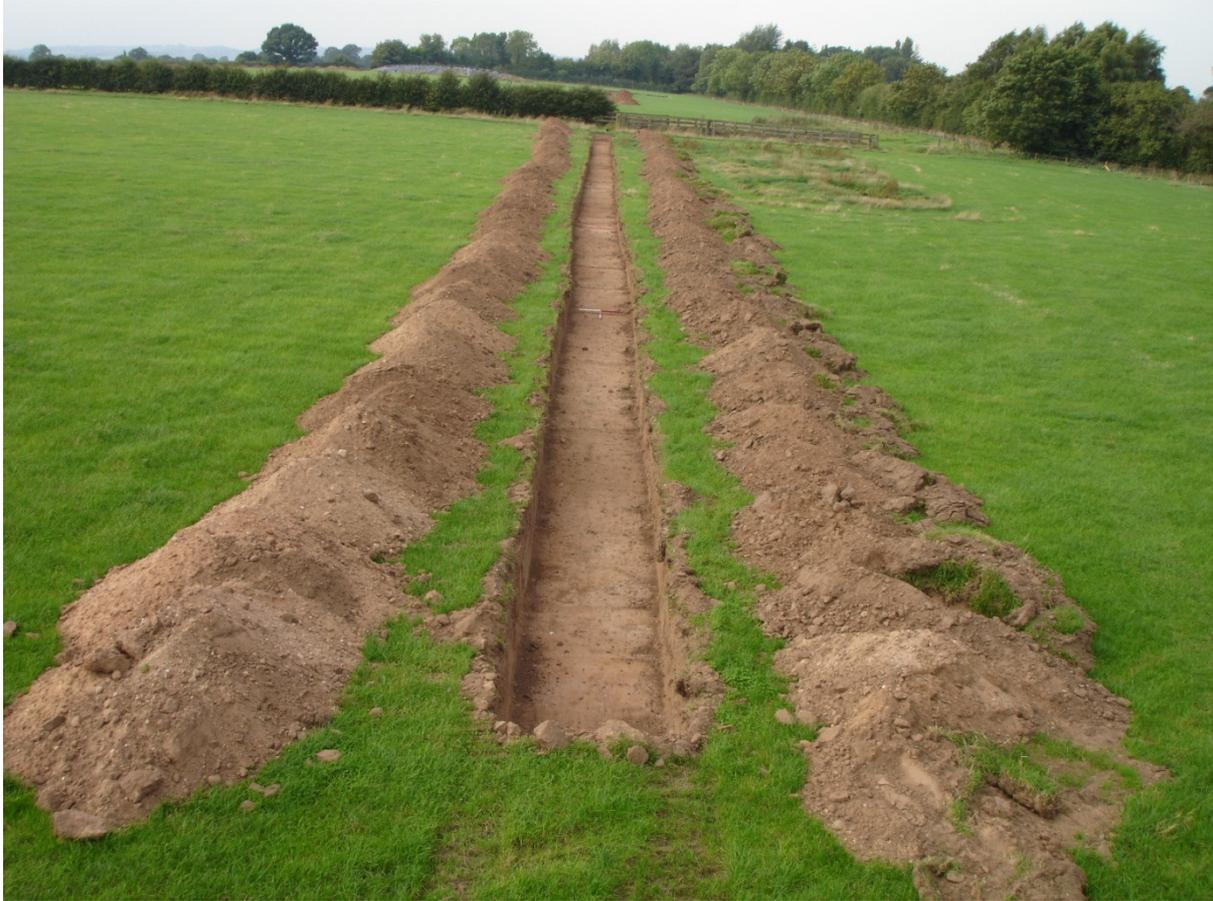
Plate 1. Trench 1 Overview. View: SE

Dimensions: 100 x 1.6m. Orientation: NE – SW.

No archaeological features were located in this trench, with the stratigraphy consisting of a loosely compacted brown silty sand topsoil (101) overlying an orangey brown silty sand sub-soil interface (102) with the natural sands (103). Natural generally occurred at a regular depth of around 0.3m, but at the eastern end of the trench the ground appeared to gradually slope off or hollow to the east, overlying which was an accumulated greyish brown sandy clay (104). The origins of this material are unclear, although it shared similar characteristics with backfills of the quarry pits to the south in trenches 2, 7 and 15. Considering its location at the base of the slope, however, it is likely to have been formed by a mixture of ploughing and colluvial activity dragging material to the lowest point on this side of the field.

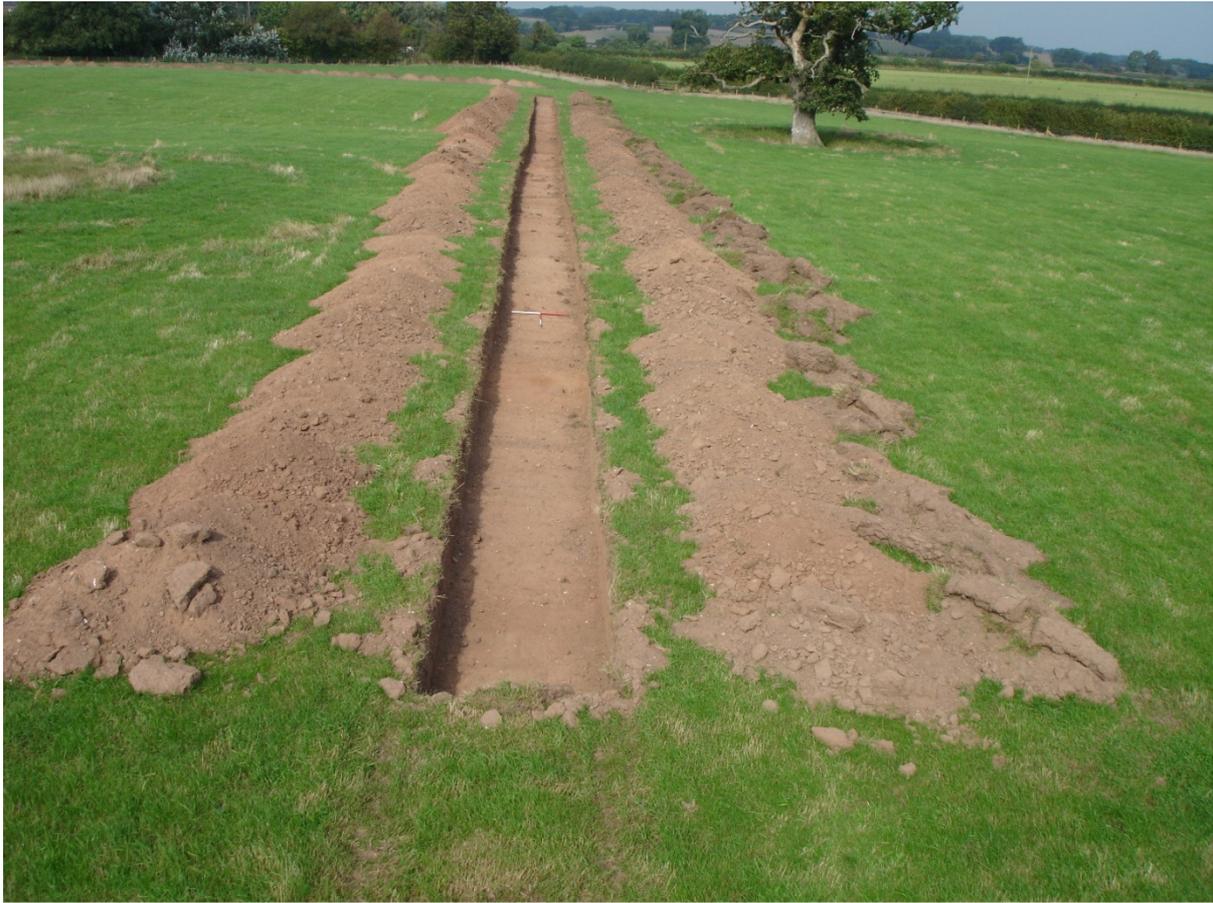
Plate 2. Trench 2 Overview. View: NW

Dimensions: 100 x 1.6m. Orientation: NW – SE.

Underlying topsoil (201) was light orangey brown sandy clay sub-soil (202). In the southern half of this trench this soil overlaid the tightly compacted greyish clay fill (205) of a gently sloped cut [204], which extended to a depth of 1.4m below the existing ground level. This cut probably relates to quarrying activity, which appears to have targeted gravel seams within the sandy natural (203), although it is possible that this is a natural depression.

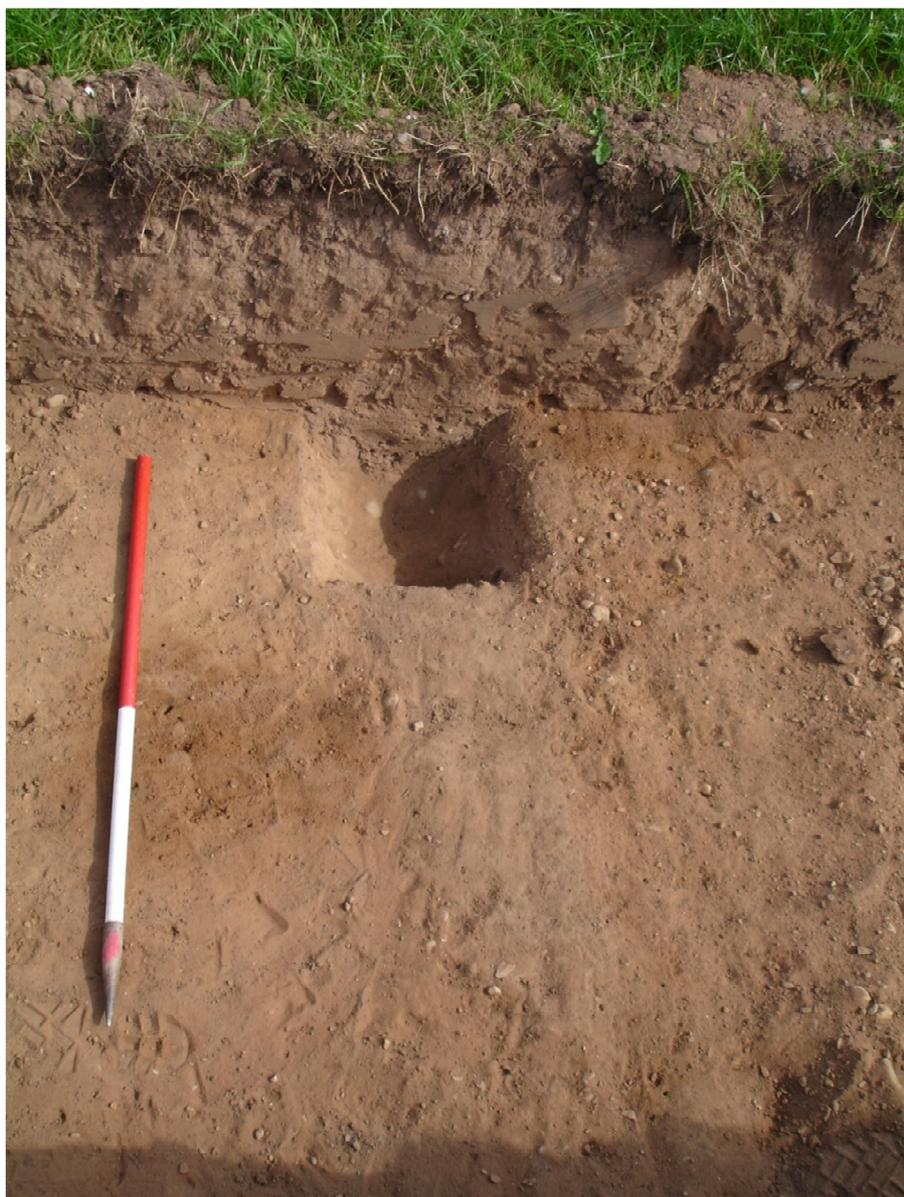
Plate 3. Feature [205]. View: NE

At the northern end of the trench was a further feature; this was possibly natural in origin, although the limited area exposed made interpretation inconclusive. It consisted of a shallow northeast to southwest orientated cut [205] (Plate 3), which tapered to a point towards the southwest. Filling this feature was a light brown sandy silt (206).

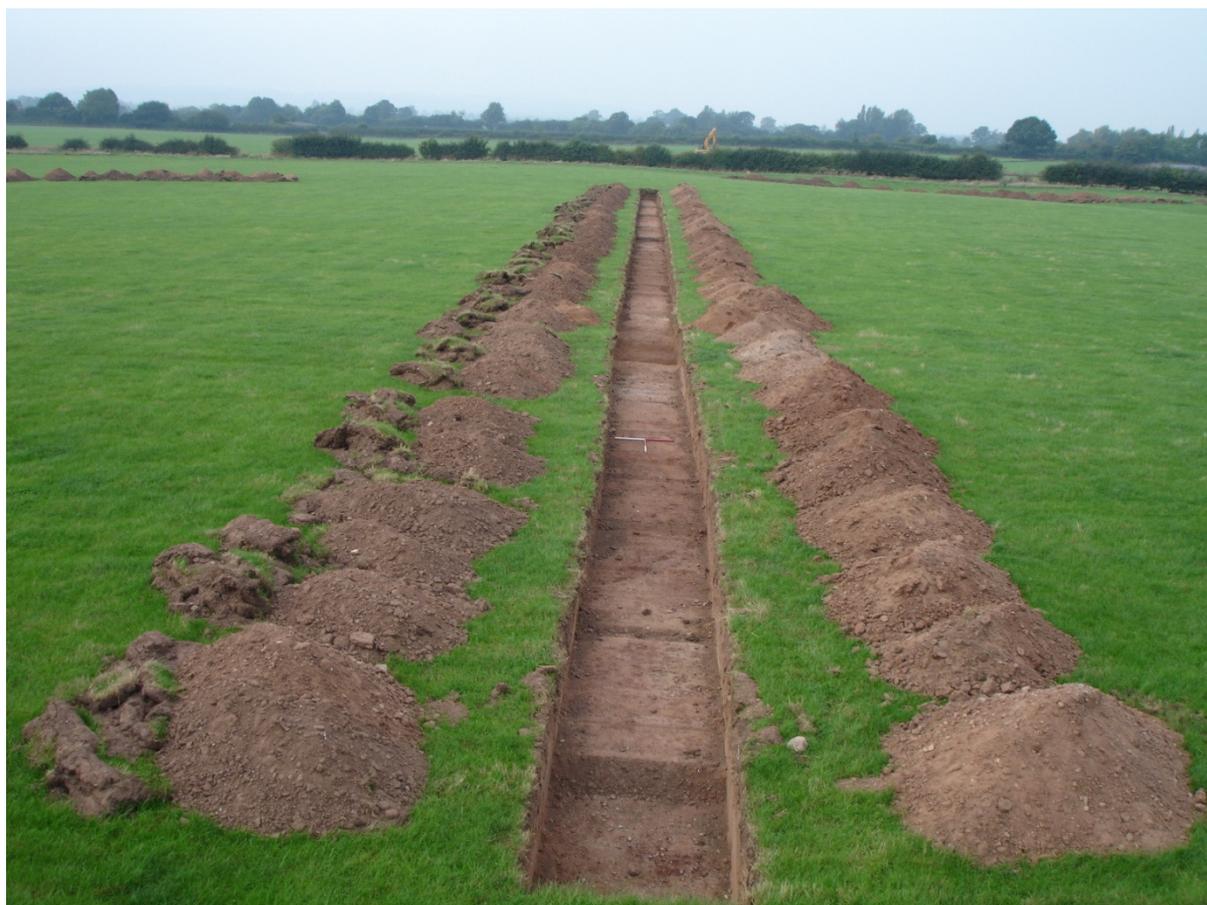
Plate 4. Trench 3 Overview. View: SW

Dimensions: 100 x 1.6m. Orientation: NE – SW.

Underlying topsoil (301) and subsoil (302) was a single feature, located at the eastern end of the trench (Figure 3). Cut [304] appeared to form part of a linear ditch, orientated in a NW to SE direction, running across the width of the trench (Plates 5 and 6). The feature was c. 3.10m in width and 0.75m deep, with a sharp break of slope top, gently sloping sides and an undulating base (Figure 4). Filling the ditch were four contexts, the uppermost of which was a 0.30m thick firmly compacted light greyish brown silty sand (305), which overlaid a firmly compacted mid-brown silt sand (306) (Figure 4 and Plates 5 and 6). Underlying (306) were two layers of slumped material, the uppermost of which was a loosely compacted mid-yellow brown silt sand (307), which overlaid a loosely compacted dark orange brown slightly silty sand (308). Ditch [304] cut into the natural sands and gravels (303).

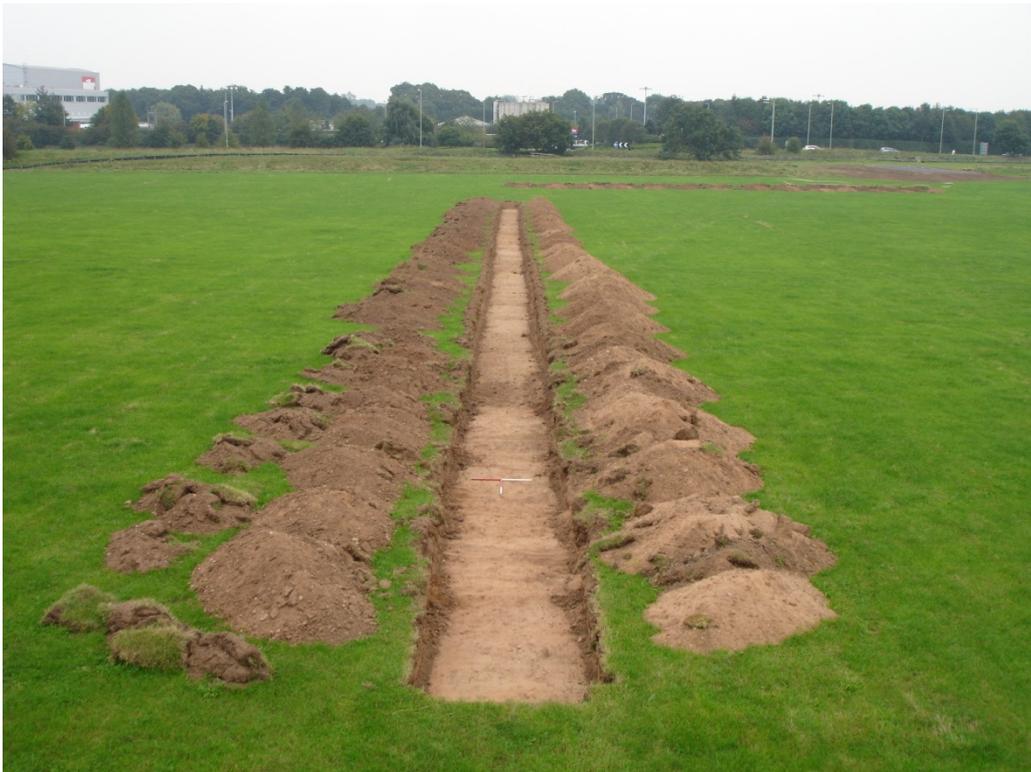
Plate 7. Trench 4 Overview. View: S

Dimensions: 100 x 1.8-1.9m. Orientation: NW – SE.

The majority of the trench had a uniform deposition sequence, consisting of topsoil (401), overlying a light orangey brown silty sand with occasional angular stones, which formed the subsoil (402). Over the majority of the trench this material overlaid natural sands and gravels (403), although at the southern end of the trench there was a single possible boundary ditch feature [404] (Figure 5 and Plate 8). Orientated NE – SW, with a depth of between 0.35 and 0.45m, the feature had a moderate break of slope top, steeply sloping sides and a sharp break of slope base. The base itself was revealed to be undulating after the feature was partially excavated with a test slot across its width. Filling the ditch was a single fill of firmly compacted mid-brown silty sand. No dateable material was recovered from this feature.

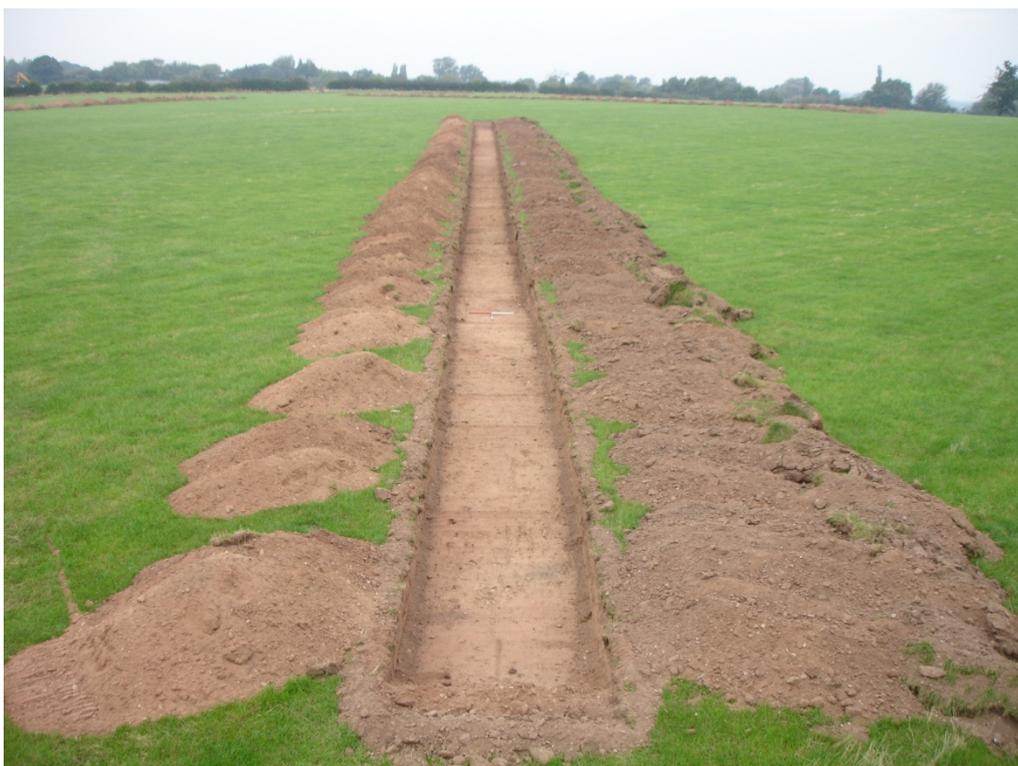
Plate 9. Trench 5 overview. View: NW

Dimensions: 100m x 1.8-1.9m. Orientation: NW – SE

Underlying the topsoil (501), was a loosely compacted subsoil of light brown sandy silt (502), which overlaid natural sands and gravels (503) across the trench, except at the southeast end, where the subsoil overlaid a pinkish brown sandy clay soil (504). This thickened towards the lowest point in the trench, and was interpreted either as a colluvial deposit shifted downslope by gravity and ploughing activity. No archaeological features were located in this trench.

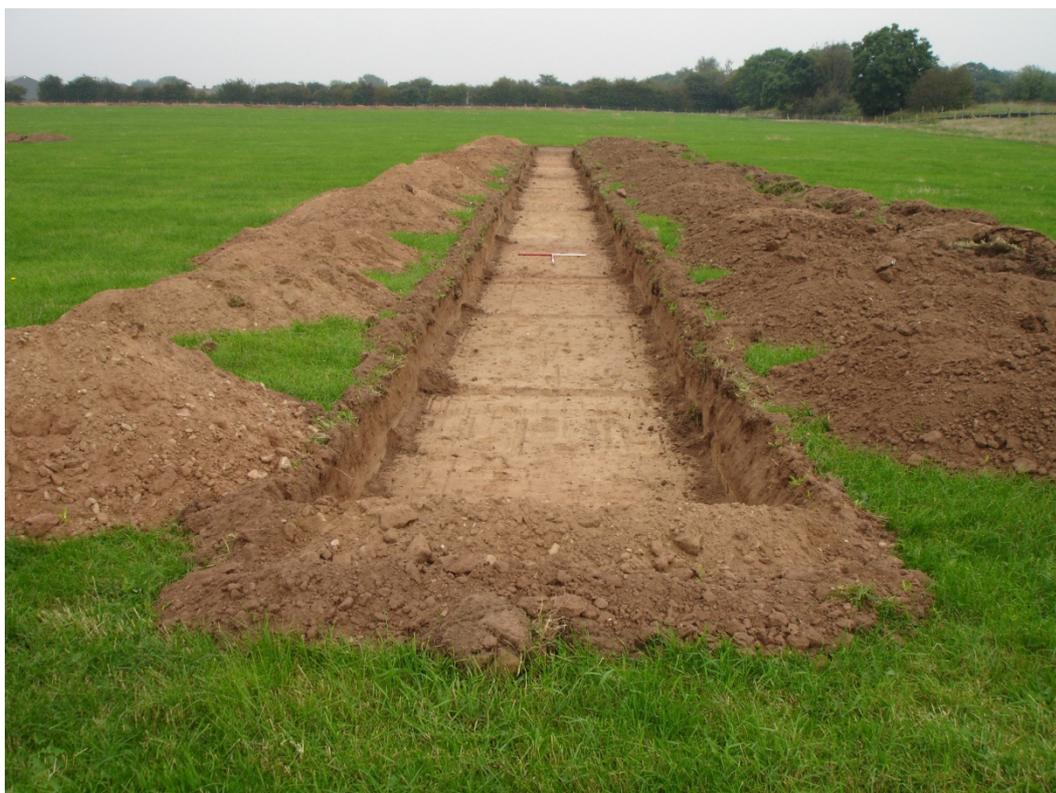
Plate 10. Trench 6 Overview. View: E

Dimensions: 60 x 1.9m. Orientation: NE – SW.

Underlying mid-brown sandy silt topsoil (601), was a loosely compacted mid-orangey brown silty sand with occasional angular stones (602). This overlaid natural sands and gravels at a depth of c. 0.50m – 0.60m.

No archaeological features were located within this trench.

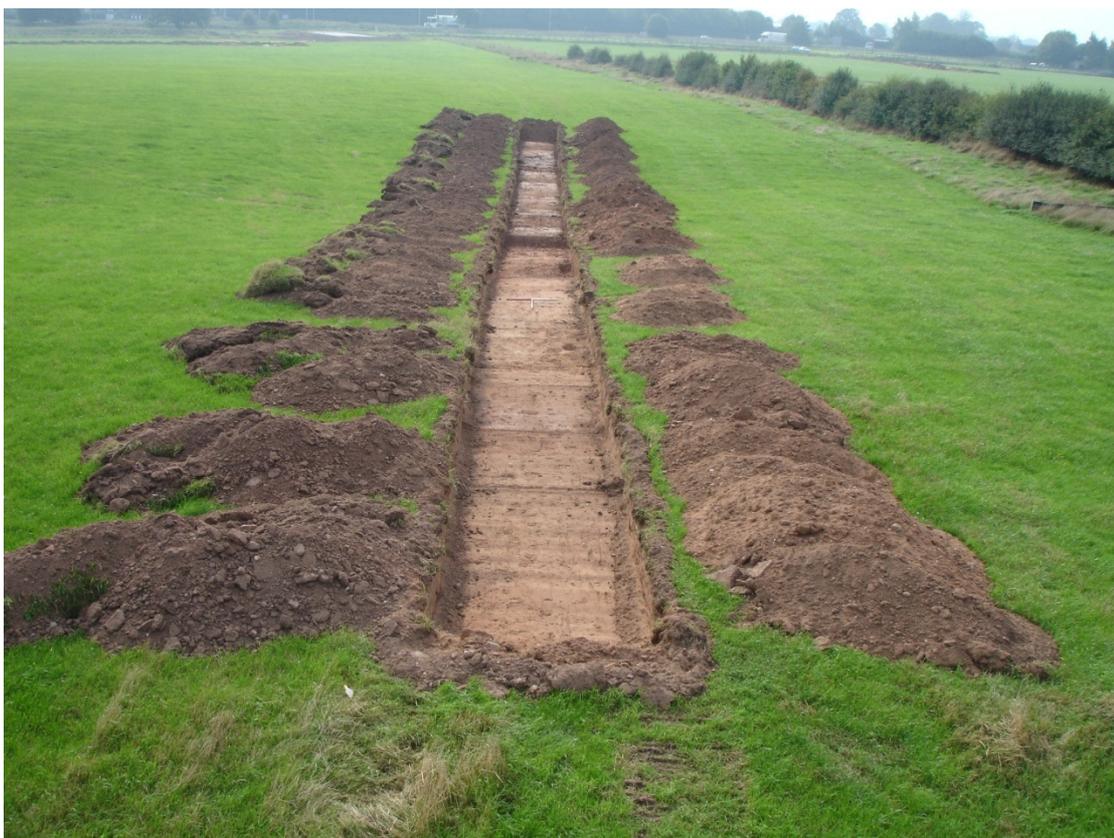
Plate 11. Trench 7 Overview. View: S

Dimensions: 60 x 1.8-1.9m. Orientation: N – S.

Trench 7 was specifically located to target some undulations located on the western side of the eastern field.

Underlying mid-brown sandy silt topsoil (701), was a loosely compacted mid-orangey brown silty sand with occasional angular stones (702). Underlying the subsoil was a gently sloping concave cut [706] (Plate 12), spanning most of the central and southern parts of the trench. Filling the cut was a pinkish brown firmly compacted clay (707), with occasional gravel inclusions and one fragment of post-medieval pottery. This cut into natural sands and gravels at a depth of c. 0.50m – 0.60m. Like the depression in Trench 2 this feature seems likely to be a quarry pit.

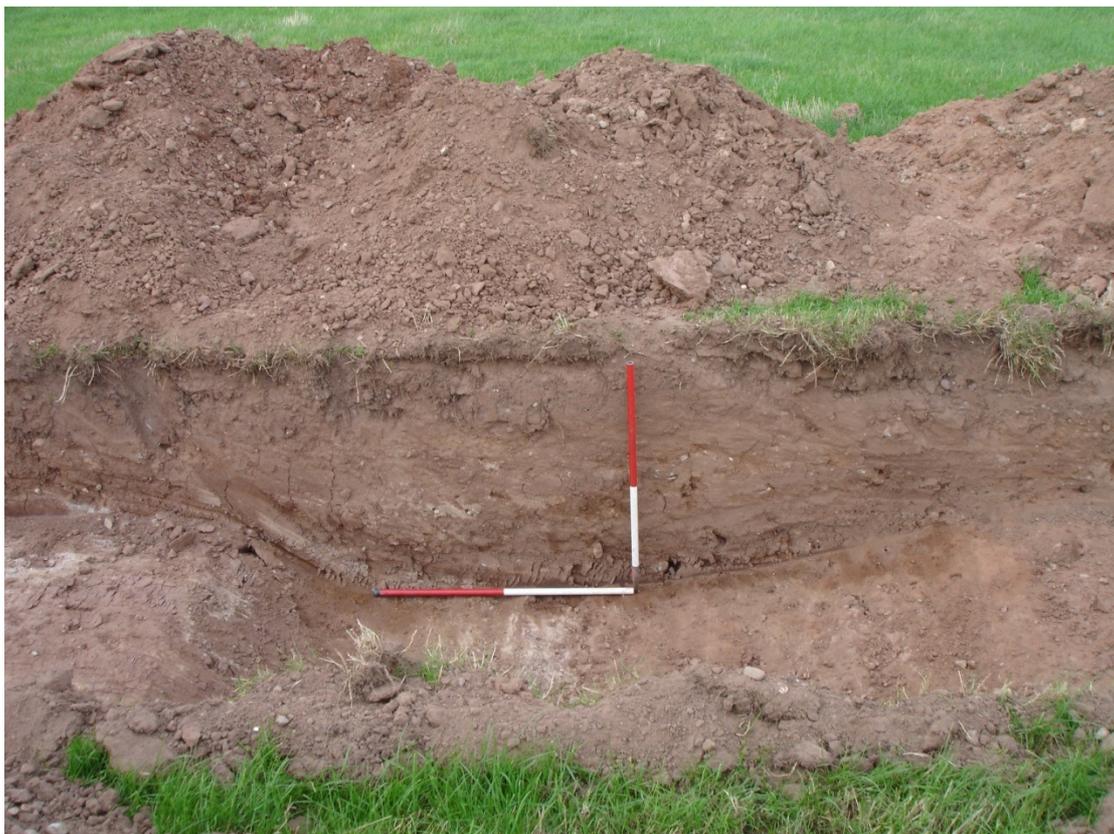
Plate 12. Quarry Pit [706]. View: E

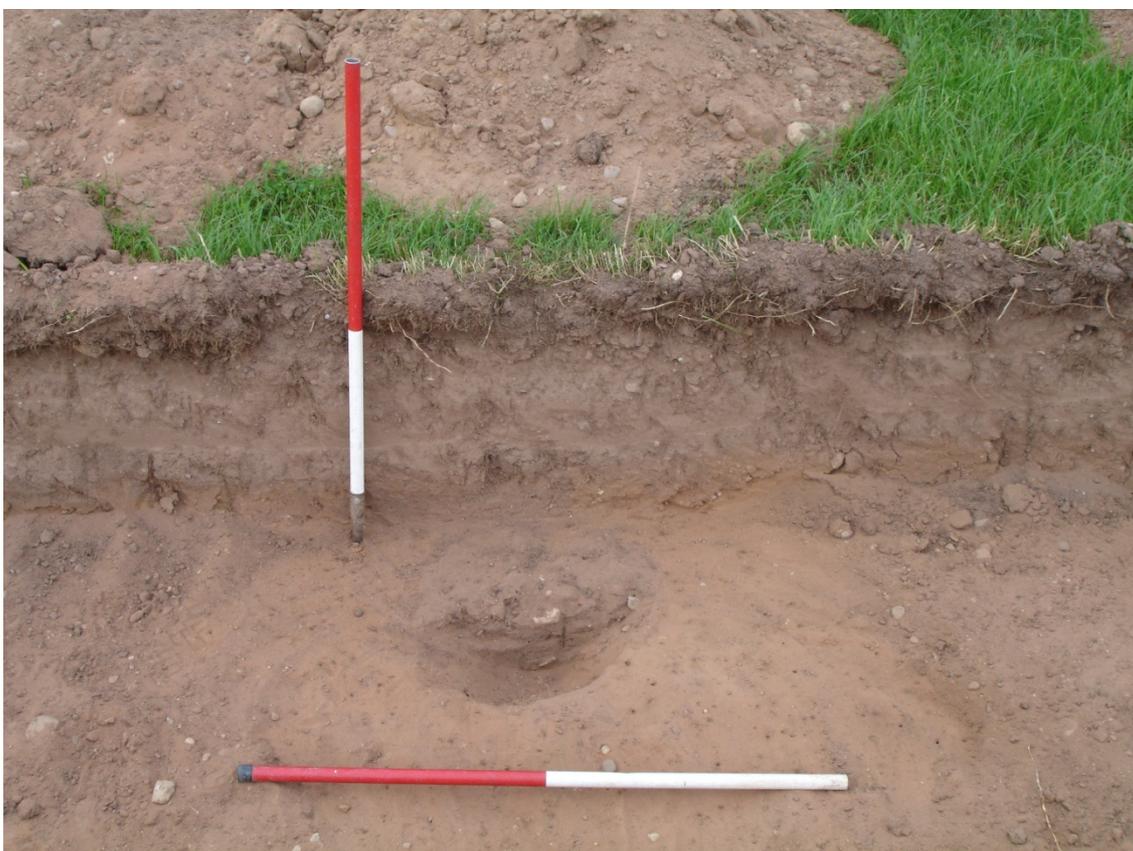
At the northern end of the trench, sealed by subsoil (702) there was a possible shallow post hole [704] (Plate 13) with gently sloping sides and a concave base. This was filled with a mid-brown loosely compacted sandy silt with occasional small angular stones (705). Given the size of the posthole it appears to have either been heavily eroded by ploughing or may be a natural feature, although its uniform shape seems to make the latter interpretation unlikely. Given its position it is quite possible that its function related to the nearby quarrying activity.

Plate 13. Possible post hole [704]. View: E

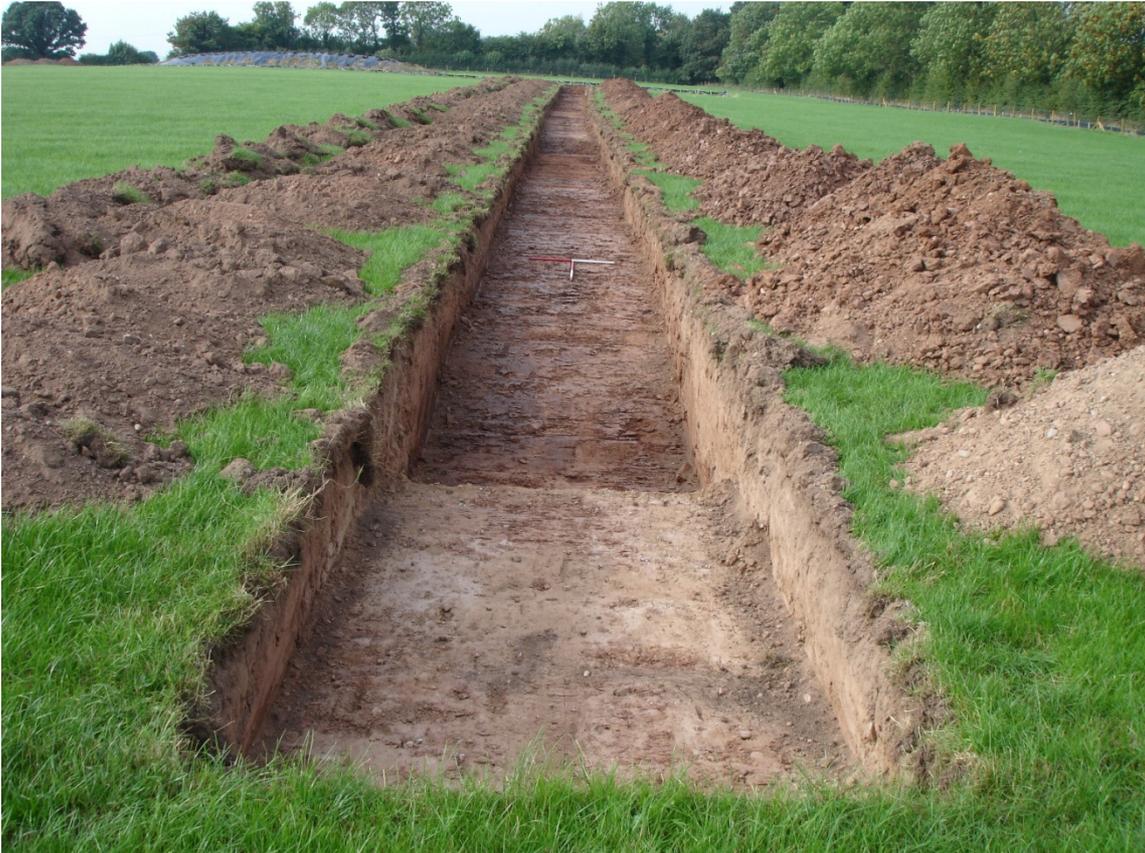
Plate 14. Trench 8 Overview. View: WSW

Dimensions: 100 x 1.8-1.9m. Orientation: NE – SW.

Underlying topsoil (801) and a moderately compacted clayey silty sand subsoil (802), was a series of clay deposits (803), within which were pockets of sand, which made up the natural geology. The clays appear to be typical of glacial till; but their location, at the base of slope at the northern end of the field, probably explains the build up of ground water in the pond to the south.

No archaeological features were present in this trench.

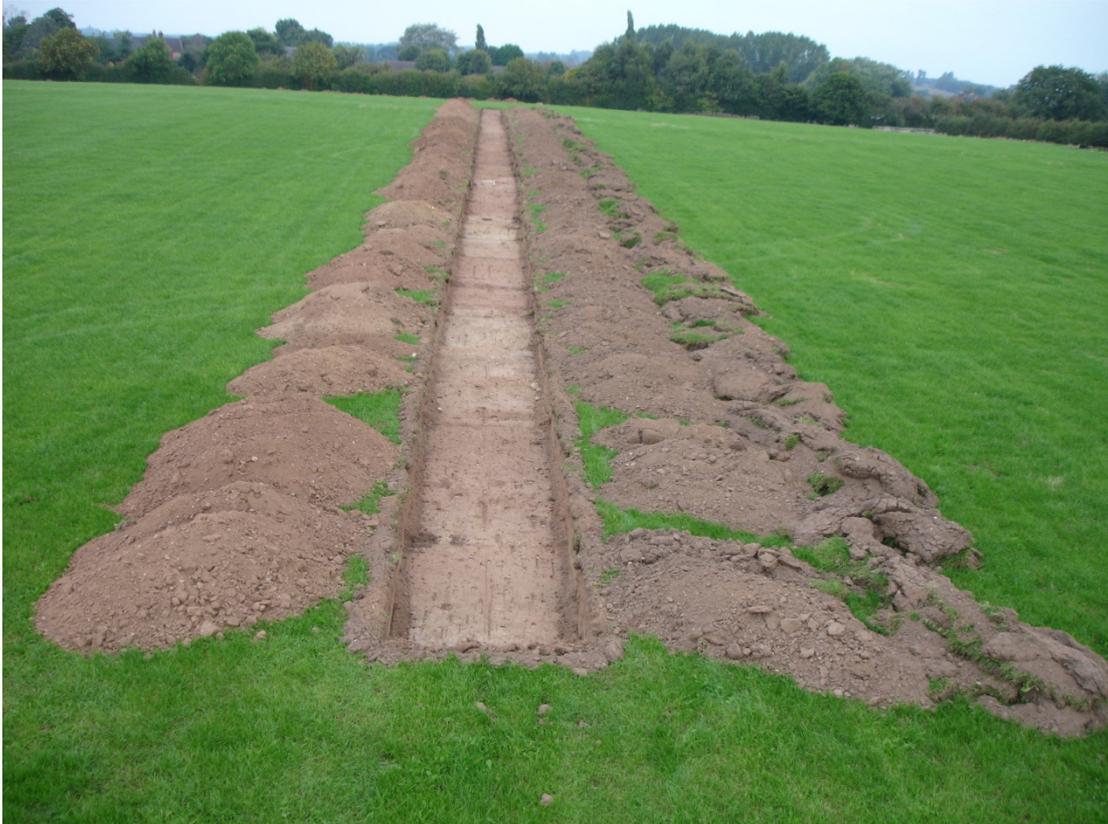
Plate 15. Trench 9 Overview. View: NW

Dimensions: 100 x 1.8-1.9m. Orientation: NW – SE.

This trench was positioned to target a slight ridge crossing the field from NE – SW, which probably represents the remains of a field boundary. Underlying mid-brown sandy silt topsoil (901), was a loosely compacted mid-orangey brown silty sand with occasional angular stones (902). This overlaid natural sands and gravels (903) at a depth of c. 0.50m – 0.60m. No trace of any features associated with the boundary were located, which was itself revealed to only consist of a slight thickening of topsoil material, rather than a definitive bank.

No other archaeological features were located within this trench.

Trenches 9 and 10 were located to cross a slight ridge running east-west near the crest of the modern field. This ridge is shown on the 1838 Tithe map as a field boundary between Top Yard (adjacent to Longford) and Town Field, but no trace of it was found beyond a slight thickening in the topsoil.

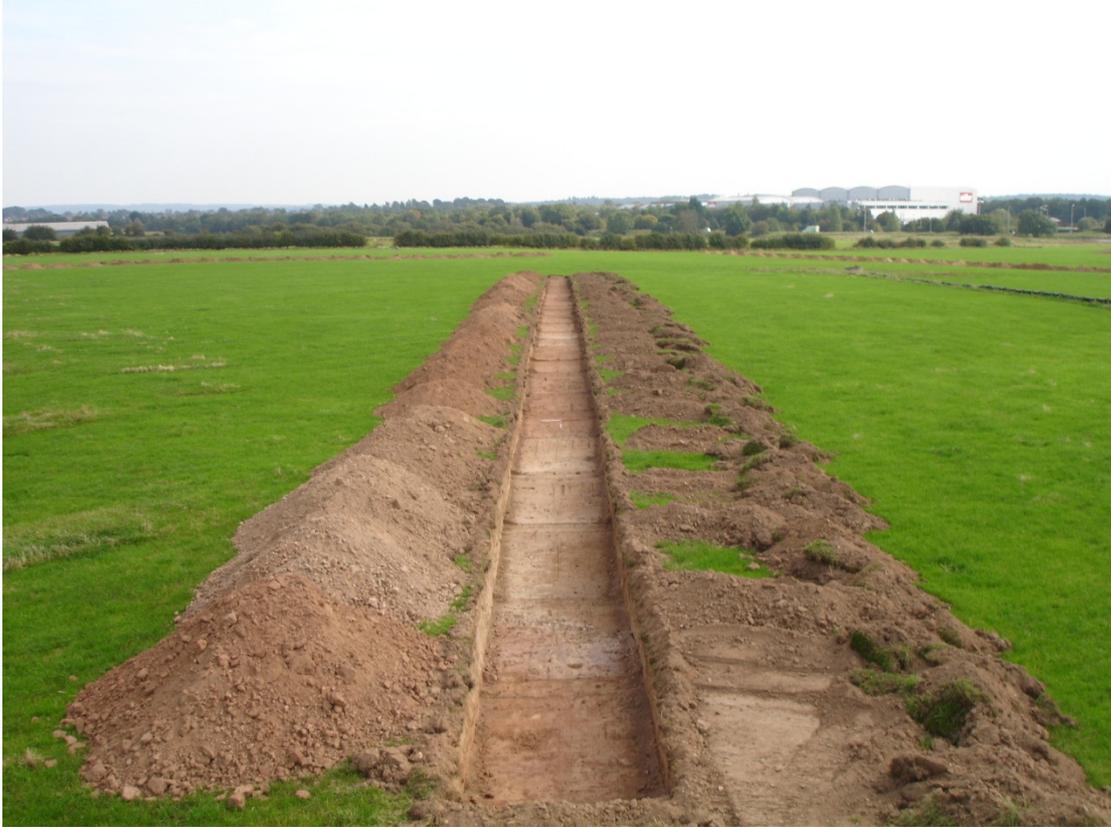
Plate 16. Trench 10 Overview. View: SE

Dimensions: 100 x 1.8 – 1.9m. Orientation: NW – SE.

This trench was positioned to target a slight ridge crossing the field from NE – SW, which probably represents the remains of a field boundary. Underlying mid-brown sandy silt topsoil (1001), was a loosely compacted mid-orangey brown silty sand with occasional angular stones (1002). This overlaid natural clays and sands and gravels (1003) at a depth of c. 0.50m – 0.60m. No trace of any features associated with the boundary were located, which was itself revealed to only consist of a slight thickening of topsoil material, rather than a definitive bank.

No other archaeological features were located in this trench.

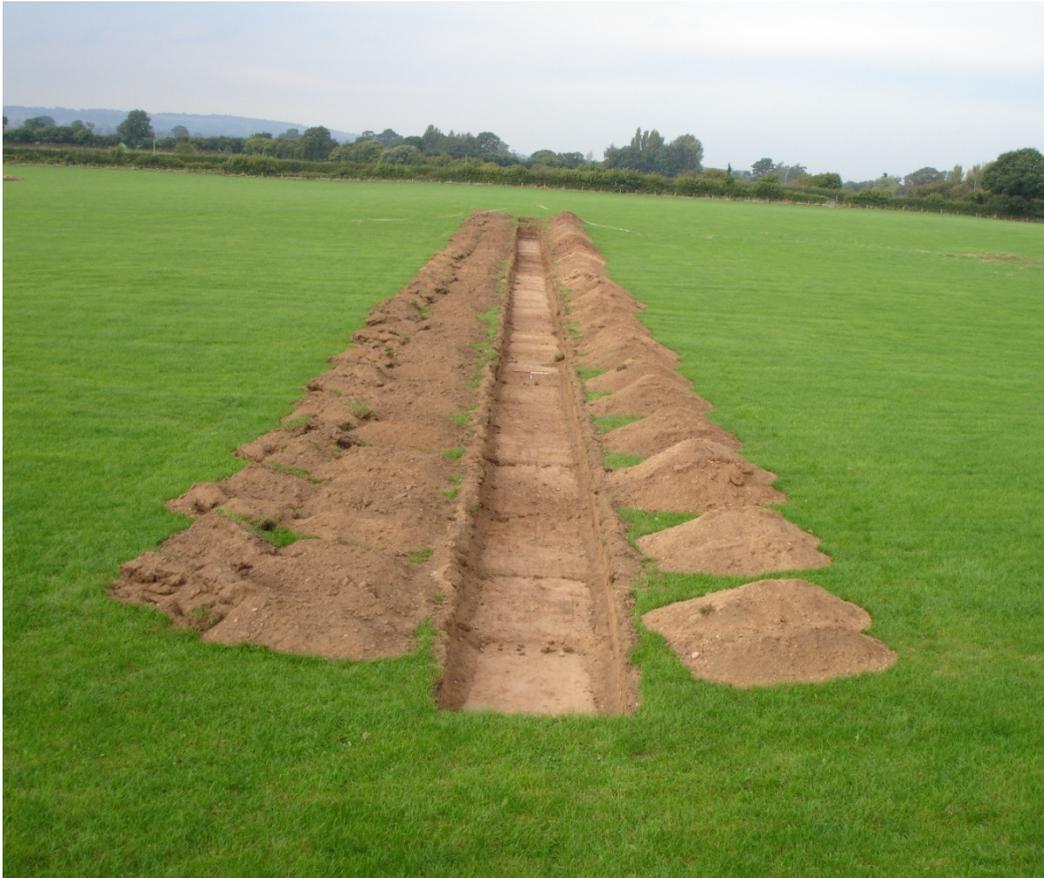
Plate 17. Trench 11 Overview. View: WSW

Dimensions: 105.10 x 1.8 - 1.9m. Orientation: NE – SW

Located in the central part of the western field. This trench crossed the line of a possible service at the southwestern end of the trench, and the trench was therefore not excavated at the point where it reached its probable course. A further extension was added at the southwestern end of the trench to make up the lost distance, therefore the trench consists of one 6.9m section and one 96.5m section.

The stratigraphic sequence of this trench consisted of topsoil (1101) overlying a light brown silty sand sub-soil (1102), which overlaid natural sands and gravels (1103).

No archaeological features or finds were located in this trench.

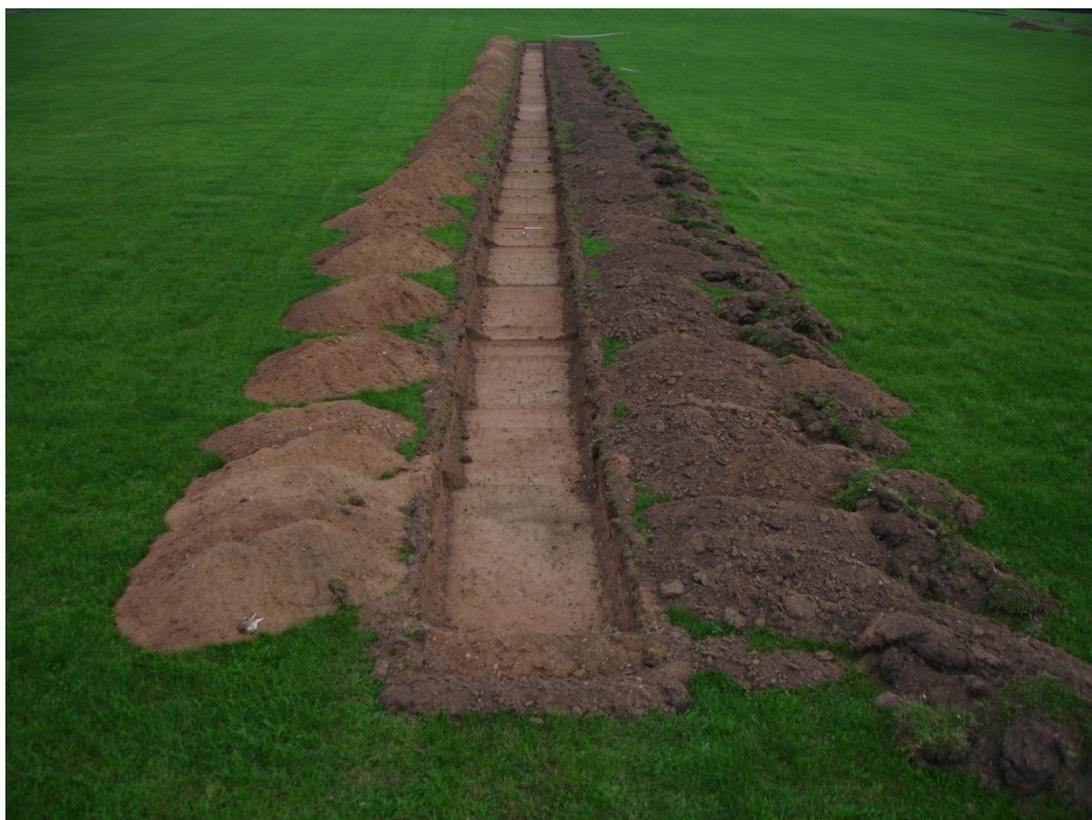
Plate 18. Trench 12 Overview. View: NW

Dimensions: 100 x 1.8 – 1.9m. Orientation: NW – SE

Located in the southwestern quadrant of the western field. Three deposits were recorded as being present within this trench. These consisted of topsoil (1201), overlying a thin layer loosely compacted silty sand subsoil (1202), which overlaid natural sands (1203).

No archaeological finds or features were located in this trench.

Trench 12 was sited to cross another east-west field boundary visible on the Tithe map. No trace of this was revealed. A further 1838 field boundary was, however, found in Trench 13a, the northern most of two features filled with sandstone blocks related to a phase of use by the railway. This field boundary separated Town Field from Big Milling on the Tithe map ([1307] and [1309] or [1318]).

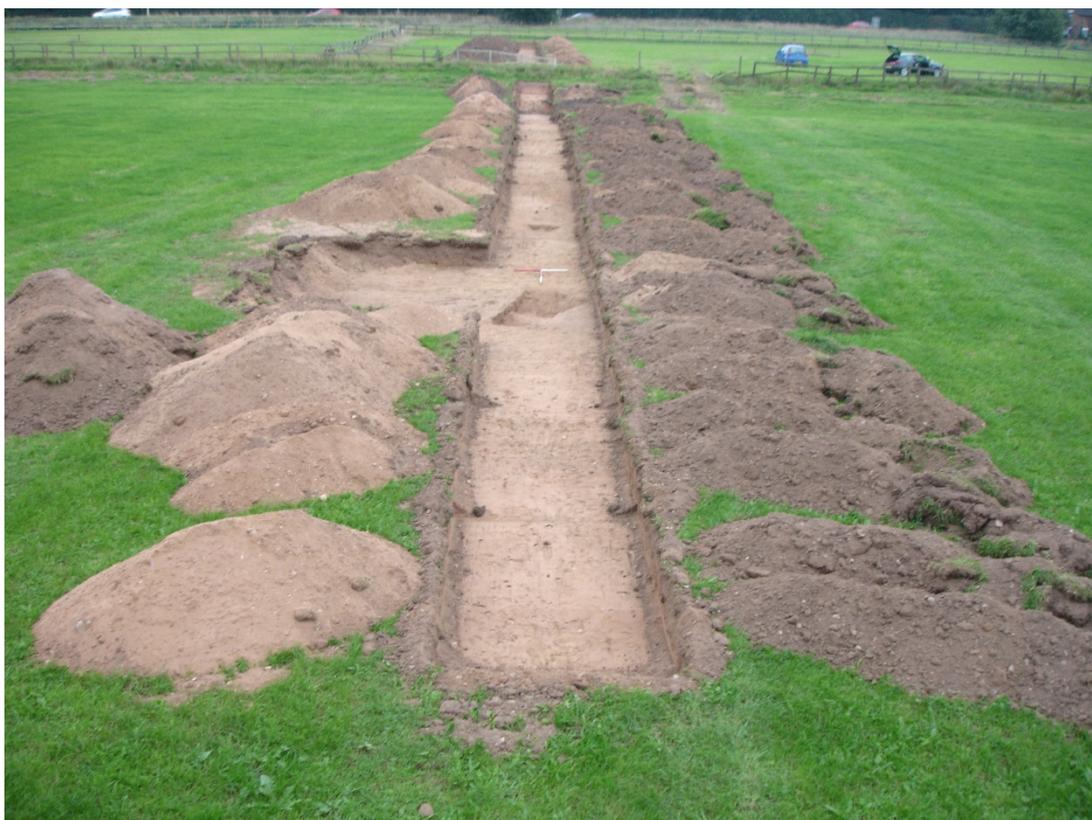
Plate 19. Trench 13a Overview. View: SE

Trench 13 was located at the southern end of the western field and was divided into two sections, due to paddock fencing running through its proposed original location.

Trench 13a was located to the north of the fencing, and was positioned to intercept the route of the Great Western Railway, which is visible as an earthwork cutting within the southern end of the western field. Underlying topsoil (1301) and light brownish yellow silty sand subsoil (1302), were a series of features. At the southern end of the trench, the railway cutting itself and the remains of associated revetting walls or drains, (1313) and (1317), were located (Figure 6). The southernmost of these (1317) was located in a 2.80m wide cut, backfilled with a mixture of clinker and soil layers (1312), (1319), (1314) and (1315) (Figure 7). The structure appeared to have been badly truncated during the removal of the railway line, but was constructed from roughly cuboid worked stones (Plate 21).

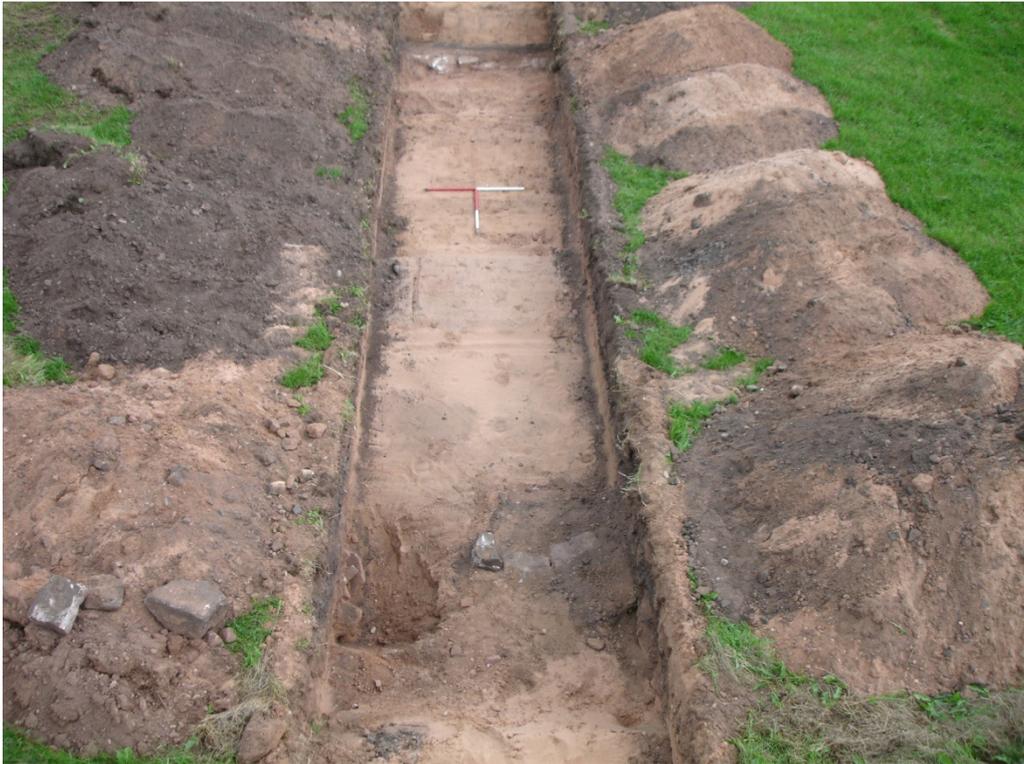
Plate 21. Overhead view of railway line remains in Trench 13a. View: NW

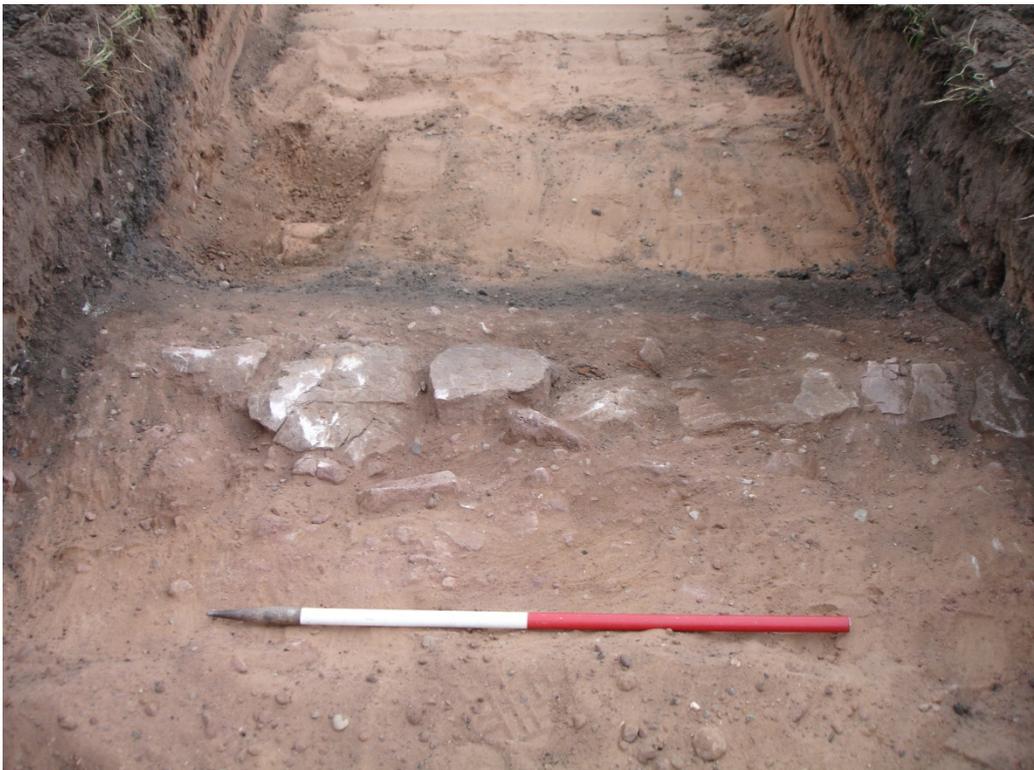
The northern structure was similarly constructed, from roughly shaped cuboid sandstone blocks (1313) (Plate 22), and lay within a linear ditch [1318] orientated on a NE – SW alignment. Abutting these blocks and backfilling the trench was a fill consisting of light brown silty sand and clinker (1319). These structural remains could be interpreted in a number of ways. Considering their depth, and their position in a cut, it seems probable that these are drainage features designed to take away accumulated water in the railway cutting. However, there is the possibility that they represent the remains of revetting walls associated with either supporting the track bed itself or the edges of the cutting.

Plate 22. Revetting wall (1313). View: NW.

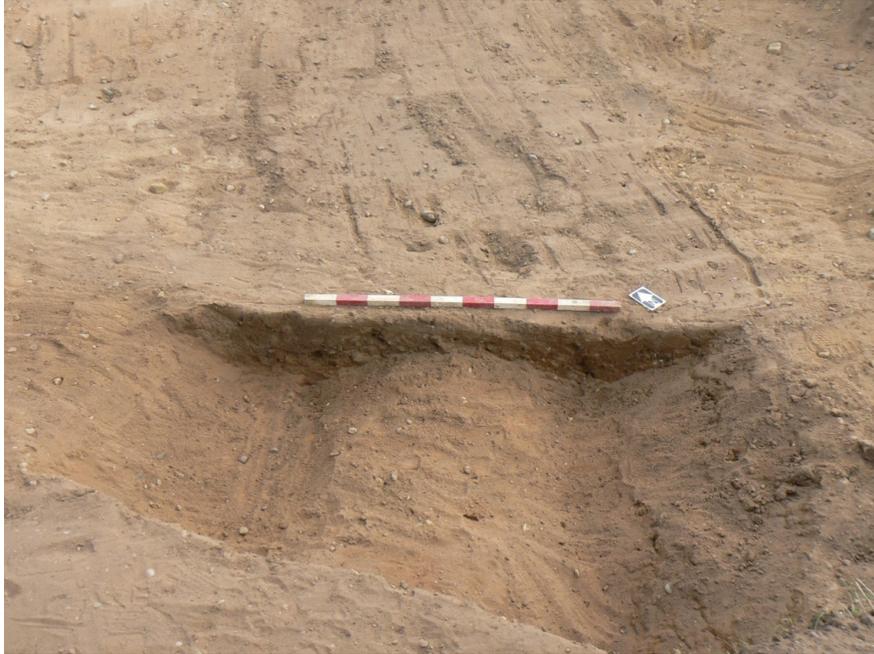
This ditch cut an earlier ditch [1309] (Plate 23), also on the same alignment. This was over 0.5m in length and 0.8m in width, with a moderate break of slope top, 50° sloping sides, a moderate break of slope base and a concave base. It was filled with mid-grey brown, moderate to firmly compacted silty sand (1308), with frequent sub-rounded pebbles and very occasional cobbles.

Plate 23. Ditches [1307] and [1309]

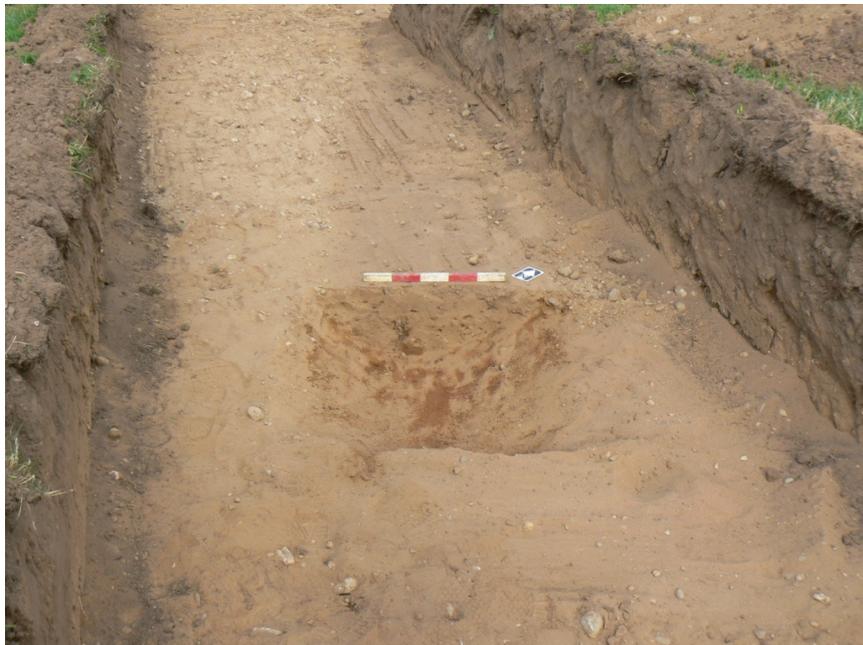
Plate 24. Ditch/ gulley [1311]. View: N

Both these ditches truncated a linear N – S aligned concave ditch cut [1311] (Plate 24), measuring over 16.5m in length and 0.6m in width. This was filled with a light grey brown loosely compacted silty sand (1310) containing occasional charcoal flecks and sub-rounded pebbles and cobbles.

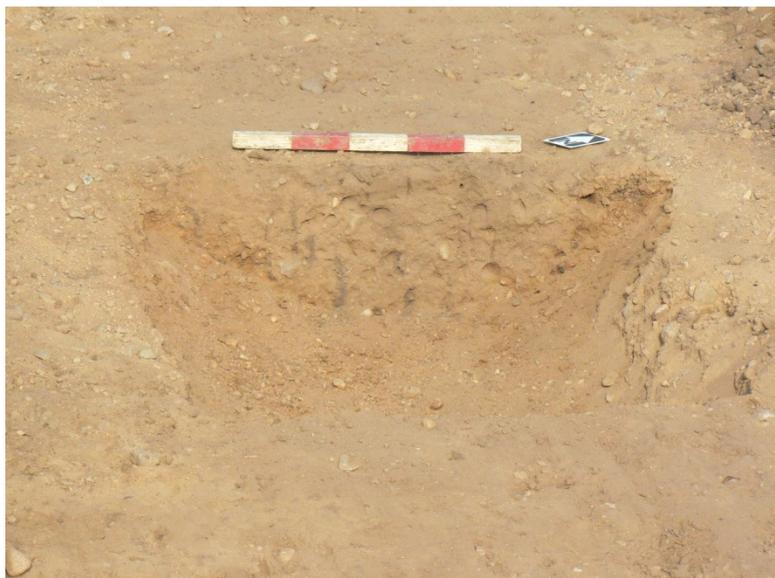
A single feature was located in trench 13b, this consisted of a single, slightly curving NW – SE aligned ditch/ gully [1305], measuring c. 22m in length, 0.85m in width and 0.25m in depth (Figure 9). Filling the ditch was a well defined, mid-brown silty sand with very occasional charcoal flecks and moderate amounts of sub-rounded, well sorted stones (1304).

Plate 25. Profile of ditch feature [1305]. View – NW

Ditches [1305], [1307], [1309], and [1311] do not appear to be shown on the Tithe map, although [1311] could be a relict field boundary between Big and Little Milling Fields.

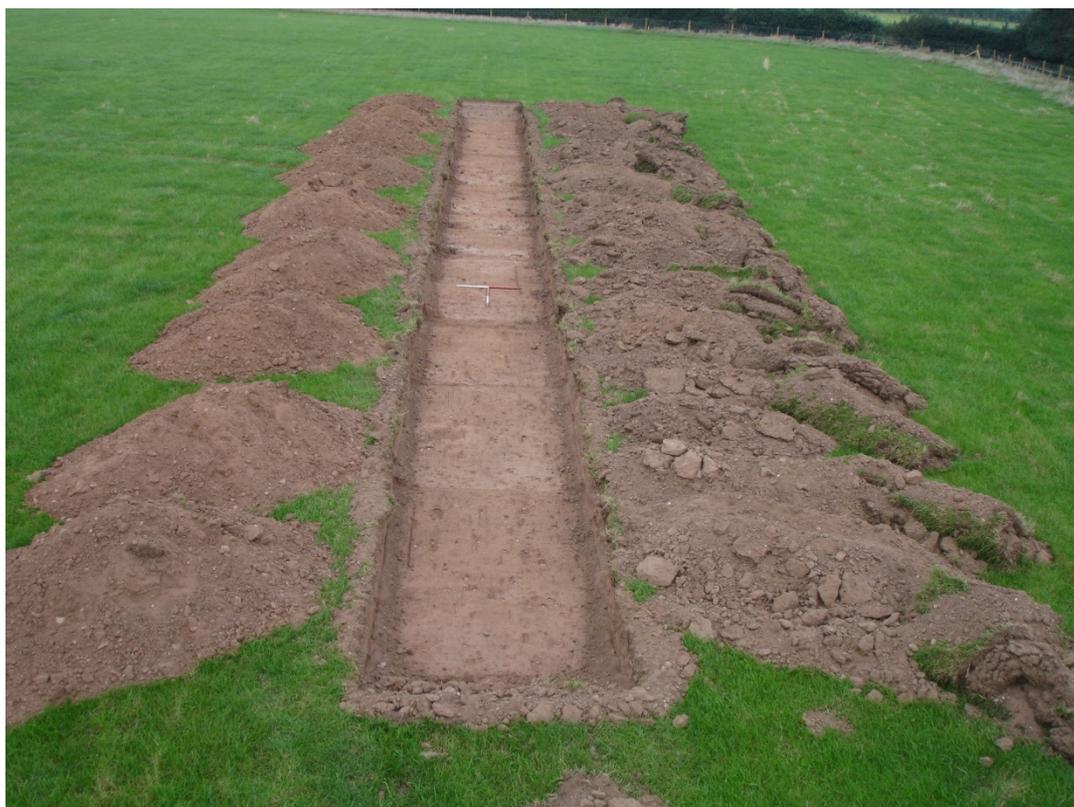
Plate 26. Trench 14 Overview. View: NW

Dimensions: 30 x 1.8 – 1.9m. Orientation: NW – SE.

Underlying mid-brown sandy silt topsoil (1401), was a loosely compacted mid-orangey brown silty sand with occasional angular stones (1402). This overlaid natural sands and gravels (1403) at a depth of c. 0.50m – 0.60m.

No archaeological features were located in this trench.
