Muller Dairy North,
Market Drayton

Archaeological Site Investigation: Trial Trenching

SLR Ref : 403-00396-00011

January 2014

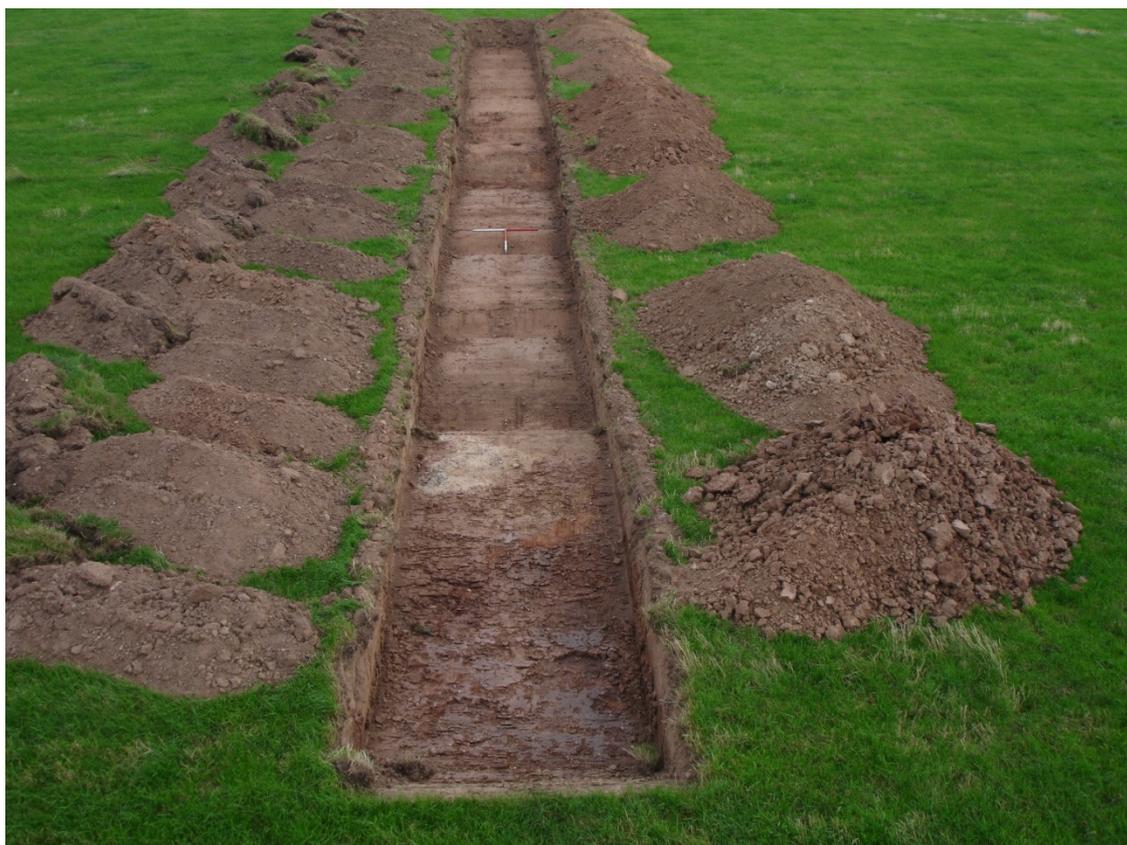
Plate 27. Trench 15 Overview. View: NW

Dimensions: 30 x 1.8 -1.9m. Orientation: NW – SE.

Underlying mid-brown sandy silt topsoil (1501), was a loosely compacted mid-orangey brown silty sand with occasional angular stones (1502). At the southeastern end of the trench a natural patch of sand and gravel with occasional clay lenses (1503) was visible (see bottom end of trench in Plate 27).

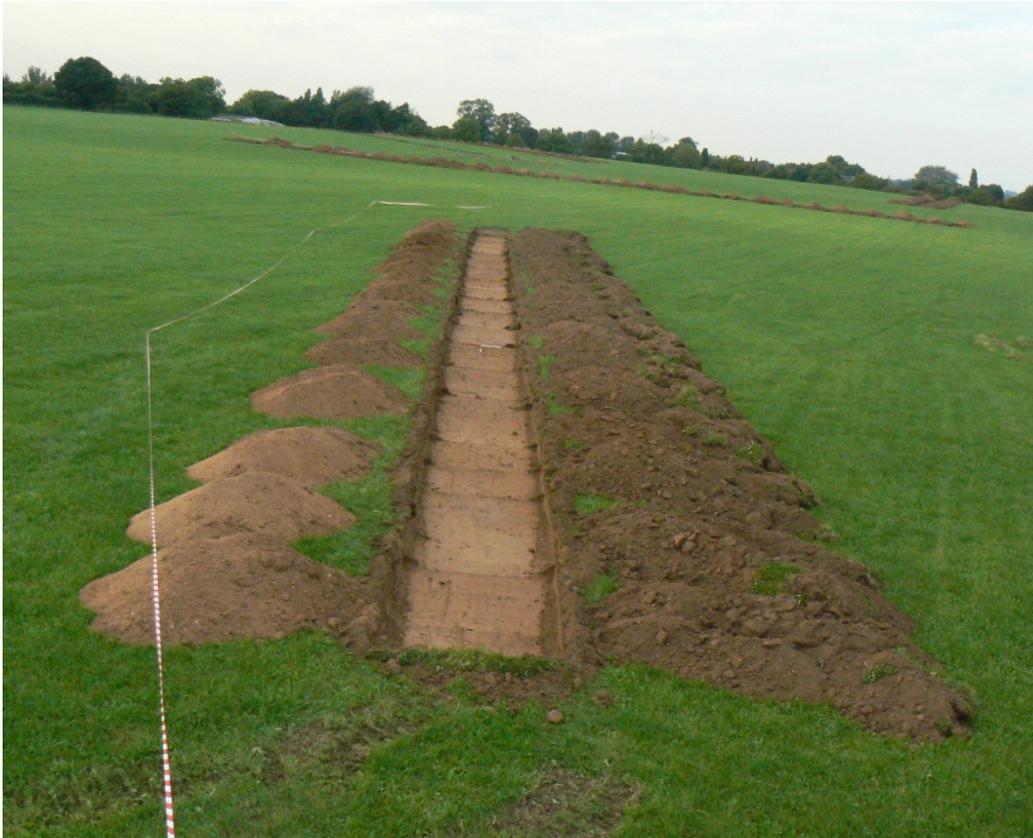
Plate 28. Trench 16 Overview. View: NW

Dimensions: 60 x 1.8-1.9m. Orientation: NW – SE.

Underlying mid-brown sandy silt topsoil (1601), was a loosely compacted mid-orangey brown silty sand with occasional angular stones (1602). This overlaid natural sands and gravels (1603) at a depth of c. 0.50m – 0.60m. No archaeological features were located in this trench.
