**Gungate Shopping Centre Redevelopment
Tamworth, Staffordshire**

**Archaeological Evaluation Report
Henry Boot Developments Ltd**

**June 2009
SLR Ref: 406.0433.00002**

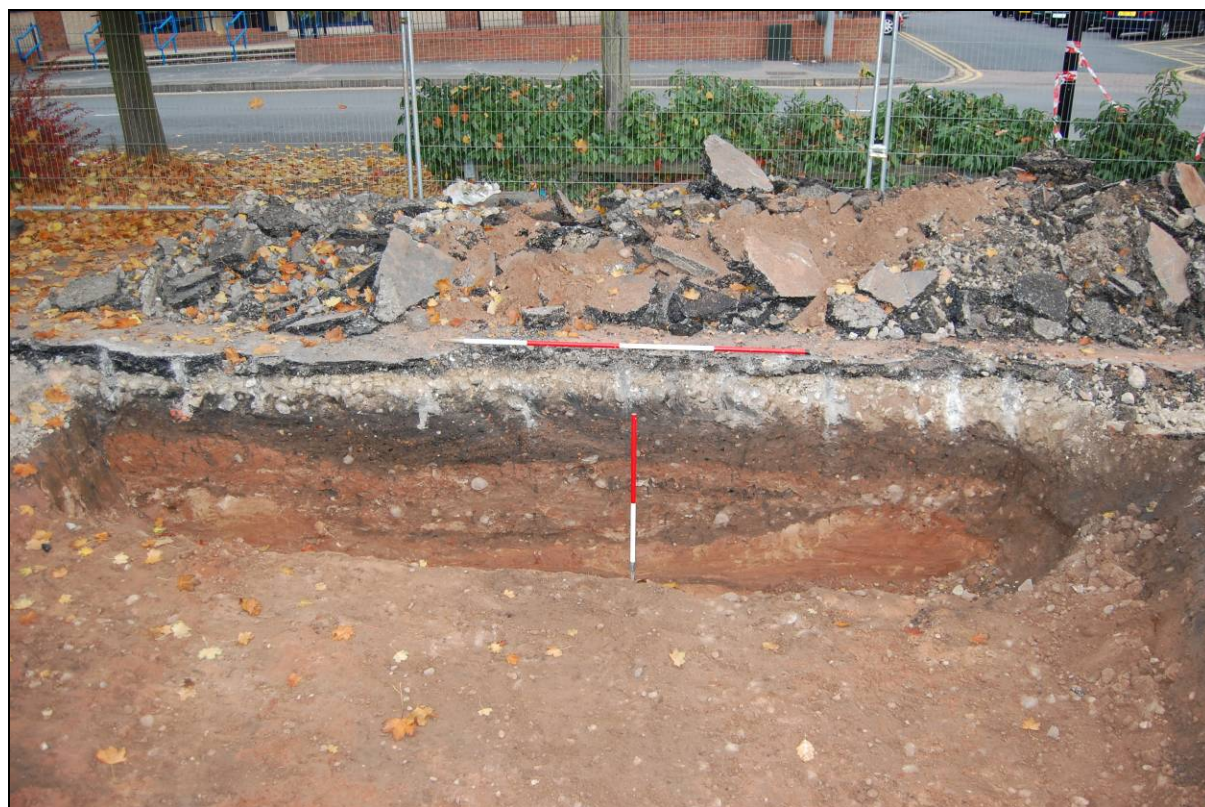
Figure 3: Trench 1 facing north

The trench was initially excavated to a depth of 0.85m below the current ground surface at which a layer of mixed clay and sand was observed. This was assumed to be the natural drift geology, but after subsequent cleaning the layer was shown to be the fill of a large post medieval feature which had been cut by two smaller post medieval pits.

The trench was machined a second time and a narrow sondage excavated along its northern edge in order to confirm the depth of the natural geology- c. 66.18m AOD. The natural comprised compact clean sand and red boulder clay. No earlier features were evident in this trench.

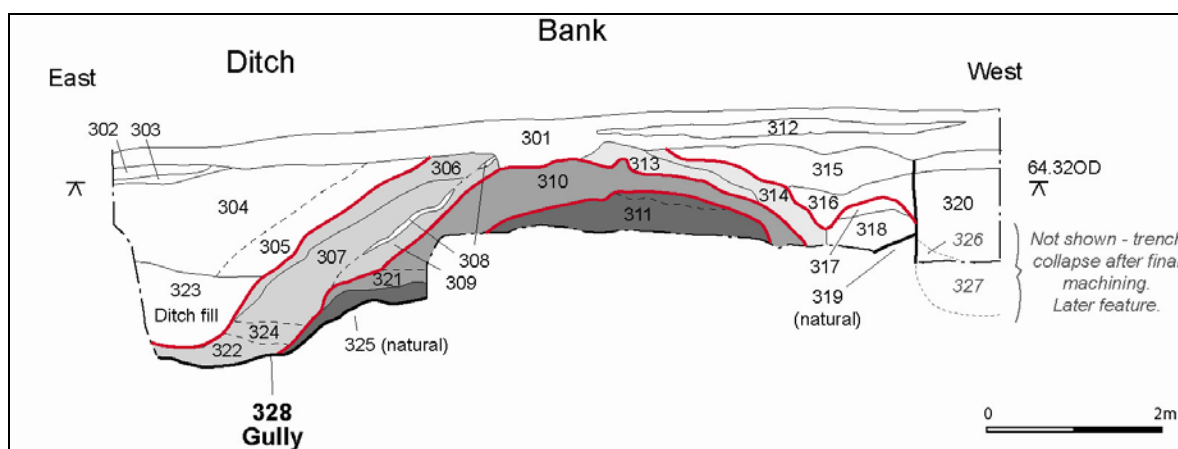
Figure 6: North-facing section, Trench 3

In the centre of the trench the earliest feature observed was a raised bank, 2.5m from the eastern end. The 'core' of the bank comprised a linear mound of redeposited sand and gravel 5.2m wide and 1.3 m deep (322)=(311), aligned roughly north-south. The upper surface of this deposit stood at 64.27m AOD. The core was sealed by a deposit of mid-grey silty clay (310)=(321) up to 0.5m deep along the top of the bank, and increasing the total width of the bank to 5.5m.

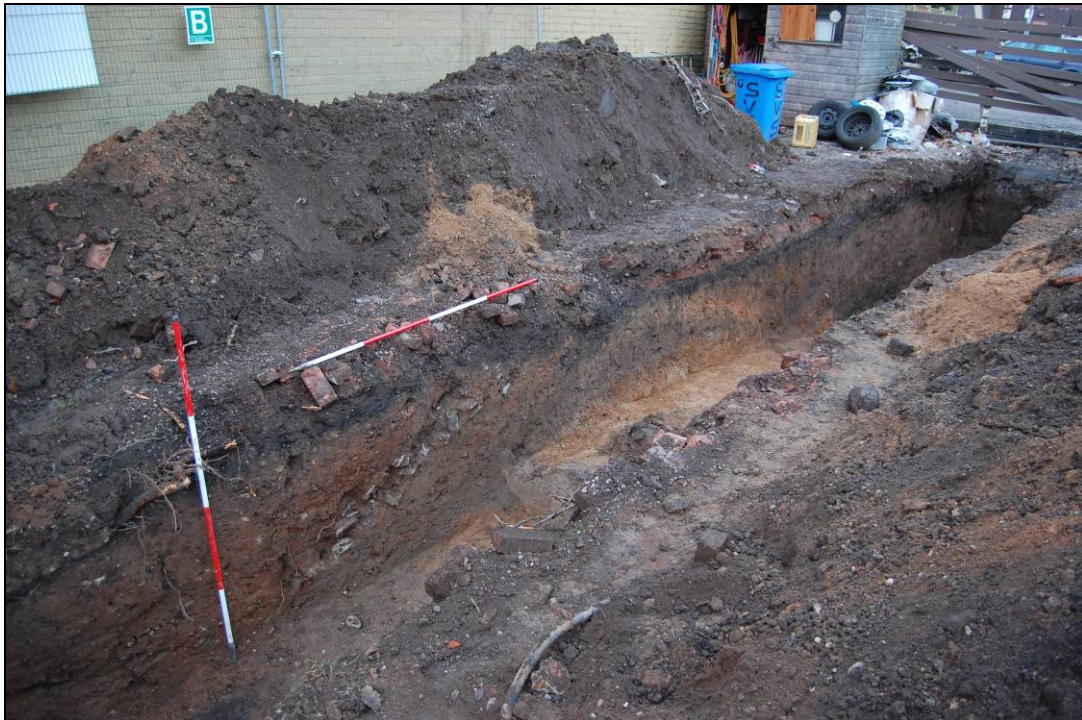
Figure 7: Trench 3 facing southwest

Layer (316) was sealed by layer (315), a yellow-brown sandy clay up to 0.6m deep, which had been truncated to the west by the cut of a large rectilinear feature dominating the western end of the trench.

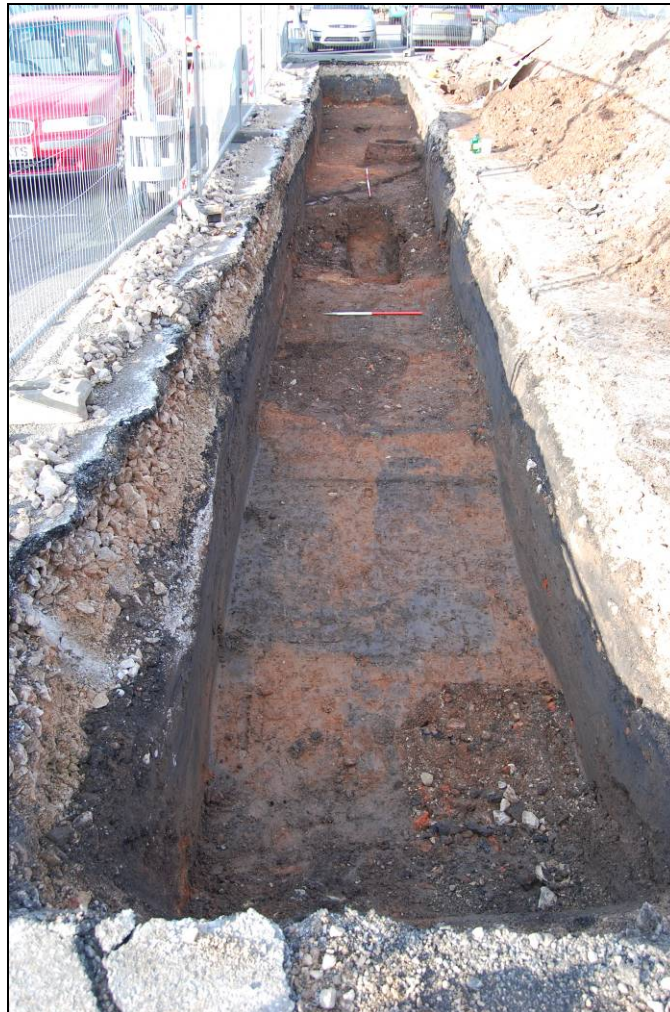
Figure 9: Pre-excitation shot of Trench 4 facing north

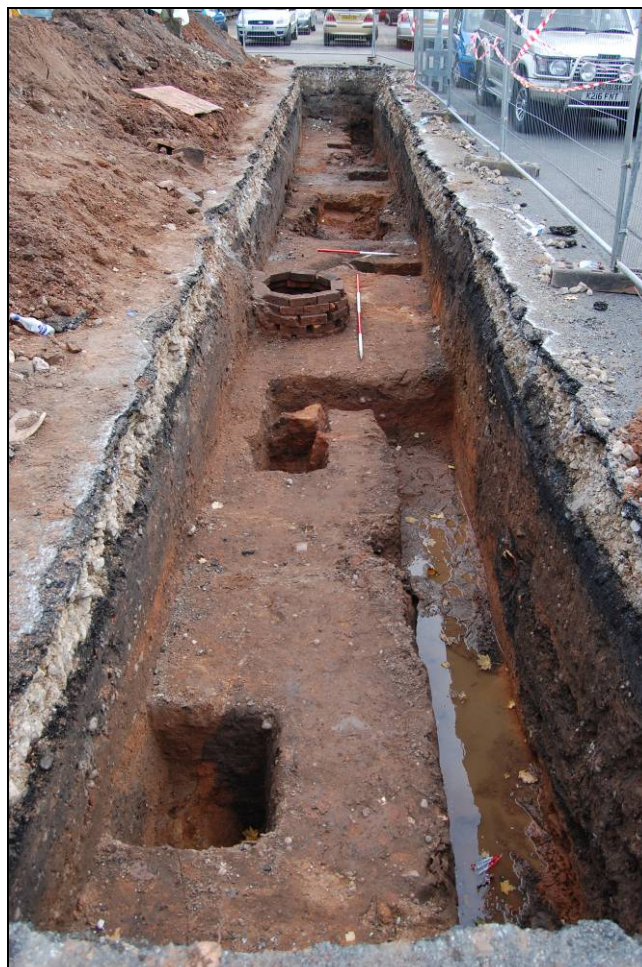
Figure 11: Post-excavation of Trench 4 facing south

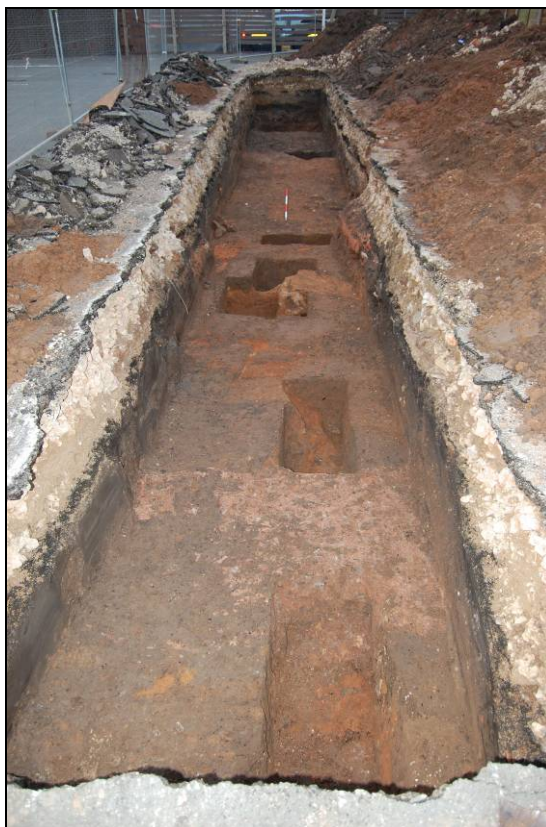
Figure 12: Post-excavation shot of Trench 5 facing east

The pits within this trench were sealed by a cultivation soil up to 0.51m thick, which had been cut by a wall foundation (524). This extended into the middle of the trench from the southern baulk on an east/northeast-west/southwest alignment for 1.8m. Three courses of brickwork survived, set on a base of rubble and mortar.

The cultivation soil and wall foundation were sealed by a buried tarmac surface 0.12m thick, above which 0.52m of hardcore had been laid. This was sealed by the modern tarmac car park surface which was 80mm thick. The existing ground surface stood at between 66.43 and 66.21m AOD, a gradual slope down from west to east.

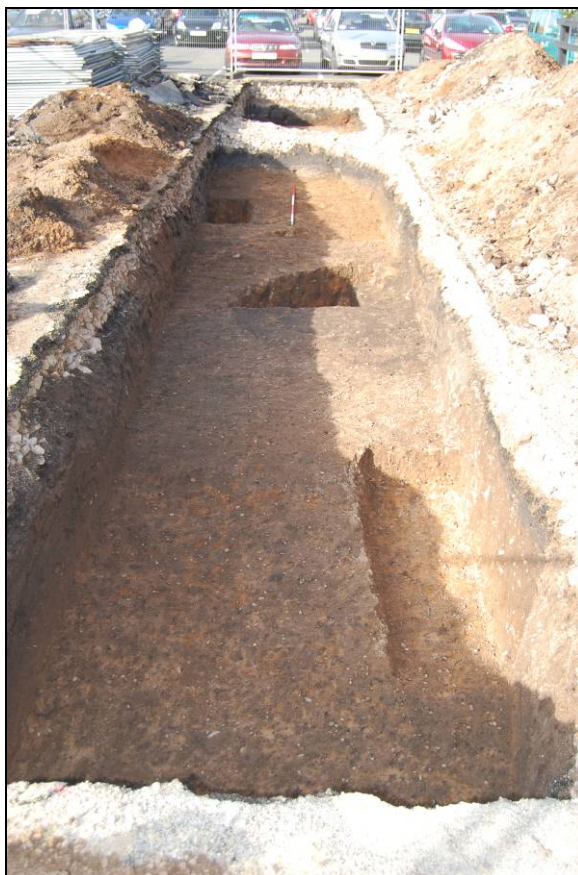
Figure 13: Post-excitation shot of Trench 6 facing north

Two further pits were identified at the northern end of Trench 6. Pits [600] and [602] were both oval in plan; [600] was 0.75m long and [602] was 0.6m long, though both had been truncated to the north by the cut for a modern drain. The fill of [600] was a dark brown silty sand (601), containing brick, sandstone fragments and sub-rounded pebbles, as well as small sherds of 17th and 18th century pottery. Pit [602] was filled with a similar deposit of dark brown silty sand (603) which was found to contain fragments of brick and tile.

A central baulk in Trench 6 was not excavated due to the presence of a live electricity cable.

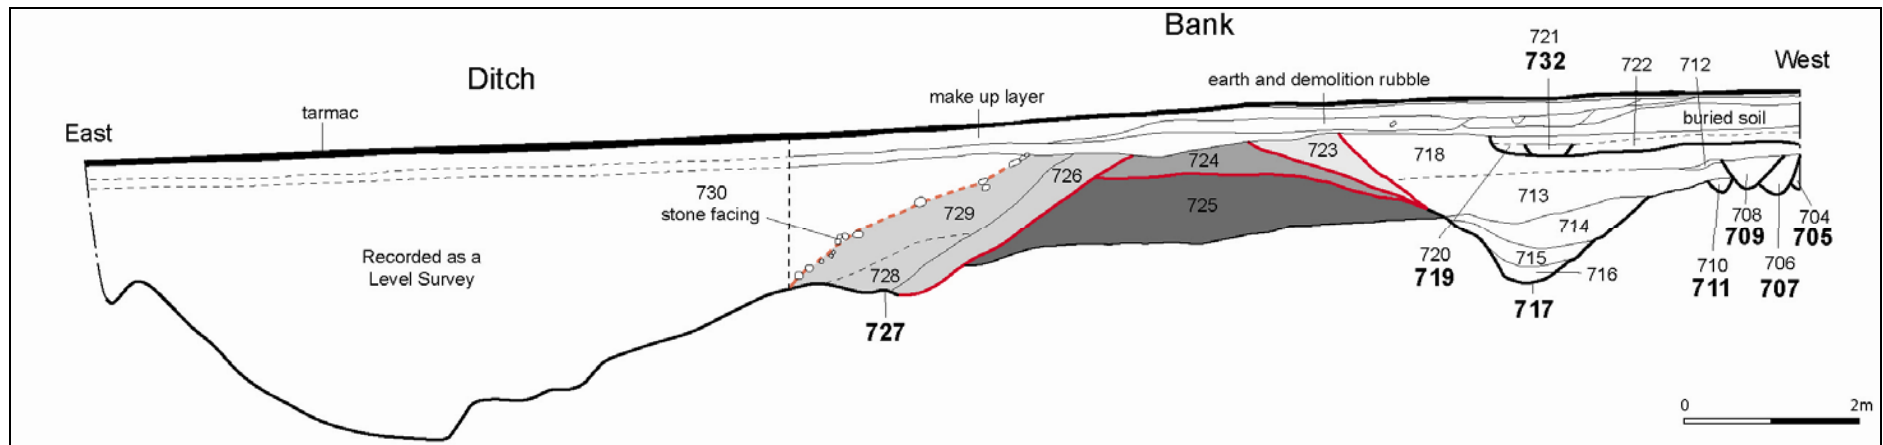
Figure 14: North-facing section, Trench 7

The earliest identified features comprised a ditch and a small gully at the western end of the trench, bounded to the east by a bank. Ditch [717] (Figure 15) was situated 1.7m from the western end of the trench and had been cut through the natural sand and gravel. It was 2.6m wide and 0.95m deep with a 'V' shaped profile. Although only a short section of the ditch was observed in the base of the trench, it appeared to follow a north-south alignment approximately 10m to the west of Marmion Street.

The upcast from the excavation of the ditch had been piled to the east to form a bank of redeposited sand 5.5m wide and 0.75m high (725) (Figure 16). The sand was noted to contain lenses of heavy iron-panning throughout, and two vertical columns of leached sand, possibly marking the position of removed posts. The sand 'core' of the bank was sealed by a deposit of grey silty sand (724), which was up to 0.3m thick on the upper surface, tapering away on the western side of the bank to coincide with the eastern edge of ditch [717]. Context (724) was in turn sealed by a deposit of red/brown sand and gravel forming the uppermost surface of the bank on its western side (723). This deposit also coincided with the eastern edge of ditch [717], becoming deeper towards the centre of the bank. The upper part of the bank had been truncated however, and its maximum recorded depth was 1.09m.

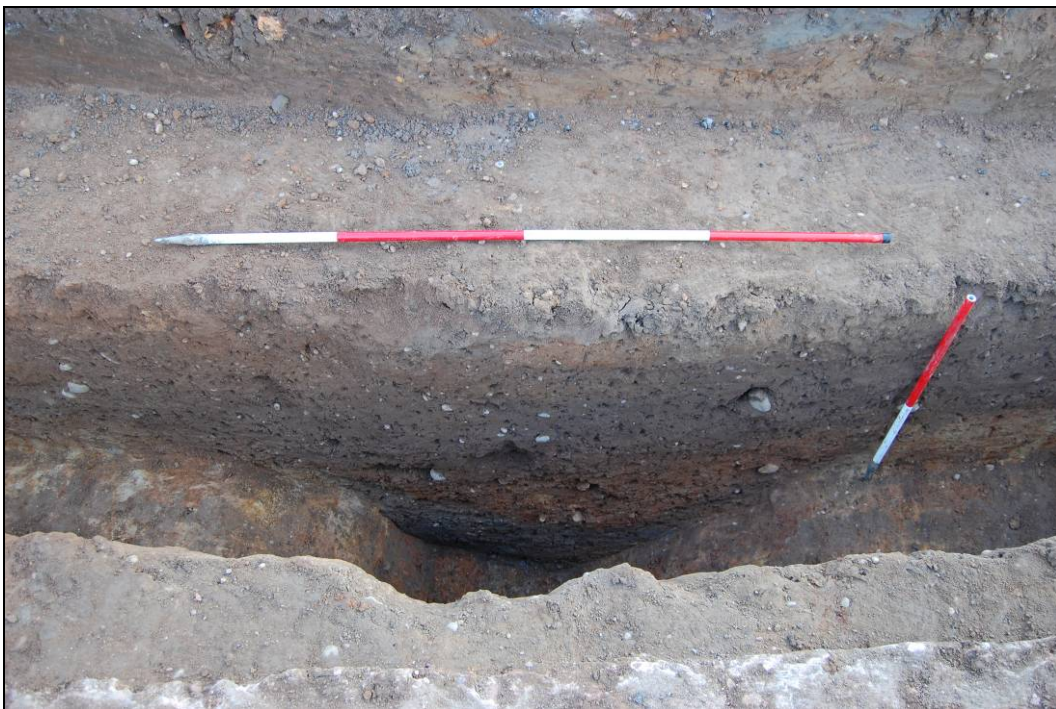
Figure 15: Trench 7- ditch [717] facing south

Ditch [717] appeared to have fallen into disuse and to have been backfilled, either deliberately or through gradual accumulation. The basal fill (716) comprised clean dark grey silty clay 0.2m deep. This contained occasional fragments of animal bone in very poor condition, but no datable artefacts. A sample was taken for flotation and palaeoenvironmental assessment, but mineral content only was recovered (see 8.4.2 below). A paler grey silty sand with frequent small stones (715) sealed the lower fill and was 0.25m deep in the centre of the ditch. A subsequent deposit of red sand and gravel (714) sealed the earlier fills; this was 0.5m deep on the ditch's western side, becoming shallower to the east. This material may have been deposited in the ditch in a single episode, possibly derived from the levelling of the bank to the east.

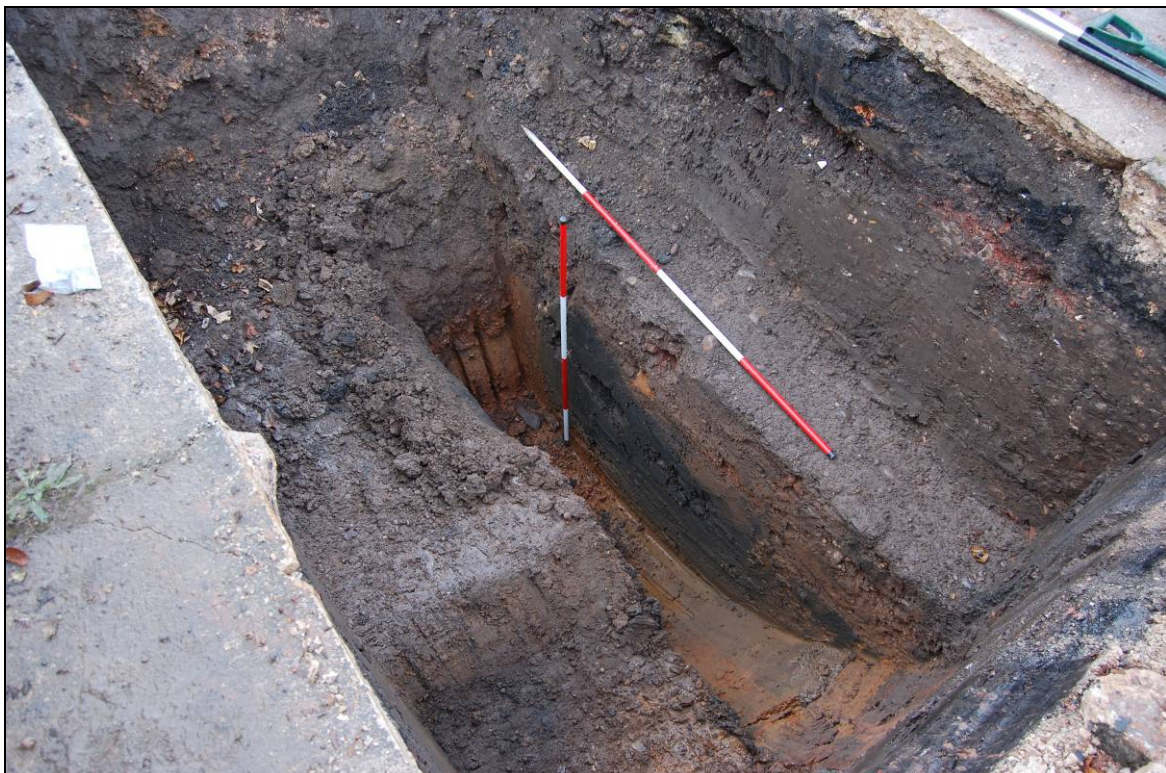
Figure 18: Trench 7- ditch [701] facing northwest

At the eastern end of Trench 7 a ditch was identified, the base of which was 3.15m below existing ground level. Due to the depth this could not be investigated by hand, but a machine sondage was excavated and level survey taken to obtain the basal profile (Figure 18). The cut [701] was c. 4.2m wide and oriented north-south. The eastern side of the ditch was steep sided (around 40° to vertical), leading to a slightly uneven base 0.8m wide. The western side was stepped, with a ledge 0.8m wide some 0.45m above the base of the ditch.

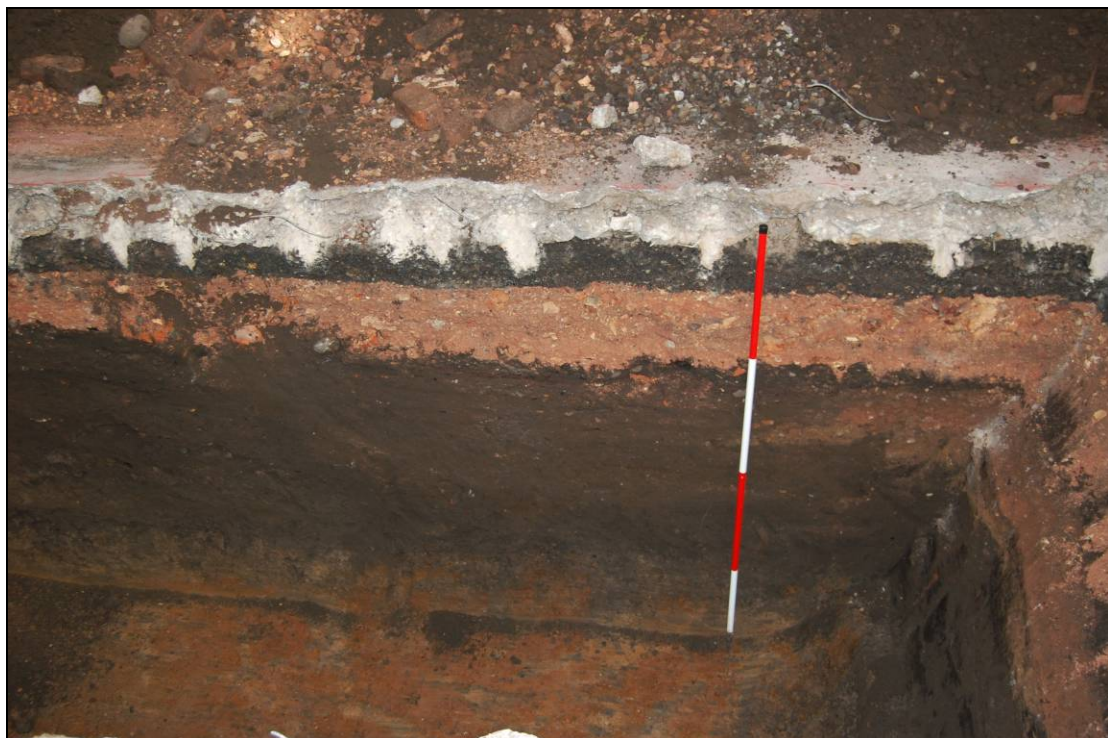
Figure 19: Trench 8A- west-facing section, southern end

The natural geology, comprising clean orange sand, was encountered at the northern end of the trench at a depth of 1.81m below the existing concrete slab (63.95m AOD), falling to 2.07m at the southern end (63.69m AOD). No cut features were observed.

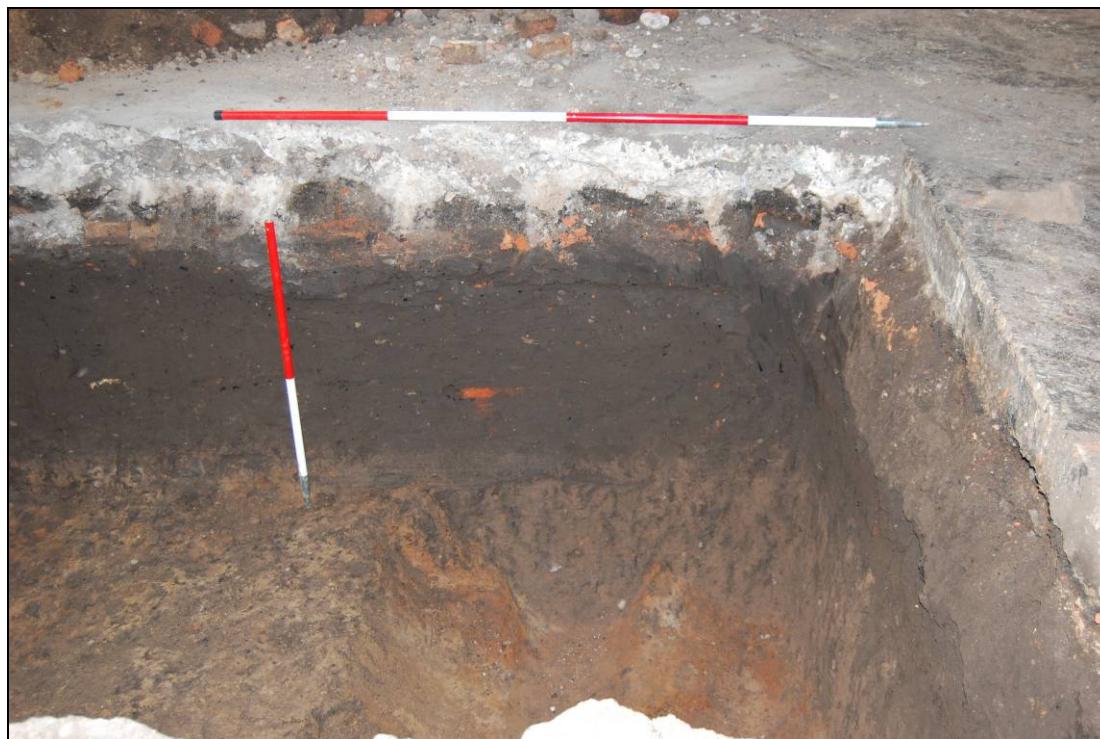
Figure 22: East-facing section through gullies [803] and [805], trench 8B

Two further gullies were located 1.8m to the north, aligned roughly east-west. The earliest, [803], was 0.9m wide (though it had been truncated on its northern side) and greater than 2m in length. The profile was steep sided with a rounded base 0.65m deep. The fill (802) comprised mid-grey/brown silty sand, and was found to contain fragments of animal bone.

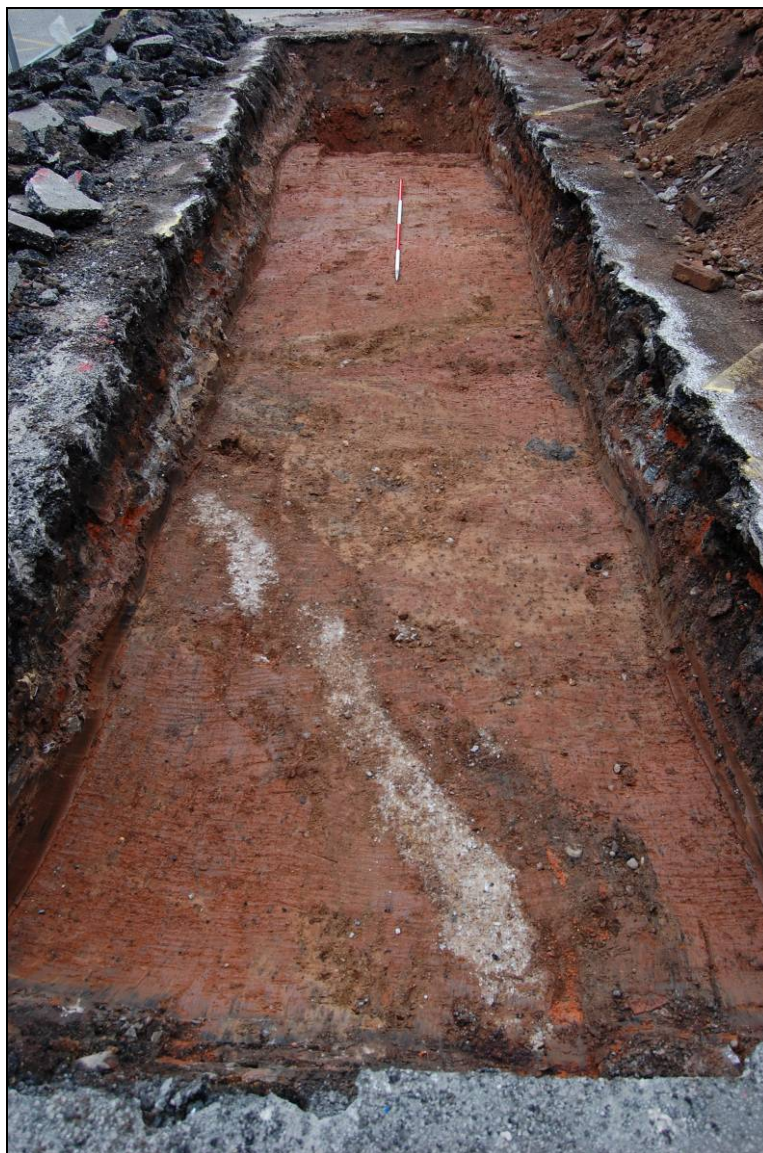
Figure 23: Trench 9/10 facing east

reduced in height when the precinct was built in order to accommodate the loading/service entry to the rear of the precinct shops. No cut features were noted, and all pre-20th century deposits had been truncated.

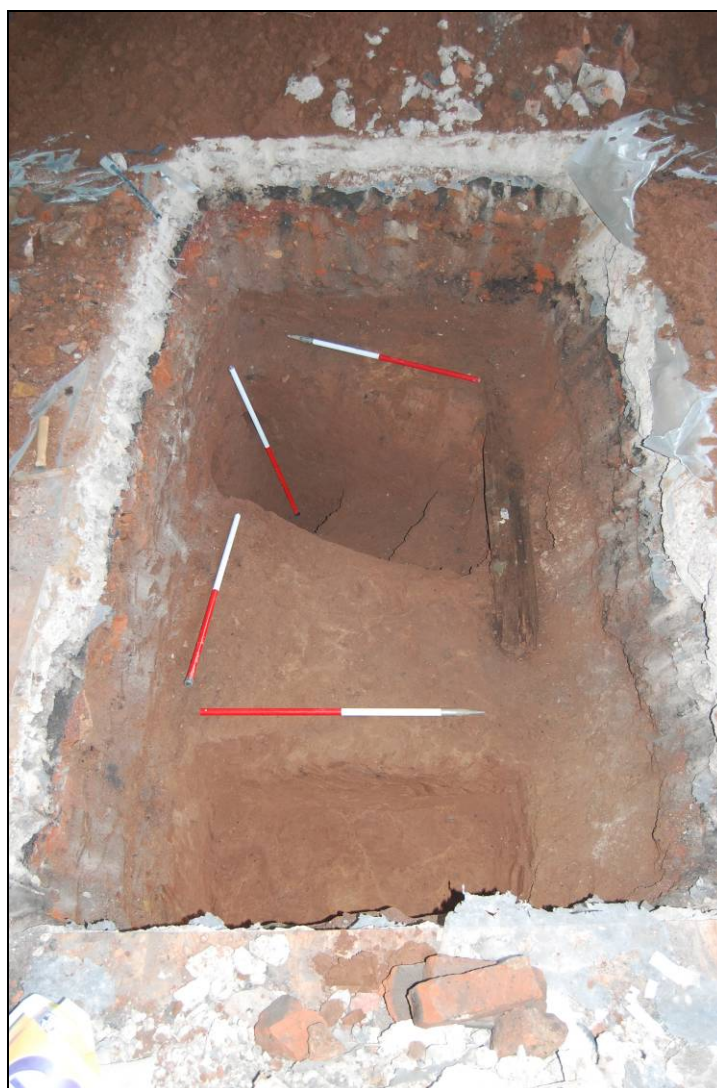
Figure 24: Trench 19 facing south

The contemporary ground surface stood at a height of 67.87m AOD.

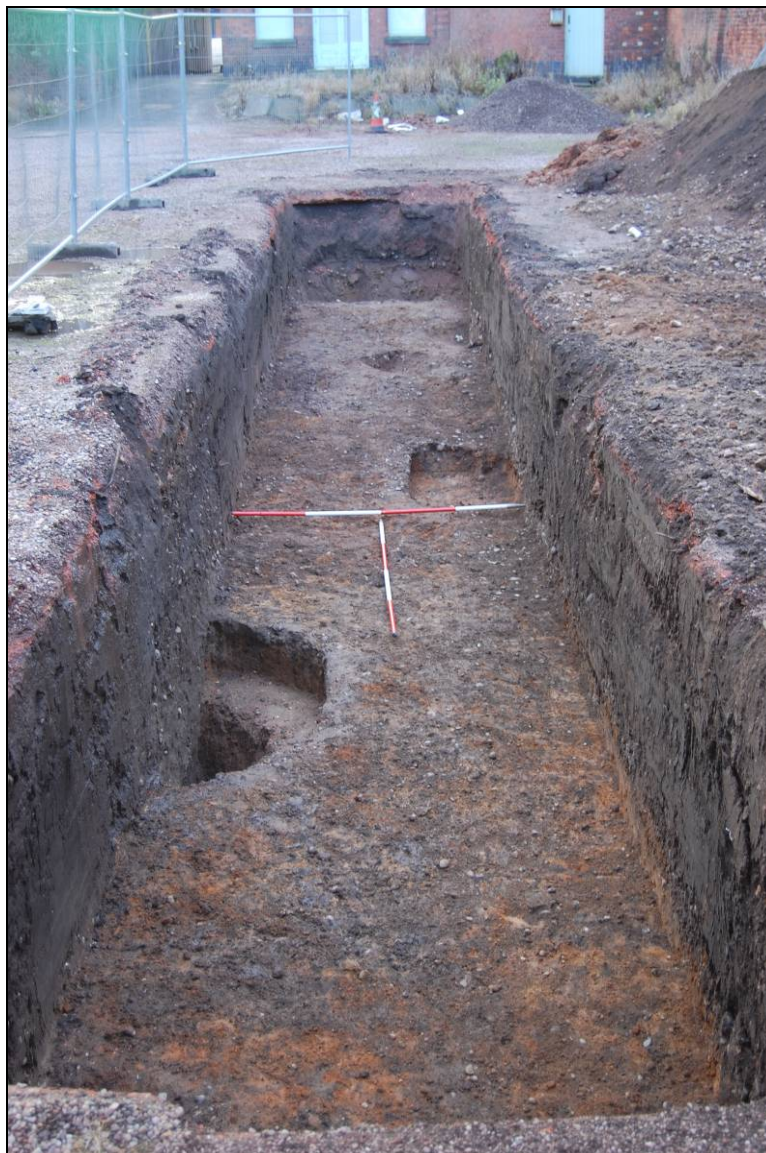
Figure 26: Post-excavation shot of Trench 20 facing west

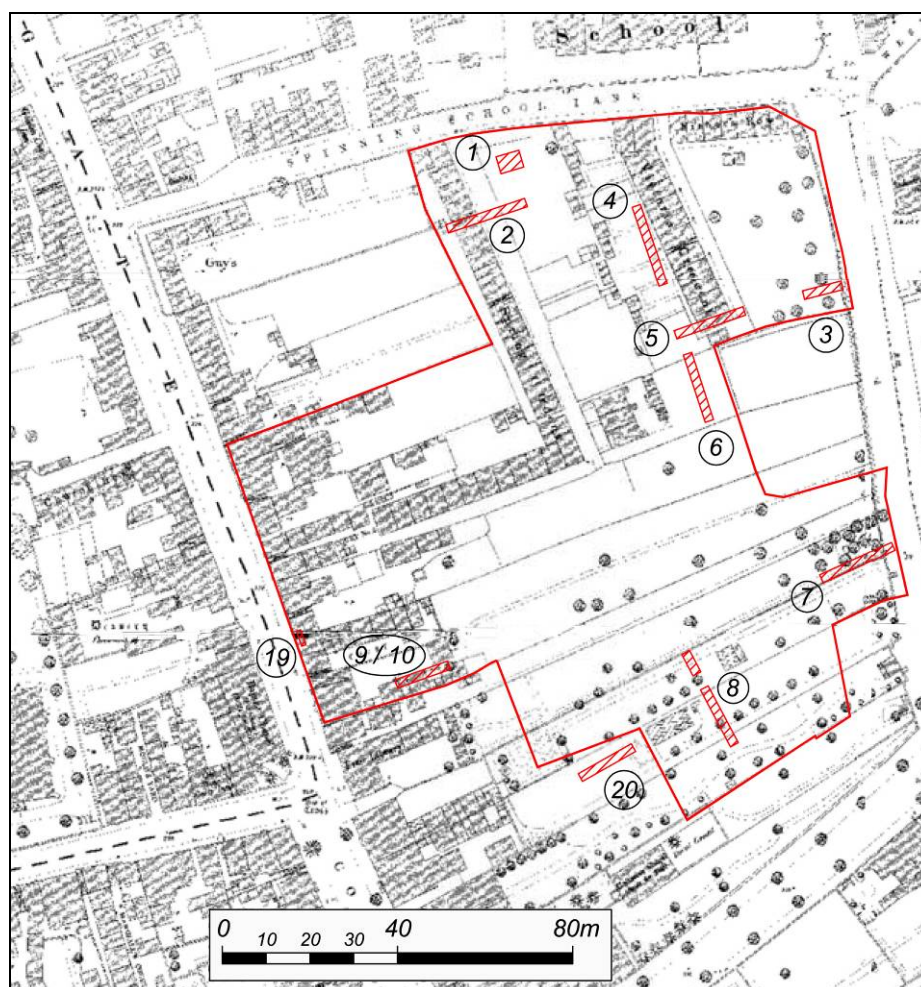
Figure 28 shows the location of the evaluation trenches overlaid onto the Ordnance Survey

1:500 town plan produced in 1884; the remnant burgage plot boundaries can be seen crossing the area, with two small structures occupying two of the plots within what is now the Co-Op depot. Many of the buildings shown on this map fronting onto Gungate may have had medieval origins, however the trenches that have been excavated in this location (9/10 and 19) suggest that the ground was comprehensively cleared prior to construction of the shopping precinct in the 1960s. Indeed, Figure 28 clearly shows that Trench 9/10 was situated directly above a range of buildings, of which no trace was seen.

Figure 28: 1884 Ordnance Survey Town Plan (1:500)

It is likely that the buried tarmac surface, drains and brick-lined well belong to the construction and use of the area for housing; the historic mapping suggests that Trench 2 was situated in the rear yards of Victoria Crescent (see Figure 28). The well may have been for communal use.

Despite this, it is worthy of note how little evidence survives of the Victorian housing in the car park. Figure 28 indicates that the western end of Trench 2 was situated directly across a row of terraced housing, yet no structural remains were seen in the trench. This would suggest either that the foundations were very shallow, or that the demolition was comprehensive.

No evidence for deep archaeological remains was discovered in any of the trenches within the precinct, though this cannot exclude the possibility of isolated features surviving elsewhere, as illustrated by the survival of a medieval ditch along the northern edge of the precinct (Zone 3). Figure 28 shows that numerous outbuildings extended eastward into this part of the site in the 19th century; deep-cut remains associated with these may still survive.

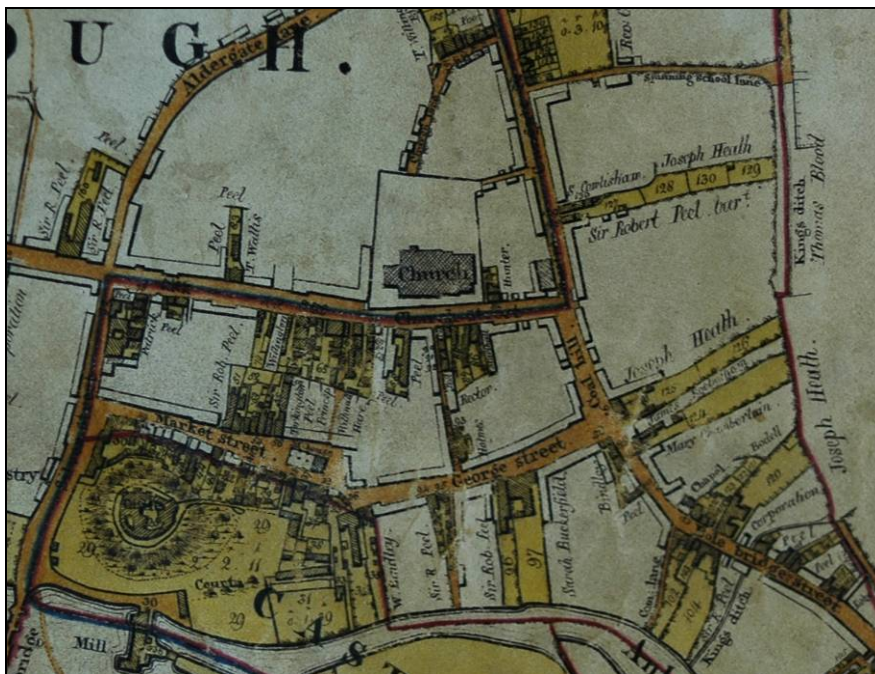
Figure 29: 1810 Marquis of Townshend Estate Map (extract)
