Land Adjacent to Park Road, Woofferton, Shropshire

Archaeological Evaluation

SLR Ref : 406-04842-00001

Ludlow Bio Energy

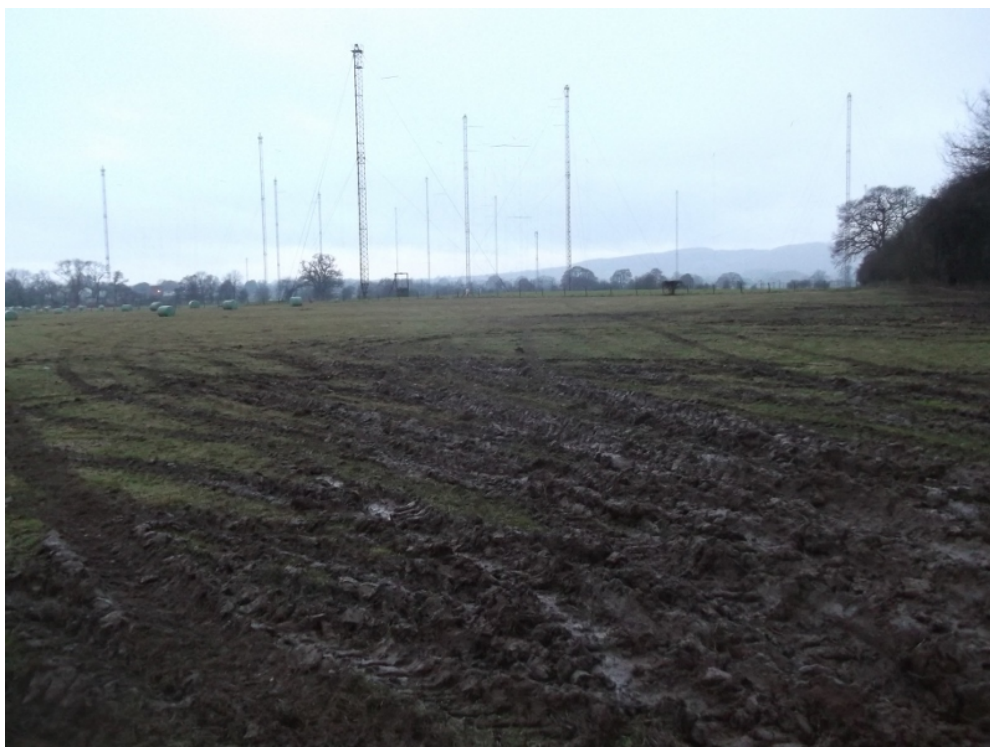
**Figure 3**  
**West facing shot of site**

In February 2014 five trenches were laid out across the site to investigate the existence of any buried archaeological remains (Figure 2). A 7.5 ton JCB mechanical excavator with backhoe with a 1.6m toothless ditching bucket was used. The underlying ground conditions were mostly dry around the evaluation trenches, however the topsoil was very wet, which made access to the site quite hazardous (figure 3).

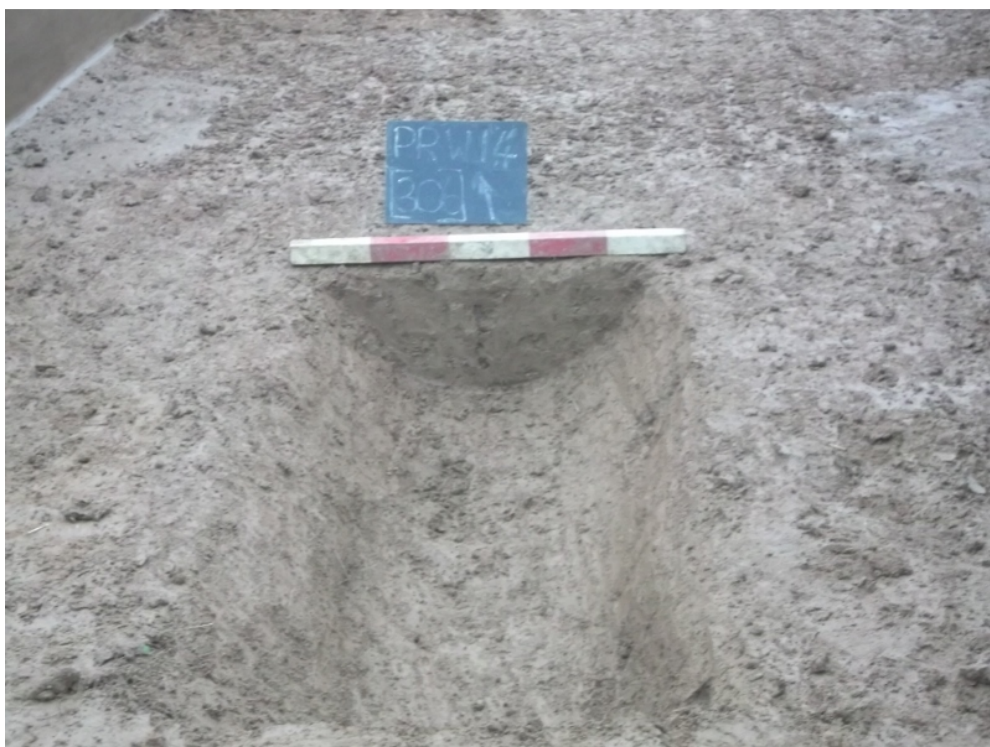
Trench 3 had a shallow gully [306] which was 0.15m deep, and 0.40m wide. It ran along across the length of the trench on a NNW-SSE alignment. This was filled by (305), a firm mid grey clay silt with very occasional charcoal flecks, and occasional rounded pebbles (Figure 4). No finds were recovered from this context.

**Figure 4**  
**NNW facing shot of [306]**

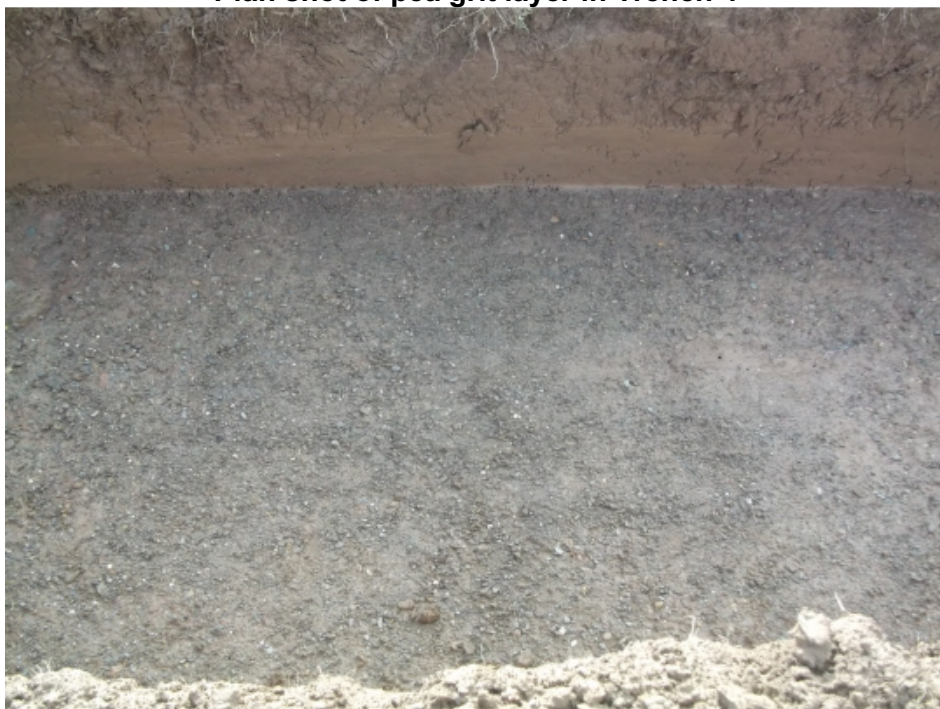
The trenches were 30m x 1.6m in area, and had a depth of 0.4m – 0.5m. In all the trenches, a firm mid brown silty clay topsoil, with very occasional brick and tile fragments, was found sealing a firm mid yellow brown silty clay subsoil, which in turn overlay the natural drift geology made up of a brown red gravel with interleaving clays and silts. Trenches 1, 2, 4 and 5 were all negative of archaeological features. Trench 4 contained a very thin (0.03m) layer of pea-grit

along the interface between the subsoil and the natural (Figure 5), which may have resulted from erosion or other natural water action.

**Figure 5**  
**Plan shot of pea grit layer in Trench 4**
