Land at 104 Llwyn Road, Oswestry, Shropshire

Archaeological Evaluation

SLR Ref : 406-04931-00001

May 2014

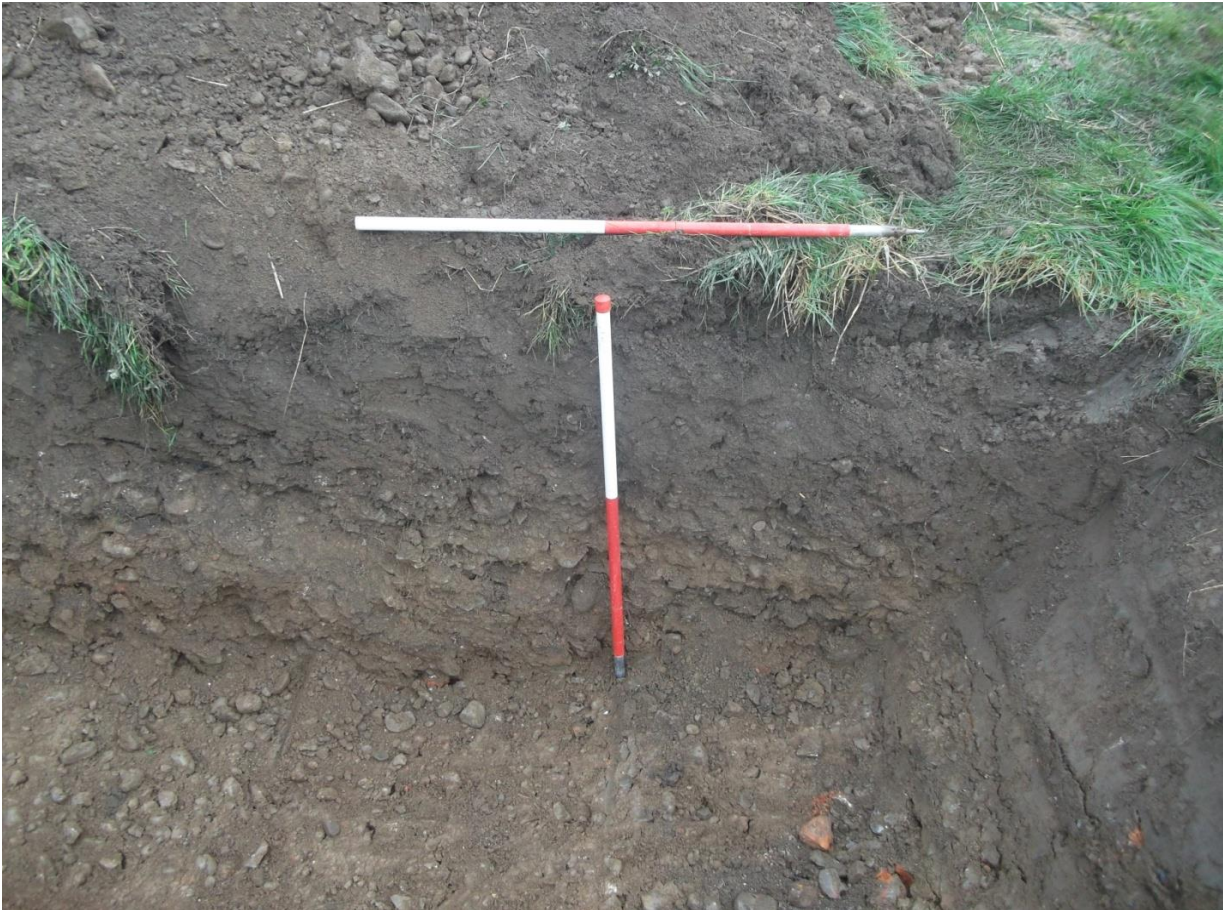
**Figure 3**  
**Section of Trench 1, original location, showing depth of made ground.**

Trench 1 was located between the house and a retaining wall marking the edge of the property with Llwyn Road. It was originally machine excavated on a NE – SW alignment about 4m west of the house, though this proved to have a negative result, as the trench was dug into made ground which was in excess of 1.2m deep, and with no natural clays and gravels reached (Figure 3).

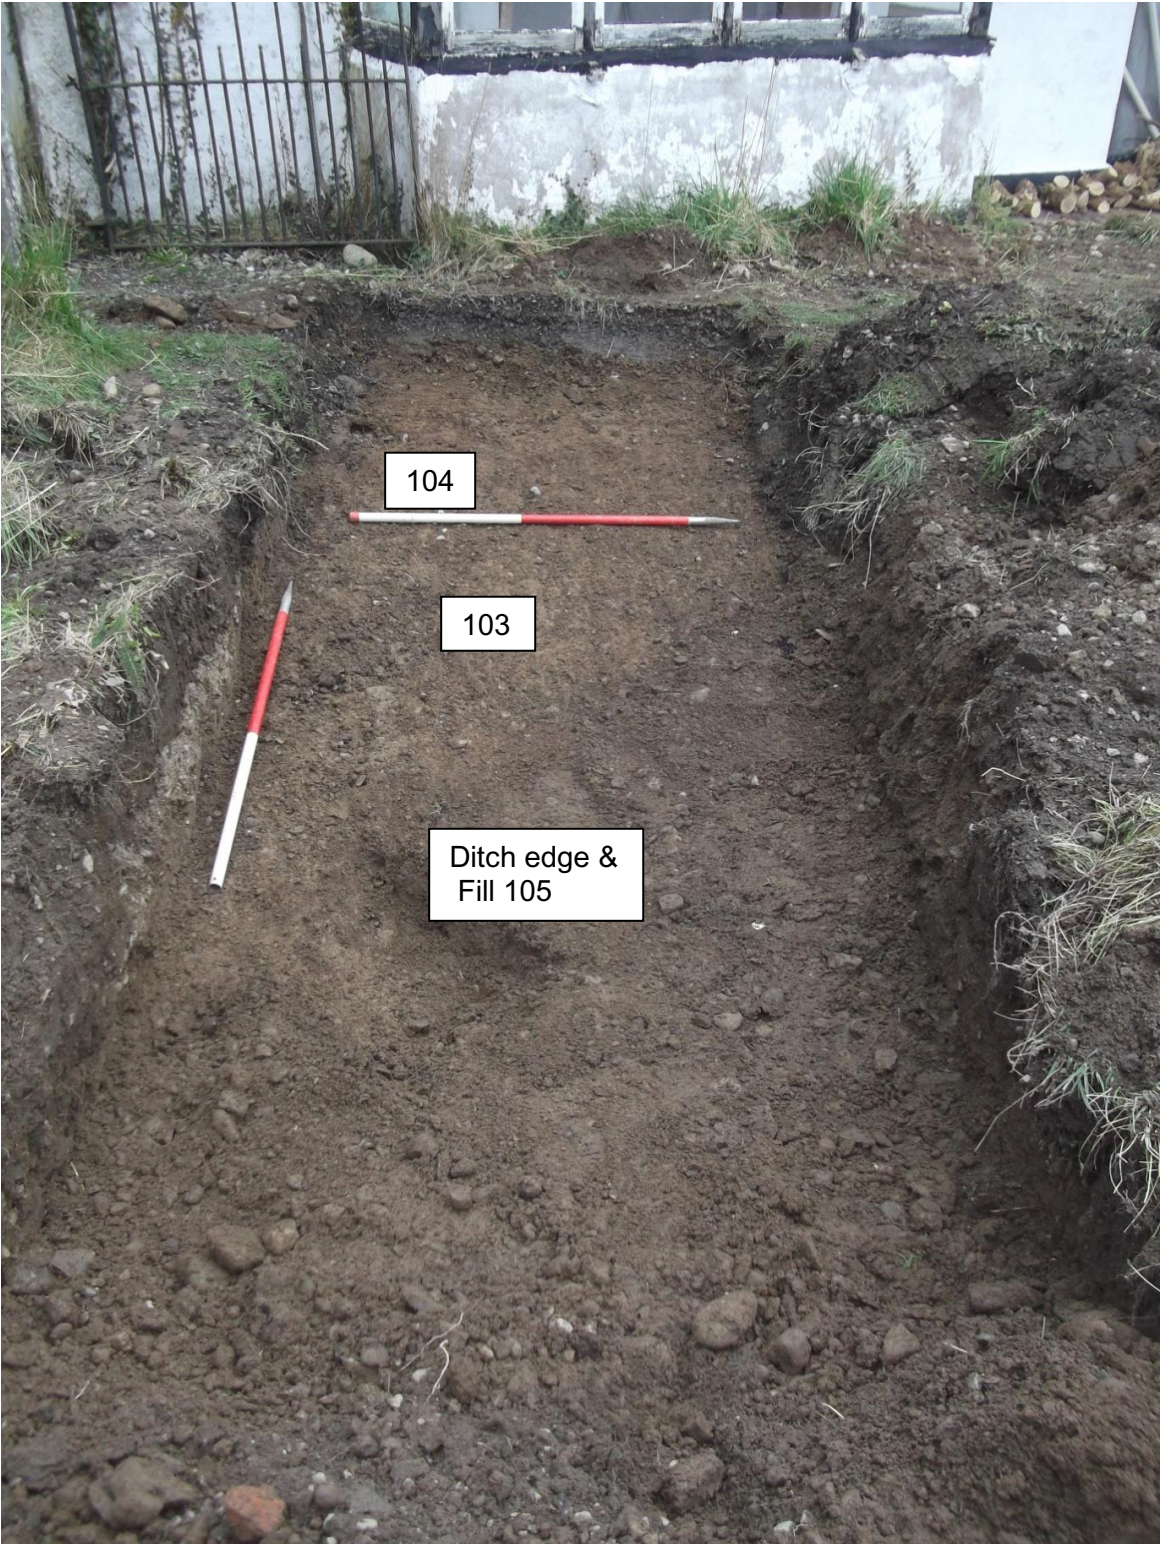
**Figure 4**  
**Trench 1, east facing, with [105] and sondage in the foreground.**

At the western end of Trench 1, (105) there was a layer overlying the natural, consisting of a mid brown sandy clay with frequent 19<sup>th</sup> century detritus including slate, porcelain and brick and tile fragments. This is interpreted as the backfill of the retaining wall built along Llwyn Road (Figure 11) and also the infill for the ditch fronting Wat's Dyke. A small sondage was hand excavated into this layer, however, the full depth of this material could not be determined as it was presumed to extend beyond a safe working depth if it continued to the retaining wall. At the eastern end of Trench 1, there was another layer (104), consisting of a light orange brown silty sand. However no further investigation of this layer was able to take place. As such, it is impossible to determine whether this deposit was of archaeological or natural origin.

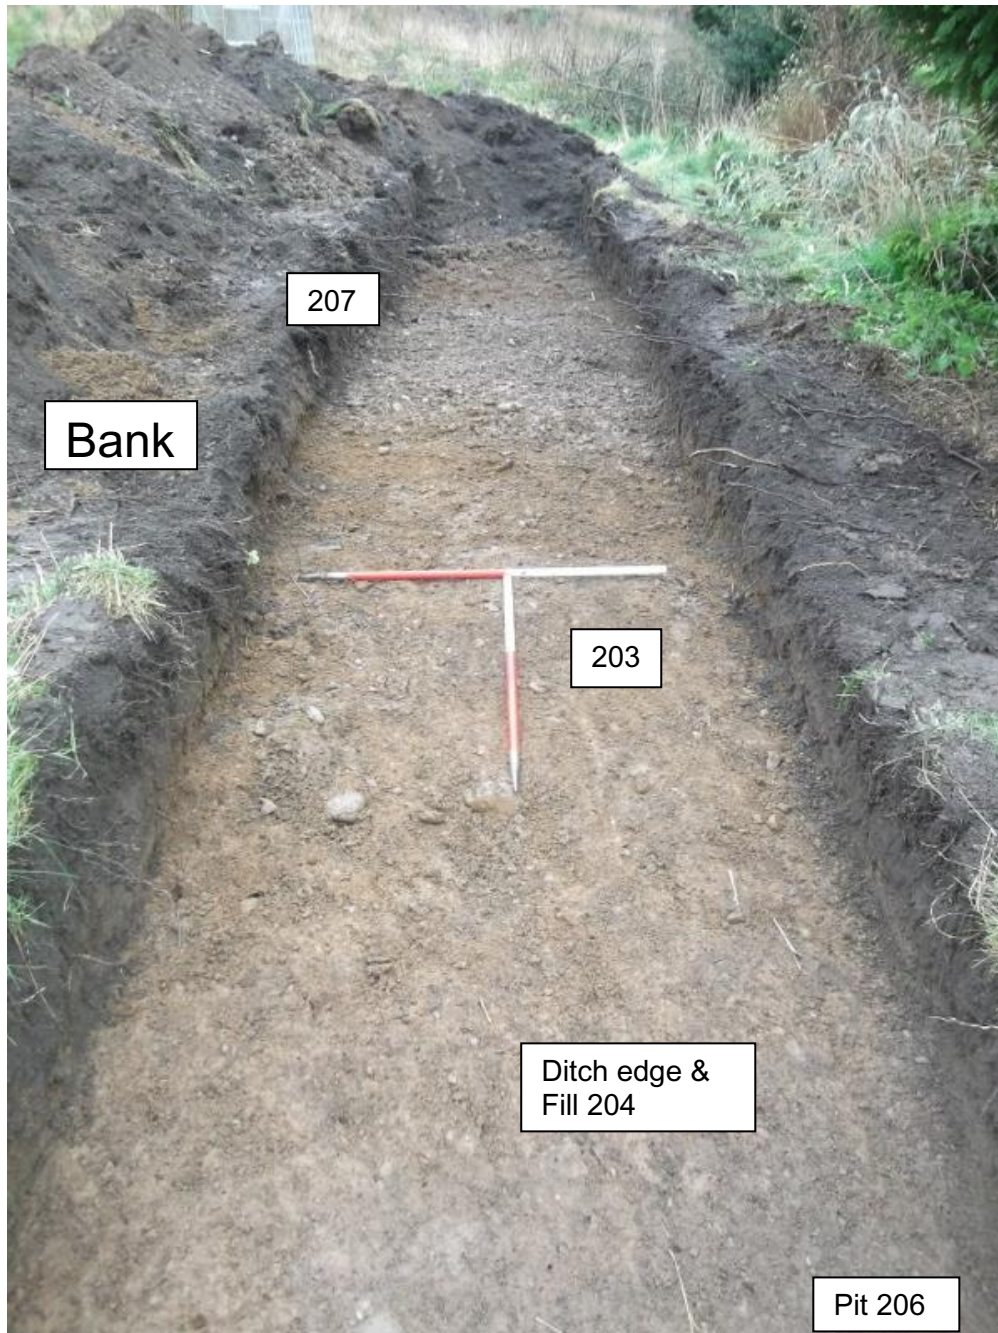
**Figure 5**  
**Trench 2, east facing**

This trench was located to the south of the existing house, on an approximately E – W alignment, and was 10.5m in length. As with Trench 1, a 0.20m thick mid brown layer of clay silt topsoil (201) overlay a 0.15 m thick mid grey brown clay silt subsoil (202), which overlay the mid orange brown glacial till consisting of natural undifferentiated clays and gravels (203).

The interpretation given to these deposits is that they represent the remnant of the bank, and edge of the ditch, for Wat's Dyke (Figures 5, 6 and 7). At the western end deposit (204) is the fill of the ditch, and further east the microtopography shows the extent of a bank approximately 6m wide, defined by a stony deposit along its eastern edge.

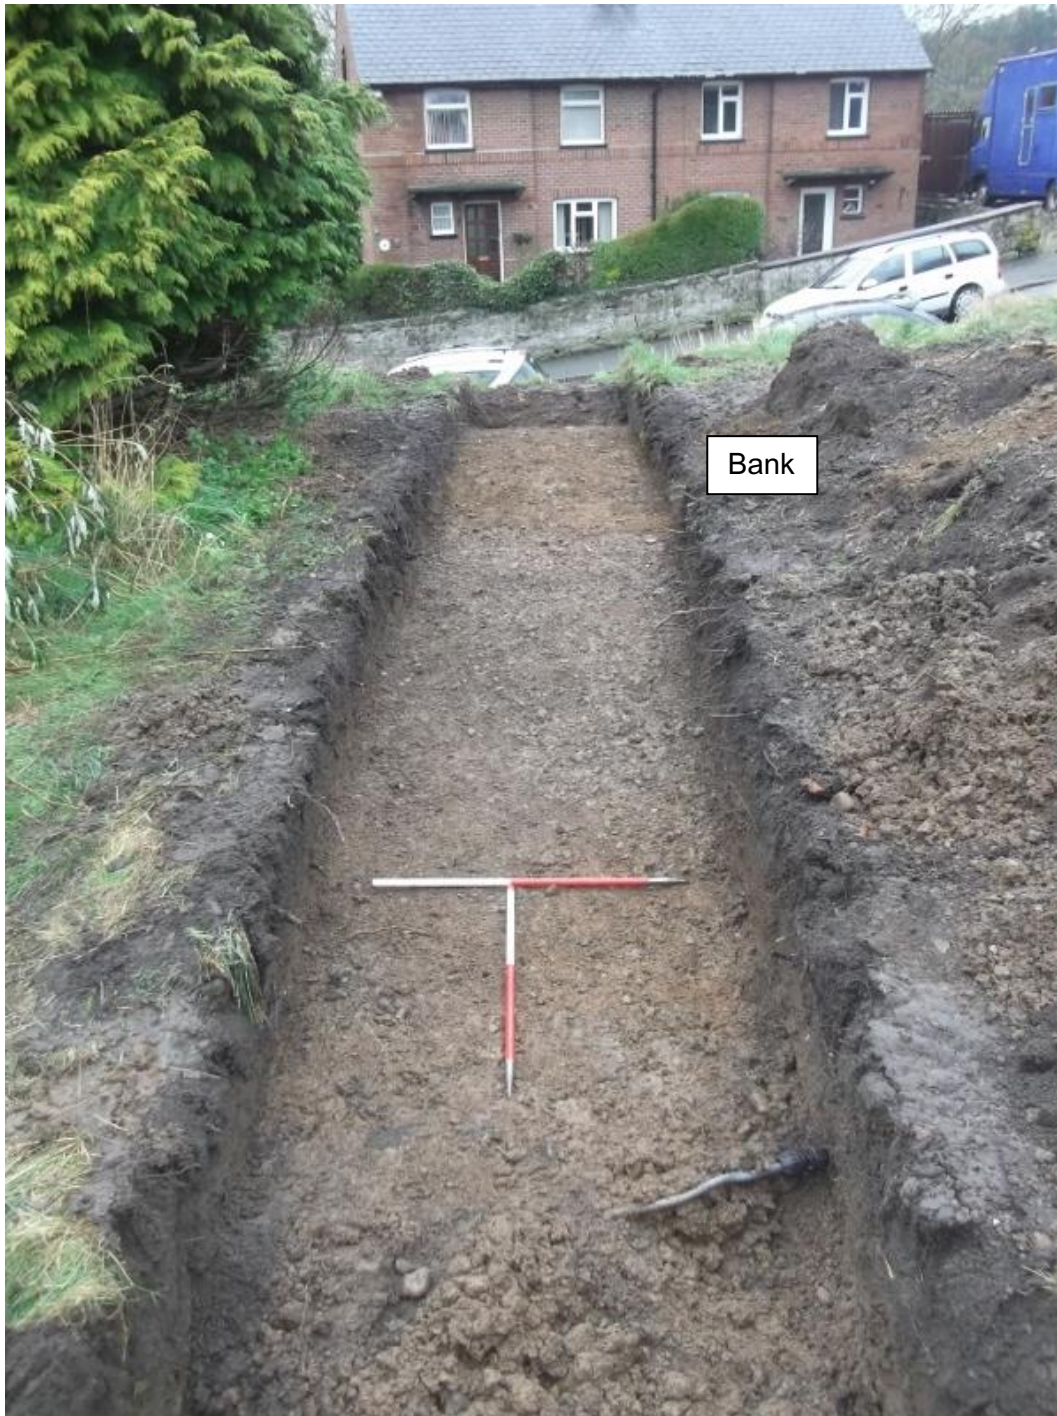
**Figure 6**  
**Trench 2, facing west, showing gravel layer (207) and domed shape to deposit sequence indicating location of bank for Wat's Dyke**

At the western end of the trench a mid grey brown sandy clay deposit (204), was found sealing the natural (203), which had been truncated by a 19<sup>th</sup> century pit [206] containing a dark grey brown firm sandy clay with slate and tile fragments (205). In the centre of the trench a layer of loosely compacted brown clay, gravel, and pebbles (207) was sealing the natural.

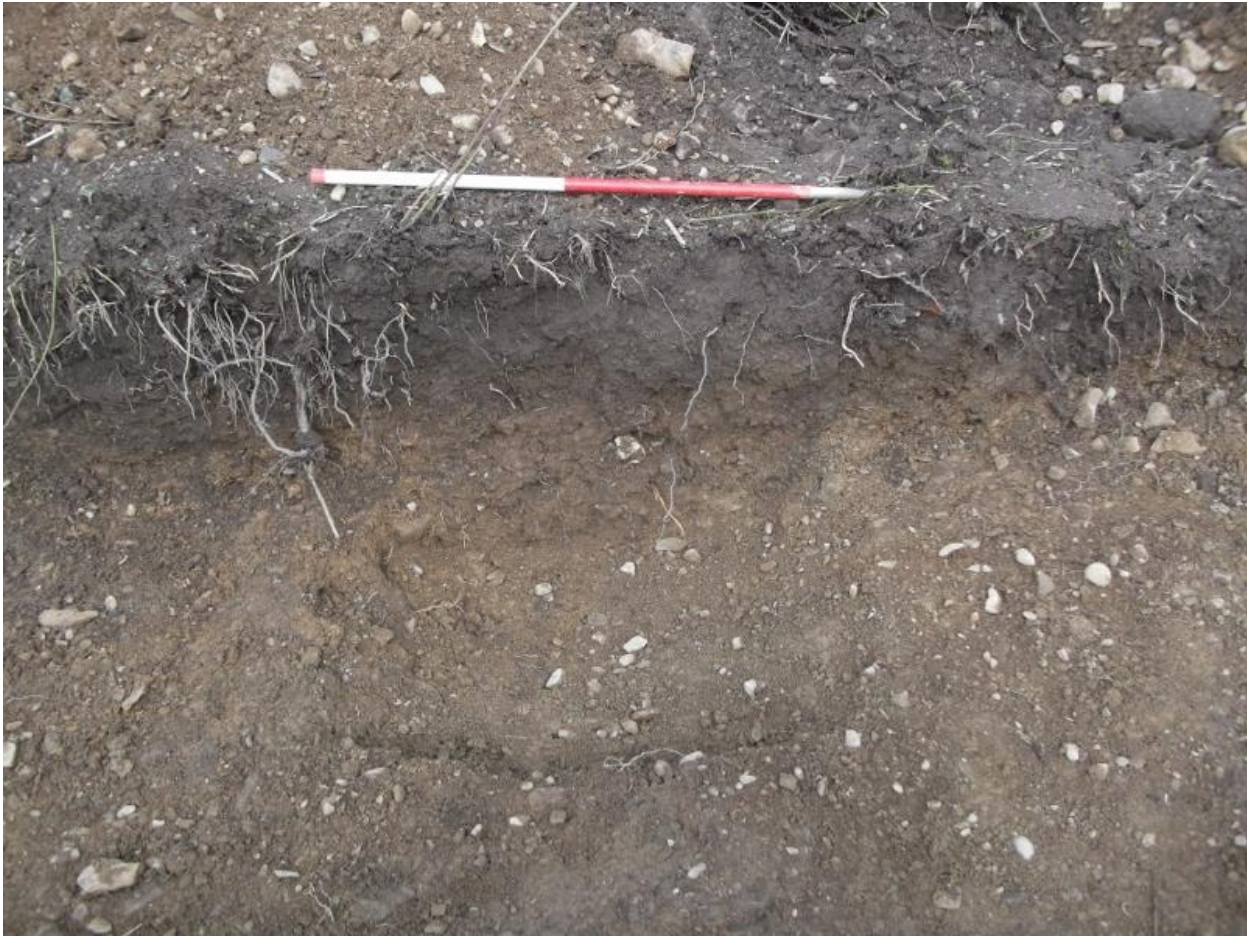
**Figure 8**  
**South facing section of Trench 3, with Ditch [307].**

At the western end of the trench an 8m+ long quarry pit [305] was exposed, which was machine excavated to a depth of 1.0m. This had been backfilled with 19<sup>th</sup> century CBM, ceramics, and assorted detritus (304). This was probably related to the quarrying activity mentioned above. Roughly in the centre of the trench was a 0.9m wide ditch [307], on a north – south alignment with a concave base, which was filled with a mid grey brown firm silty clay (306) with occasional sub-rounded pebbles (Figure 8). No artefactual dating material was recovered from this context.

Trenches 3, 4 and 5 show the past use of the allotment area, with the varying depth of the topsoil indicative of the agricultural use of the land. The two linear features in these trenches are interpreted as field boundaries, though no evidence of these has been found through a map regression. Both are perpendicular to Llwyn Hill, and are parallel to Llwyn Road, and show past land use in the Oswestry area. The backfilled quarry pits show a more recent past, with extensive gravel quarries having been in operation around Llwyn Hill.

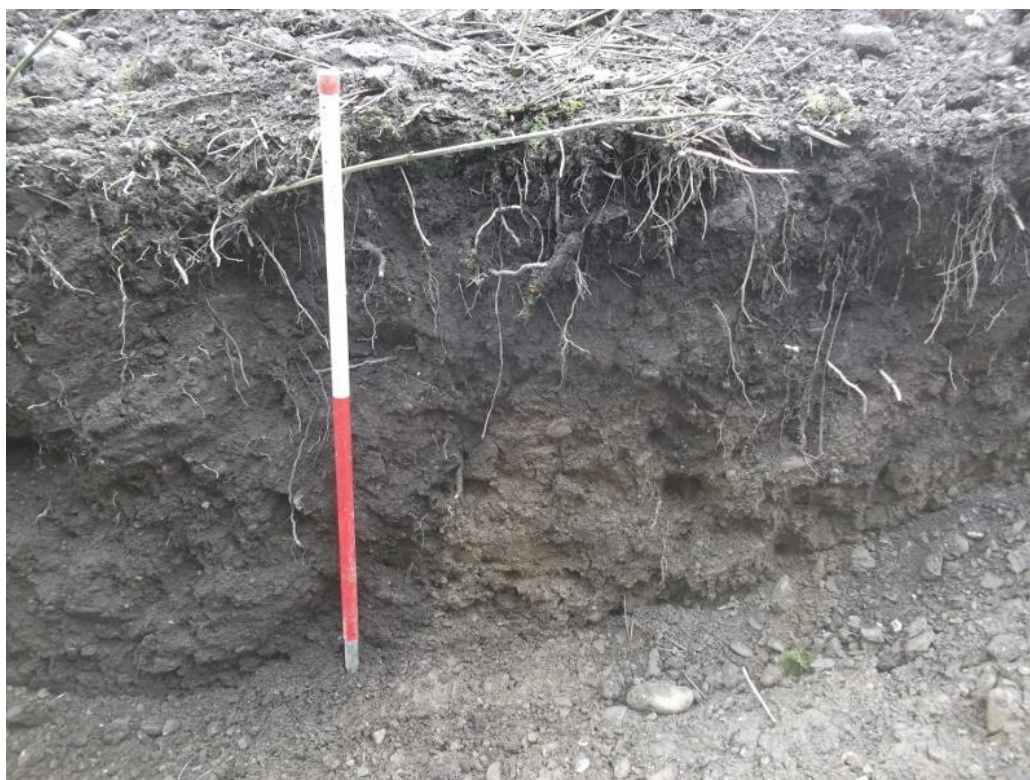
**Figure 9**  
**North facing section of Trench 5, showing cut of quarry pit [505].**

The topsoil (501) subsoil (502), and natural (503) in this trench were very similar in colour and consistency to those in Trenches 3 and 4. As well as this a further quarry pit [505] was located in Trench 5, at the eastern end, which had also been backfilled with 19<sup>th</sup> century rubbish (504) (Figure 9), though with a higher concentration of 18<sup>th</sup> century CBM than the quarry pit in Trench 3, possibly indicating the demolition of a nearby structure. A 1.3m wide north – south aligned V-shaped ditch [507] was found (Figure 10), which had been filled with a 0.5m deep mid grey brown silty clay (506) with frequent sub-rounded pebbles, though no finds were retrieved from this context.
