Cambridge Court (The Hollies), Ellesmere, Shropshire

Archaeological recording of historic garden features SLR Ref : 406.04362.00001

May 2013

Gordon Mytton Developments Ltd

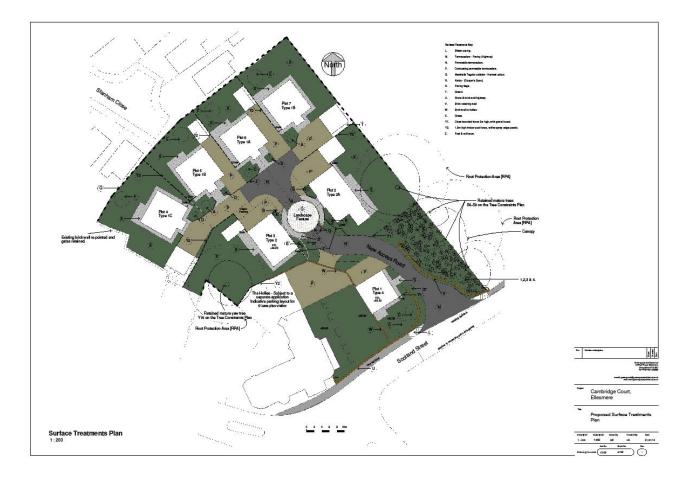
Figure 2 Scheme design

Development of Cambridge Court was begun at the end of April 2013, and involved demolition of the property boundary wall along Scotland Street, the excavation of service trenches and creation of an access road to 700mm depth, ground reduction and landscaping (Figure 2). While the site was still being set up, but after vegetation had been cleared, an archaeologist attended site on 1<sup>st</sup> May to record the historic garden features.

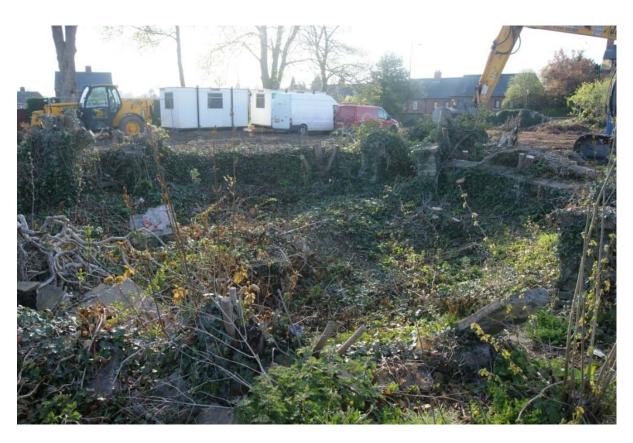
The sunken garden (Figure 3) measured 12.5m in diameter and was 0.87m in depth, defined by a wall of irregularly coursed sandstone slabs, 0.2-0.8m length, 0.35m width and 0.2m thick (Plates 1 and 2, Drawing 1). The wall was probably of dry-stone construction originally, but earth and modern cement were noted as bonding material in places, and the wall had been capped with cast concrete. It was founded on broken brick mixed with concrete to a depth of 0.25-0.30m, set into a brown sandy-silt subsoil, above the natural orange sand.

Plate 1: Sunken Garden during clearance of vegetation

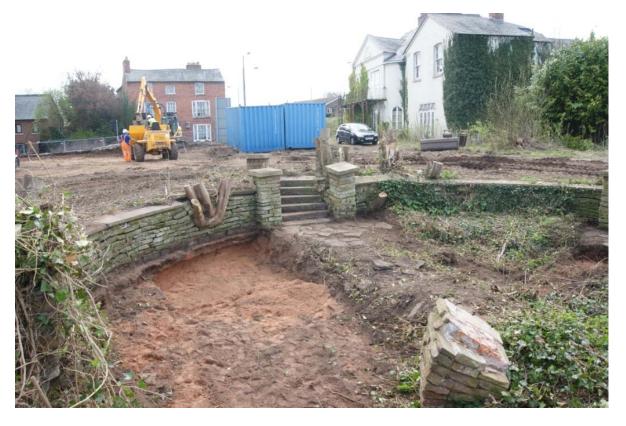
Plate 2: Sunken Garden after removal of vegetation and archaeological investigation

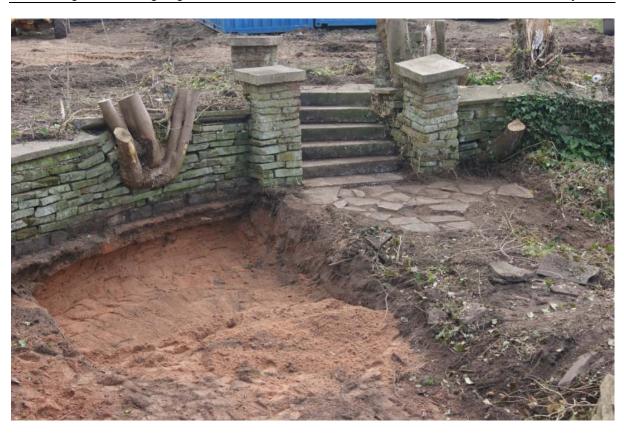
The design of the sunken garden was circular with opposing entrances to the north-west and south-east (Drawing 1). These consisted of six steps, the top two of stone, and the basal four steps cast concrete (Plates 3 and 4). Dimensions were 1.3m length, 0.36m width, with 0.16m between steps. The steps were arranged with a slight curve down to the garden, and the steps were flanked by a pillar on each side at the top and base, constructed in a similar style to the coursed stone wall of the garden feature. These pillars were capped by square cast concrete blocks. The pillars were 0.7m high at the top of the steps, and c.1.3m high at the base.

Plate 3: Sunken Garden wall, foundation, raised path and steps looking southwest

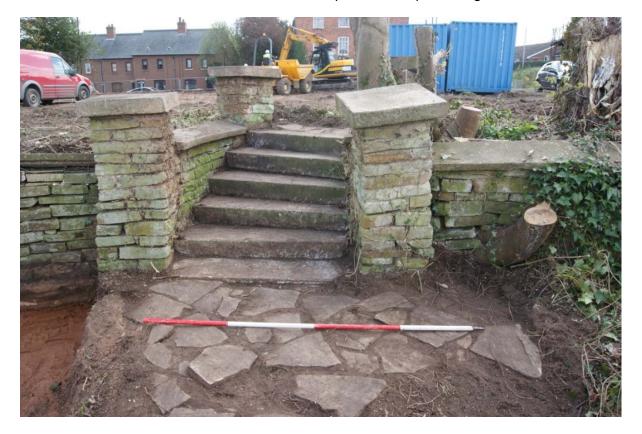
Plate 4: Detail of steps and path construction

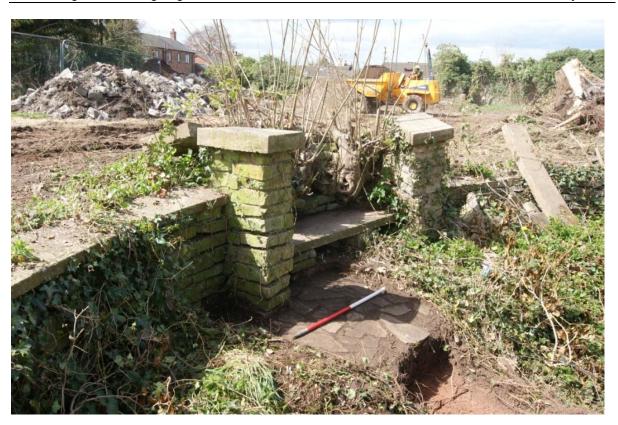
Two benches were part of the sunken garden in opposing directions, set into the main wall on the south-western and north-eastern sides. These consisted of a single sandstone slab each 2.0m by 0.5m, and 0.10m thick. The front of the benches were supported on two pillars each of which were three courses of sandstone high, 0.25m, and were 0.50m x 0.32m in dimension (Plates 5 and 6).

Plate 5: Bench on north-western side of Sunken Garden

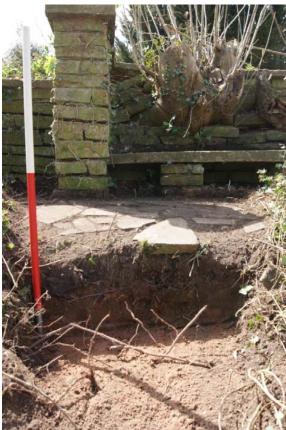
I Plate 6: foundations for bench

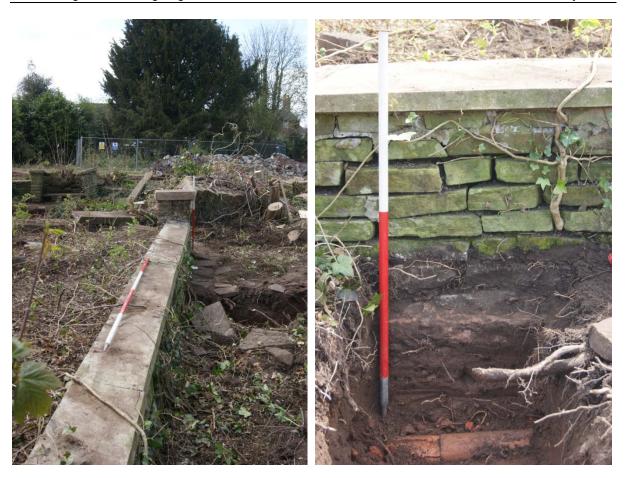
Built in the same style as the sunken garden wall, a retaining wall ran north-eastwards from the sunken garden (Figure 3, Plate 7). It was 7.8m in length, 0.32m wide, and 0.7m high constructed of roughly squared sandstone slabs and concrete. Two courses of stone had been laid into the brown sandy-silt subsoil as a foundation above natural sands (Drawing 1). Two sandstone steps connected the retaining wall with the top of the sunken garden. The top one was 0.75m in length, 0.3m wide, and 0.2m high, the bottom one was 1m in length, 0.3m wide, and 0.15m high (Plate 8).

A path followed the retaining wall along its north-western side. It was constructed in the same fashion as the paths within and around the sunken garden. Beneath it a ceramic drainage pipe was detected at c.0.4m below the garden surface (Plate 7).

Plate 7: Retaining (dividing) wall looking southwest, and foundations looking east

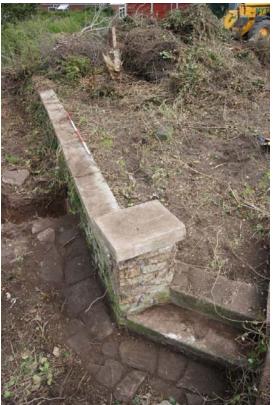
Plate 8: steps down from retaining wall on to path
